U.S. Department
of Transportation
**Federal Aviation
Administration**

ADVISORY CIRCULAR

AVIATION MAINTENANCE ALERTS

**ALERT
NUMBER
345**

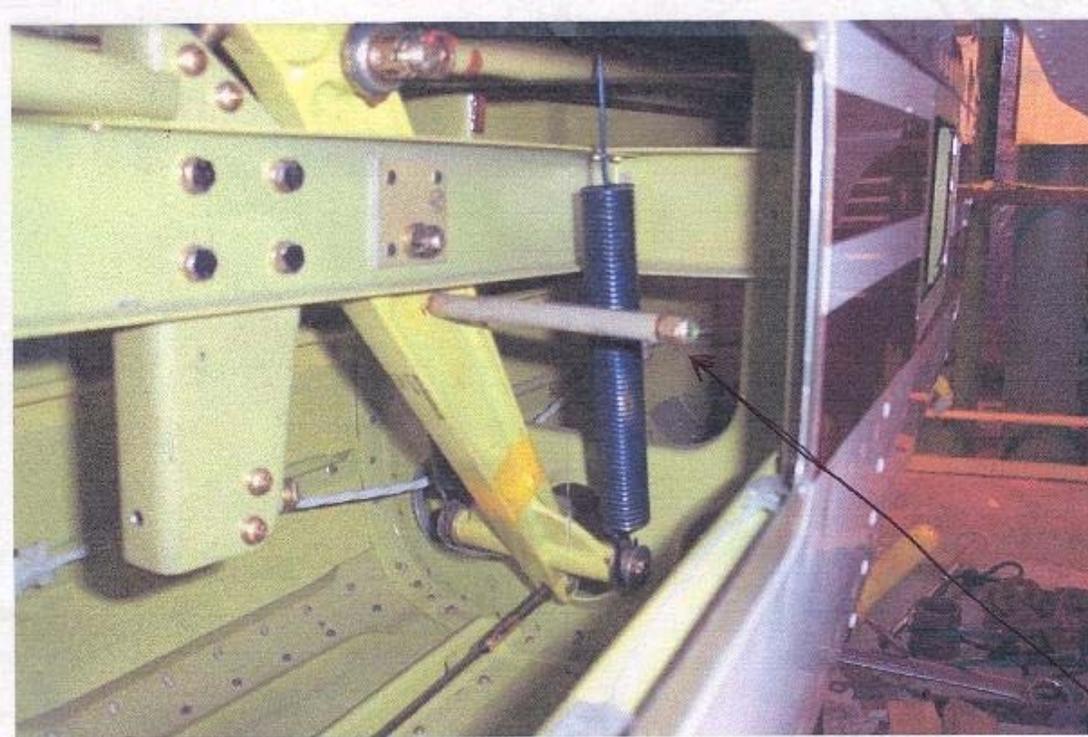
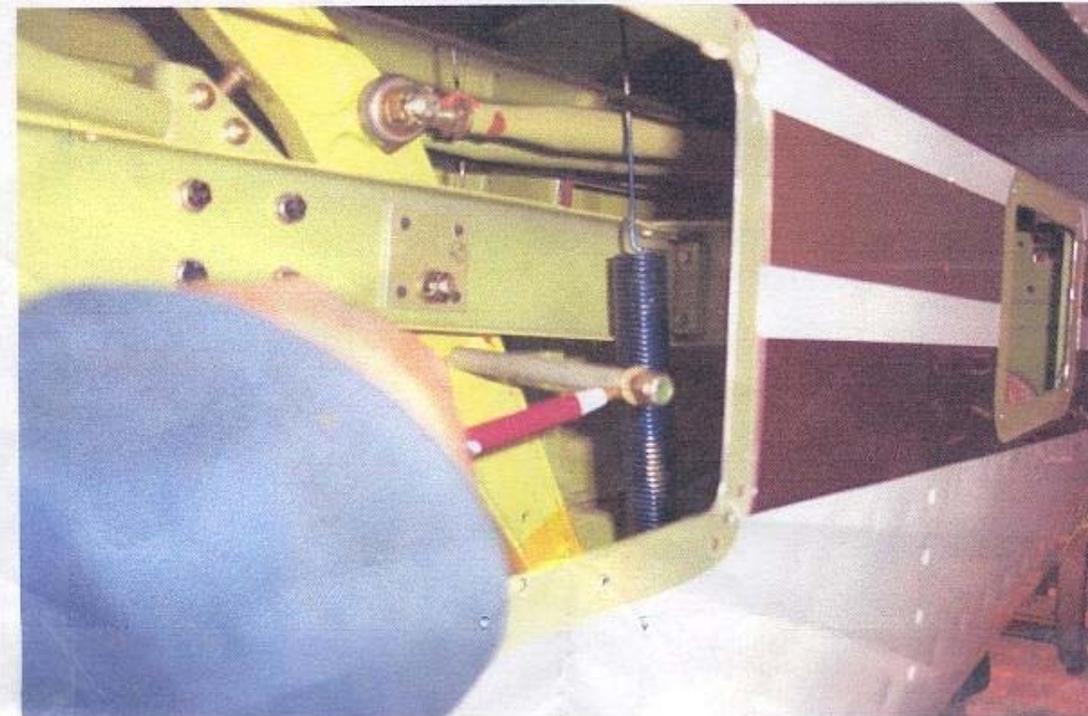
Beech: A36; Loose Auto-Pilot Connecting Rod, ATA 2730

A submitter writes, "The auto-pilot hook-up rod should be tightened up or removed from the aircraft at the factory. This is the second aircraft in one week (*in which*) this rod (*and/or its attachment nuts*) has been found loose...." (*Elevator control bell crank P/N: 002-524024-51.*)

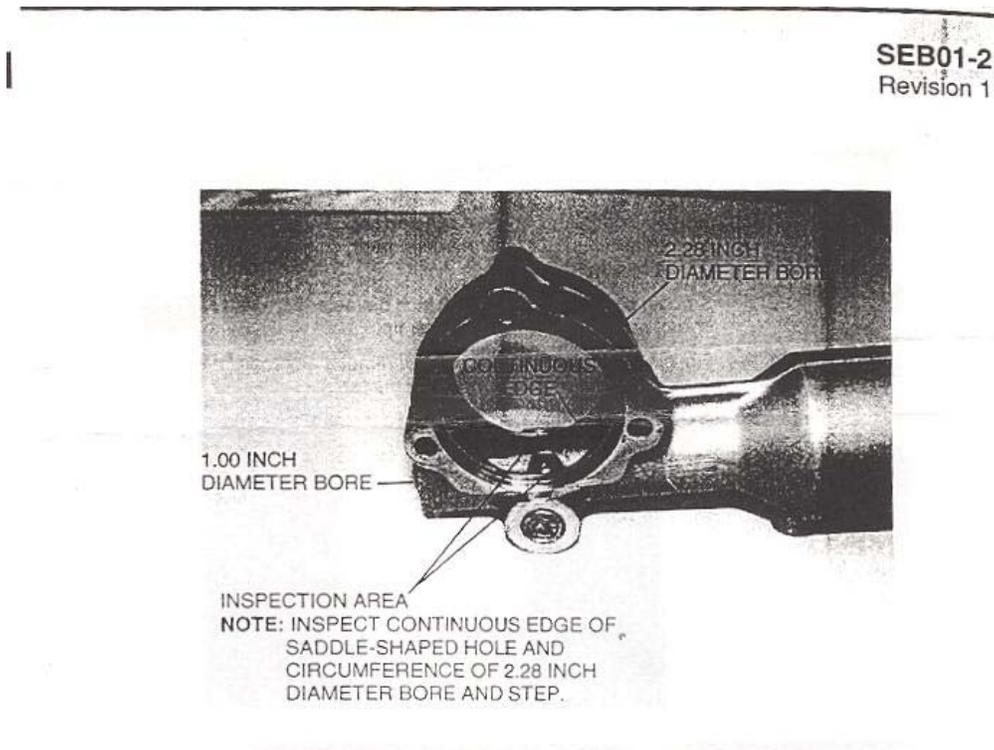
FIGURE 1. MAIN LANDING GEAR ACTUATOR INSPECTION

“While complying with Service Bulletin number SEB01-2 R1,” writes the submitter, “I found the large bore (of this actuator) cracked (see attached illustration).” (Provided actuator P/N: 9882015-2. See January 2006 Alerts for a more thorough description of this same defect.)

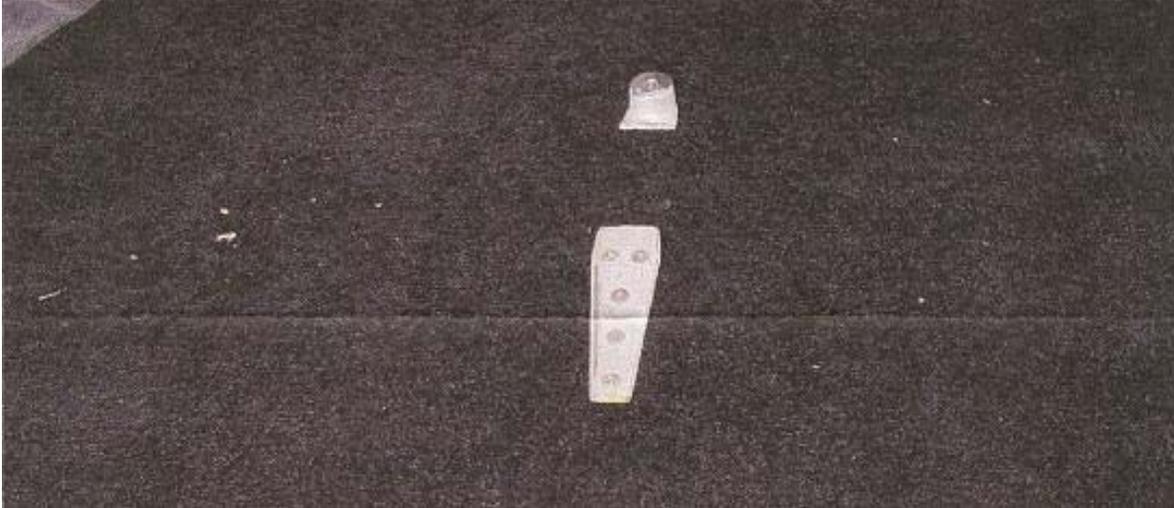
Cessna: T207A; Broken Horizontal Stabilizer Attach Fitting; ATA 5340

A repair station technician states, “The pilot found the horizontal stabilizer loose on preflight. Maintenance inspected and found the R/H forward attachment fitting broken. (I) replaced both forward fittings (P/N 1232013-2F) with new parts.” *(A search of the FAA Service Difficulty Reporting System data base revealed five additional entries for the part’s base number.)*

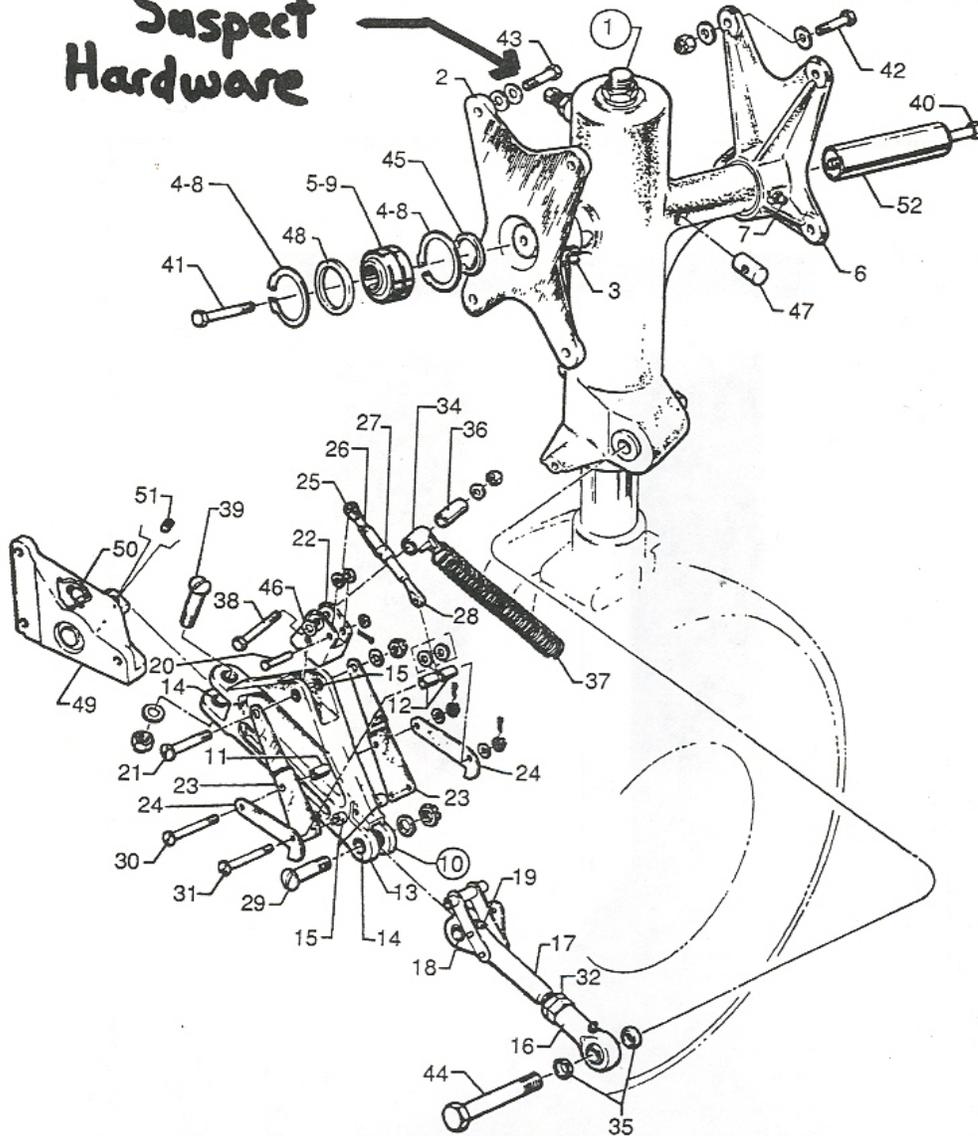
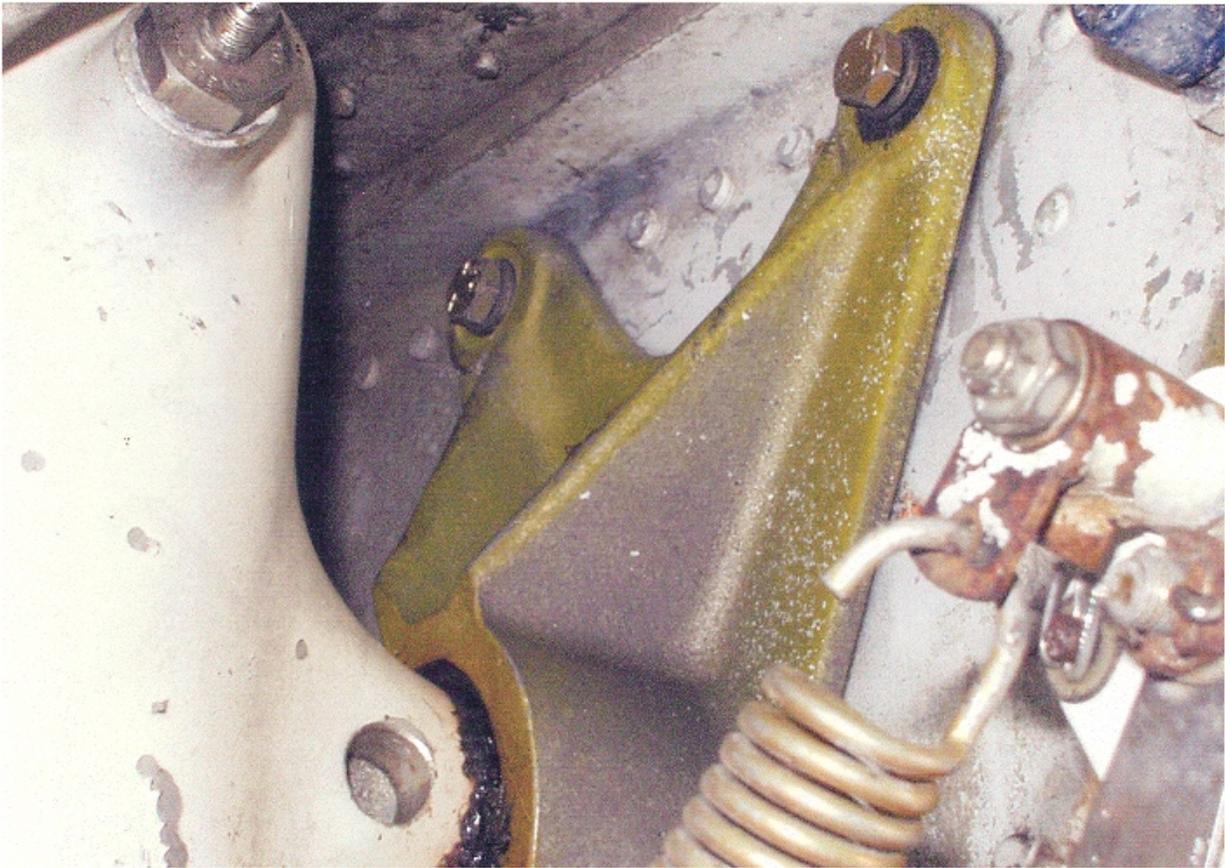
Figure 27. Main Gear Installation

This description is written by a mechanic who also functions as the Director of Maintenance for his operation. “The main landing gear pivot casting (forward trunnion fitting assembly) attach hardware continually comes loose, allowing chaffing between the casting and the wing spar—enlarging the attach bolt holes in *(both)* the casting and the spar. The effected L/H casting had been previously removed, inspected, and installed per the Piper maintenance for this *(specific)* reason only 100 hours prior to this *(second)* occurrence. This condition had been noted on the R/H casting at the same inspection and had been corrected by replacing the casting. *(The attachment holes)* in the casting and spar were reamed to accept AN5 bolts rather than the original AN4. The original nut-plates on the forward side of the wing spar (MS21047) do not seem to adequately accept the stresses imposed

**Suspect
Hardware**

on them and are likely the leading factor in the continual loosening of the casting. *(They)* were replaced with MS21078-5 nut-plates which provide more strength and *(apparently)* prevent the attach bolts from loosening. We operate a fleet of PA34-200, -200T, and -220T Senecas. The-200 and -200T *(aircraft)* have exhibited the same tendency regarding the loosening of the forward pivot casting attach hardware. *(I)* suggest inspecting the pivot casting attach hardware regularly and replacing hardware as stated above.”

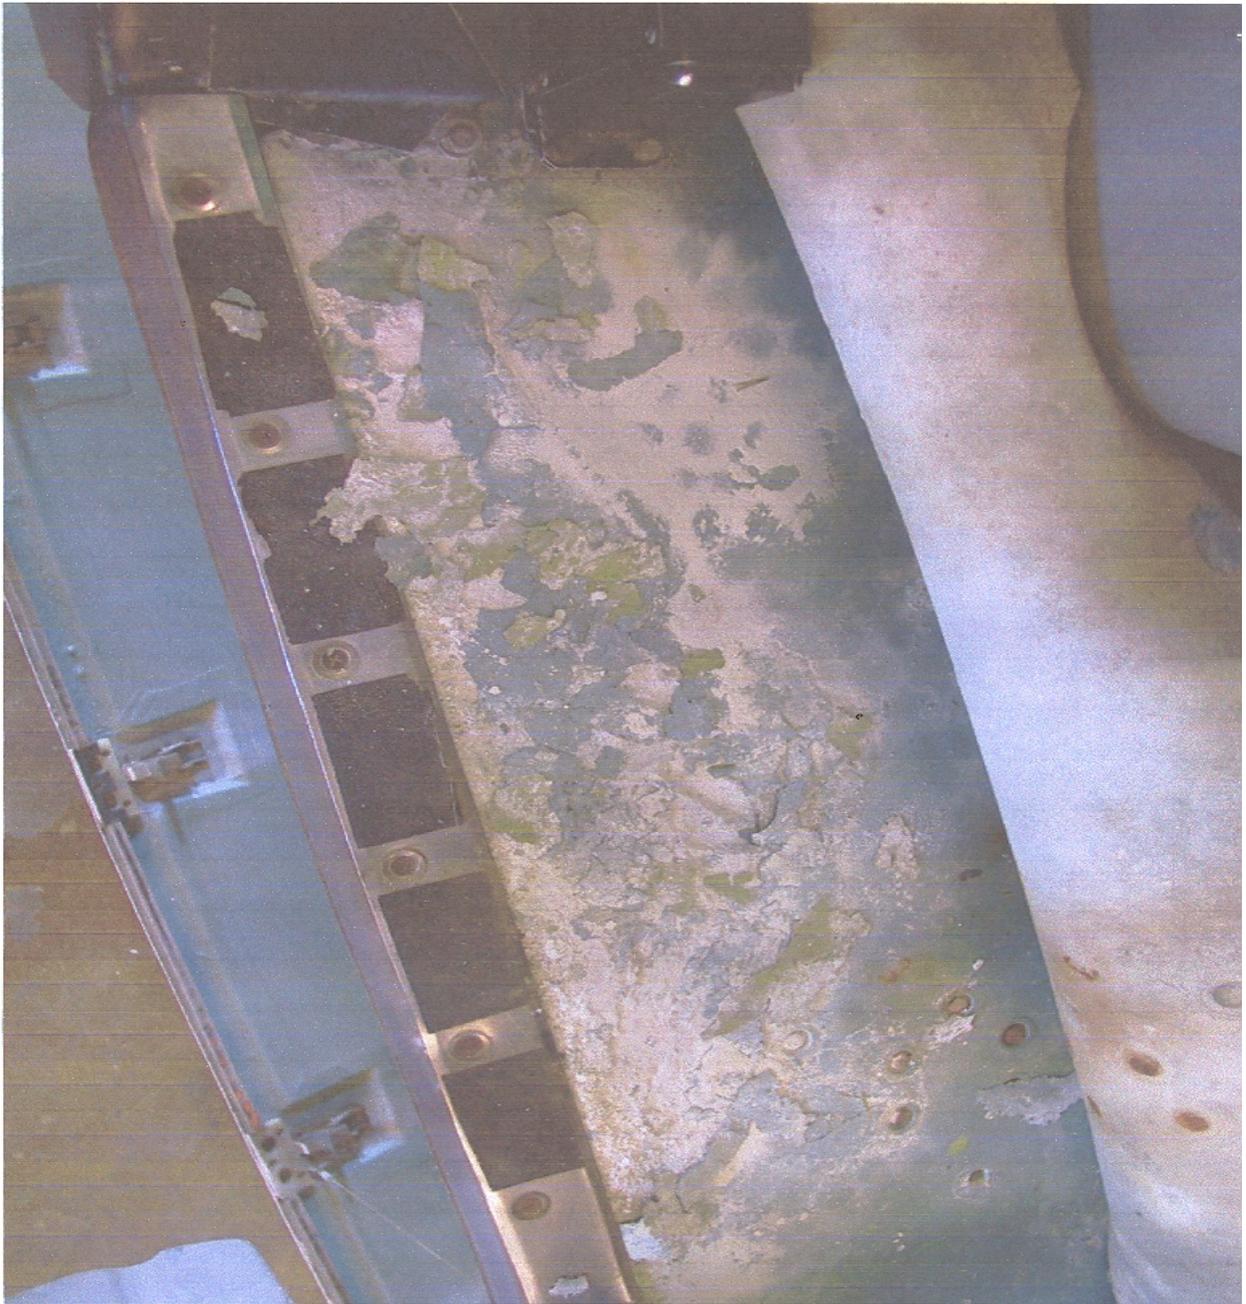
Aerospatiale: SA365N1; Corroded Floor Panels; ATA 5321

A repair station submitter writes, "During a pre-buy inspection, the Loncoin rubber mats were pulled up from the cockpit floors. Under the pilot's side of these mats major corrosion accumulation was discovered. These mats were still damp underneath, (*indicating*) why this corrosion existed. We suspect salt laden water from the pilots feet during winter operations contributed to this corrosion. The rubber mats allowed the moisture to penetrate, but would not let it dry. This floor panel (*P/N 365-21-0059-0501*) is completely destroyed and must be replaced. More stringent cleaning and inspection (*procedures*) must be practiced in (*such*) environments."

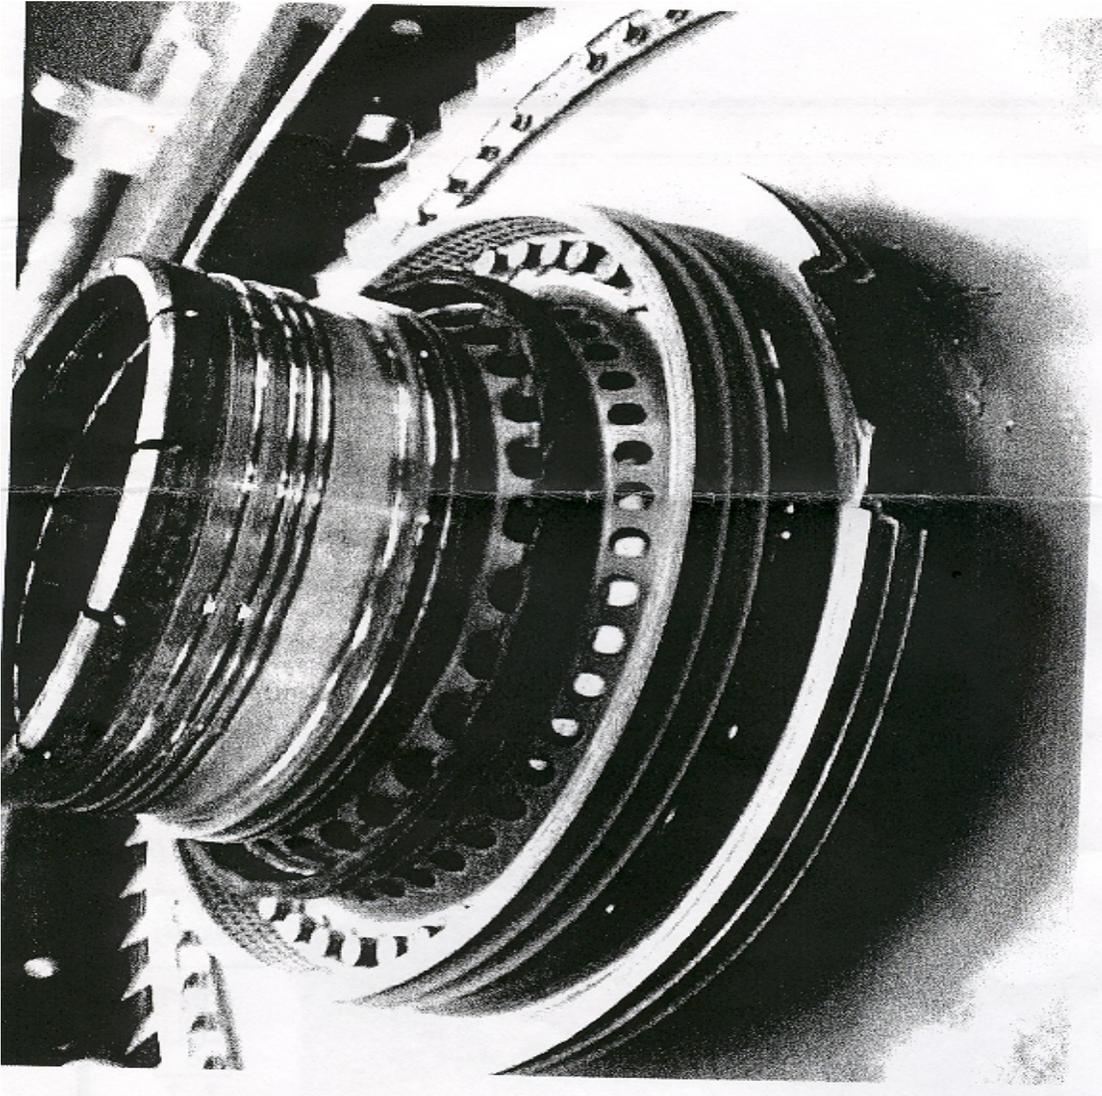
CFM: 56-3CI; Failed HP Turbine Shaft-Seal Rack Structure; ATA 7250

“A Boeing 737...suffered an aborted take-off,” states this submitter. “Investigation revealed failure and liberation of the HPT (*high pressure turbine*) rear shaft where a section of material measuring 3.5 inches of circumference had liberated around the three seal tooth rack. Similar failures have been experienced on the CFM56-3 engine. The parts were returned to CFM for investigation. (*Shaft P/N: 9514M71P04.*)

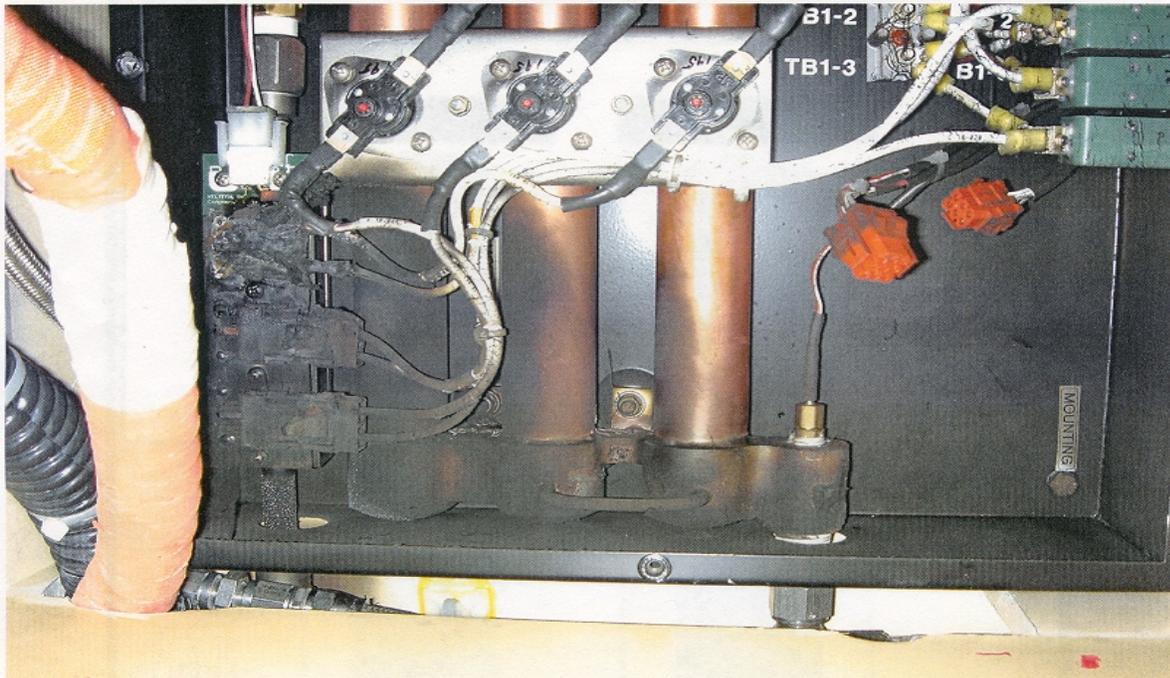
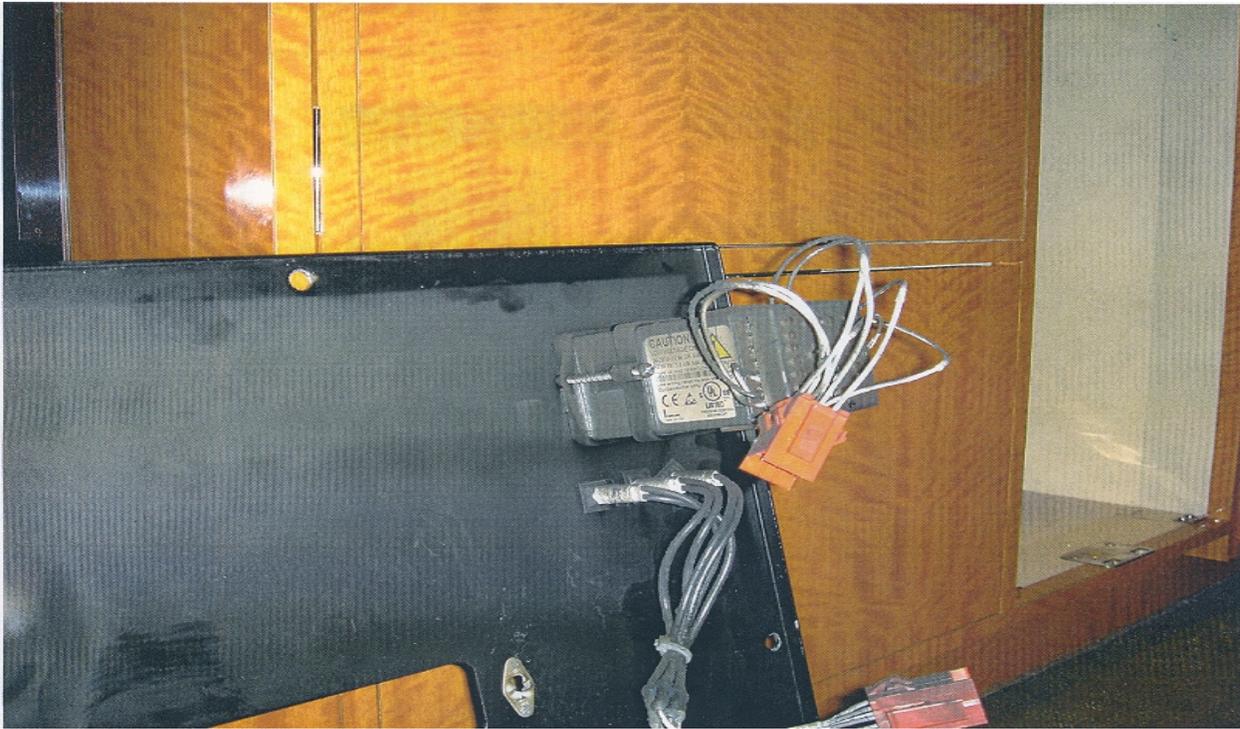
Keltech Water Heater: ES7.1-183/206-400DK; Failed Fire Protection; ATA 3820

A repair station submitter states, “The flight attendants complained about no hot water at the galley sink shortly before landing, after a transatlantic flight. Once on the ground, maintenance personnel exposed the water heater and got a heavy burned smell. Once they removed the false panel covering the water heater, they noted no circuit breaker either on the unit itself or on the galley circuit breaker panel had tripped.

“They decided to look at the inside of the installed unit to see if there was something they could repair. It looked as though there *(had been)* a fire inside the unit. It *(had)* burned itself out and no external damage was done. Prior to the opening *(of the heater enclosure area)* there was no smell anywhere in the galley from the fire and no circuit breakers *(had been)* tripped. The unit was removed from the aircraft and sent to the manufacturer for teardown and troubleshooting—to find the cause *(of the fire)*—and to repair this water heater. No reason or cause has been found at this time. This water heater is installed in an aircraft with a VIP interior under an STC *(supplemental type certificate)*. These units have been installed in a variety of VIP interior installations by several completion centers throughout the world.”

(The unit is described as a Keltech Water Heater, P/N ES7.1-183/206-400DK. The pictures are dramatic—period.)

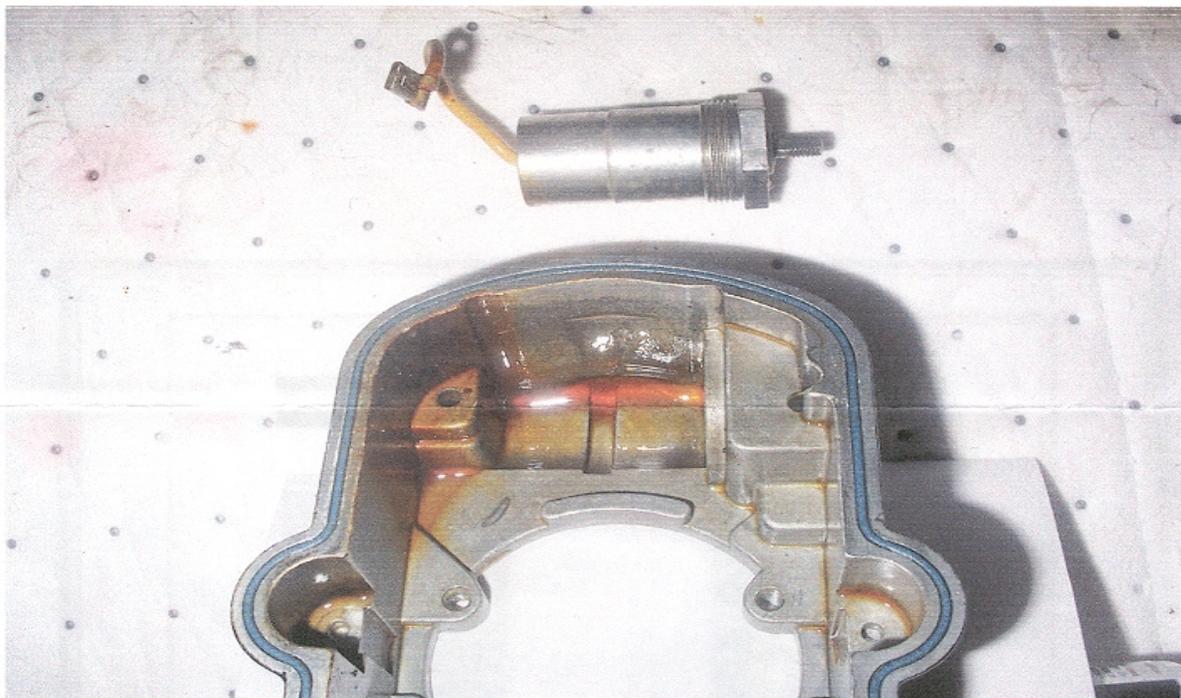
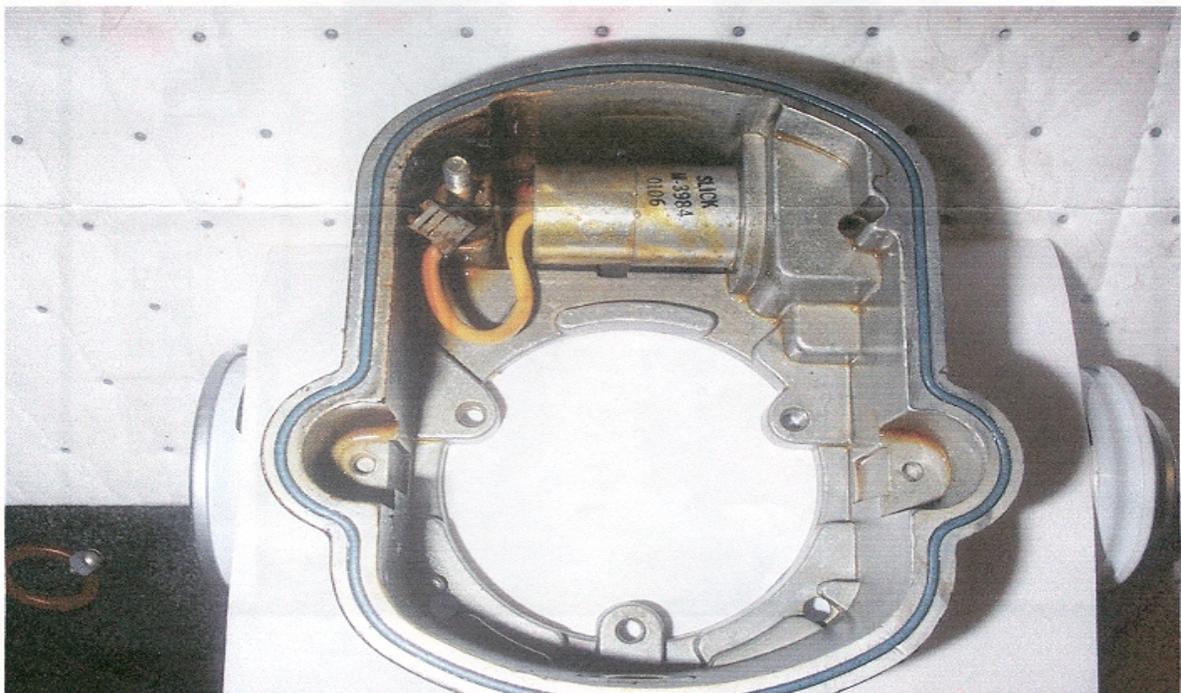
Slick Magneto: 6361; Leaking Capacitor; ATA 7414

A repair station technician states, “(I) opened the pressurized magneto to inspect for corrosion during an annual inspection *(and found)* a large amount of oil in the aft case *(housing)*. Further investigation revealed *(this oil)* to be dielectric fluid from the capacitor. (I) tested the capacitor with a Simpson meter and found it to have failed. Magneto failure *(was probably)* imminent due to oil contamination to the points and distributor. (I) suggest inspection of all magnetos containing this part number capacitor (P/N M-3984) before further flight.”
