ADVISORY CIRCULAR

43-16A

AVIATION MAINTENANCE ALERTS

**ALERT
NUMBER
381**

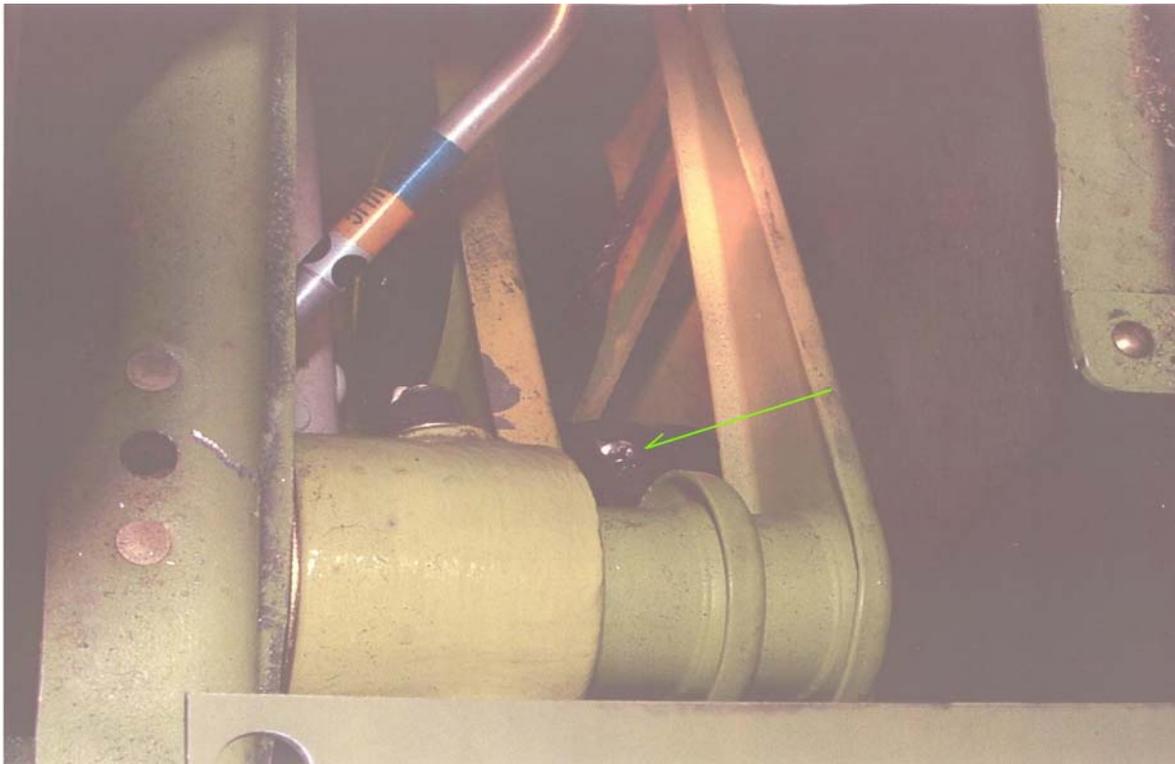
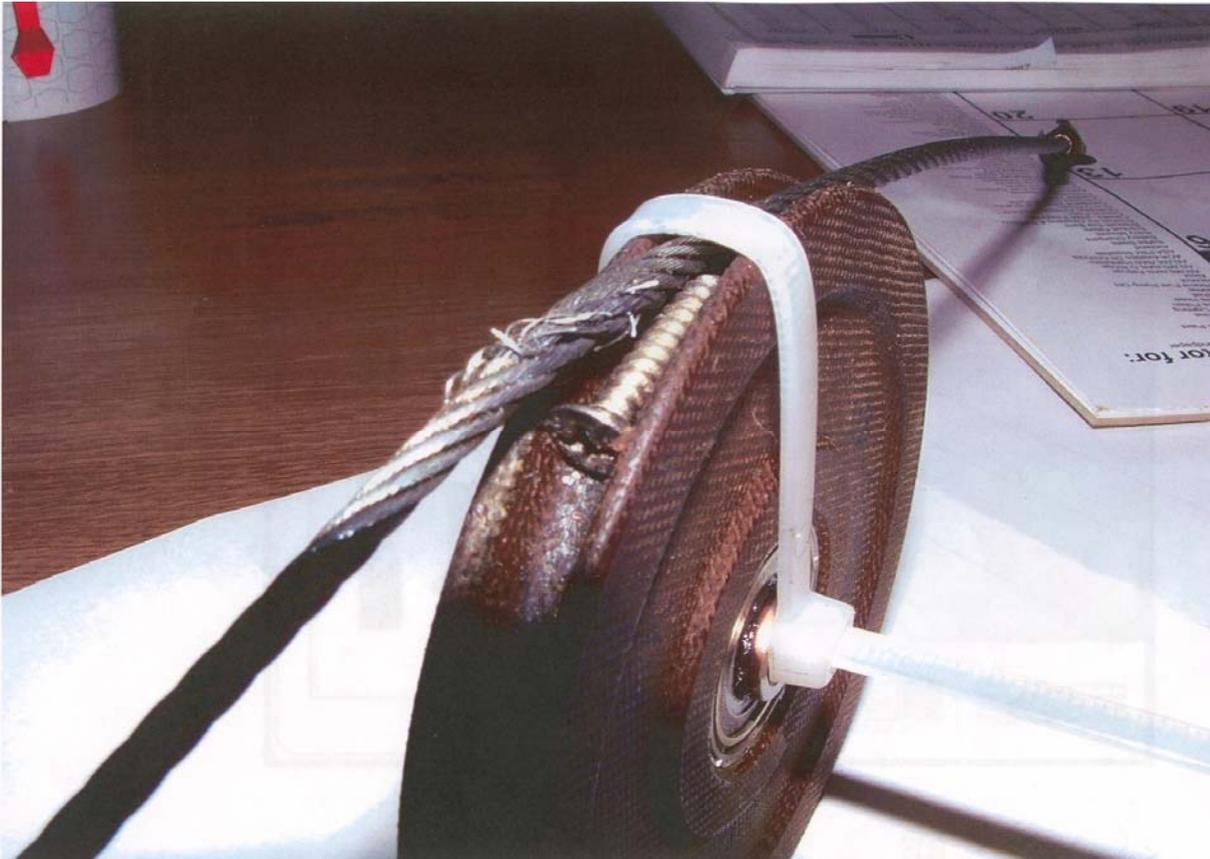
Beechcraft: A36; Jammed Aileron Control Cable; ATA 2710

A repair station submitter writes, "During a pre-purchase inspection, (I) found the control yoke binding when turned to the left approximately 45 degrees. I inspected the aileron control system and found a screw lodged in a pulley groove—and the cable damaged. This aircraft had flown 2.0 hours since the last annual inspection. The screw appeared to be a floor panel screw."

(Aileron cable P/N: 106-524044-19.)

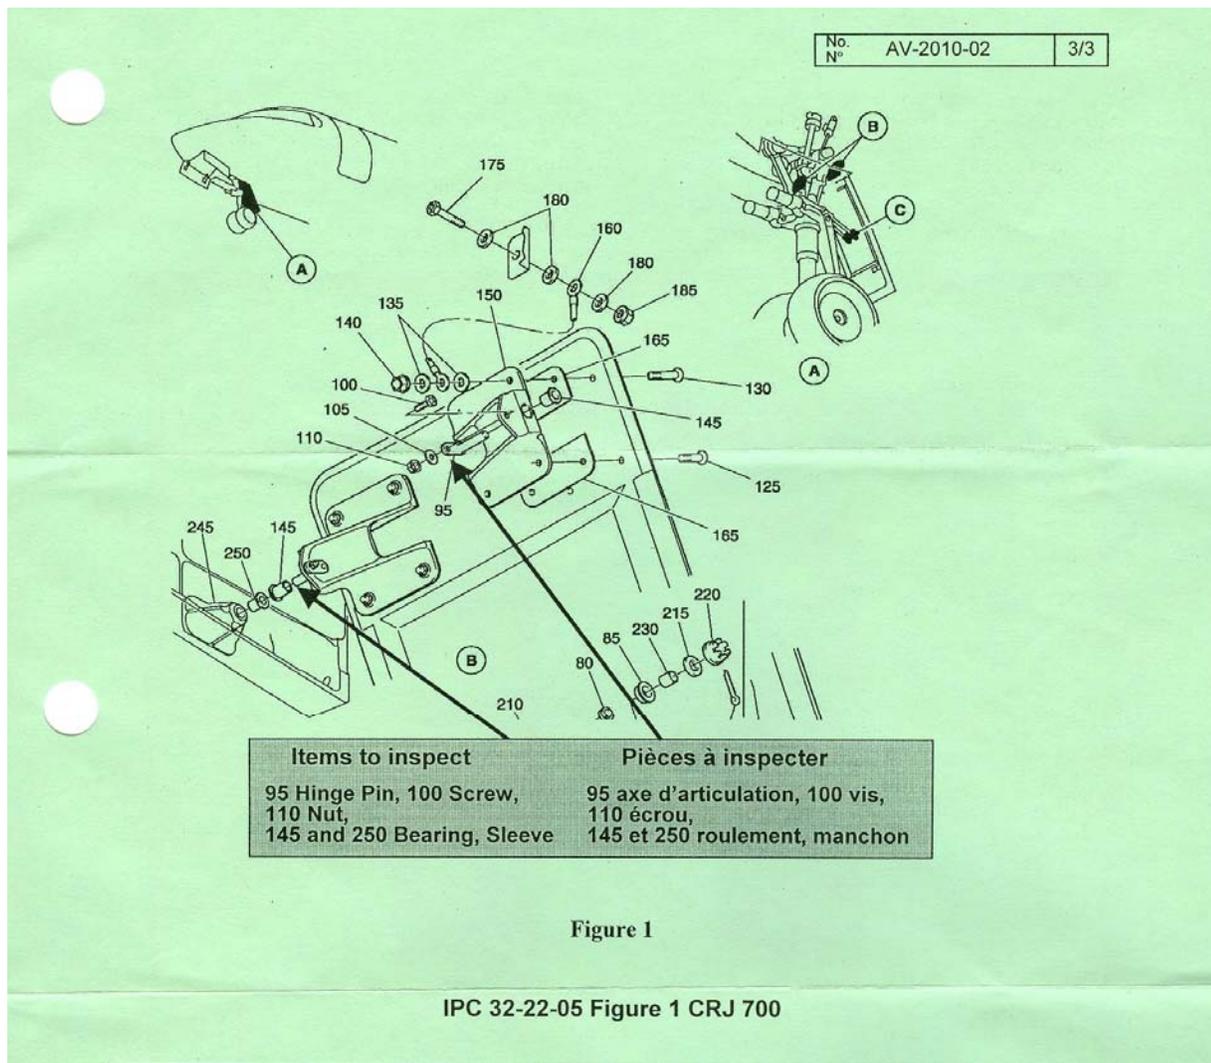
Figure 1

Transport Canada Civil Aviation (TCCA) has become aware of problems with the ANLGD upper attachment hinge assemblies. In one instance, during flight operation on a CL-600-2C10 aircraft, the landing gear extension appeared to function normally, although unusual noises were heard from the nose landing gear area. The post landing inspection revealed damage to ANLGD and to the surrounding structure. In that case, evidence suggested that one of the self-locking nuts (Refer to figure 1, Item 110), which held the hinge pin (Item 95) in place, backed out enough to cause the hinge pin to disengage. This caused the door to bind, causing damage when the landing gear extended.

While conducting this investigation, Bombardier Inc. also became aware of excessive bearing (item 145 & 250) wear on the fleet and is currently investigating this issue.

Bombardier Inc. has since revised the relevant Aircraft Maintenance Manuals (AMM) through temporary revisions recommending installation of a new nut (Item 110), each time the door is removed and reinstalled.

In the interim, TCCA strongly recommends that Operators and Maintenance Personnel pay extra attention to the upper attachment hinge assemblies for security and any abnormalities whenever maintenance is carried out around the ANLGD area.

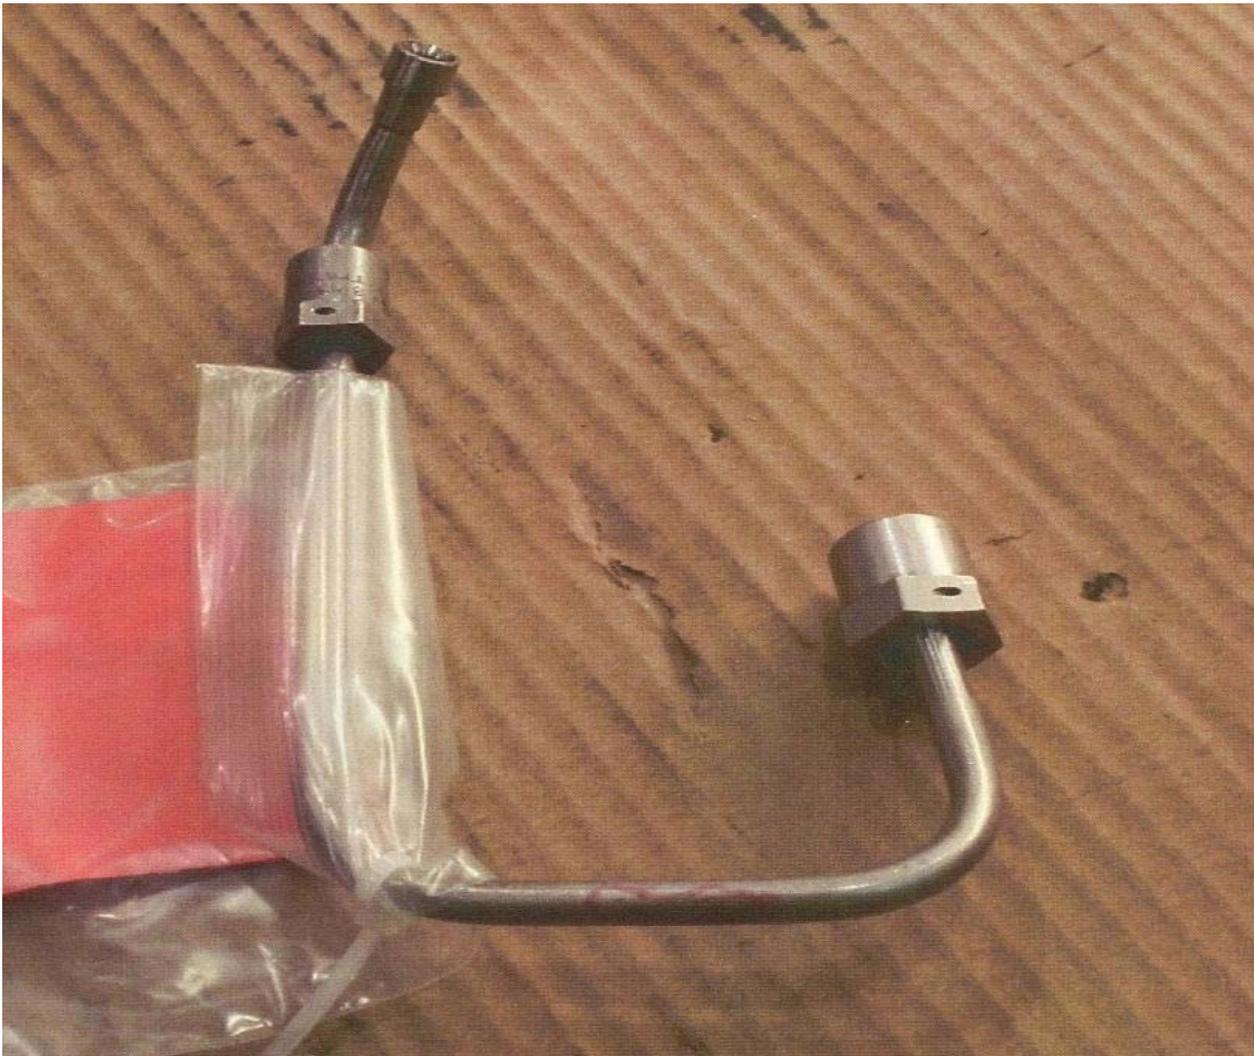
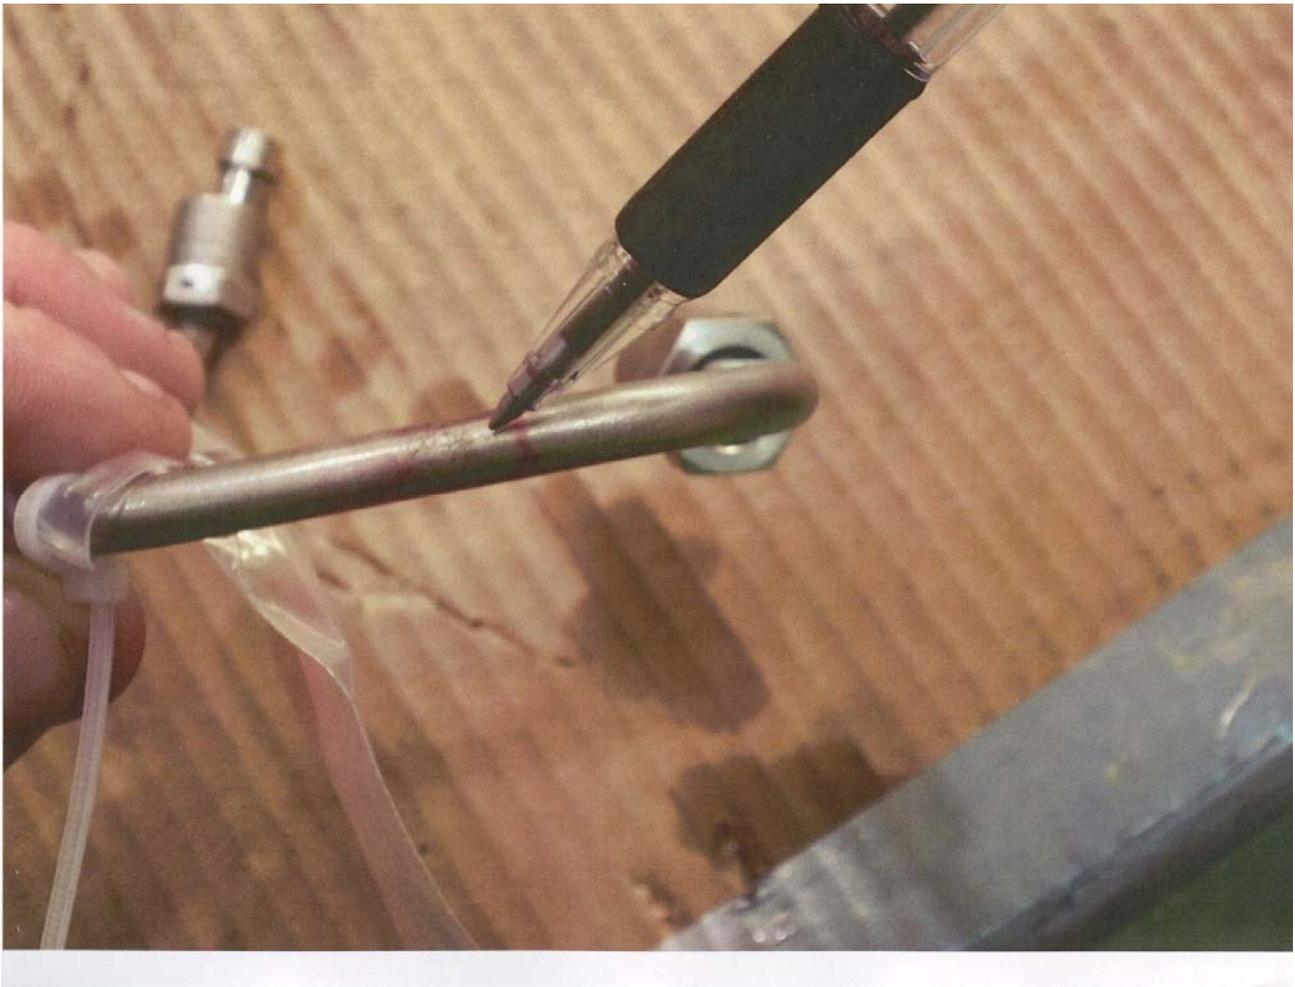
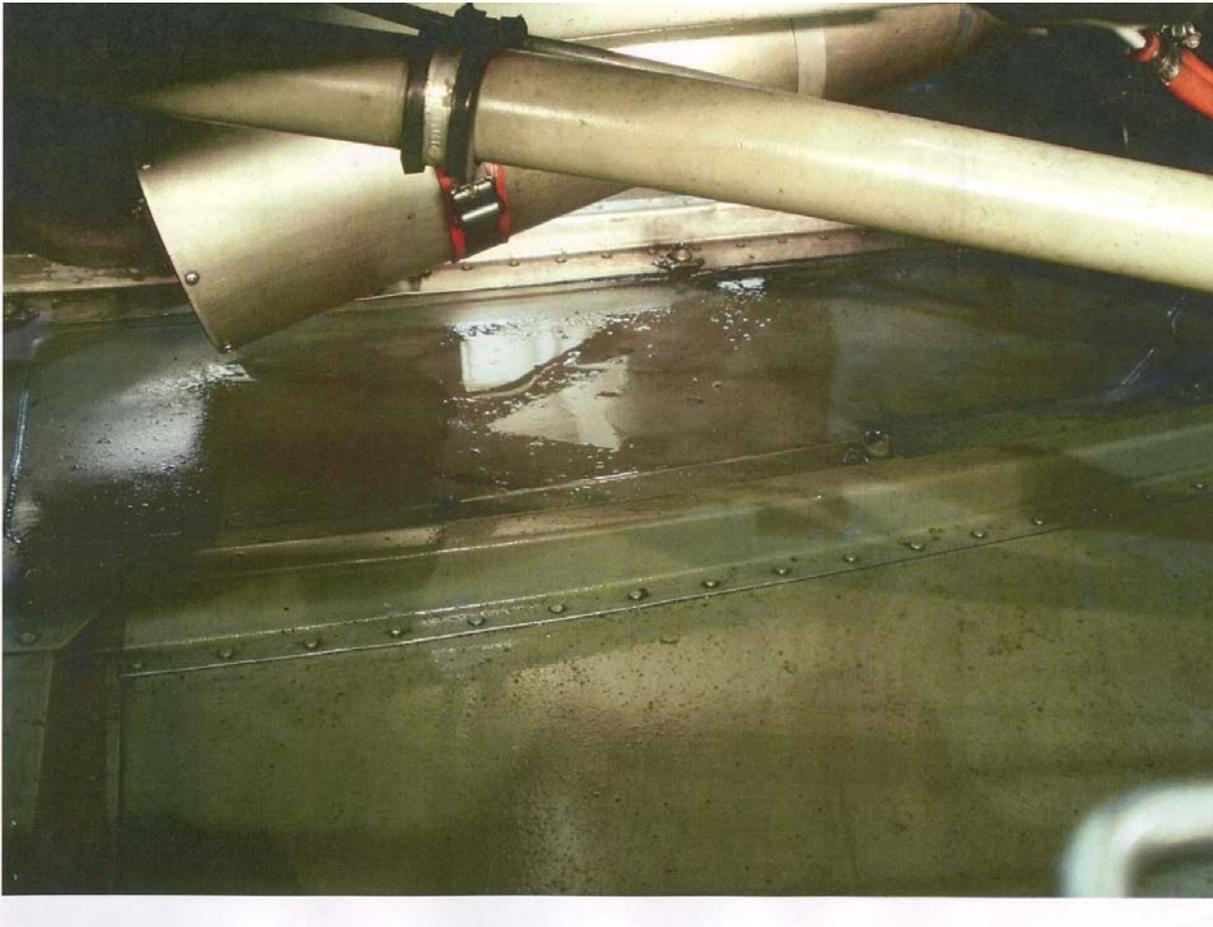
Cessna: 208B; Leaking Oil/Fuel Heater Tube; ATA 7312

A repair station technician says, "The ridged steel tube that feeds into the oil/fuel heater has developed little pin holes underneath the attached fire loop bracket. When this line is removed (*the little pin holes*) look like little dots of corrosion, but when pressurized with air it leaks at an extreme rate. The possible cause could be Adel clamp chafing or corrosion." (*Heater tube P/N: 3013446. A Pratt & Whitney PT6A-114 is attached to the nose of this aircraft.*)

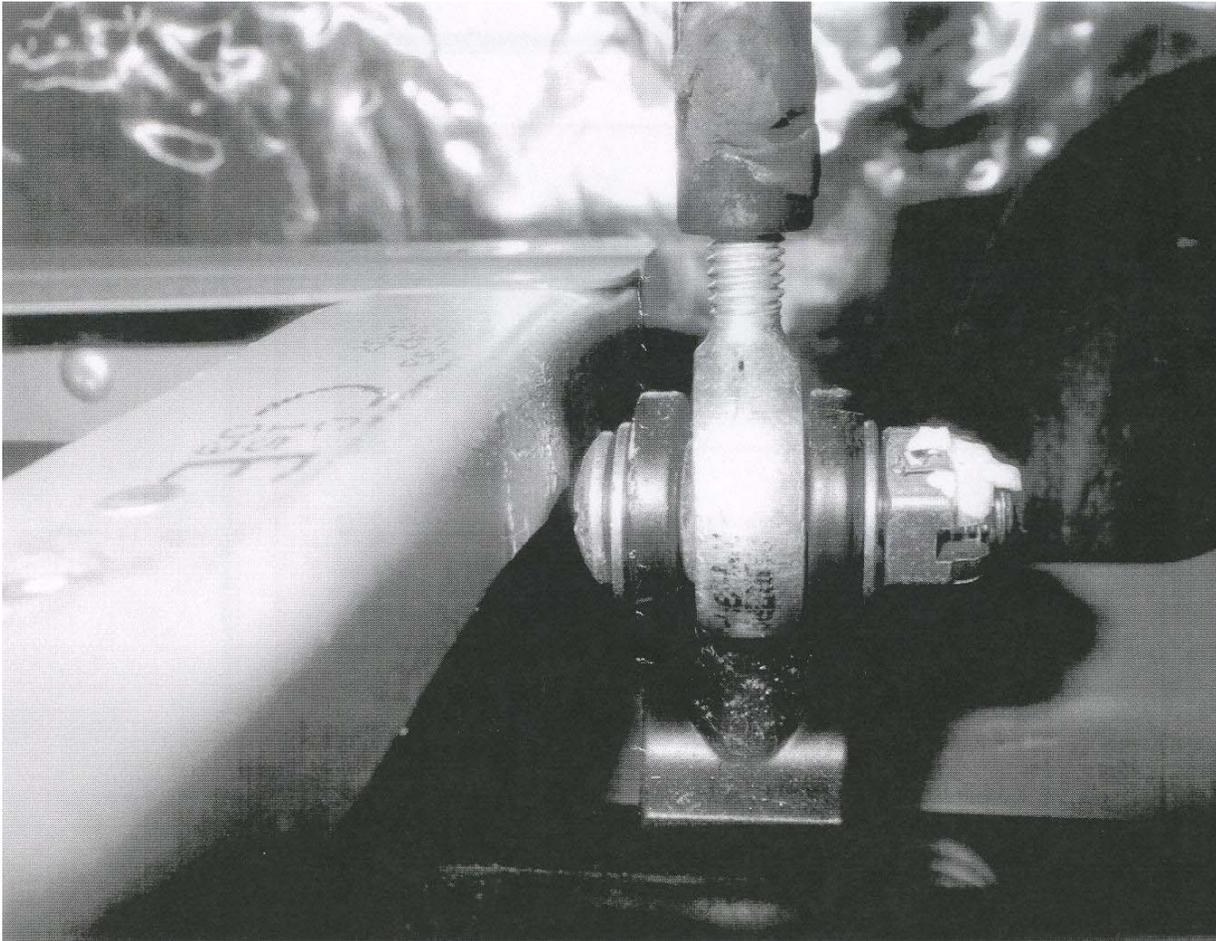
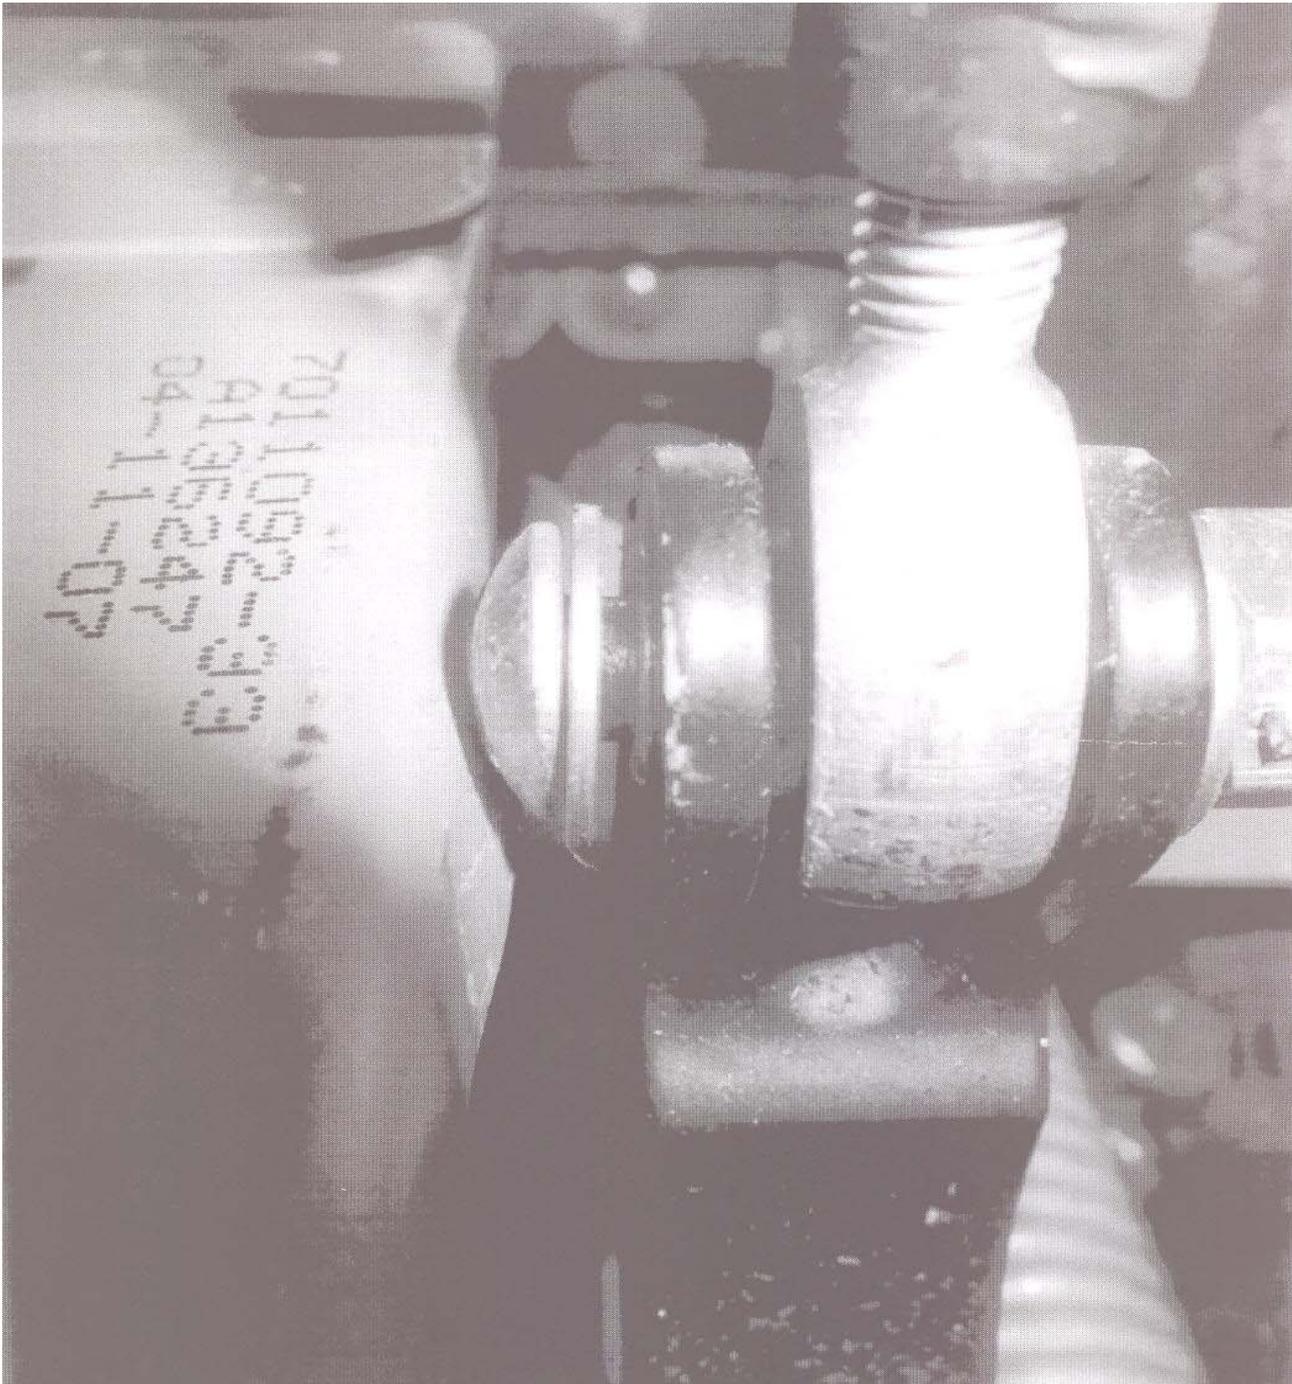
An English operator submitted this defect report, stating, "During a maintenance inspection in the area of the pilot's rudder pedals, it was noticed that the right brake pedal pushrod had (at some point) made contact with an adjacent, floor support angle, causing minor distortion to the angle's vertical flange. This condition could have resulted in the brake pedal remaining in a partially depressed state.

"Clearance from structure in this location is very limited. This condition was compounded by the fact that the bolt has lateral play due to insufficient washers being installed under the nut. The installation, however, was in accordance with the IPC (*illustrated parts catalog; 27-20-01, figure 1, item 30*)."

(The "component" P/N is provided: 7060310-3. Note also the first number in the above picture—angle part number?)

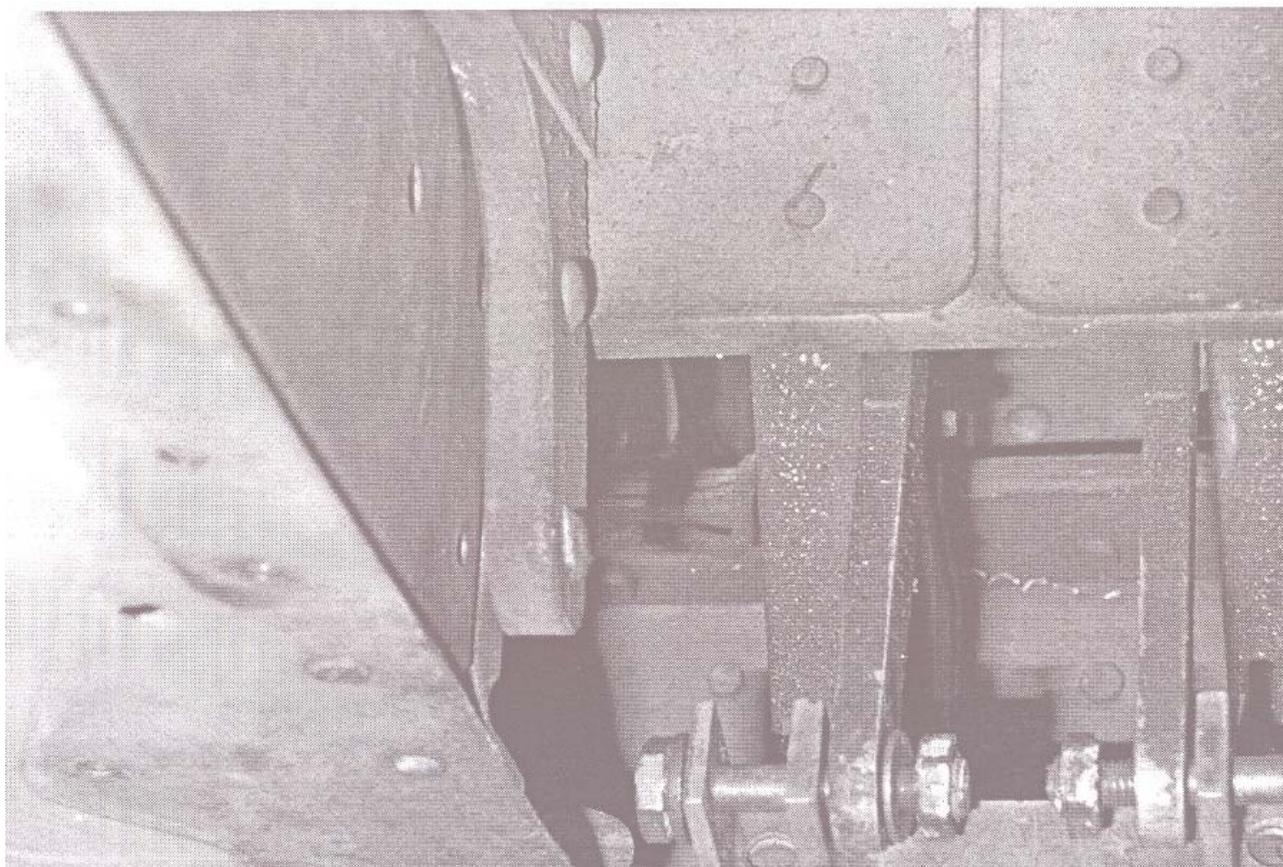
Piper: PA46-350P; Sheared Elevator Actuator-Arm Rivets; ATA 2730

"An 'inoperative elevator trim' discrepancy was found to be caused by a frayed cable jamming the trim drum," writes a repair station technician. "(I) also found the elevator actuator arm (P/N 83515-02) to be loose—(*free*) to move in all directions. All actuator arm-to-elevator rivets (except one) were sheared or loose. Since both up and down stops are on this (*actuator*) arm, we believe a jet blast or severe wind caused the elevator to hit the stops (*with damaging force*)."

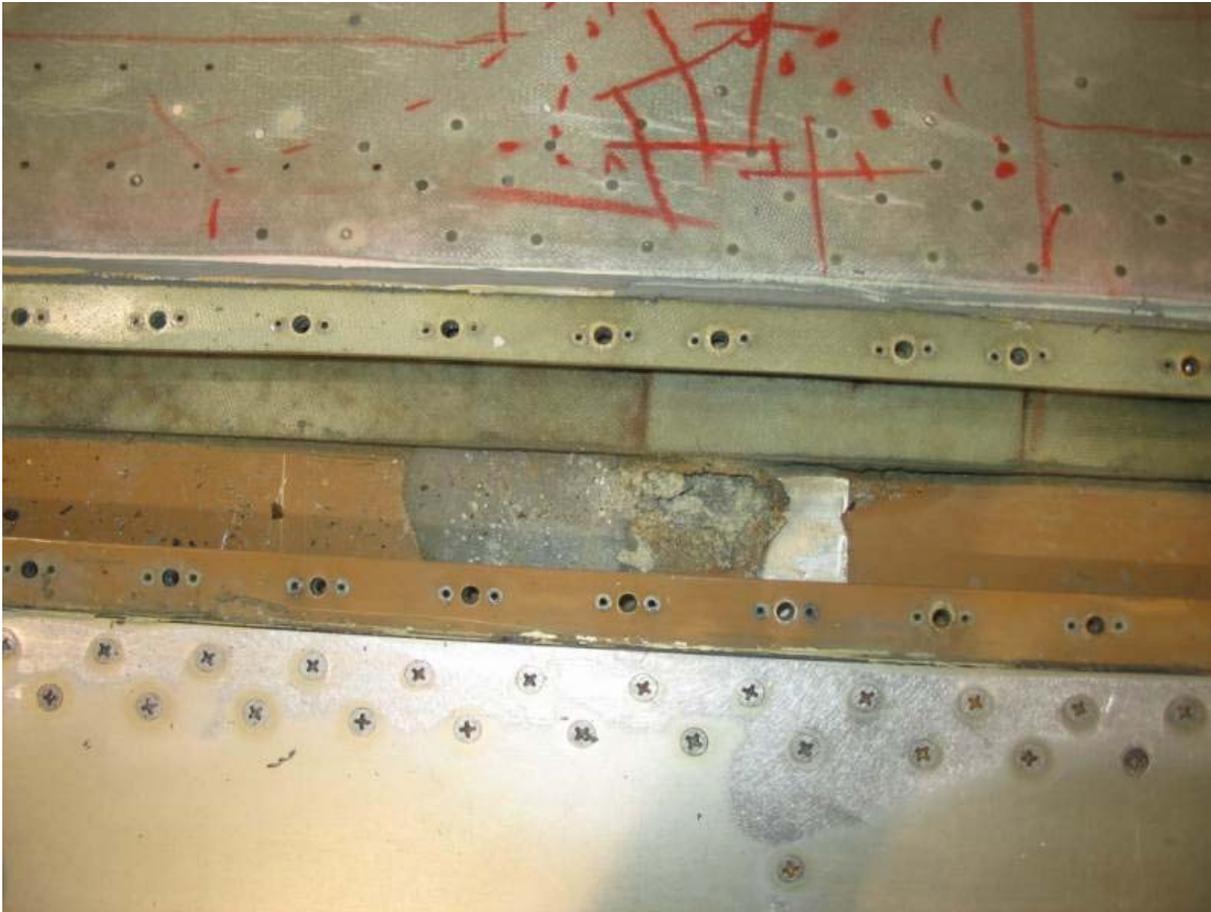
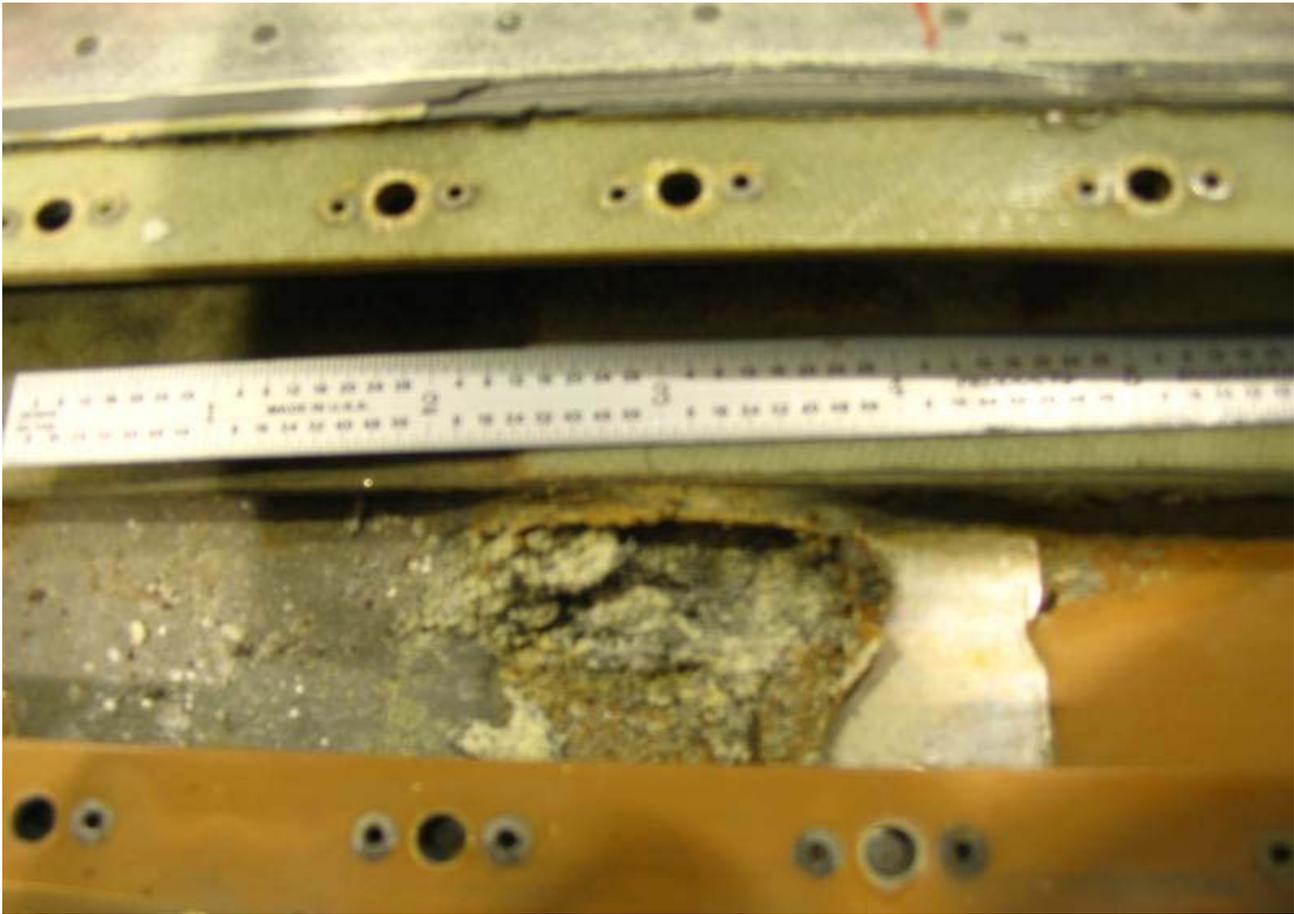
Rockwell: NA265-65; Wing Panel Corrosion; ATA 5730

An unidentified submitter writes, "While the aircraft was stripped for a paint job, a visual inspection of the L/H over-wing fairing (*revealed*) delamination. After panel removal, corrosion was found extending under the over-wing panel...(and) through the L/H wing plank at wing station 102.5—107, approximately 10.0 inches from the front spar...." (*The exfoliation corrosion covered approximately 15.0 inches.*) "This area is only inspected by visual means during a 150 hours inspection, and the wing planks are covered up by the over-wing fairings (fiberglass overlays)." (*Skin panel P/N: 3701301213.*)

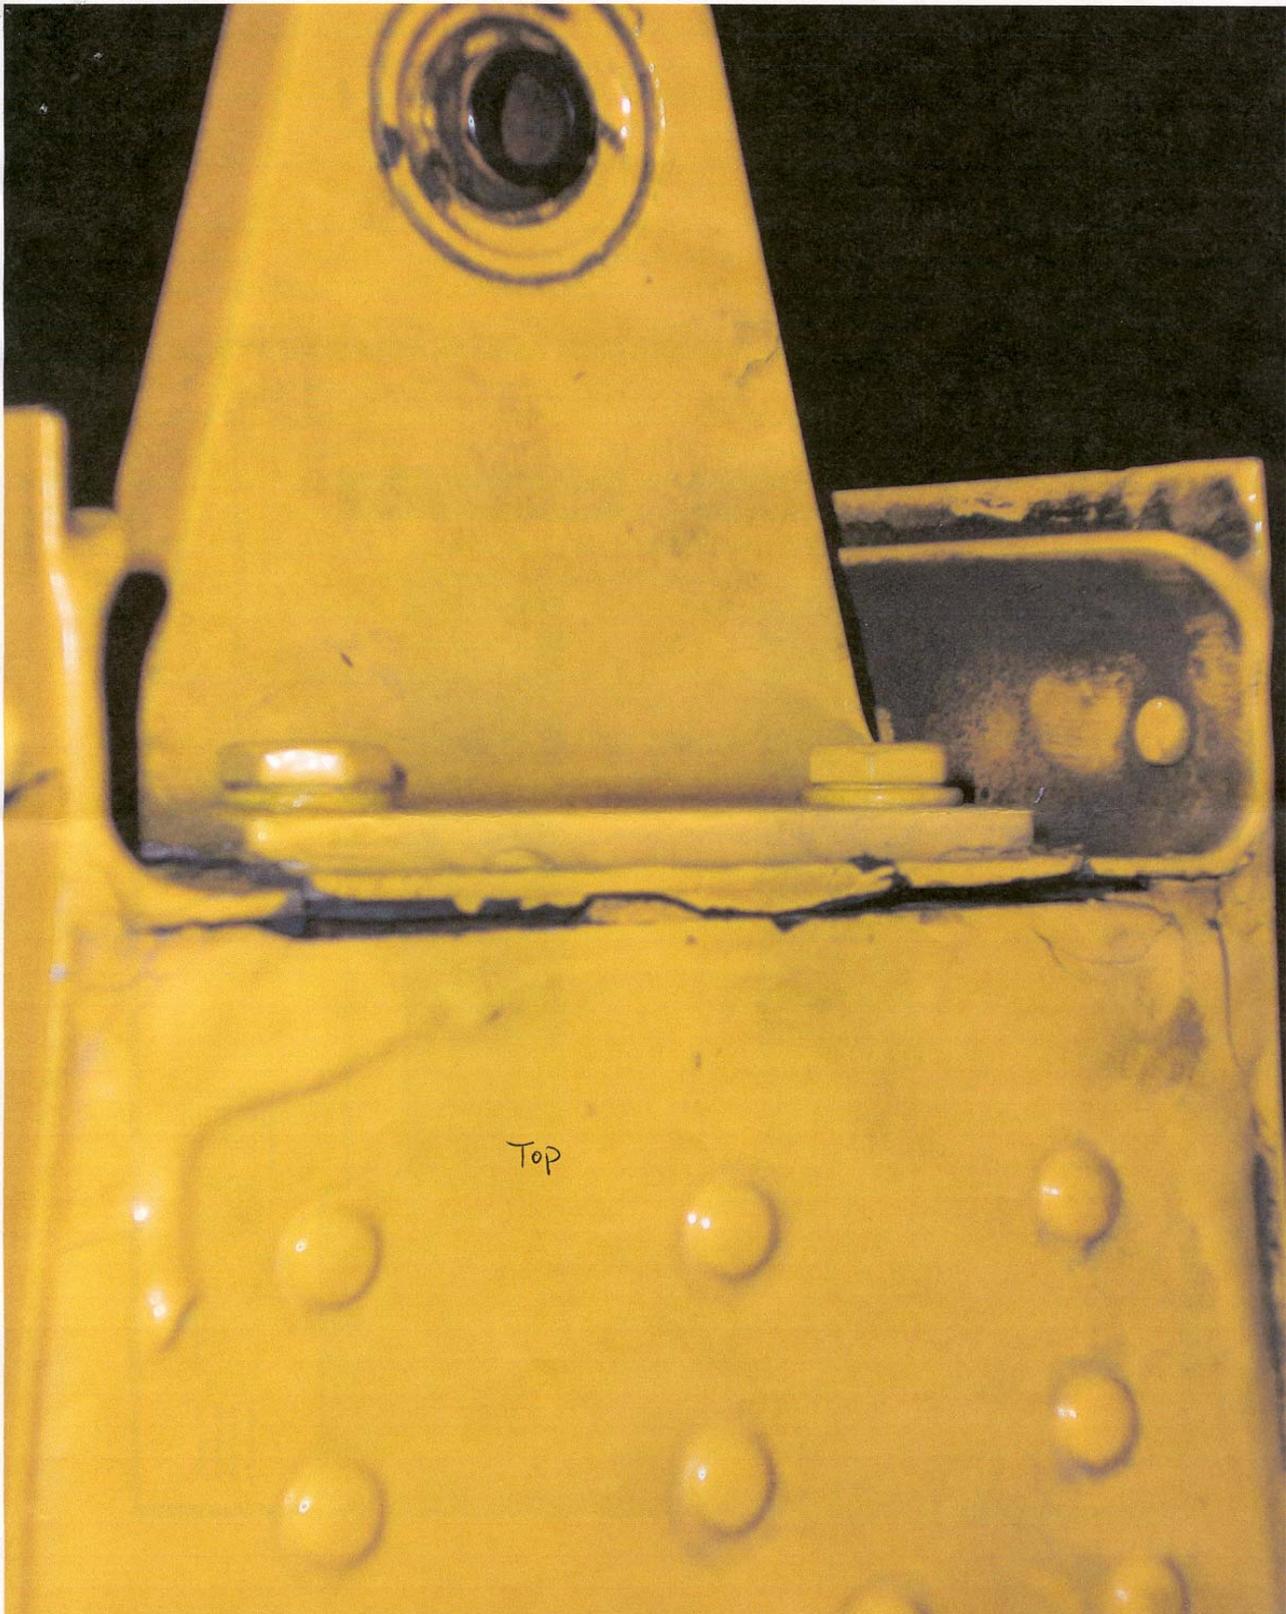
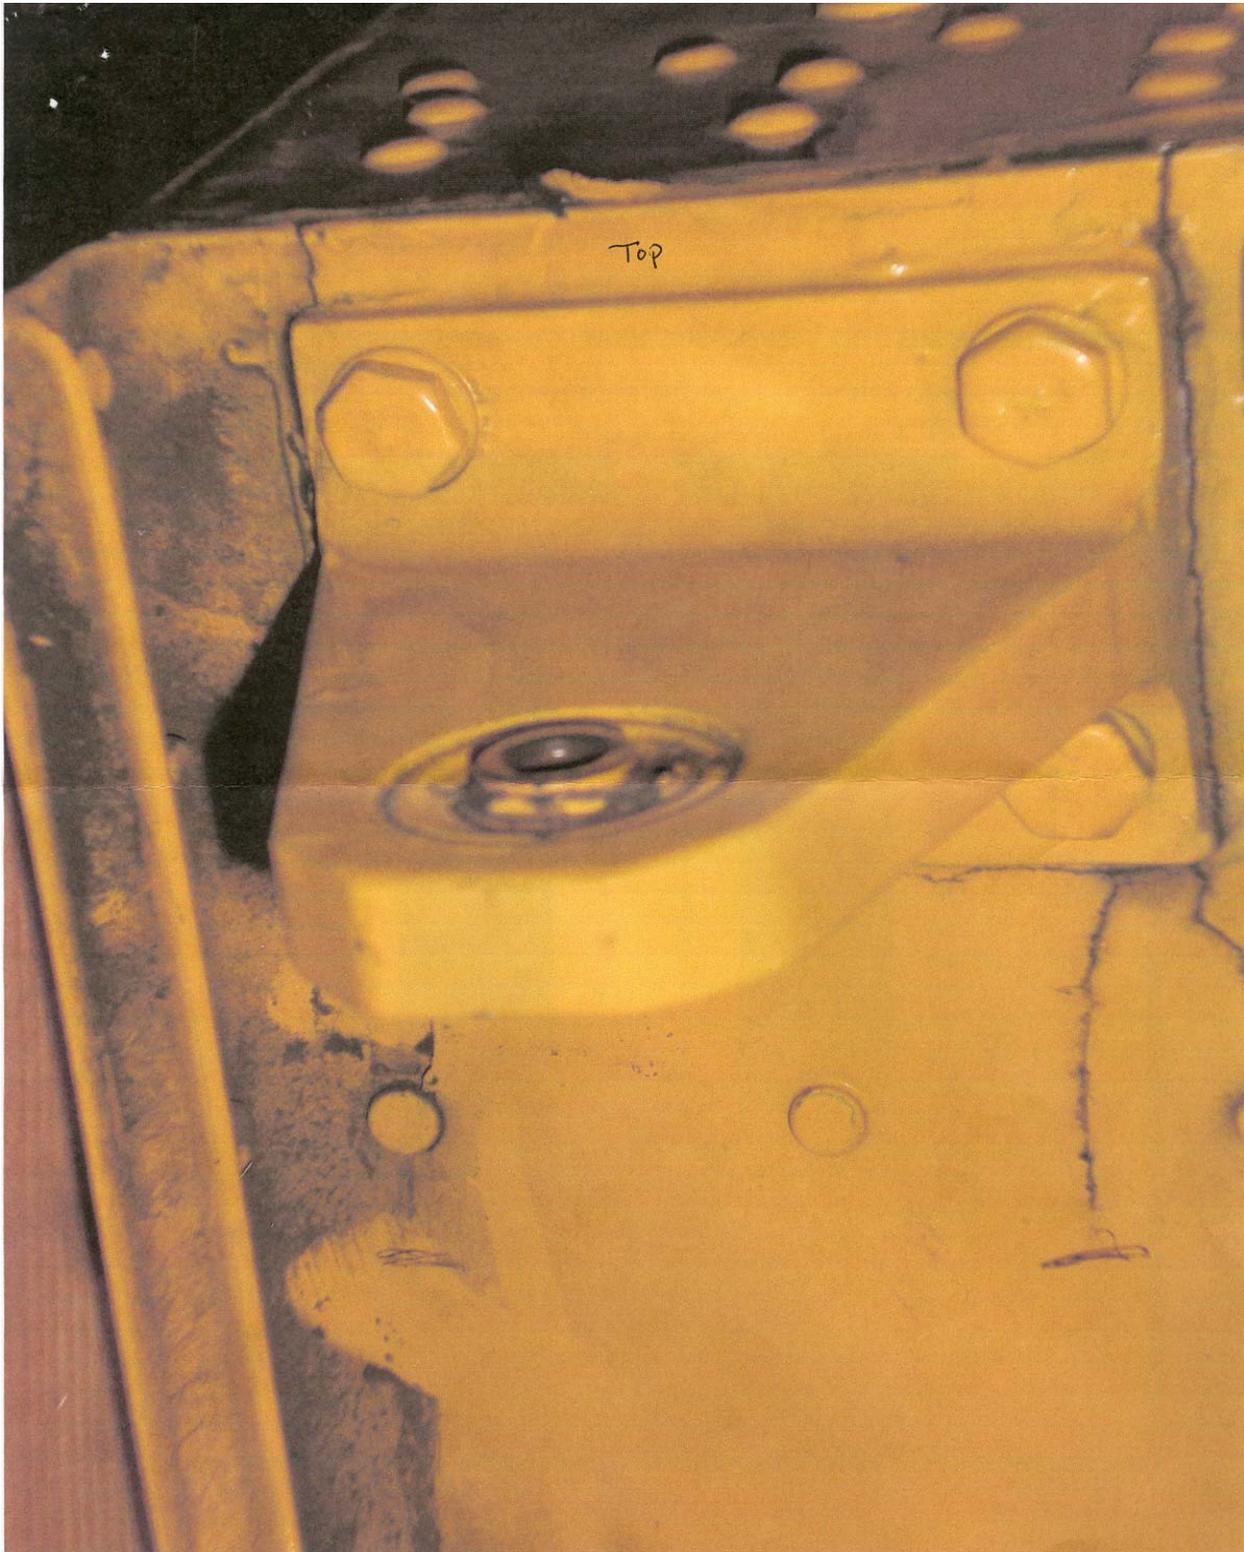
Rockwell: S2R; Cracked Vertical Stabilizer Spar; ATA 5531

A mechanic says, "The top rudder attach bracket cracked out of the rear spar on the vertical fin. (I) noticed this crack at Annual Inspection. (*One might...*) possibly install a heavier rear spar or other (*support/doublers*) in that area. (*An included example is the Ayres Corporation Service Bulletin, number SB –AG-38. Aft spar P/N: 40261T023.*)

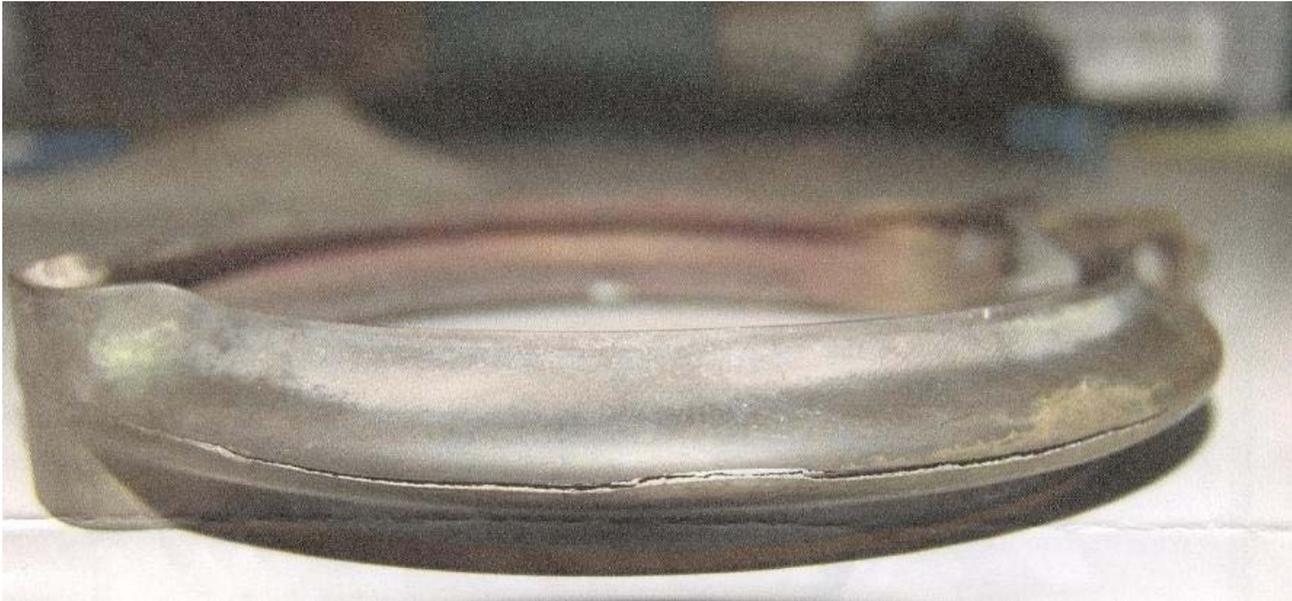
Continental: GTSIO520-H1; Cracked Turbo-exhaust Clamp; ATA 8120

"During an Annual Inspection," says a repair station technician, "the clamp between the turbocharger and exhaust on the left engine was found with a 4.5 inch crack along the circumference." (P/N: NH1000897-50. The SDRS database has four, similar reports on these clamp failures.)

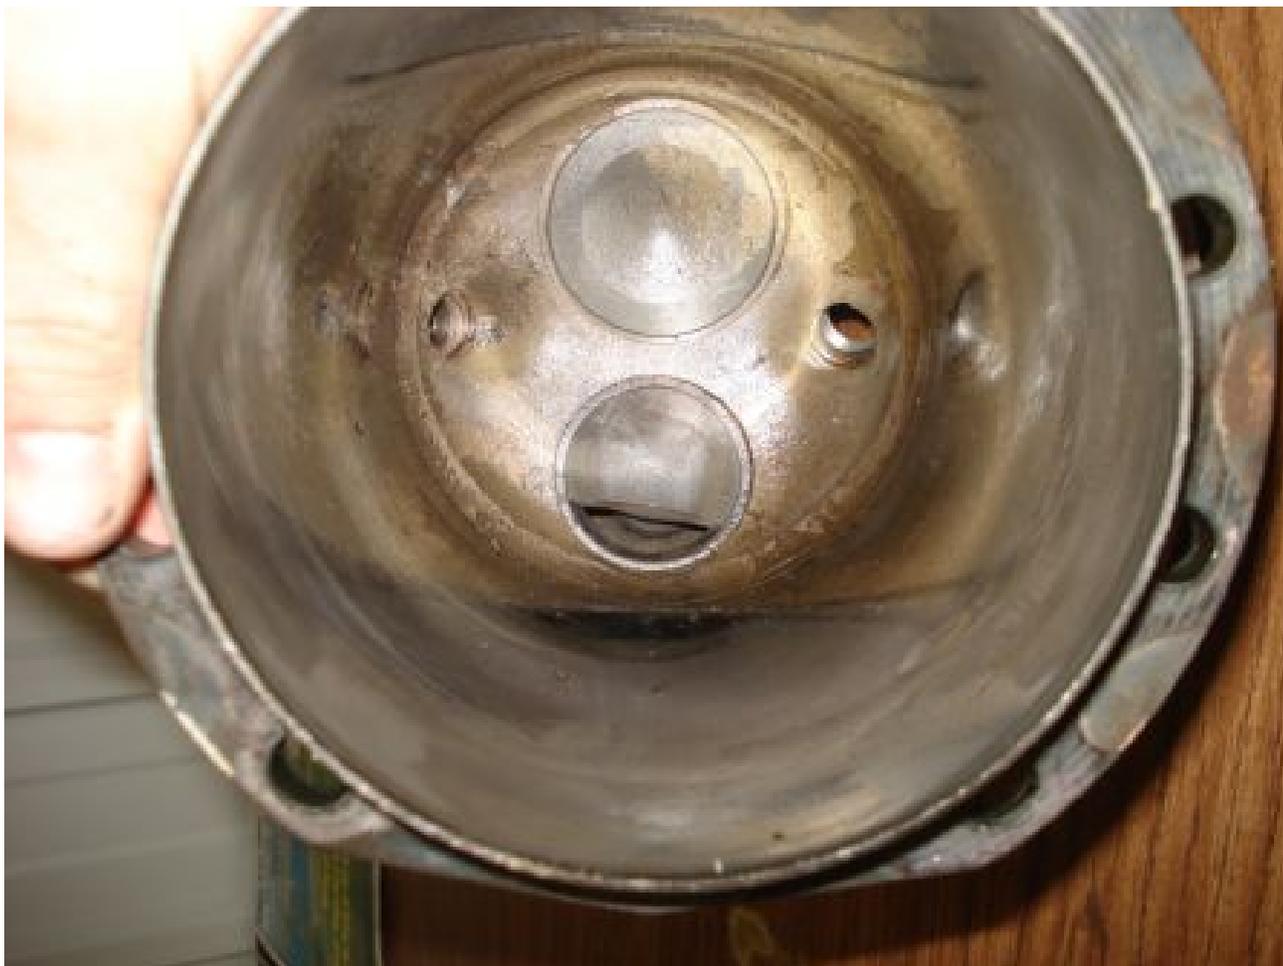
Continental: IO550-B; Cracked Exhaust Valve; ATA 8530

An unidentified submitter states, "This aircraft (*Beech A36*) experienced power loss, vibration, and low number 2 EGT (*exhaust gas temperature*). Upon inspection the number two cylinder exhaust valve (P/N 646286) was found to be missing about half its face." (Cylinder P/N: 655469E.)
