**Federal Aviation
Administration**

ADVISORY CIRCULAR

AVIATION MAINTENANCE ALERTS

**ALERT
NUMBER
393**

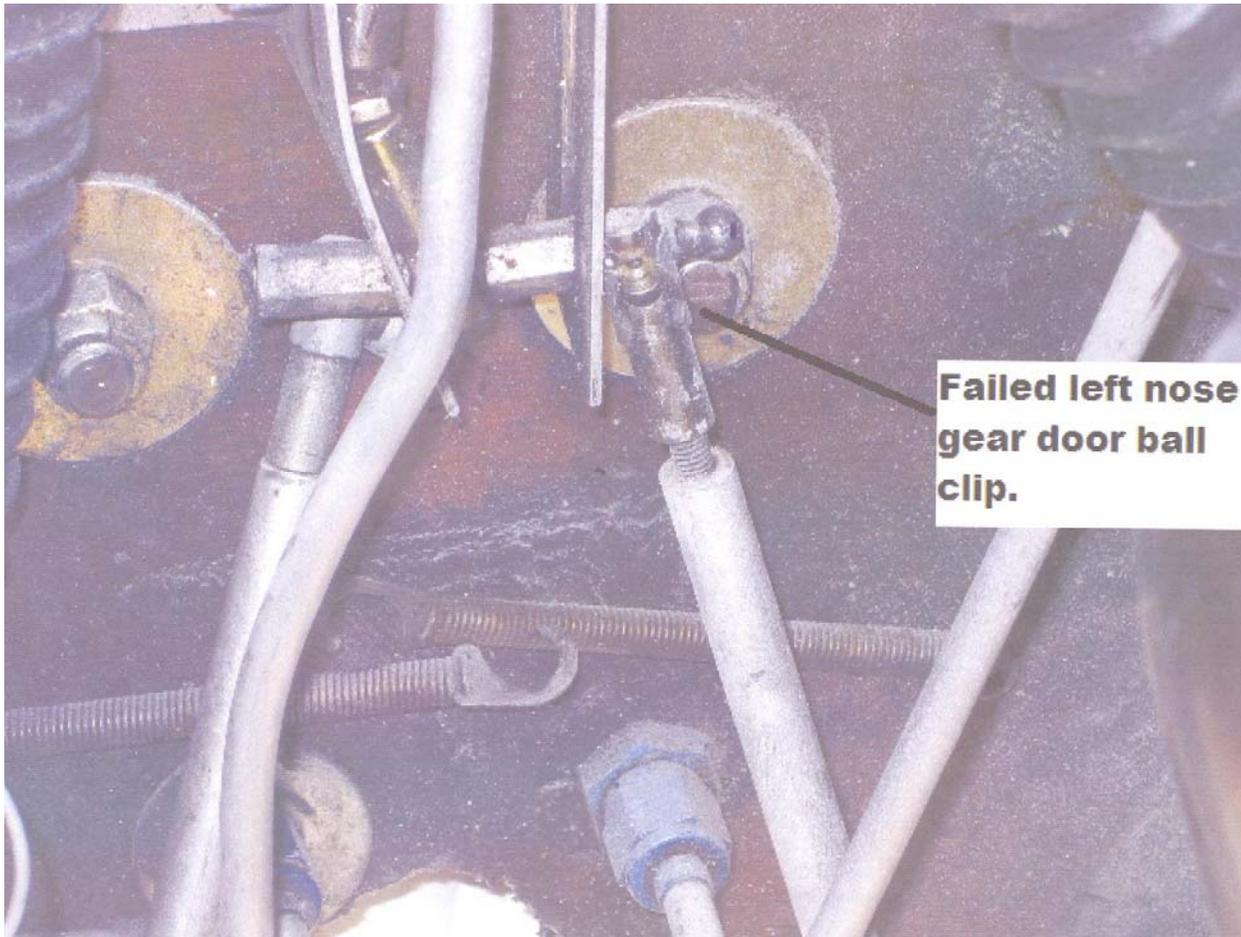
(Amateur): Velocity SRG; Nose Gear Failure; ATA 3231

An unknown submitter states, "The left nose gear door would not open to let the nose gear come down. After landing with the nose gear up, *(I)* found that the linkage had come off in flight and jammed the door closed. After removing an inspection cover, I was able to free the linkage and drop the nose gear while a fireman held the *(aircraft)* nose up. An online *(search)* found a recommendation to modify the doors so they spring open if the linkage failed. Minimum damage *(occurred to this experimental aircraft)* , and was limited to the nose gear door area."

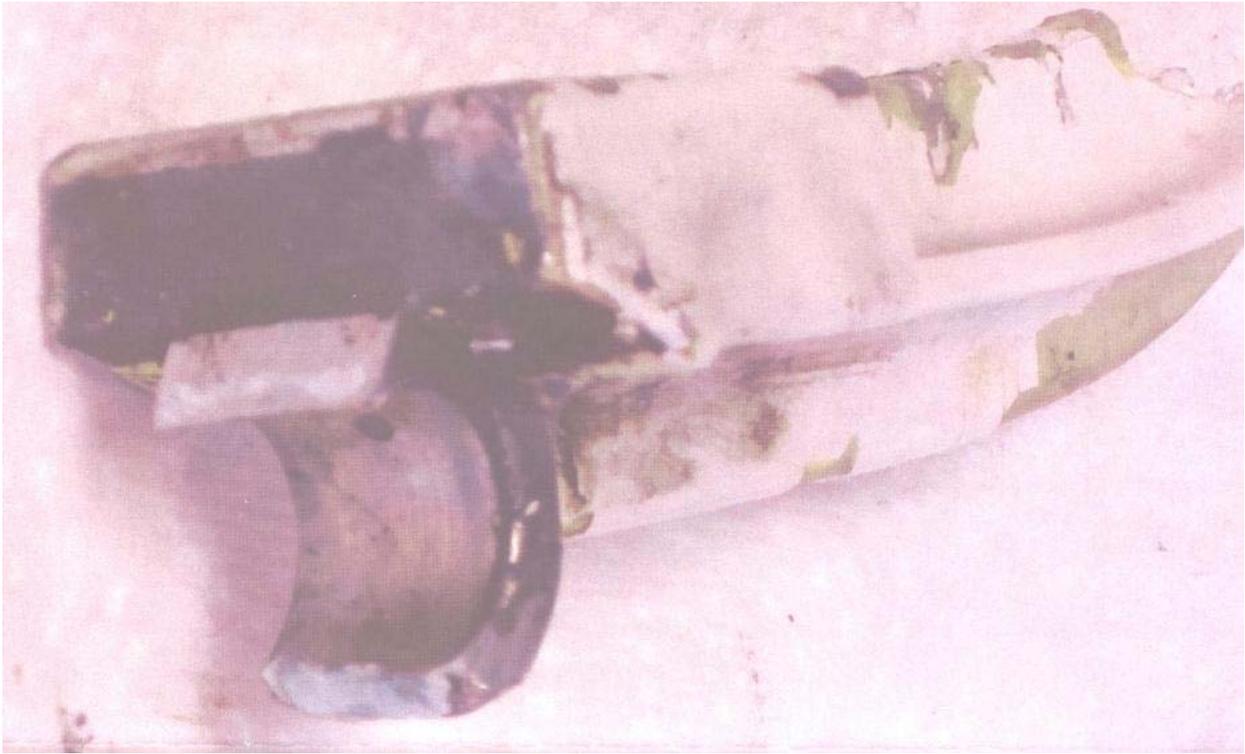
Beechcraft: 58P; Failed Nose Gear Drag Leg; ATA 3230

An FAA inspector says, "*(This aircraft)* landed with the nose landing gear in the unlocked position. The pilot reported on take off the aircraft had a severe vibration at (approximately) 85 knots. He continued the flight, *(allowing)* a second aircraft to verify the nose landing gear was 'flopping around'. The pilot burned off fuel, and then landed with crash response at the airport. The aircraft nose settled upon landing, remaining on runway center. Damage was minor. The nose landing gear drag leg assembly had failed at the top end of the casting (P/N 002-820017-1). The metal broke apart—with indications it had been cracked for some time. This *(area)* cannot be inspected with the part on the aircraft."

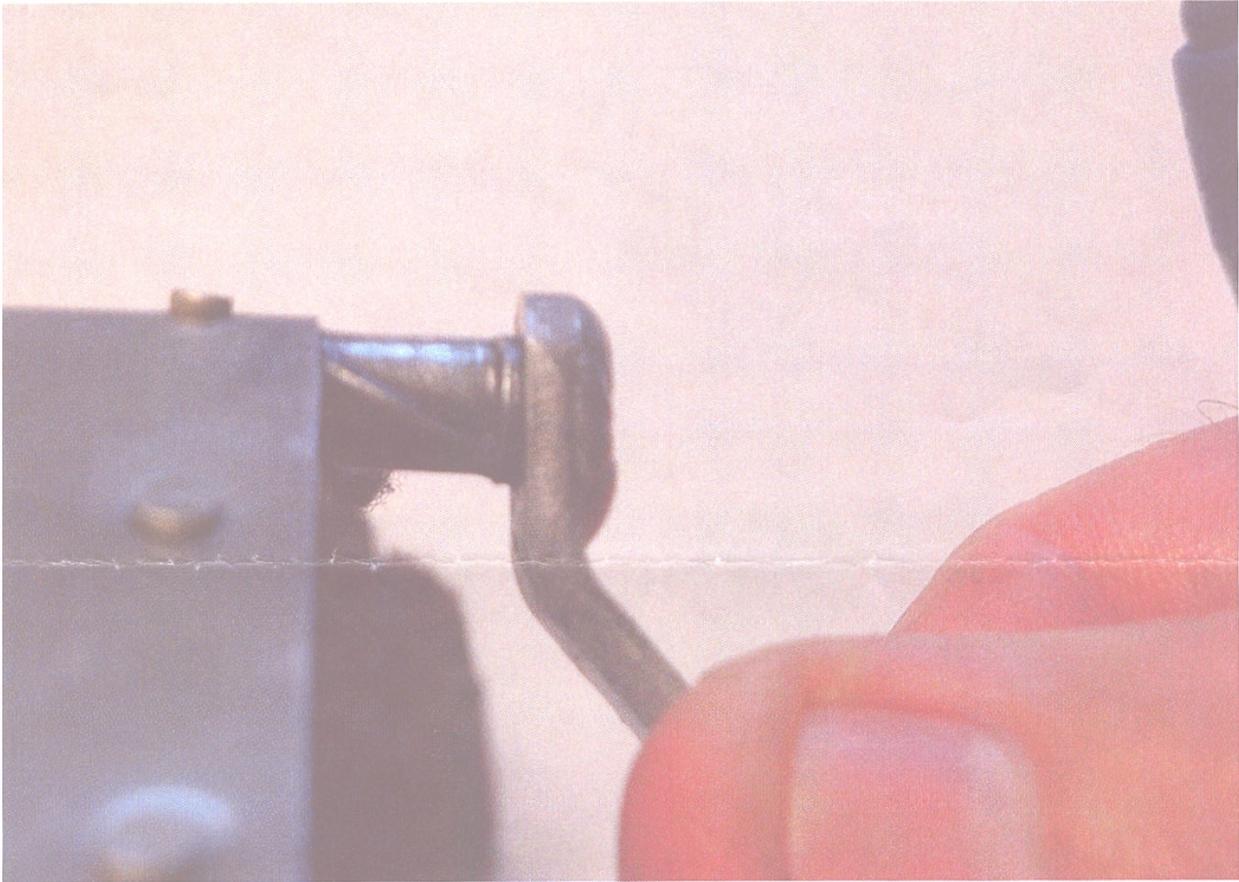
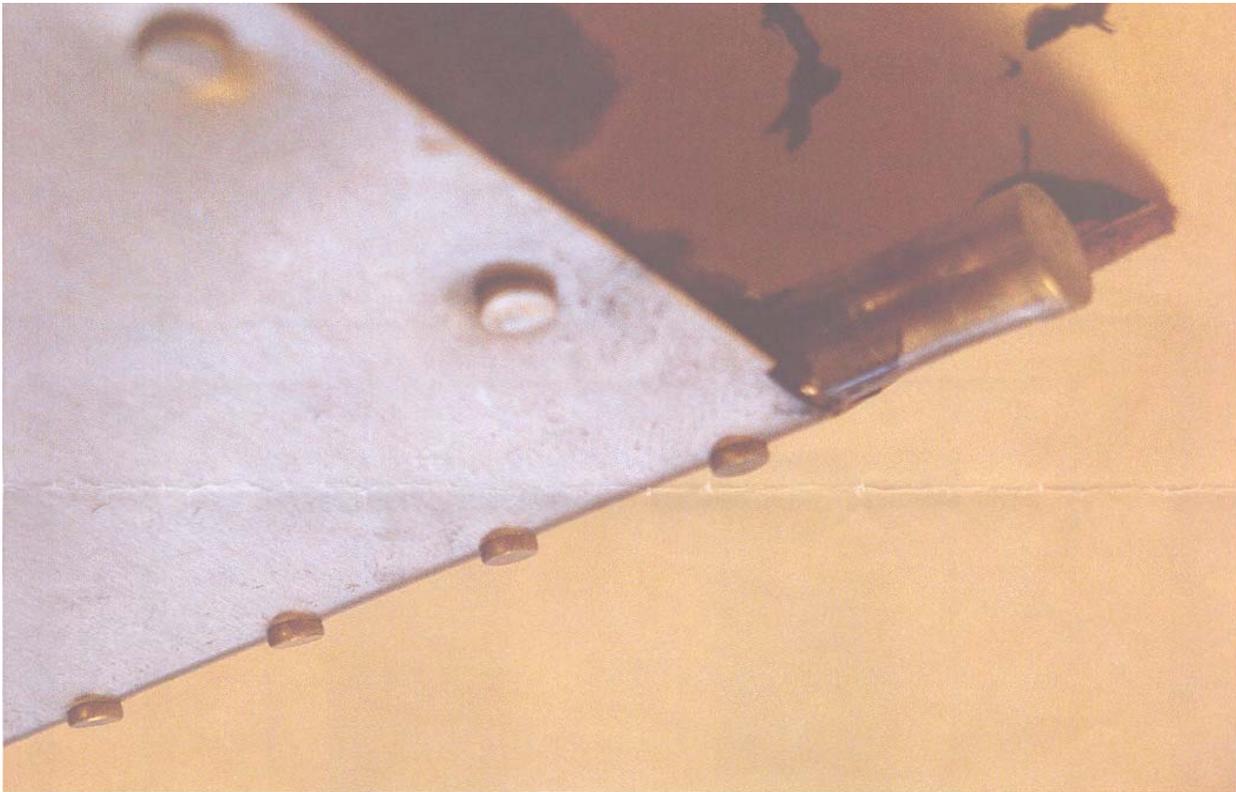
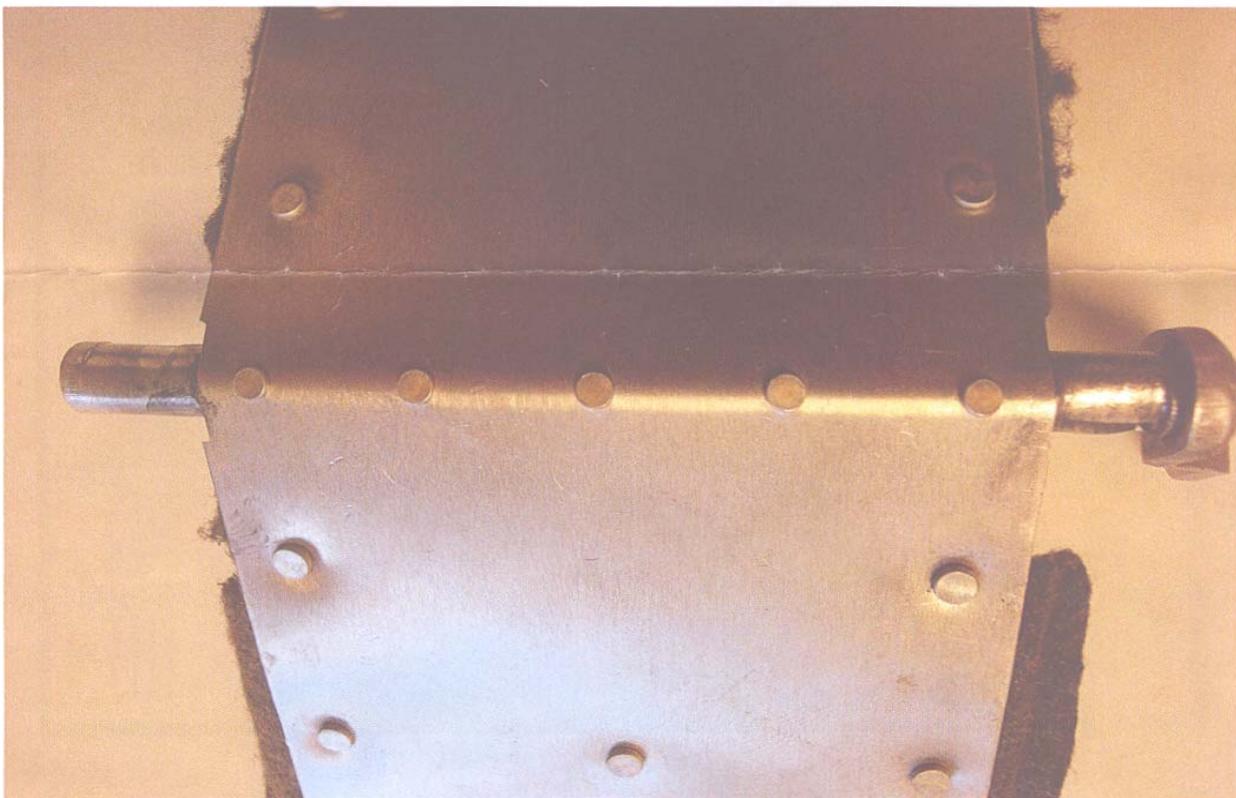
Piper: PA28-161; Carburetor Heat Valve Shaft Damage; ATA 7160

"Both grommets (*failed*) and damaged the carburetor heat valve shaft," states this mechanic. These Teflon bushings (*became*) worn out in approximately 2,000 hours of operation and (*subsequently*) damaged the pivot shaft. This aircraft was manufactured in 2008." (*Carburetor heat valve P/N: 87327-002.*)

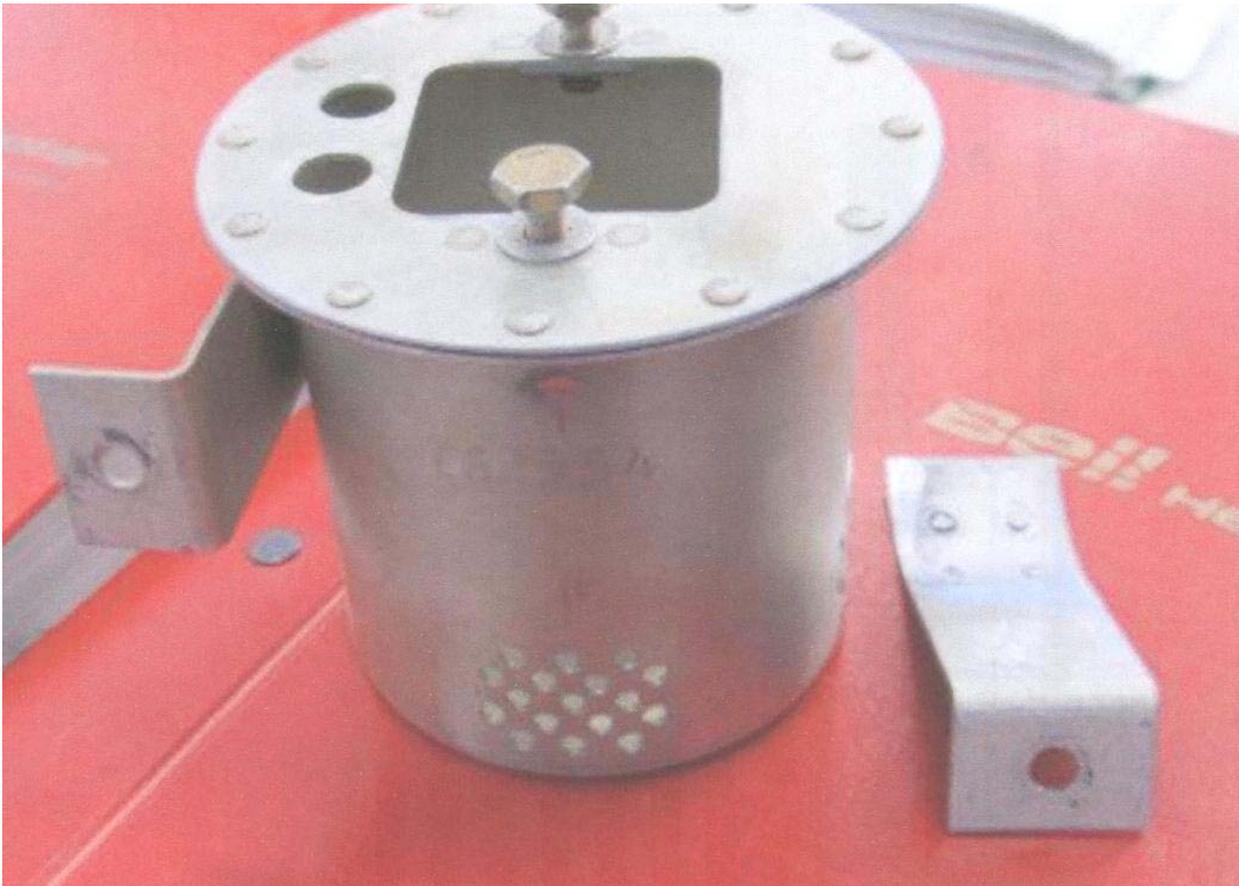
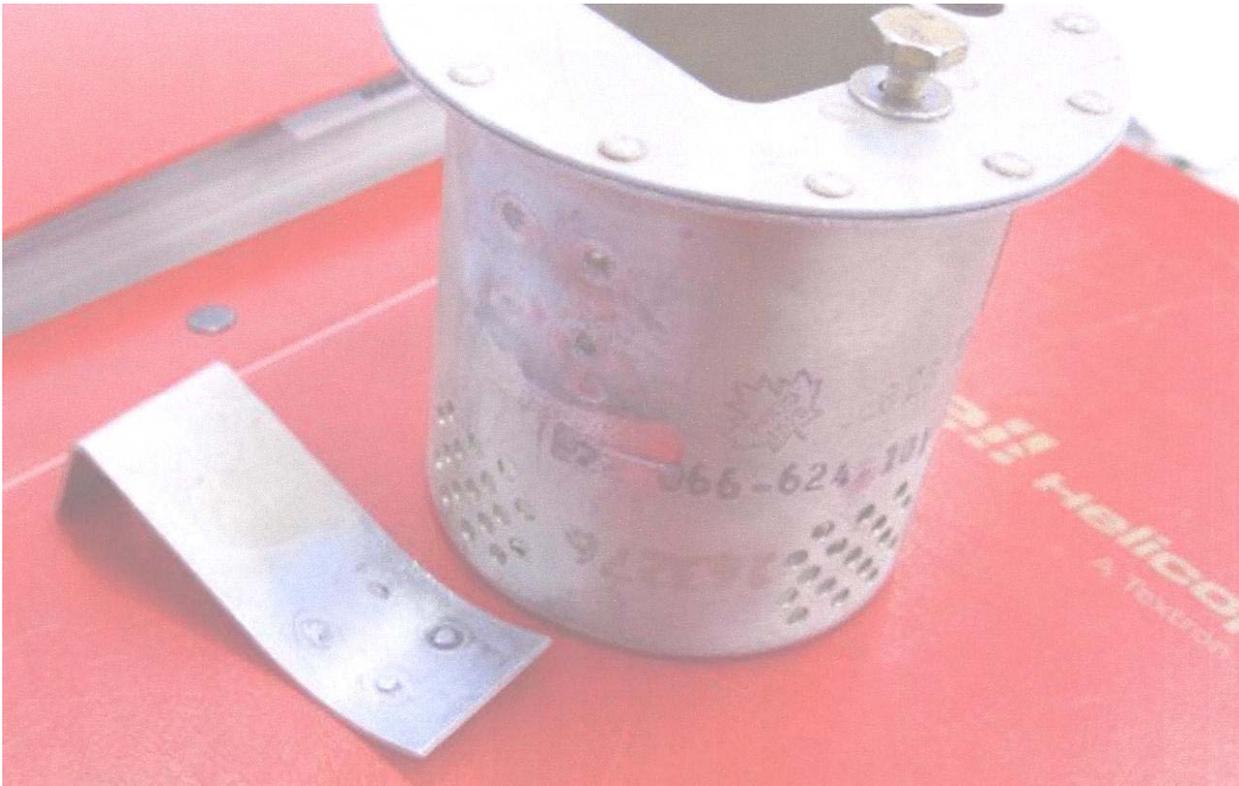
Bell: 430; Broken Fuel Screen Mounting Bracket; ATA 2821

A repair station submitter says, "A broken fuel screen mounting bracket was discovered by inspection when installing the fuel cell (ref. item 66; figure 28-1003; BHT-430-MM-4; P/N 222-066-624-101).

"This mounting bracket is a two part (*assembly*) and is attached to the screen housing by spot welding. These spot welds on one part of the bracket completely failed—the remaining spot welds on the second part of the bracket appear to have cracks in the area of the welds. This bracket and housing hold the engine fuel supply hose in place. Complete failure of the bracket could allow the supply line inlet to drift up in the fuel cell and lead to engine flame-out.

"The probable cause is (*either*) the design or bad welds. Recommendations are to be determined after review."

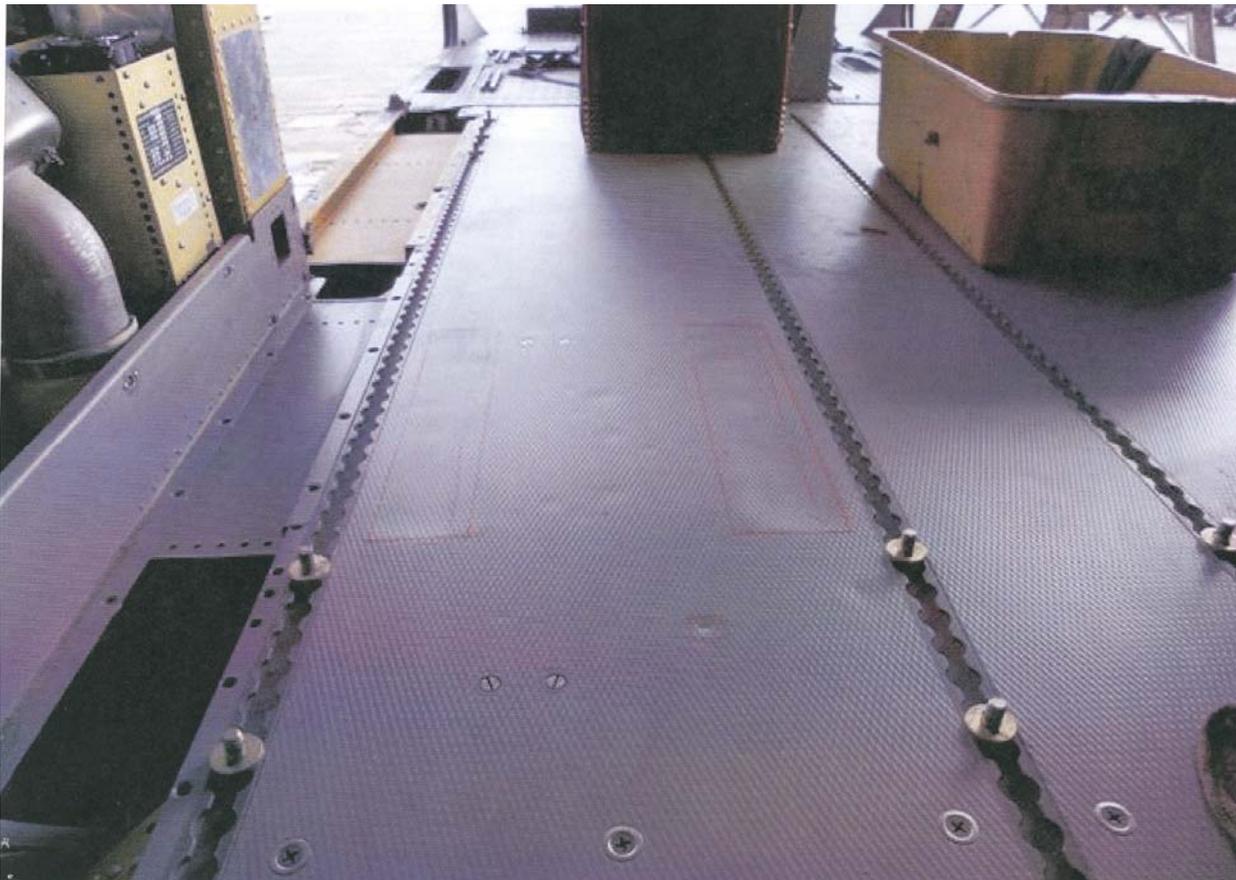
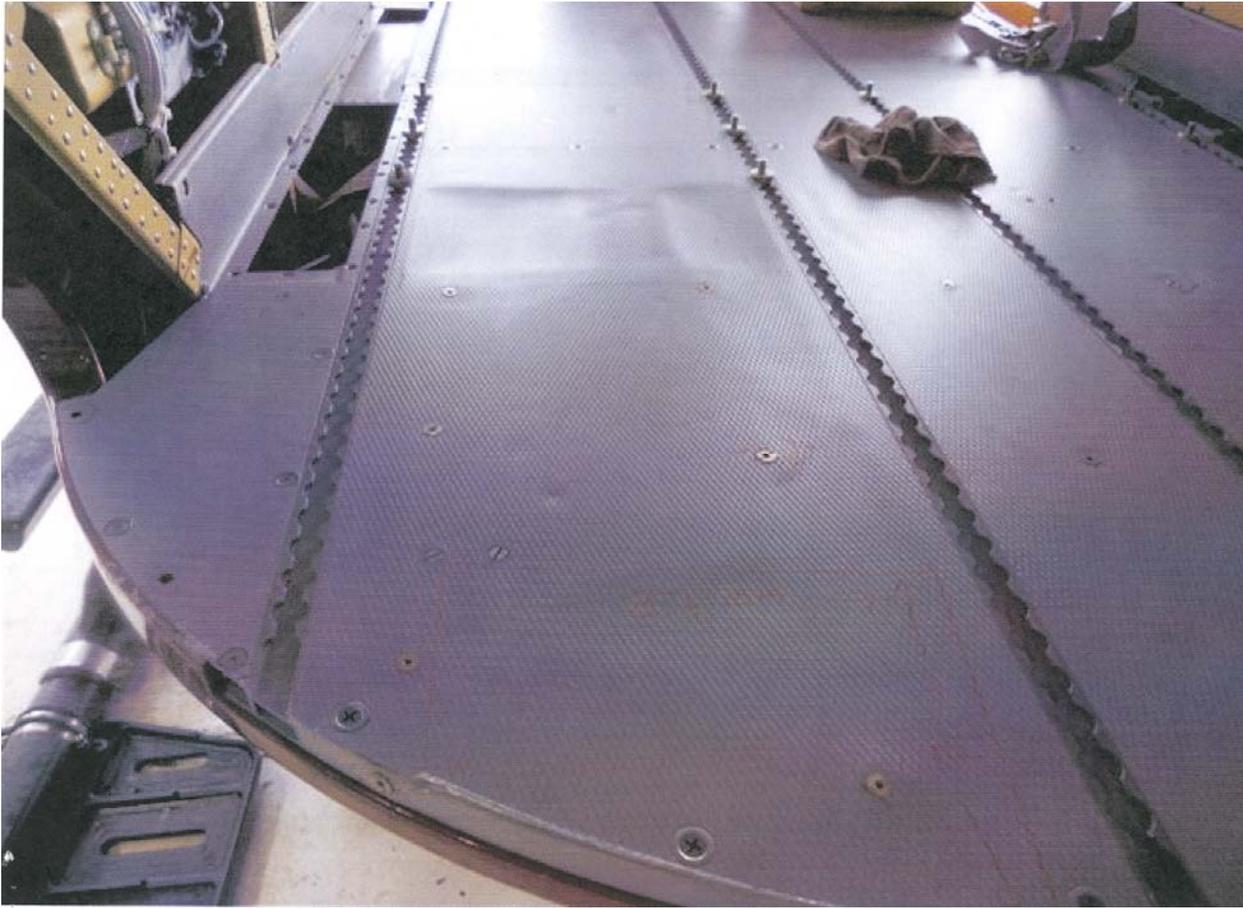
Eurocopter: EC135T2; Damaged Floor Paneling; ATA 5321

"The aircraft floor has multiple dents and crushed honeycomb core," say this submitter. "This aircraft was altered with the Metro Aviation EC135 EMS (Kit Number 135M-100). (I) suspect...the medical floor palate (P/N EC135M-2000-1) is inadequate to support the stretcher assembly when loaded with a patient, (resulting) in the front wheels crushing the floor. (We) are awaiting a repair from American Eurocopter engineering." (Floor Assembly P/N: L533M1015102.)

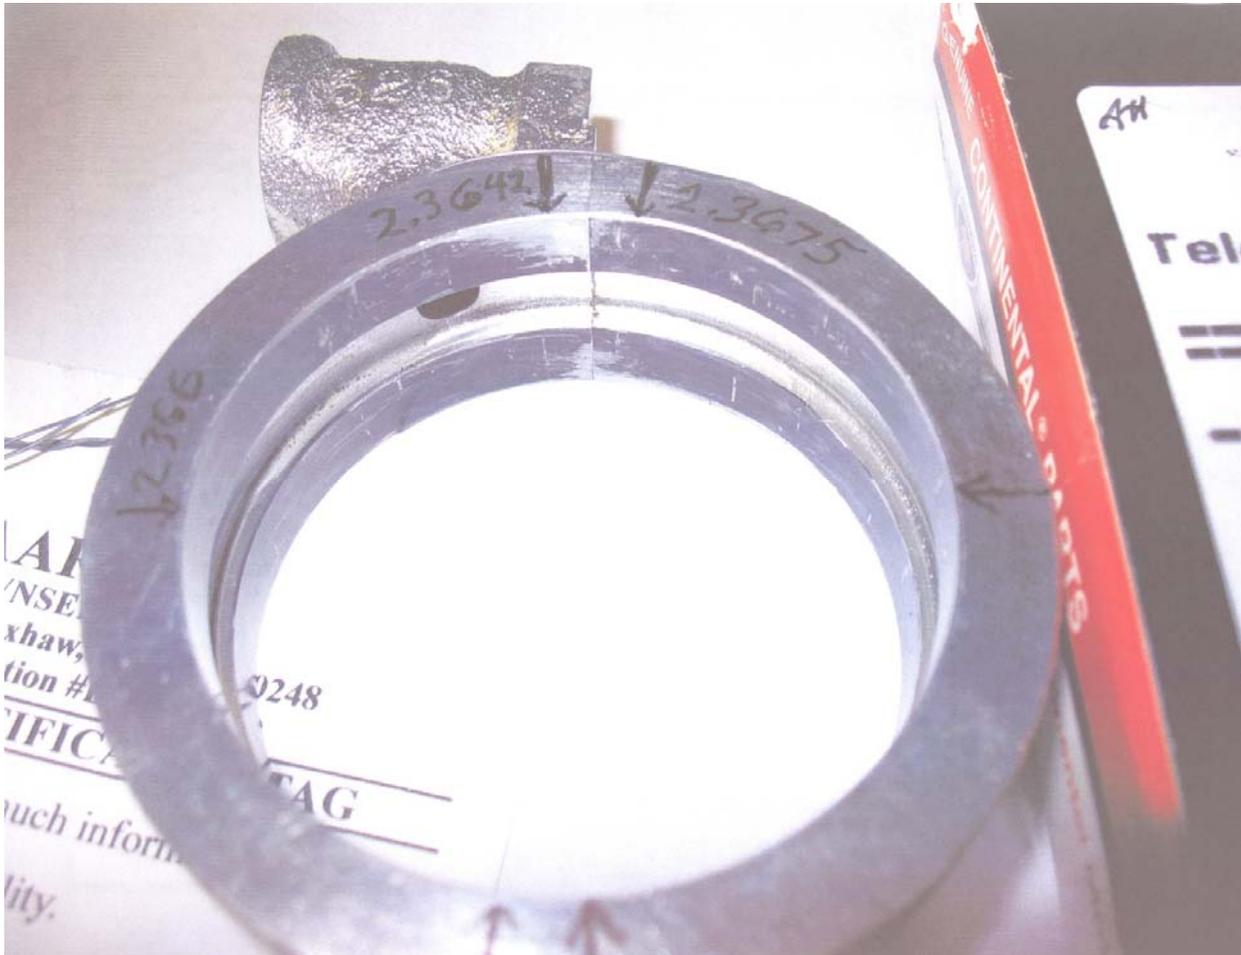
Continental: TSIO520; Damaged Transfer Collar; ATA 8500

A technician says, "This TCM Transfer Collar (P/N 626739M010) seems to have been damaged after it was (*machined*). One side of the split line does not line up—you can catch a fingernail on it. When installed it is tight, and rubs at the point shown by the rubbed-off Magic Marker. When the diameter is measured with a bore gauge on each side of the split, there is a difference of 0.0033 inches. The maximum clearance on the shaft is 0.0018. This part was returned to the vendor for warranty replacement."
