U.S. Department  
of Transportation  
**Federal Aviation  
Administration**

## ADVISORY CIRCULAR

# AVIATION MAINTENANCE ALERTS

**ALERT  
NUMBER  
325**

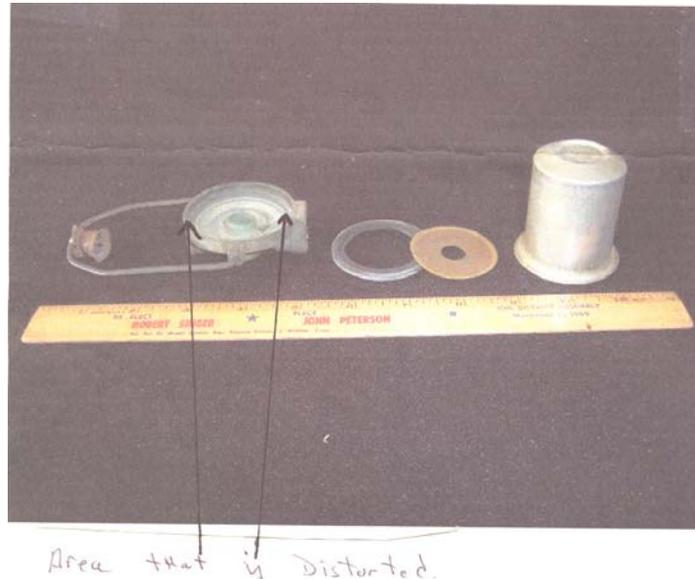
This technician has observed bending deformation in the fuel filter's bowl cover (P/N 14428-00) as result of the wire assembly bail (P/N 494-644) being tightened. "Over the years, the force of the bail actually bends the frame (*to the point*) the gasket will no longer seal, and fuel will seep by the gasket when the bowl is rocked forward and aft -- 90 degrees to the location of the bail assembly. The only option to remedy the situation is to replace (*the gascolator*) with factory new or an STC replacement."

Part Total Time: 2,895.0 hours.

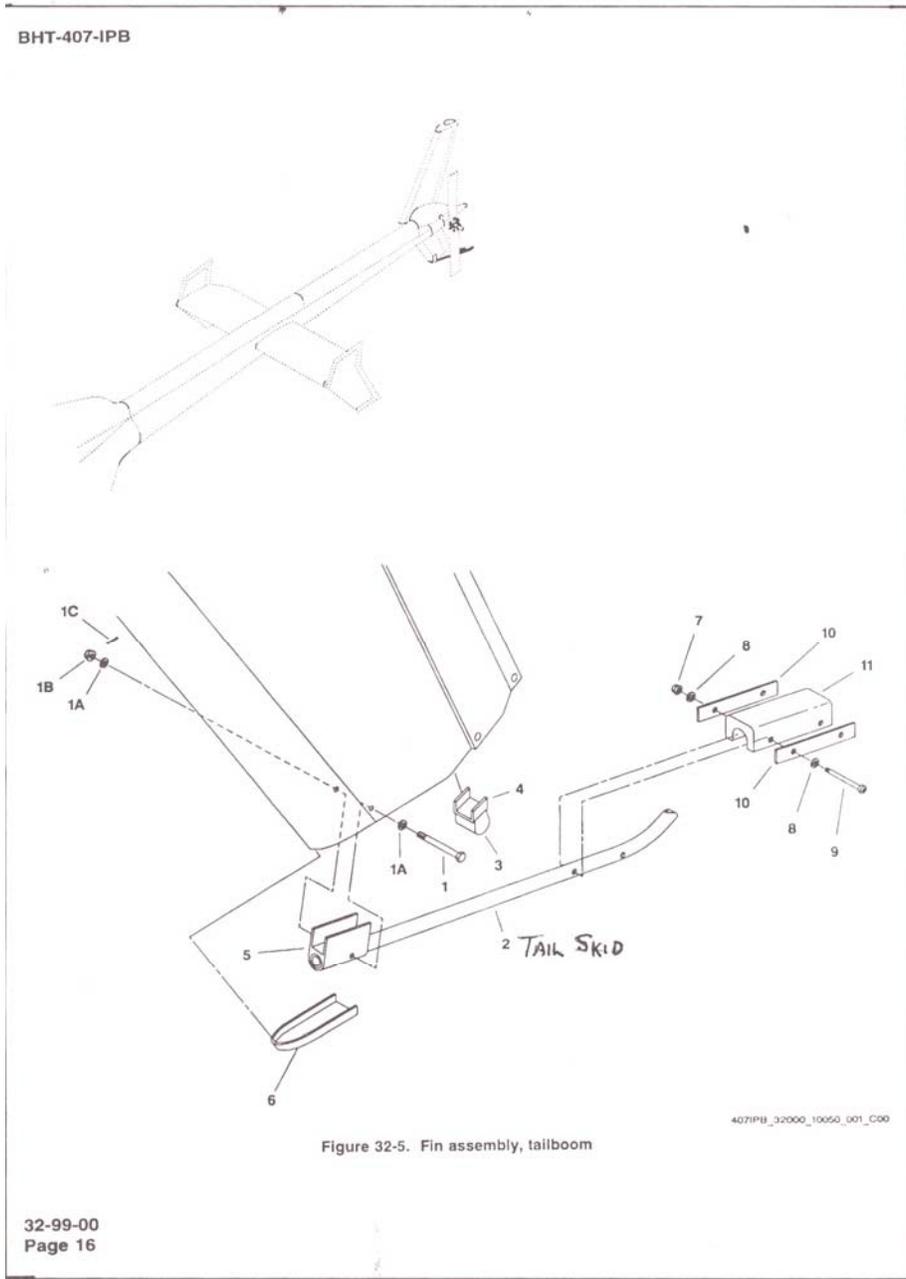
#### **Bell; 407; Cracked Tail Skid; ATA 3270**

A pilot found the tail skid (P/N 206-020-110-103) to be loose during a preflight inspection. "Upon closer examination, the tail skid pulled out from the fin assembly. The tail skid had cracked completely around and through at the attachment bolt hole. By the appearance of the broken ends of the tube, this crack propagation was slow." (*He notes one occurrence of a hard landing 4 years and over 2,700 hours prior to this defect. The SDR database records another three occurrences of cracked tail skids at this same location.*)

Part Total Time: 4,517.5 hours.
