U.S. Department  
of Transportation  
**Federal Aviation  
Administration**

## ADVISORY CIRCULAR

# AVIATION MAINTENANCE ALERTS

**ALERT  
NUMBER  
349**

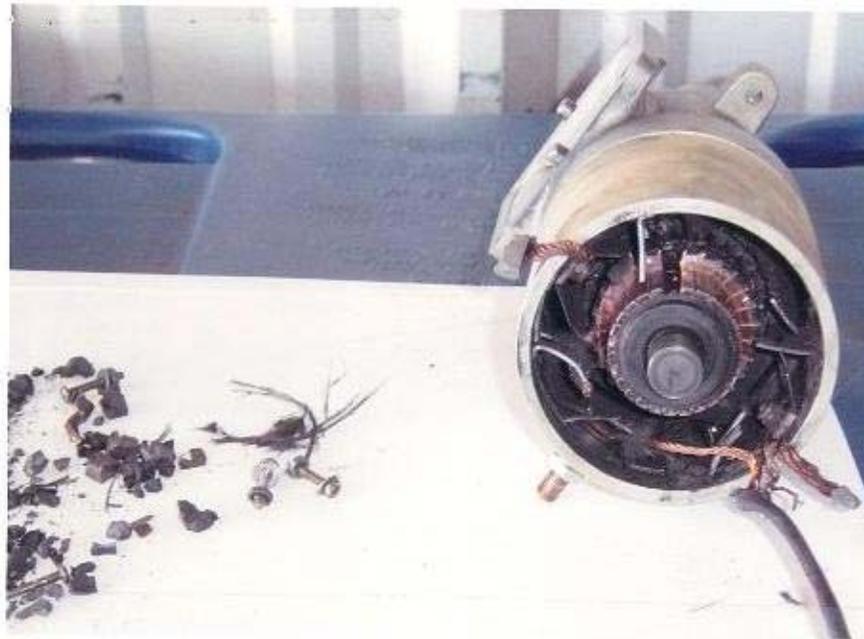
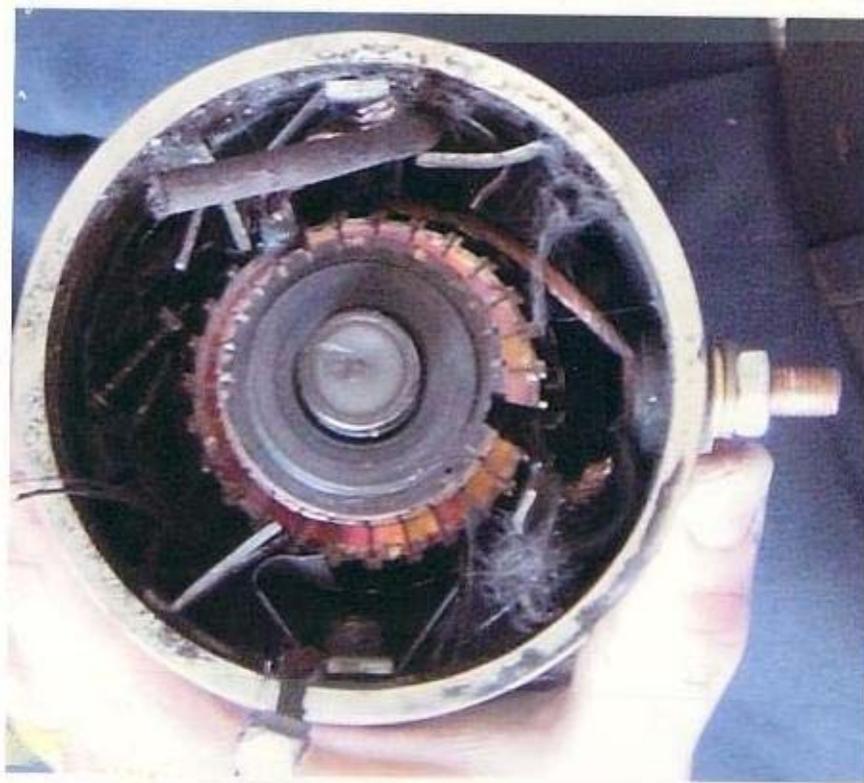
*(A repair station technician provides a short description of a failed starter for a 320 Lycoming on a Cessna 172. His pictures speak volumes.)*

“A segment of the commutator came off during starting, completely destroying the brushes on the inside of the starter.”

Part Total Time: 1,198.9 hours.

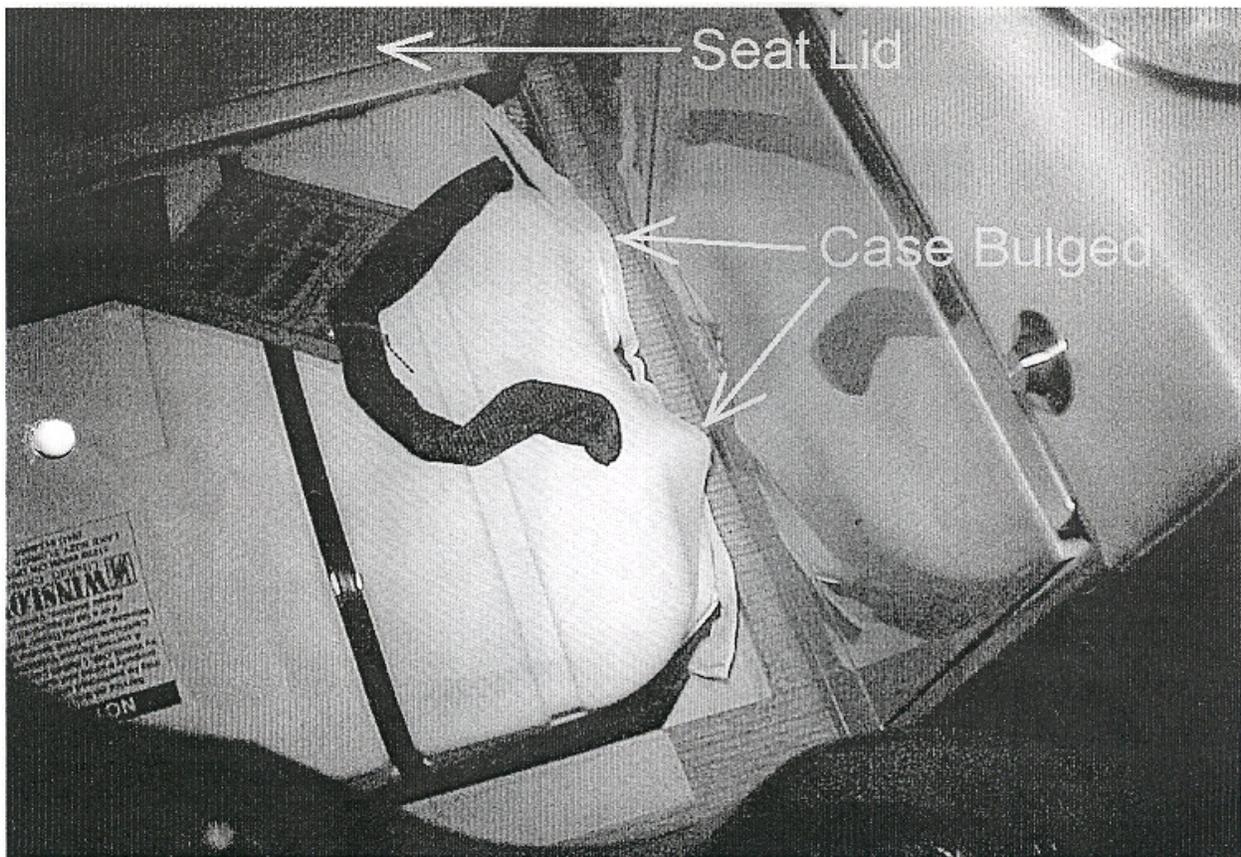
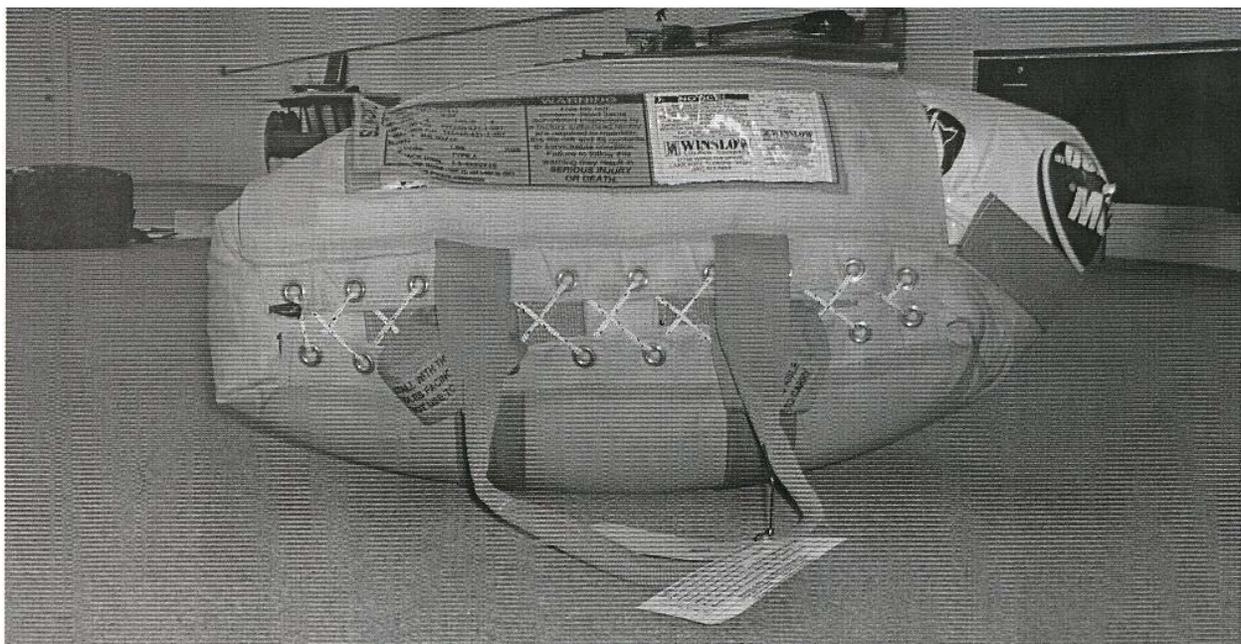
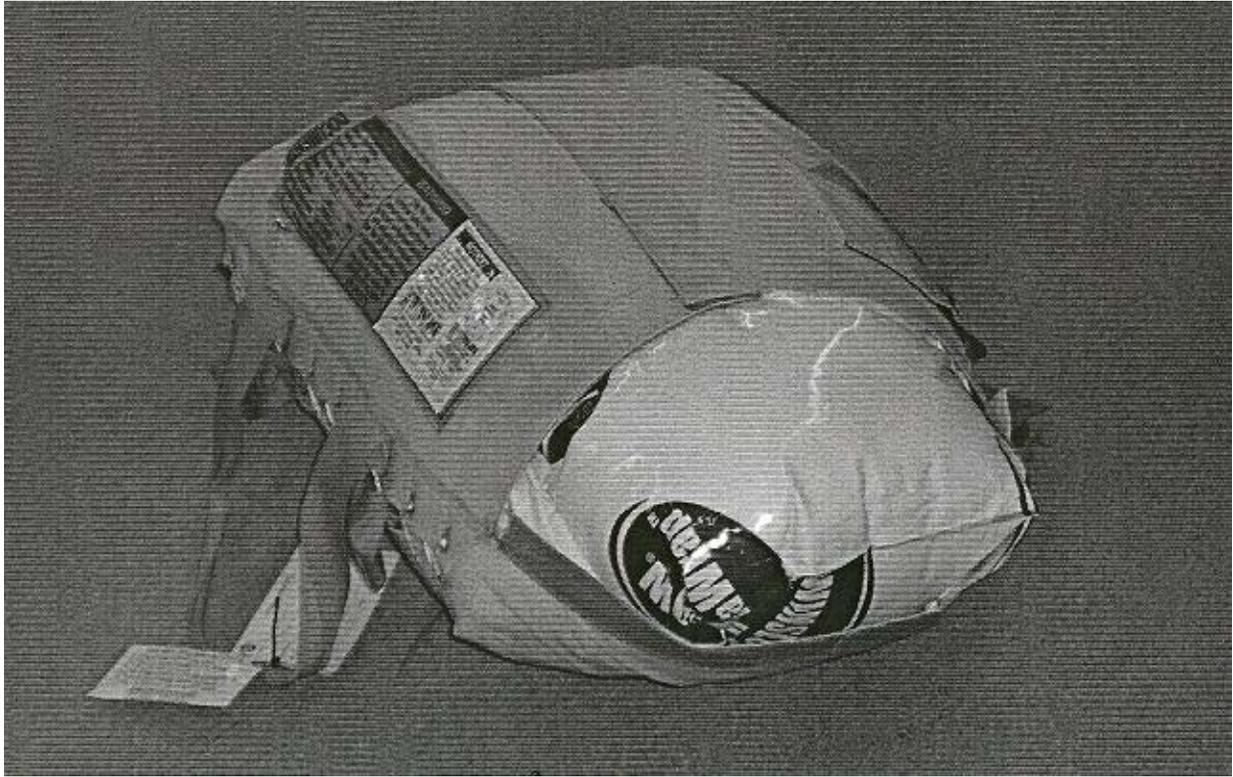
*(A repair station technician provides two reports in a span of 8 days. Both describe the same defect on the same model raft, though specific aircraft application information was not included. Here, both reports have been combined. Winslow’s Director of Quality Assurance Steven Saunders provided their previously distributed service letter addressing an O-ring lubrication procedure. It follows this article.)*

“The life raft partially (and inadvertently) inflated in the customer's aircraft....” “This ‘under the seat cushion’ (*installation*) could have possibly caused damage to the aircraft, injury to persons, or loss of aircraft control had the life-raft completely inflated in flight. This raft was removed from the aircraft cabin by the operator before it had completely inflated, minimizing the possibly of severe damage.” (*The part number for both reports is 46FASA-230-603.*)

A Quality Investigation was immediately conducted in order to determine the cause of the deformations, the extent of those life rafts that might be impacted, as well as the corrective action necessary to alleviate the issue.

The model 46FASA, 46FAUL, and 57FASA life rafts manufactured since March 2004 use a unique and specific cylinder-to-cylinder head interface. It has been determined that in those rare instances in which pack deformation occurred, the cause was due to a minute passing of cylinder gas, past the cylinder-to-cylinder head "port seal" interface, and into the vacuum pack itself. An inadequacy of a special lubricant that is applied to the surfaces of those components that comprise the seal has been determined to be responsible for these rare deformations. Even the slightest escape of a gas in an otherwise evacuated environment can cause noticeable deformations.

It is recommended that the models list above, manufactured between March 2004 and September 2005, be inspected for pack deformation every three months or until the next re-servicing of life raft. An obvious increase in pack size may merit further inspection at WINSLOW. Additionally, WINSLOW encourages you to contact us at any time with any questions one might have regarding this very limited issue. Any 46FASA, 46FAUL, and 57FASA life rafts that may be discovered to have dimensionally changed should be brought to our attention so that appropriate remedial action may be provided. The expense of any remedial care will, of course, be paid for by WINSLOW LifeRaft Company.
