U.S. Department
of Transportation
**Federal Aviation
Administration**

ADVISORY CIRCULAR

AVIATION MAINTENANCE ALERTS

**ALERT
NUMBER
361**

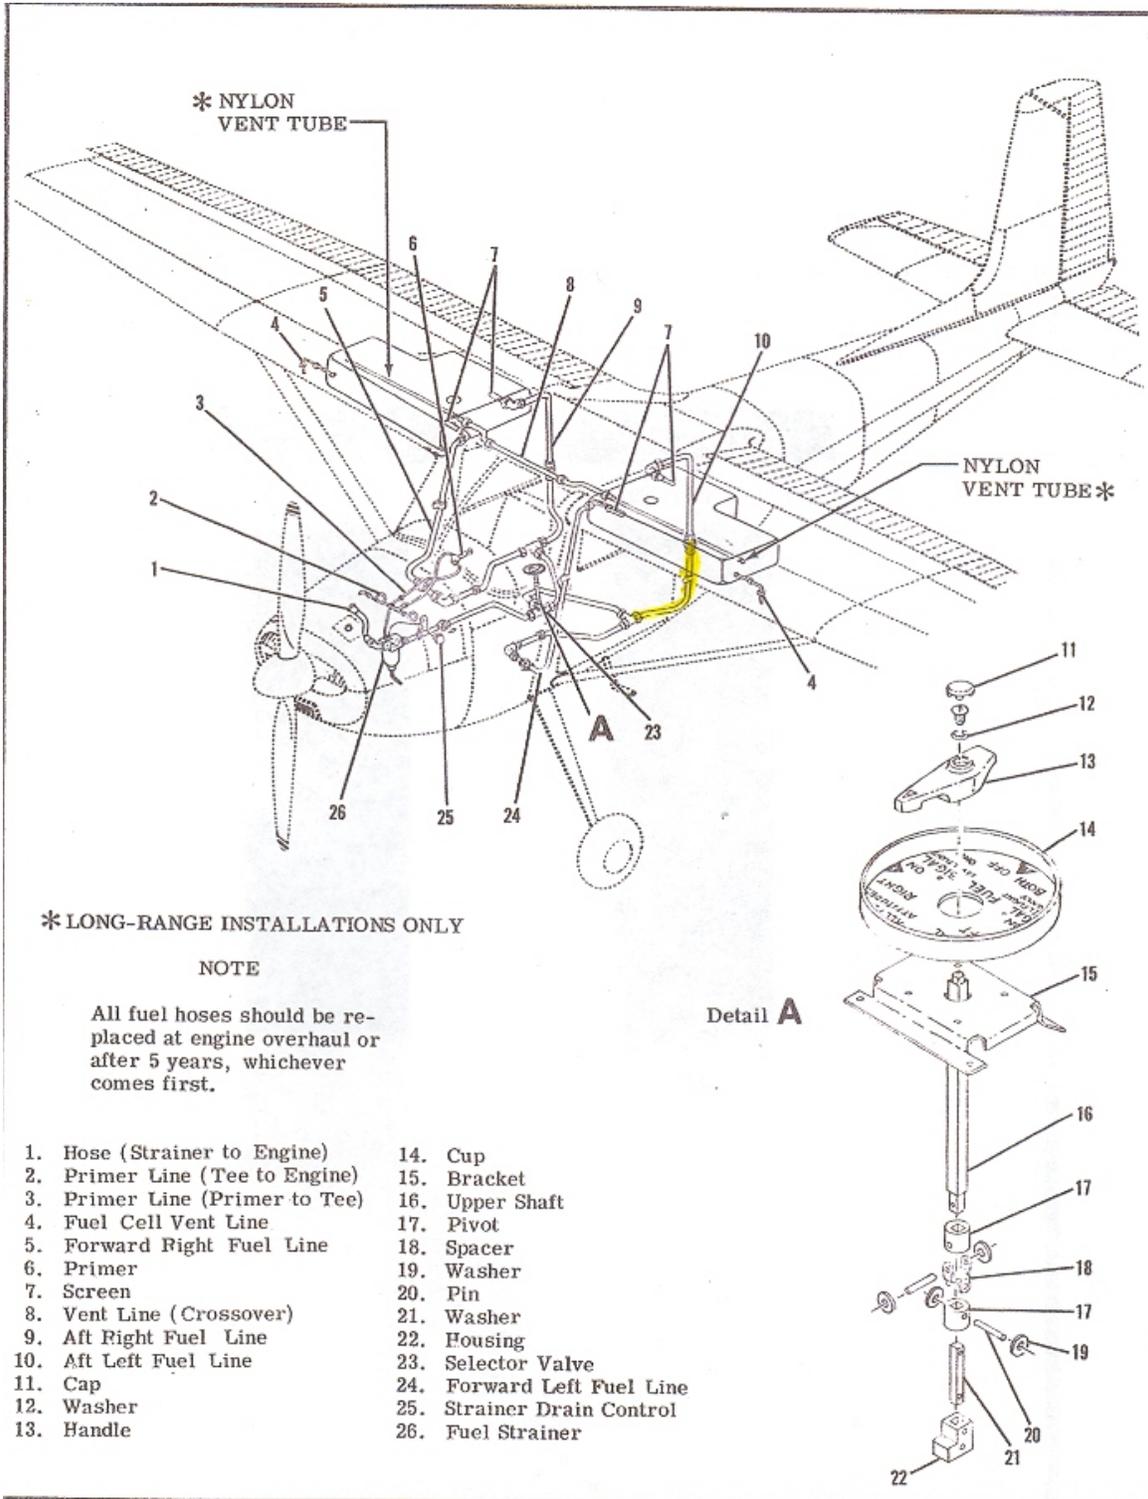
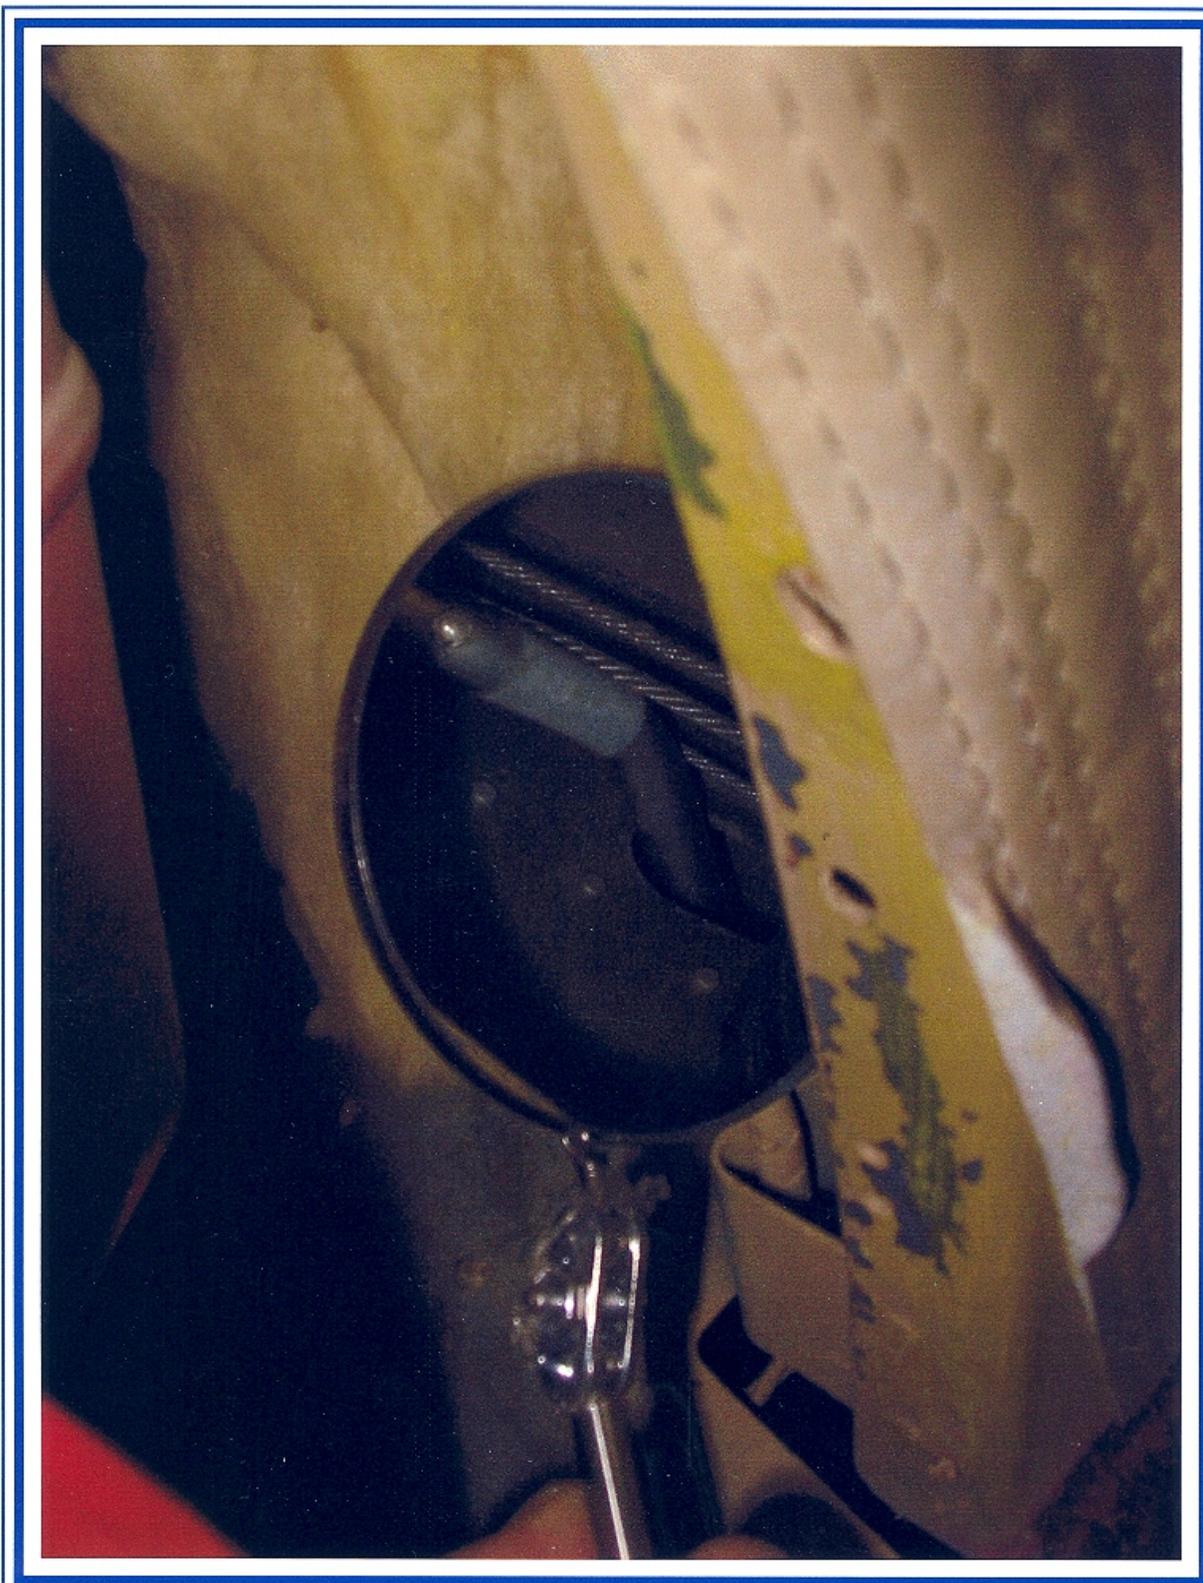
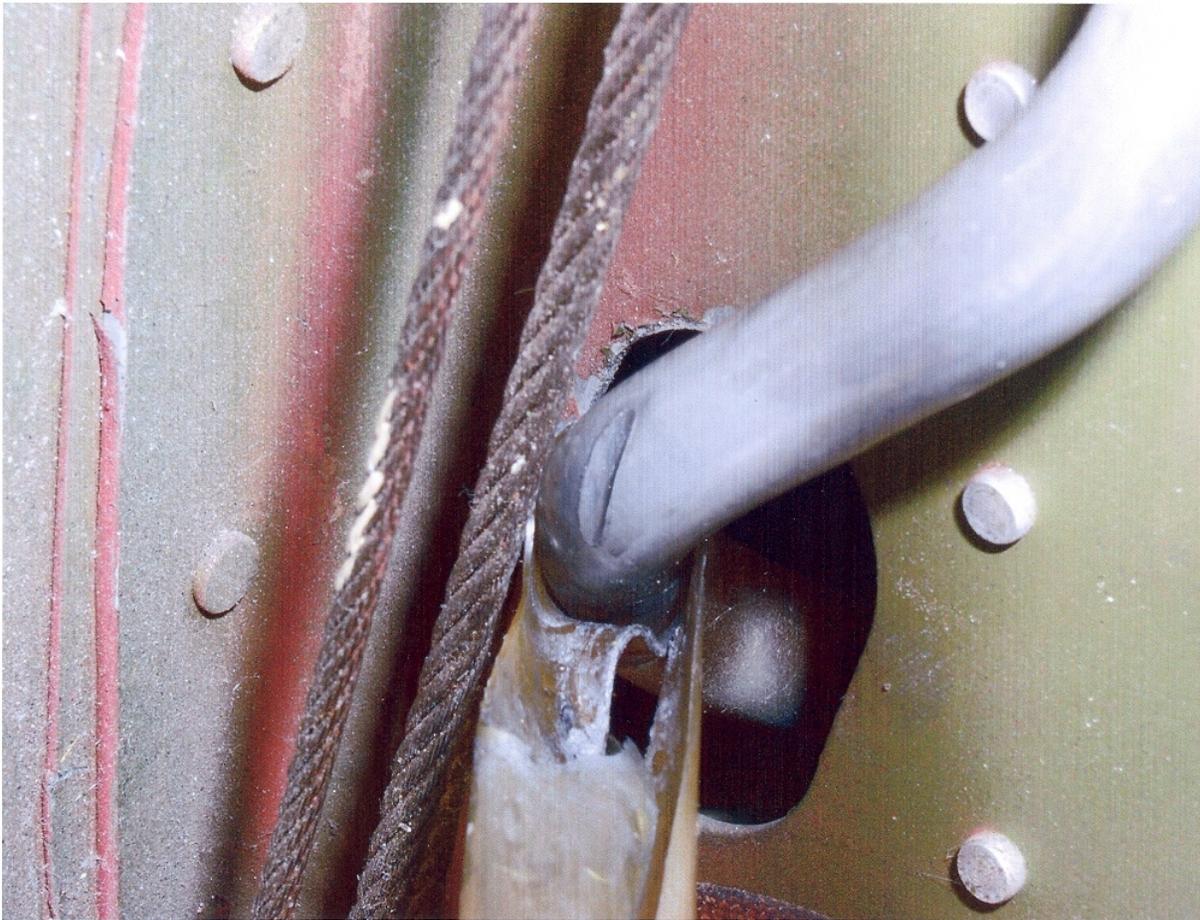
Figure 12-2. Fuel System

Cessna: 180J; Chafed Fuel Line; ATA 2820

A mechanic writes, "Two aileron cables, one flap cable, and the fuel line are all routed through the L/H lower aft door post area. This fuel line is protected by a plastic sleeve, but an (*aileron*) cable wore through the sleeve (*and began cutting*) into the fuel line. This line (*P/N 0500106-326*) is approximately 20 inches long with four bends. I suggest a one time inspection in case other aircraft might have this problem."

(A search of the FAA Service Difficulty Reporting System data base revealed five additional reports for this part number, all from similar chafing cables. See following pictures.)

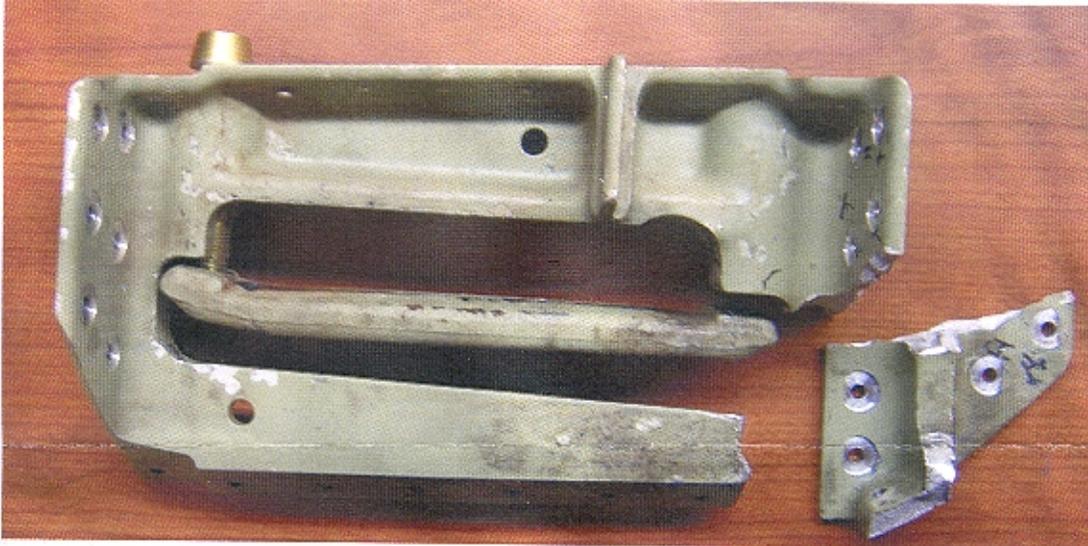
Cessna: T206H; Failed Main Gear Castings; ATA 5343

A technician states, "This aircraft is operated on mostly unimproved airstrips in Lesotho, South Africa. The part is the same *(as found on)* 206 F and G models, and was installed at the time of aircraft manufacture *(P/N 1211601-3)*. This casting cracked and failed upon landing. The aft bolt was also cracked and sheared. *(This aircraft)* had a normal approach and landing *(which resulted in)* the L/H gear leg breaking loose from the outboard casting and pushing backwards, pinching the brake line and locking up the left brake." *(Part time: 1,776.6 hours.)*

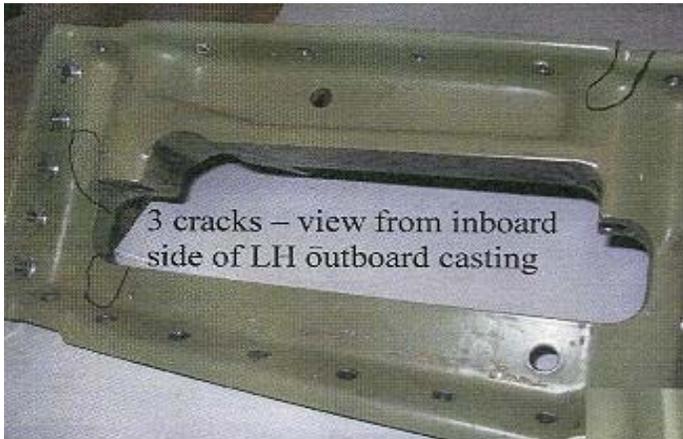
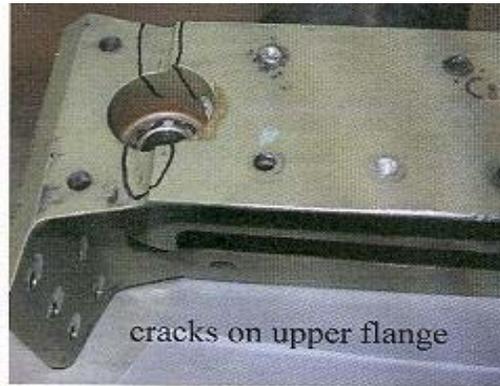
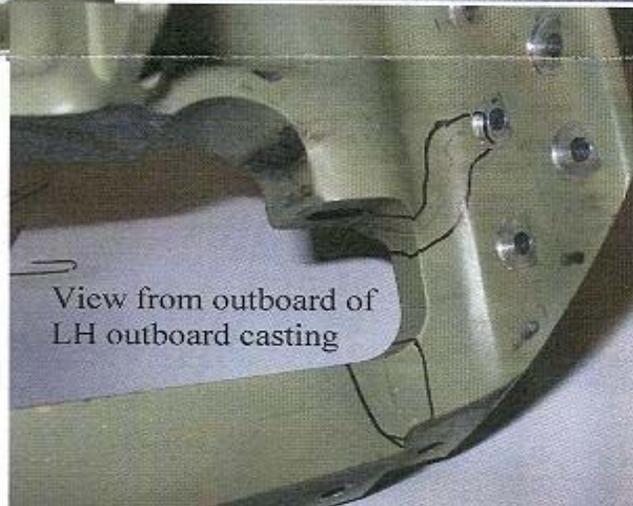
About the second aircraft Rocky says, “This casting is cracked in three different locations. We operate (*many*) of these aircraft and have a long history with the (*model*) 206. We have seen cracks of this nature before, but rarely with so little time in service.” (*Part Total Time: 1,250.0 hours.*)

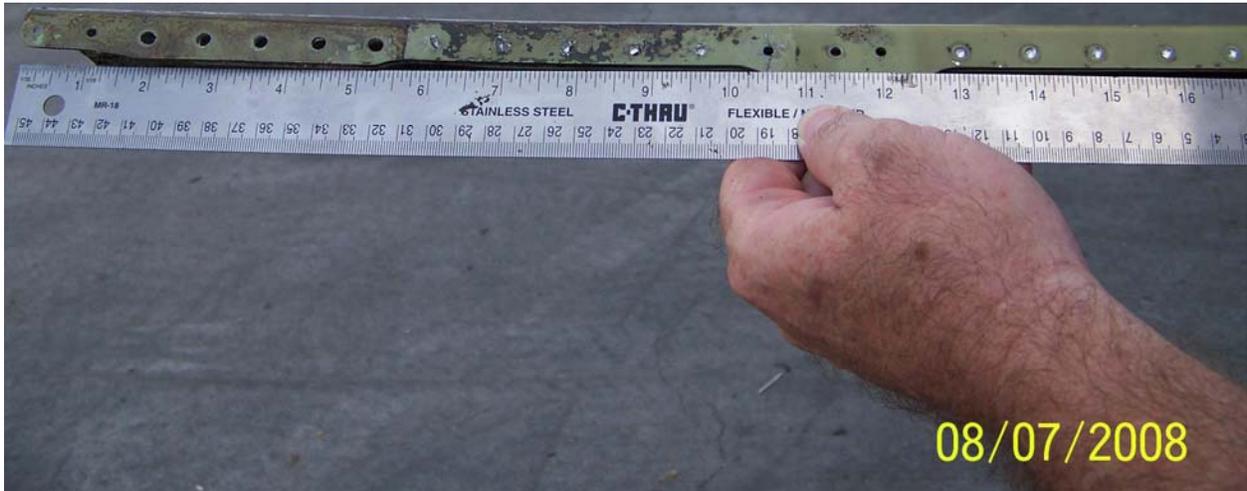
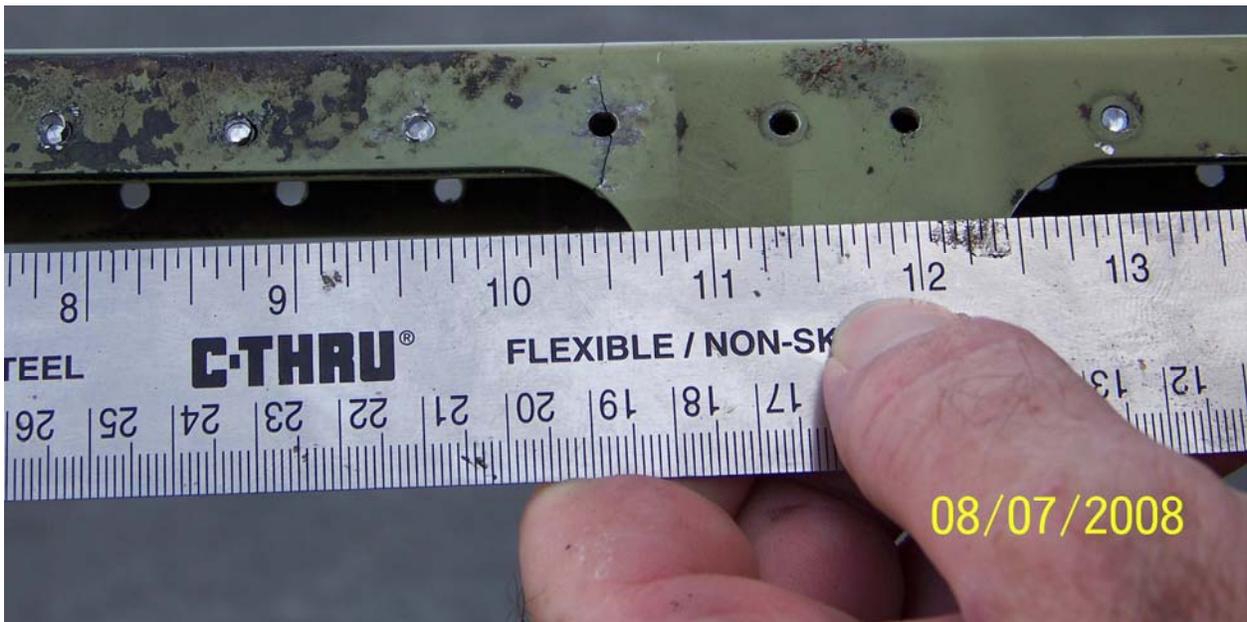
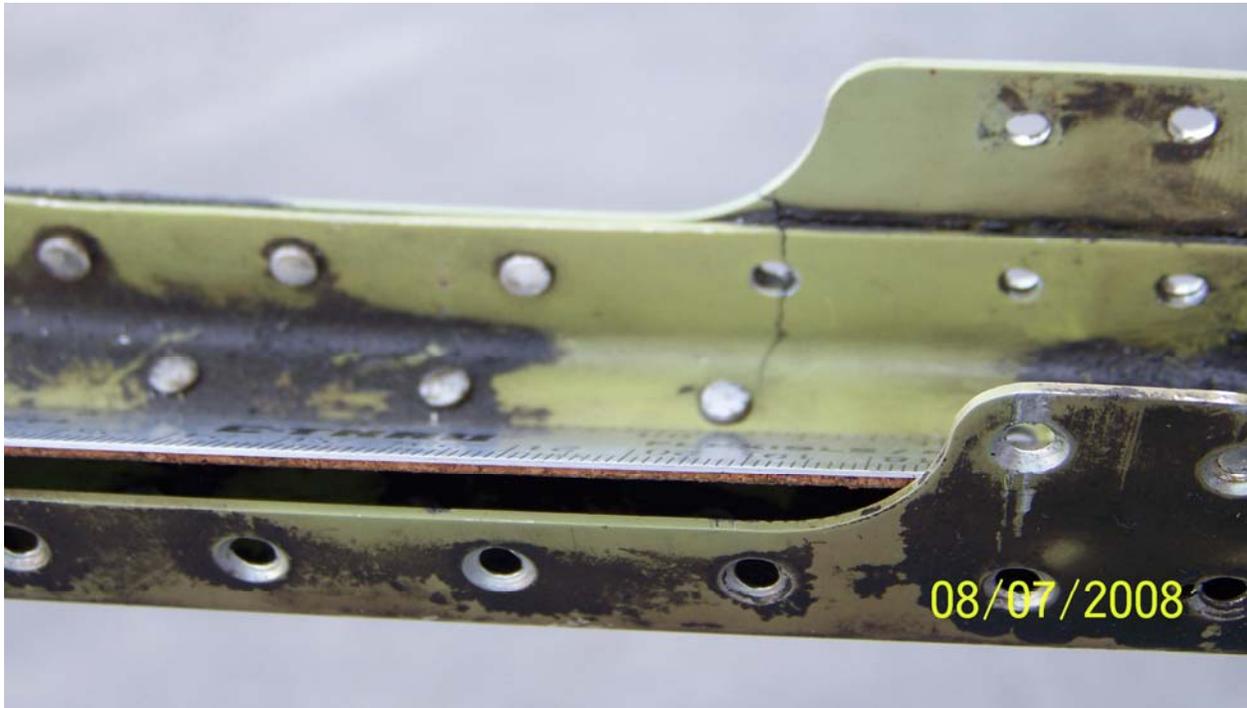
De Havilland: DH6-300; Cracked Nacelle Longeron; ATA 5413

A submitting mechanic says, "The R/H nacelle inboard longeron cracked 10.5 inches aft of the forward end (P/N C6W1512141). I removed and replaced the R/H inboard longeron...and verified modification 6/1655 is installed per AD 80-13-12 R1."

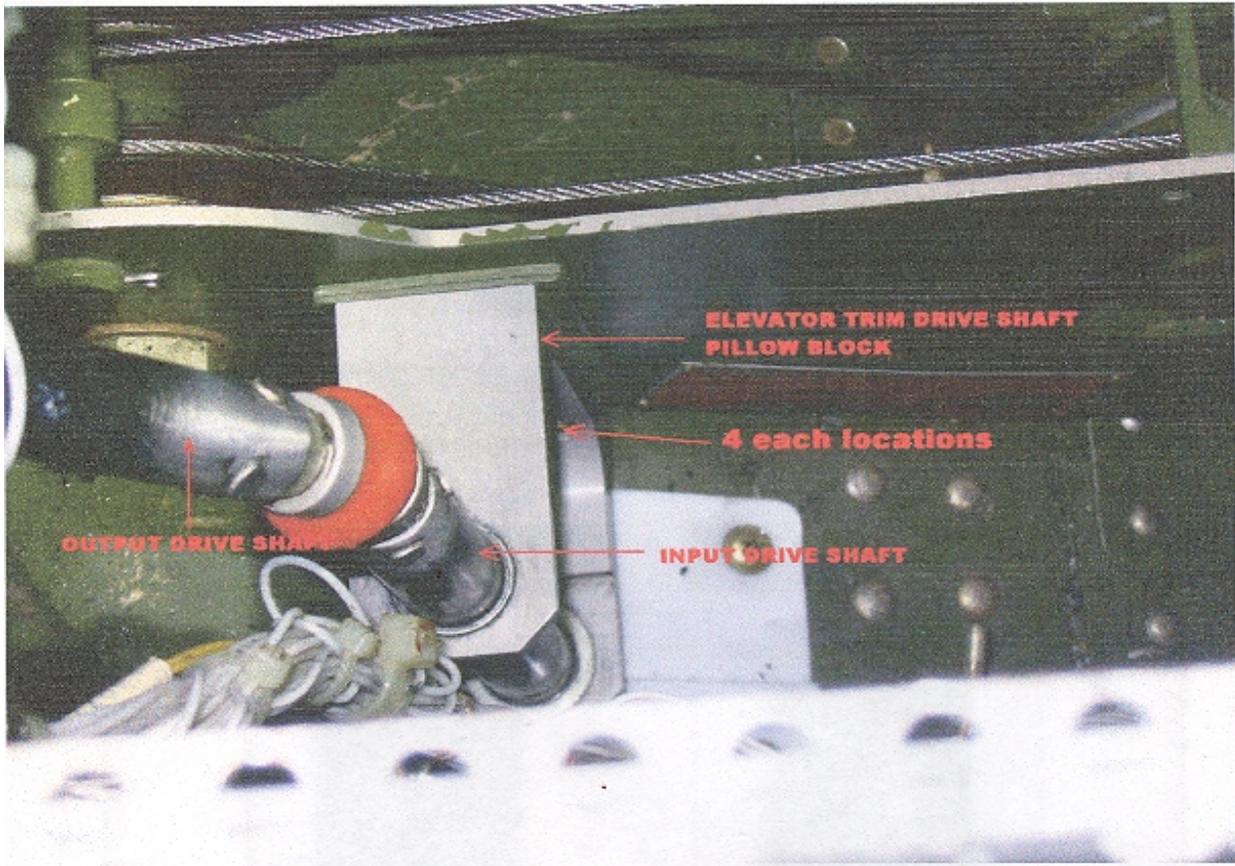
Gulfstream: GIV; Loose Pillow-block on Elevator Trim; ATA 2742

About this aircraft the Director of Maintenance for an air carrier writes, “...upon descent from 41,000 feet (*the flightcrew*) got an ‘FGC1 fail message’ along with a ‘forward trim limit’ message. They were unable to trim the aircraft elevators. They complied with the checklist to reset both messages with no success. The autopilot was disconnected and an emergency declared with Air Traffic Control..., manually landing the aircraft without incident.” “Technicians found the hardware attaching the elevator trim, driveshaft pillow block had loosened, causing the driveshaft to separate from the output shaft. They secured the hardware and attached the output shaft

to the drive input shaft. Then the elevator trim system was rigged IAW GIV, AMM 27-04-00 (*maintenance manual*). No other discrepancies were noted. After further investigation it has been found that Gulfstream issued an ASC (Aircraft Service Change) number 70 which (1) installs cotter pins on the output to the input drive rods, and (2) changes the attachment hardware for the pillow drive block (*to accept*) cotter pins. I strongly recommend this ASC to prevent an occurrence like this in the future. It surprises me that Gulfstream only has this as a 'recommended ASC' (*instead of a*) 'mandatory'." (*The "pillow-block" part number was not provided.*)

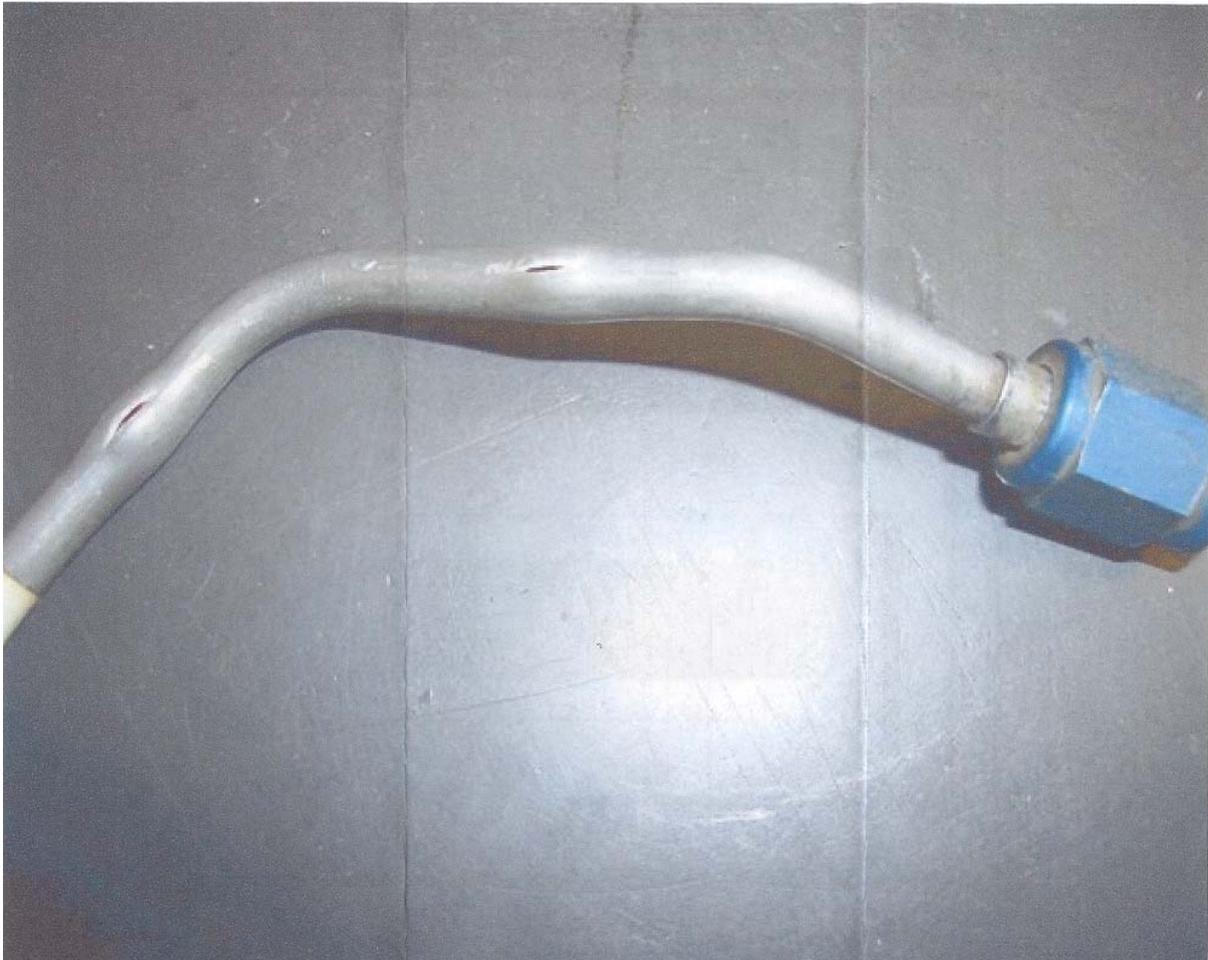
HELICOPTERS**MDH****MDH: 369d; Split Bypass Reference Tube; ATA 7220**

A repair station technician writes, “During an annual inspection of the particle separator it was discovered that the bypass switch reference line was split—(*its cause*) obviously from frozen water. The aircraft had (*previously*) flown in snow (*precipitation*). After landing it spent a couple of days out in subzero weather.”

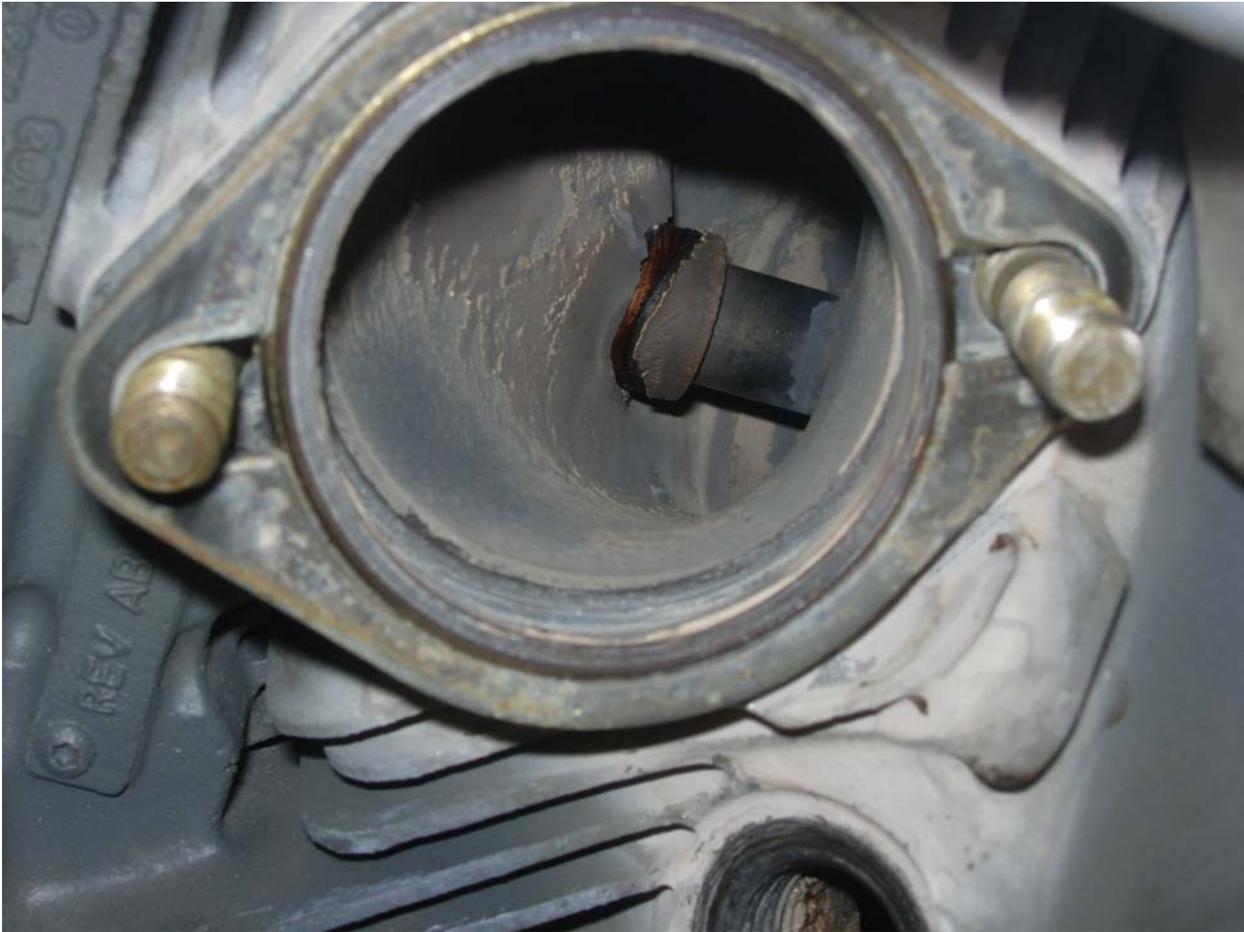
Lycoming: IO360-L2A; Seized Exhaust Valve; ATA 8530

An inspector for a repair station provides the following discrepancy report concerning a Cessna 172. “During flight the engine started running rough and lost power. An emergency landing was completed without damage or injury. Maintenance found the number three exhaust valve seized in the valve guide. Further investigation found the guide (P/N 74230) broken in the cylinder head. This operator has seventeen Model 172S aircraft with the new roller tappet engines. We have been performing an SB388C (*service bulletin*) inspection on the rest of the fleet and have found the majority of the exhaust valves for all cylinders to be tight in the guides. Lycoming SI1485 (*service instruction*) recommends a 1000 hour interval for these engines for the SB388C inspection. Our current fleet has between 650 and 900 hours total time per aircraft. We will be initiating a 600 hour interval for the SB388C for our fleet. We have also revised our (*fuel*) leaning procedures.”
