## ADVISORY CIRCULAR

43-16A

# AVIATION MAINTENANCE ALERTS

**ALERT  
NUMBER  
373**

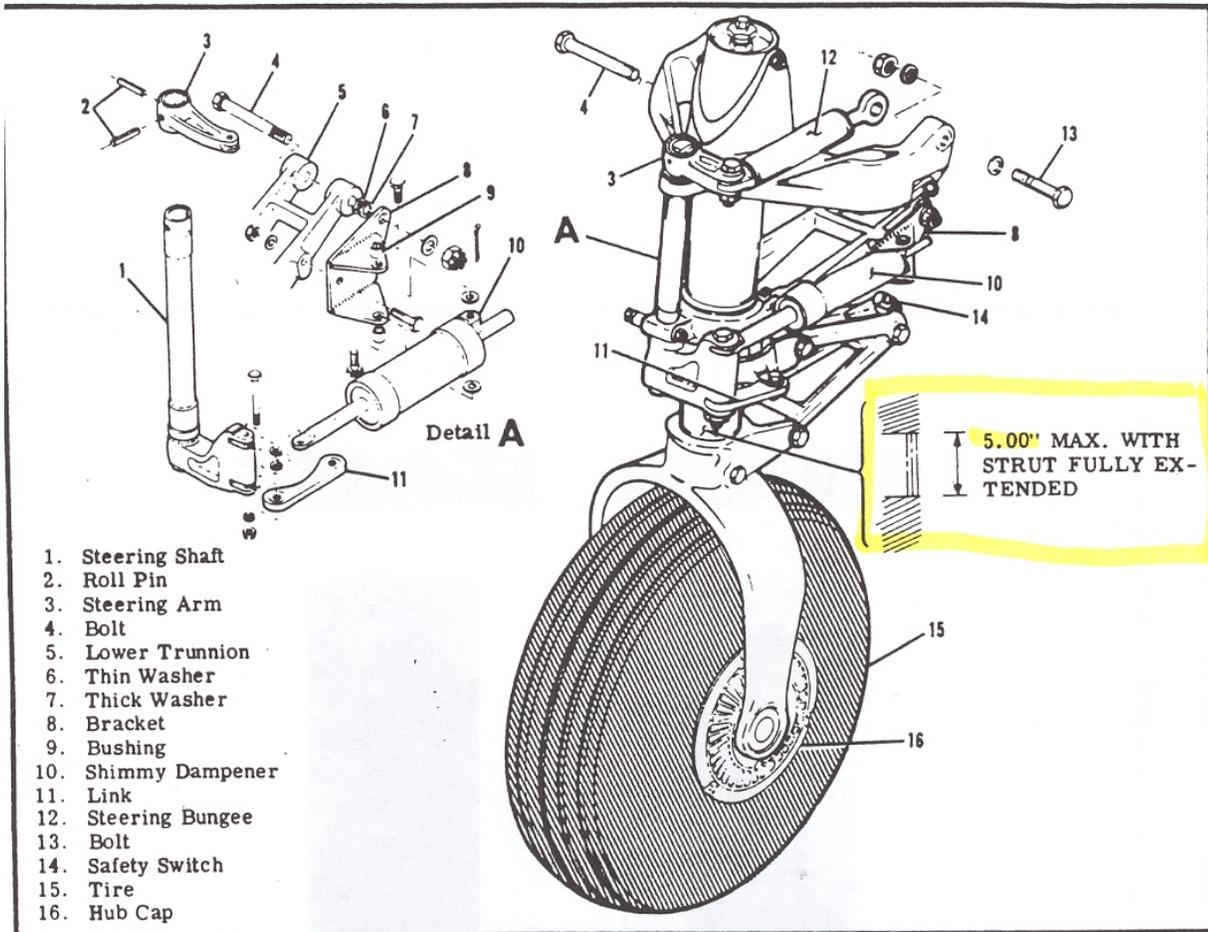
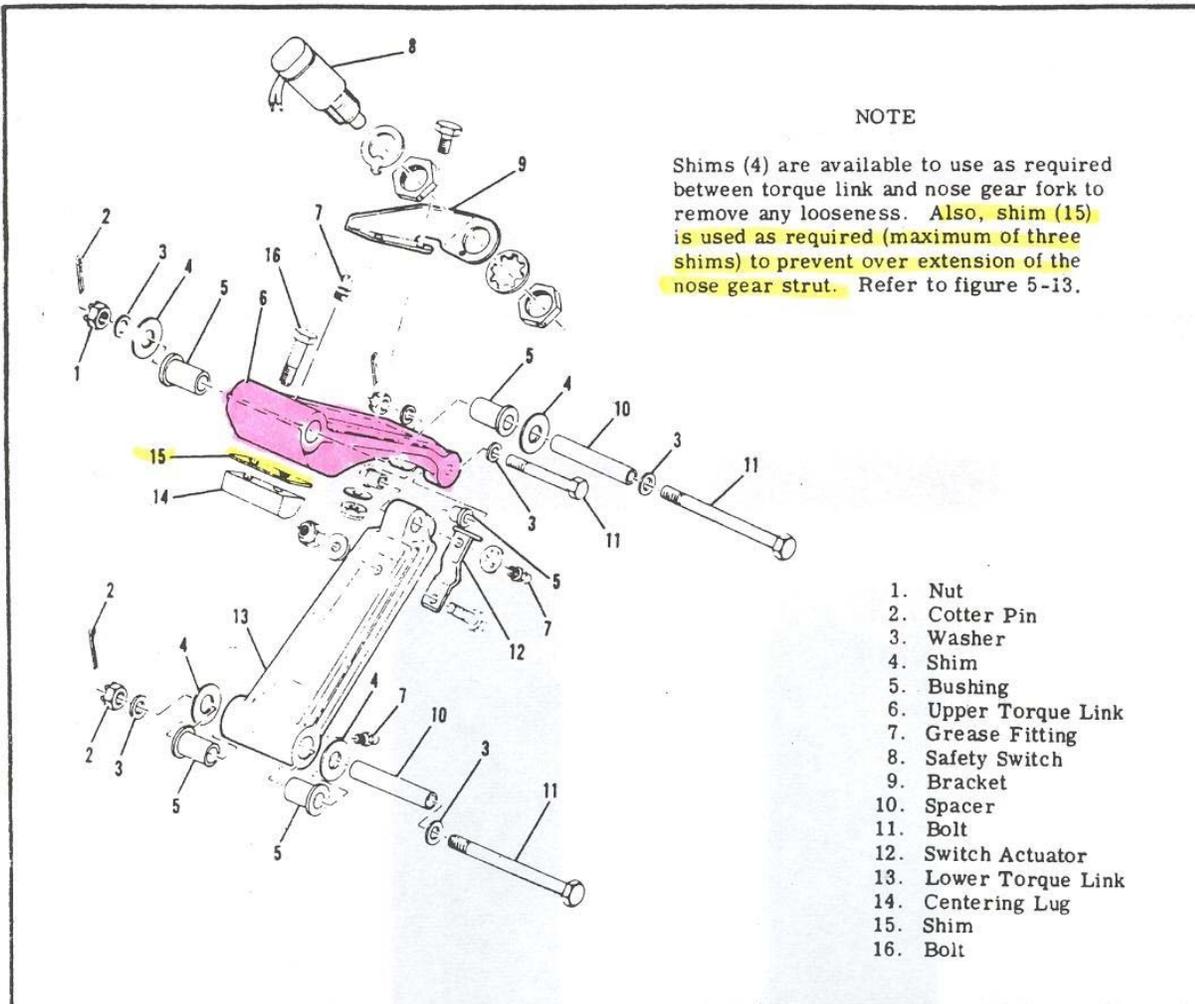
Figure 5-18. Nose Gear Torque Links

**Cessna: 210; Cracked Nose Gear Torque Link; ATA 3222**

An aircraft technician states, "Our repair station has replaced several of these same upper torque links due to finding them bent at inspection (approximately five *have been found*). This is the first one found cracked.

"I believe the probable cause is landing impact with more than the recommended strut extension (5.00 inches max.), according to Cessna Service Manual, figure 5-15. (*This strut extension...*) is adjustable by adding shims (item 15; three maximum) in accordance with the note on figure 5-18." (*The shim P/N is 1243618-2.*)

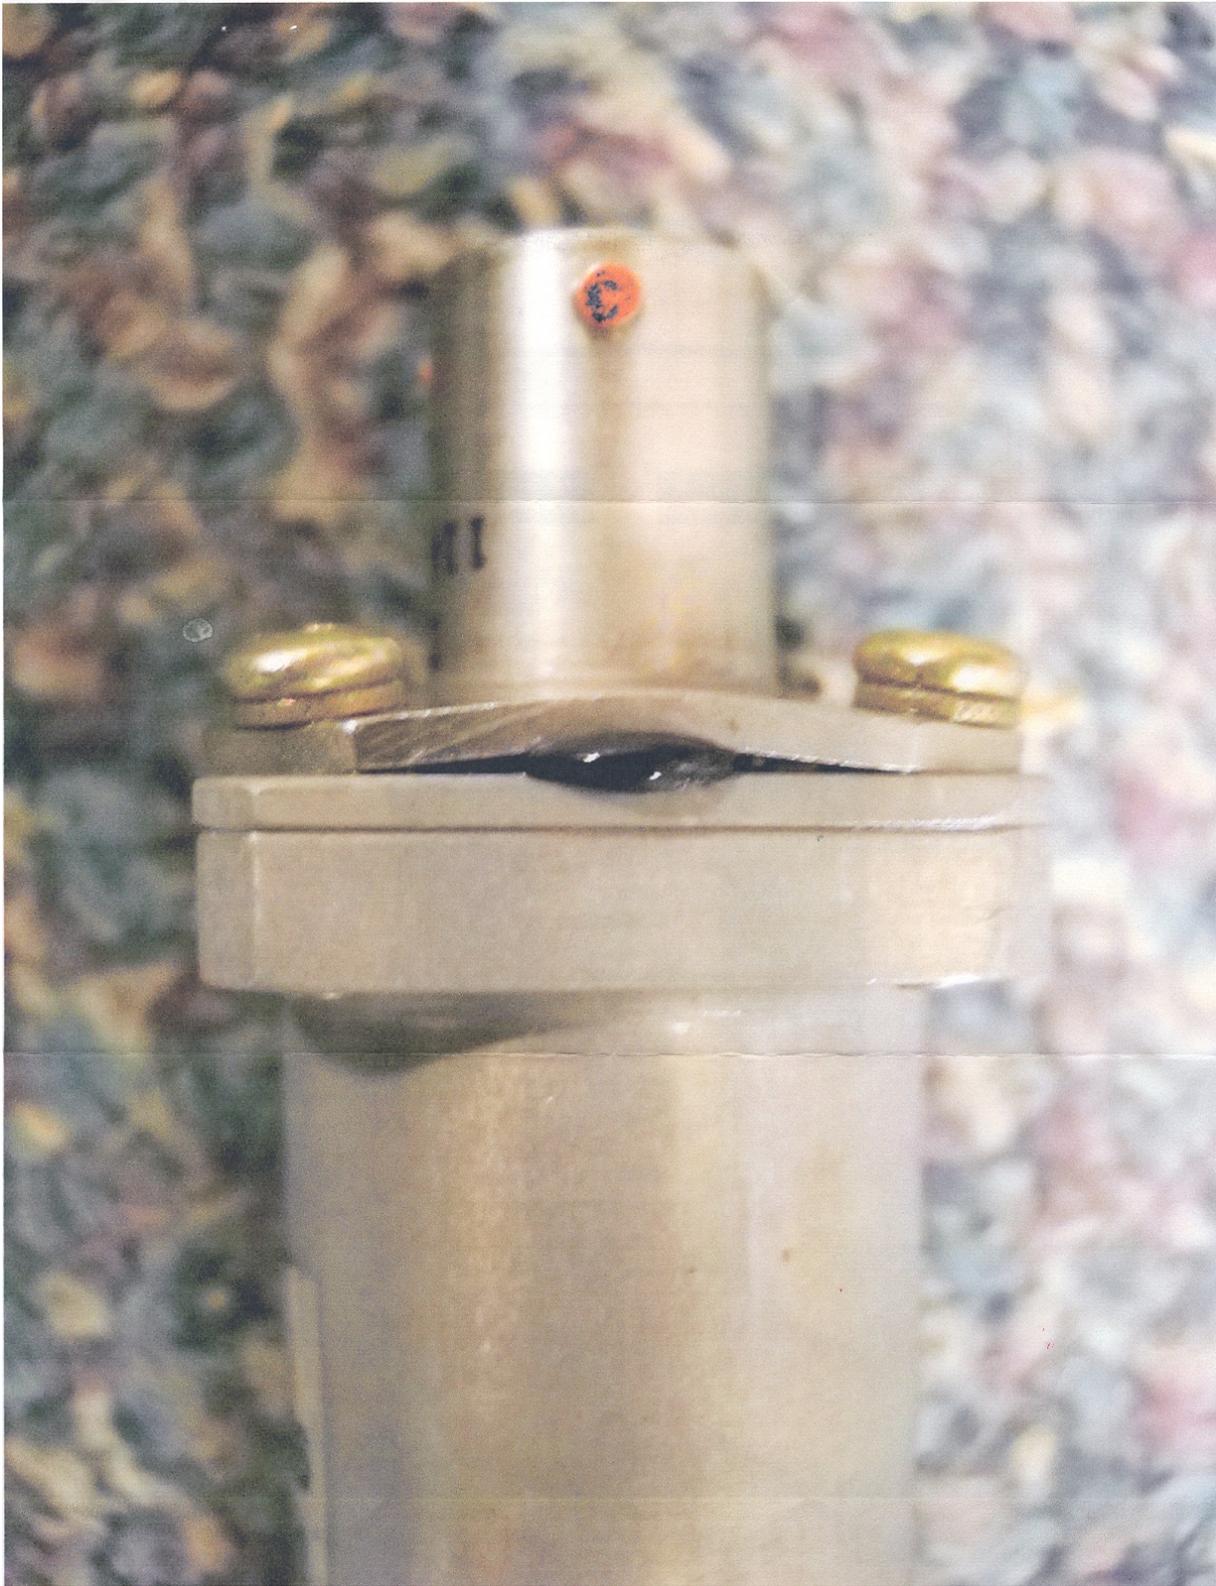
**Learjet: 45; Failed Hydraulic Pressure Switch; ATA 2915**

An inspector for a repair station writes, "The Cannon plug adapter on the back of the switch deforms under pressure; the o-ring displaces and hydraulic fluid leaks *(past)*. Loss of hydraulic fluid led to complete hydraulic failure. *(The pilots allowed the landing gear to free-fall to the down position.)* Learjet is working to replace this and four similar switches in the aircraft. *(I)* recommend replacing this switch *(P/N 7629001004-001)* with a stronger unit."

*(The submitter includes the manufacturer's P/N: 51158, and locates this pressure switch below the hydraulic reservoir. Okay—the background is a bit difficult...but the subject is spot-on, tells the story, and removes any doubts. Thank-you for the photo effort—Ed.)*

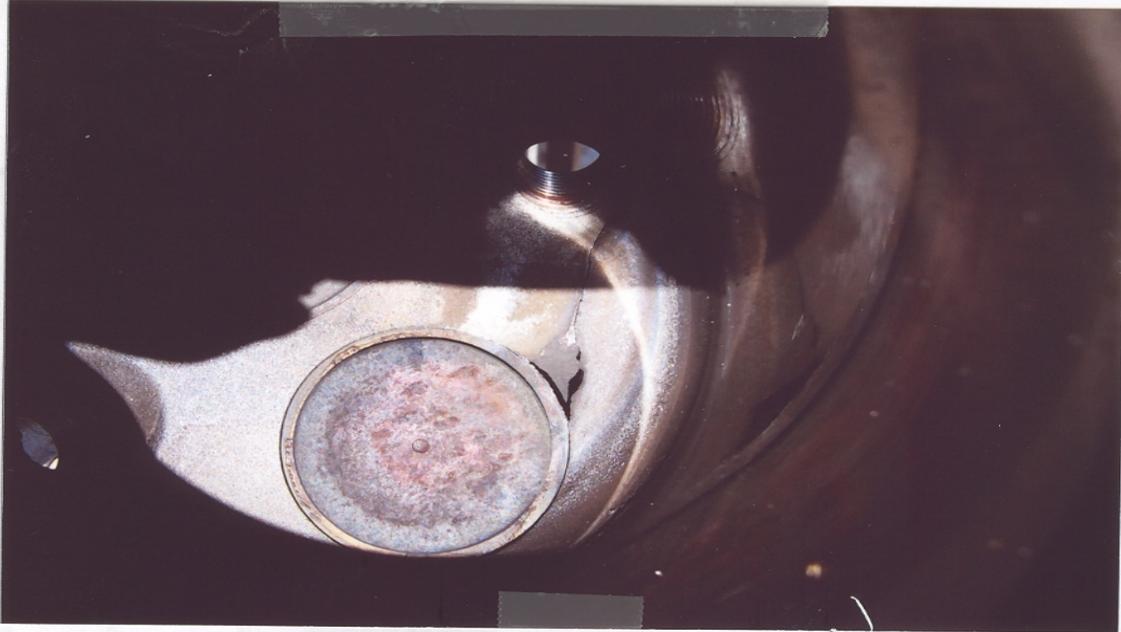
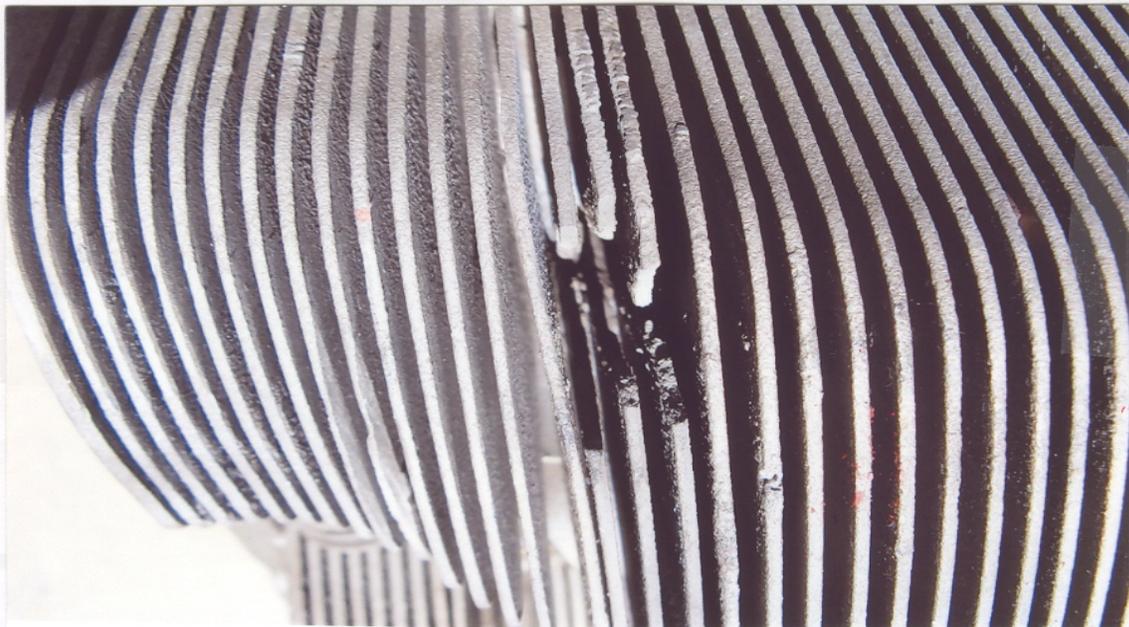
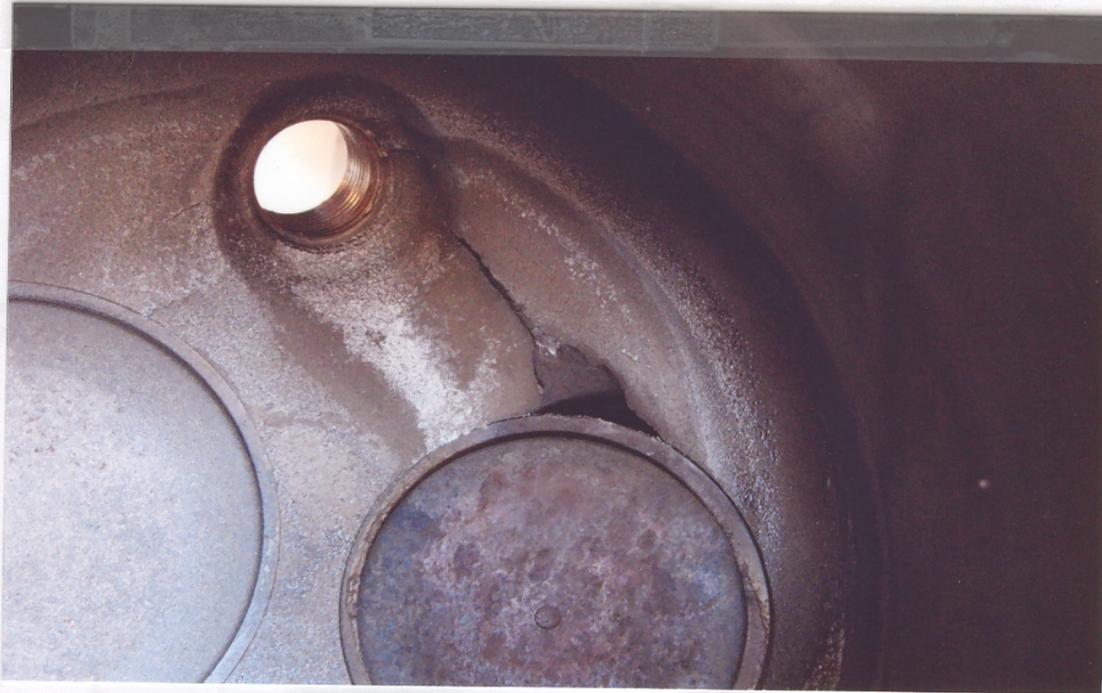
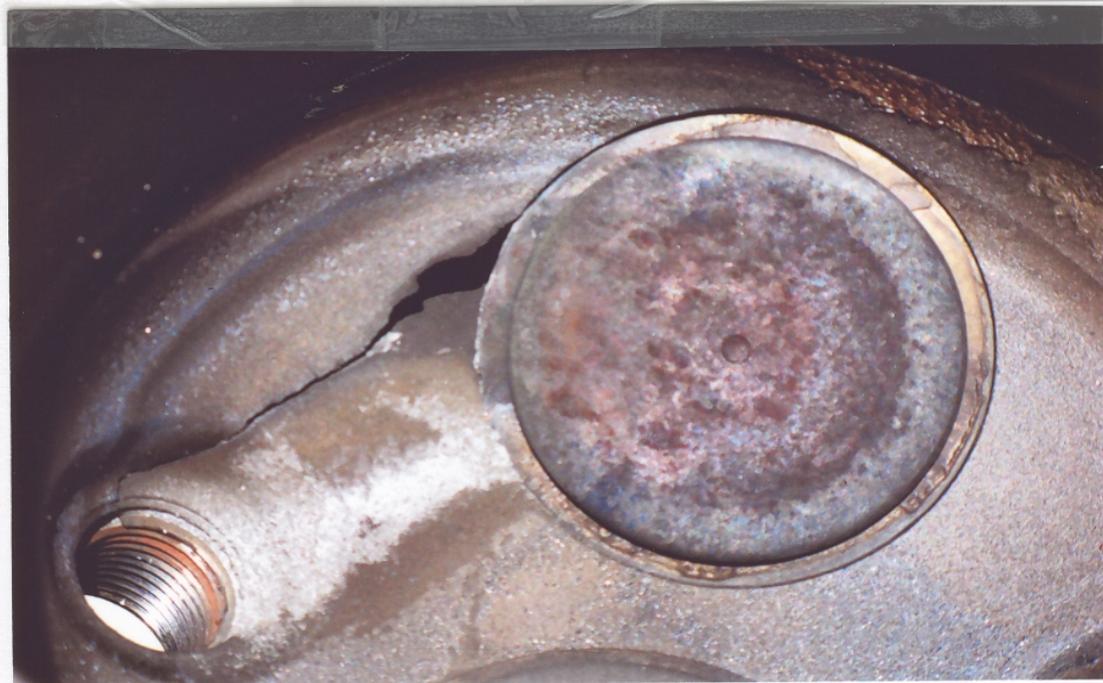
AEC631397 SN.71.2  
S/N 25526.22

### **ECI Cylinder; AEC 631397; Cracked Cylinder Heads (6 ea.) ATA 8530**

A mechanic for a Cessna 414A describes the following engine defects. "The ECI Titan cylinder head failed in flight and blew out a section of the head and fins. Investigation revealed a 0.50 inch hole had developed from a crack that progressed from the exhaust valve seat to the upper spark plug hole. An additional crack was found on this (*particular*) cylinder, (*moving*) from the upper spark plug hole to the injector boss. After inspection of all cylinders on both engines, five other of the original cylinders installed at overhaul were found cracked. All cracks were either from the injector boss to the upper plug hole or from the exhaust valve to the upper plug hole. Both engines were overhauled at the same time—the cylinders all had the same amount of (*operational*) time.

"No metallurgical analysis was performed and no cause could be determined (*for these defects*). All cylinders were sent back to the manufacturer."

*(All six reports include the additional cylinder marks: SN71.2 REV P. These are great pictures—slightly stretched by this editor to fit the page. Note the previous entry for additional information.)*

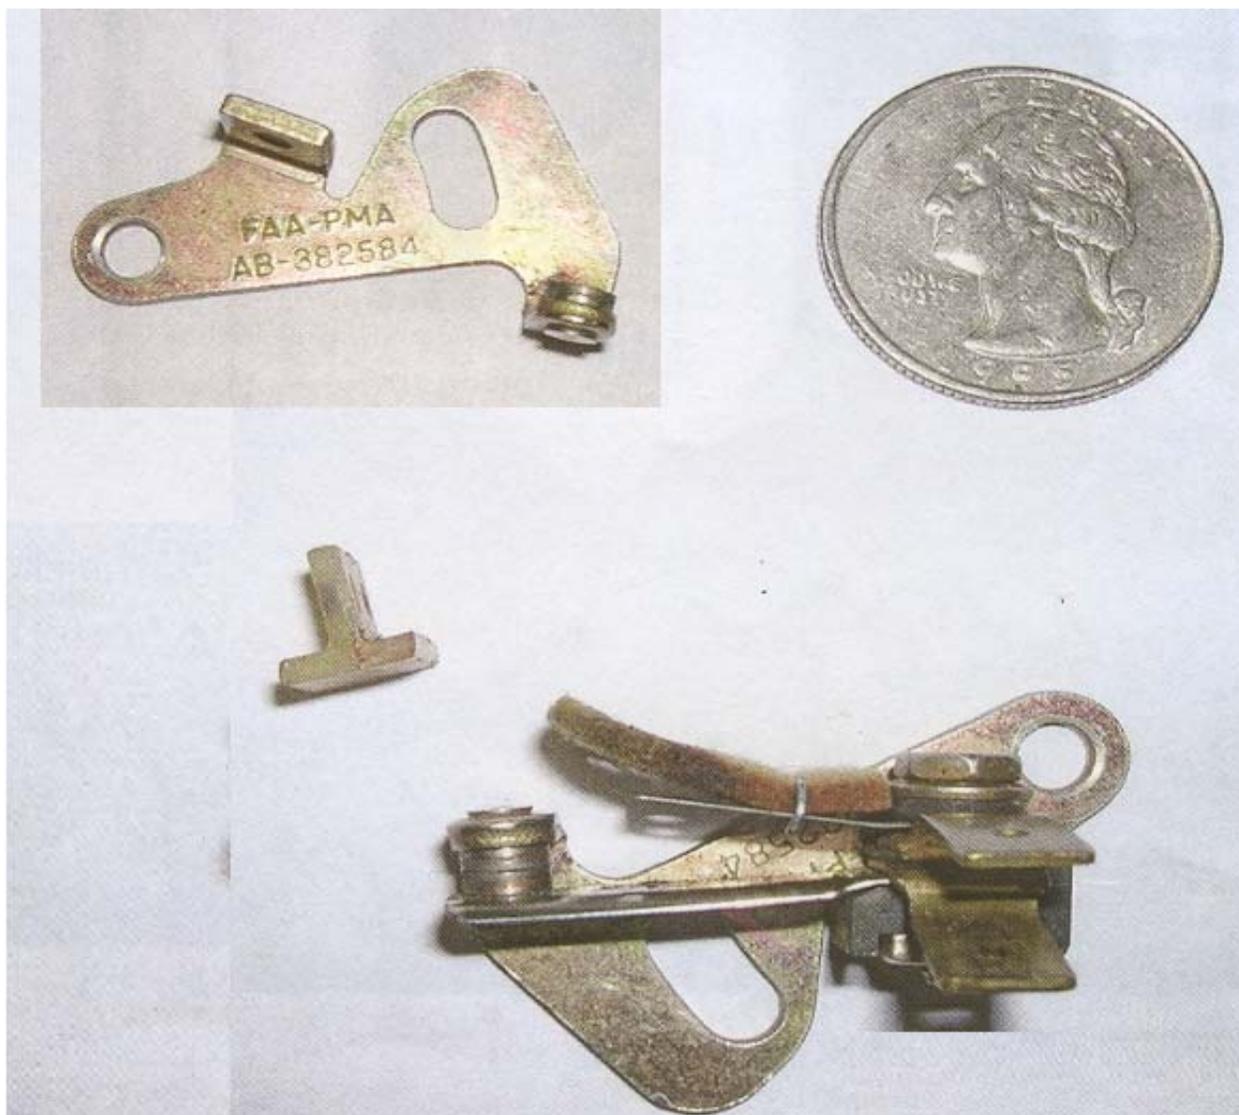
### **Bendix Magneto: S6RN-1208; Broken Contactor Rivet; ATA 7414**

An FAA inspector states, "A broken contact breaker was found during troubleshooting of an ignition problem on a Bellanca 17-31ATC. The contactor rivet was broken in this Bendix Magneto. This rivet may be insufficient (*referencing size/strength*) to properly hold the contactor in place."

*(The above photo combines two of the three submitted pictures. Contact P/N: AB-382584.)*

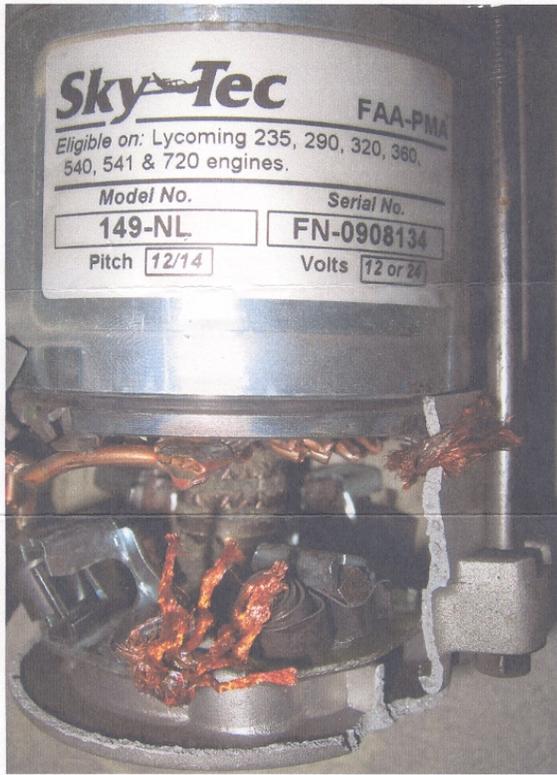
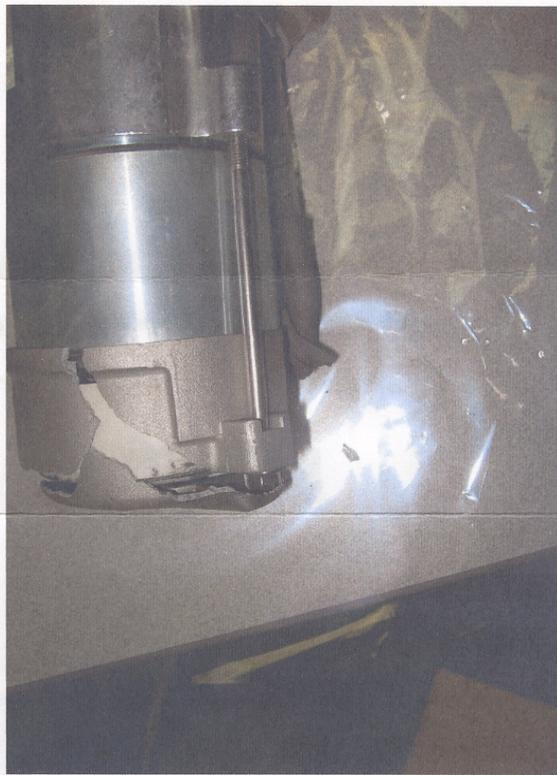
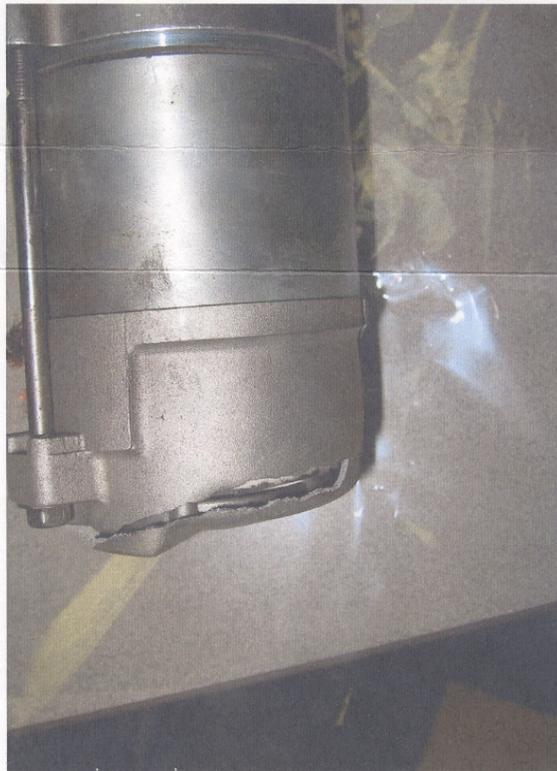
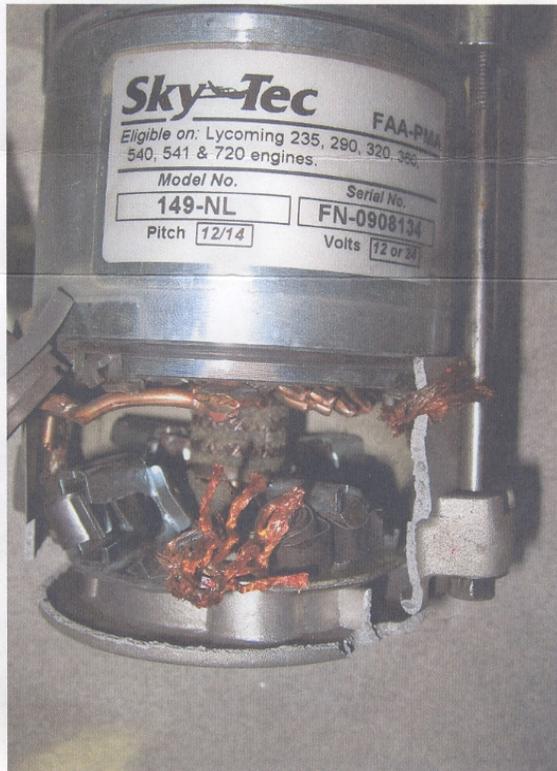
**Sky Tec Starter: 149NL; Shattered End Cap; ATA 8010**

A repair station technician says, "The starter end cap shattered. This is the third occurrence that we have seen on the Cessna 172S aircraft."

*(This picture evokes a flinch and cringe! It is dramatic. It does make a statement, and your reporting will make a difference. There are 12 of these listed in the SDRS database now—keep filing those reports!)*
