ADVISORY CIRCULAR

43-16A

AVIATION MAINTENANCE ALERTS

**ALERT
NUMBER
397**

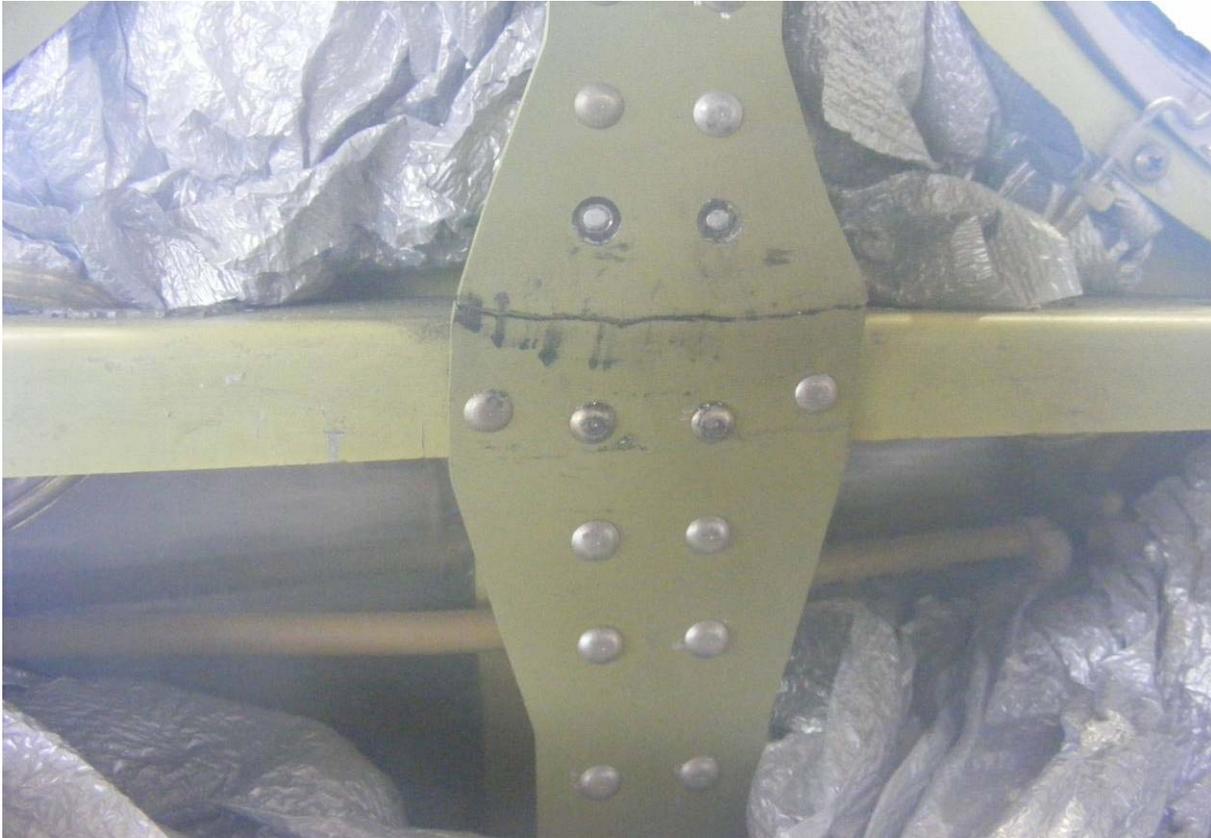
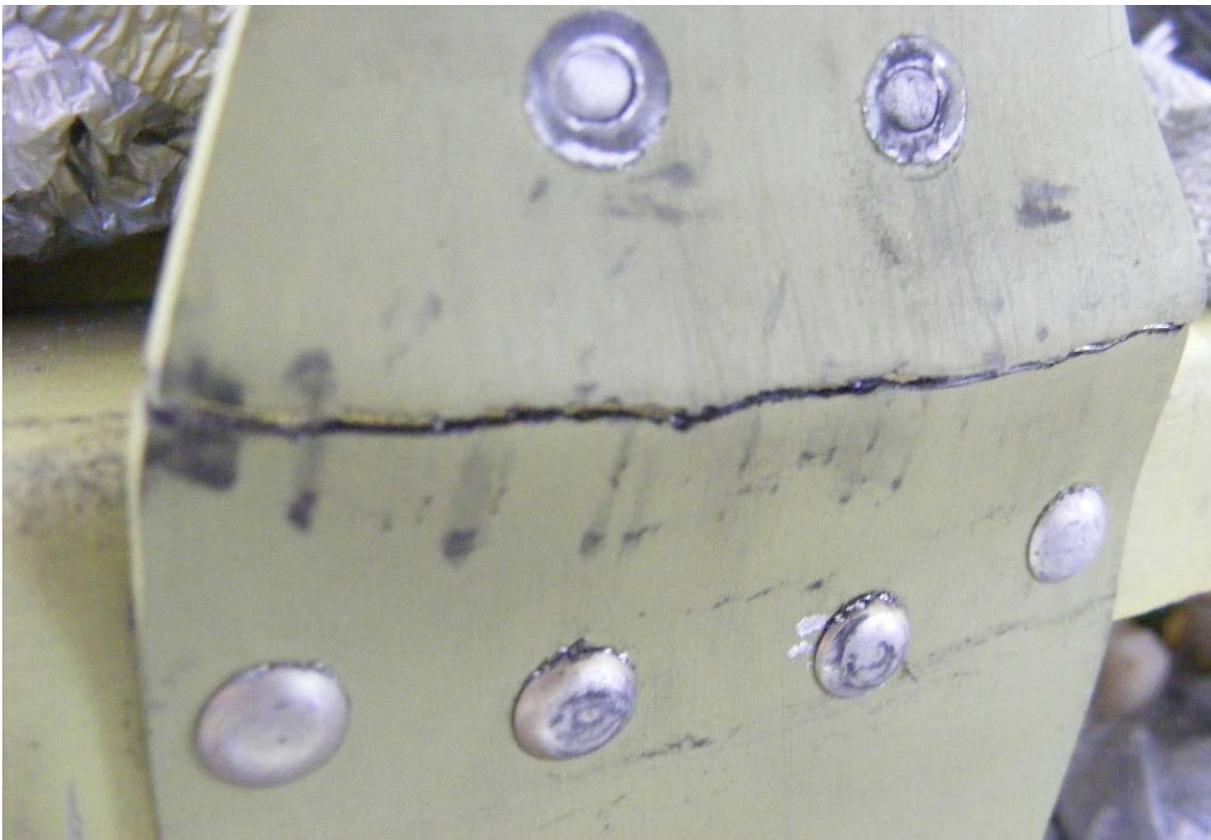
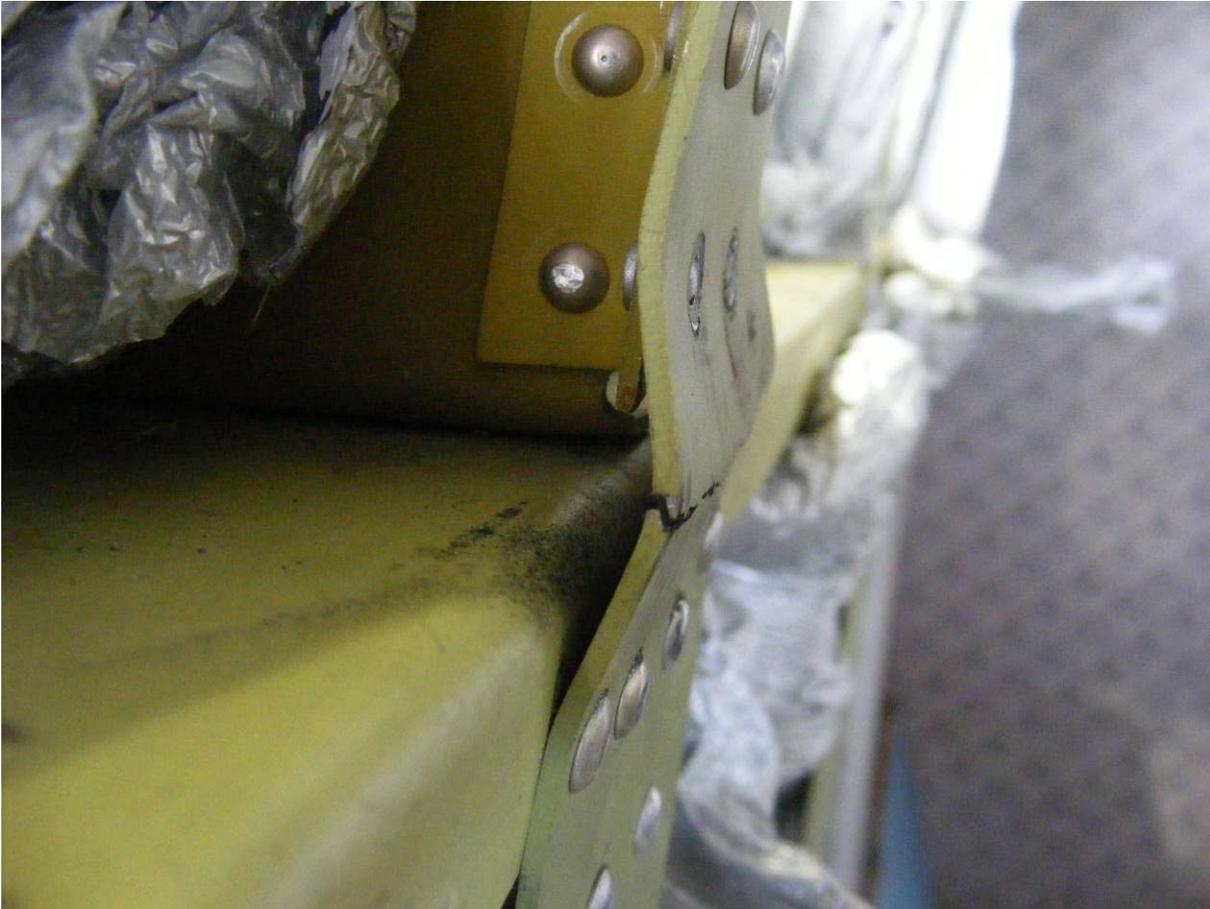
Beech: 300; Failed Fuselage Crosstie; ATA 5320

"Inspection of the sidewall structure revealed a failed crosstie at fuselage station 227.125," says this repair station submitter. "This structural tie is situated between the number three and four right cabin windows—vertically *(between)* the lower sidewall to overhead the passenger seat. The part has cracked fully in two *(pieces)*, and it is deformed from its original 'flat' shape—apparently from compression. Two rivets immediately above the break have failed. No other crossties *(P/N: 101-420013-1122)* display any deformation, cracking, or evidence of preload."

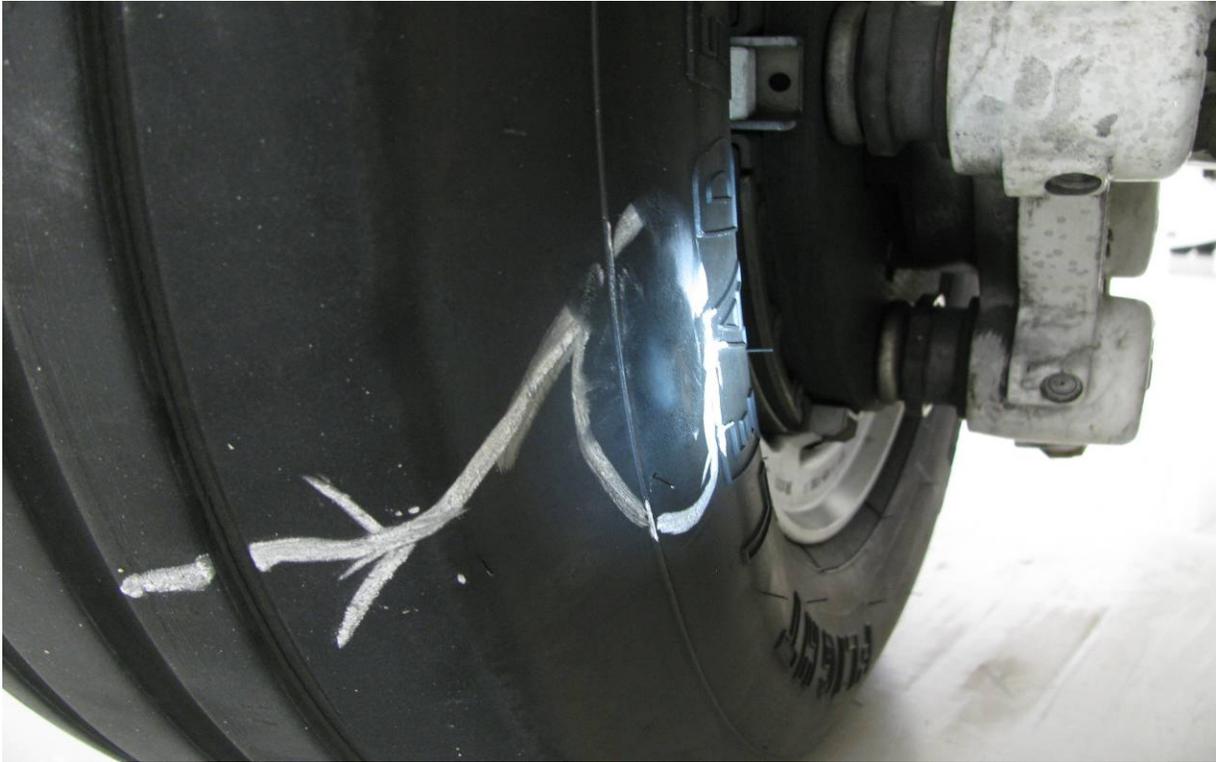
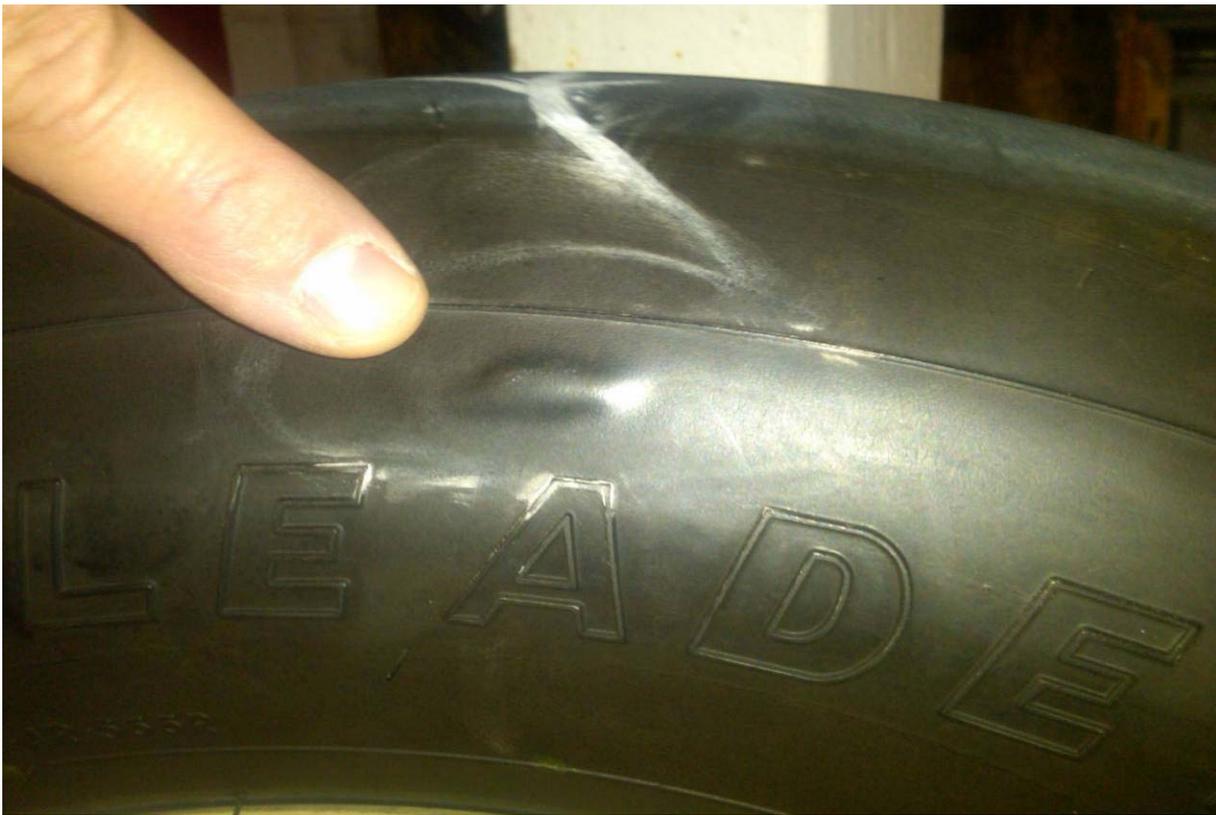
Bombardier: BD1001A10; Defective Tire; ATA 3244

"(I) found a bulge on the sidewall of the number one main landing gear tire," states this mechanic. "The bulge is just below the tire cap and is 0.875 inches long, 0.375 inches wide, and protruded about 0.0625 inches. This (*bulge was found*) on the newer -2 tire for this aircraft—(*this new tire was*) suppose to alleviate bulging as seen on the older -1 tires. I recommend all operators keep a close eye on their tires; this (*particular*) tire (*P/N: 269K432*) only had 56 landings."

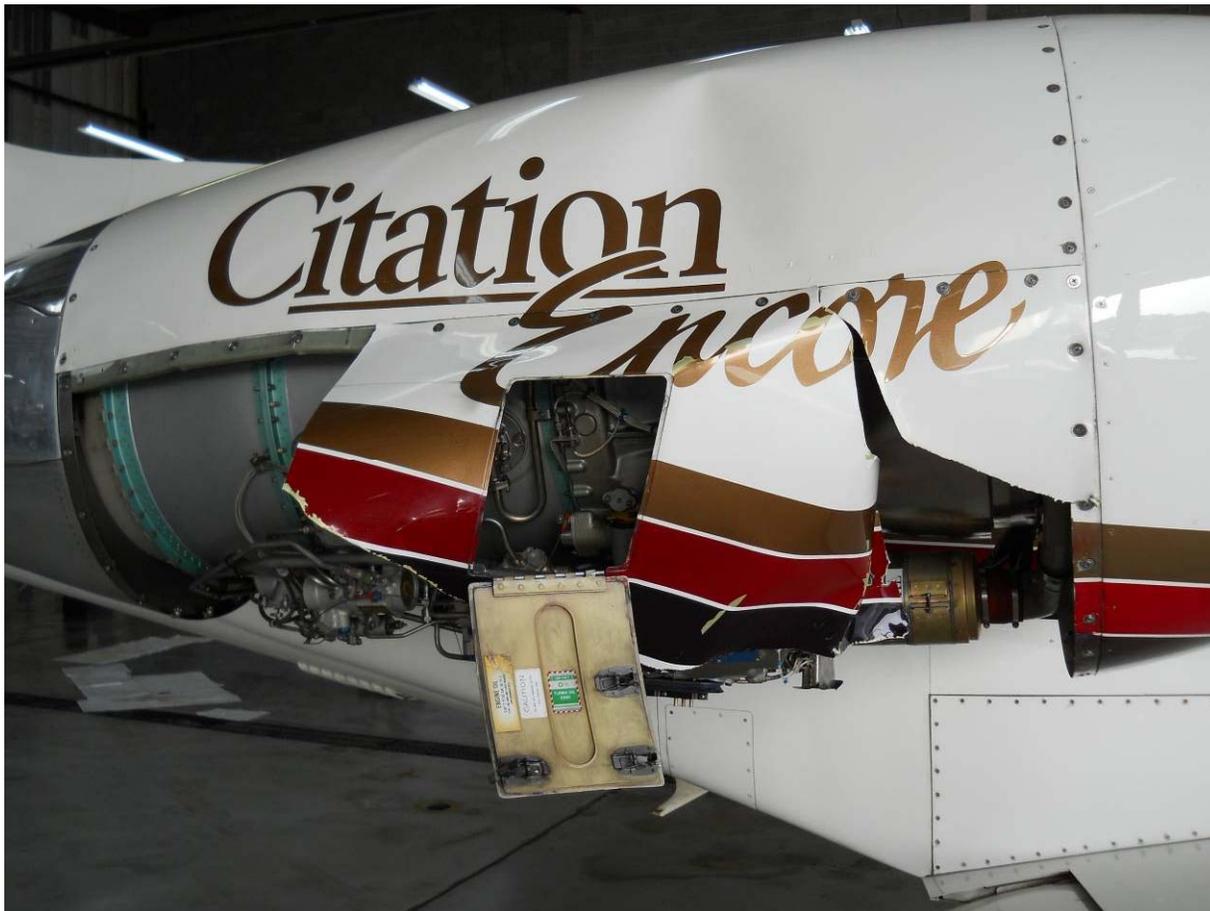
Cessna: 560; Failed Engine Cowling; ATA 7110

"While in descent (*through*) altitudes 25 to 20 thousand feet," says this submitter, "a faint *bang* was detected and a small jolt was felt throughout the airframe. The flight continued without difficulty to the scheduled destination where landing occurred without incident. Post flight inspection revealed the lower right engine cowling had separated from the aircraft—80 percent of the part was missing. The upper right engine cowling was found bent, but still fully attached. Note: all cowling attach fasteners were found in place—except three lower cowling attach studs located at the inboard trailing edge." (*Engine cowling P/N: 65526508.*)

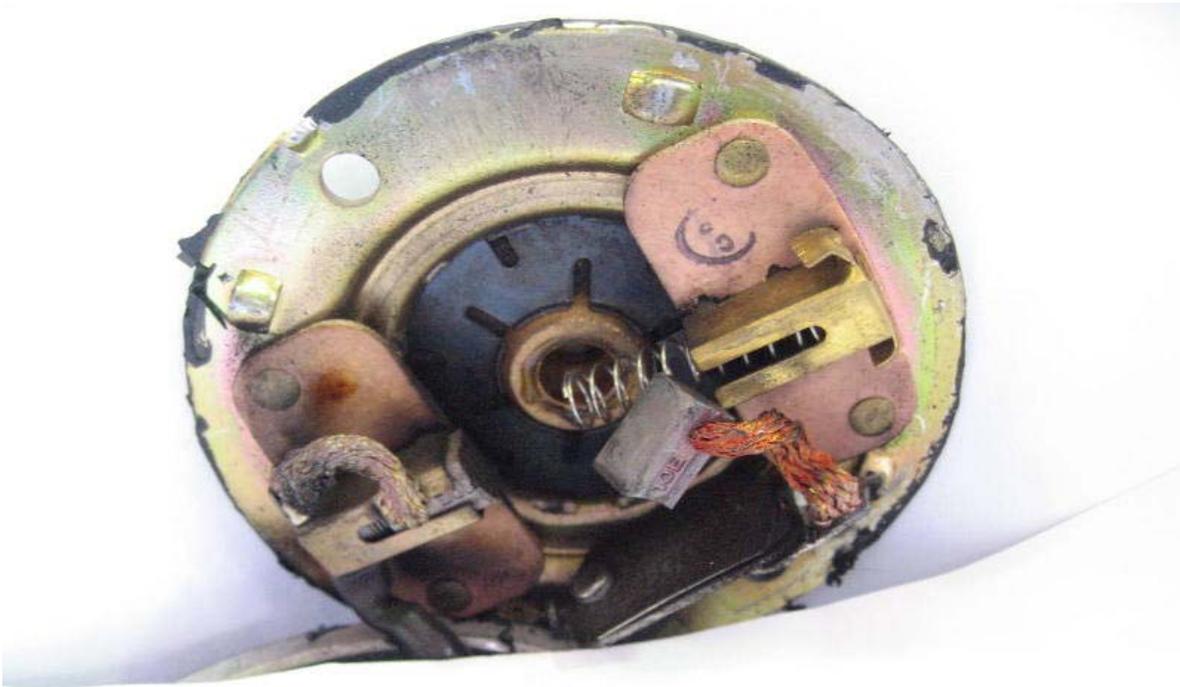
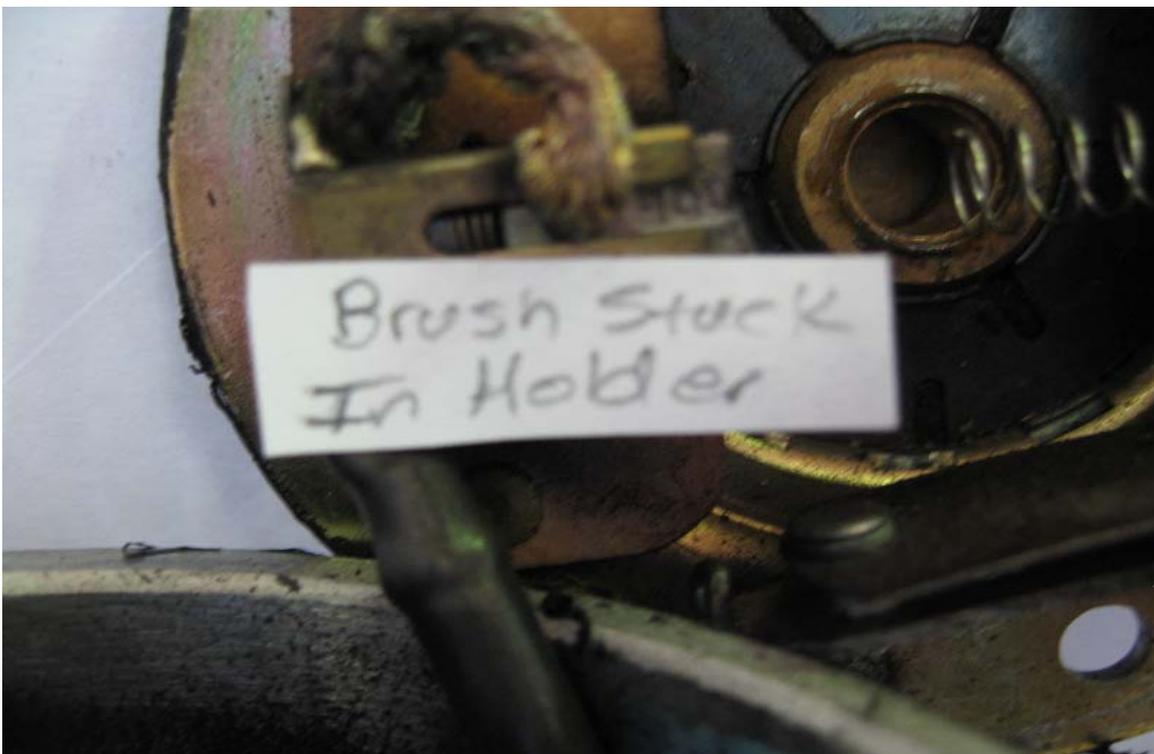
Piper: PA28-RT201; Failed Landing Gear Power Pack; ATA 2913

A repair station submitter says, "After (*the pilot's unsuccessful attempt*) to perform emergency main landing gear extension several times, this aircraft made a successful, gear-up landing. The hydraulic (*landing*) gear Power Pack motor (*P/N HYC5005*) failed during initial gear retraction after takeoff. Investigation and troubleshooting determined the cause of the Power Pack failure was due to a fracture of a questionable solder joint that attached one electric motor brush pigtail to the brush holder. The broken solder joint created enough heat from high resistance to discolor the brush holder and anneal the brush spring. This re-heated spring's free length measured 0.330 inches instead of the (*normal*) 0.960 inches. The Power Pack had been overhauled 29 months earlier (or 142.5 hours). Further troubleshooting revealed the static port in the left automatic MLG extension airspeed mast was solidly plugged with a mud (*type*) insect's nest." (*Brush P/N: ESQ12SBRUSHERH22. Power Pack manufacturer: Prestolite; model HYC5005. This motor has 15 entries in the SDRS database.*)

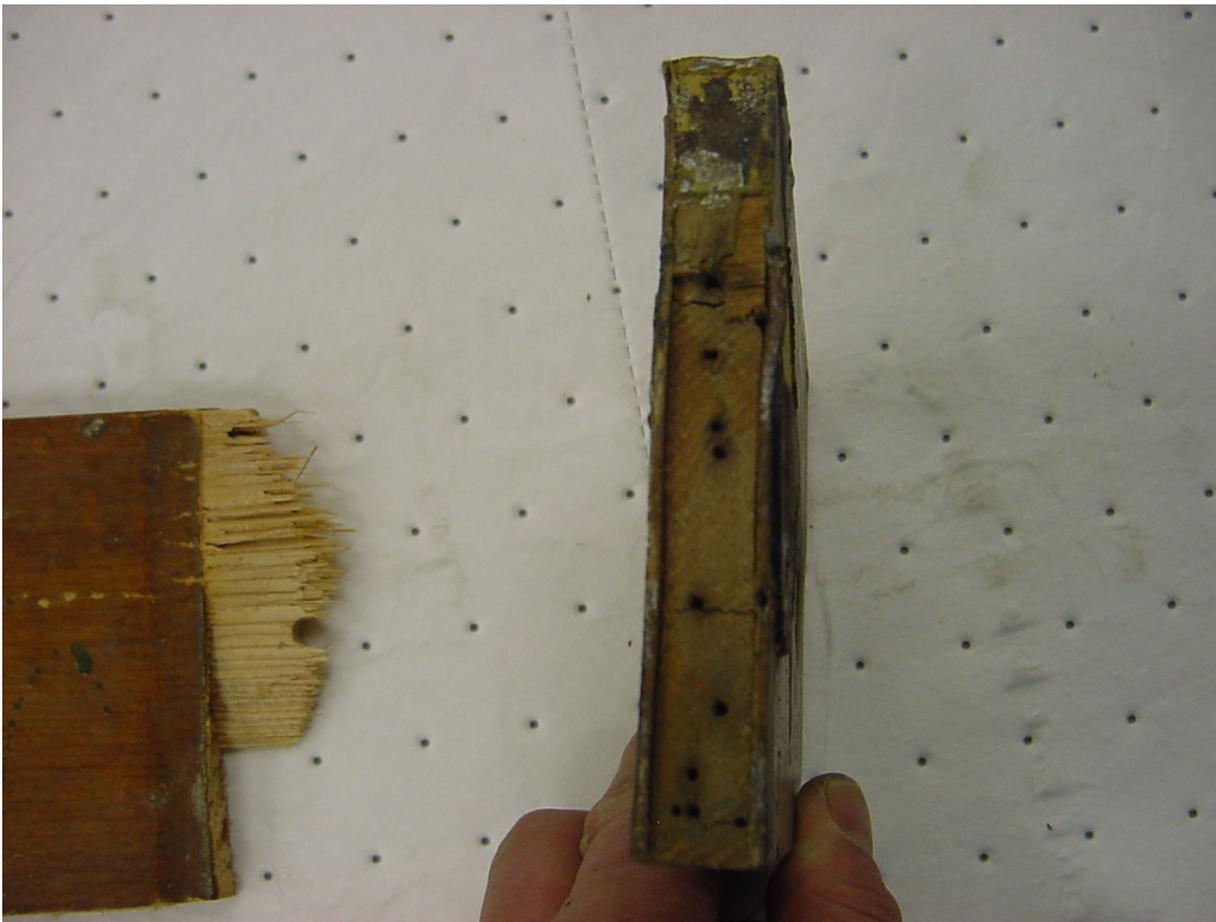
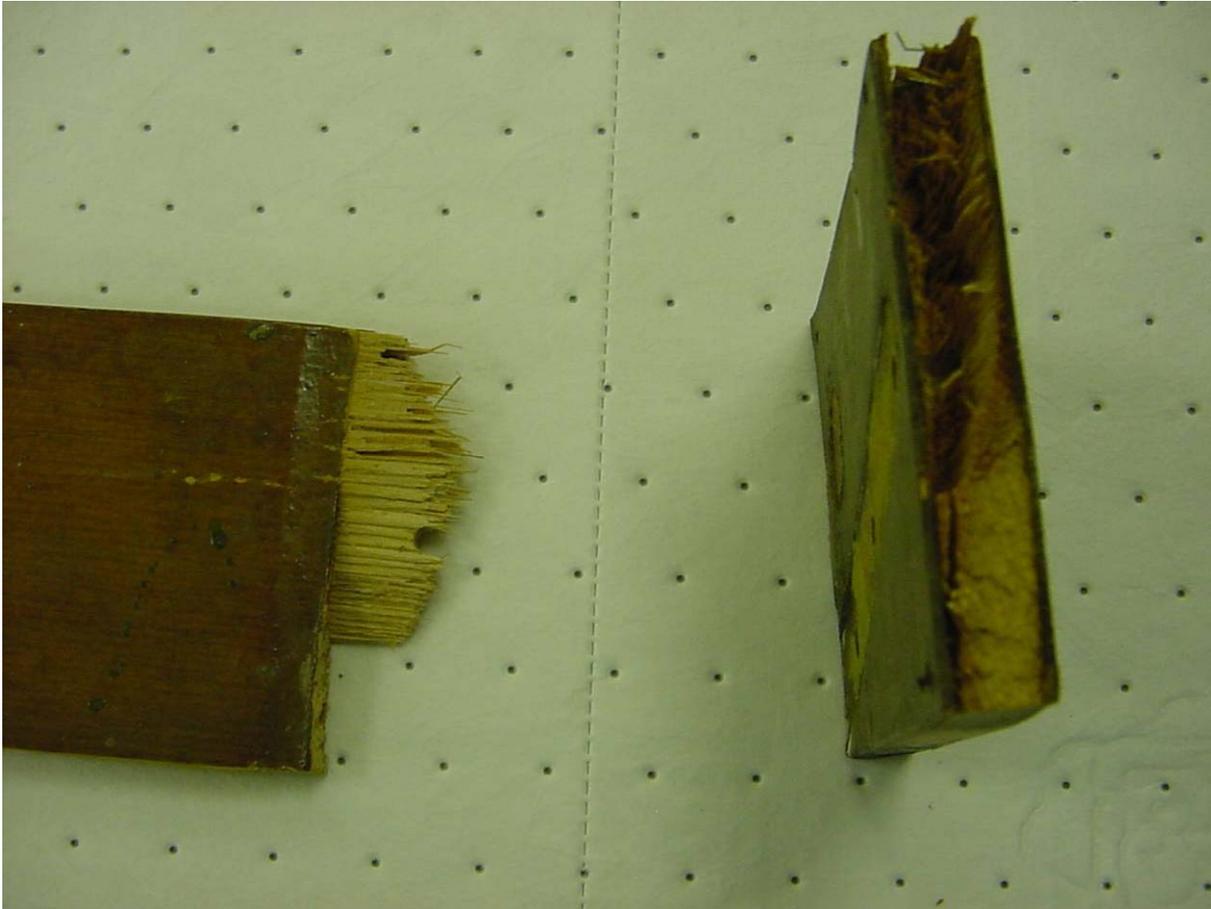
Taylorcraft: BC12D; Cracked Rear Wing Spars; ATA (N/A)

"I am submitting these photos of the rear spars removed from a 1946 Taylorcraft BC12D," says this mechanic. "The photos show several cracks on both spars. One spar was intentionally broken to show the extent of the vertical crack. This aircraft has 185.8 hours since restoration, and 9 years in service. At some point in the history of this aircraft it apparently had been ground looped on both wings before the previous fabric replacement. We have now replaced all four spars due to questionable wood.

"I recommend very extensive visual inspection techniques using high intensity lights and mirrors. Pay particular attention to the upper and lower spar surfaces for vertical cracks—especially near the butt end where the plywood reinforcing plate ends and the spar mill taper begins. If in doubt, remove the fabric cover for better inspections."

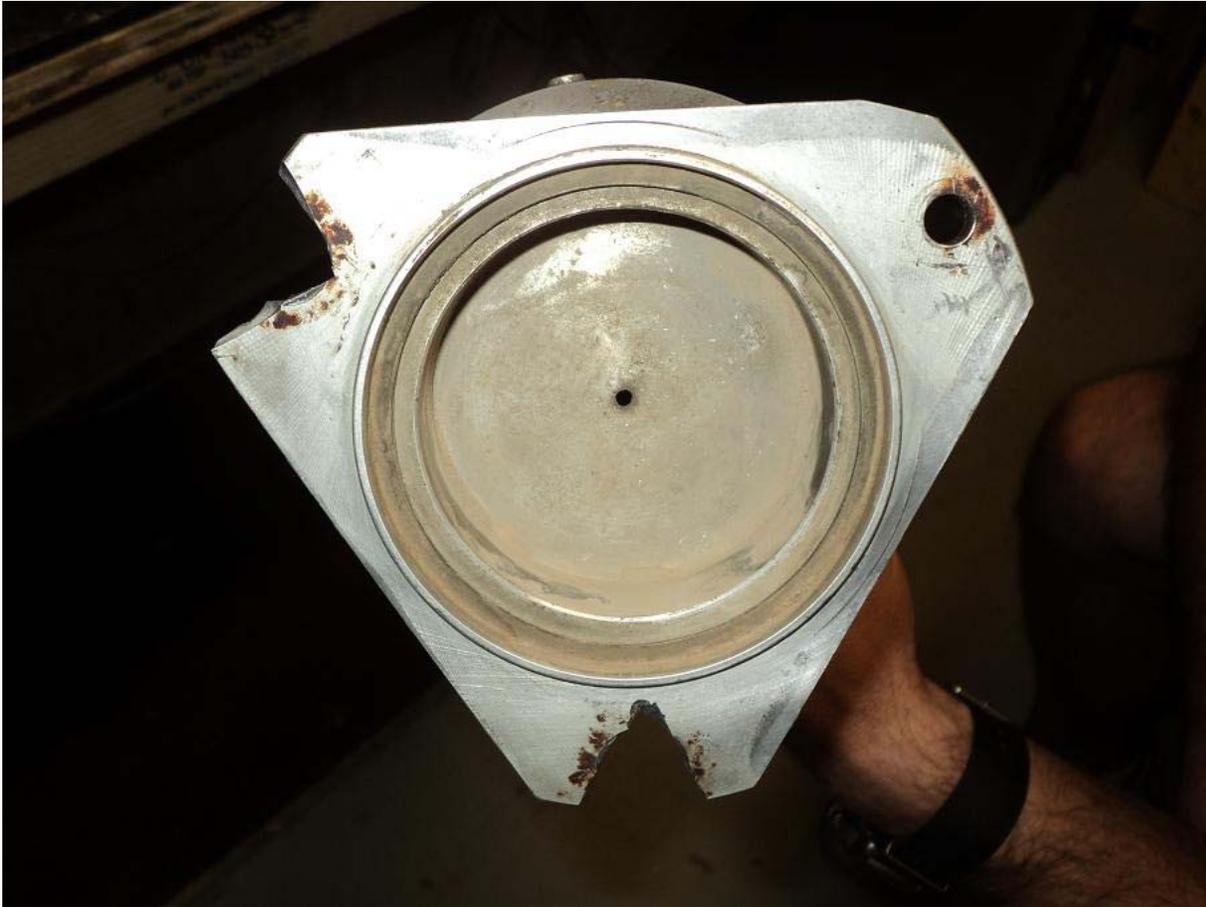
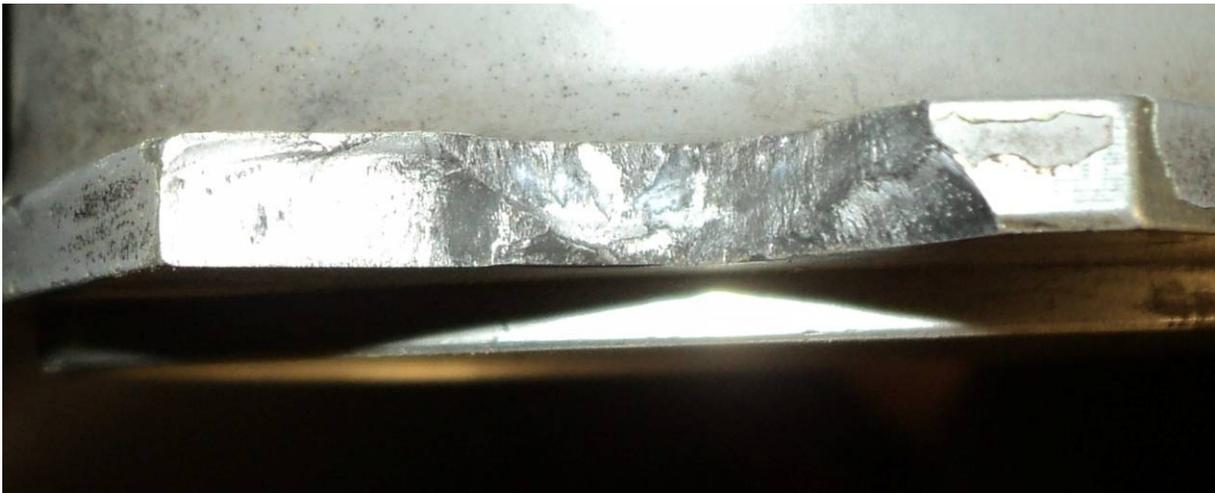
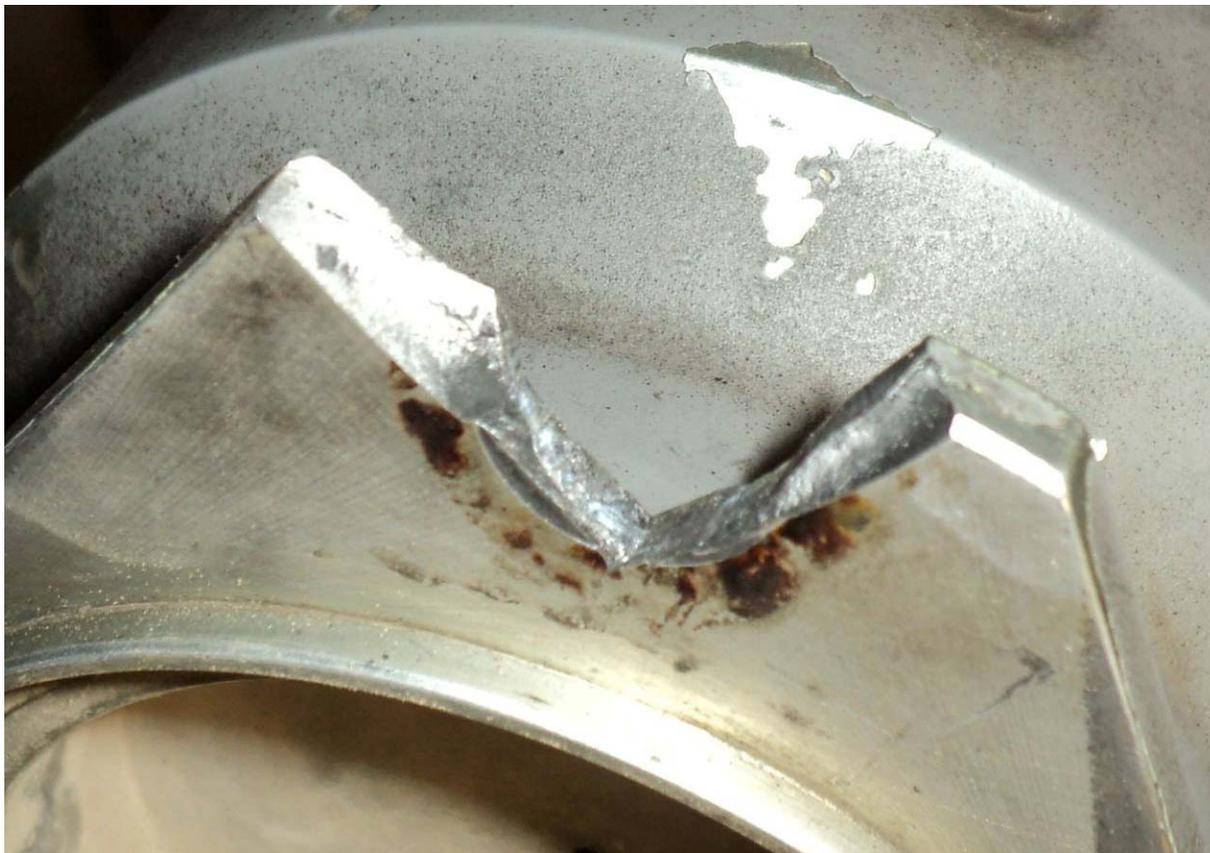
Bell: 214ST; Cracked Tail Rotor Mounting Flange; ATA 6510

"During a 25 hour check," states a technician, "the number six tail rotor driveshaft mounting flange was discovered cracked on the output side of the IGB (*intermediate gearbox*) coupling. The cracks are (*located*) around the bolt holes. The tail rotor drive shaft is on-condition (*replaced if needed*)." (*Drive shaft P/N: 214040622005. There are nine of these P/N's in the SDRS database.*)

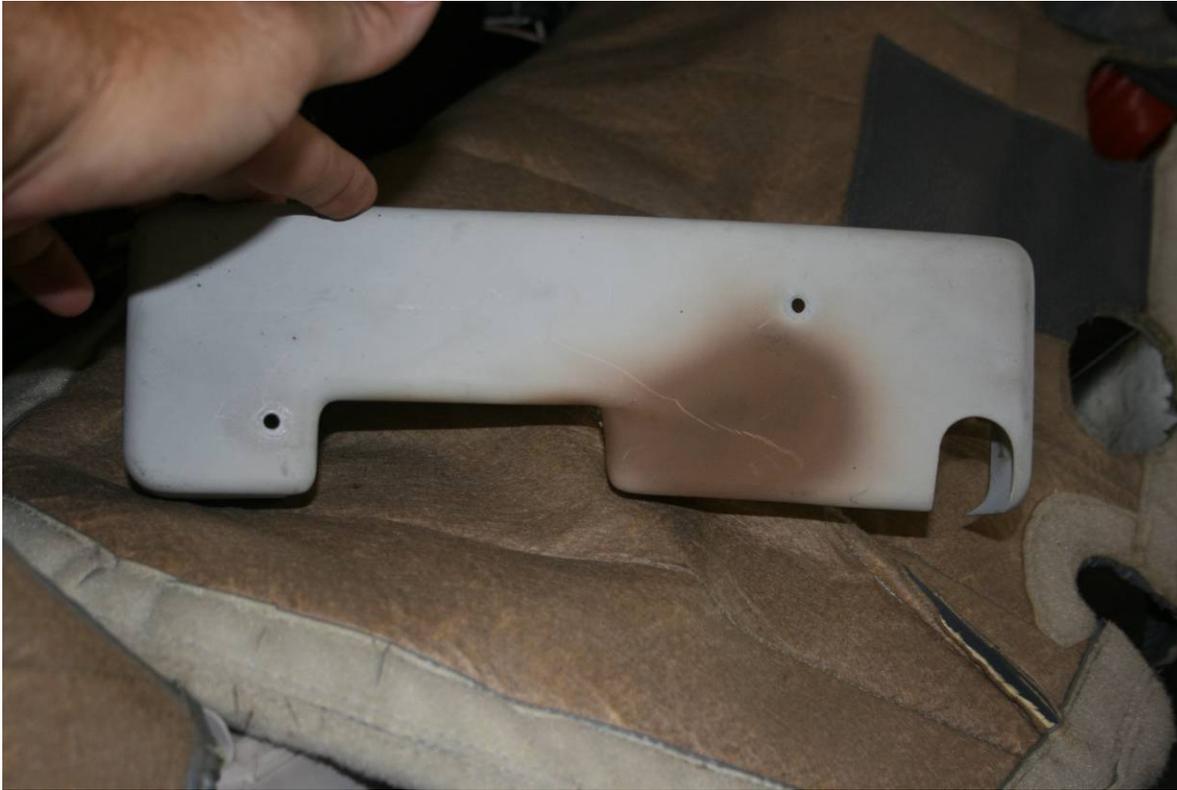
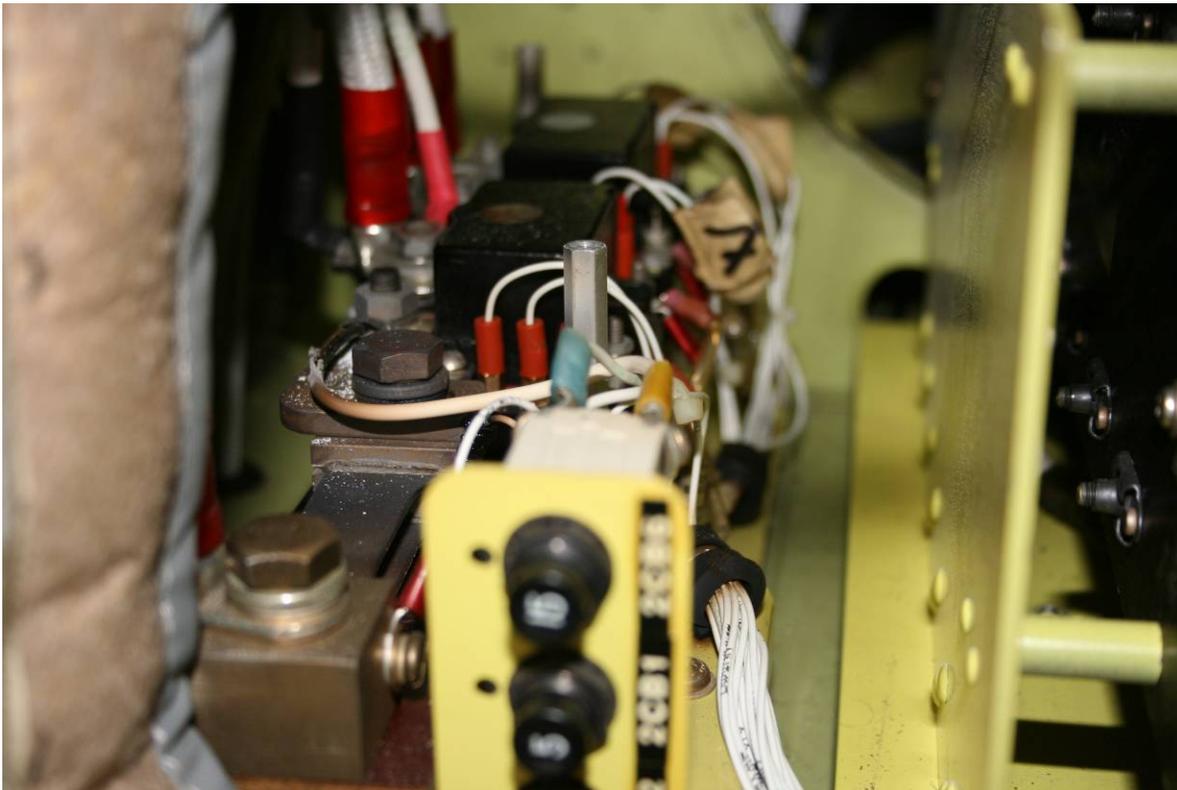
Bell: 407; Generator Relay Malfunction; ATA 2430

"While enroute, an attempt was made to start the searchlight," states this pilot. "Upon noticing the searchlight did not light off, (I) checked the instruments and found the voltmeter below 25VDC. I attempted to reset the generator with no success. I noticed the ammeter at zero—and then returned to the airport without incident. The next morning an inspection and ground run was performed to troubleshoot the system. We found the generator output at 28VDC, no amperage, and no generator fault Master Caution Light illuminated. These indicators led us to believe the generator relay to be at fault. Access was made to the DC power panel (FS 155). There we noticed discoloration of the power panel cover. Upon removal of this panel we found a wire (P20A12) between the 2K3 generator relay and the 15A circuit breaker (2CB6) 'Generator Field' had melted insulation at the bus bar. And the wire (D10A22) between (its) 5A circuit breaker (2CB2) 'Ammeter' and the 2R1 shunt (we found) to have a melted wire terminal at the shunt. Neither circuit breaker had opened." (Part number for DC Power relay: SM20ACD300A21; manufacturer name: Eaton. There are 31 of these relays listed in the SDRS database.)

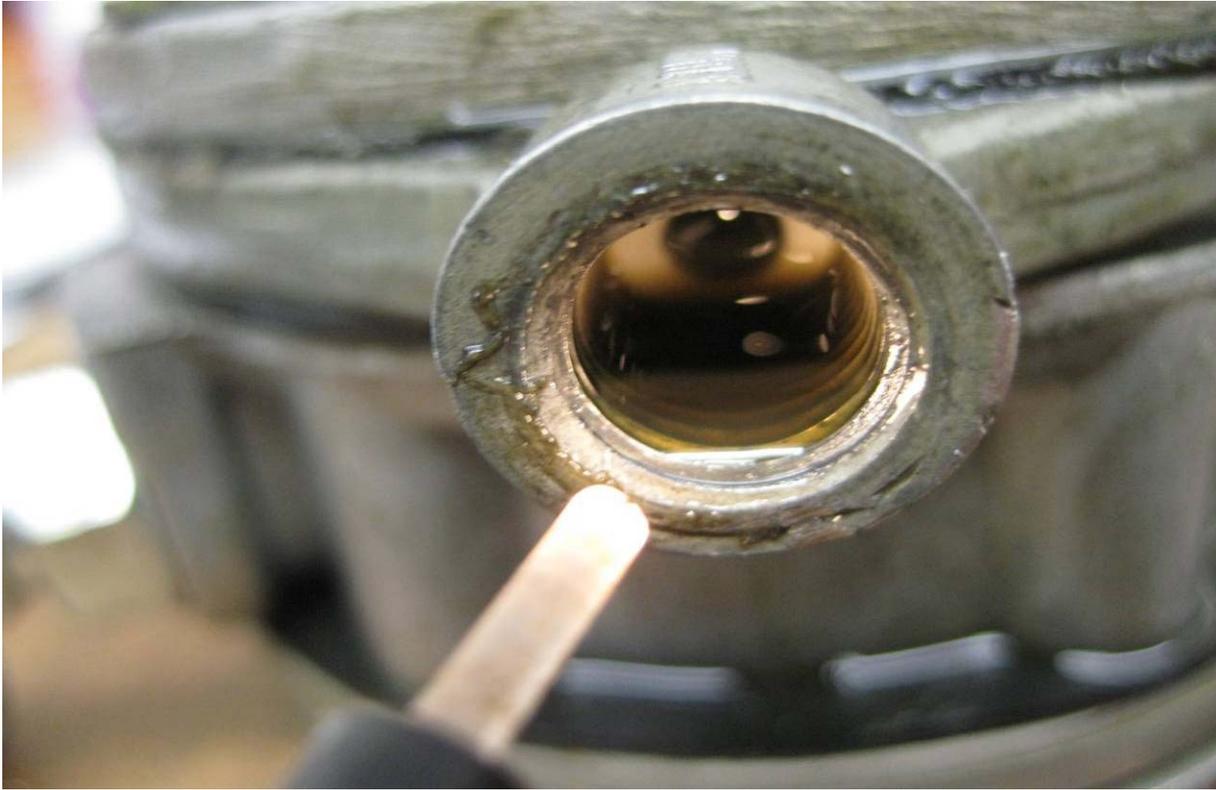
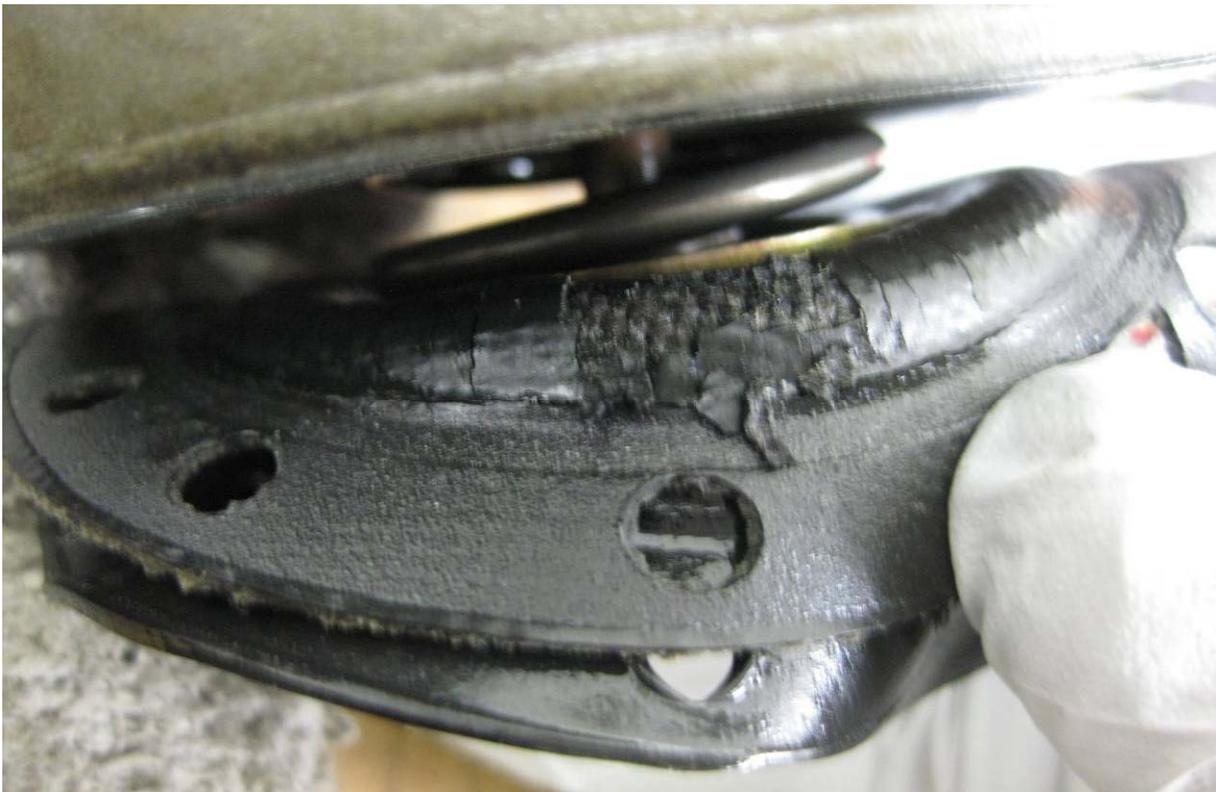
Lycoming: IO360L2A; Failed Fuel Pump; ATA 7314

"(We saw) evidence of oil streaming down the belly and to the tail (*of this 172S*)," says this mechanic. "And oil was noted dripping from a drain tube below the firewall. This drain tube connected to an overflow fitting on the engine mounted mechanical fuel pump (*P/N LW15473*). The pump core was disassembled and oil was found leaking through the first of two diaphragms in this dual diaphragm pump. The rubber material covering the base material of the diaphragm was found flaking off. This base material is porous—allowing oil through the first diaphragm and into the ring chamber that allows oil to drain overboard without contamination of the fuel side of the pump. Failure of the second diaphragm would allow fuel injection to become contaminated. In a two month period, we have found two pumps draining oil overboard. A third aircraft was found with oil contamination in the fuel injection system." (*The SDRS database reflects 49 entries for this P/N fuel pump.*)
