U.S. Department
of Transportation
**Federal Aviation
Administration**

ADVISORY CIRCULAR

AVIATION MAINTENANCE ALERTS

**ALERT
NUMBER
329**

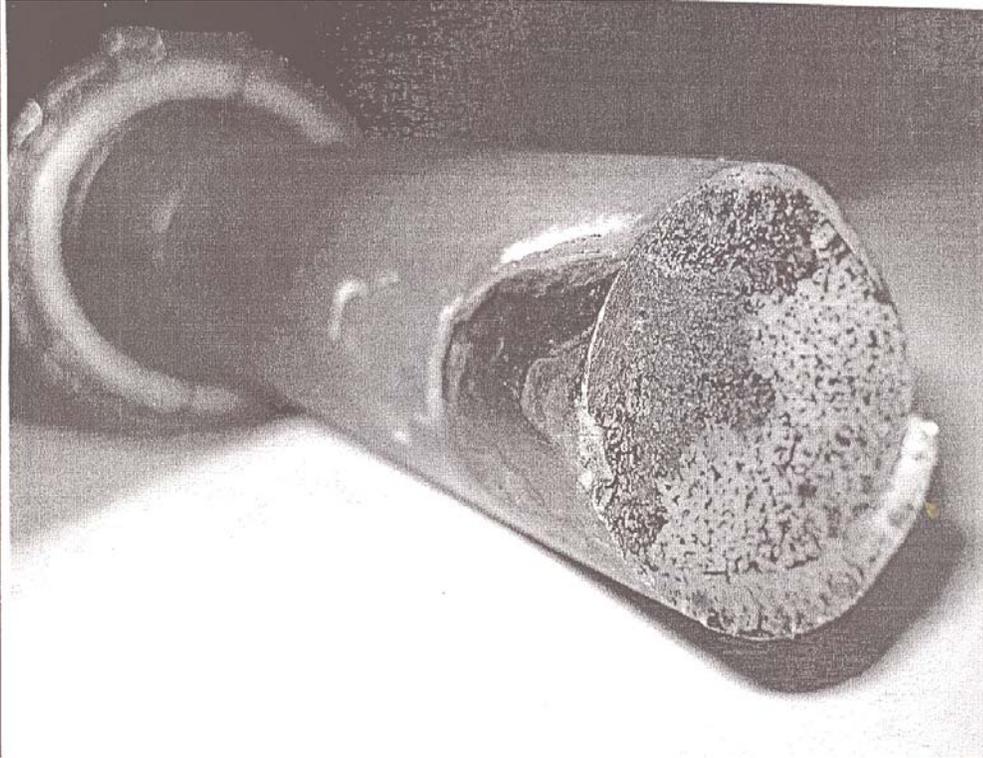
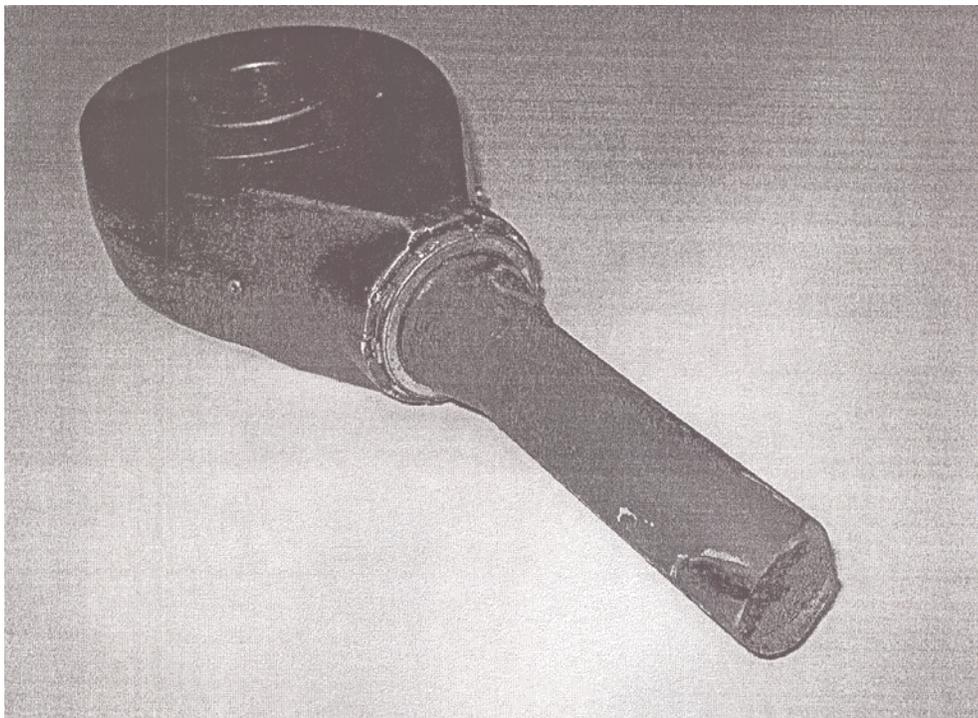
Boeing: 747 SP-21; Broken Aileron Power Control Rod; ATA 2710

"On August 5th, during the flight control rigging operation, the L/H aileron power control unit's rod-end was found broken," states the submitter. "This rod-end is part of the Bendix PCU (P/N 317012-1) assembly. Evidence of corrosion is apparent at the cracked location. See the attached photo's of the PCU rod end..." *(The part's total time and/or time since last overhaul was not provided. The attached photographs are low resolution, but clearly show the consequences of undetected corrosion.)*

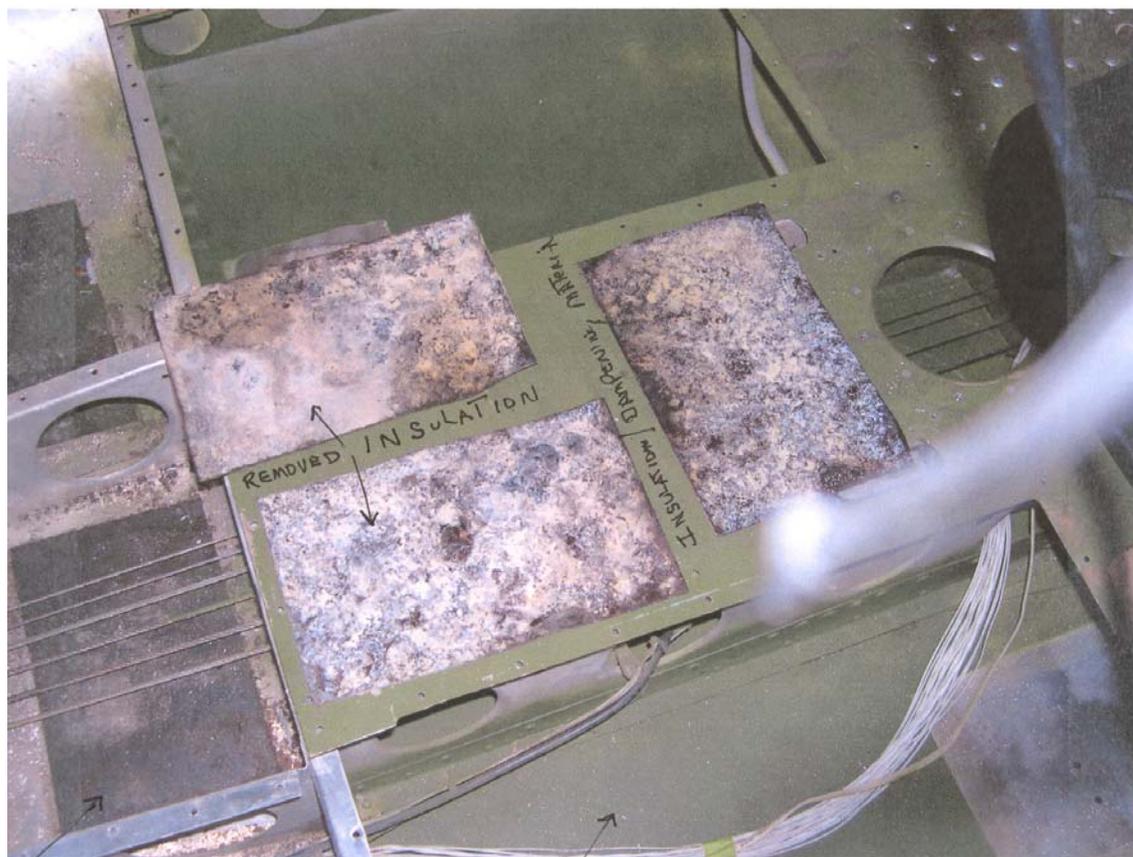
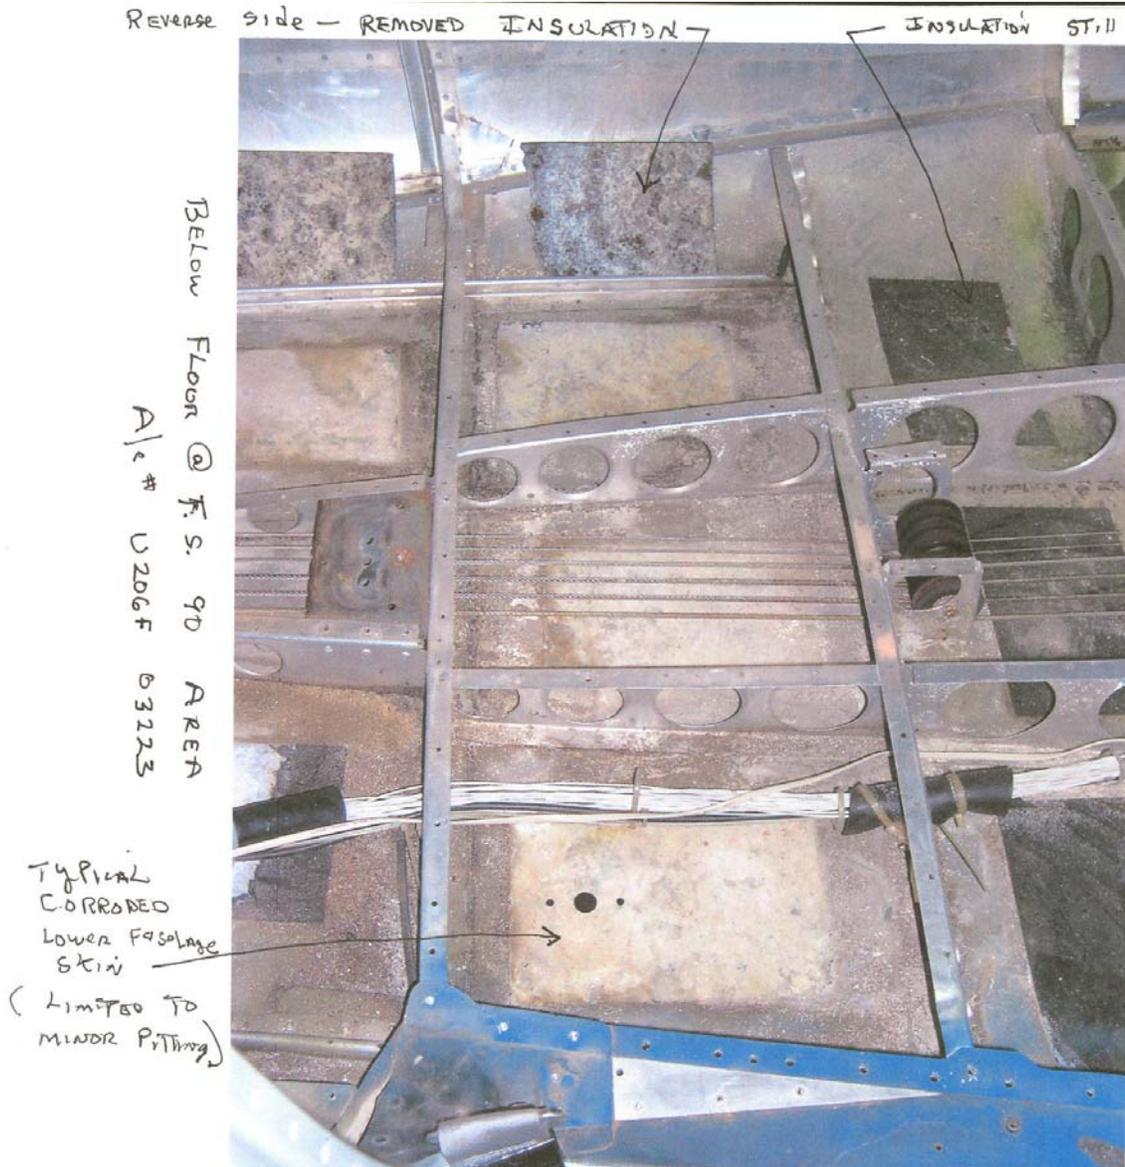
Cessna: U206F; Corroded Fuselage Skins; ATA 5330

This aircraft was undergoing extensive avionics upgrade installations. During some of the antenna installations "...a technician noticed corrosion under factory installed dampening/installation material," writes the submitter. This corrosion was found on the lower fuselage skins only beneath those pieces of insulating material that were apparently coming loose. He describes removing the minor corrosion and treating the affected areas. *(I)* suggest close inspection of this area in all aircraft. *(This)* problem is more than likely caused by age and moisture accumulation." *(There are two additional internal skin corrosion reports in the SDRS data base.)*

INSULATION STILL
INSTALLED

POST REPAIR AREA

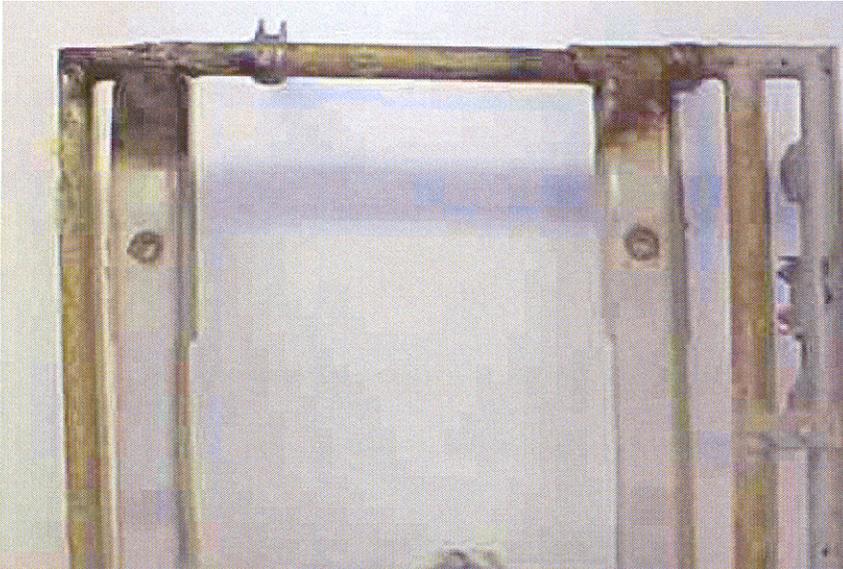
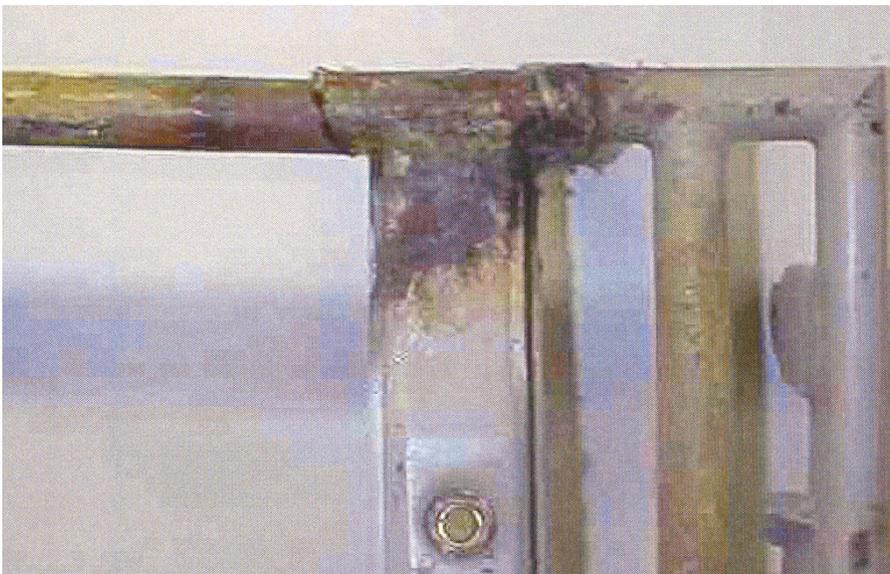
Cessna: 550; Cracked Seat Frames; ATA 2510

“The upper chair base assembly(s) are cracked at the chair back attach points.” These discrepancies include notations that these assemblies both show previous, inappropriate repairs. The technician references Aviation Fabricators STC (*supplemental type certificate*) ST01042WI structural seat repair as proper guidance. Part numbers for the left and right assemblies were noted as 5519015-13 and -14. *(See also the Alerts for July, September, and November for almost identical reports. From 2002 to the present, the SDRS data base records 19 reports related to this ATA code, 15 of which specifically reference cracks.)*

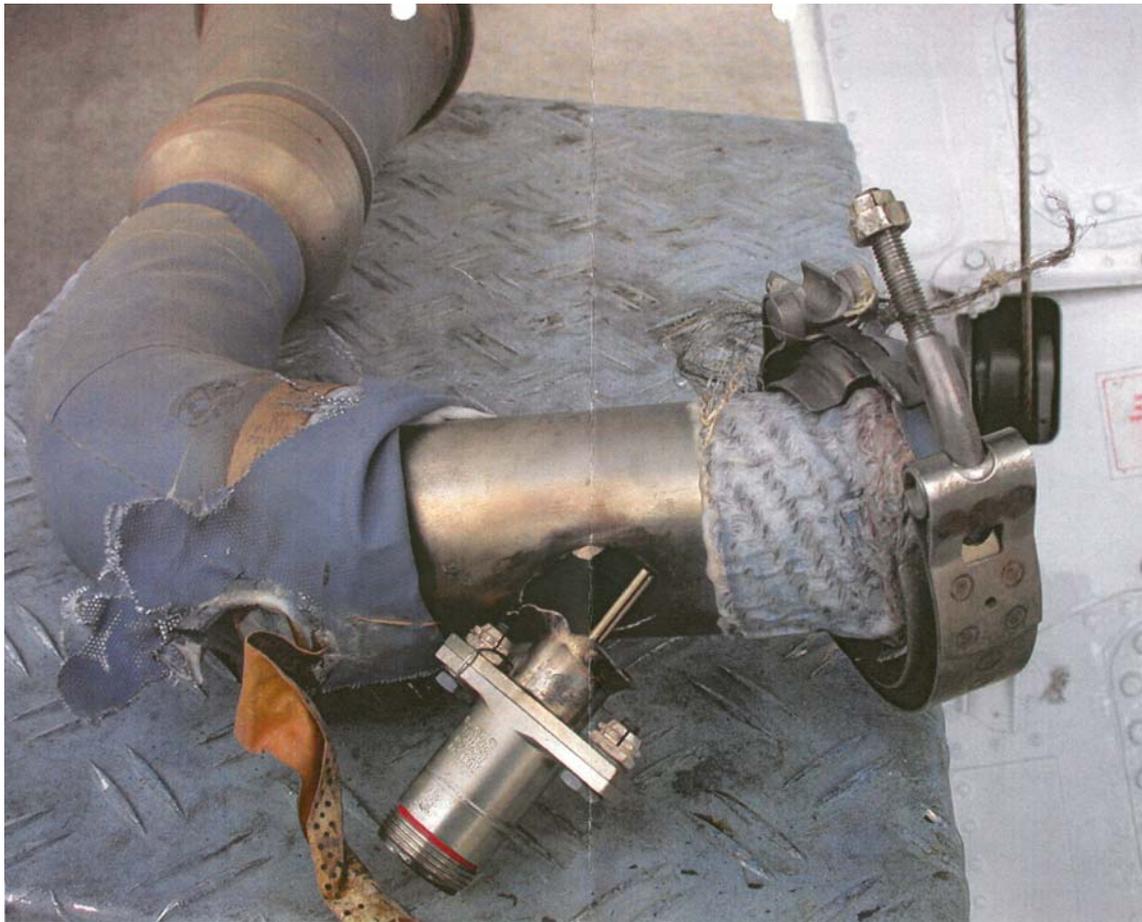
DASSAULT**Dassault: 900B; Bleed Air Temperature Probe Support Cracked; ATA 7500**

A mechanic's investigation into a problem with an oil pressure transmitter for this aircraft's number one engine led to the discovery of a hot air leak from the supporting pylon. Further observation revealed a large crack in a bleed-air duct around a temperature probe. No secondary damage was found as result of the cracked duct, or speculation offered for its cause. *(One of two photographs is shown below.)*

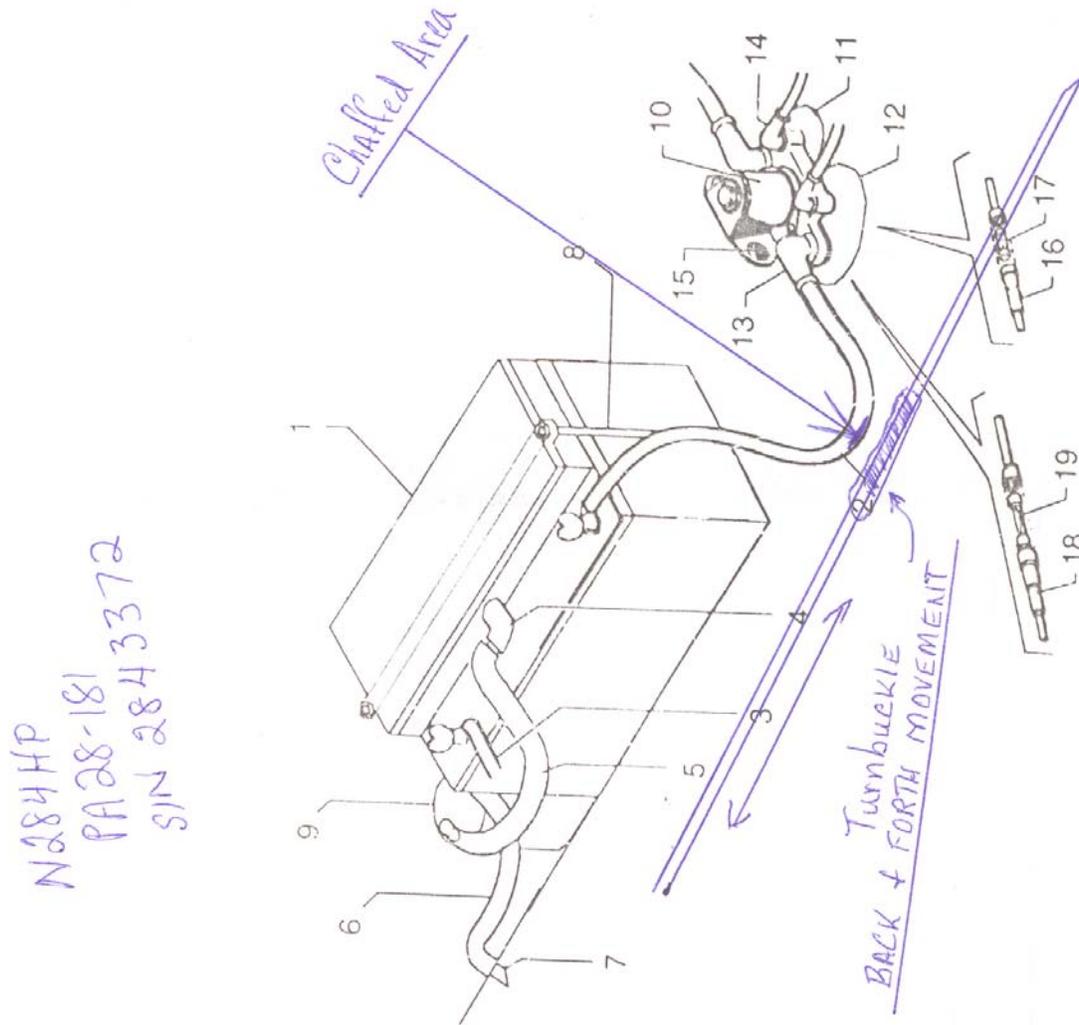
Piper: PA 28-181; Chaffed Battery Cable; ATA 2432

Routine maintenance found this aircraft's positive battery cable (P/N 78140-39) progressively chaffed by a control cable's turnbuckle. "This sawing motion of the turnbuckle almost wore through the battery cable insulation jacket," says a mechanic. "This battery cable was repositioned during the last 100 hour inspection for the same reason. Apparently the cable has taken a 'set'—it keeps returning to its original bend configuration. (My) recommendation is to shorten the cable and to crimp the terminal ends 90 degrees to the lay of the cable."

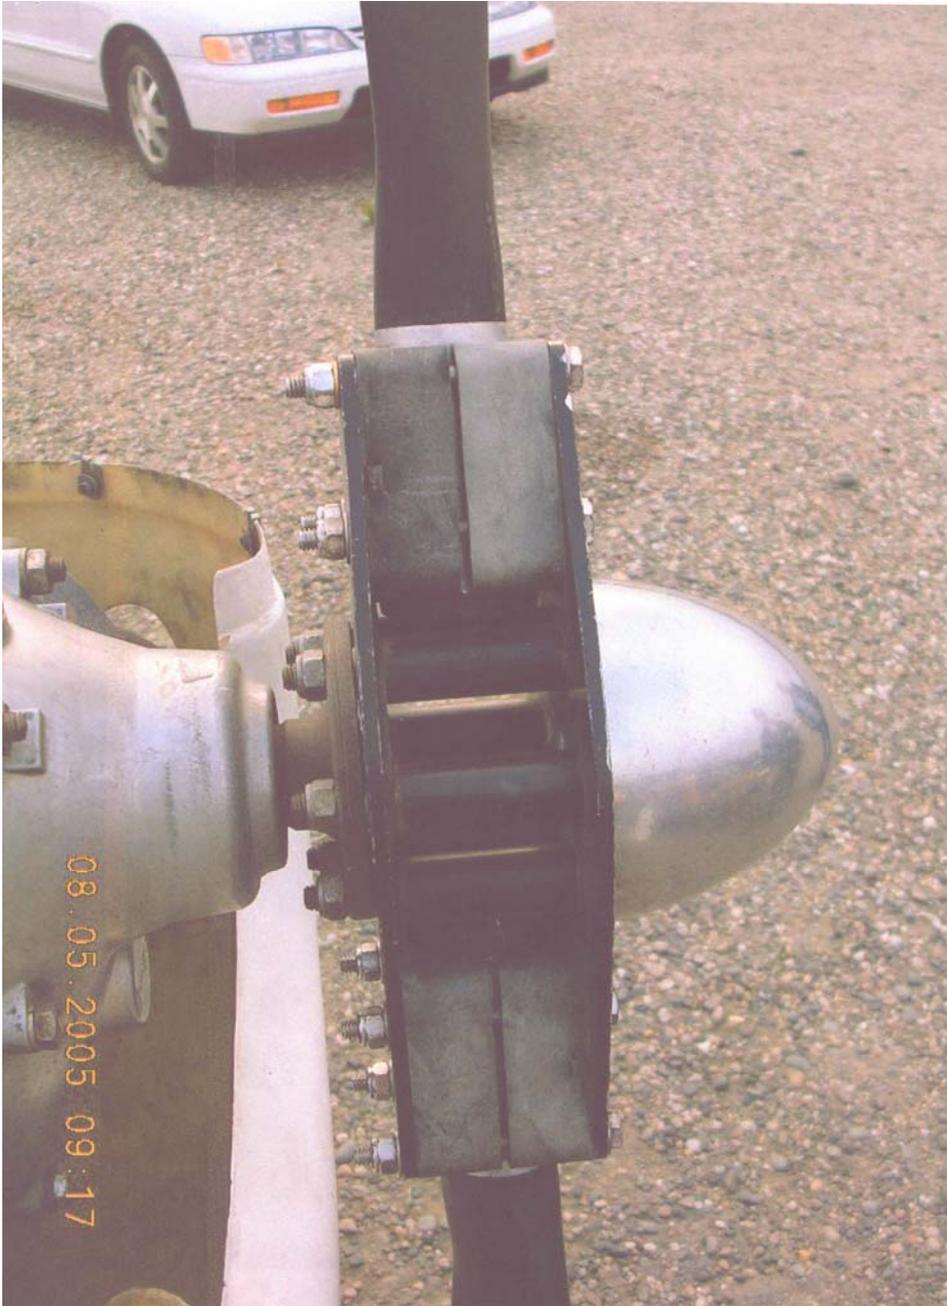
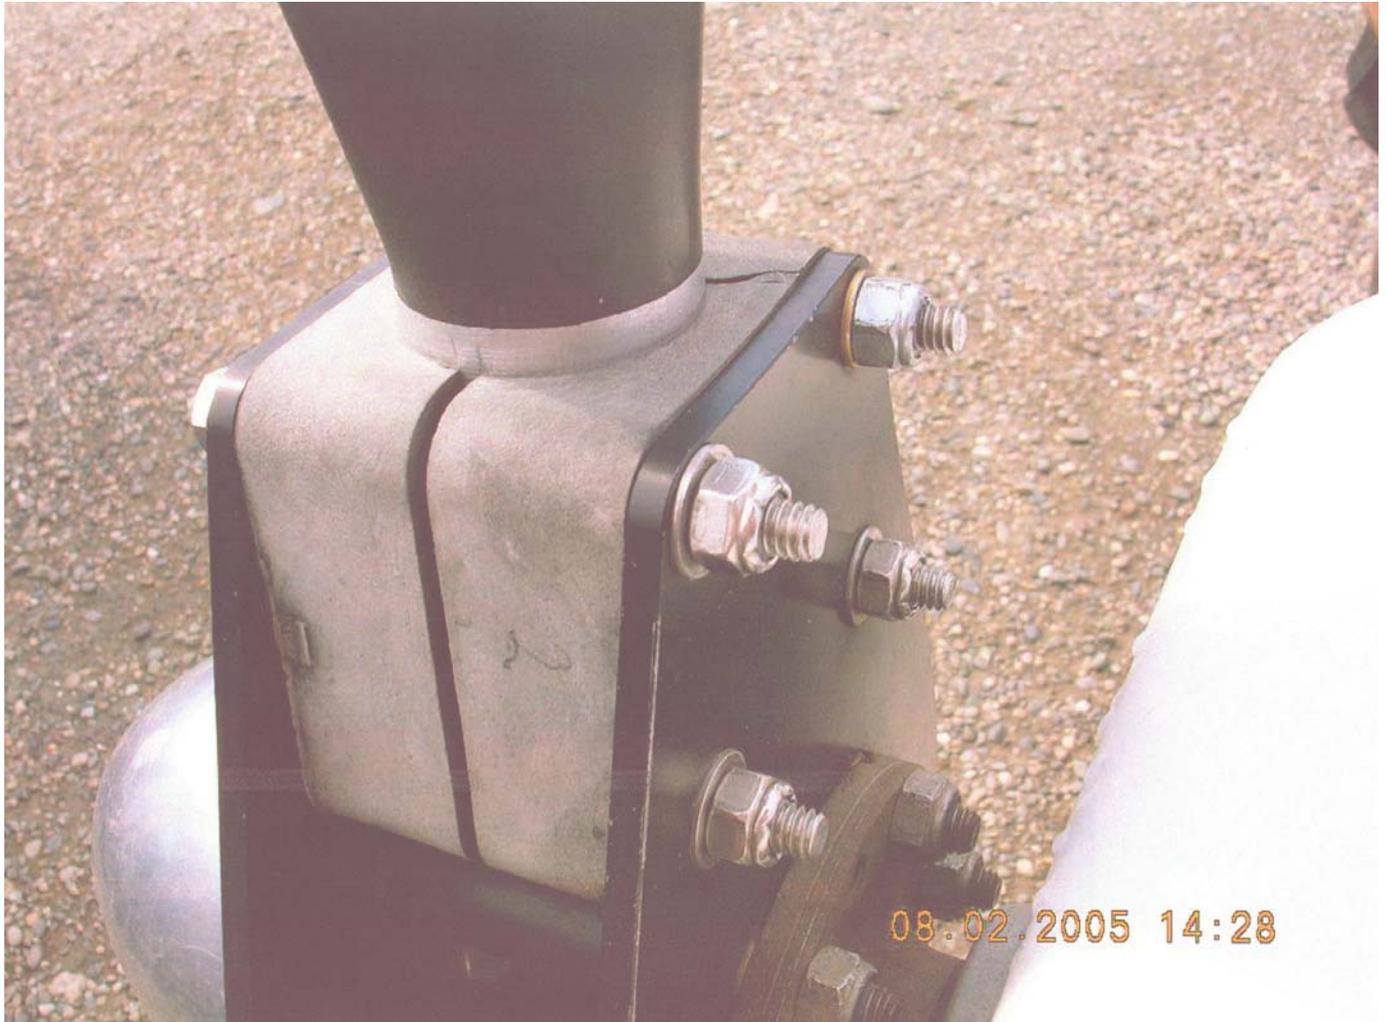
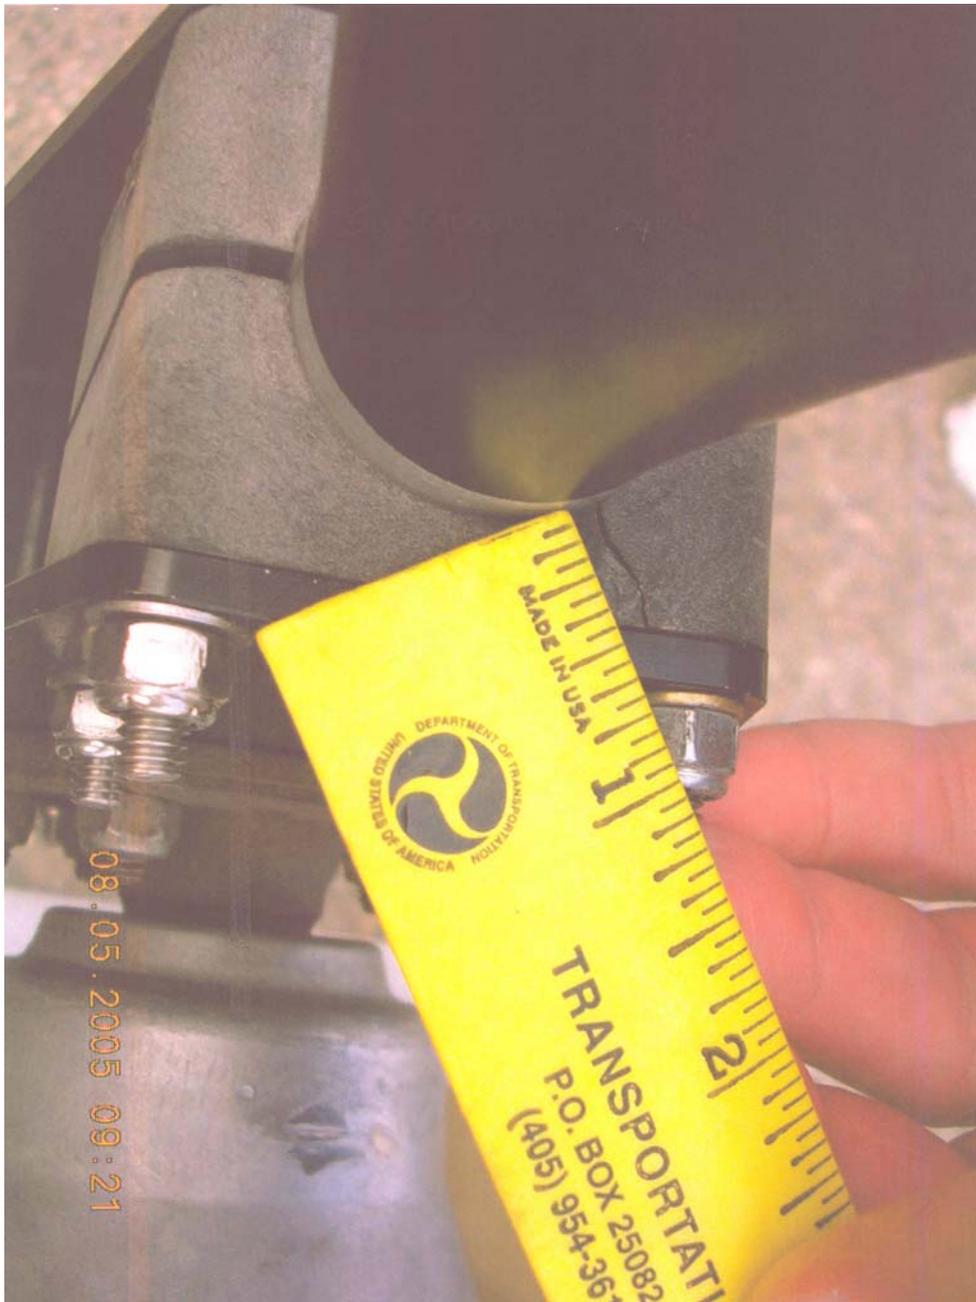
Zenair: CH-701; Cracked Warp Drive Propeller Hub; ATA 6114

“During an inspection,” states the submitter, “it was noted the Warp Drive, 2 bladed propeller (WD-2B-68) had a crack in the hub (*extending*) from the base of the blade to one of the outer flange bolts. This is the flange that lashes (*mates*) up to the reduction gear box hub on the Rotax 582 installed on this aircraft.” (*At the time of this writing, requisite permissions have not yet been extended for other source references. More on this propeller issue will hopefully follow next month. Relevant discussions may be read at the “www.ultralightnews.ca” website. Look under “advisories”, and then “Warp Drive”.*)

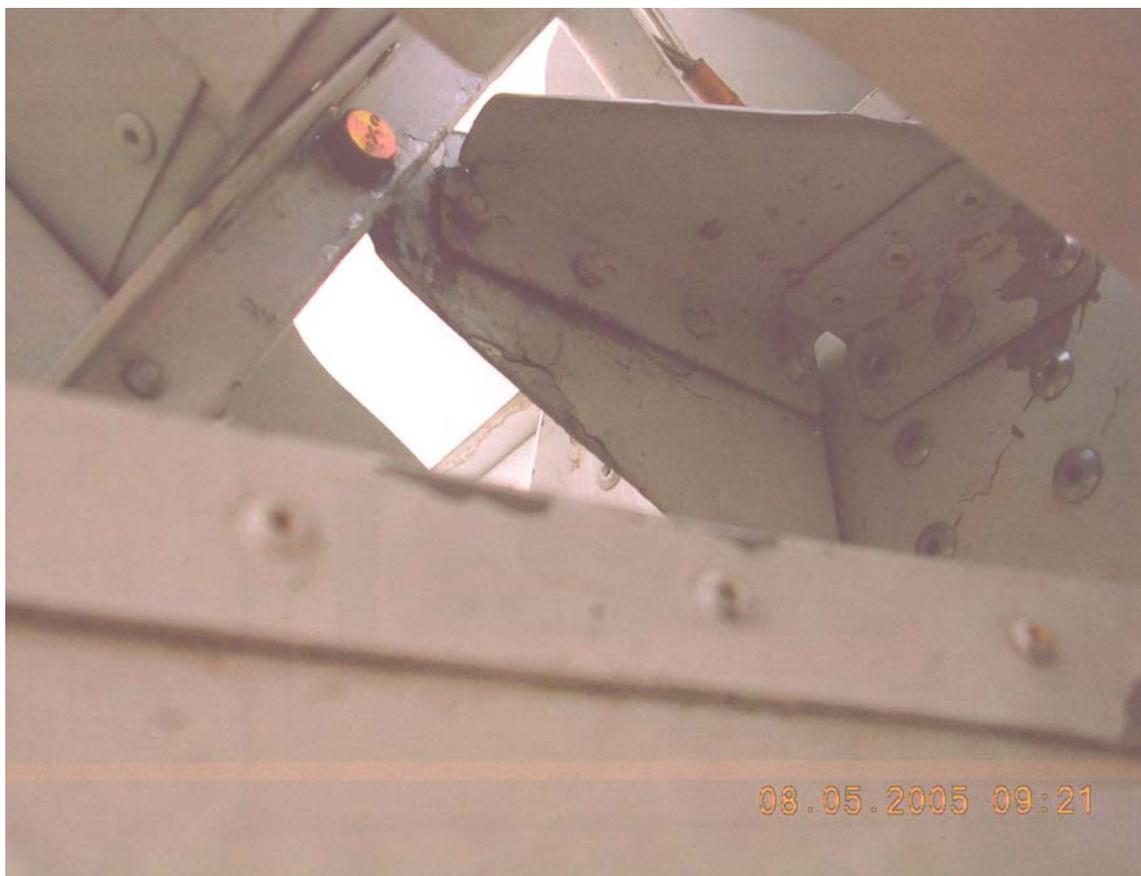
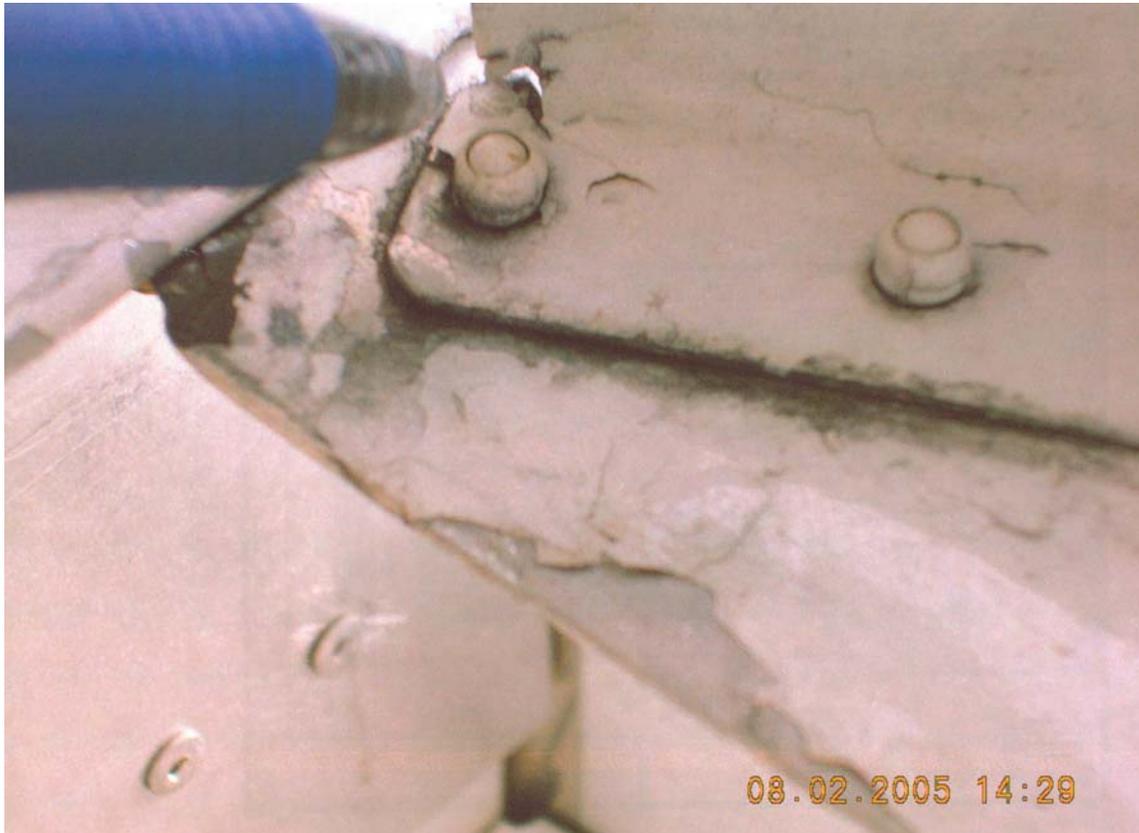
Zenair: CH-701; Cracked Elevator Hinge Bracket; ATA 5552

The submitter describes finding the elevator's forward hinge attach bracket "...cracked at the aft bend in the radius near the aft attach rivet. The owner stated this was a common occurrence on these model aircraft and that...*(he knew of two other planes having the same defect).*" No part numbers were provided with this report.

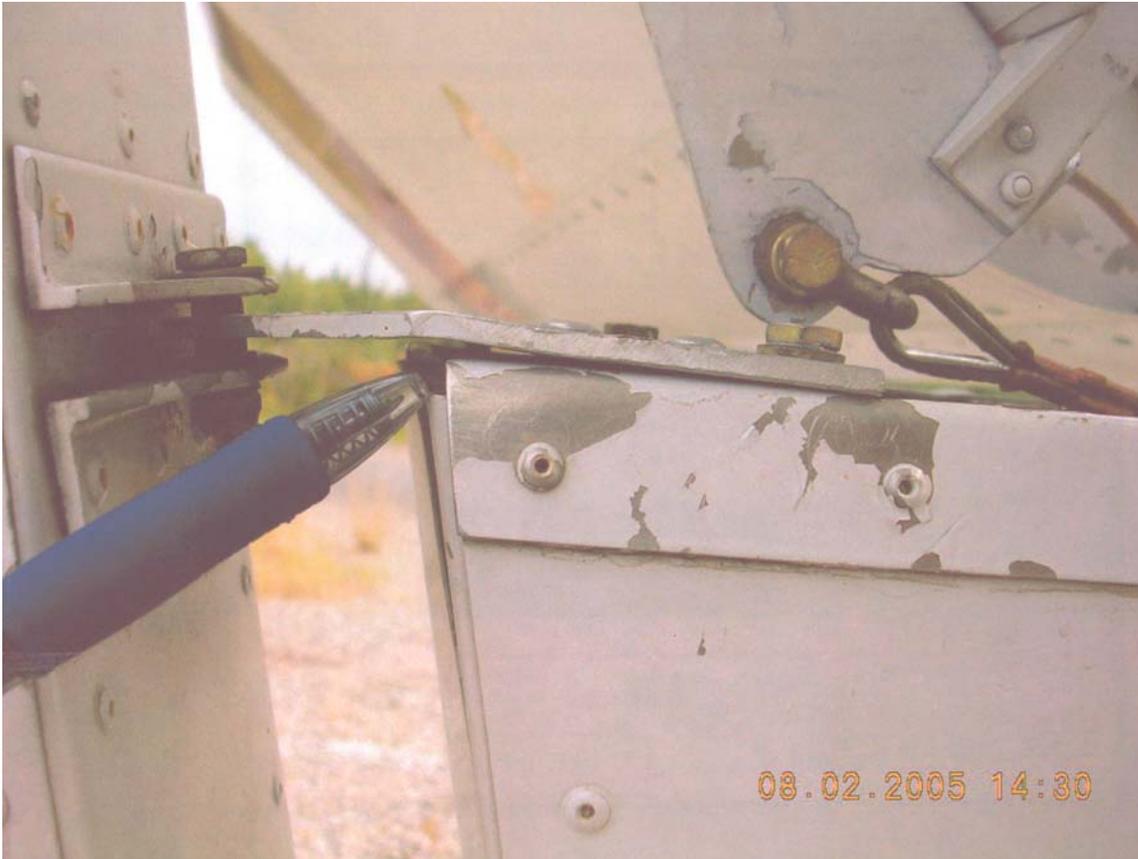
Zenair: CH-701; Loose Rudder Hinge Fitting; ATA 5554

The same submitter from the preceding report found another significant structural defect on the same aircraft and during the same inspection. The rudder lower hinge attach fitting's aft two attach rivets were found pulling free from the reinforcing channels. "It should be noted the rudder is also the vertical fin on this aircraft. (I) recommend these pop-rivet type fastener be removed and aircraft hardware be installed, either bolts or MS screws. Aircraft owners should also consider installing doubler channels on the bottom side of this attach point." No part numbers were provided with this report.

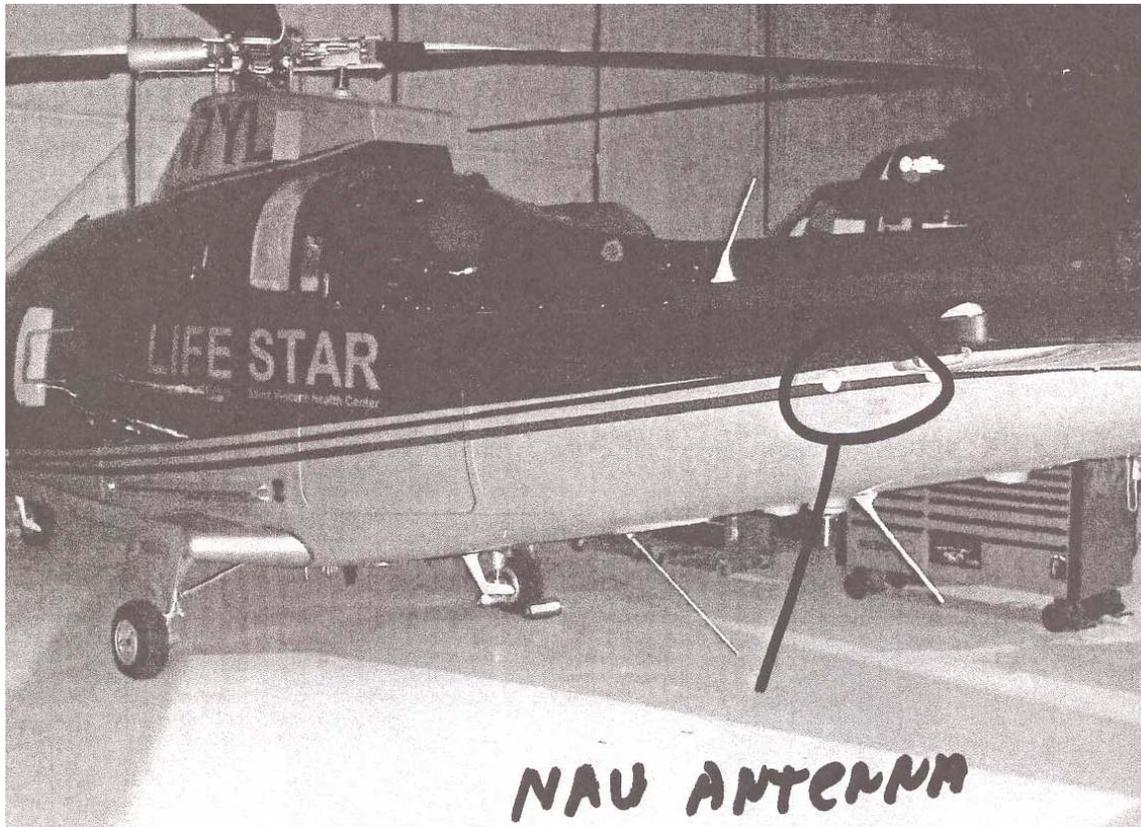
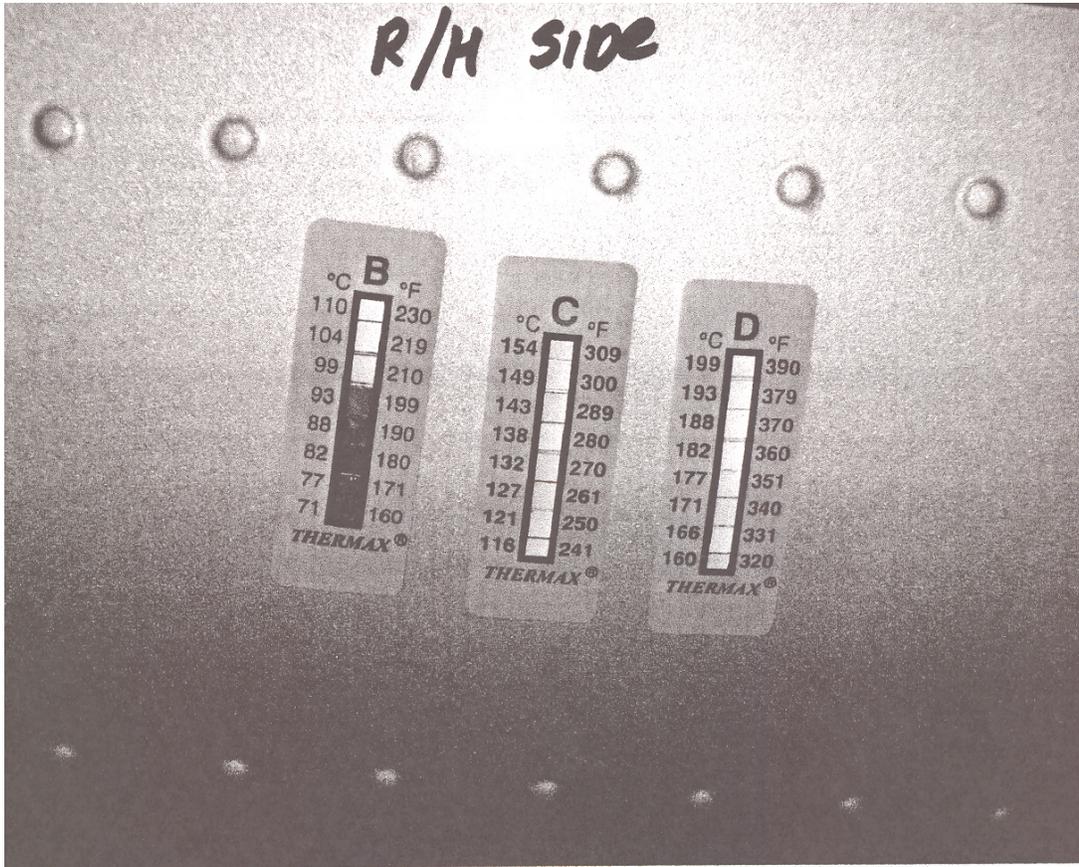
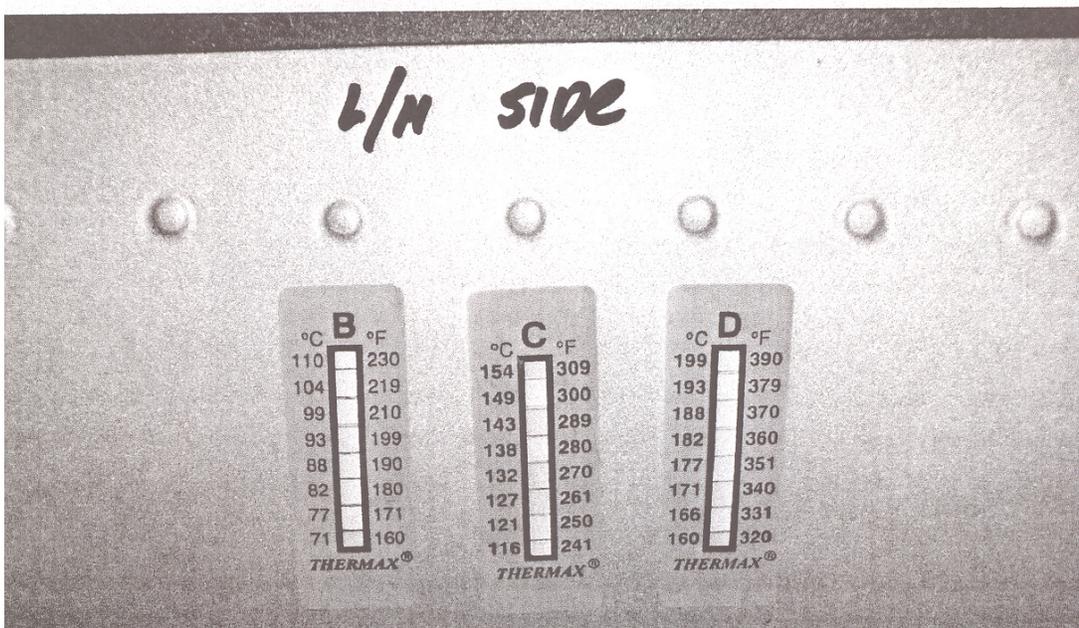
Augusta: A109E; Flawed Antenna Placement; ATA 3454

A technician describes having difficulties with the placement of this aircraft's navigation antennas. "Over the past 24 months this aircraft has had four sets of navigation antennas installed. The failure mode of the antenna is 'right hand element becomes extremely weak', which causes navigation indicator display errors of up to 5 degrees. Visual inspection indicates the R/H antenna element is exposed to a much higher temperature than the L/H element. A recent flight performed with temperature strips affixed to the aircraft proved this as fact. The temperature strips on the R/H side of the aircraft indicate an 'in flight' temperature in excess of 199 degrees F. The design limit for this antenna is 185 degrees F (*according to*) the manufacturer. (*My*) recommendations include either using an antenna suitable for higher temperature exposure or re-locating the antennas (*to fuselage positions*) away from the exhaust. (*Antenna part number is DMN48-1.*)
