ADVISORY CIRCULAR

43-16A

AVIATION MAINTENANCE ALERTS

**ALERT
NUMBER
353**

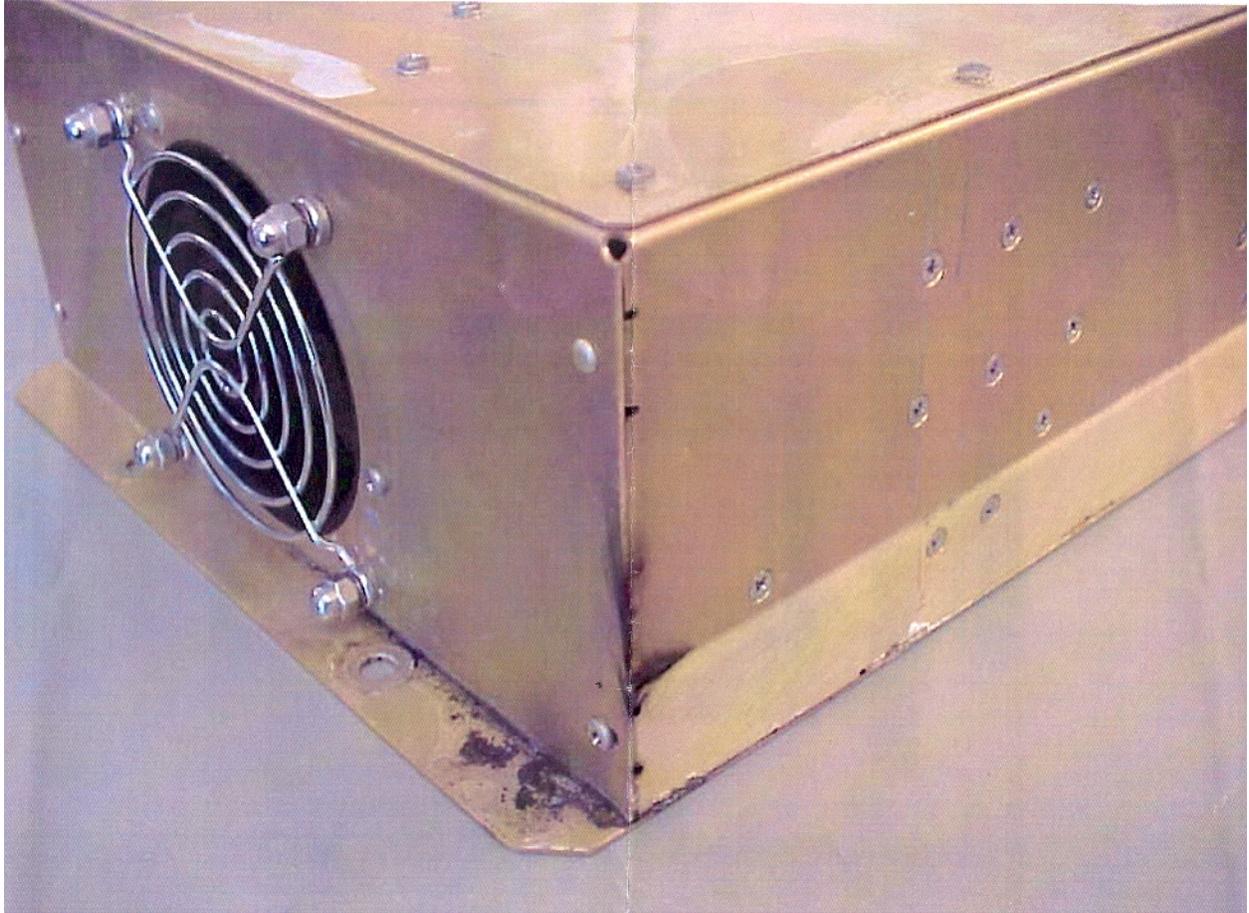
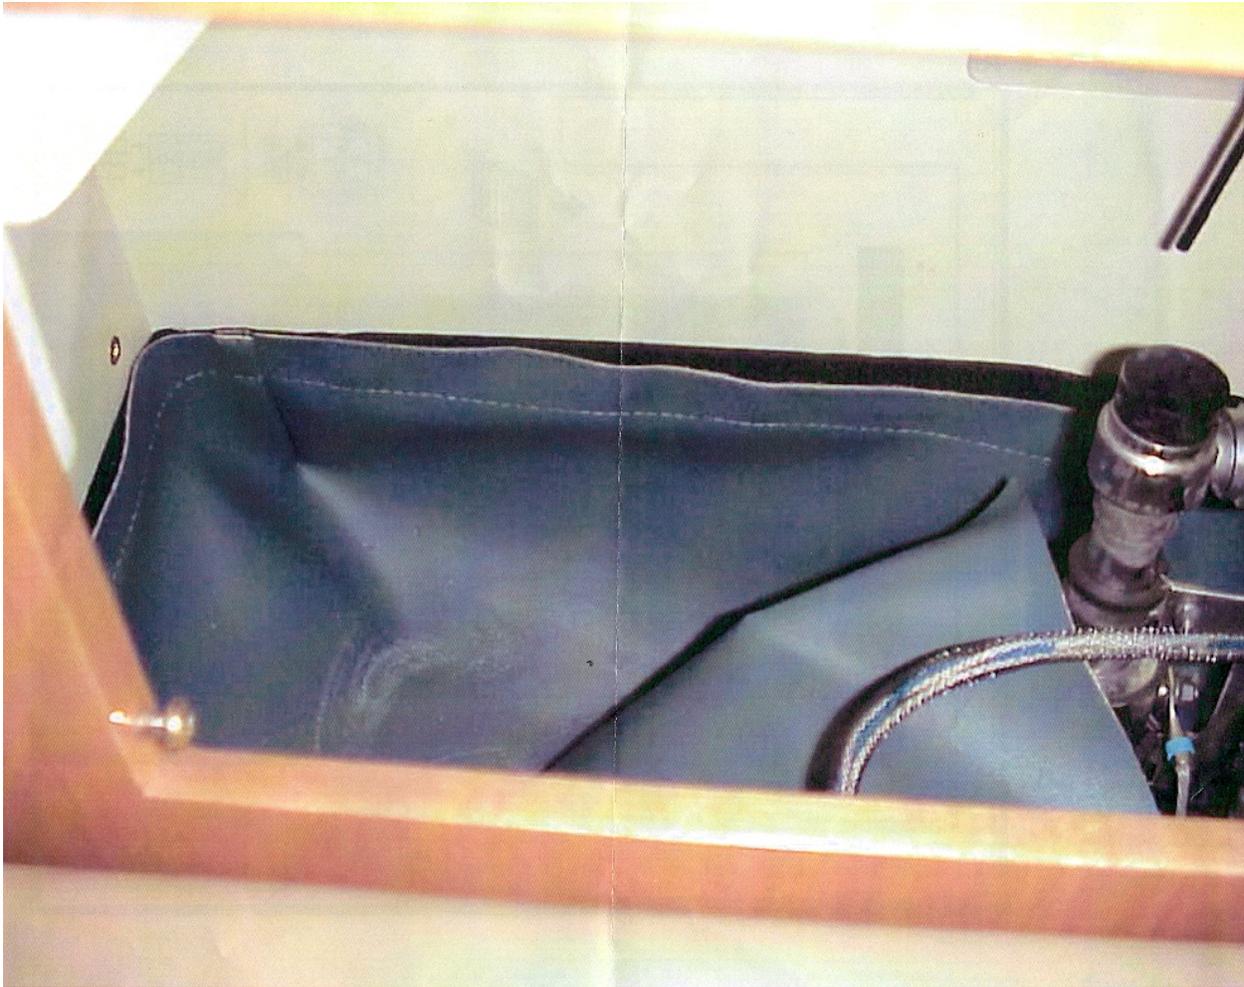
Gulfstream: G550; Arcing Emergency Inverter; ATA 2422

“When turning the main battery switches on,” writes the submitter, “the mechanic heard a loud popping sound, followed by the aroma of smoke in the entrance area of the aircraft. The floorboard was removed and *(we)* found water from the forward lavatory area had been running onto the top of the emergency inverter *(P/N 1-002-0102-1346)*, causing water and AC voltage to meet (the water won). The lavatory areas on both of our G550’s were inspected for leaks...*(none were found, but...)* areas were found where water had been sitting. It is possible that, when stowing the sink (it’s hinged—folds up into a close-out) residual water is dumping into the close-out. The emergency inverter was replaced, and we shut the water supply off to the forward lavatory sinks *(on both aircraft).*”

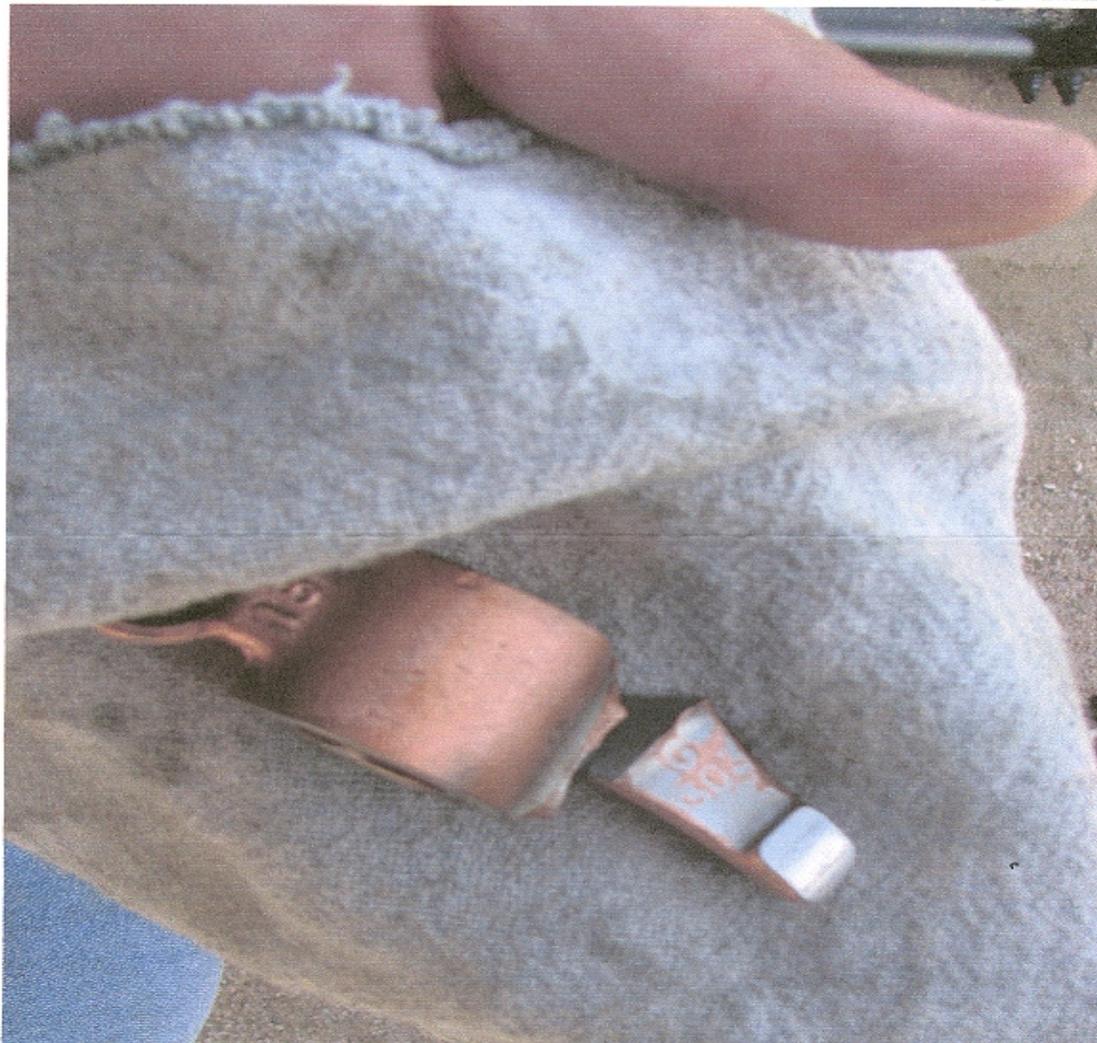
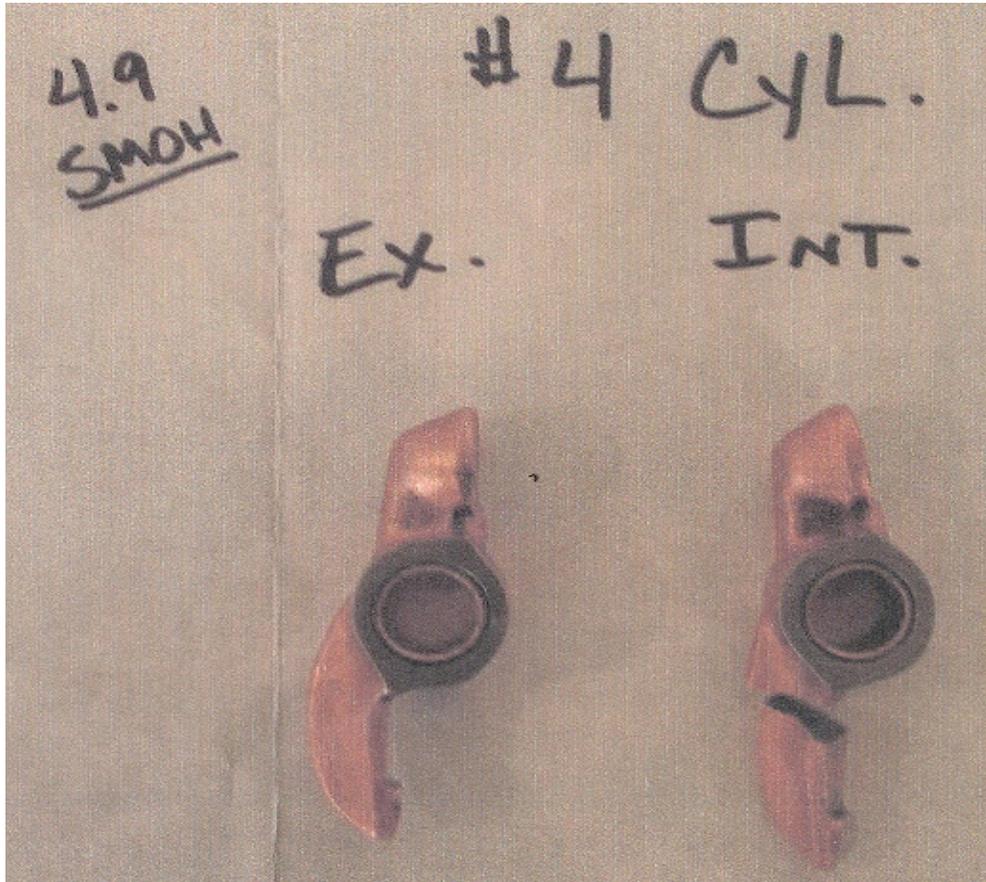
Lycoming: O-360-J2A; Broken Rocker Arm; ATA 8530

A mechanic working a Robinson R22 Beta II provides a short description and two photographs of this engine’s defect. “The number four cylinder intake rocker arm cracked and split into two pieces (*P/N 17F19357*). The probable cause (*for its failure*) is aggressive machining of the rocker arm and/or the rocker arm incorrectly contacting the keeper spring assembly. (*Part time since overhaul: 4.9 hours.*)
