ADVISORY CIRCULAR

43-16A

AVIATION MAINTENANCE ALERTS

**ALERT
NUMBER
365**

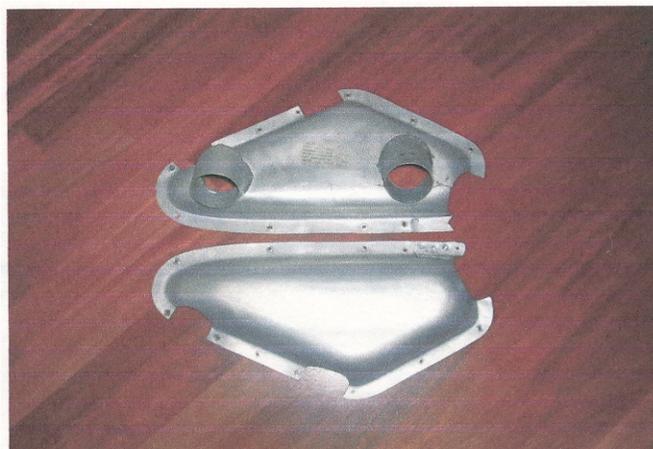
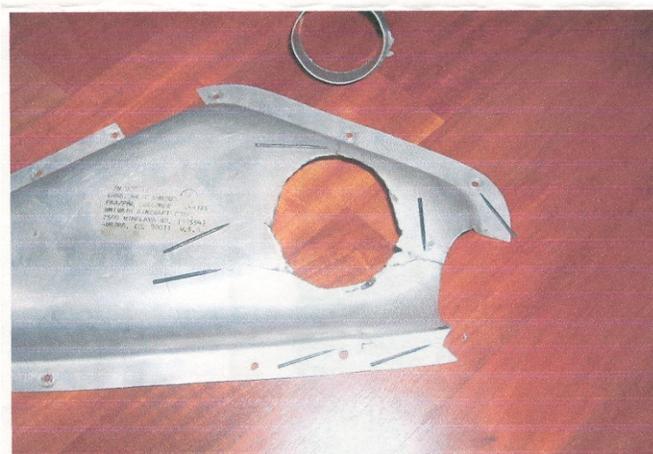
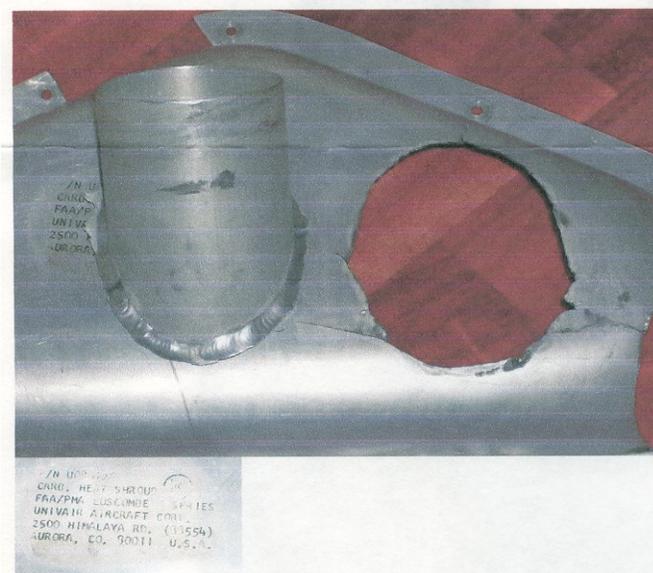
Luscombe: 8E; Broken Carburetor Heat Muff; ATA 7160

Another A&P/IA mechanic says, "After a flight it was noted a portion of scat hose was hanging from the bottom of a cowling opening. Inspection found the carburetor heat flange had separated with the scat hose and attached clamp from the inboard half of the right carburetor heat muff. The heat muff halves were removed and inspected. Examination of the failed round duct flange found the entire tube broken off at the circumference along the edge of the weld. Secondly, there were about six "spider-like" cracks around the broken hole, propagating outwards. A total of 16 cracks and broken tabs—including a previous "patch" repair were noted on both inboard and outboard muff halves. An inner muff rib which was tack-welded in three places had one tack weld broken, and on the opposite (outside) were slight burn-through areas (*also having*) two small cracks (*from these tack-welds*).

"This part was stamped by Univair Aircraft Corporation (*P/N U086126*). It had approximately 560.5 hours time in service. According to Univair the type alloy material used in the FAA/PMA part is 2024-T3. AC (*Advisory Circular*) 43.13-1B (paragraph 4-89d) mentions '...2024 and 7075 Aluminum. Do not weld these two aluminum alloys....' This (*part's*) material is contrary to the FAA Advisory Circular and to ASTM and AWS codes and standards in welding."

7N 111
COND. HEAT SHROUD
FAA/PHM LUSCOMBE 1541ES
UNIVAIR AIRCRAFT CORP.
2500 HINCLAVA RD. (33554)
LORORA, CO. 90011 U.S.A.

(This report is particularly strange—given no one on planet Earth with the least welding experience could long endure coaxing 2024 not to crack—Ed.)
