ADVISORY CIRCULAR

43-16A

AVIATION MAINTENANCE ALERTS

DECEMBER
2009

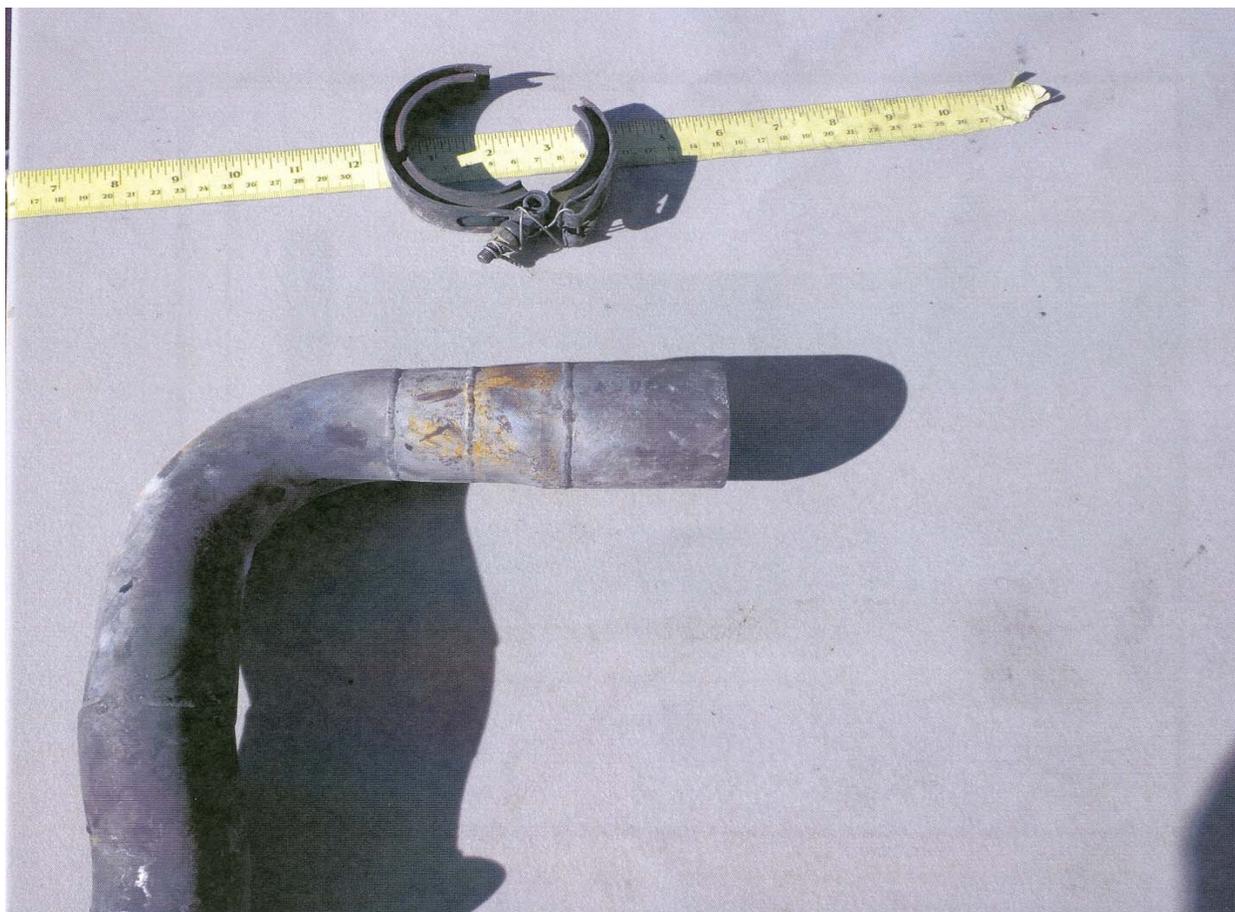
Beech: A36; Loose Exhaust Manifold Pipe; ATA 7810

"During an accident investigation," writes an unidentified submitter, "(I) found the top L/H engine cowling with evidence of fire (*damage*) and burned holes. The L/H exhaust manifold pipe was lying loose, and the L/H clamp for the turbo-compressor was broken and lying in the bottom of the engine cowl. This aircraft was destroyed in fire, (*sustaining*) one fatality. The engine had separated (*from the fuselage and lay 25 feet from the wreckage*). It was fully intact and still in the cowling." (*Exhaust clamp P/N: MVT69183200LW1.*)

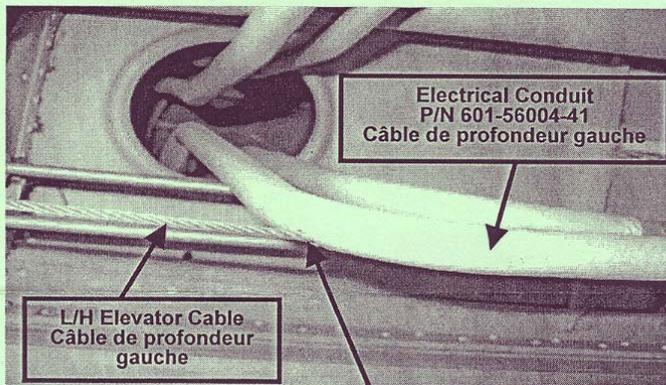
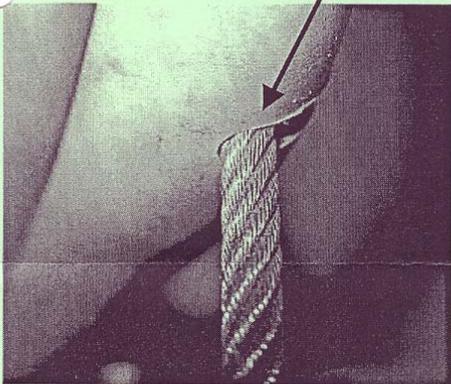
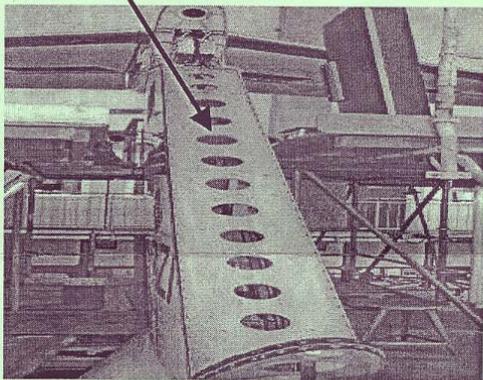
APPENDIX "A" / APPENDICE « A »

Transport Canada Civil Aviation (TCCA), through the Web Service Difficulty Reporting System, was made aware of three cases where the elevator cable assembly Part Number (P/N) 600-90020-125, located in the vertical stabilizer just above rib #4, was found rubbing against and had partially worn through the electrical conduit P/N 601-56004-41(LH). Some of the electrical wires inside the conduit for the horizontal trim actuator (HTA) were damaged, but the HTA system was still operational. (See Appendix "A")

The above defects were found while conducting the 180 and 240 months inspections. Maintenance records were researched but the cause of the cable/conduit interference could not be identified.

Electrical Conduit
P/N 601-56004-41
Câble de profondeur gauche

L/H Elevator Cable
Câble de profondeur
gauche

Area to inspect can be viewed through the spar once the vertical leading edge is removed or through panel 321 GL L/H side of Vertical Stabilizer.
La partie à inspecter est visible à travers le longeron, une fois que le bord d'attaque vertical a été déposé ou, à travers le panneau 321 GL du côté gauche ou de la dérive

TCCA recommends that maintenance personnel pay extra attention during the next scheduled cable inspection to ensure that the entire cable run is fully inspected as per the AMM. Confined areas that are difficult to gain access to warrant close examination to ensure adequate clearance exist to prevent interference.

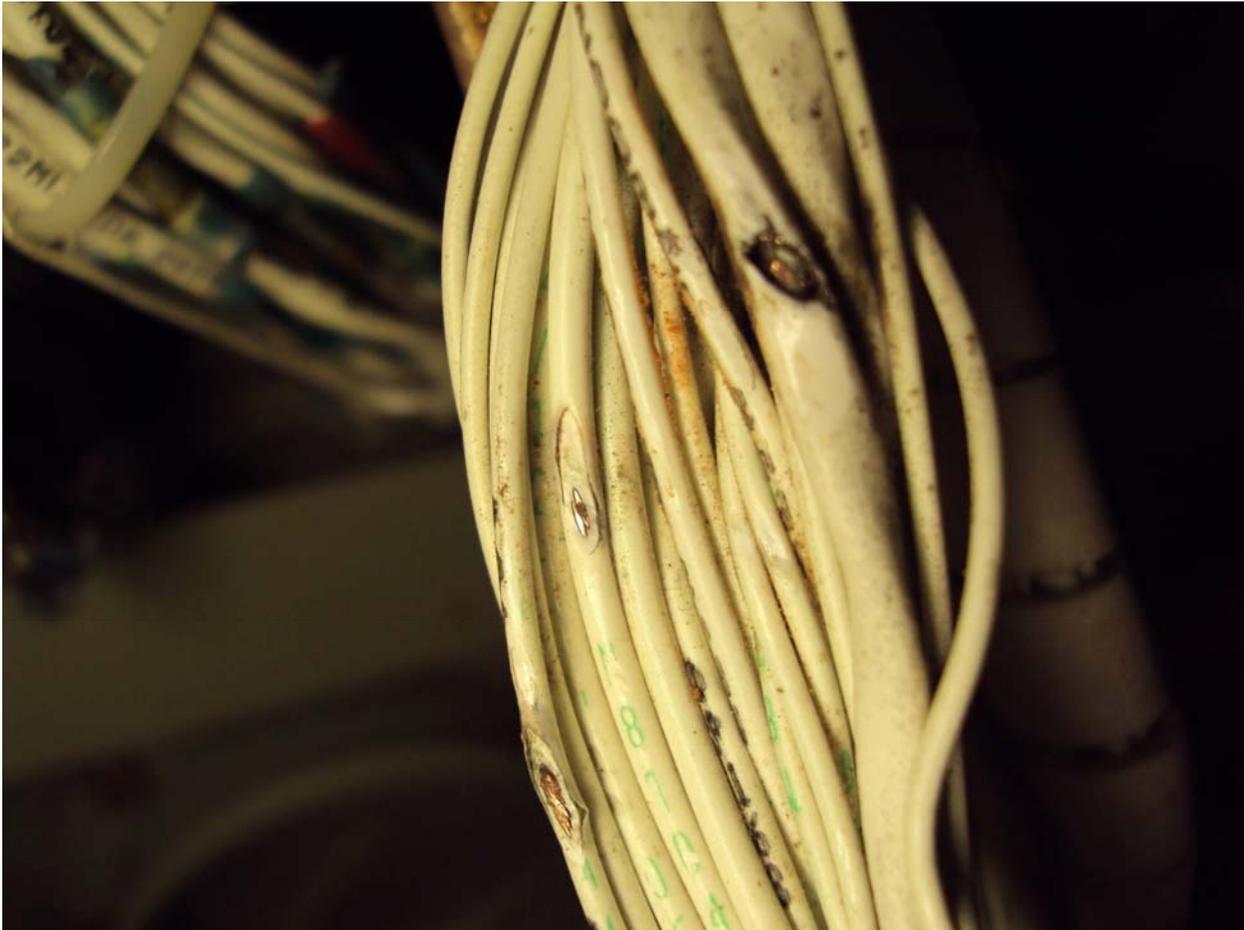
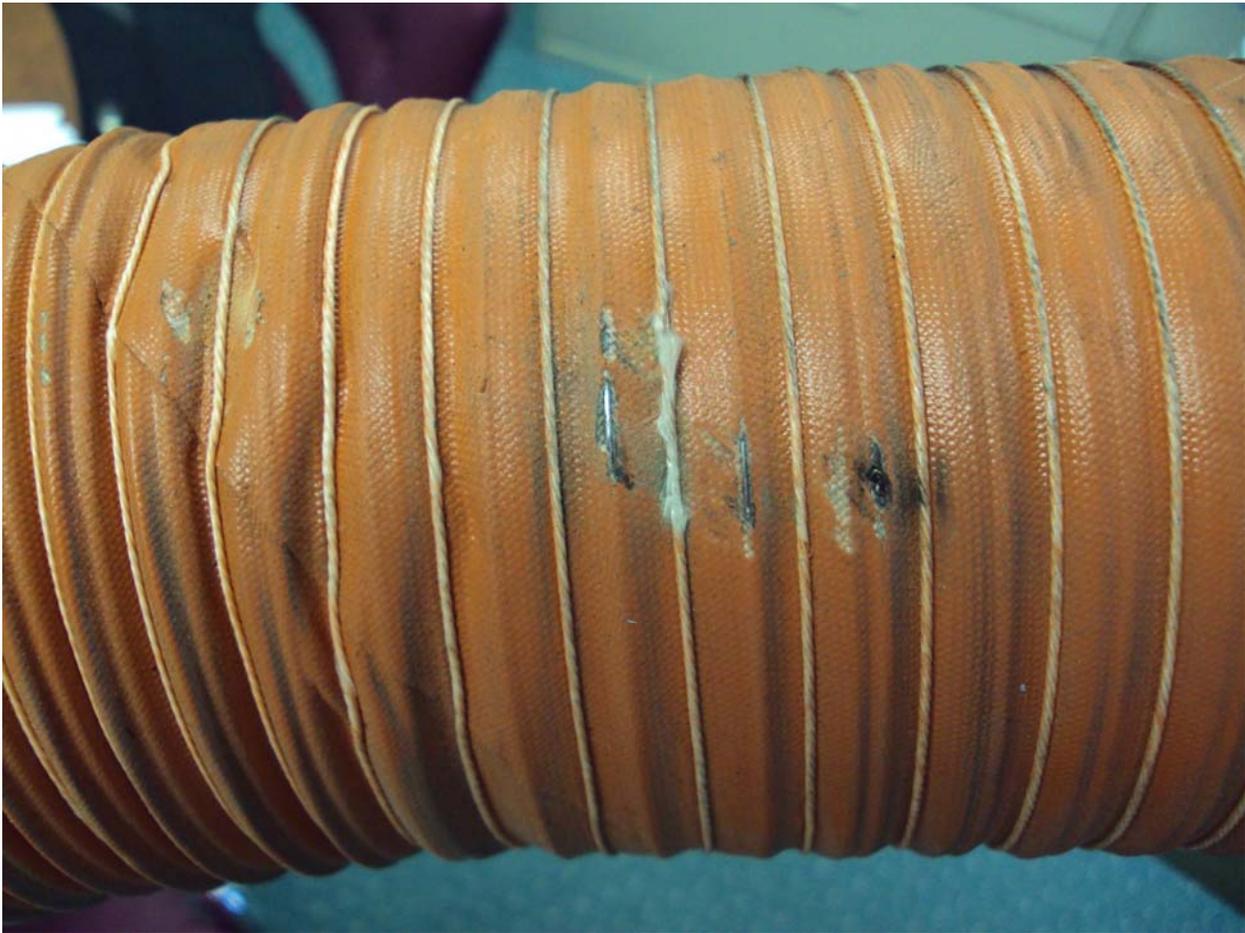
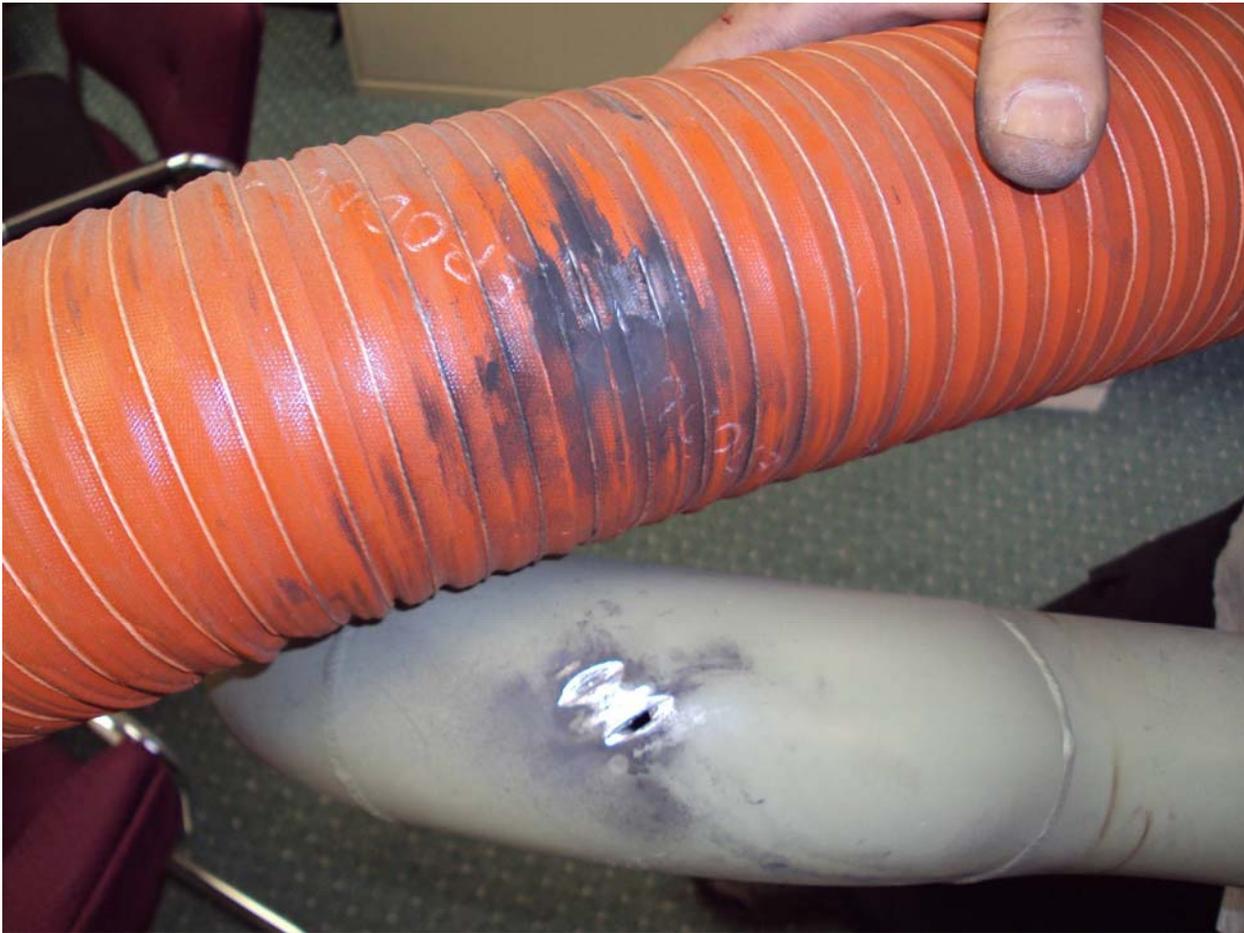
Cessna: 560; Chafing Wire Bundle; ATA 7797

A technician states, "During unscheduled maintenance, a wire bundle was discovered chafing to the point of exposing the copper wire to the N1 (*engine: low pressure section*) indicating system. Also, a conditioned air hard tube was chafed by a flex duct (*in addition to*) a service air line. All damage occurred in the hellhole below the J-box, adjacent to the R/H vertical web. All damage has been repaired."

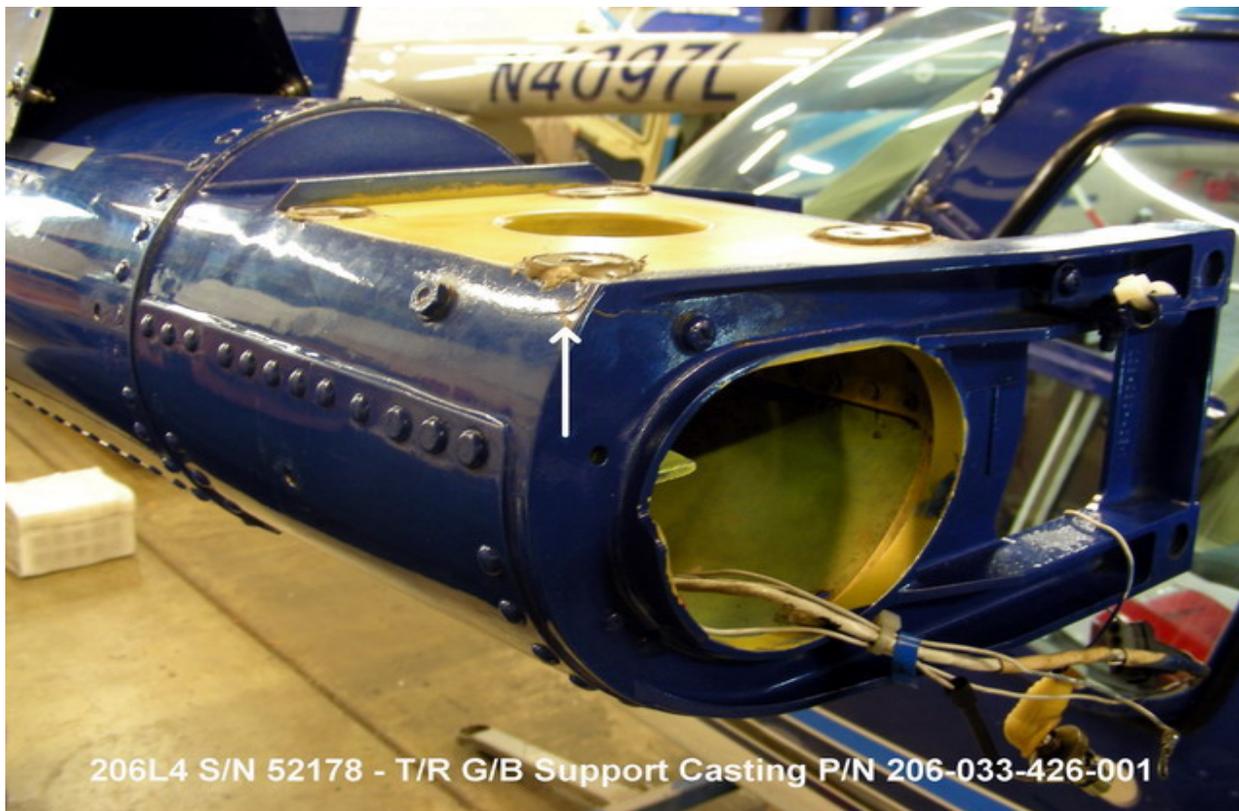
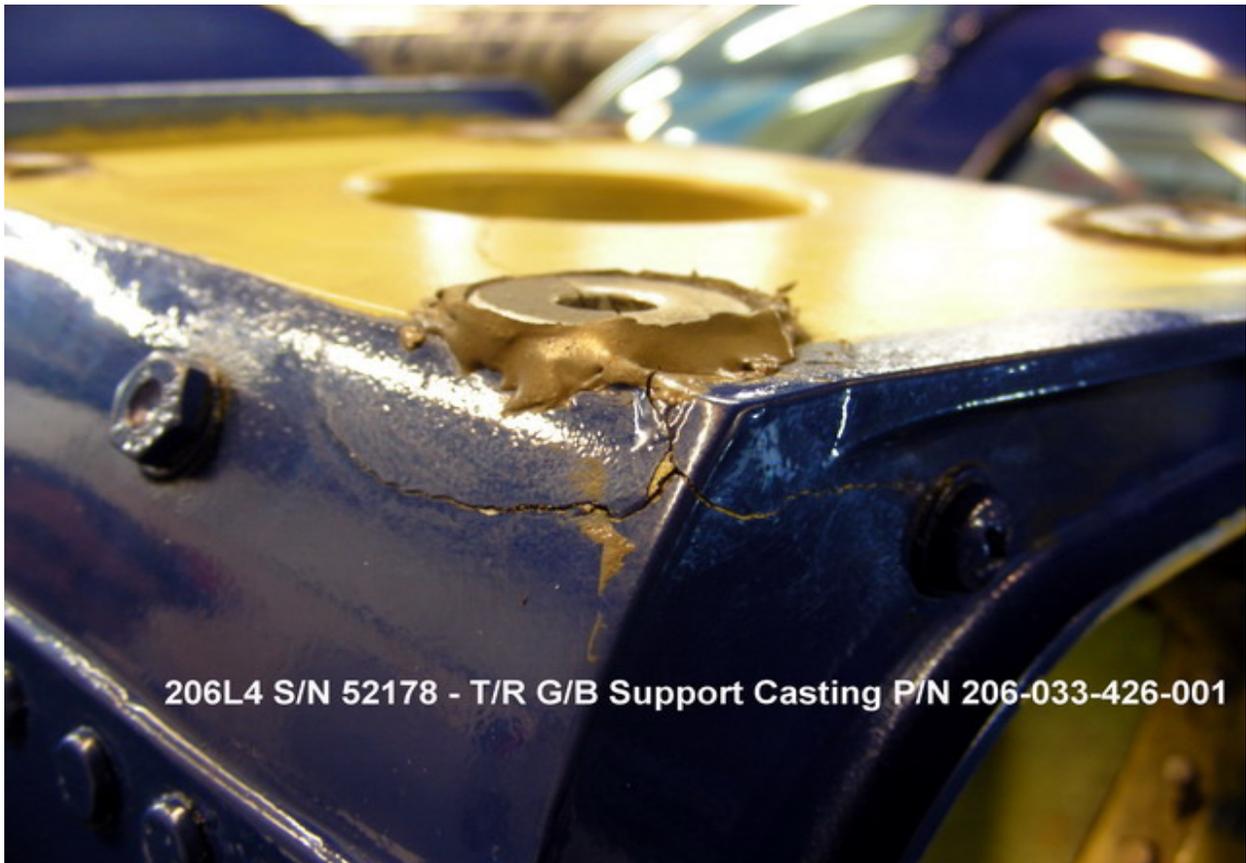
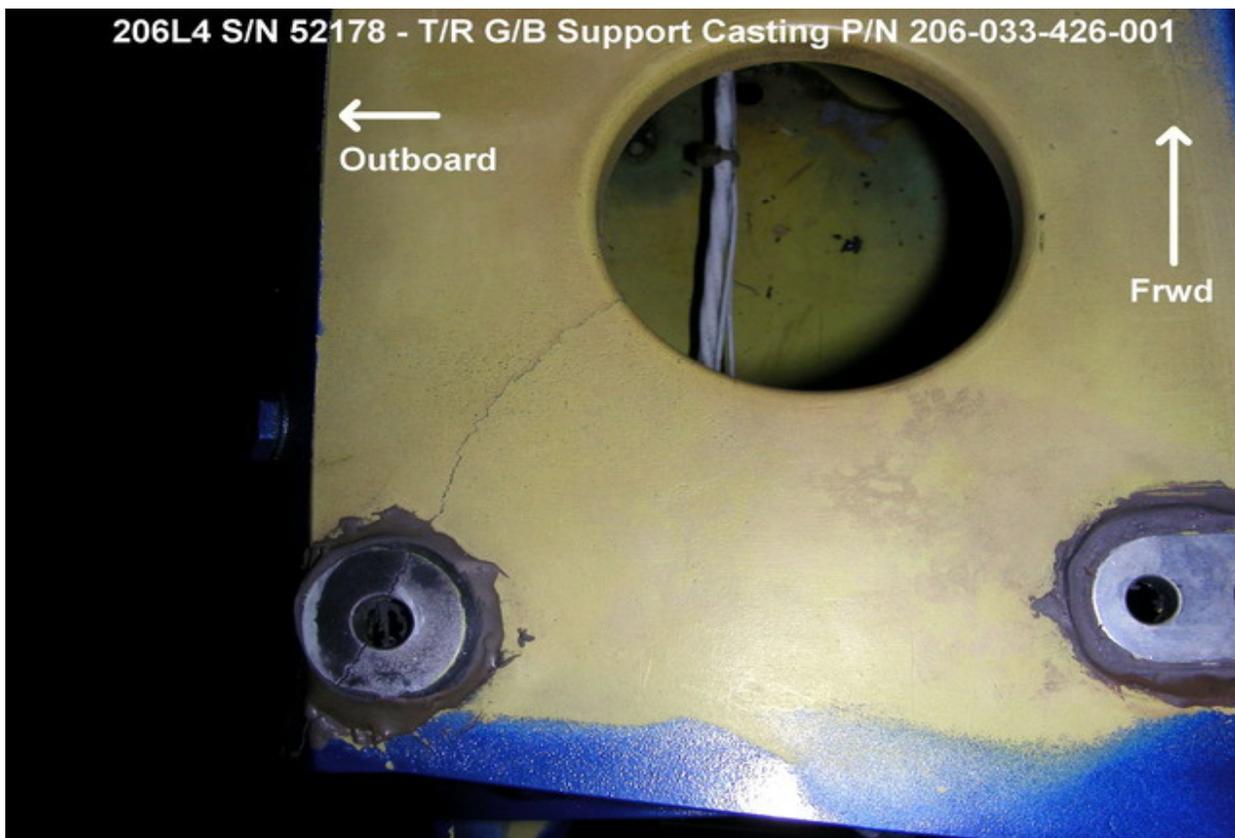
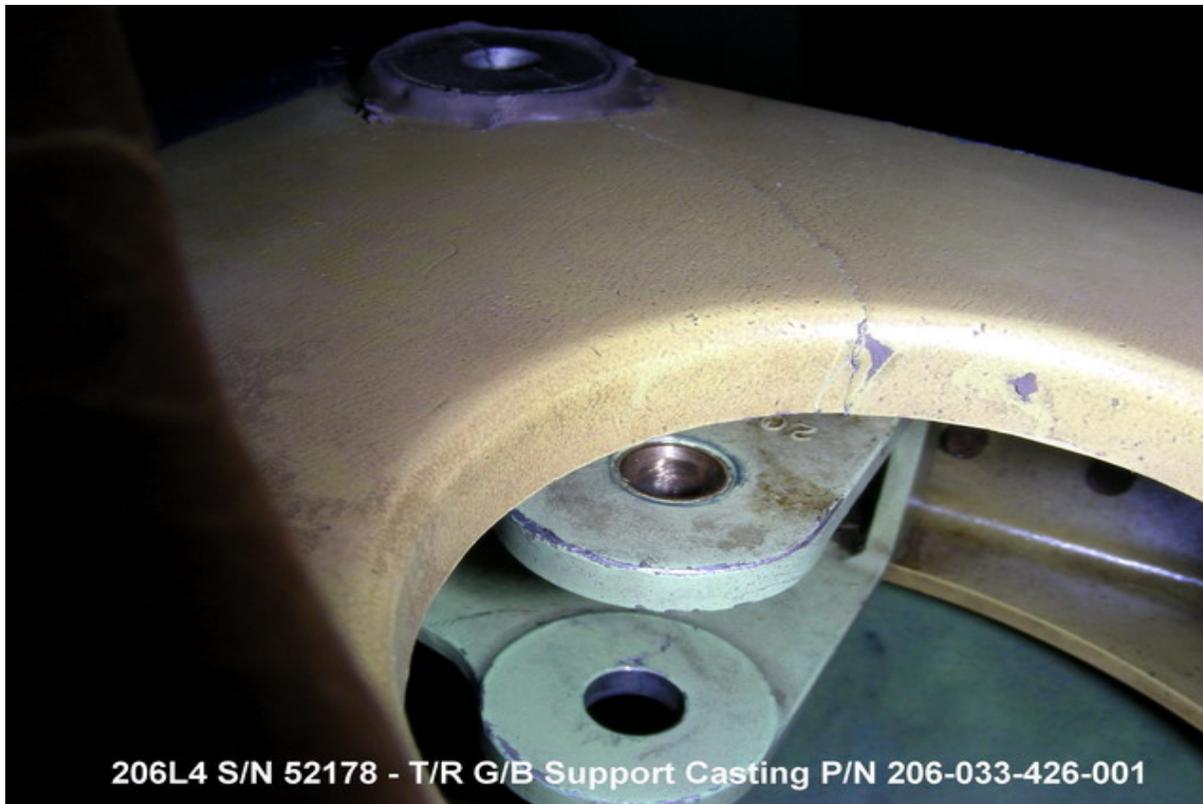
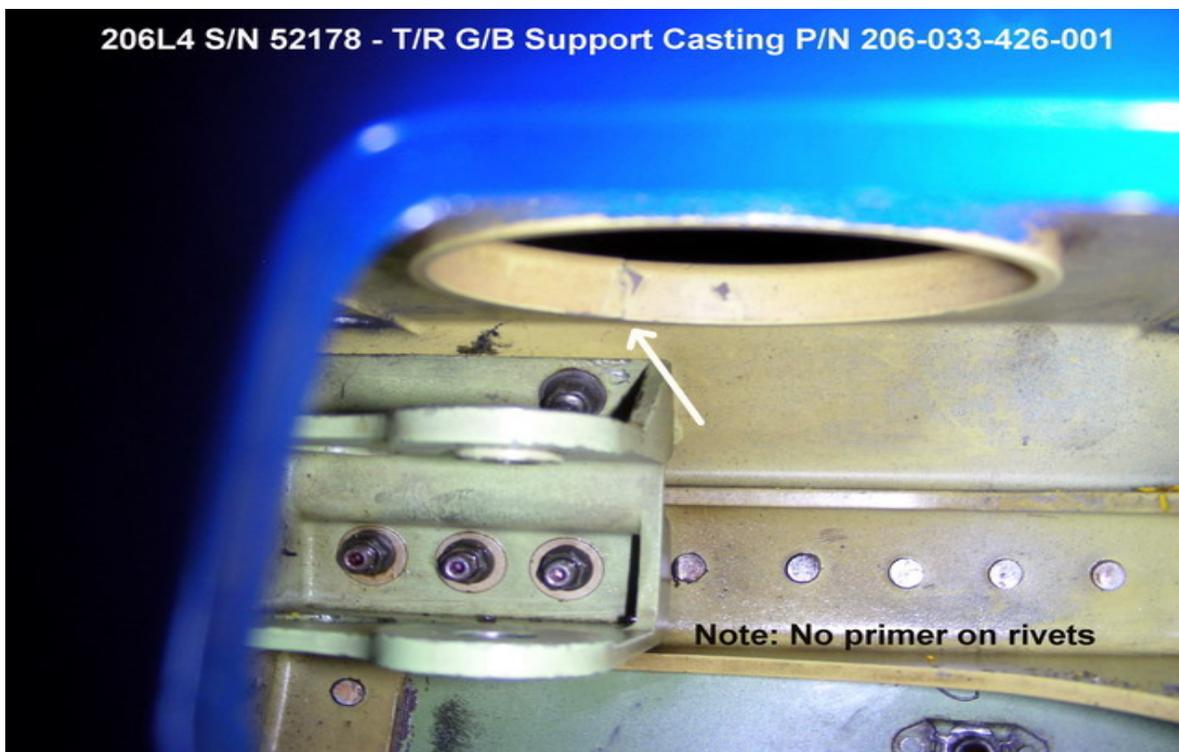
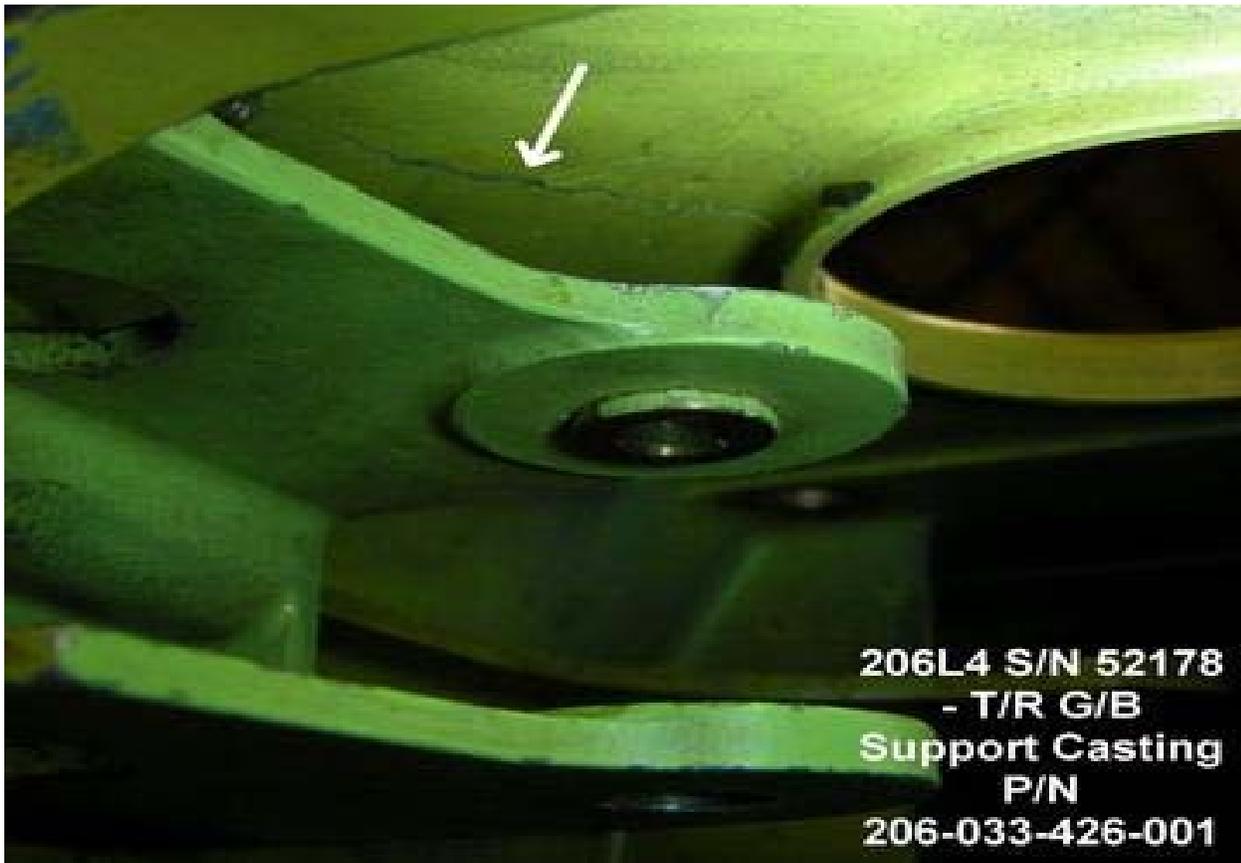
206L4 S/N 52178 - T/R G/B Support Casting P/N 206-033-426-001

Bell: 206L4; Cracked Tail Rotor Gear Box Mount Casting; ATA 5302

"During inspection of this aircraft, a crack was identified in the tail rotor gear box support fitting (P/N 206-033-426-001) at approximately the 7 o'clock position. This ship is fitted with a High Altitude Tail Rotor Kit." *(Four similar cracked mount reports list in the SDRS database.)*

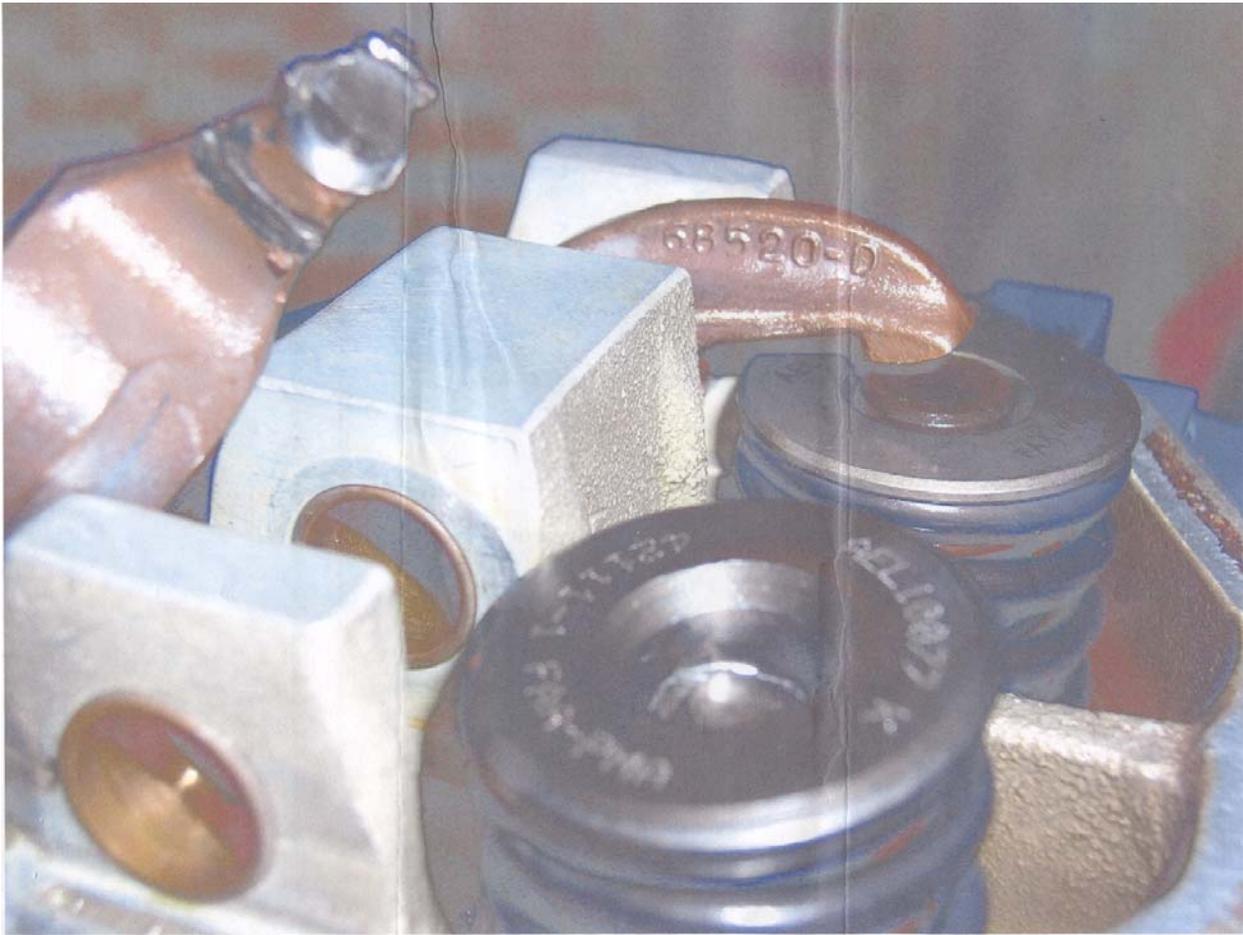
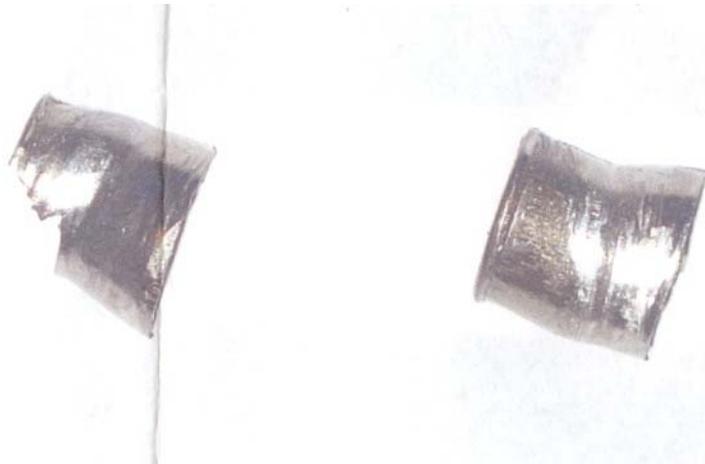
ECI Cylinder: (*unknown*); Failed Valve Keys; ATA 8530

"The valve keys (P/N 60009) are pulled through the (*spring*) seat (P/N AEL 10077)," says this repair station submitter. "The rocker arm tip is destroyed. A hole wore through the valve cover from the upper spring seat, and the (*valve*) keys were stuck on the valve stem. This valve stem is damaged and will not pass through the valve guide." (*See last month for a very similar report and additional photographs.*)

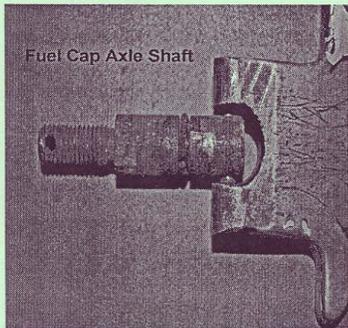
Fuel caps from an accident aircraft were tested to simulate the fuel pressure within an aircraft fuel tank. No leakage is considered permissible. The fuel caps leaked by the axle and handle assembly with a minimum pressure of 0.5 psi. Following disassembly and inspection, O-rings on the axle shaft were found cracked and broken. The corrosion on the axle shafts indicated long-term exposure to moisture. (see attached photo).

- inspect the condition of the fuel cap gaskets, seals and O-rings to ensure they are in place and not damaged;
- inspect seal surfaces to ensure they are smooth; and
- inspect locking mechanism to ensure it is properly adjusted.
