ADVISORY CIRCULAR

43-16A

AVIATION MAINTENANCE ALERTS

**ALERT
NUMBER
343**

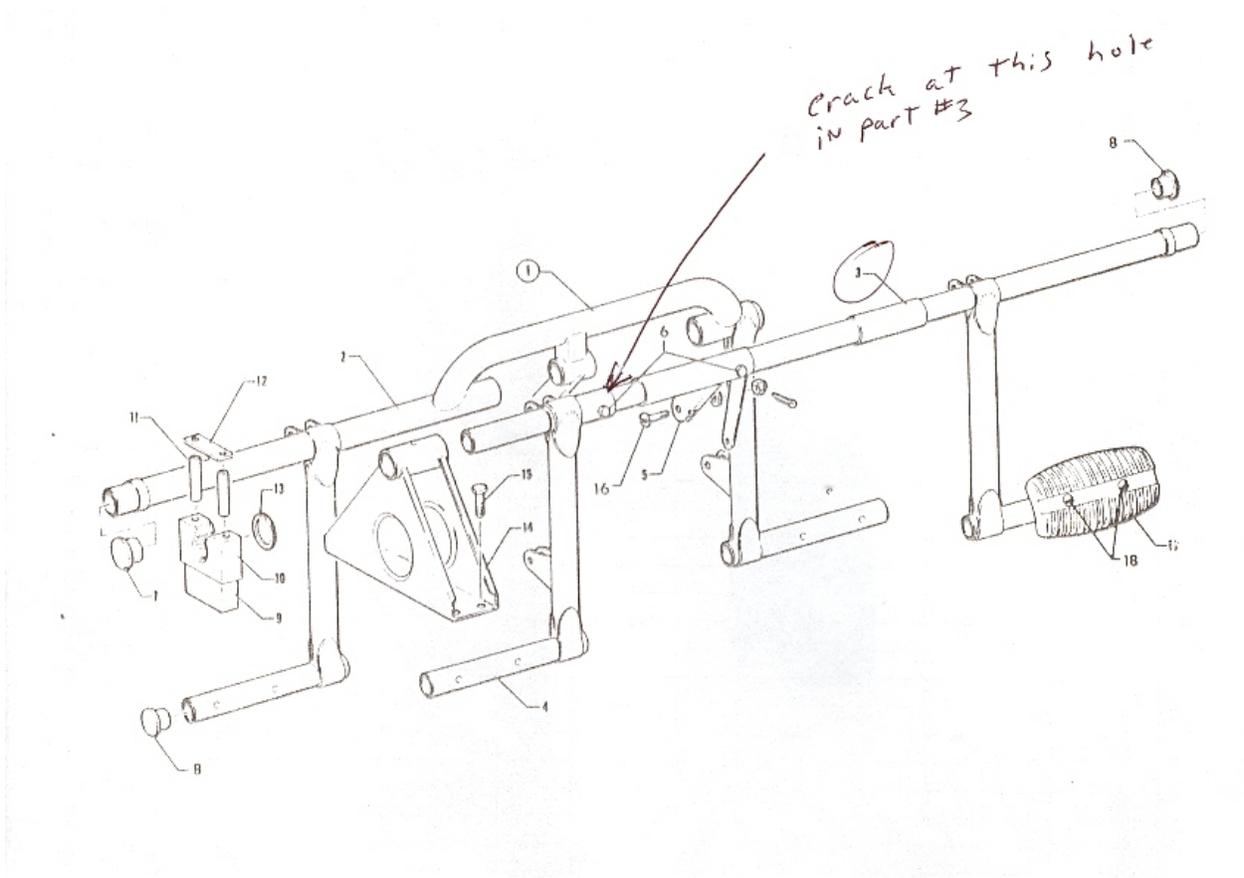
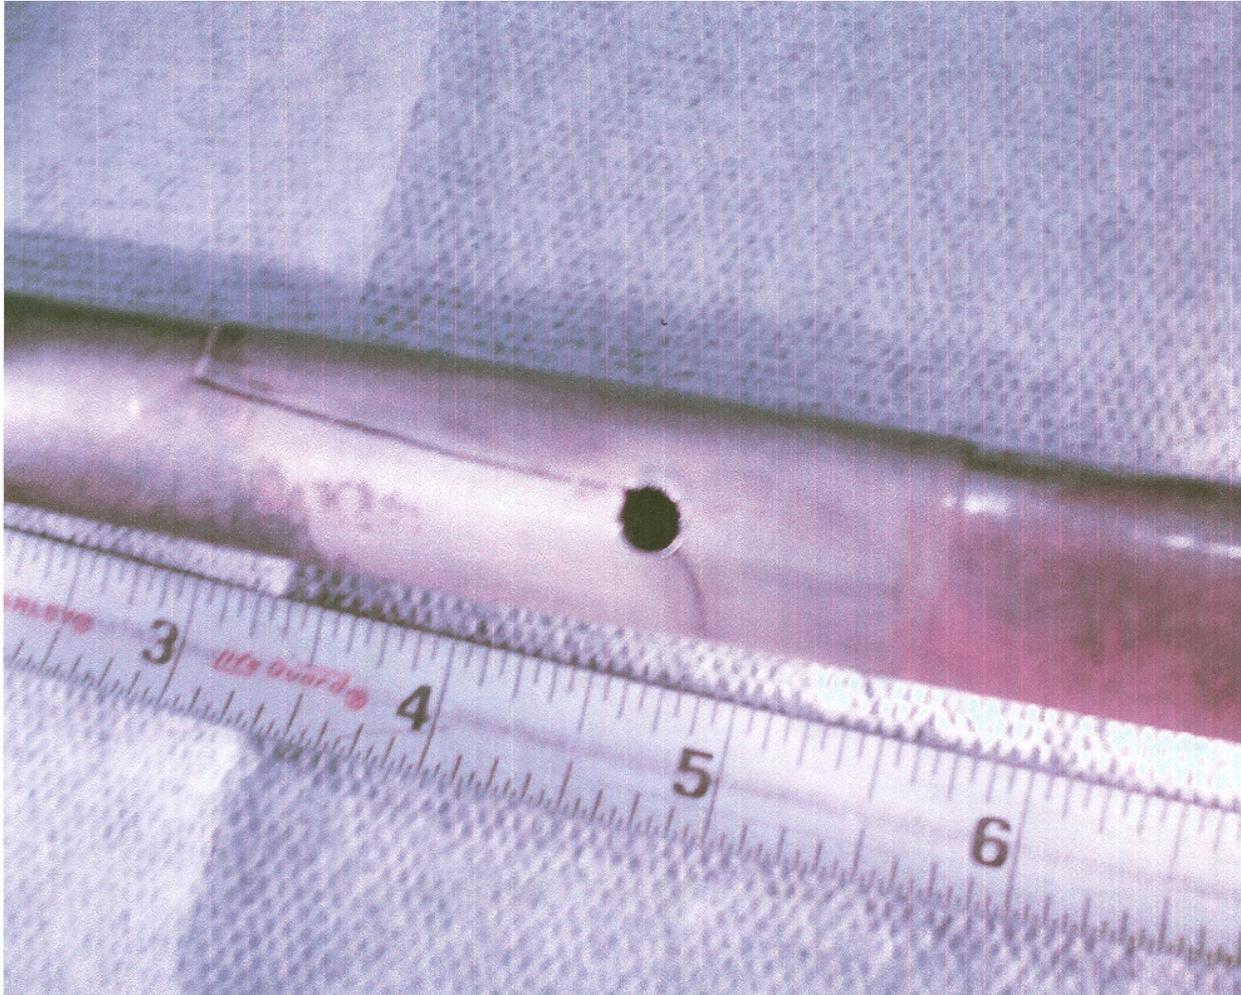
Piper: PA32-300; Cracked Rudder Bar; ATA 2720

A technician for a commuter service states, “Upon removal and disassembly of the rudder pedal assembly (*P/N 63419-02*), a crack was found approximately two inches long, extending out from the center bolt *through-hole*. (*I*) have found two other assemblies cracked in the same area. These cracks could be caused by

steering pressures applied while turning on the ground. All of these effected aircraft have had more than 10,000 hours total time. Other aircraft inspected (as the Cherokee 6) were *(also)* found to have elongated bolt holes.

“This part cannot be inspected in any way except for removal from the aircraft—a time consuming endeavor. *(I)* would suggest arbitrary replacement of this part at or about 10,000 hours.”

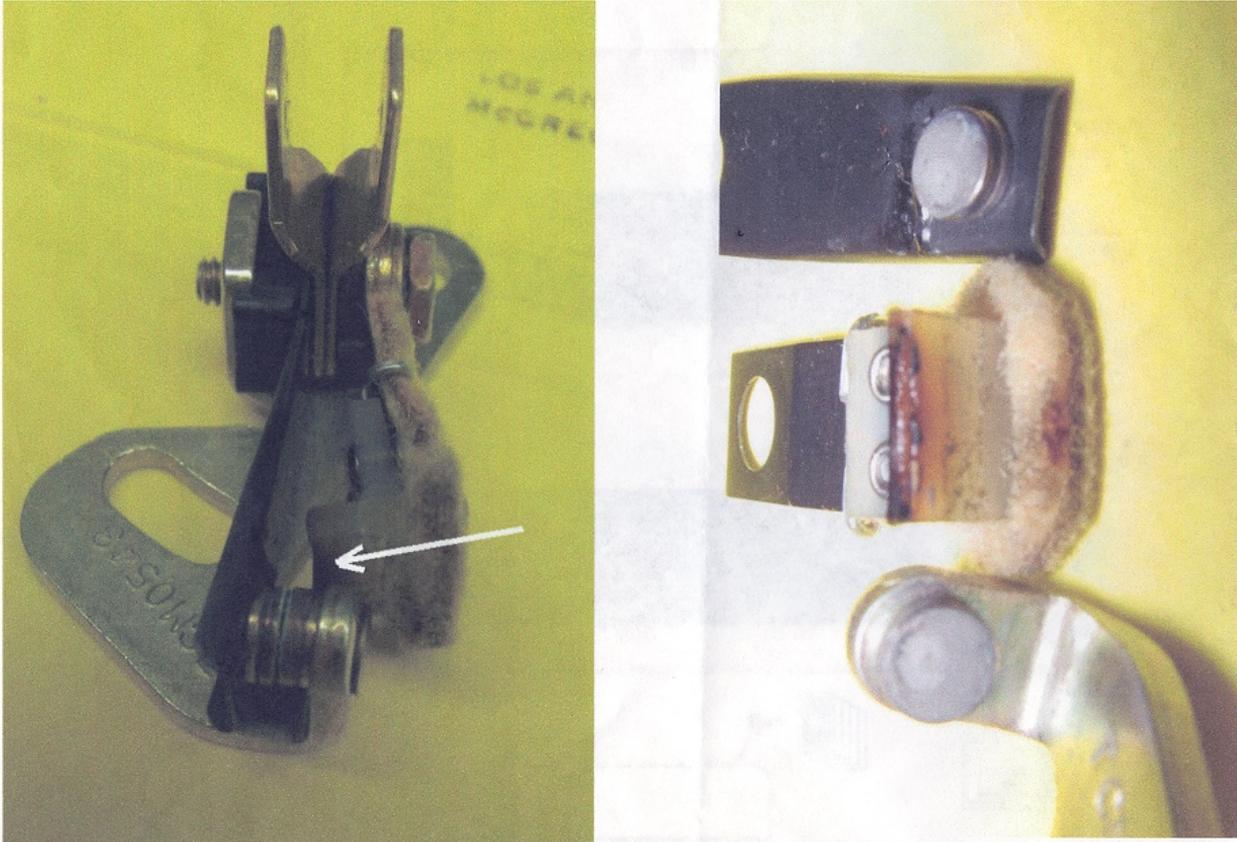
TCM Magneto: S6LSC-25; Melted Cam Follower; ATA 7414

A mechanic states this magneto's point set only had 9.3 hours when misfiring began to occur. Inspection revealed the plastic portion of the cam follower had melted, causing the misfire.
