U.S. Department
of Transportation
**Federal Aviation
Administration**

ADVISORY CIRCULAR

43-16A

**ALERT
NUMBER
355**

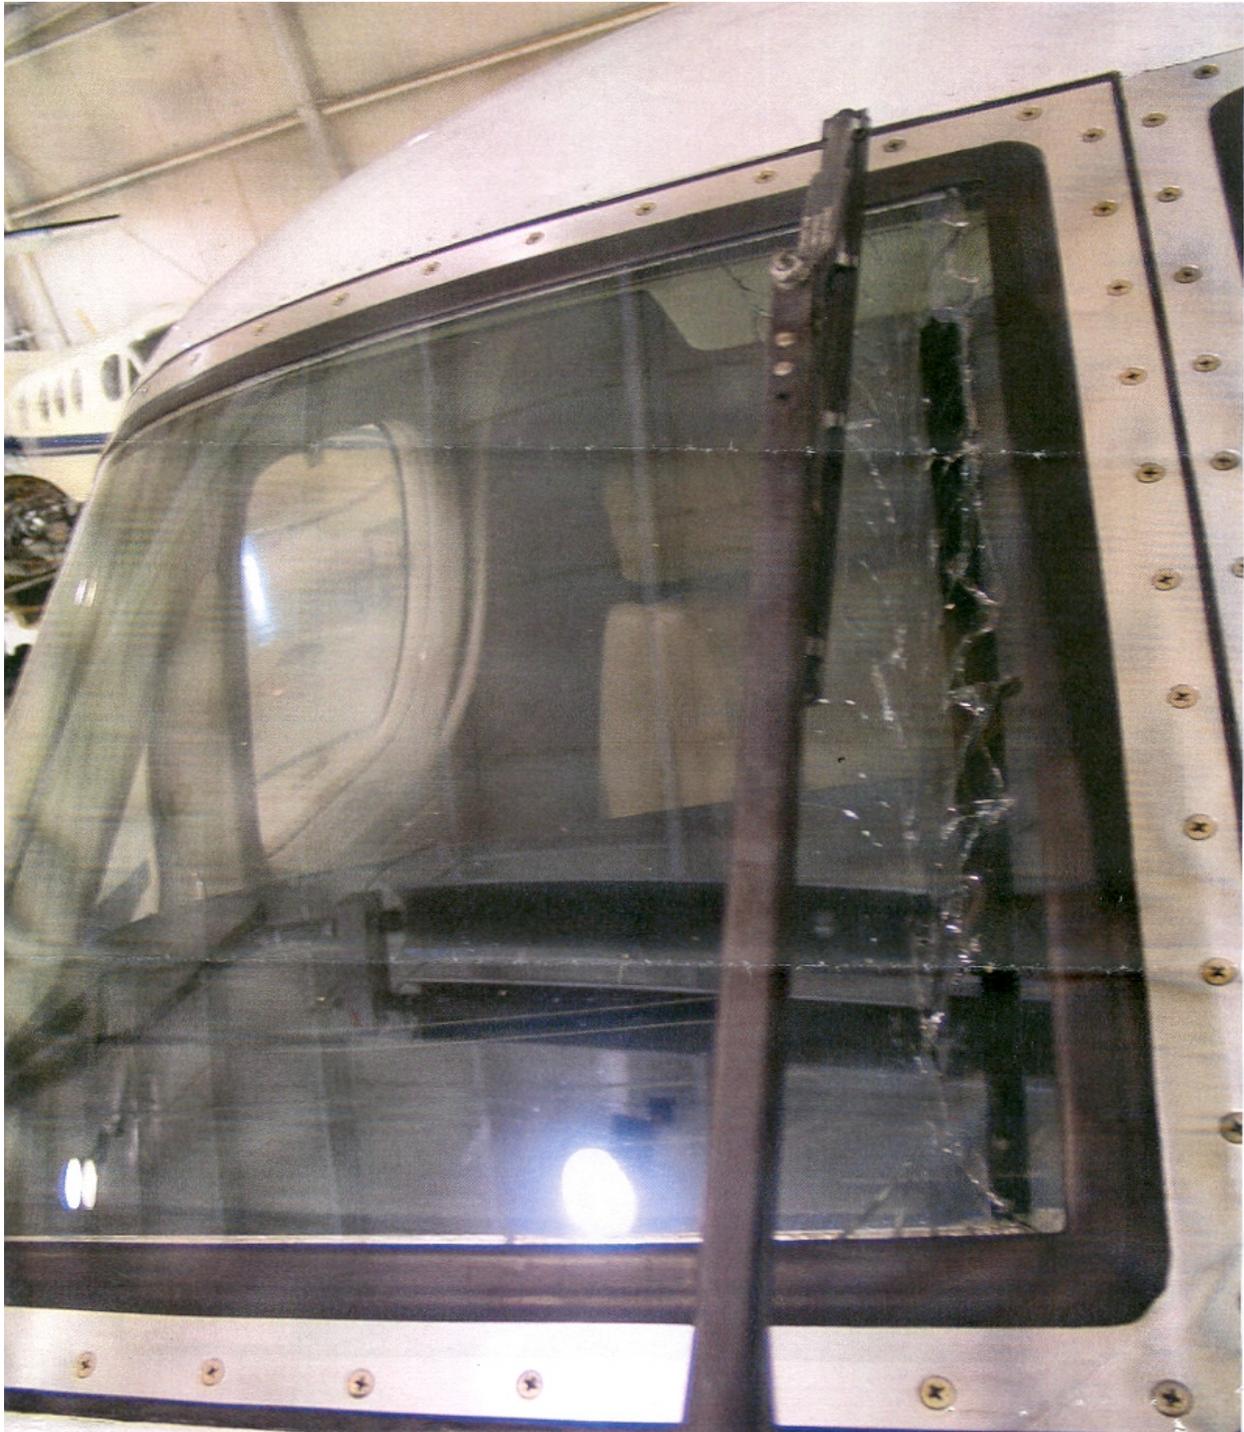
Beechcraft: B300; Cracked Windscreen; ATA 5610

A repair station submission reads, "At an altitude of 17,000 feet (*and an outside temperature of minus 6 degrees Celsius*) the right windshield cracked (*about 2 inches outboard of the center post*), from the top to the bottom in the outer pane. The aircraft returned to the departing airport without any problems (*and*) the windshield (*P/N 101-384025-24*) was replaced. There was no known cause for this part to have cracked."

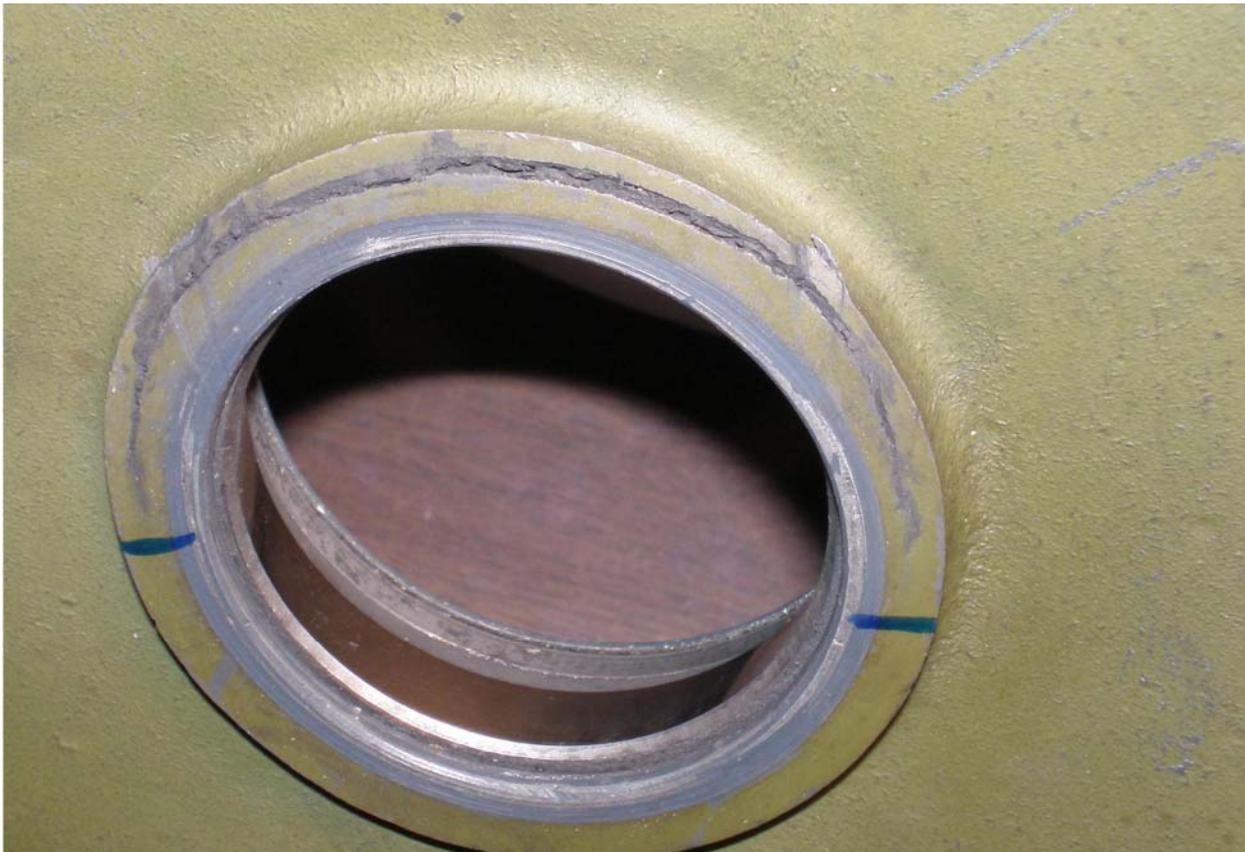
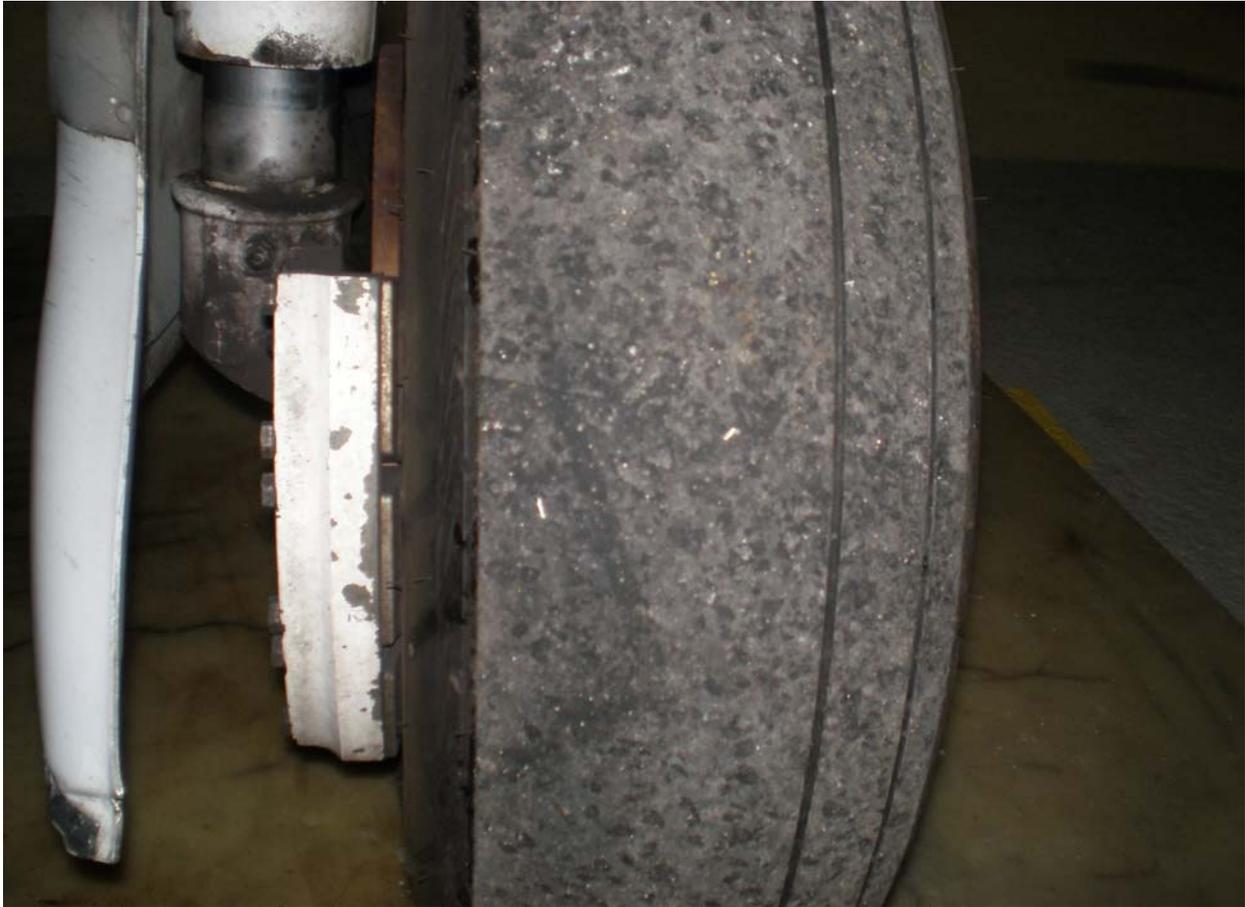
Cessna: 310L; Cracked Wheel; ATA 3246

A mechanic writes, “Upon changing a tire on a Cleveland wheel assembly on this aircraft, it was discovered the wheel half holding the bearing race was cracking. It had cracked over 180 degrees around the opening, which eventually could have *(led)* to a serious accident.”

Contact with the aircraft owner provided additional discussion and two excellent photos. Don Higgins writes, “Some tips for owners and mechanics: we noticed the first indication of this problem as uneven tire wear. When we had *(our mechanics)* turn the tire 180 degrees to even out the wear, they found the loose race—*(prompting)* them to look further. The wheel crack was *(then)* found, *(having progressed)* more than 180 degrees around the axle hole. My suggestion is anytime a wheel is off the axle, not only do the bearings need to be checked, but also the races. If the race is loose the tire needs to be pulled apart and checked to see if there is a crack causing the race to loosen up.”

“Cessna 310’s touch down in the 90 knot range. To have a wheel assembly fail (as this one was working up to) would render the aircraft uncontrollable and easily cause injury or death to the pilot/passengers.” *(Provided wheel P/N’s are 199-64 and/or 40-40A.)*

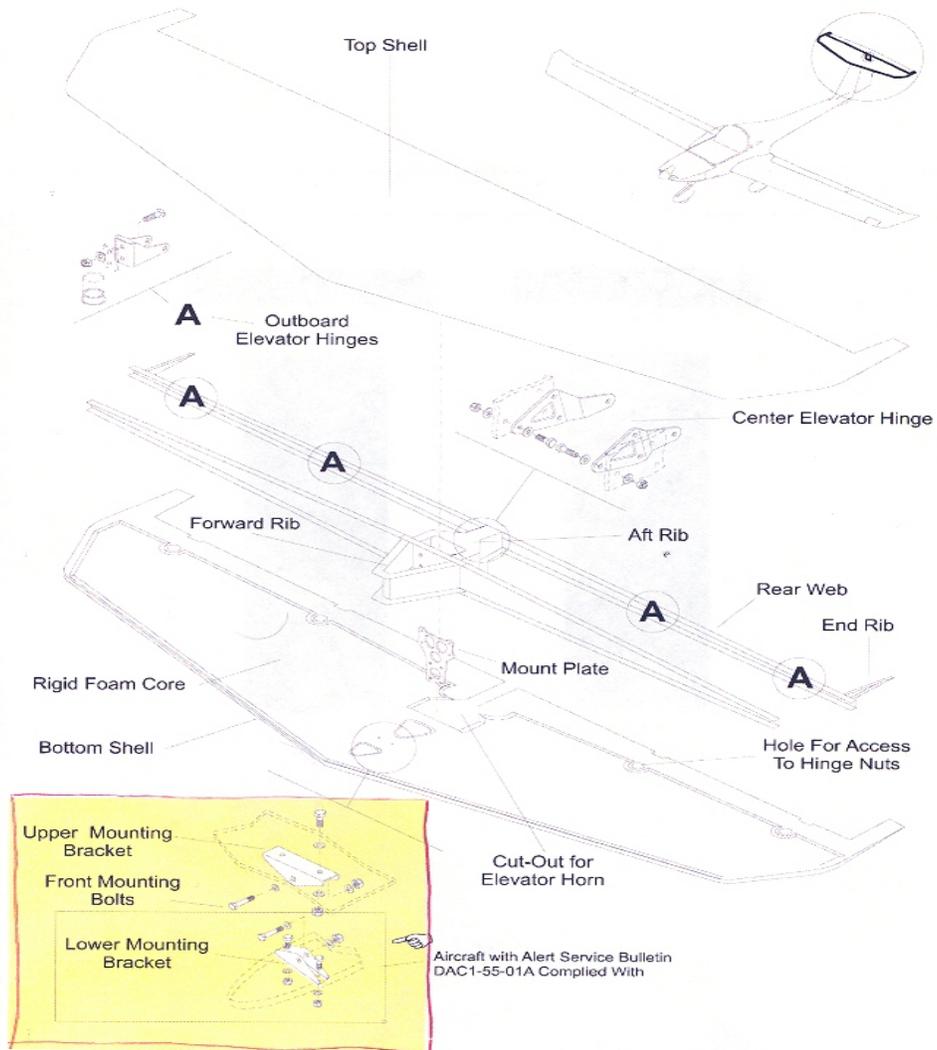
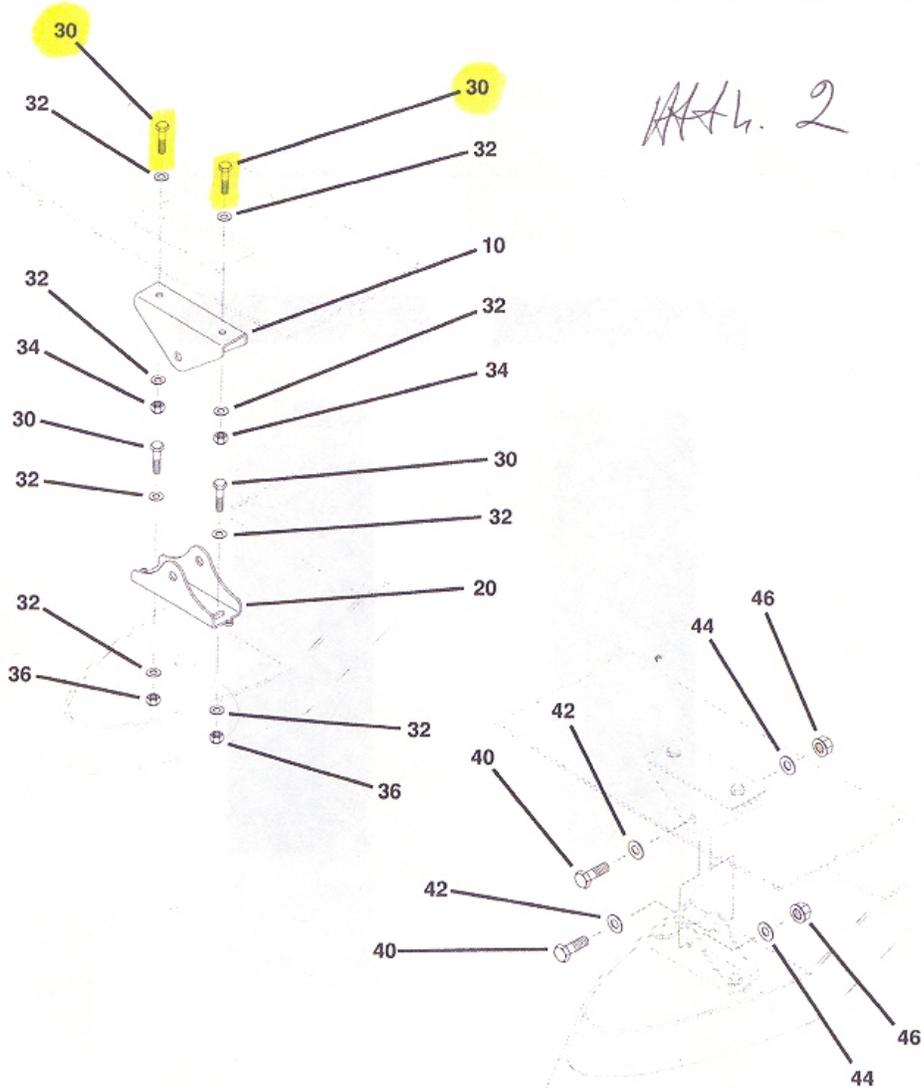
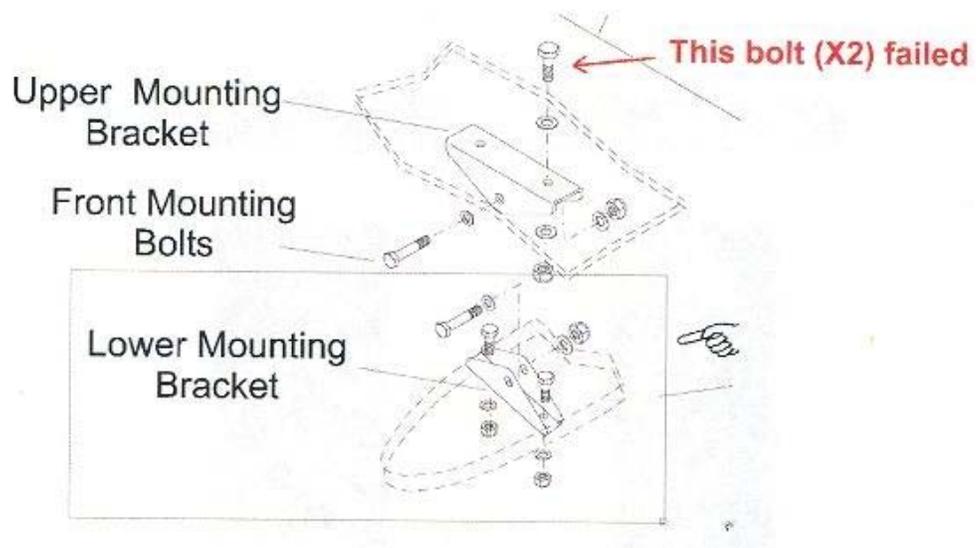
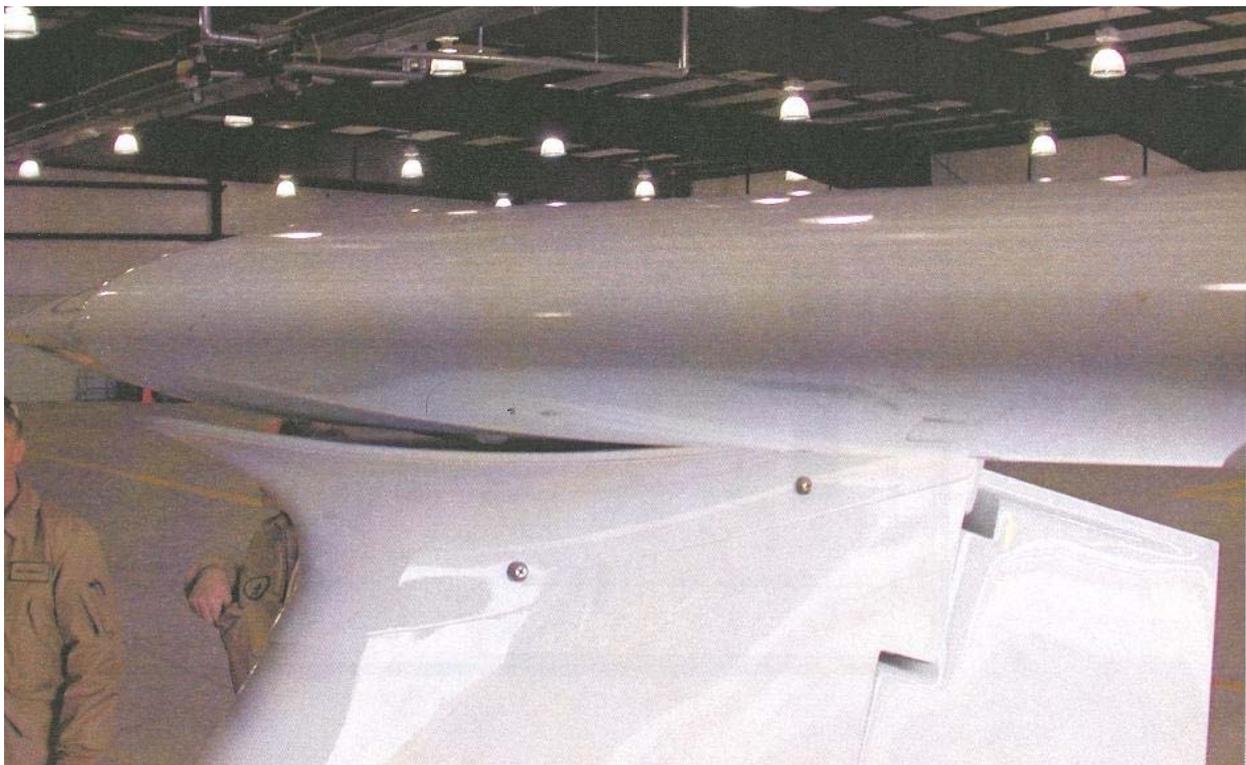
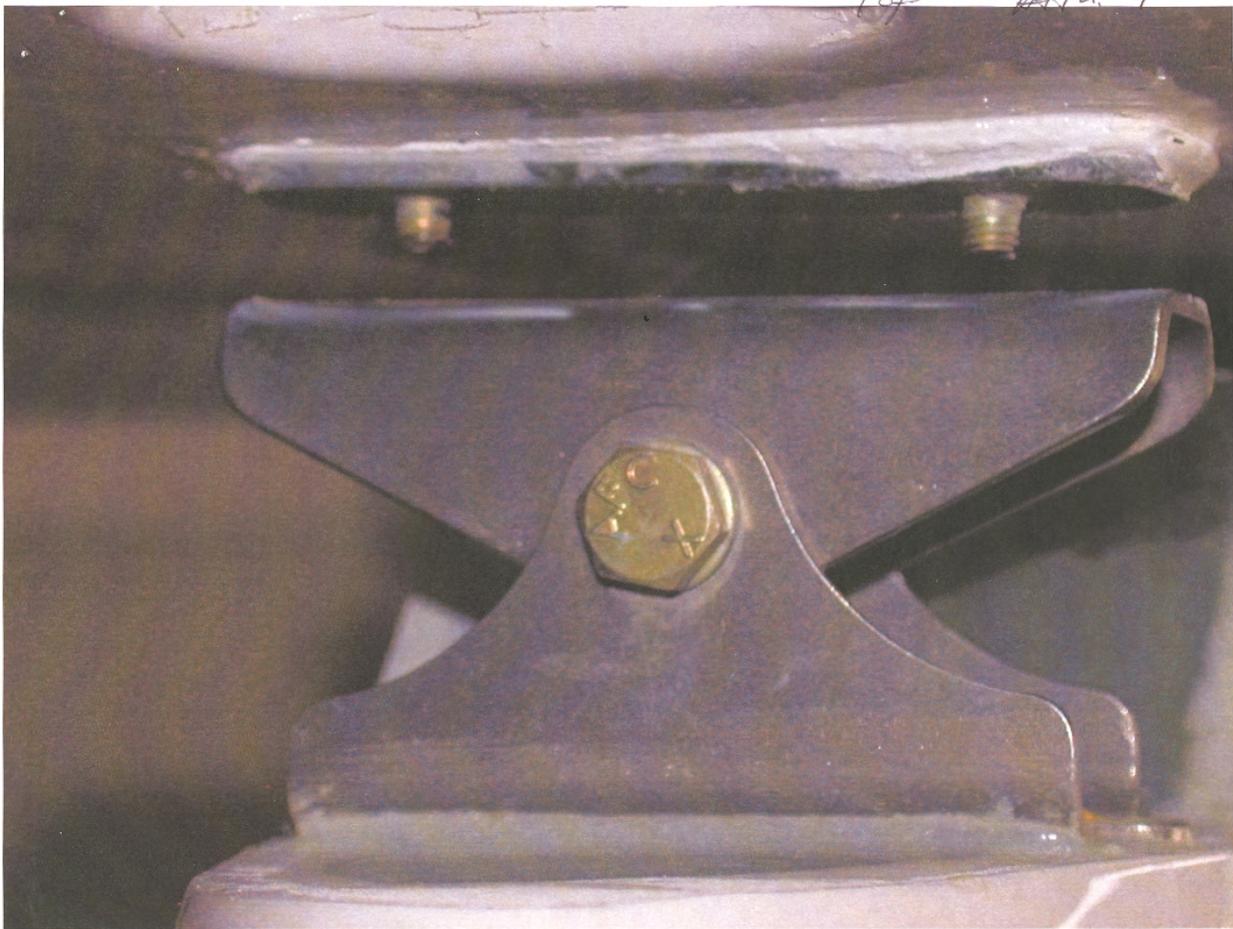
Diamond: DA-20; Broken Horizontal Stabilizer Bolts; ATA 5551

A technician for a flight training school writes, “*(This aircraft)* returned from flight with both horizontal stabilizer mount bolts broken (*P/N AN3-11A*).” “We removed the rudder and horizontal stabilizer to inspect the entire area. The aft mount plate and forward mount bracket were replaced, along with all new bolts, washers, and nuts. We also inspected our other (*DA-20*) aircraft and replaced all of their (*horizontal stabilizer mounting*) bolts. No other issues were found on our aircraft. Diamond Aircraft has been briefed and they are working with the NTSB (*National Transportation Safety Board*).”

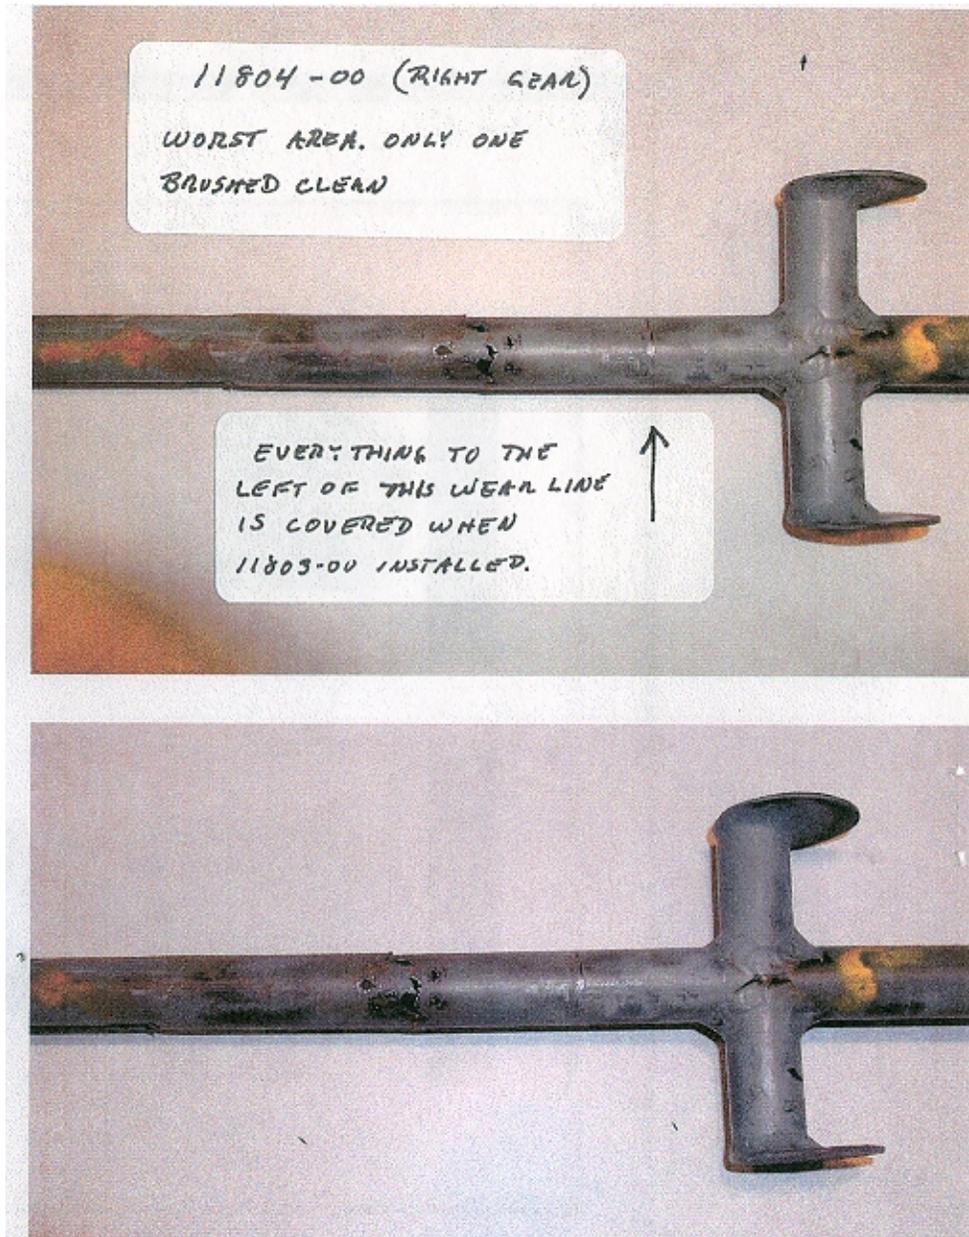
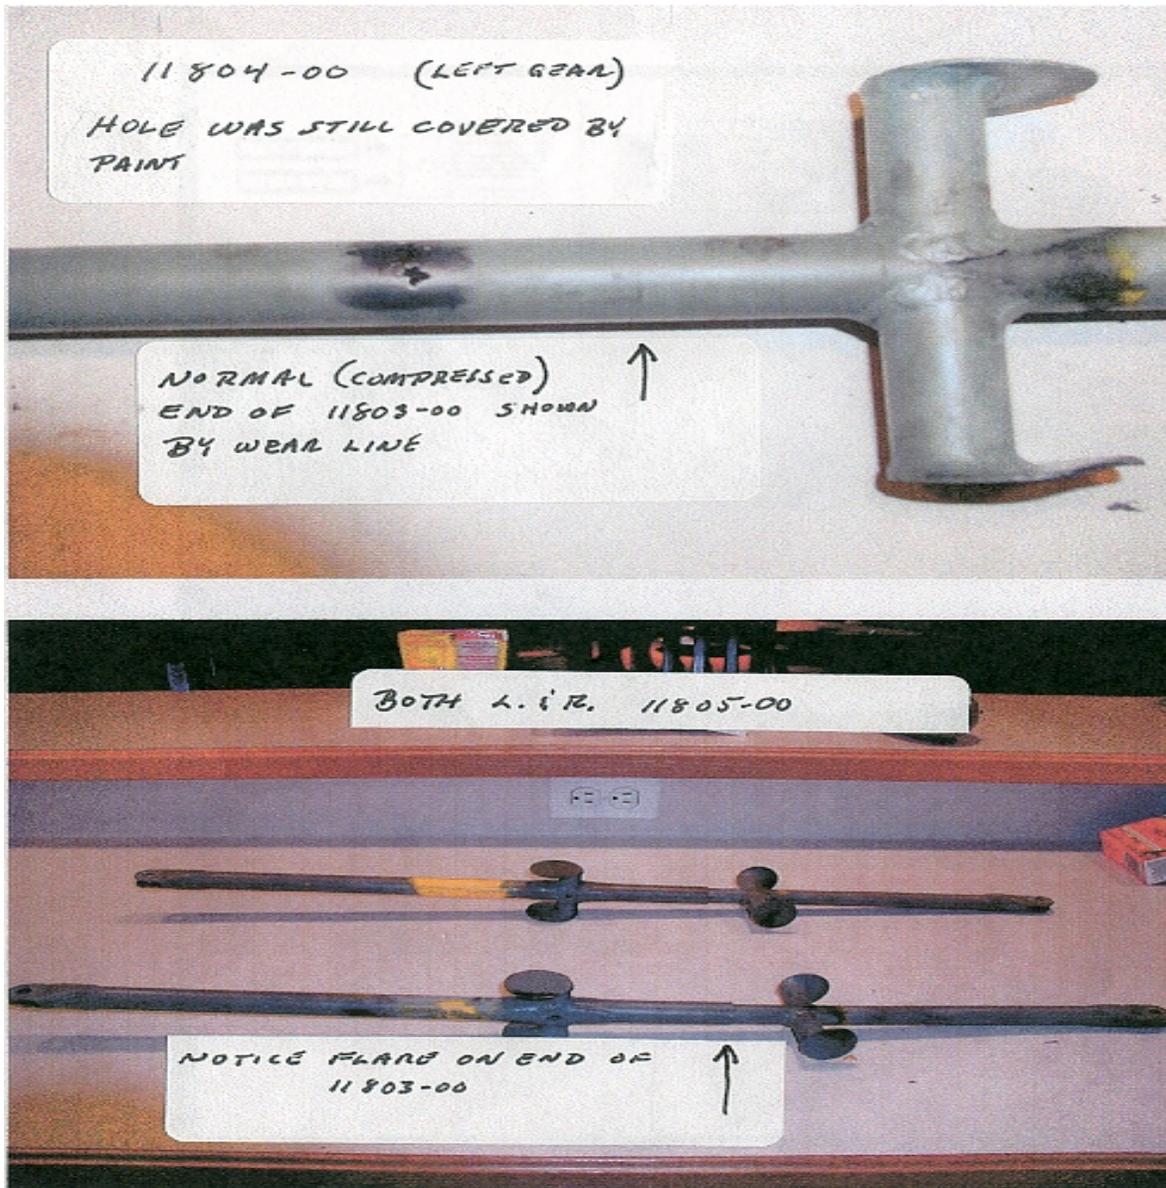
PIPER**Piper: PA17; Corroded Strut Tubes; ATA 3230**

A mechanic holding an IA (*inspection authorization*) says, “When changing shock cords on this aircraft, I noticed a discoloration of the inner strut tube (the longer tube—P/N 11804-00). I removed it from the outer tube (the shorter tube—P/N 11803-00). One of these inner strut tubes was corroded approximately 50 per cent (*around*) its circumference. The other inner strut had multiple corrosion holes through out (*the part*). Both outer short tubes showed oval elongation at the ends, indicating flexing/bending of this assembly during landings and takeoffs. I believe only the relatively new bungees kept this gear from final failure and (*the predictable*) ground loop.

“Installed bungee cords cover this (*corrosion*) area and they also (usually) have a cloth or aluminum fairing over them. Detection of this (*defect*) requires removal of the fairings at a minimum, and (*preferably*) removal of the bungees to clearly see the outer tube’s circumference. To inspect the area that failed, it is necessary to disassemble the unit (P/N 11803-00) and view the inner and outer pieces separately. I would recommend whenever bungees are changed, the pieces should be removed from the aircraft, disassembled, and inspected for corrosion.”

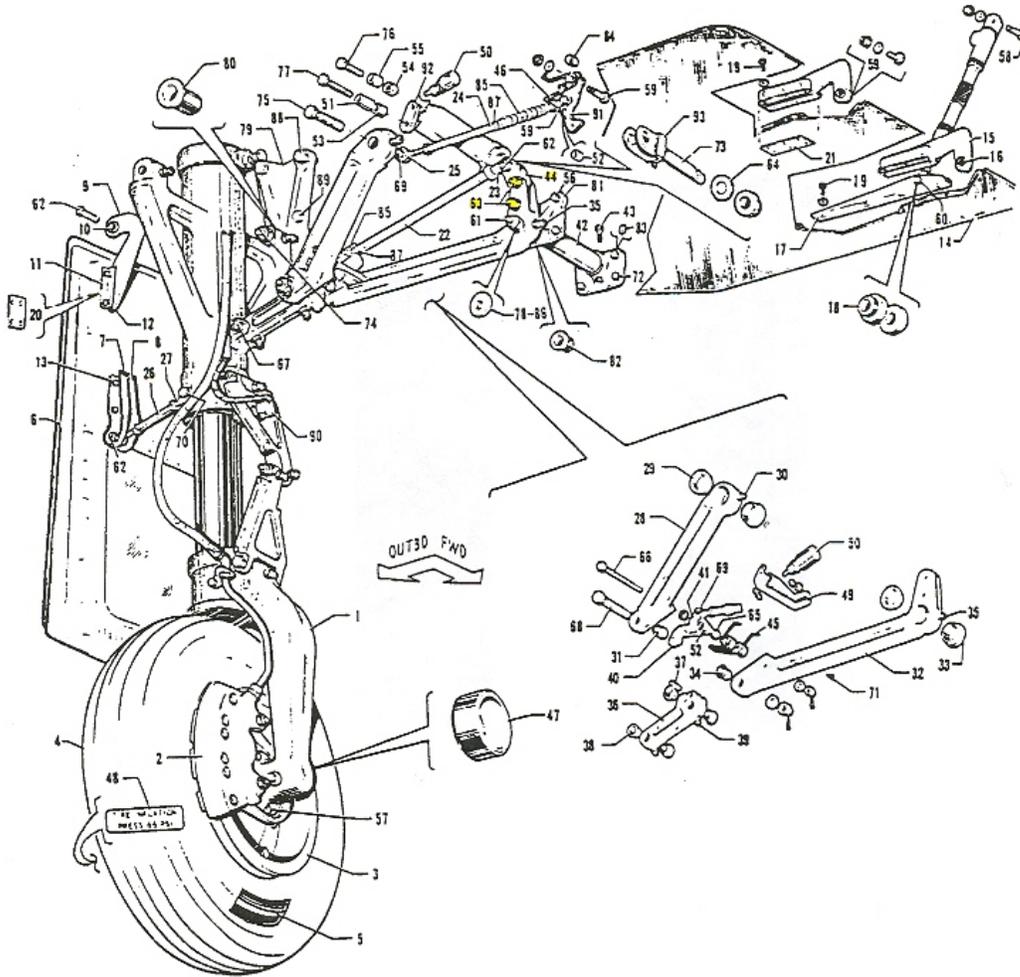
Figure 39. Main Landing Gear Installation

Piper: PA31-350; Failed Main Gear Bolt; ATA 3230

A mechanic writes, "Our aircraft had a 'gear unsafe light' and no 'left down and locked' indication light. The gear handle (*also*) would not return to neutral position. The aircraft landed with out incident. We believe the upper bolt retaining the main gear retraction arm broke due to fatigue. This allowed the main gear actuator to bind on the upper section of the drag leg, breaking the main gear actuator ball end out of the main shaft of the actuator.

“There is no requirement for the bolts (P/N AN6-17) that retain the main gear retraction arms to be inspected or replaced. These bolts are (*given a cursory*) inspection during retraction arm removal by a visual check for wear and corrosion. We believe these bolts need to also have a life limit or be magnaflux inspected. These bolts showed little wear. The bolt that failed appears it may have been cracked for sometime before it failed completely, but it was not detected during the last compliance with SL-1092.” *The FAA Service Difficulty Reporting System (SDRS) data base returns 14 similar entries for the base part number 42042 with ATA 3230.*)

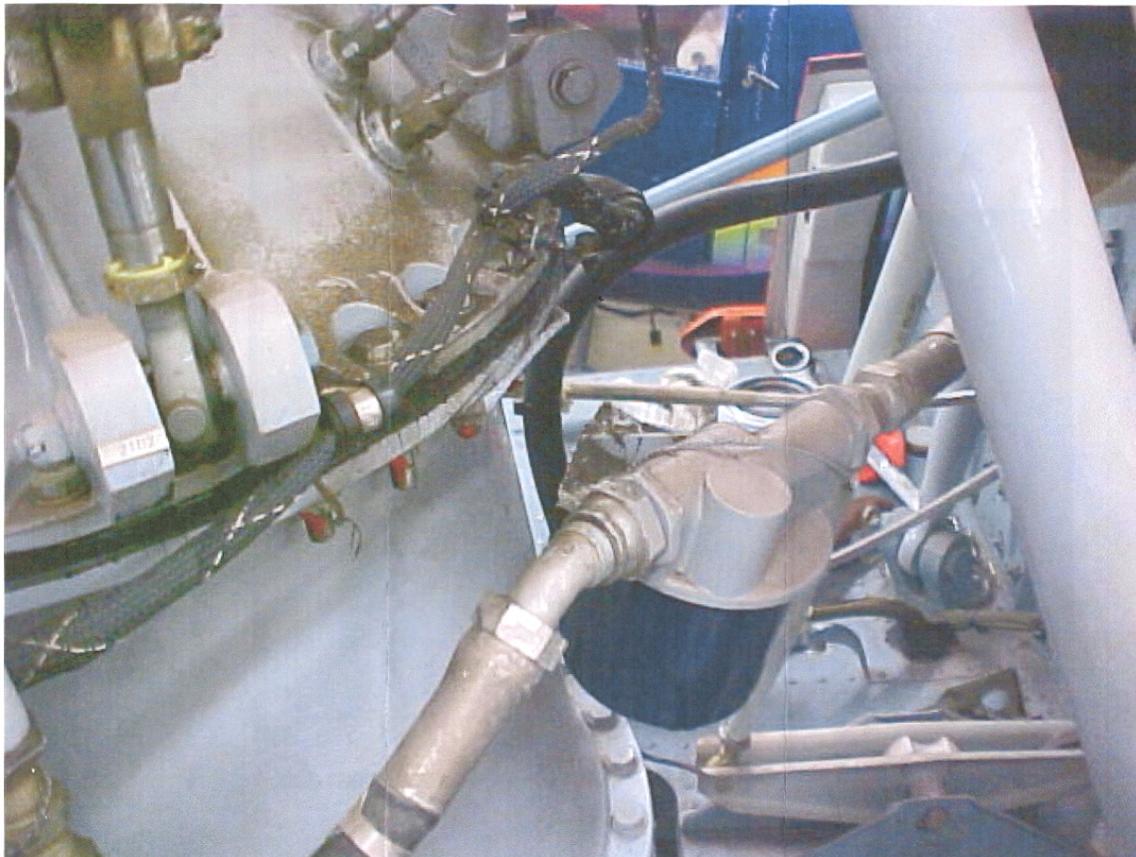
Aerospatiale: AS350B3; Broken Oil Filter Mount Bracket; ATA 7261

A repair station technician states, “During a 100 hour inspection, the mechanic reached to unscrew the oil filter and the bracket broke off in his hand (*P/N N325400A*). This part was replaced. The entire break looked fresh—even with 10 power magnification. It (*appears to be*) a pot-metal bracket.”

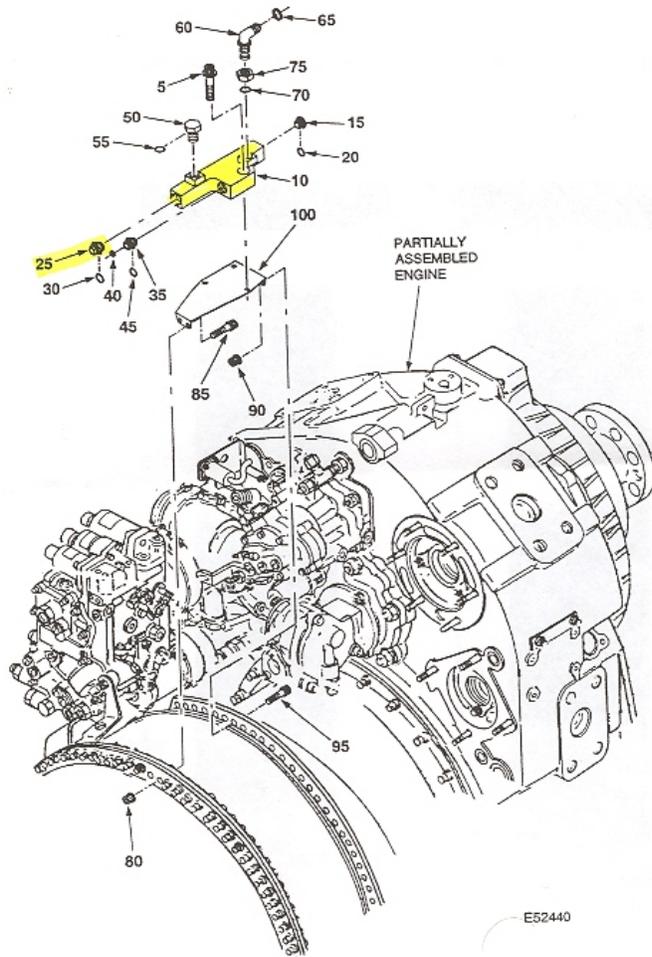
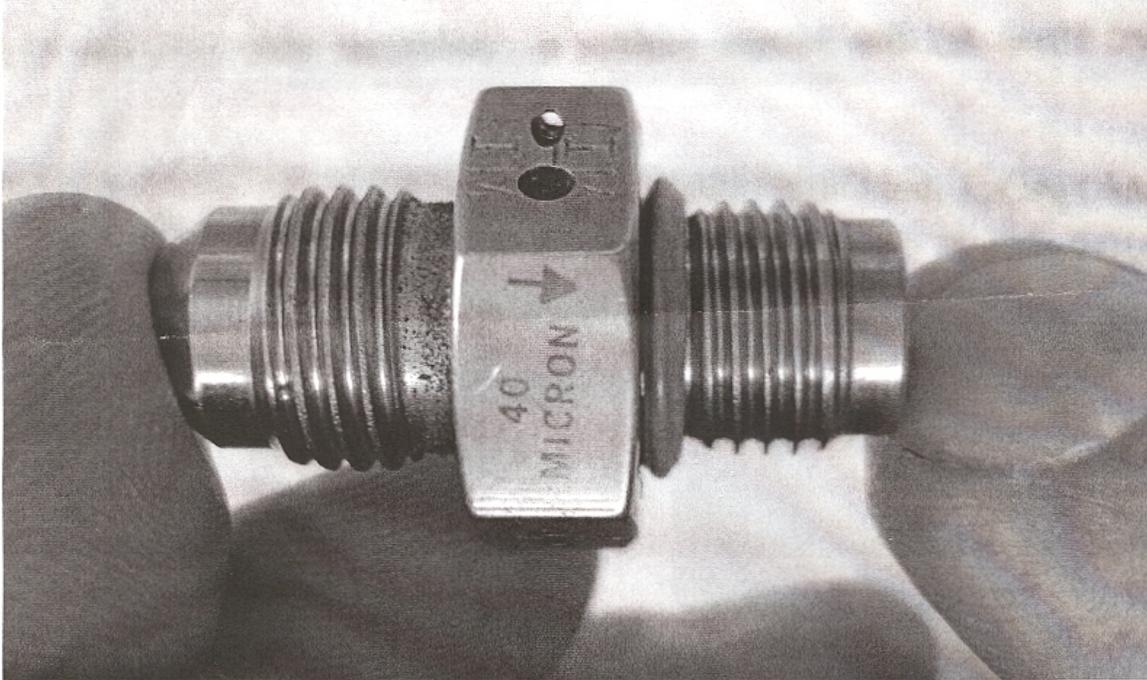
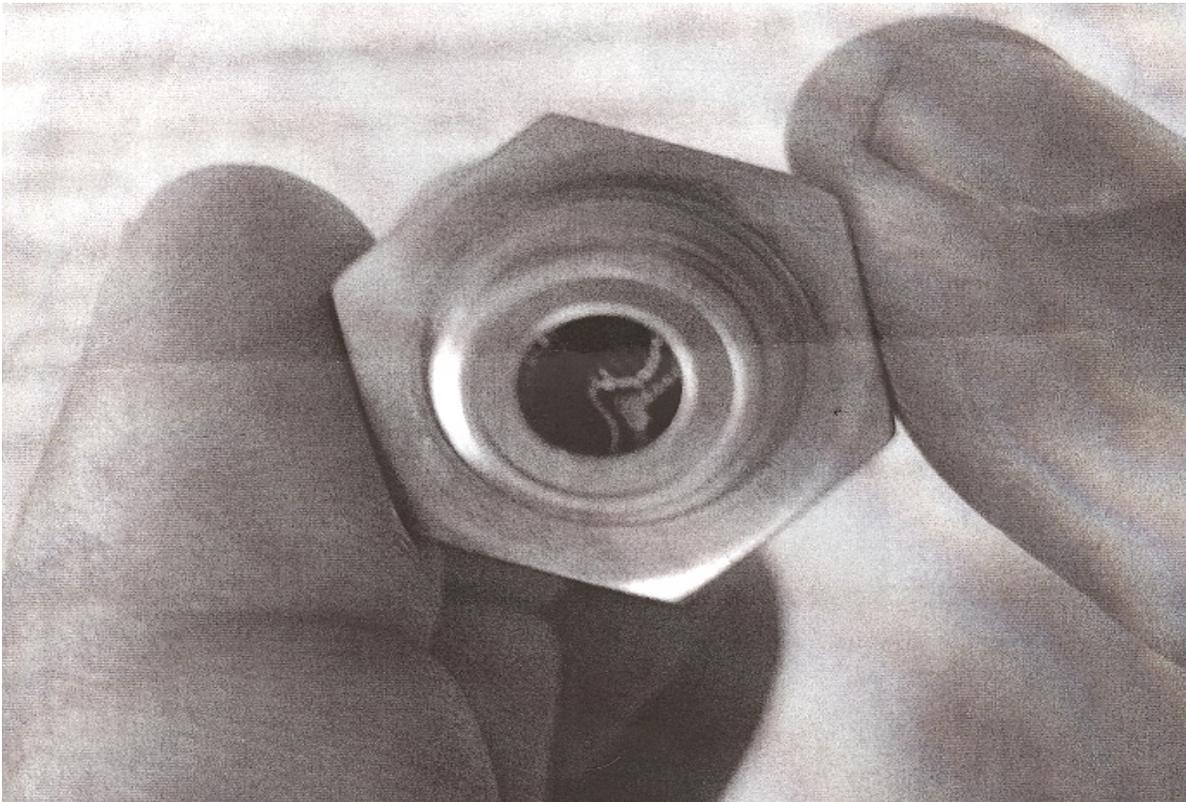
Flow Control Manifold Installation
Figure 1

A lead quality control inspector for this repair station writes, “During this aircraft’s 200 hour progressive inspection of the L/H engine fuel manifold (P/N 3105455-1), the in-line 40 micro fuel filter (P/N 337-541-9106) was removed to inspect for fuel limitation issues. The filter screen was found to be clogged and collapsed. This filter is not referenced in the Honeywell Illustrated Parts Catalog (73-20-40 page 0) and it is not required to be inspected and/or cleaned during routine or special inspections. This filter needs to be removed, inspected, and cleaned every 200 flight hours until a suitable solution to this issue is found by the engine manufacturer. A collapsed filter could lead to fuel limitation and performance issues—and improper troubleshooting by maintenance technicians.

“Honeywell technical representatives have been contacted and (*they*) are aware of this (*problem*). Since then several filters have been found clogged and collapsed on other, same type aircraft and engines. Other, similar engine installations could (*also*) have this manifold/filter installed.”

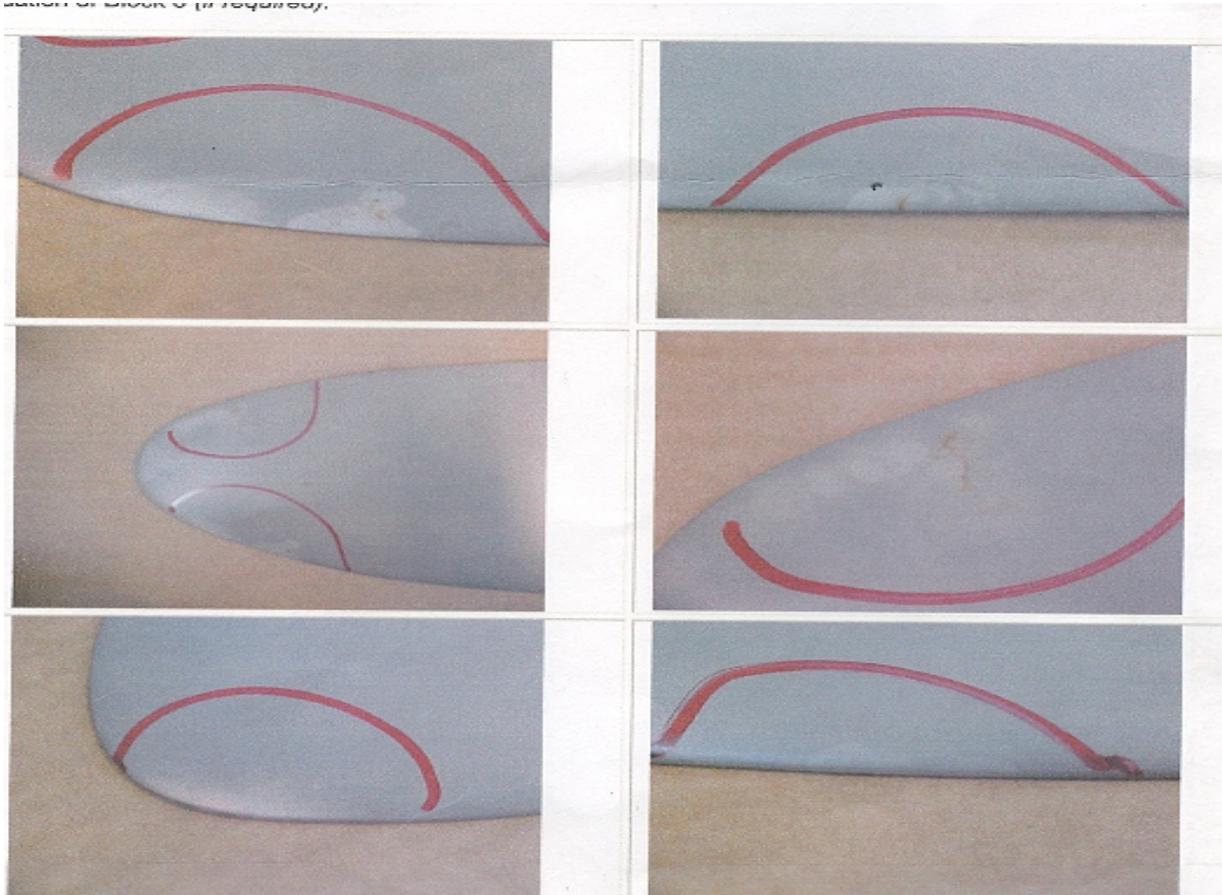
Hartzell Propeller: HC-C3YR-1RF; Unapproved Repair; ATA 6111

A repair station manager submits this defect report. He states, “Two of three propeller blades (*on this unit*) were previously repaired using an unapproved weld method in several locations on the blade airfoil. The blades have been scrapped—pending disposition instructions from Hartzell Propellers, Inc. The customer has been contacted for historical records.” (*P/N's for the propeller blades are F8483.*)
