## ADVISORY CIRCULAR

43-16A

# AVIATION MAINTENANCE ALERTS

**ALERT  
NUMBER  
379**

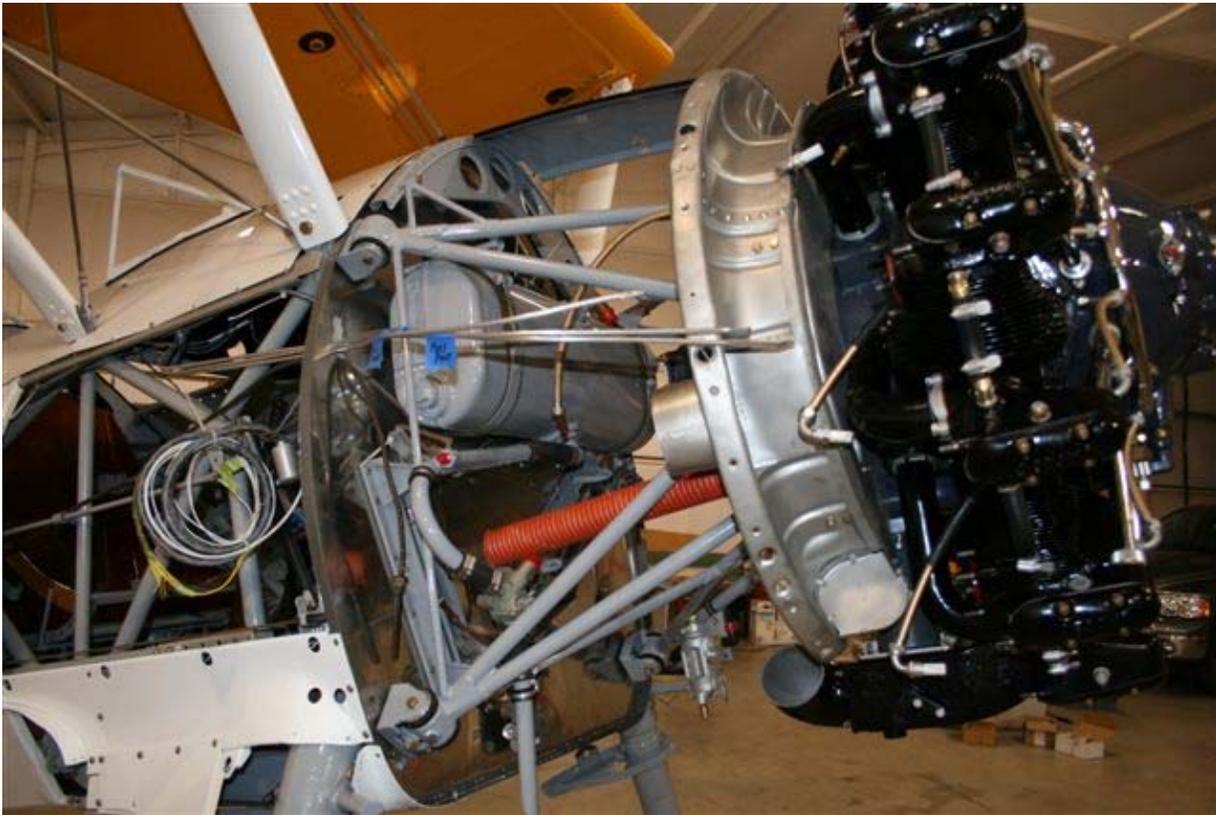
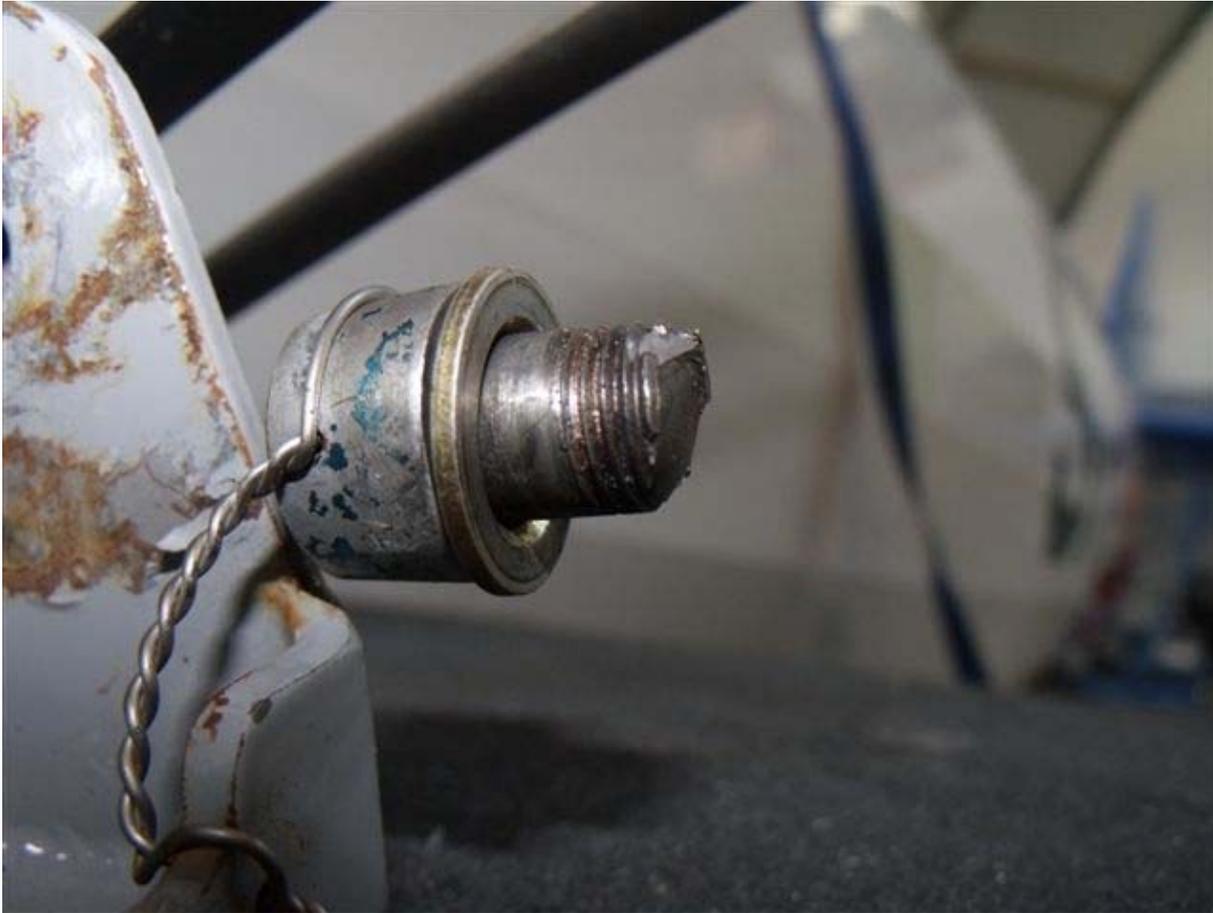
A mechanic states, "During inspection of the engine installation on this aircraft, it was determined that one of the four high strength NAS-148 bolts that hold the engine mount to the fuselage was fractured completely through -- under the head of the bolt. This bolt has 100 hours total time in service. After informing the STC (*supplemental type certificate*) holder of the failure, we were informed we should have re-torqued these bolts after 25 hours of operation. This information was not included in the STC. According to the STC holder (*this data*) was referenced in the original aircraft maintenance manual where it states the original engine mount 'studs' should be re-torqued to 450 to 500 inch-pounds after the first 25 hours. These original engine mount studs are not installed in the STC aircraft as they have been removed, and the entire assembly was replaced with a different mount and hardware assembly. The replacement bolts are NAS 148 (internal wrenching) and are oversize from the original studs. The original (*maintenance*) manual torque values would not be sufficient, and no further instructions (*were*) given.

"These bolts are hidden and it would require the removal of the engine to re-torque them. We believe a critical safety issue exists, as the failure of these bolts will result in a catastrophic (*accident*). (See accident report CA18/2/3/8321 where the failure of an identical bolt in a similar STC caused the separation of the engine and a fatality accident.) (*This*) STC is inadequate in its description for maintenance to ensure continued airworthiness."

*(That is a dramatic shot! Thanks for the photo effort—Ed.)*

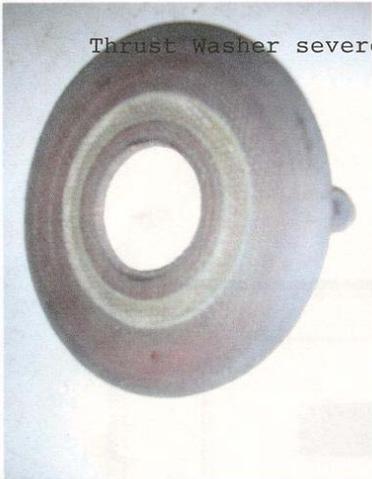
Thrust Washer severely worn

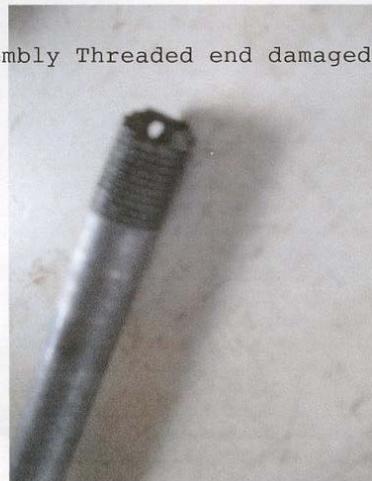
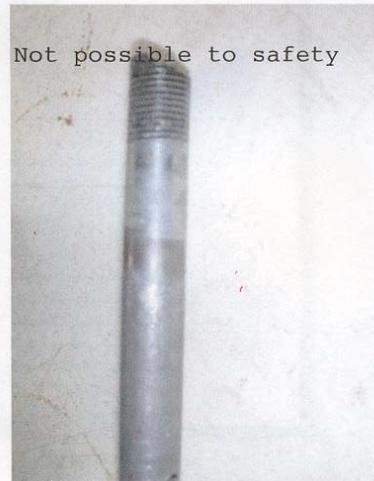
Wheel Axle Assembly Threaded end damaged. Not possible to safety

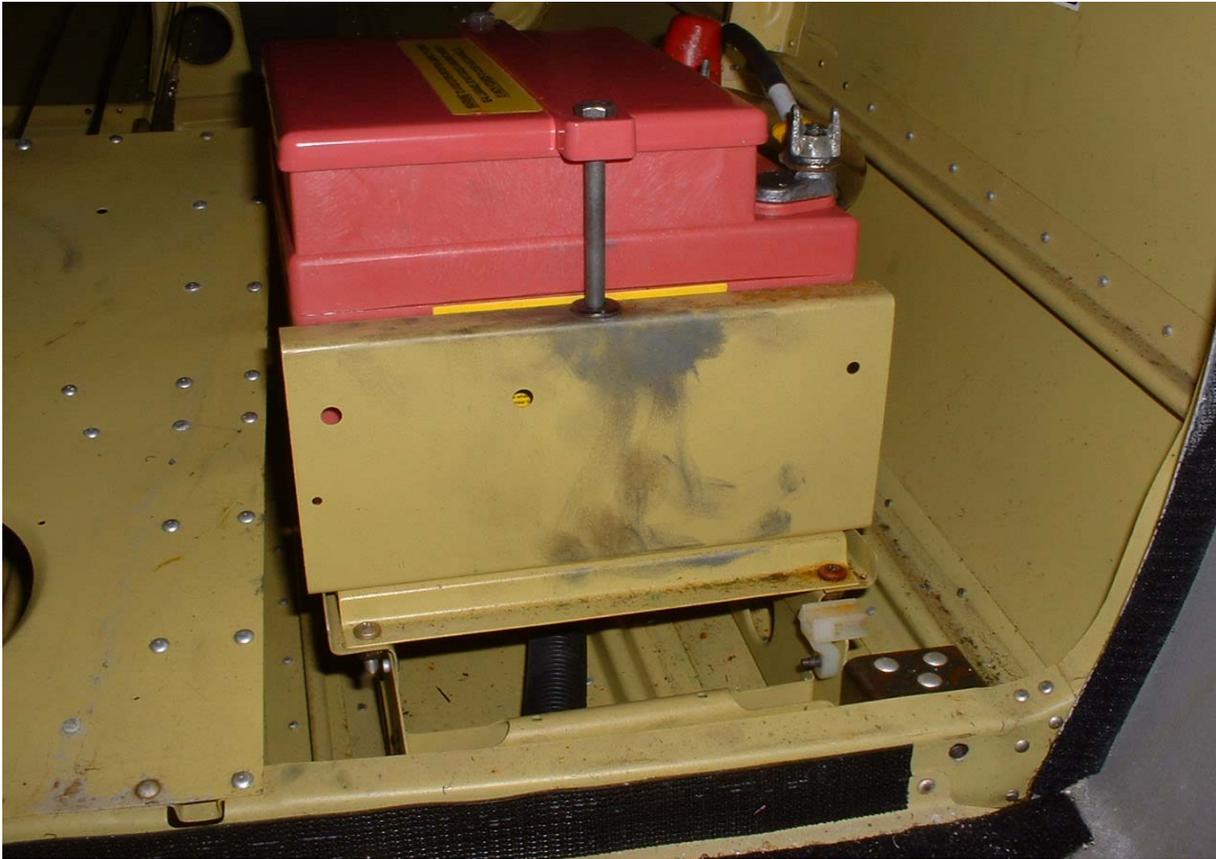
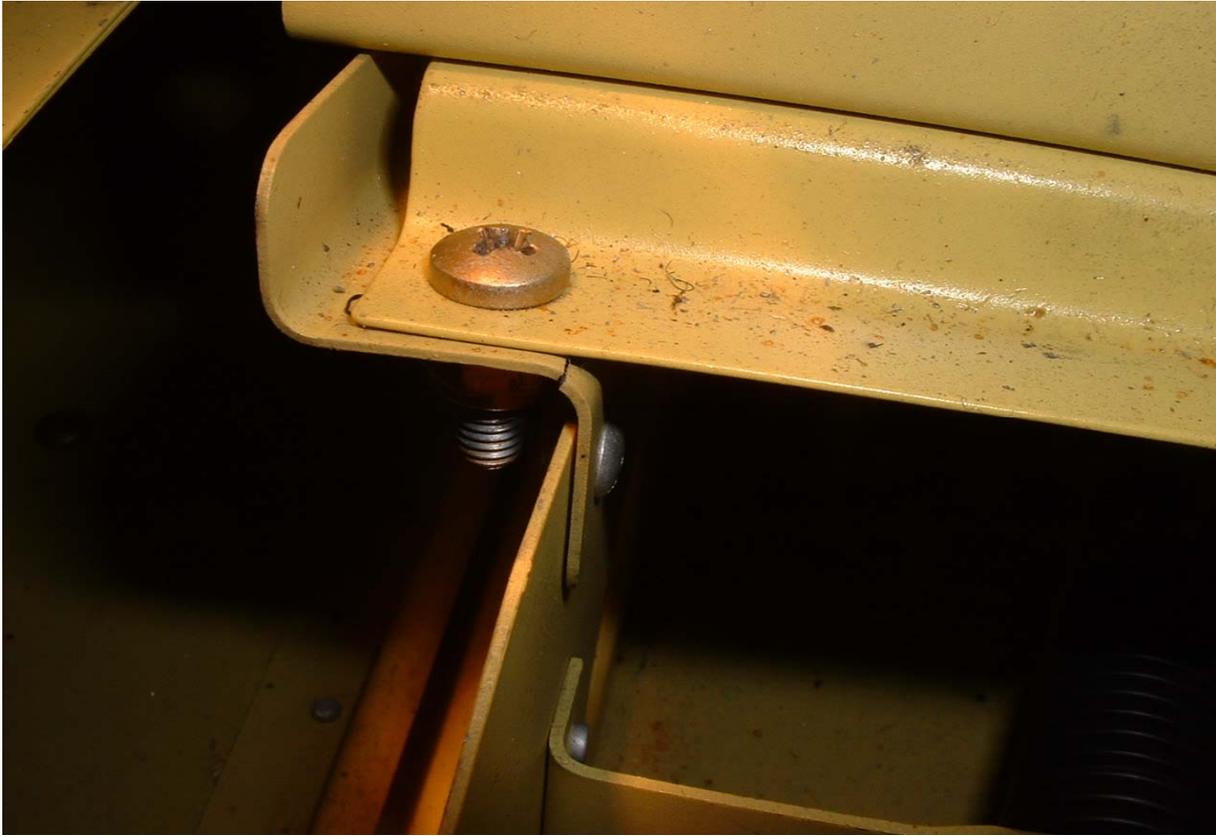
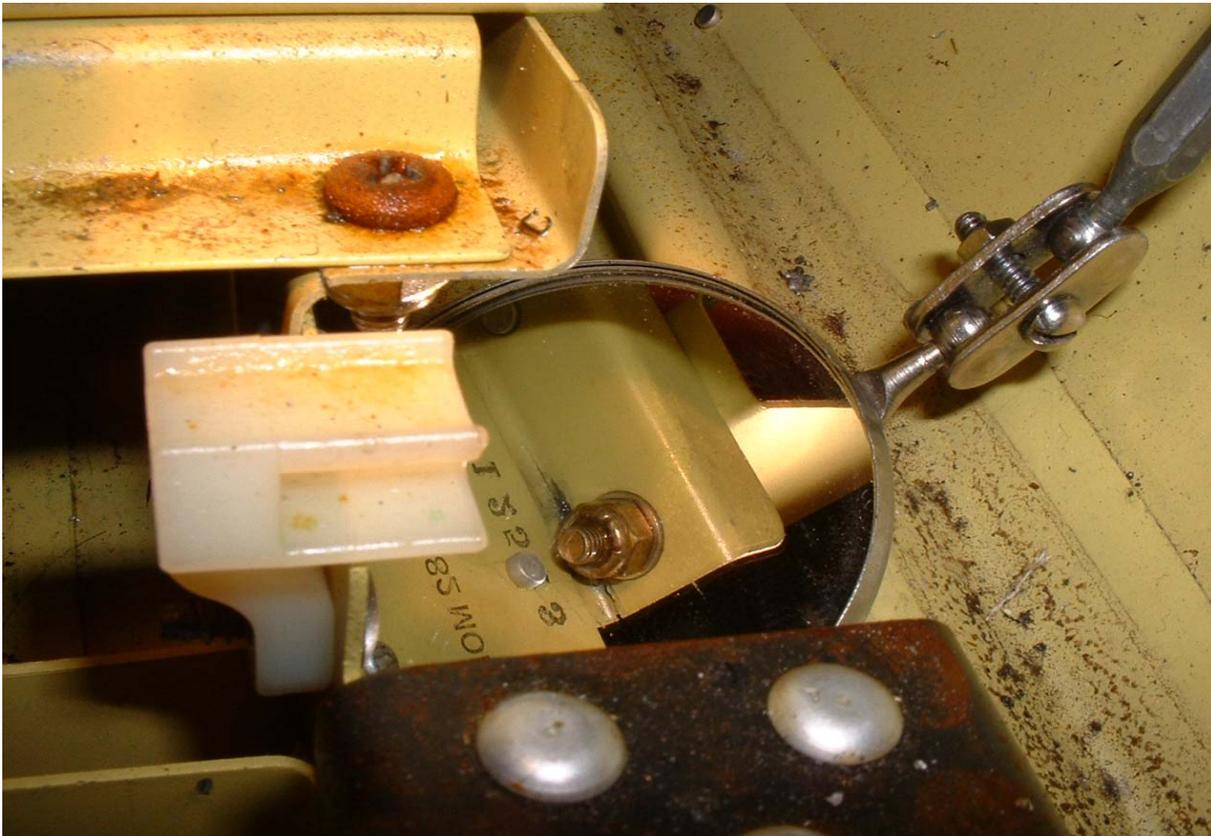
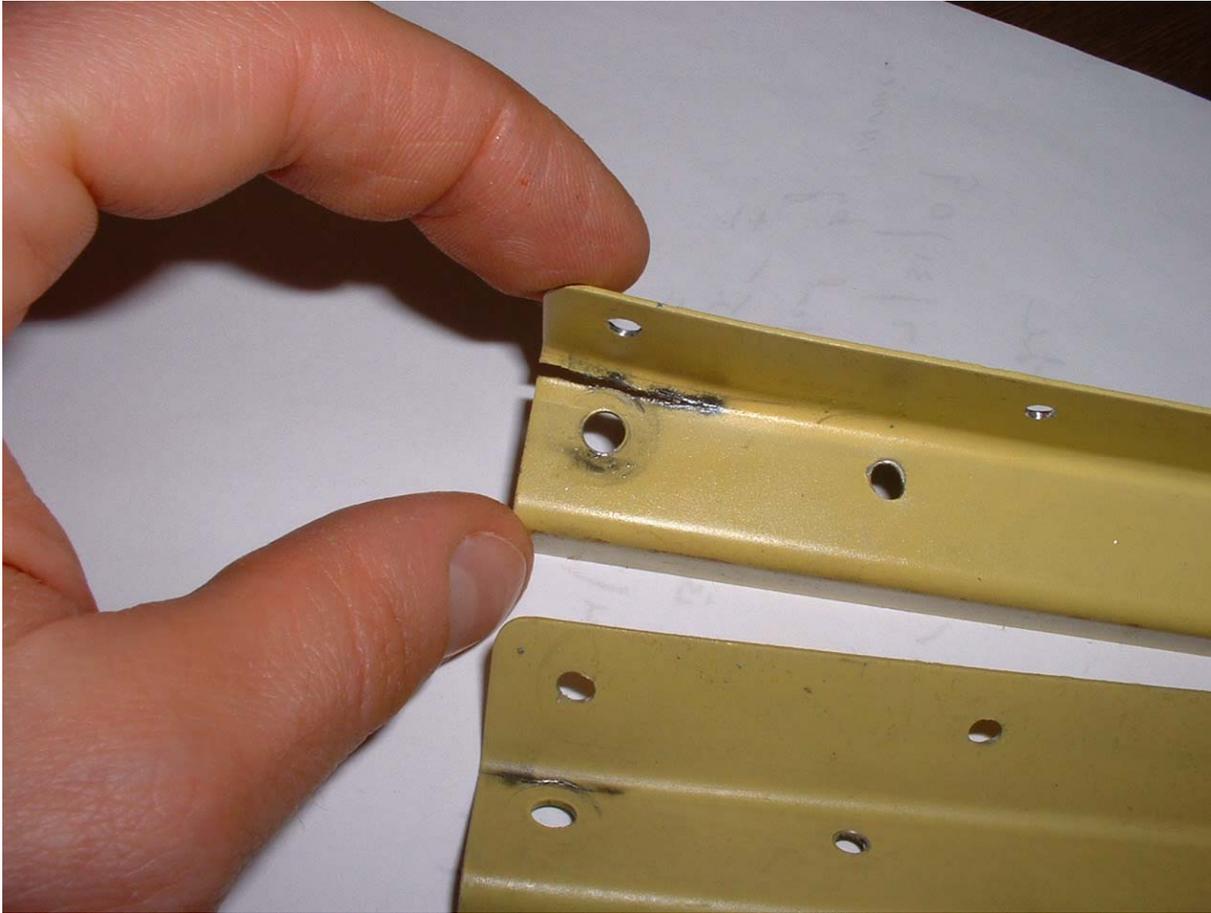
An unidentified mechanic writes, "During an annual inspection, both aircraft battery-shelf support brackets were found cracked in their forward and aft ends (four cracks total). Each crack started at the end of the support in the 90-degree bend radius, propagating toward the center of (*the part*). Cracks (*measure*) from 0.25 to 0.75 inches long. This is the fourth 182S/T model we have found to be cracked in this manner, (*each requiring*) replacement supports (P/N 0712059-1). One previously repaired aircraft has already cracked the replacement parts, requiring yet another set to be installed. These support brackets are not (*sufficiently*) thick to withstand both the weight of the 24V battery and normal airframe vibration. (*I*) recommend close (*observation*) at every annual and 100-hour inspection with a small mirror. The area in question is not readily visible. I recommend the manufacturer improve the design (*by using*) thicker supports—and offer (*this new*) design as replacement parts."

*(While you are waiting for the "new & improved" thicker metal, I see two issues that will buy you a lot more time. In the second and third pictures both the inside and outside edges of the part's radius are clearly sharp and ragged—as are almost all factory produced parts. Five bucks argues you will never replace another set if you would feather both inside and outside radius edges of new parts with 220-grit paper, then polish the same with Scotch-Brite until glass smooth—takes 2 minutes per end, plus recoating. In picture four, the washer impression can be seen encroaching into the radius—the telltale edge "gleam" is very apparent in the bottom view. Under torque, that washer's edge is not only cutting/chafing a stressed area of the metal, but may also be transferring load into the radius if not sitting perfectly flat. Consider chamfering the edge of that washer if it is even close, and/or flipping the sharp edge of the washer to face the nut during installation. If they still crack, scream at Cessna and come beat lunch out of me—Ed.)*

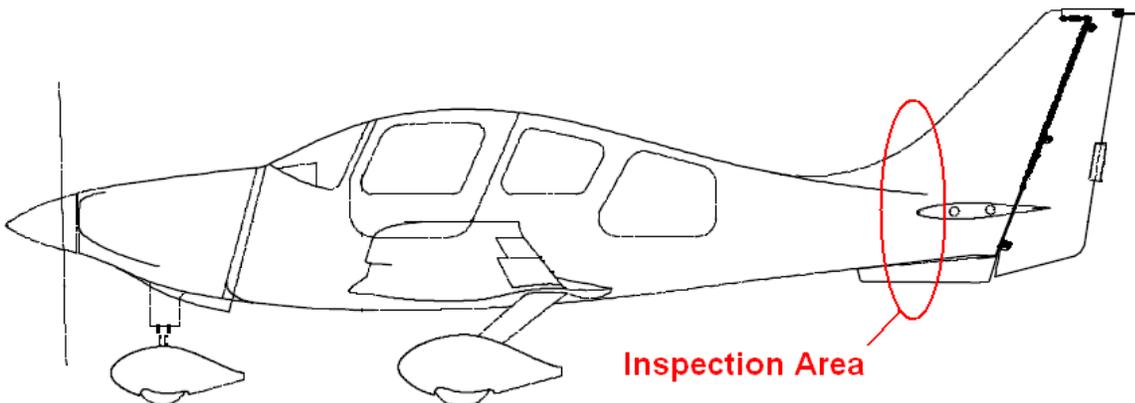
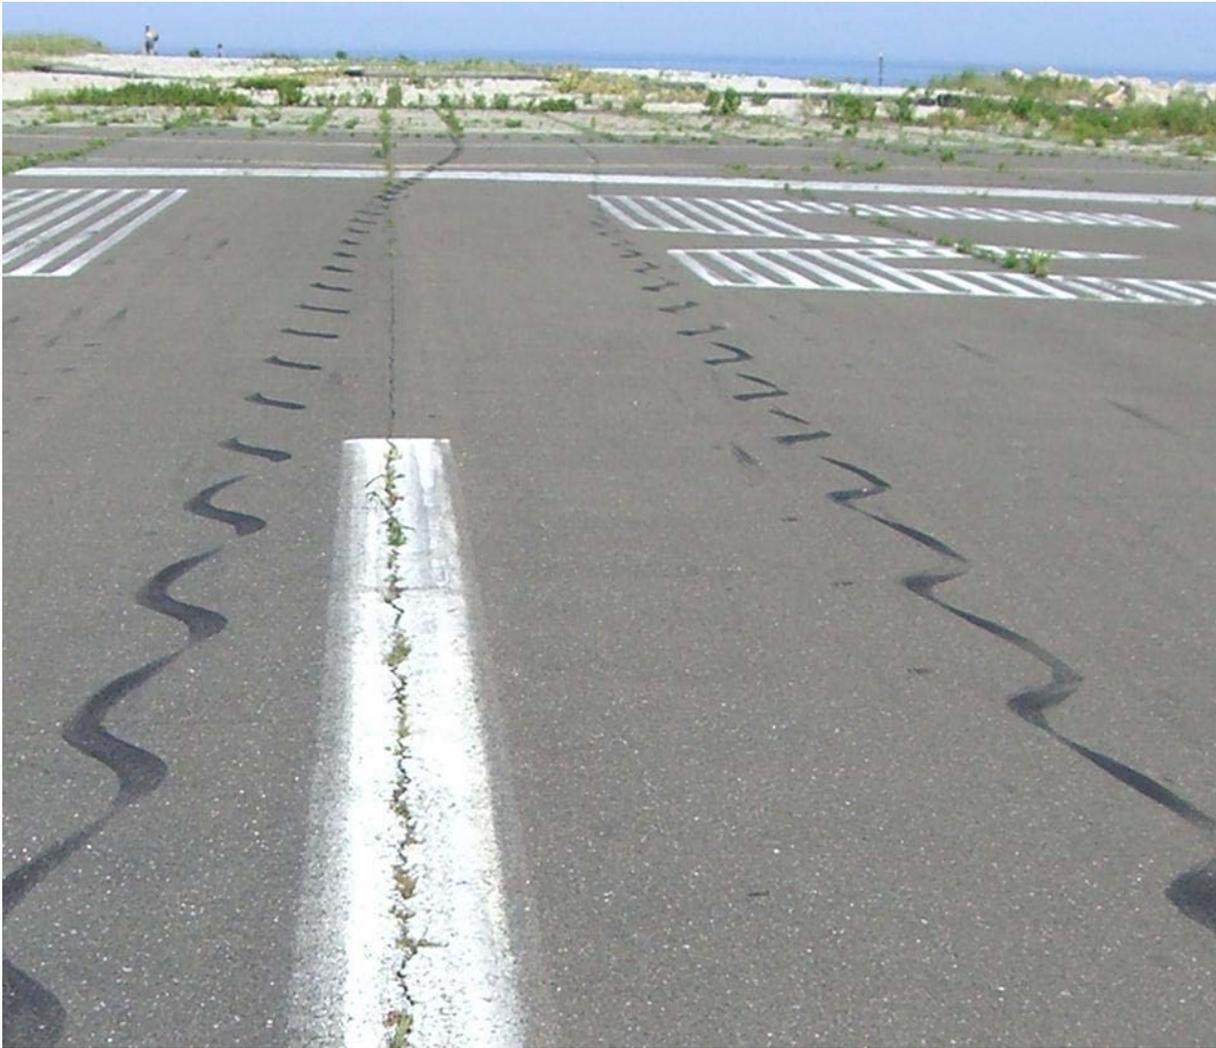
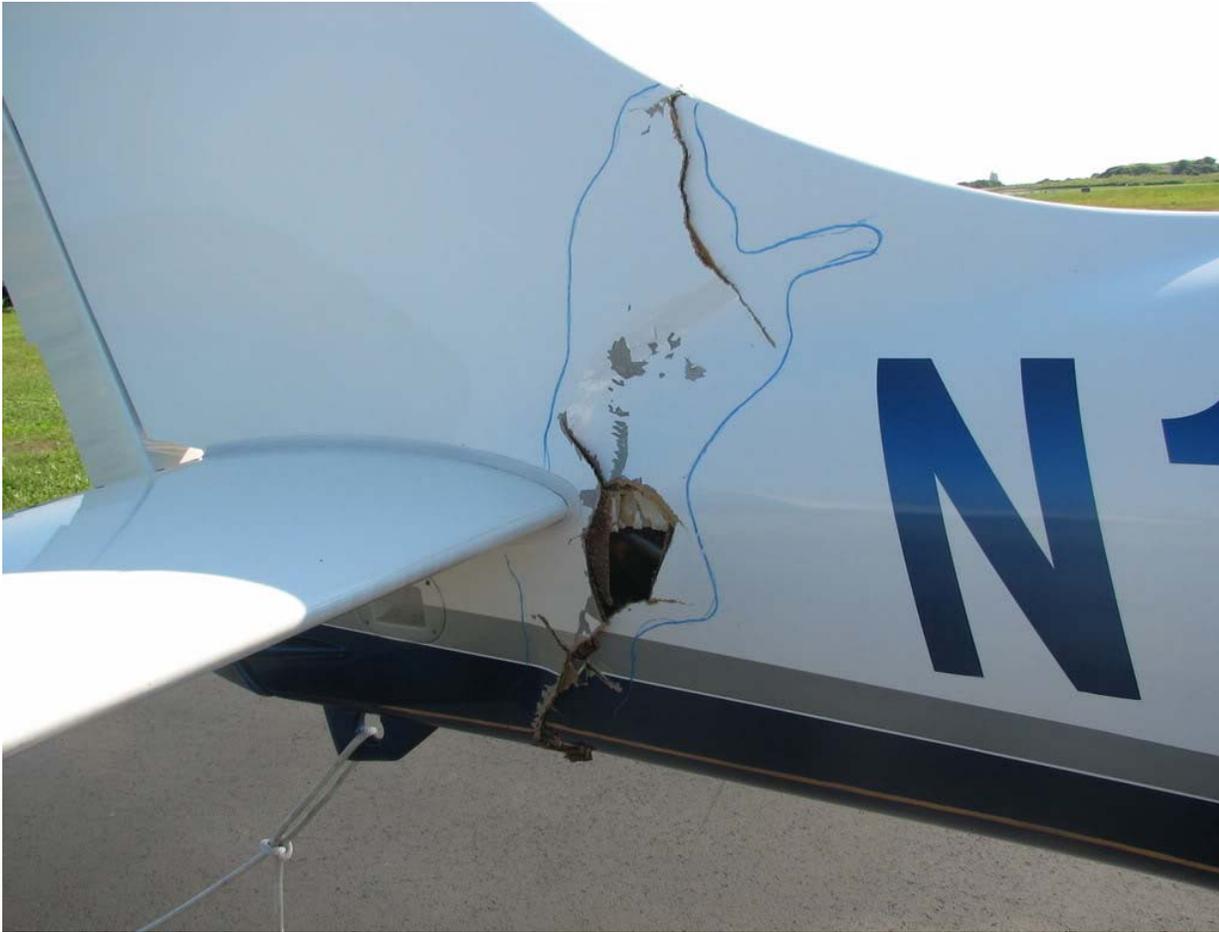
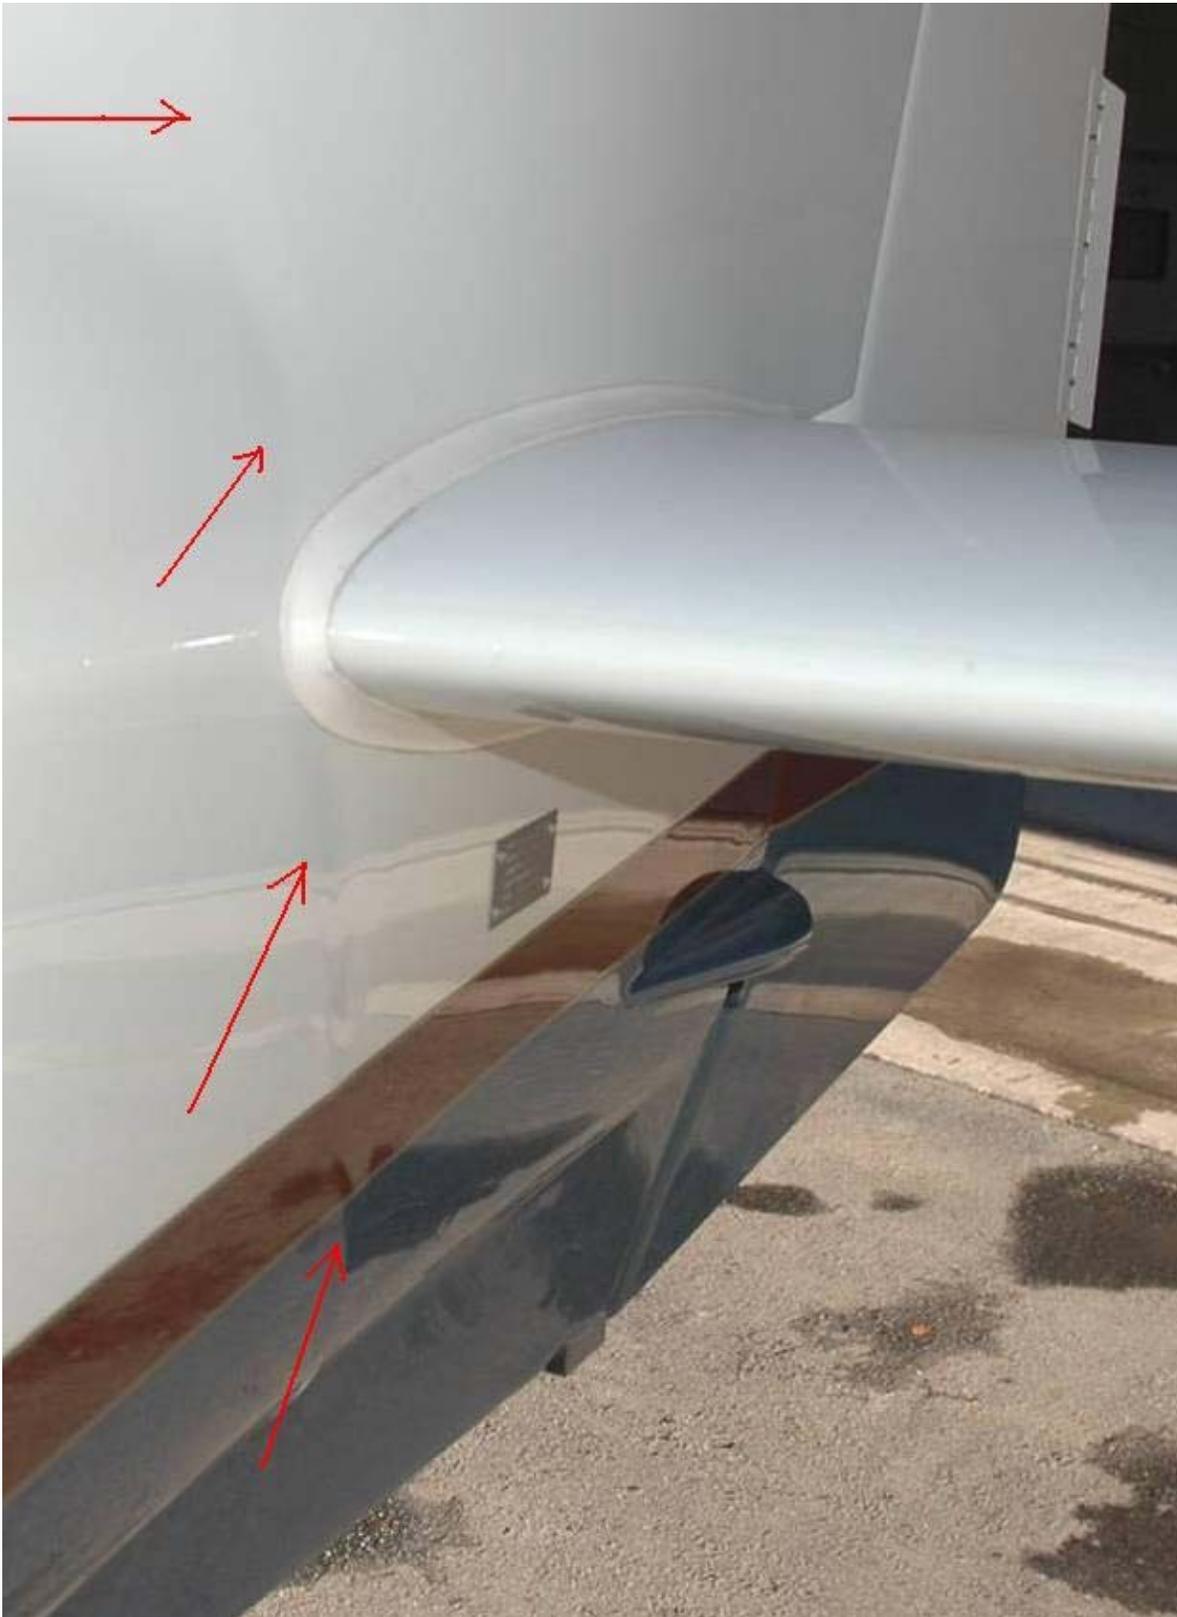
"The FAA has four reports dating back to 2006 of structural damage being sustained to the empennage after extreme braking (see tire skid marks in first photograph below). The second and third photos indicate the range of observed structural damage. Extensive damage in the second photo is obvious—this failure opens up the structure. Another failure example is shown in the last picture. De-bonding of the composite fuselage can be seen just forward of the horizontal stabilizer (see arrows). Although this failure does not open up the structure, the damage is quite apparent.

"These extreme braking maneuvers consist of prolonged periods of heavy braking and tire skidding, resulting in large oscillatory motions known as *gear walk*. These conditions can be avoided by operating the airplane in accordance with the applicable POH (*Pilot's Operating Handbook*).

"Cessna is proposing a Service Newsletter that communicates important safety information about the proper use of brakes as noted in the POH. Additionally, this Newsletter will provide notification that TRs (Temporary Revisions) to the POH and the Airplane Maintenance Manuals are available and should be inserted into the appropriate manual upon receipt."

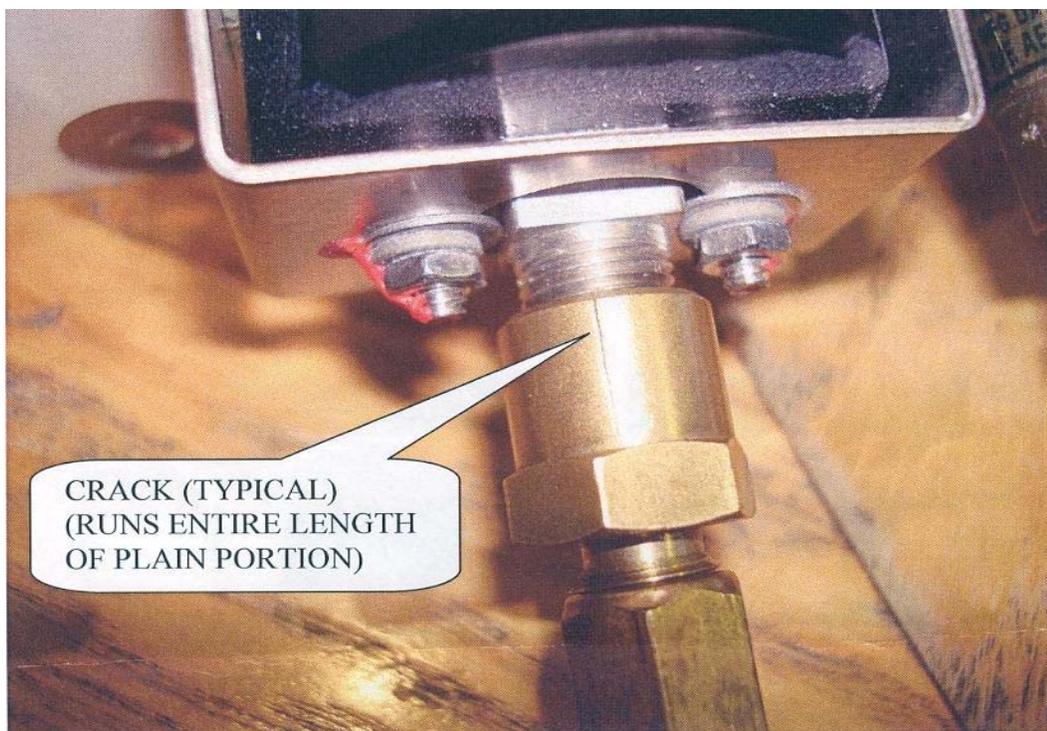
A repair station quality engineer writes, "During routine maintenance (*I*) investigated a 'low oxygen contents' indication for the passenger and crew systems. A gas leak was identified behind the oxygen-charging panel at station 3900 (R/H) while attempting to charge the system. Upon removing the ground charging panel assembly, cracks were discovered on two brass fittings (P/N 500189)—part of the gage assembly (P/N 171013) common to both passenger and crew systems. Oxygen leaks were apparent at these fittings. (Reference IPC 35-11-00 item 1; panel assembly P/N 135-05153-401 item 150; pressure gage P/N 171013 item 50; Capillary Tube item 155; Brass Oxygen fitting P/N 500189).

Above- Picture of one of the two original gauges found with cracked fitting, with complete oxygen panel assembly and tubes as removed from the aircraft.

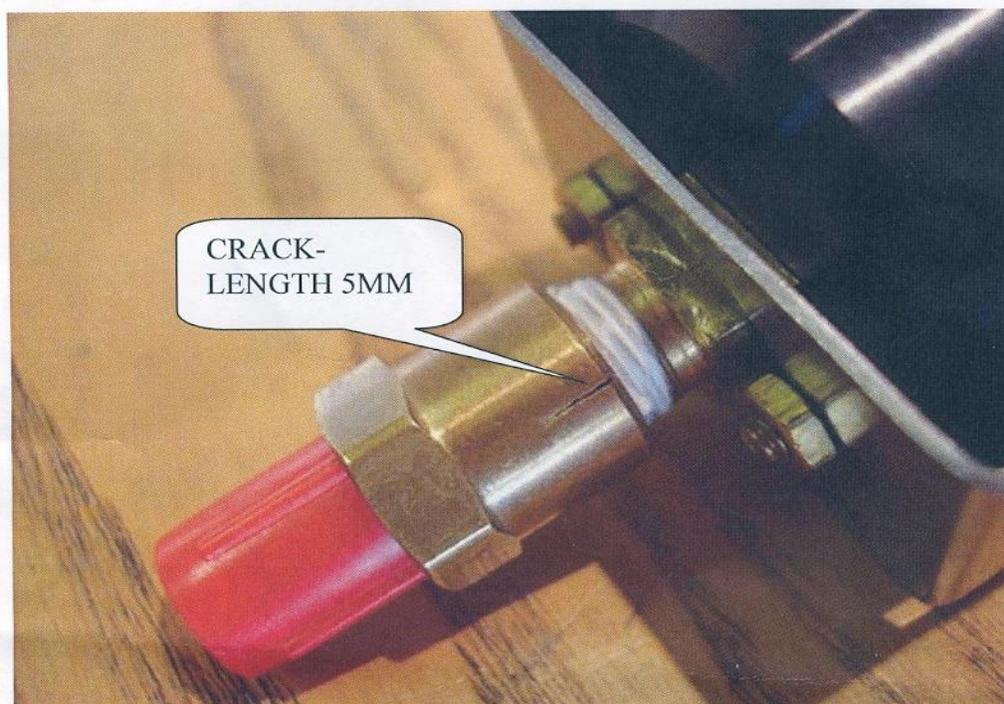
"Replacement items were ordered from the manufacturer (Embraer) for defect (*resolution*). Upon receipt (*of a new*) replacement gage assembly (P/N 171013), an identical crack was found on fitting (P/N 500189)—the gage was rejected." "The cause of cracking can not be positively (*identified*), but it may be due to over-torquing of the fittings to the gage."

Above- picture of the new gauge as received from Embraer, with similar crack.

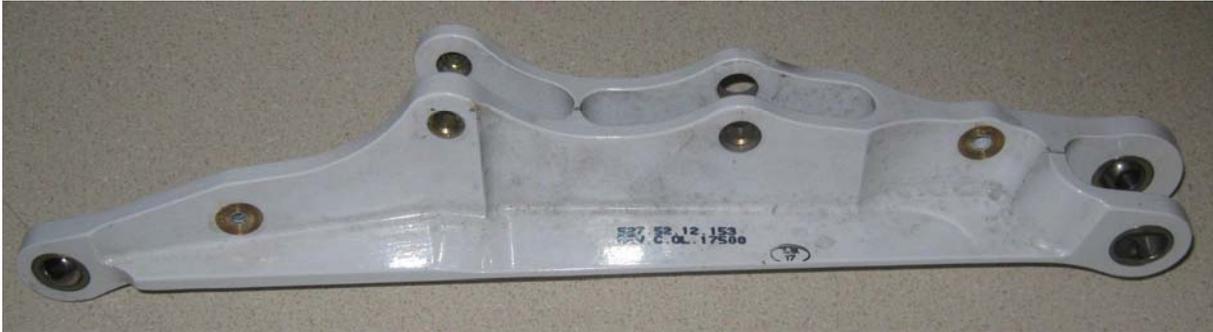
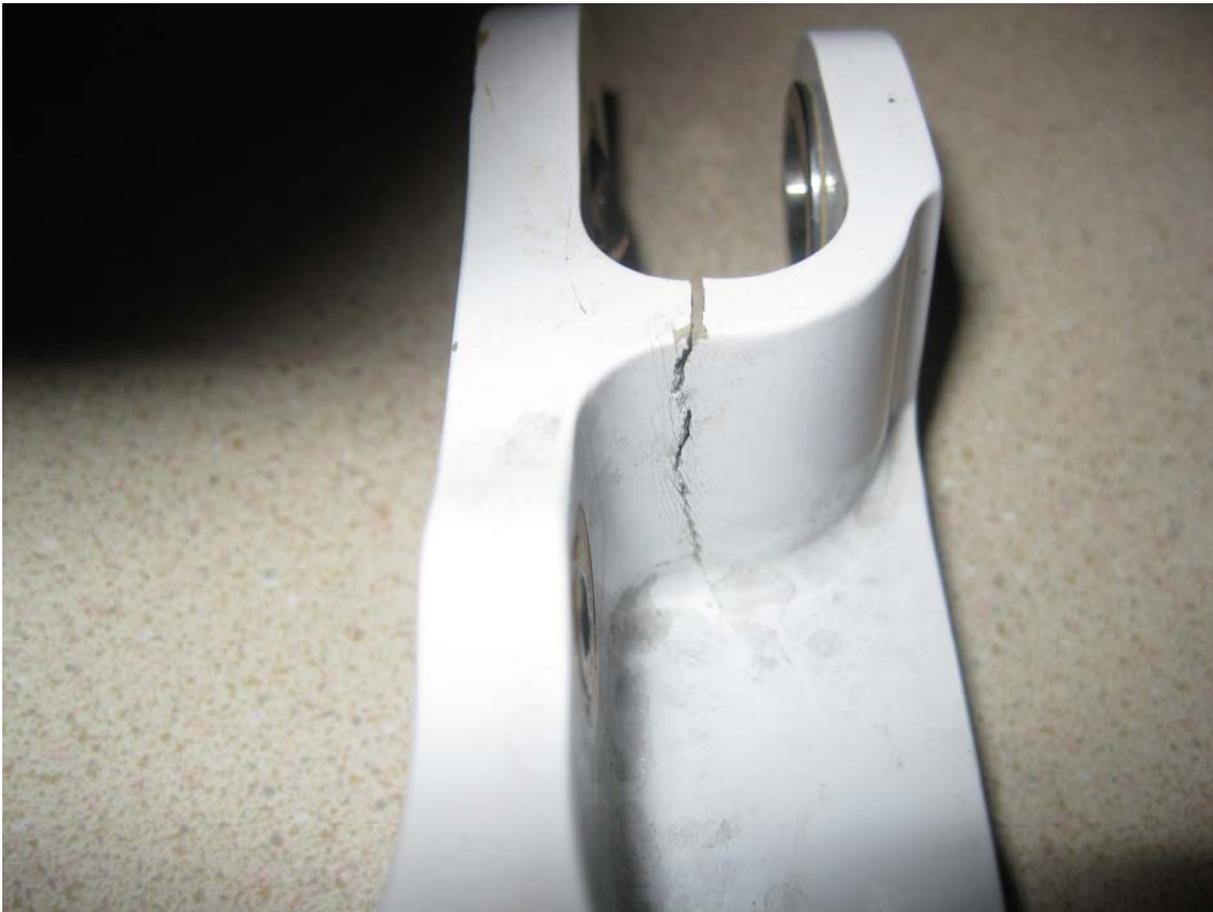
A technician for a repair station states, "*(The pilots received a flap warning light...)* on rollout after landing. *(I)* checked the *(CAS: Crew Alert System's)* flap errors and found several E211 codes. I then inspected the left inner resolver installation and found its drive pin pulled from the socket. Further inspection found the inboard, L/H flap drive arm assembly (P/N 527-52-12-153) cracked in several places. The cause is unknown. There are no recorded over-speeds on the CAS system and no signs of impact side loads. Rigging of the flaps checked okay—no further damage was found."

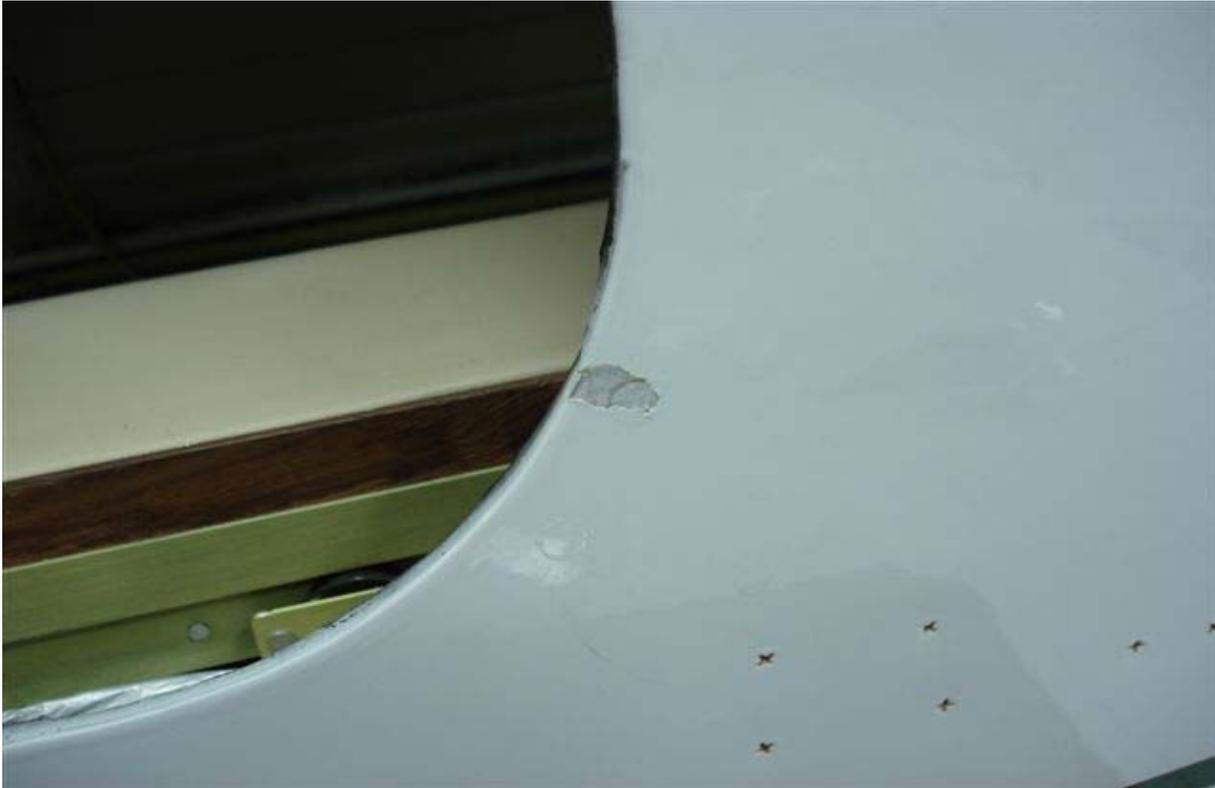
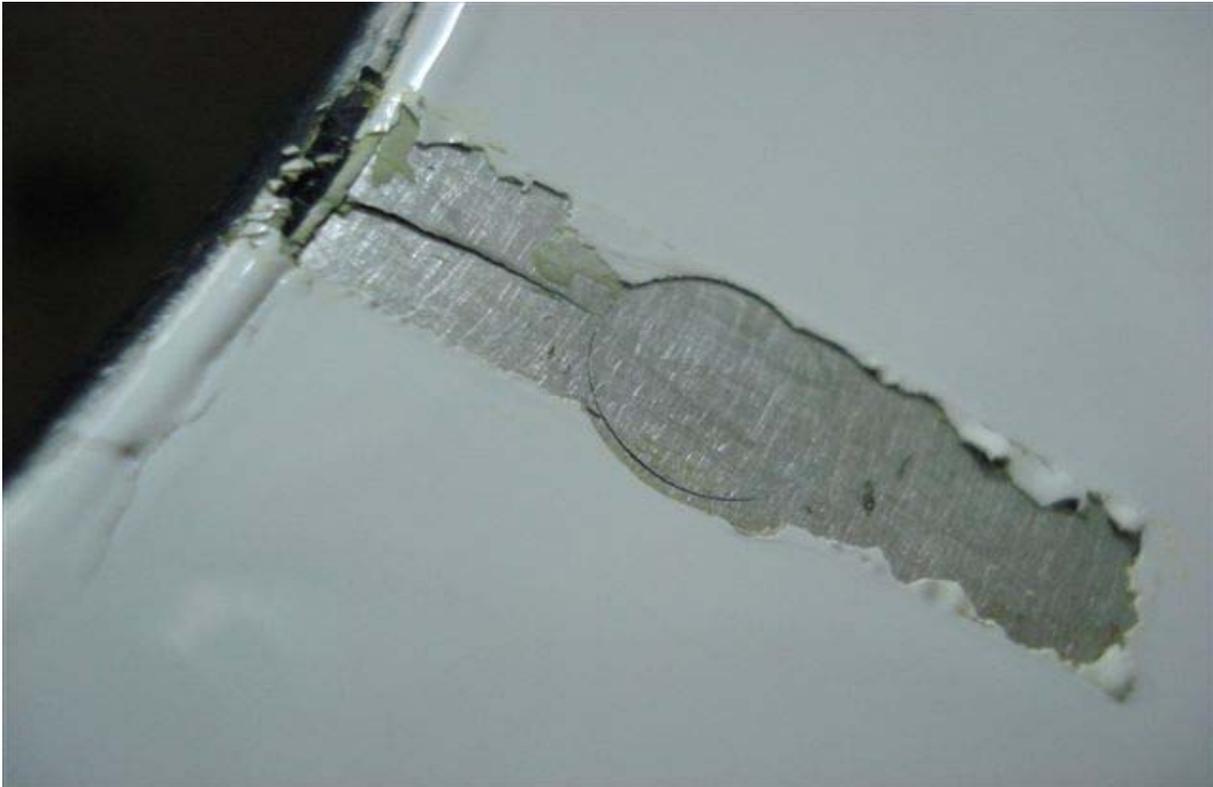
A repair station submission says, "The fuselage skin (*was found*) cracked at the lower aft corner of the left, over-wing escape hatch opening."

(Cracked skin: P/N 30631201621; location: fuselage station 262. Okay—the tiny crack self-terminates into the rivet hole, but the pressure vessel business is going to require a little engineering/maker guidance. Guess we are done, right? See the next entry....)

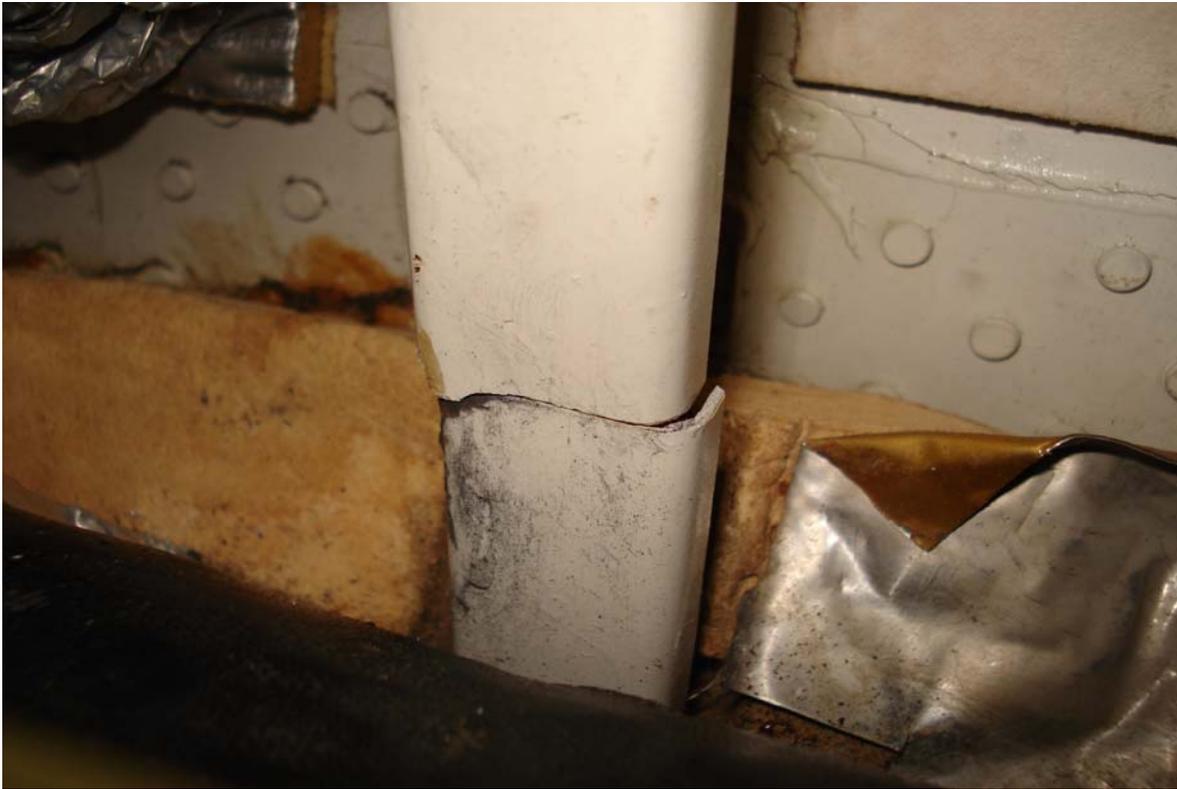
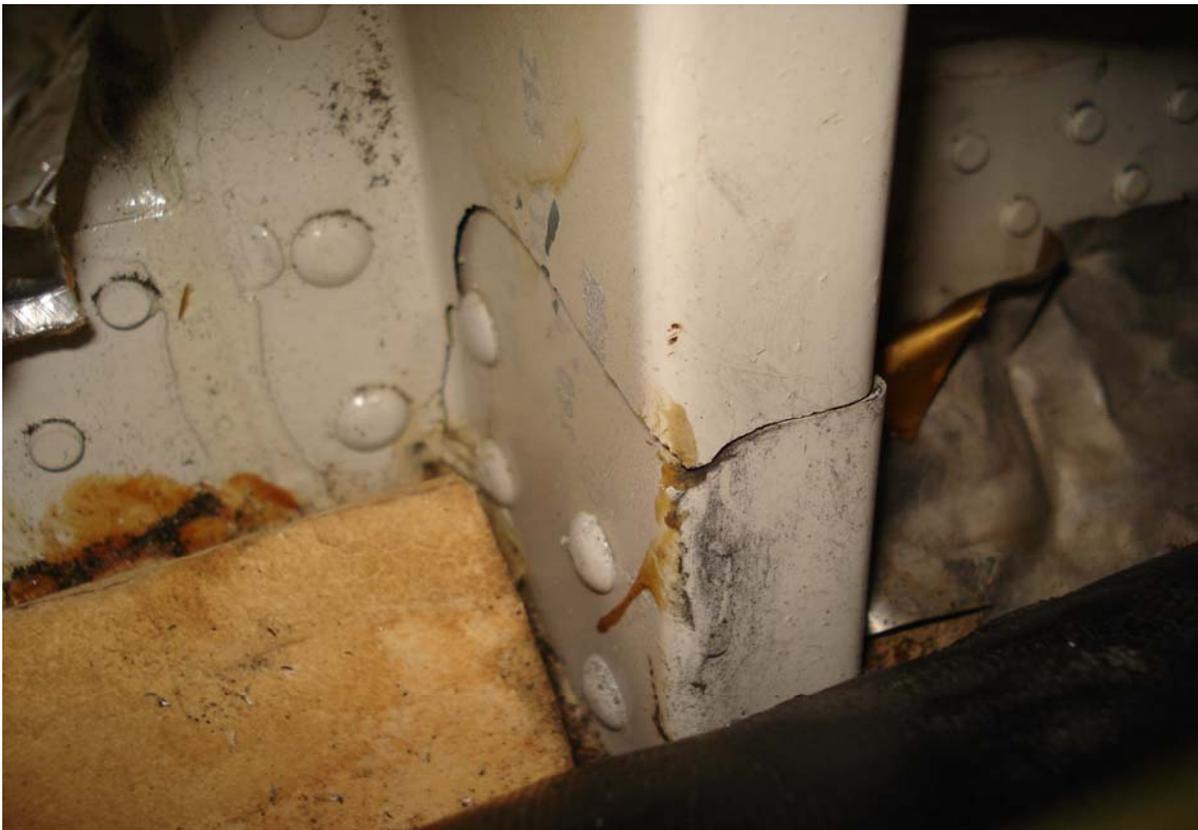
Our submitter writes, "A three-inch crack (*was found*) in the left fuselage side frame at station 257.65, approximately two-inches above the cabin floor." (*Frame P/N: 265312254031*)

*(Wow! This is a terrific safety catch. Did the tiny outside crack in the previous report peak your curiosity for an immediate inside inspection, or were the two discoveries incidental to one another? This will make for an interesting repair—Ed.)*

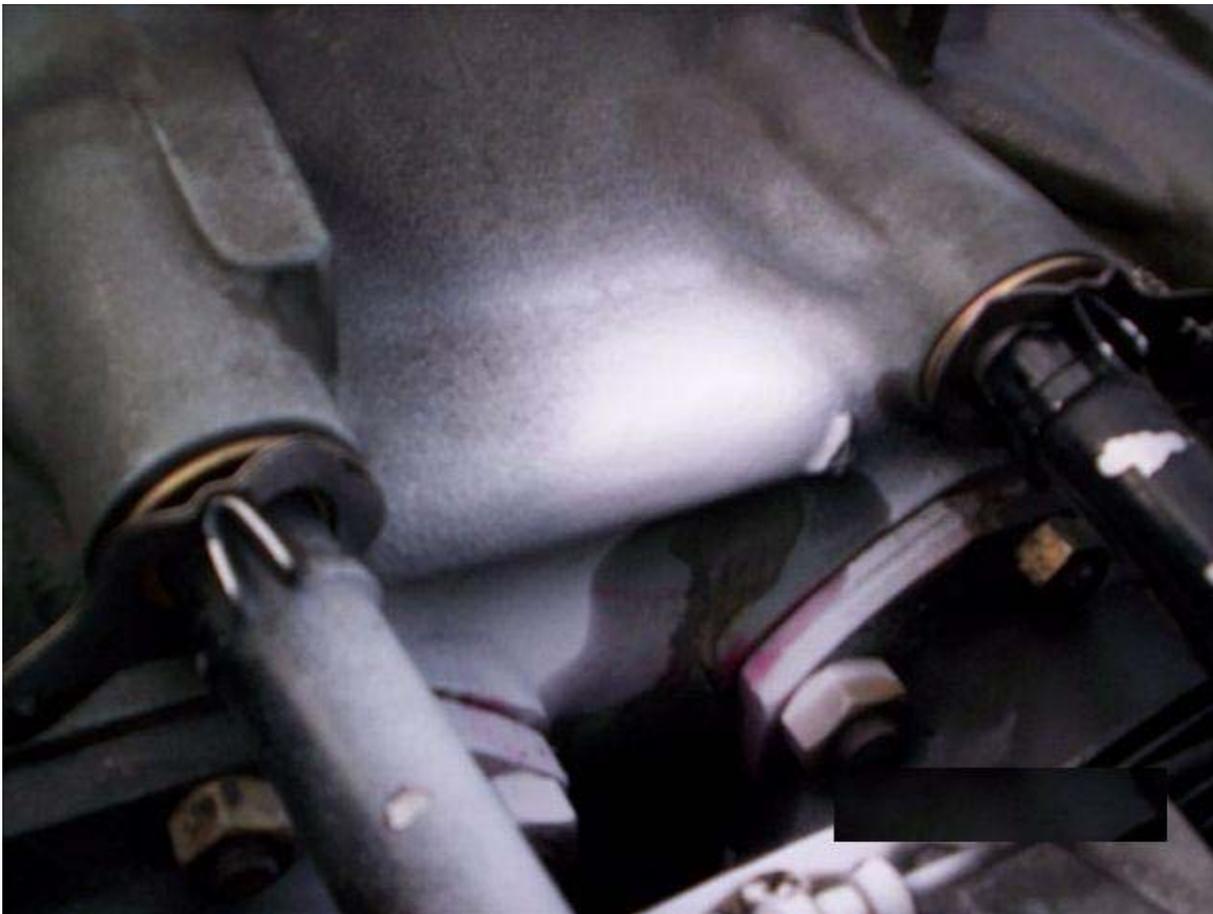
An unidentified repair station technician writes, "The operator requested troubleshooting of low oil pressure on the R/H engine. Upon removal of the engine cowl, the mechanic discovered oil film on the L/H side of the engine case. Further inspection revealed what appeared to be a crack on the L/H case half. Paint was removed and dye penetrant applied, revealing a 1.3-inch crack on the case half at the number four cylinder (forward top stud area). The penetrant was cleaned (*from the surface*) and developer applied to the area. (*I*) ran the engine to verify the crack (*propagated completely...*) through the case. Run-up revealed oil coming from the suspected crack area. The operator was advised and the aircraft grounded until a repair (*is completed*)."
