ADVISORY CIRCULAR

43-16A

AVIATION MAINTENANCE ALERTS

**ALERT
NUMBER
391**

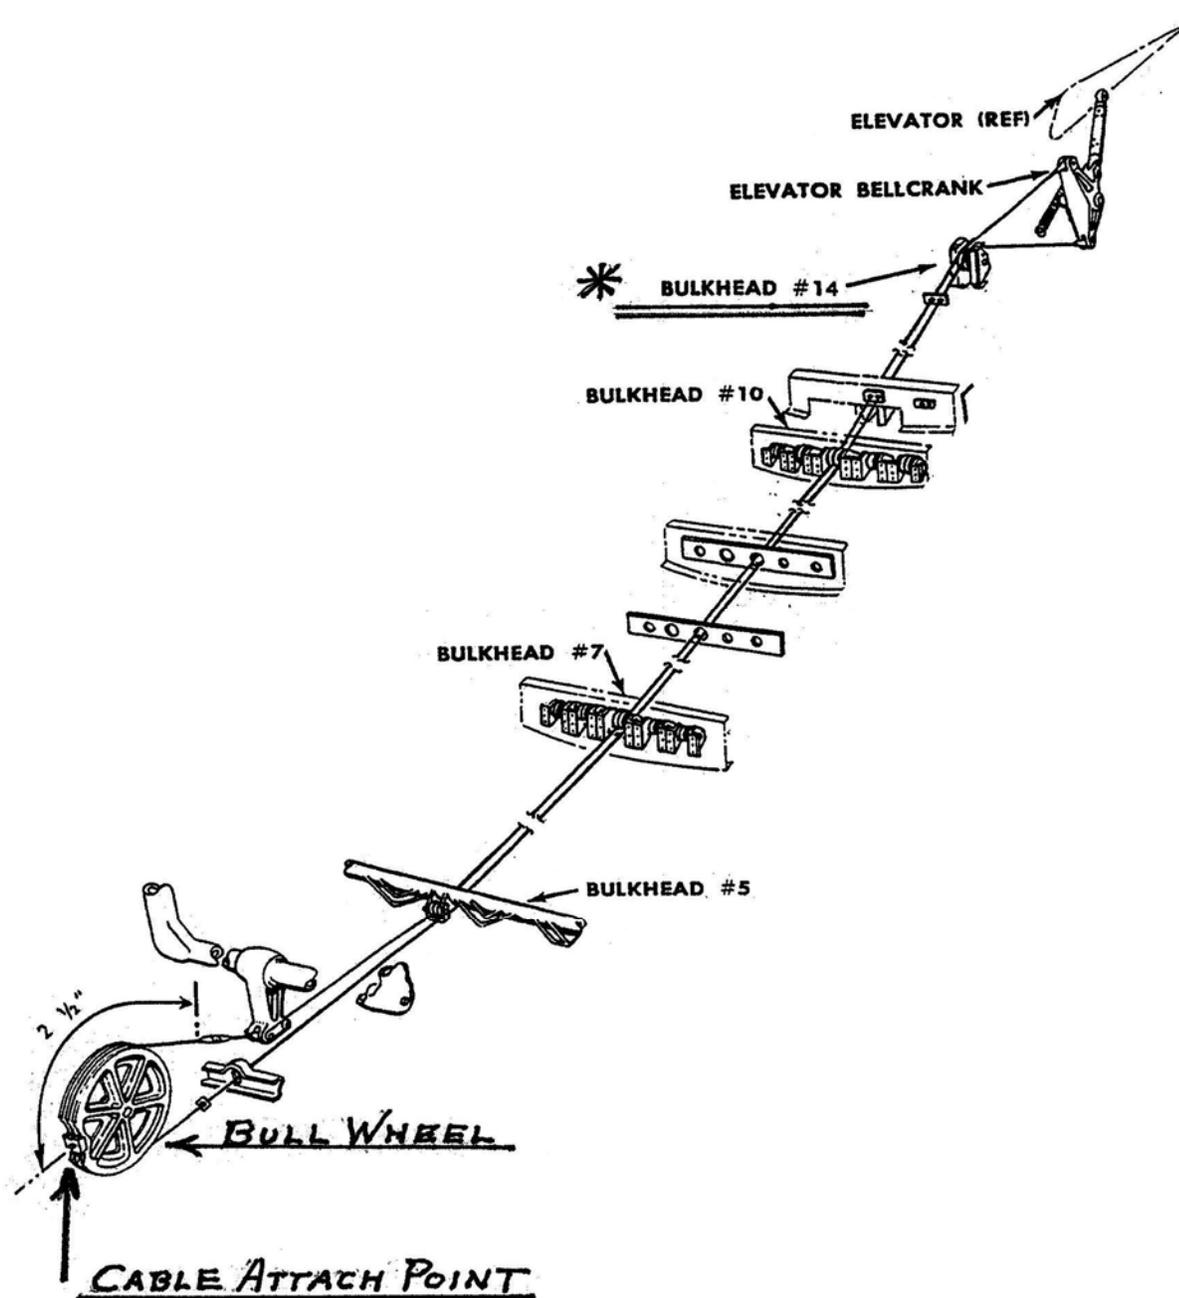
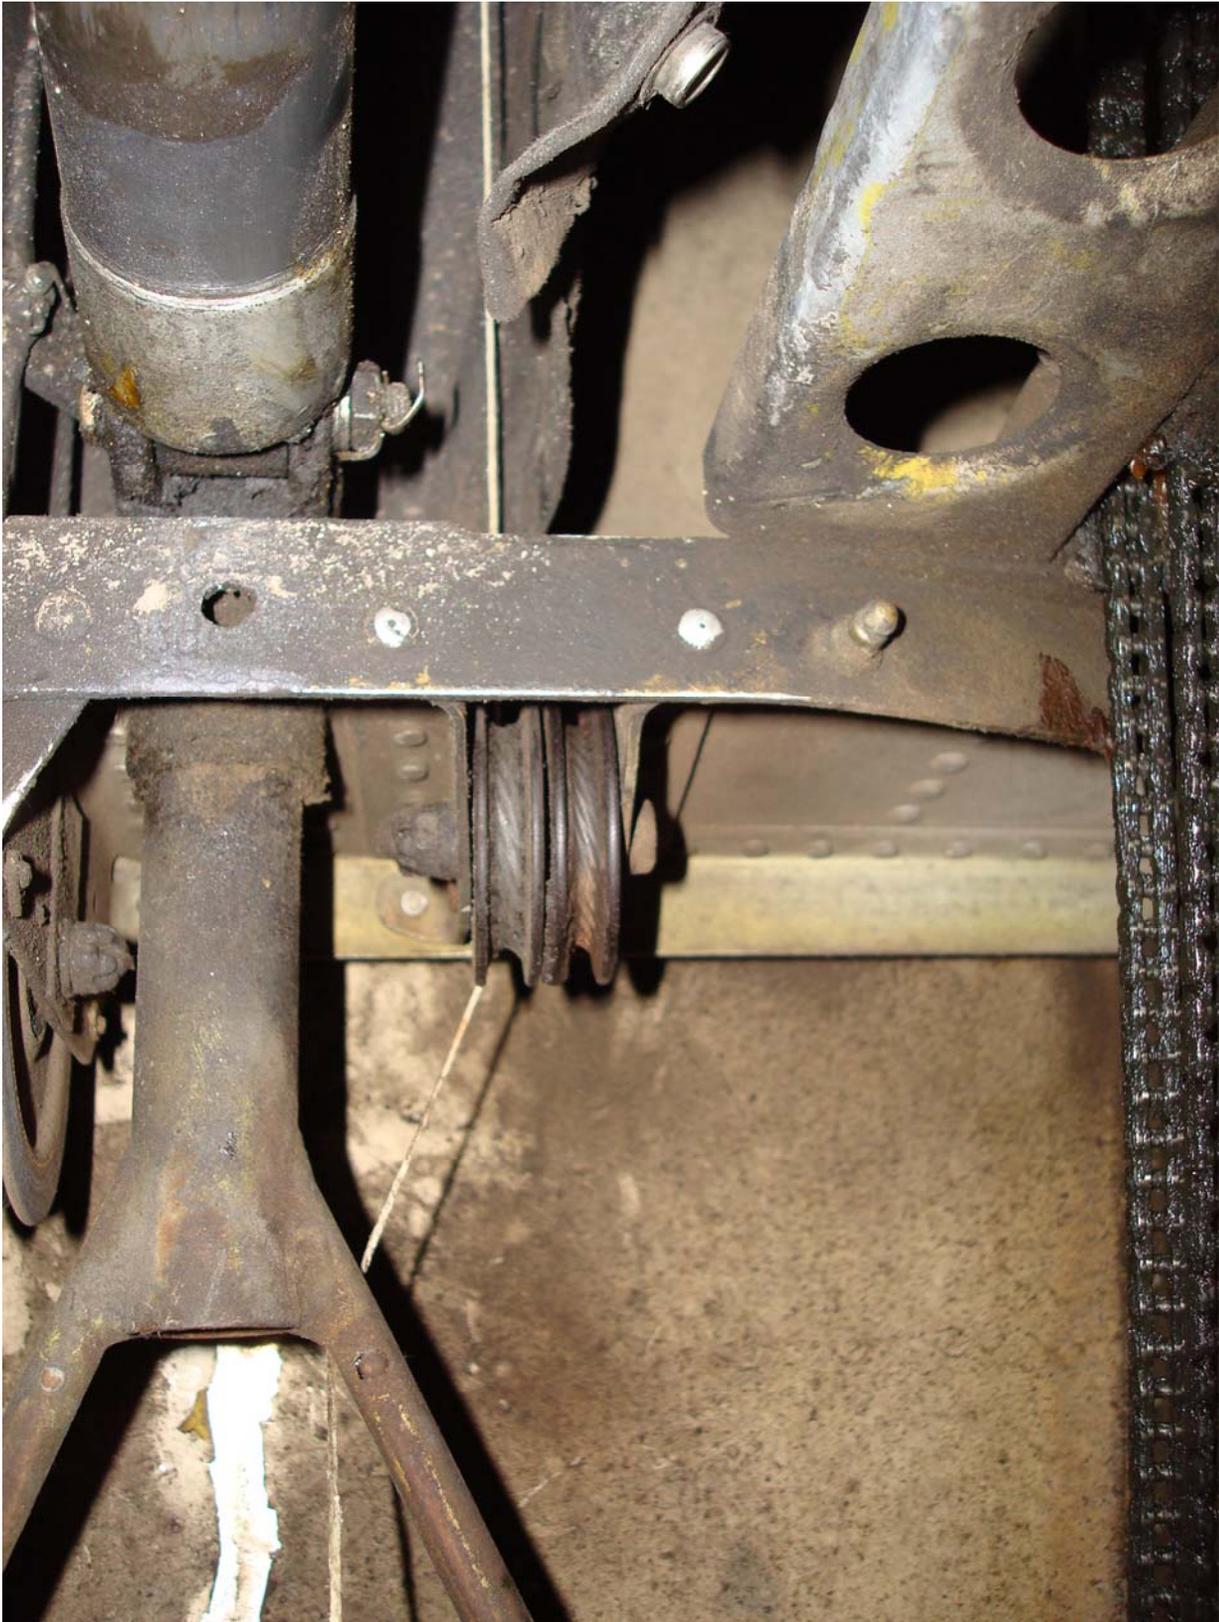
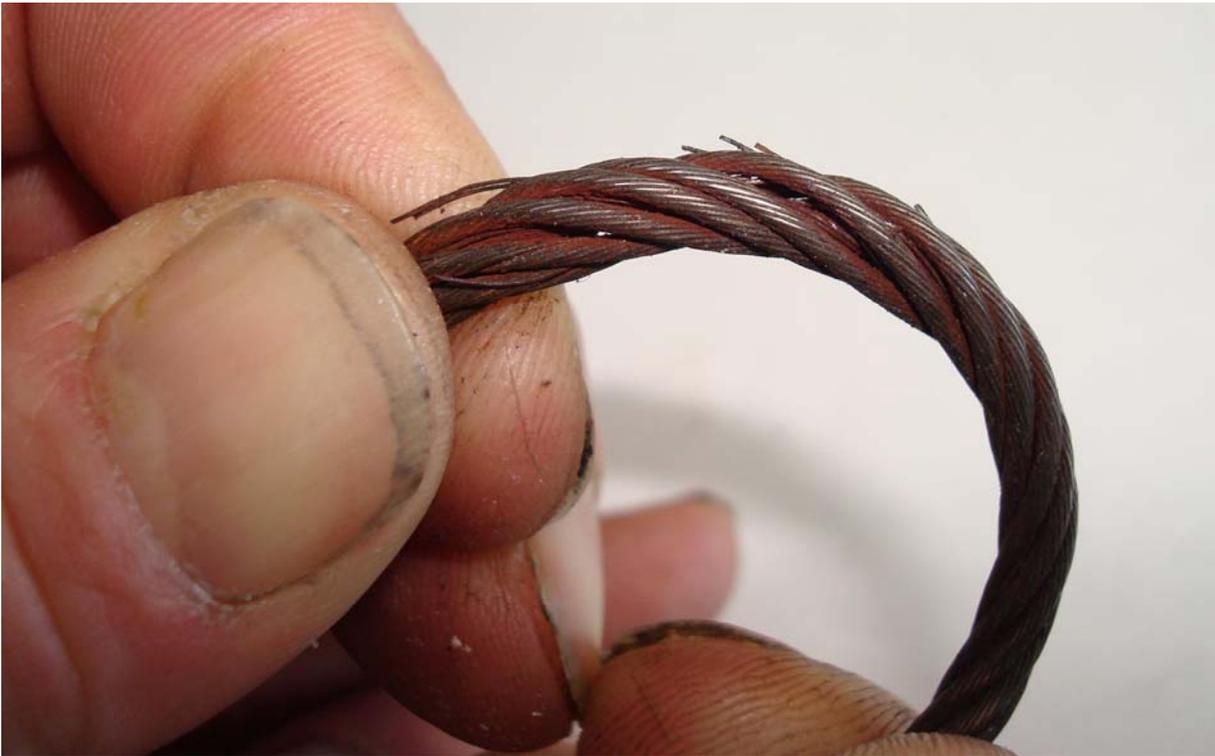
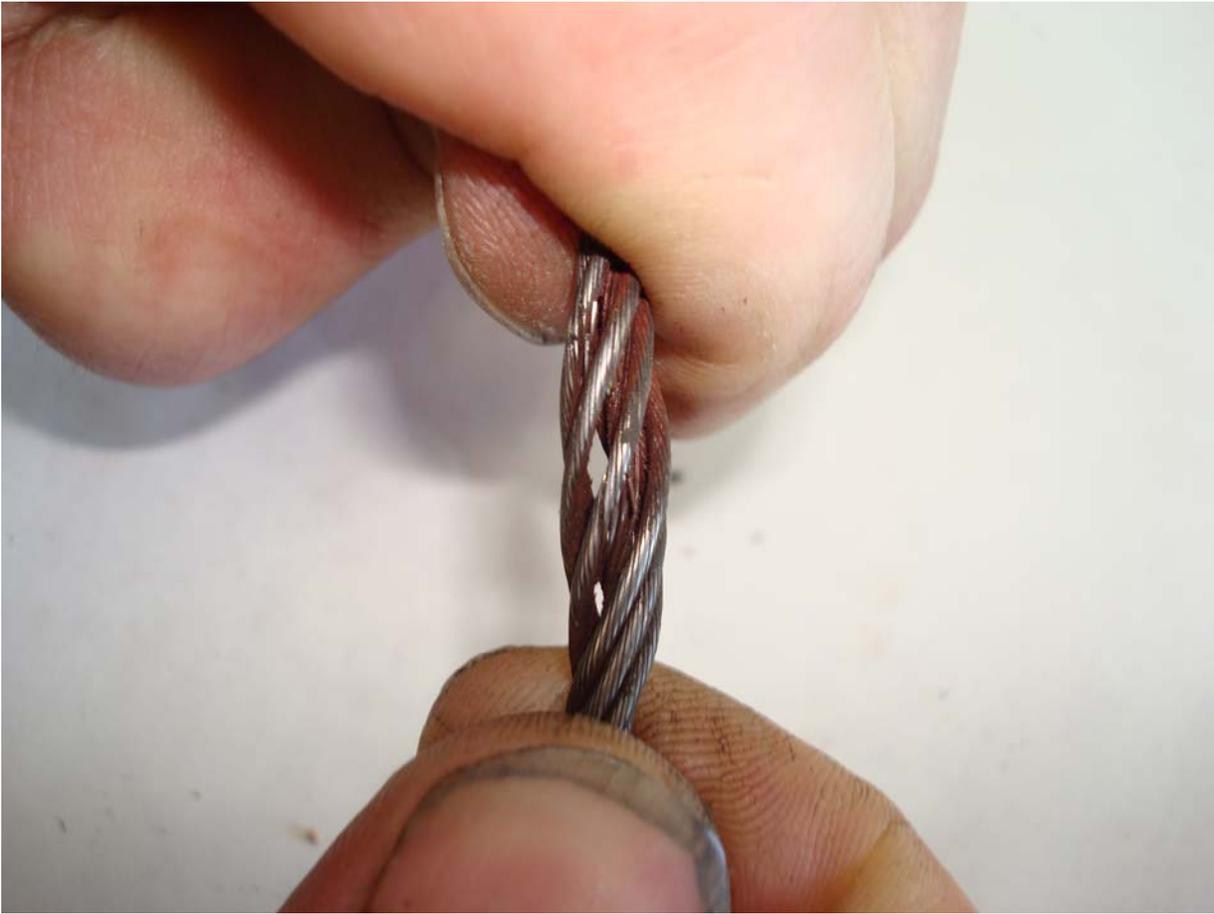
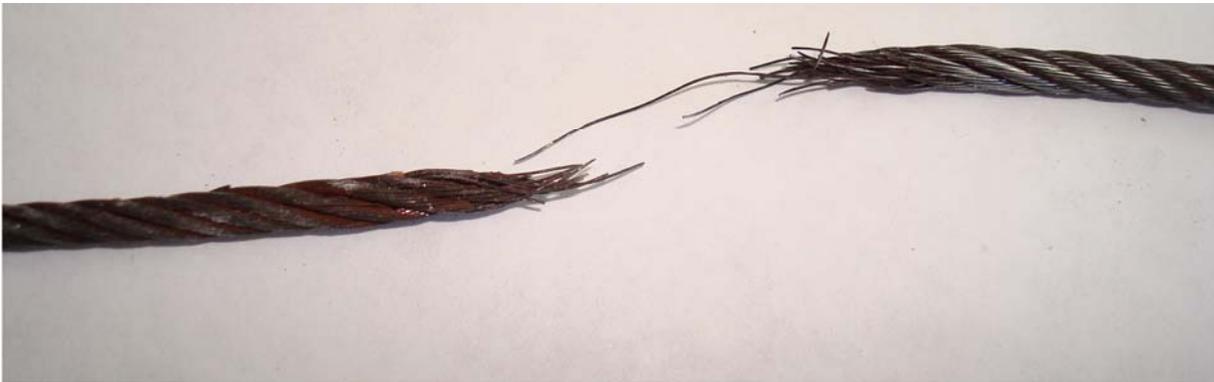
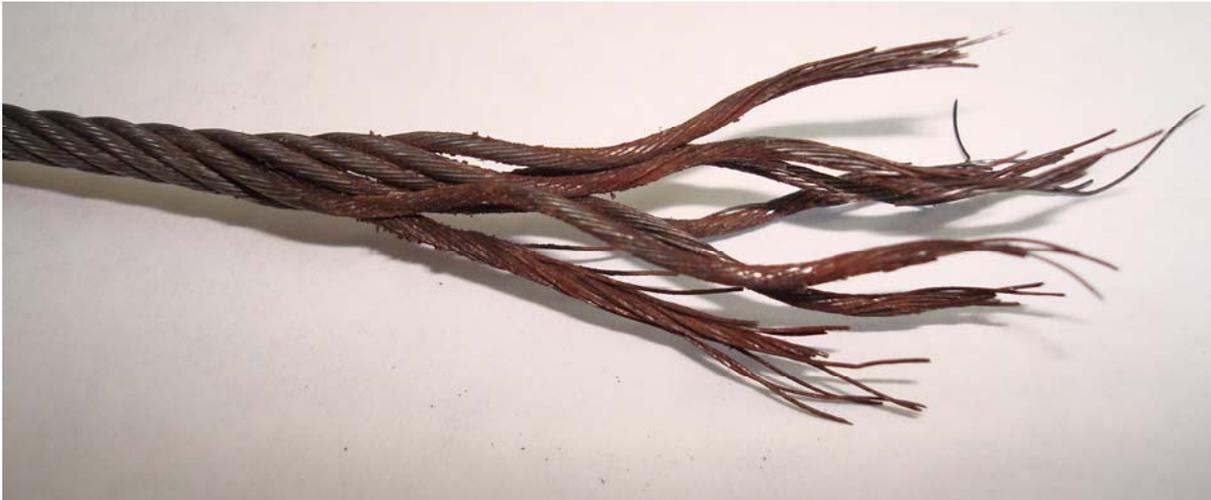
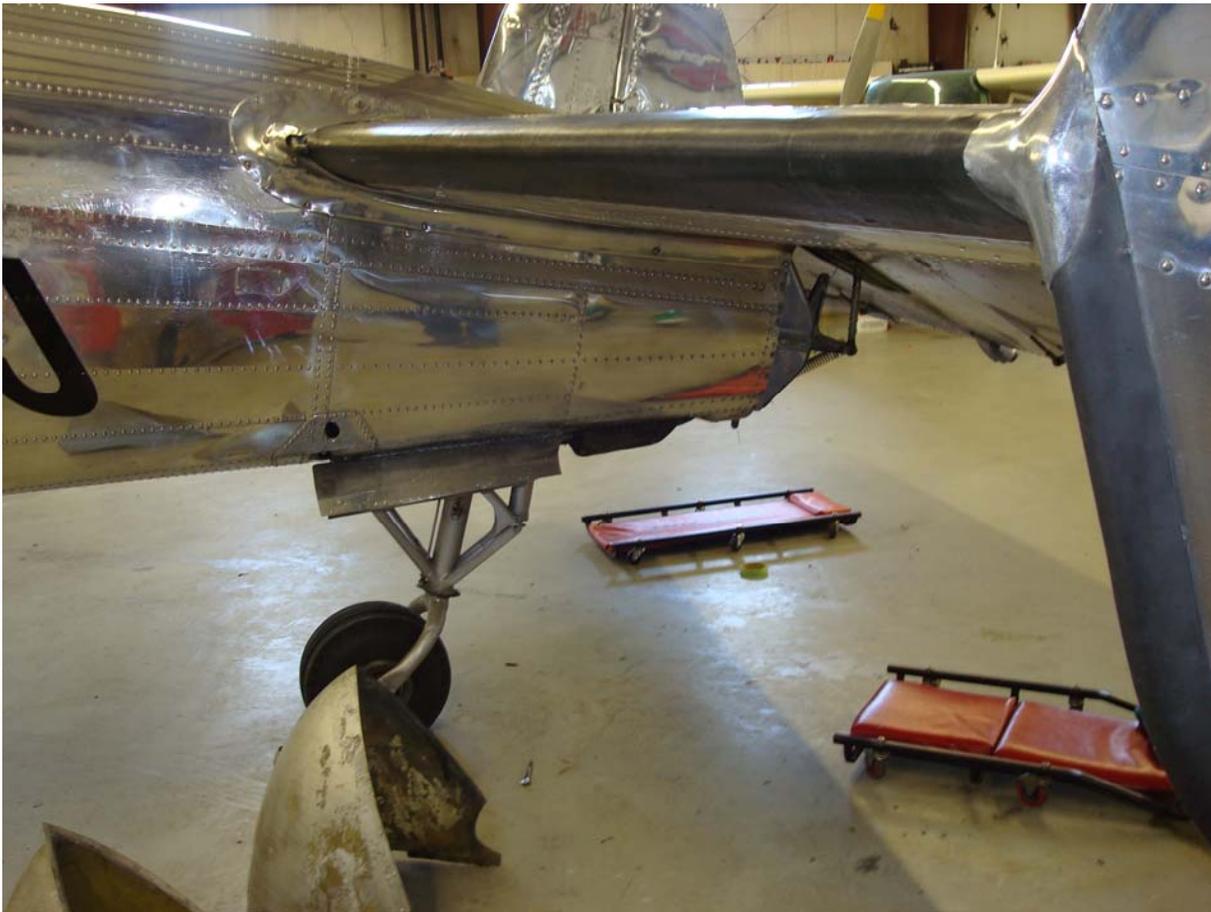
Inspector Anderson states, "This report concerns an operational check flight after an Annual inspection. After takeoff, the pilot heard a "snap" and the aircraft pitched up. The pilot realized he had lost down elevator. Control of the aircraft was regained by the use of power reduction, help from the passenger in the right hand seat, and elevator trim. The aircraft returned for a successful high speed wheel landing.

"The cable appears to be galvanized steel and was completely covered with Paralketone. The break was at the pulley above the tail wheel, at bulkhead number 14. The pulley was free to rotate, however, it did show signs of wear—possibly from over tensioning of the cable. After removal of the cable from the aircraft, further inspection revealed broken strands in the area of its attachment to the elevator control *bull wheel* (reference the attached figure). Note the total time on the elevator cable (P/N 414-187097-1) is unknown."

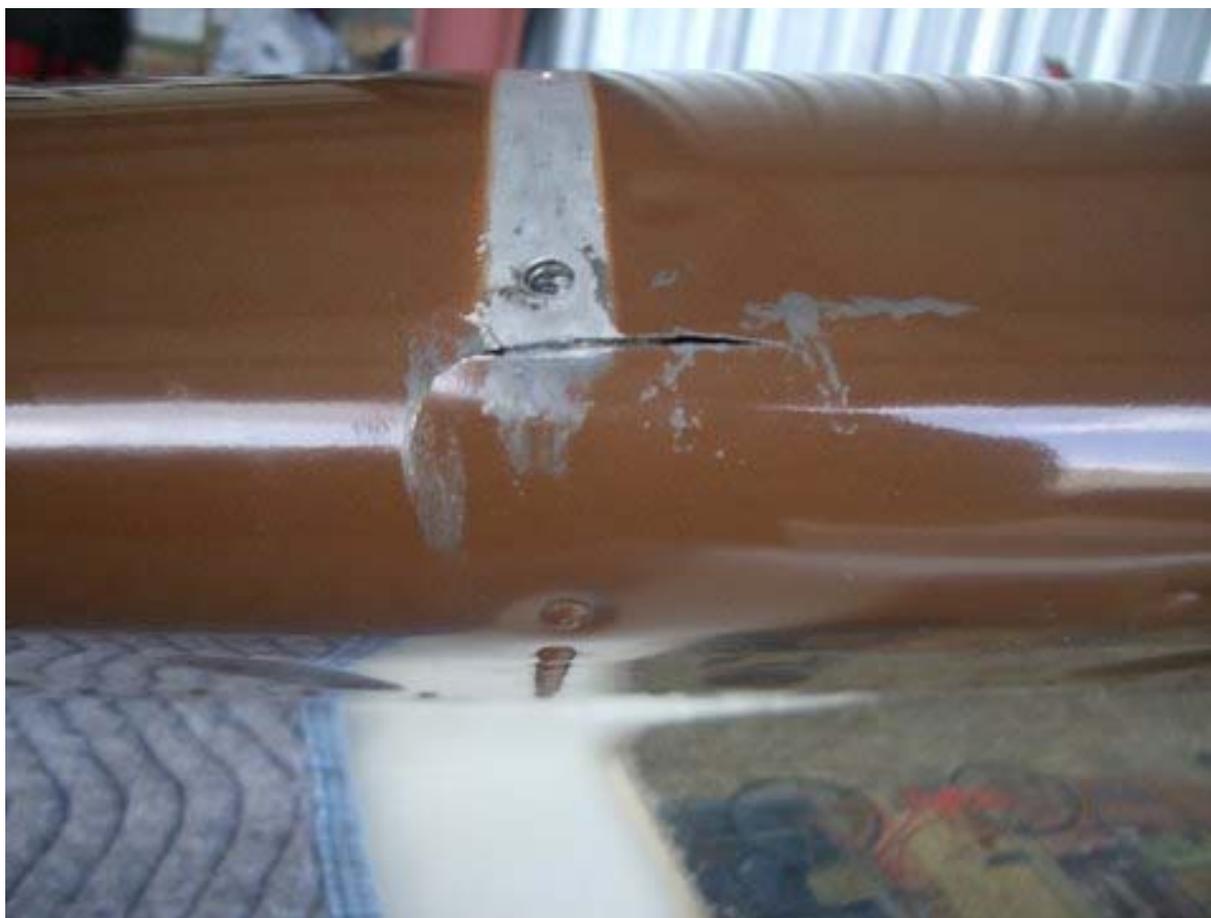
"(I) performed an inspection," says this repair station submitter, "according to Hawker Beechcraft Safety Communiqué number 313/FAA SAIB CE-11-21. The R/H flap leading edge was found cracked (approx. 1.50 inches) in the vicinity of the 'flap actuator bracket'. The nose rib was also cracked. This flap (P/N: 35165050606) was removed for repairs."

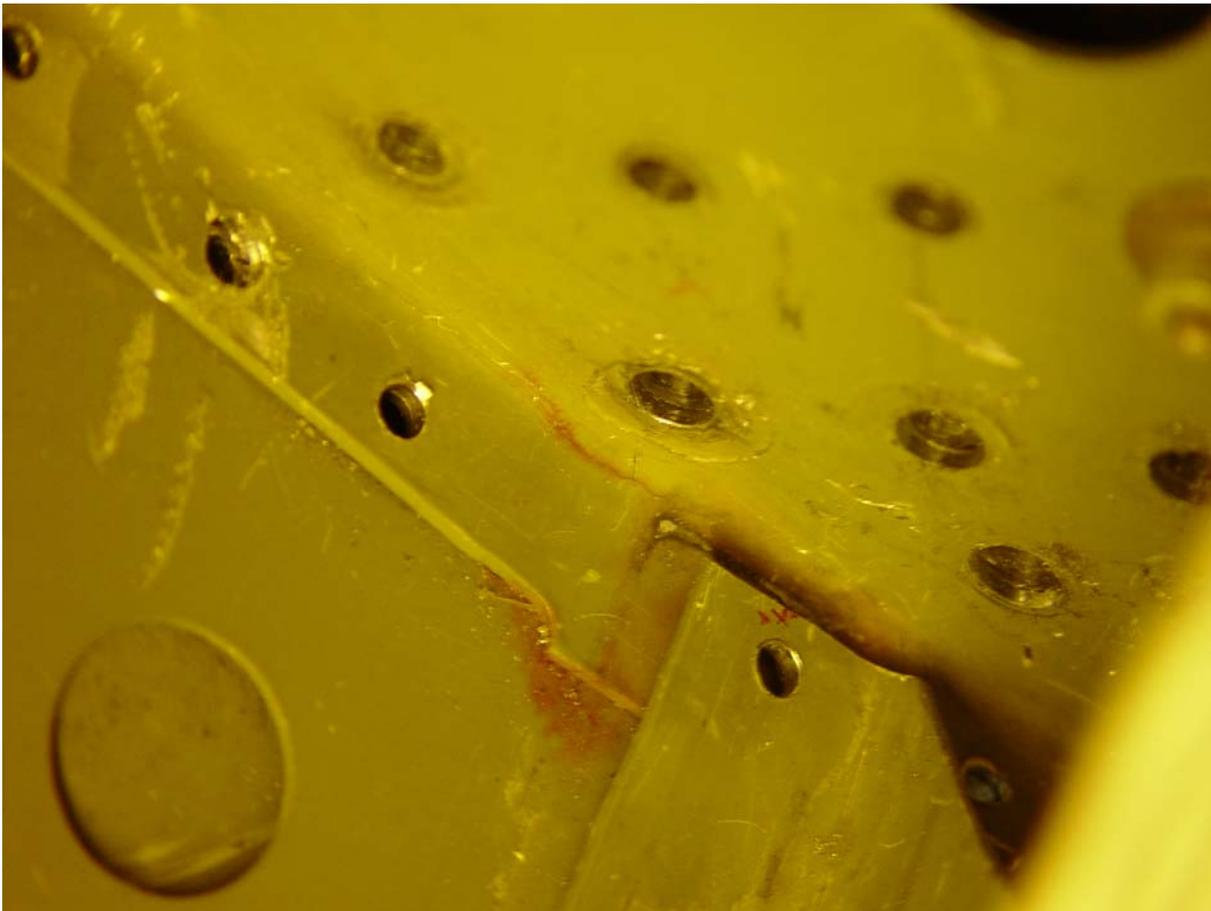
"A Beechcraft Barron 58...was in for a routine maintenance inspection at the operator's home facility," says this technician. "During the Annual Inspection a crack in the right forward spar web bend radius (forward side) was noticed during a visual inspection of the area. A dye penetrant inspection was performed and the crack was verified. The inspection was performed following the Hawker Beechcraft Corporation Barron 55 and 58 Maintenance Manual: P/N 55-590000-13G, Rev. G2, dated October 1, 2010; Section 53-00-00, page 202; B(1) 'Wing Forward Spar Carry-through Structure Inspection—Without Repair Kit'. The aircraft was then flown to our facility for verification of the crack and the installation of Hawker Beechcraft Corp. Kit P/N 58-4008-9 (which is applicable to this aircraft serial number TH-1990). It should be noted AD90-08-14 'Wing Spar Structure'—and Beechcraft MSB2269 Rev. 1 'Fuselage: Wing Forward Spar Carry-Through Structure Inspection and/or Reinforcement' are not applicable to this aircraft by serial number. The crack was found in the area referenced in both the AD and MSB, but 'stop' applicability for this aircraft model 58 was at serial number TH-1475. The Hawker Beechcraft Corp. Kit P/N 58-4008-9 was installed on both the right and left forward spar, forward web structure in accordance with Beech Aircraft Corporation Kit Information—Reinforcement Installation Instructions, Drawing number 58-4009 and Kit Information Drawing number 58-4008, Revision C."

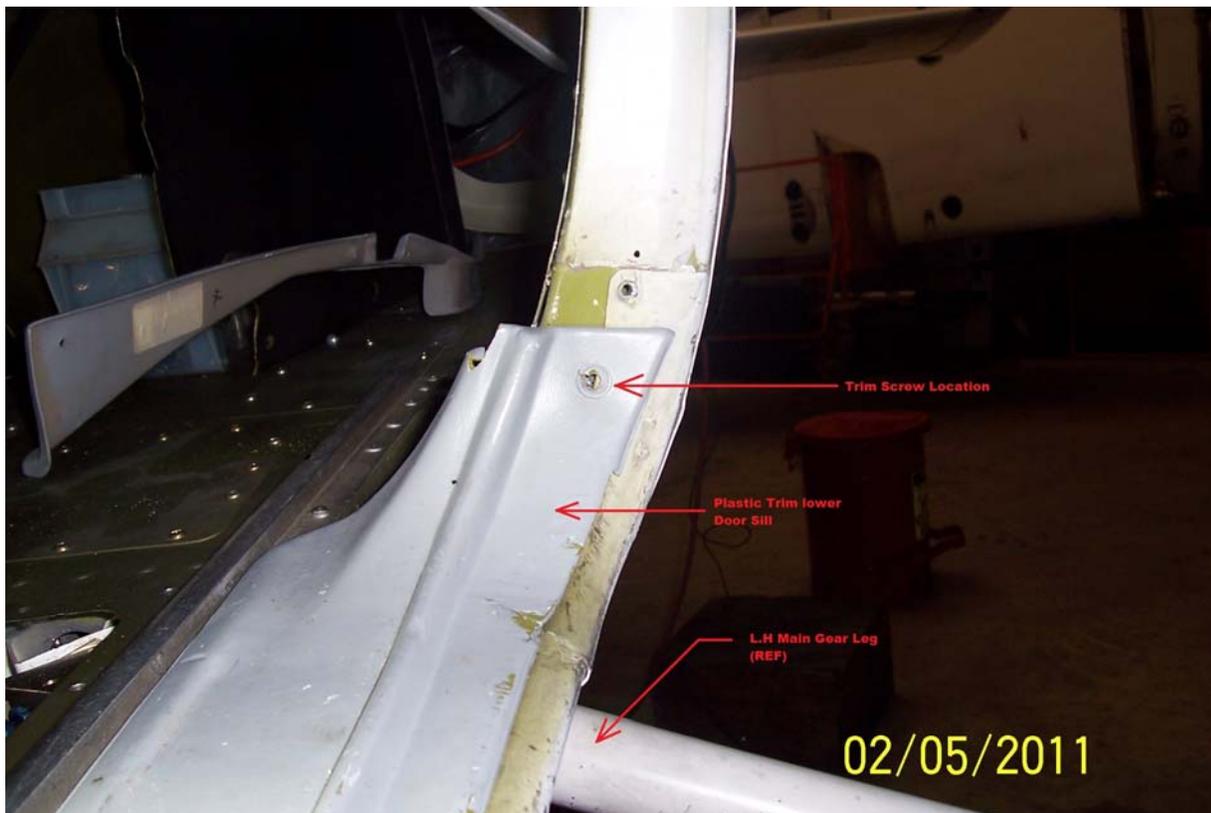
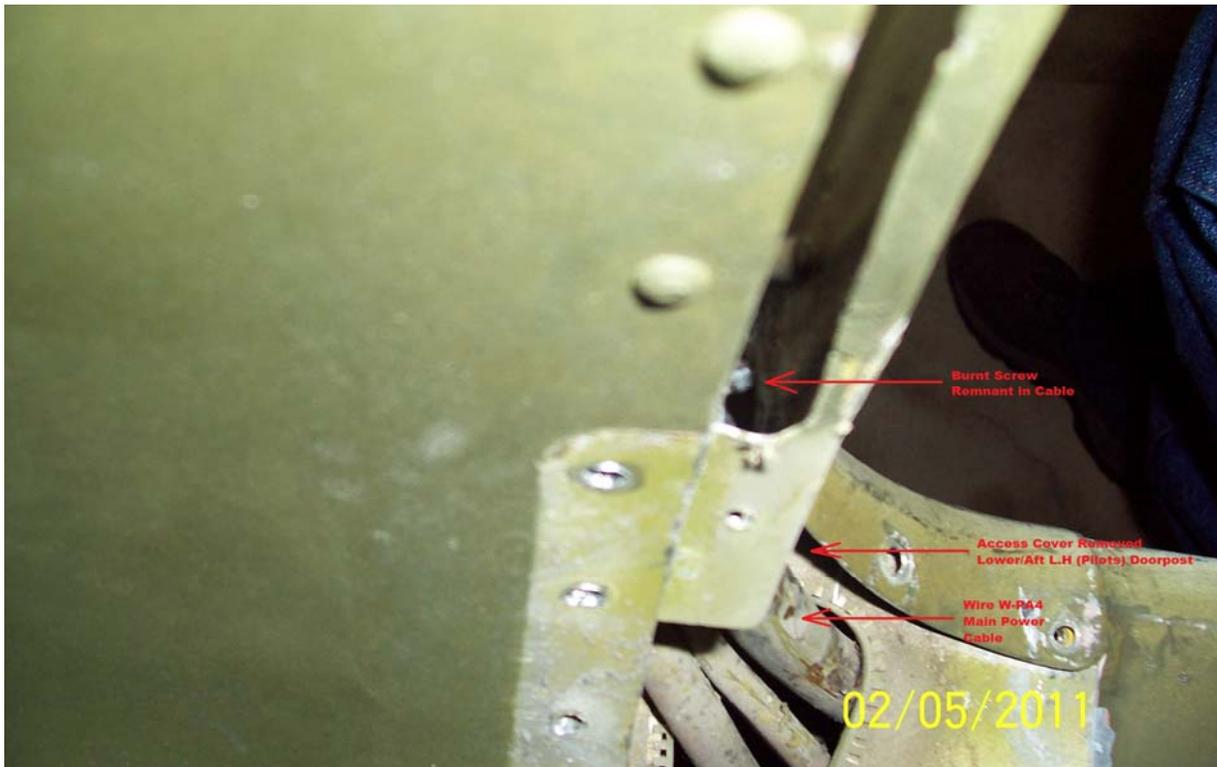
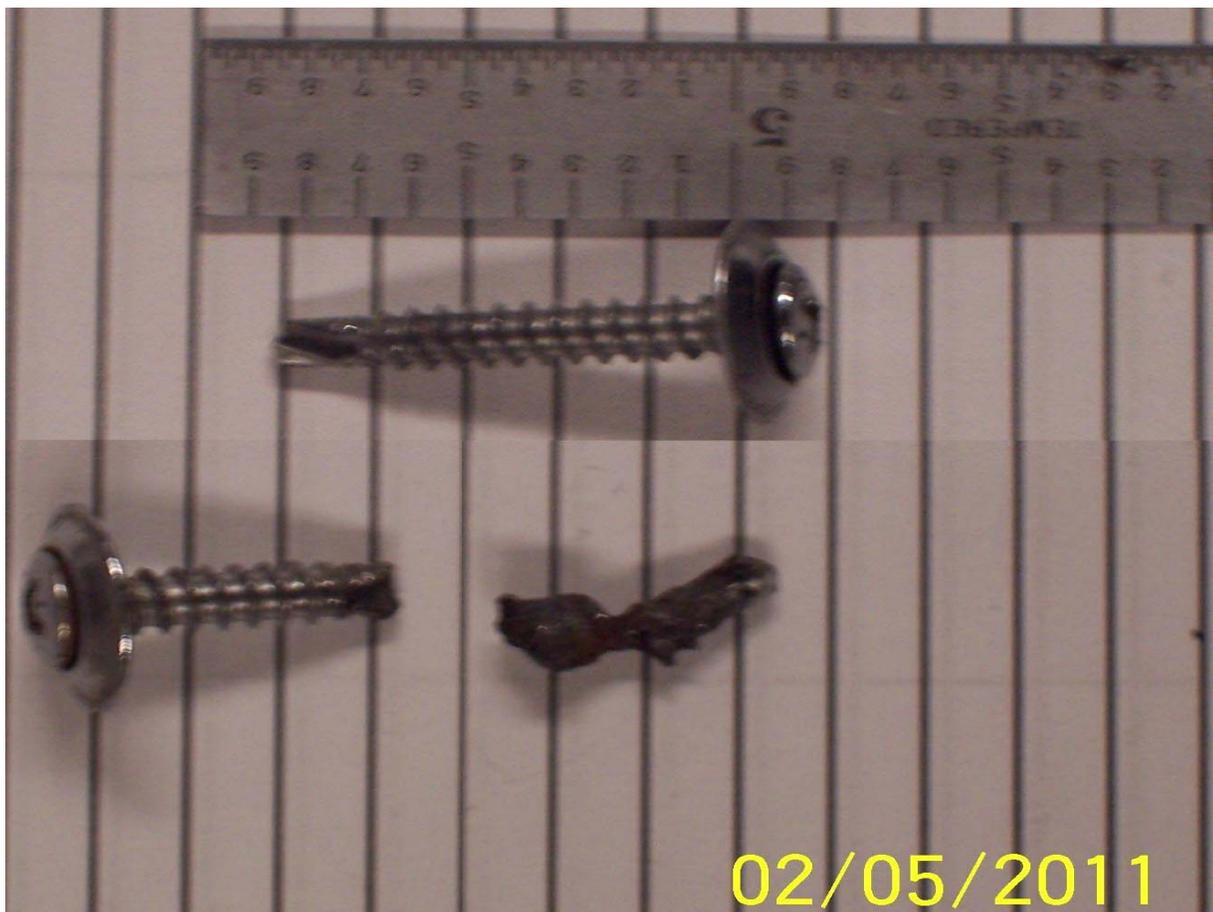
A technician writes, "(I) found an improperly sized (too long) interior trim replacement screw installed in the pilot side lower door sill opening, shorting into the Main Power Cable (P/N W-PA4). The pilot (*had*) complained of intermittent panel lighting/flickering, and recent regulator replacement (twice) and alternator/charging issues."

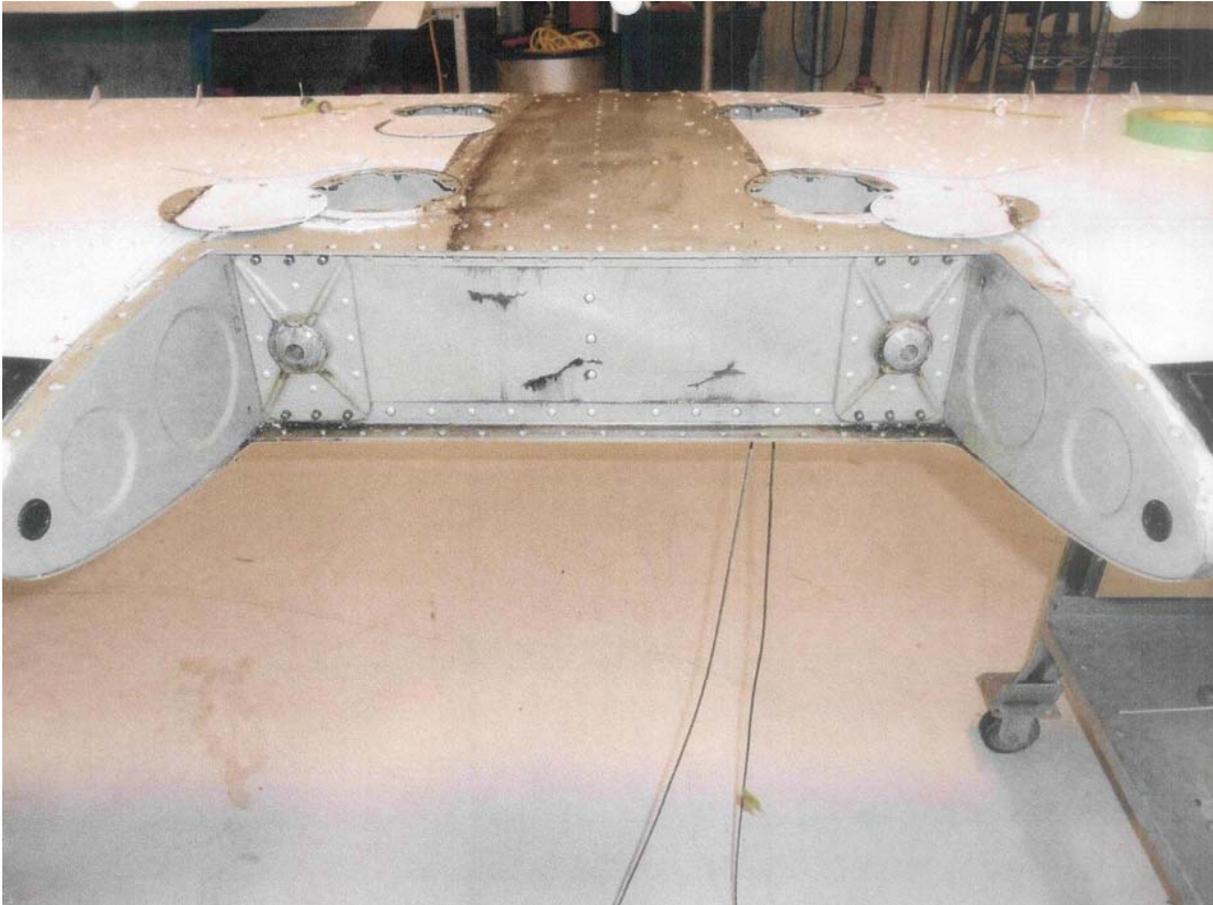
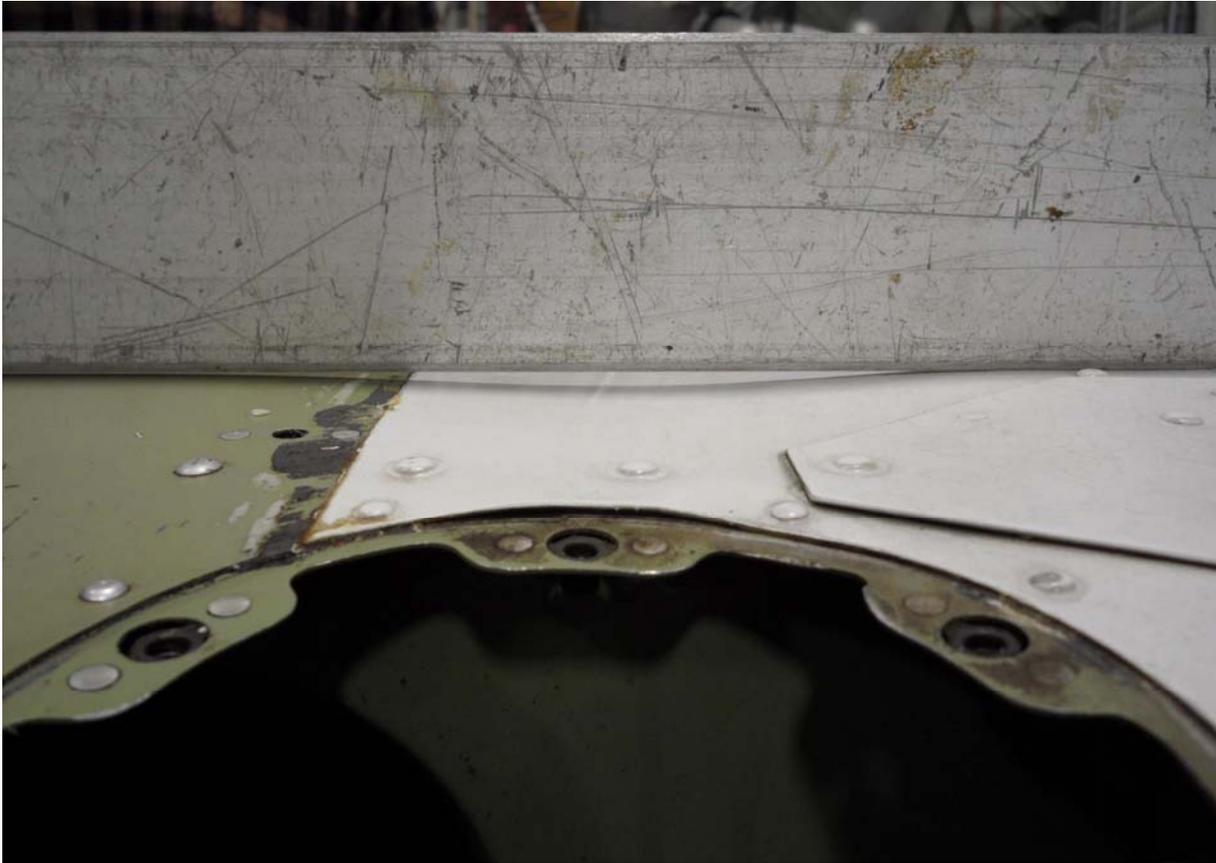
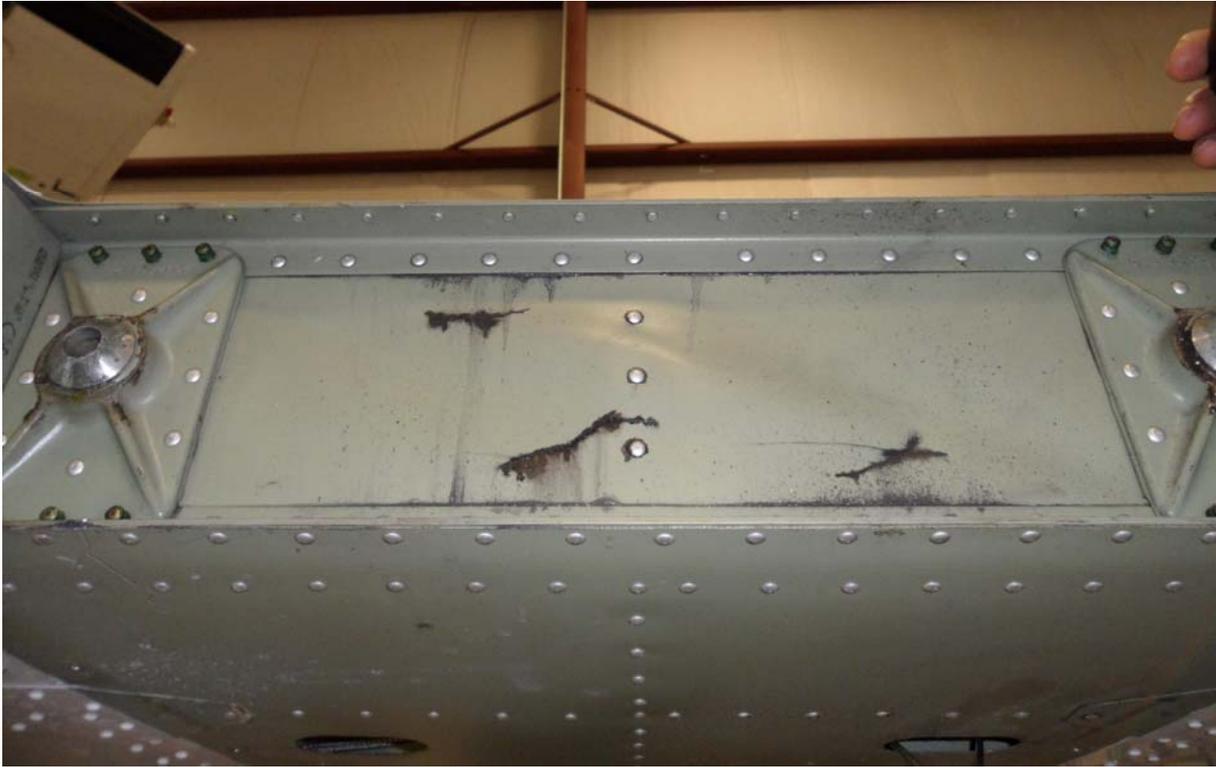
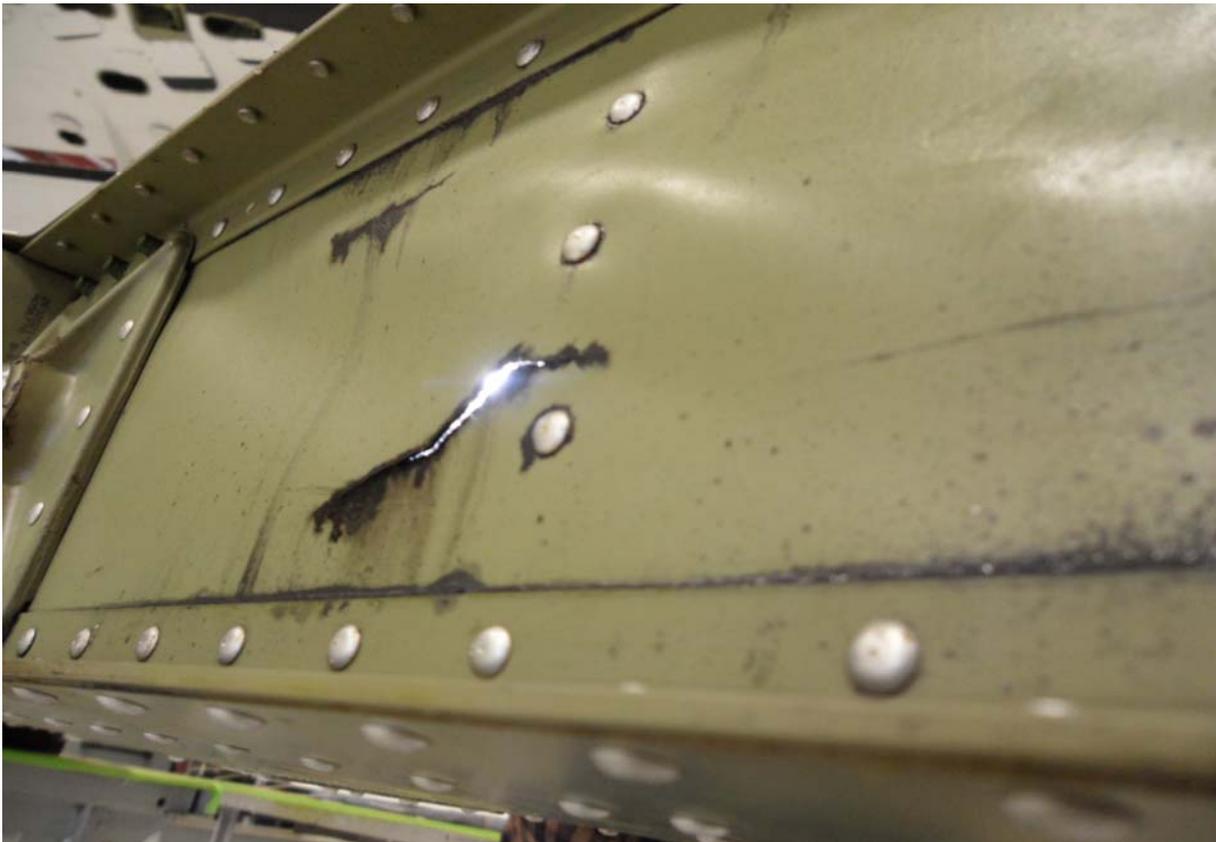
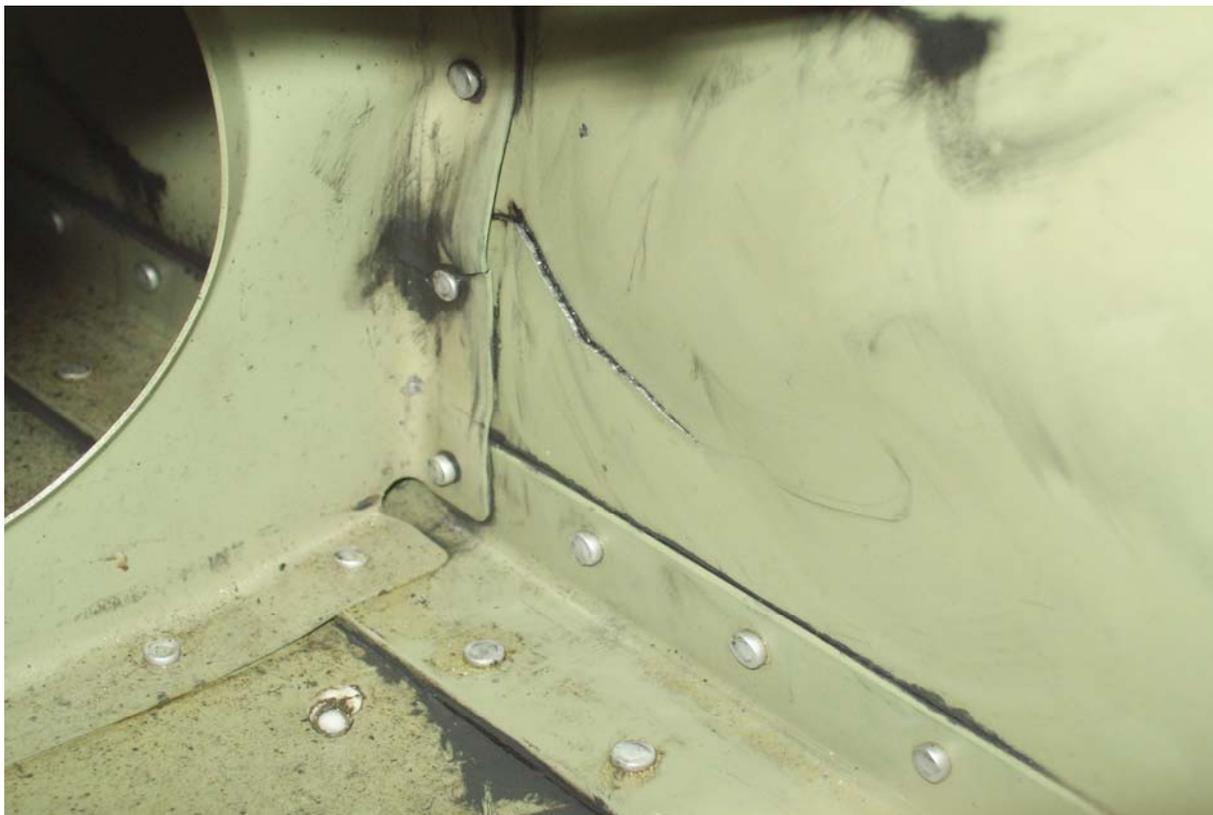
"During a phase 10 inspection of a Cessna 208 (on floats), maintenance personnel discovered multiple cracks in the center section spar of the horizontal stabilizer (P/N 26300038). Several ribs were also found wrinkled and distorted, and a straight-edge confirmed deformation of the stabilizer's top surface.

Removal of this stabilizer revealed extensive damage to the center spar web, rendering it unairworthy. Subsequent investigation determined the damage was caused by cleaning personnel using this critical flight surface as a work platform during cleaning of the tail area.

Inspection of this operator's remaining fleet of aircraft found no other problems. The stabilizer was repaired and reinstalled. *No Step* placards were fixed on all subject aircraft in the effected areas. The total cost of this repair exceeded \$17,000.00—not including down-time of the aircraft.

Operators should be vigilant for those ground operations that can cause aircraft damage—cleaning activity is but one example. Proper training and adequate support equipment (proper stands) are critical elements for elimination of this kind of safety hazard and economic waste."

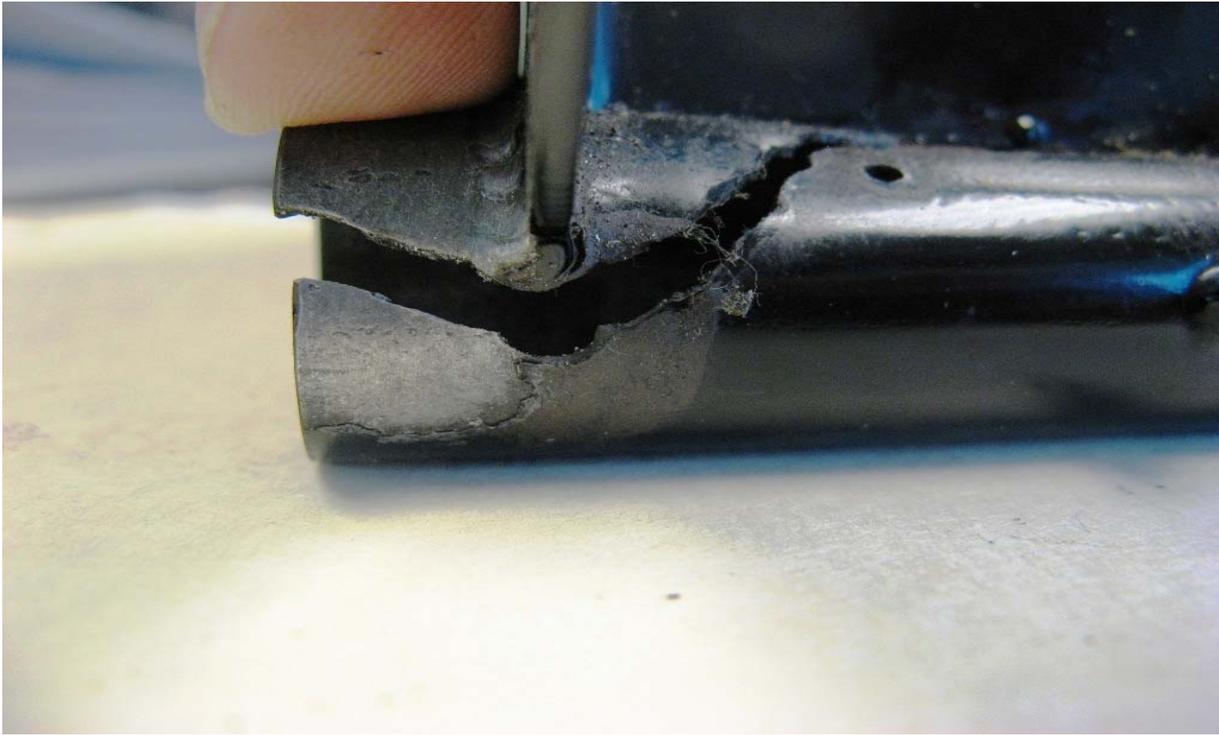
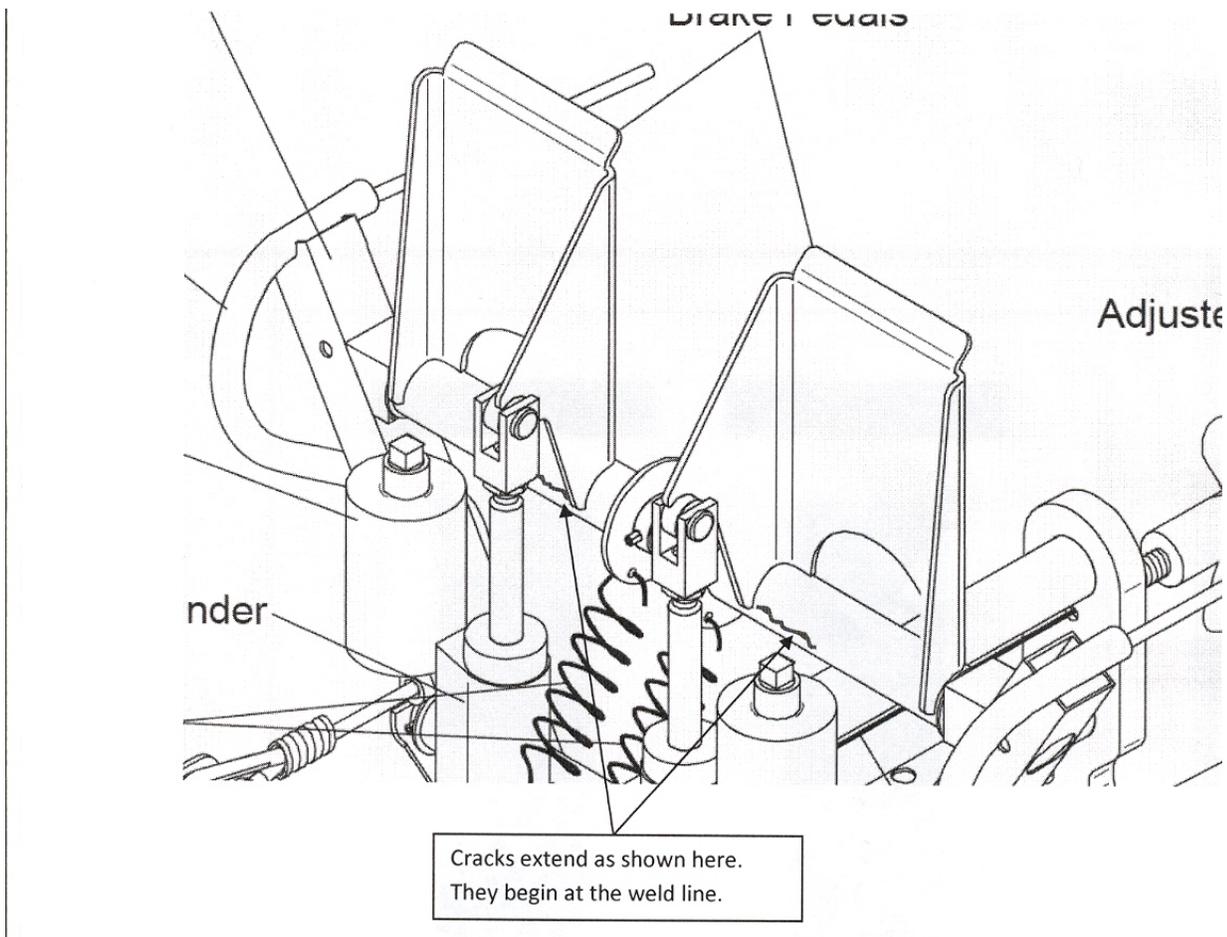
A flight school submission states, "During preflight, the flight crew noticed the rudder pedals were no longer symmetrical, compared to each other. A maintenance technician inspected the co-pilot's L/H pedal (P/N DA4-2723-35-00) and noticed the vertical web connecting the pedal to the brake master cylinder rod had torn at the welded intersection of the tube. The tear/crack in the horizontal pedal pivot tube indicates a torsion failure of that tube."
