ADVISORY CIRCULAR

43-16A

AVIATION MAINTENANCE ALERTS

**ALERT
NUMBER
391**

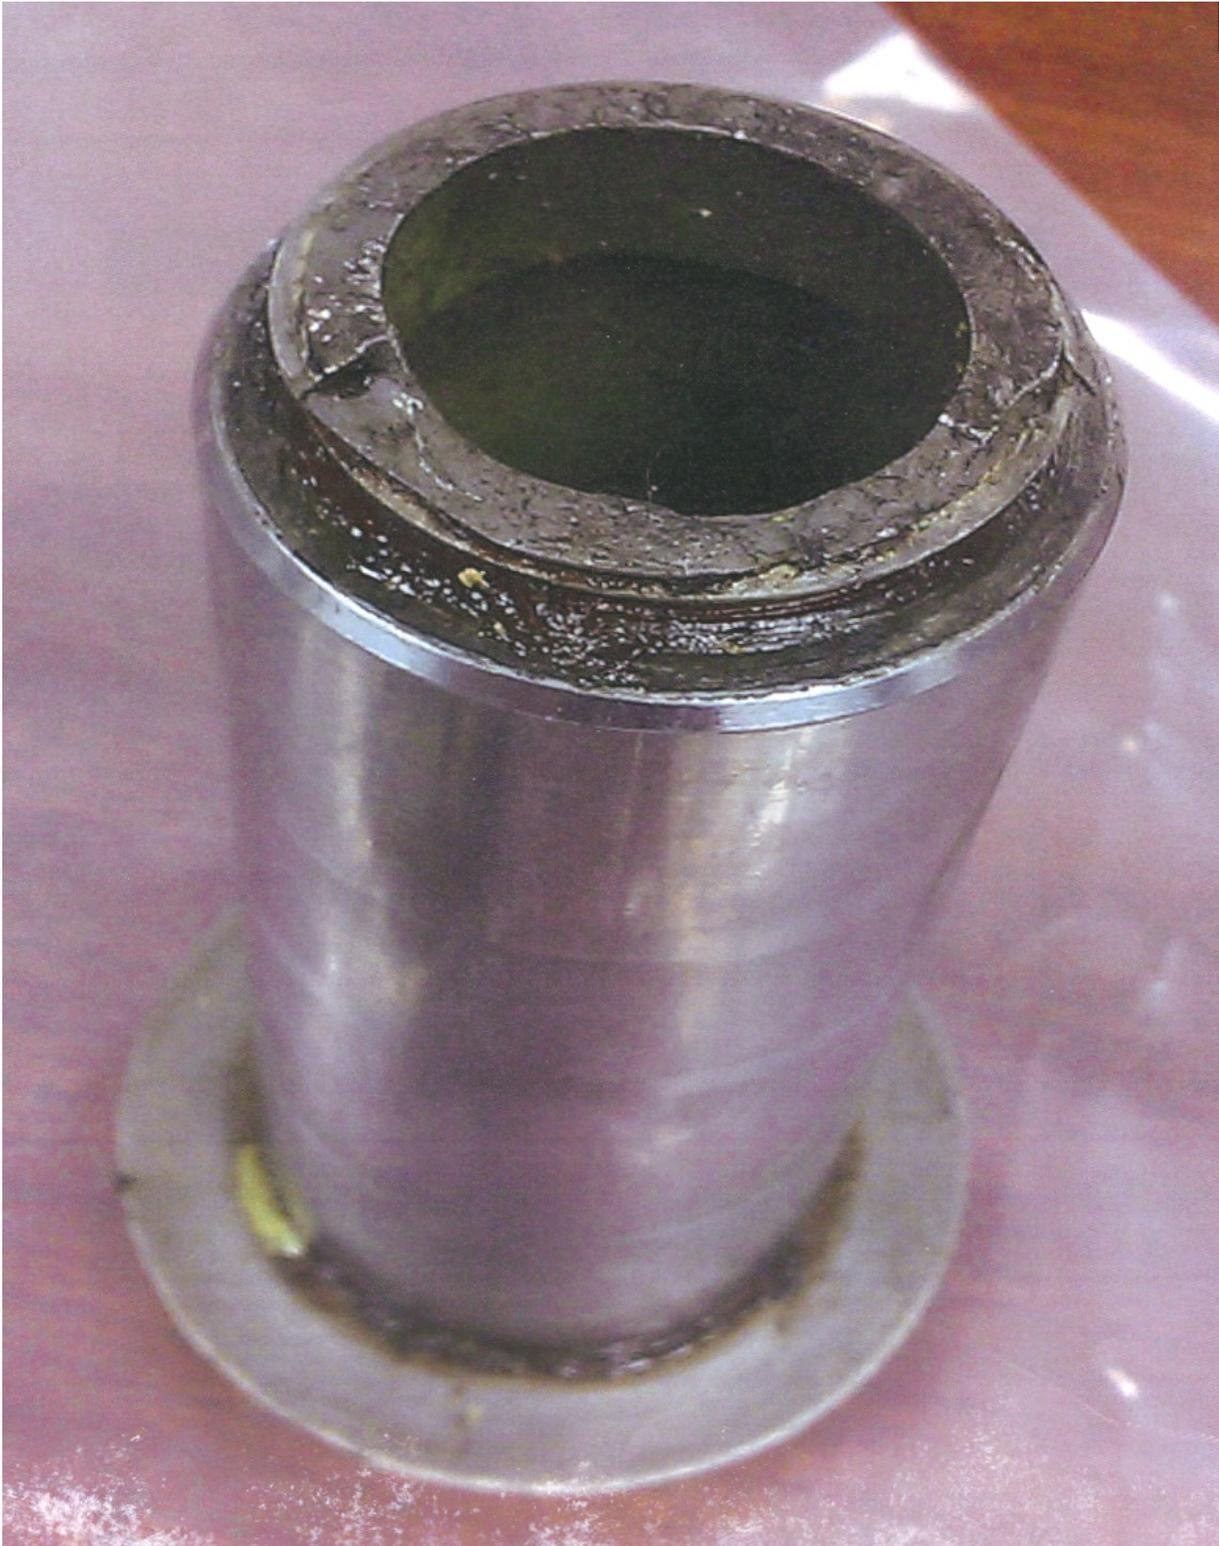
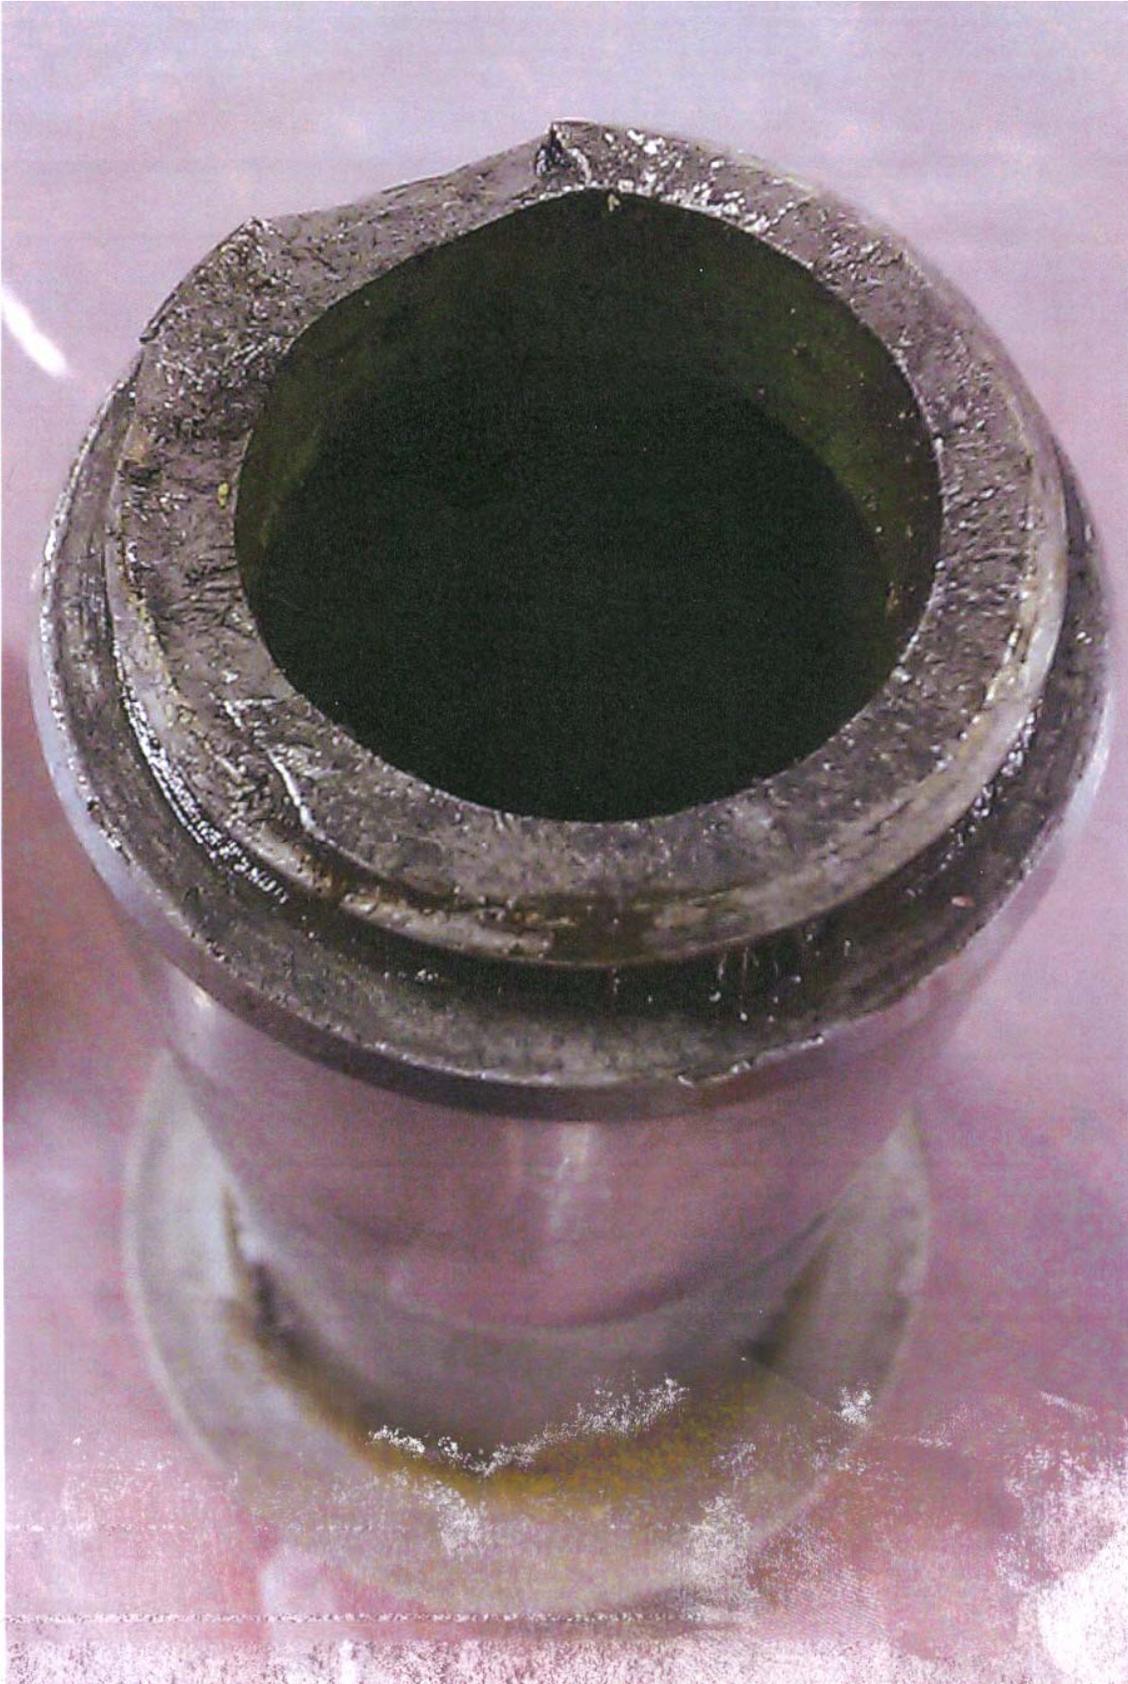
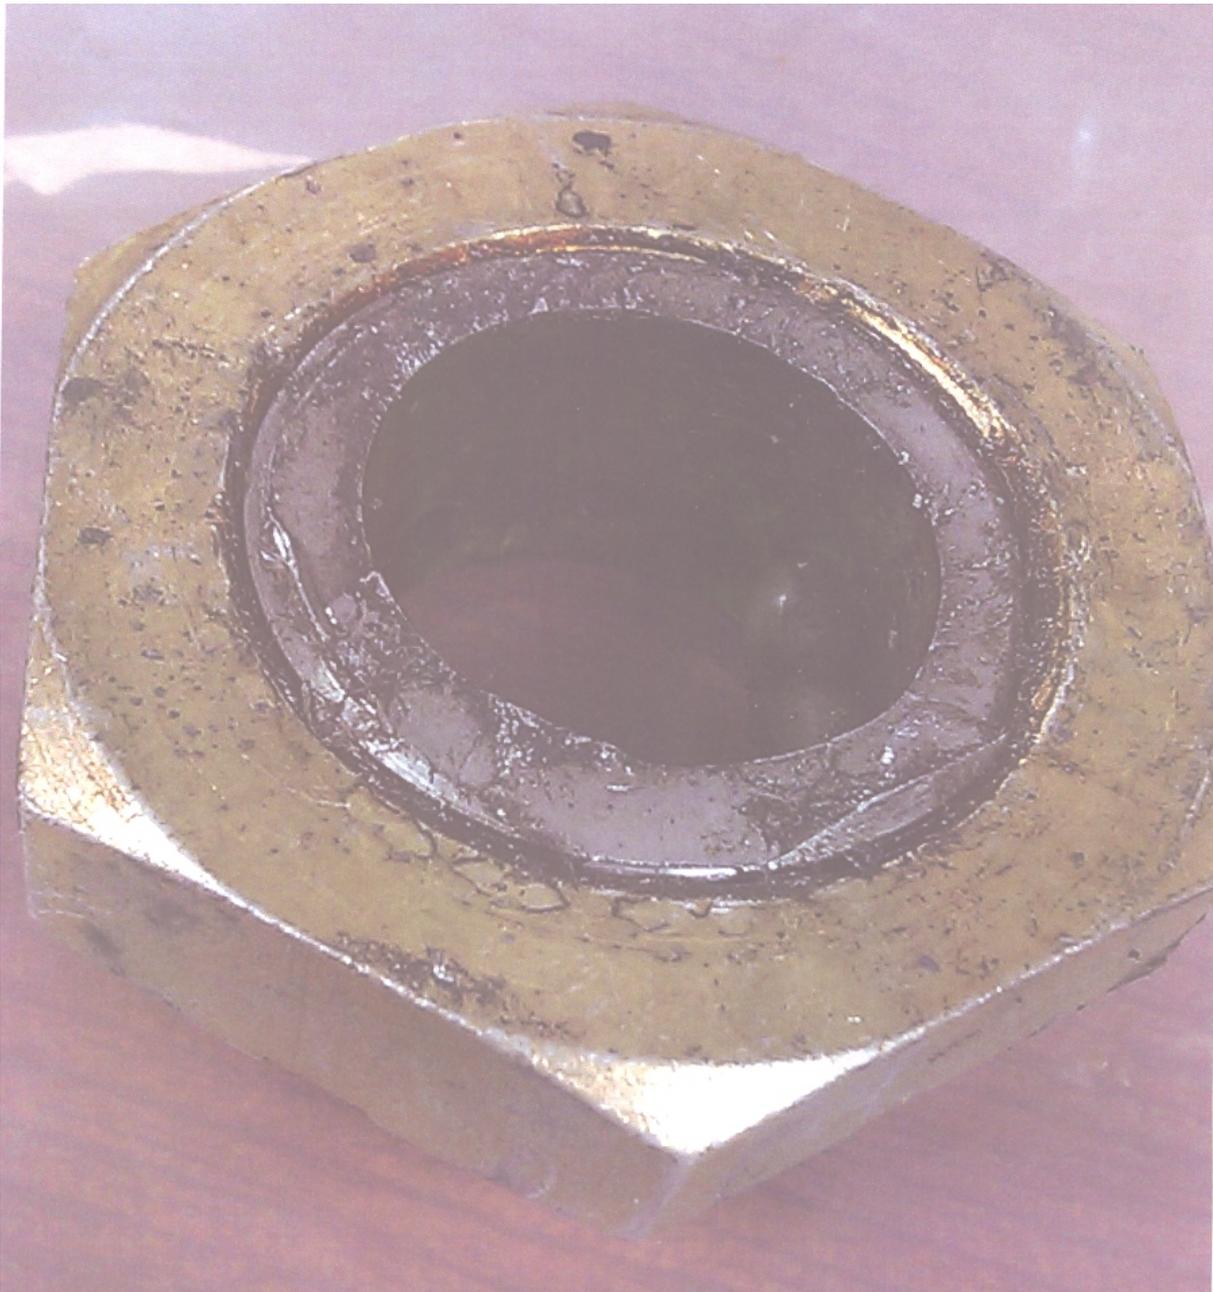
"This event occurred late in the evening," says a quality manager, "during disassembly of the landing gear at overhaul. While accomplishing the un-torque check IAW SP145-32-0097, the nut fell off the subject axle as torque was applied to the upper attach axle (P/N 23092029001). The axle had sheared at the point where the threads entered the nut. The operator was informed of the defect by phone and e-mail, (*and provided this defective*) axle."

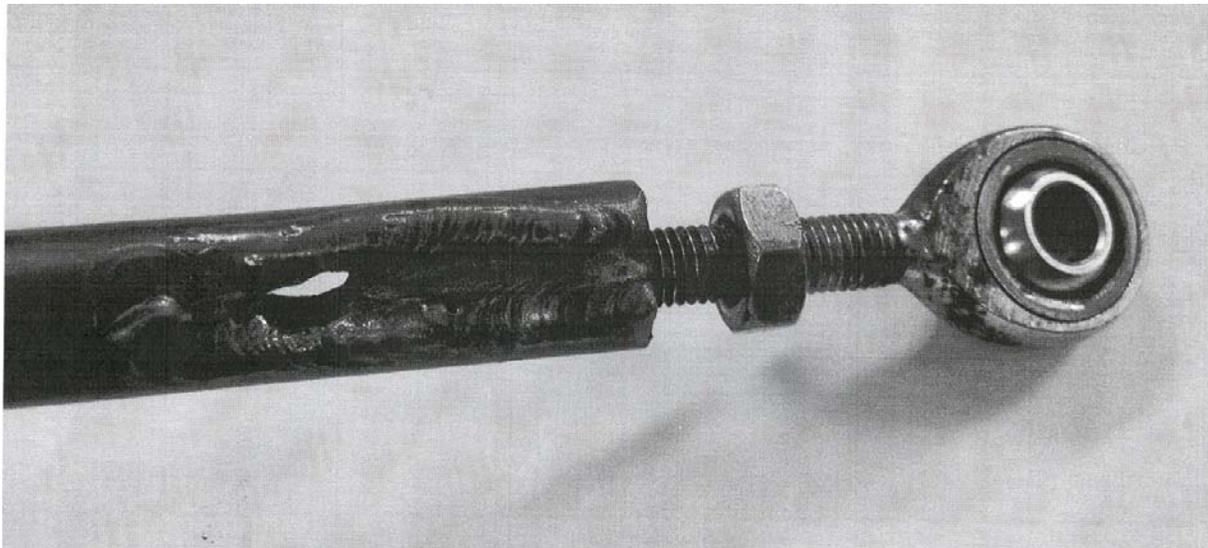
A repair station technician states, "The elevator trim arm assembly (P/N 15618-05) is corroded to the point of having a 3/16 inch hole through both sides of the aft end of the tube."

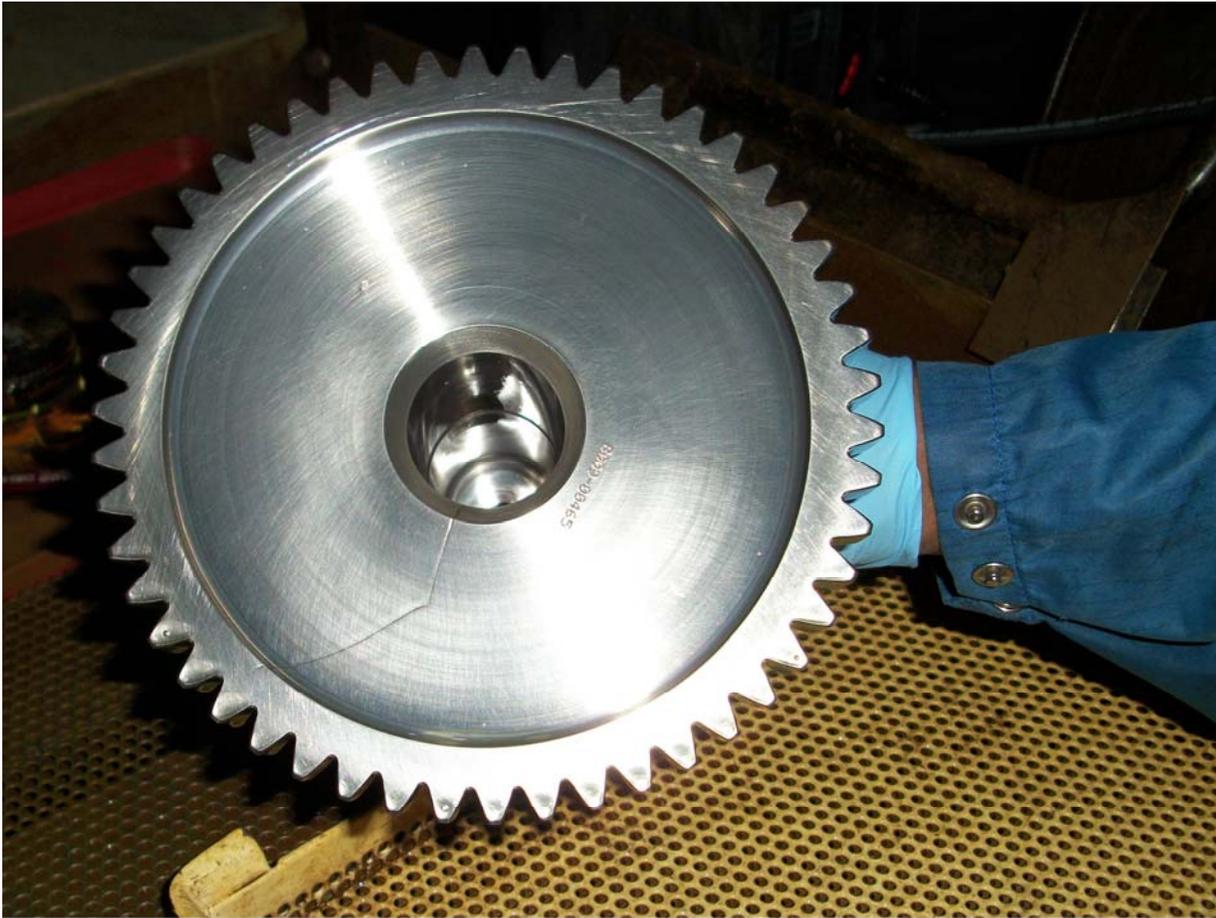
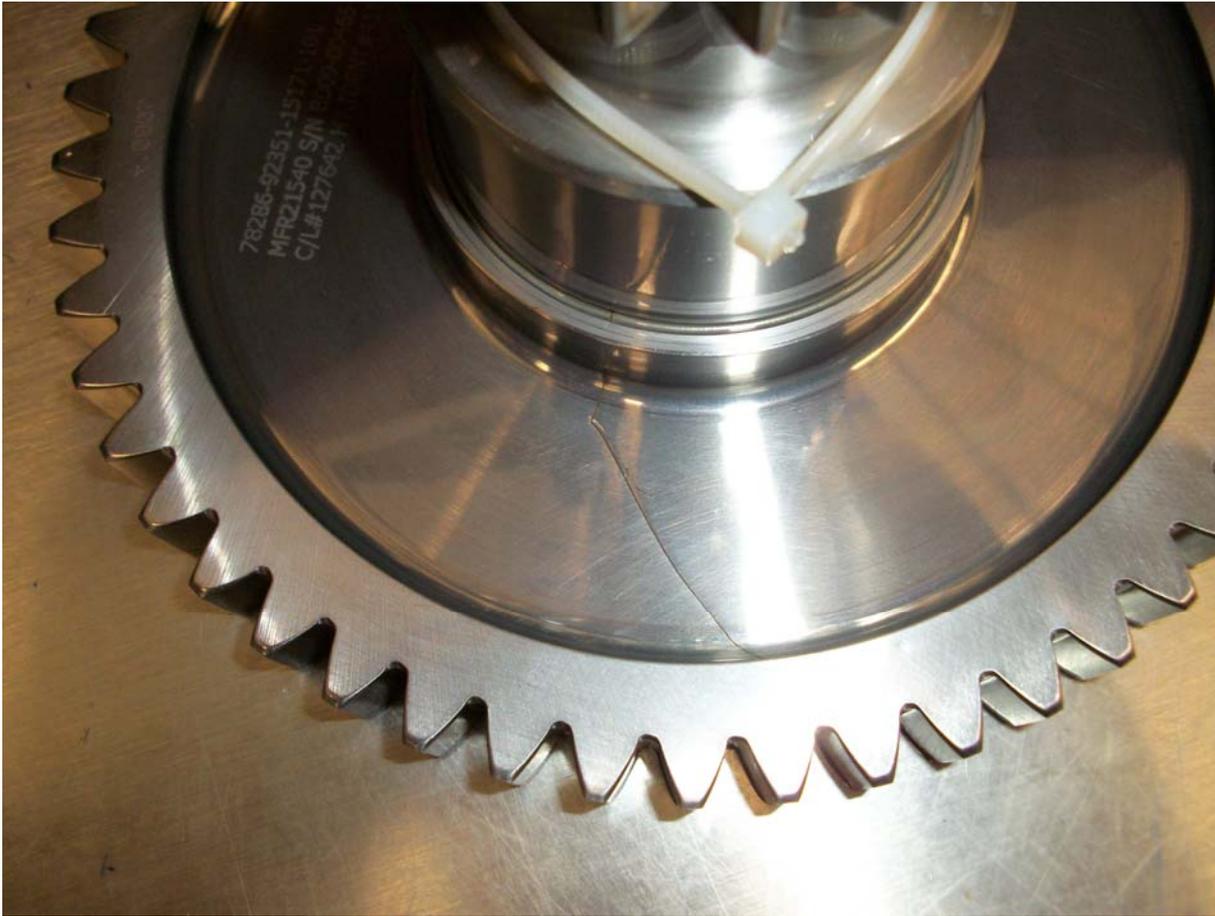
"A large crack was discovered (*propagating*) through the web section of this planetary gear," says a chief inspector. "(*It was found...*) while conducting an MPI (*magnetic particle inspection*) as a normal part of the repair process. Sikorsky and HSI have been notified; they will be conducting a full metallurgical investigation." (*Gear P/N: 9235115171101.*)

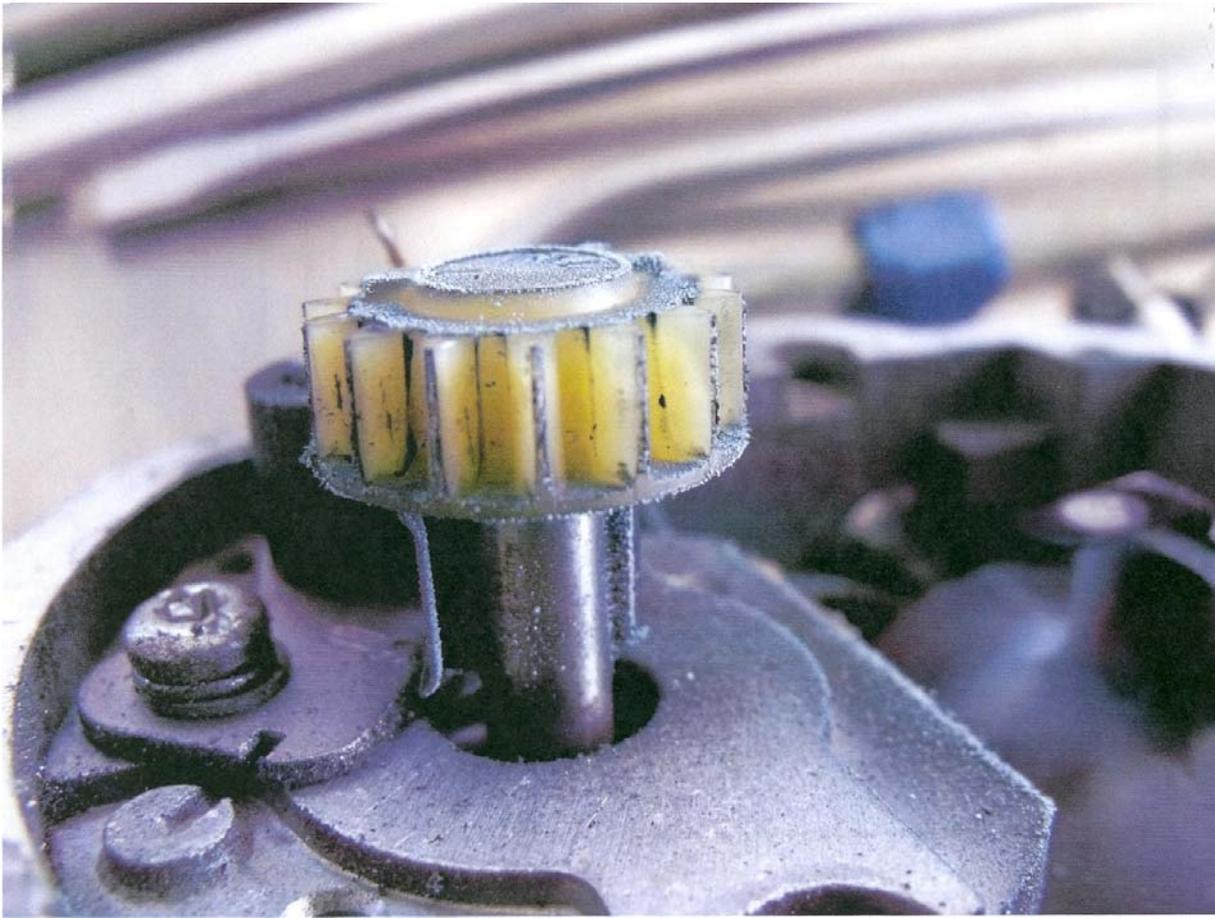
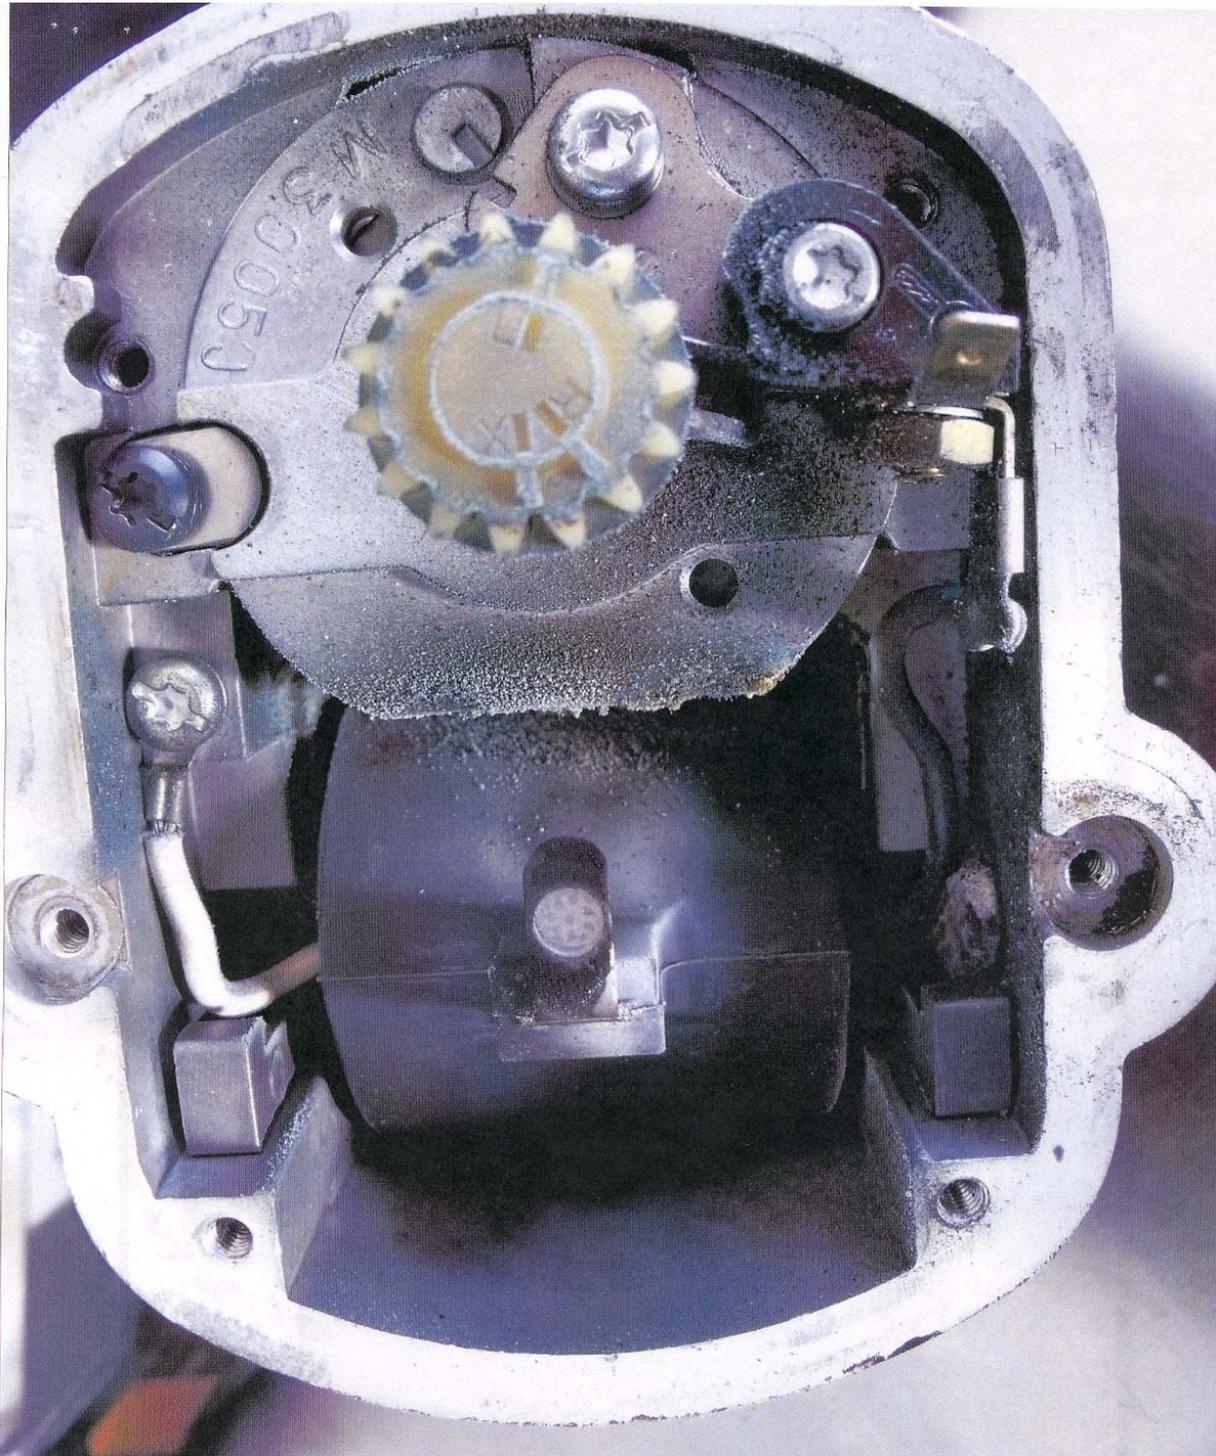
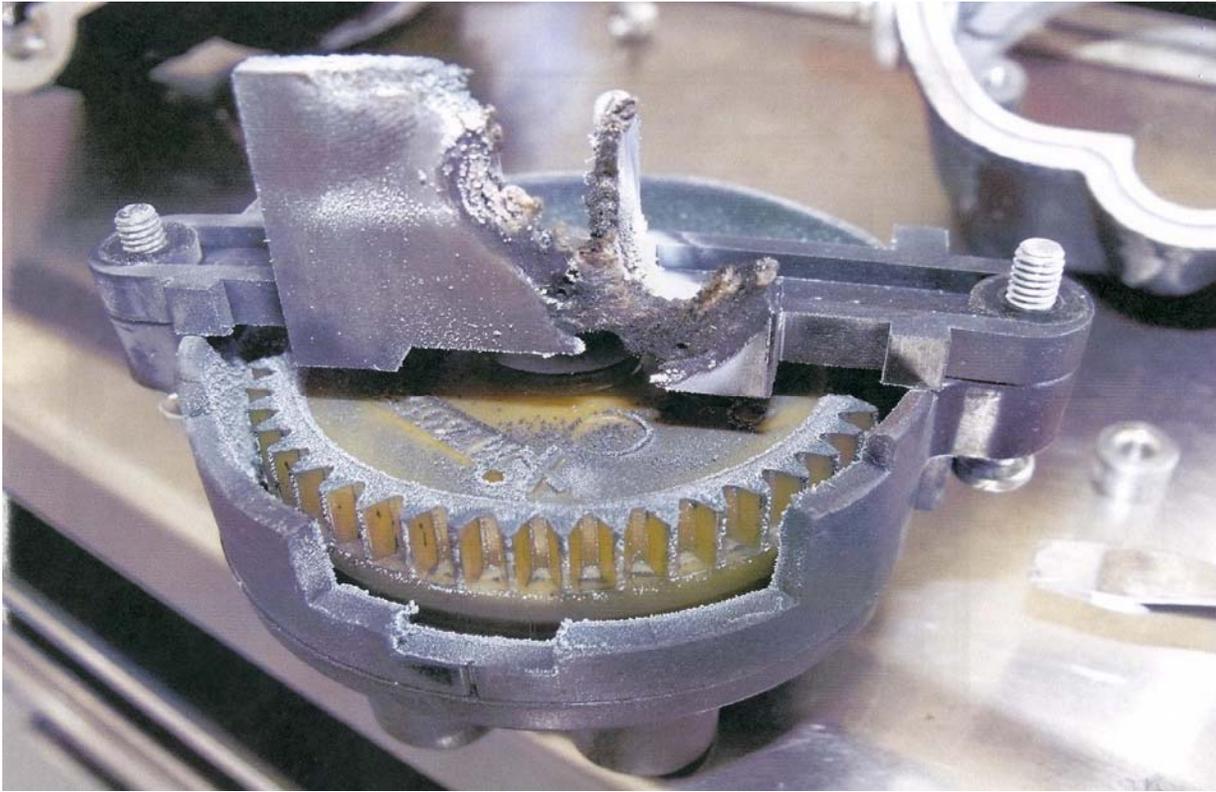
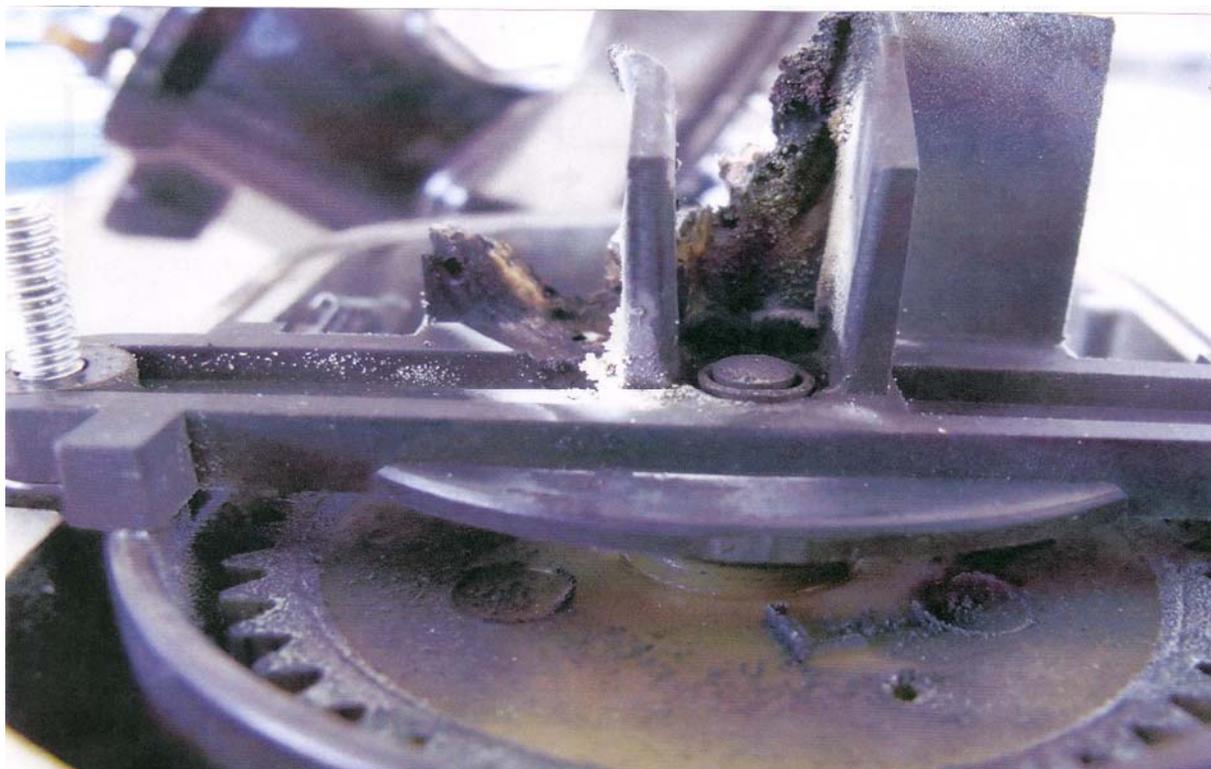
A general aviation submitter states, "(I) removed the left magneto (*from a Cessna 182T*) for a 500-hour inspection and found the distributor block assembly burned through—pieces were floating around inside the (*unit*). A large amount of dust coated the surfaces, and burning was evident on the coil and rotor housing. The carbon brush and cam were extremely worn. During pre-inspection run-up the magneto drop was no more than 75-80 RPM at 1800 RPM—mixture full rich.

"According to the engine log the magnetos were removed and replaced at tachometer time of 1,007.7 hours for a 500 hour inspection." (*The SDRS database reflects at least ten of these particular magnetos.*)
