U.S. Department  
of Transportation  
**Federal Aviation  
Administration**

## ADVISORY CIRCULAR

43-16A

# AVIATION MAINTENANCE ALERTS

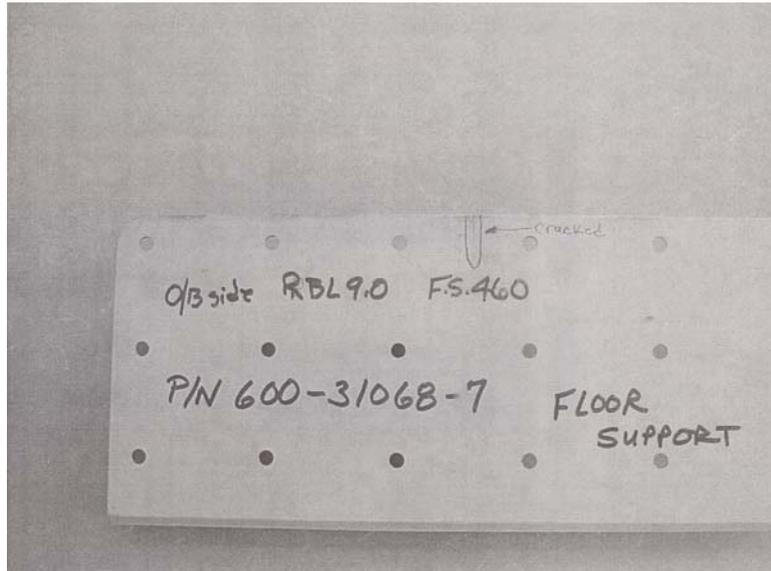
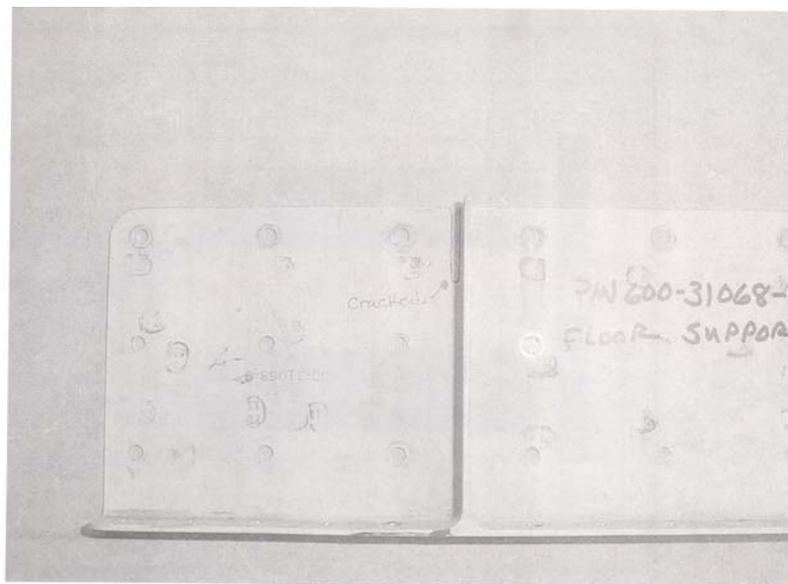
**CANADAIR****Canadair: CL-600; Cracked Floor Support; ATA 5315**

This defect report describes a cracked flange found on supporting floor structure (P/N 600-31068-7). It was found by visual inspection during a floor beam replacement and described by the submitter as being included in the 60 month *below floor inspection task*. This cracked floor support was located at RBL 9.0, F.S. 460 (*right buttock line and fuselage station*). Inspection of three additional CL-600 aircraft did *not* find similar cracks. (*Low resolution, black and white photos accompanied this submission, two of which are included.*)

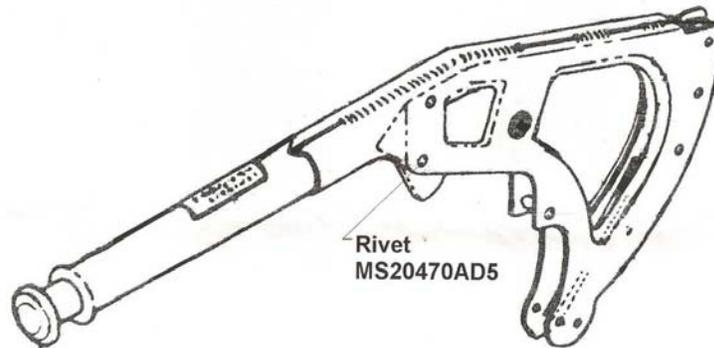
### Cessna: 170B, 172-172E, 180's, 182-182D, 185's: Worn Flap Handle Latch; ATA 2750

“The FAA has received reports of problems associated with a tubular spacer found within Cessna flap handle latch mechanisms (P/N 0510166-0 through -5). Specific models include 172 through the 172E (1964), all 180's, 182 through 182D (1961), and all 185's. The spacer's relative position within the handle can be seen in the attached drawing. It is transfixed by a rivet having washers at each end. Continued use of this latch mechanism causes wear on the handle. Should this occur, the spacer can work itself sufficiently out of the handle to jam the latching mechanism. Wear may be evidenced by paint or surface scrape-type marks found just below the washers on either side of the flap handle. It is recommended this latch joint be inspected for wear during every 100 hours or annual inspection.”

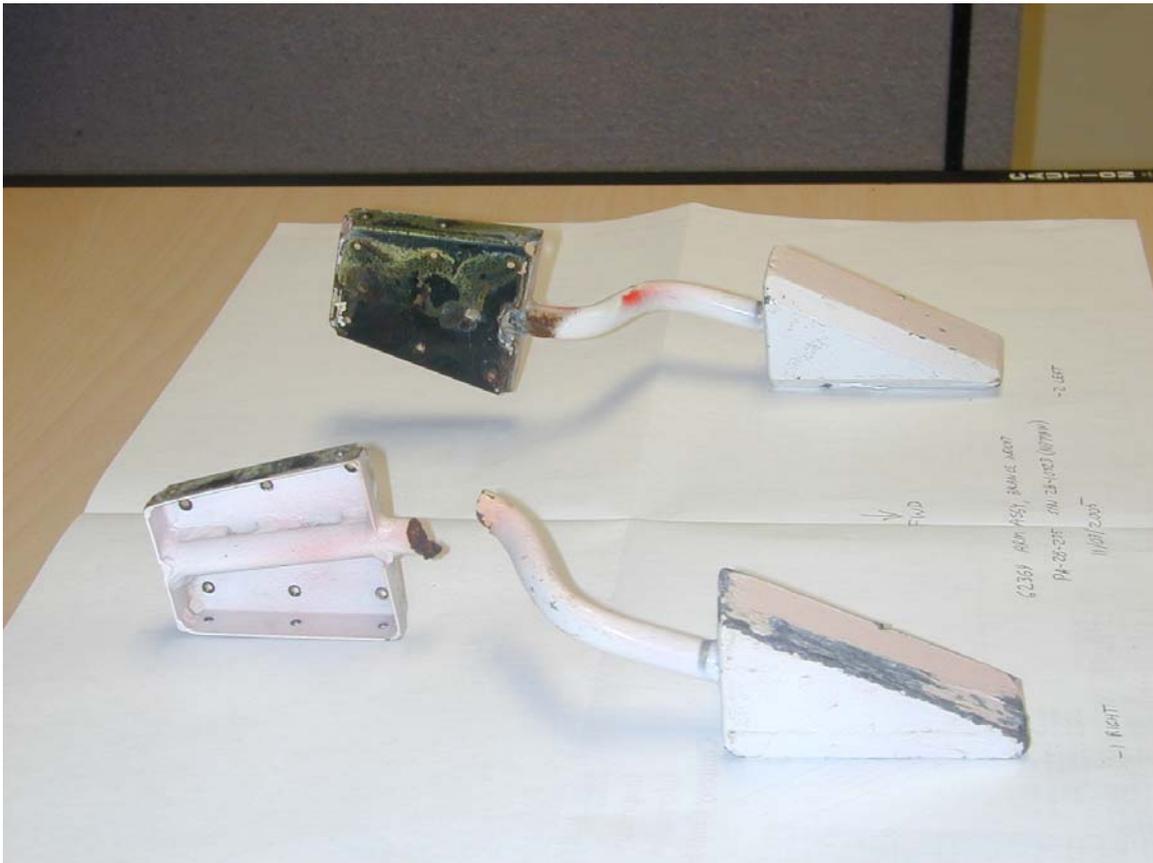
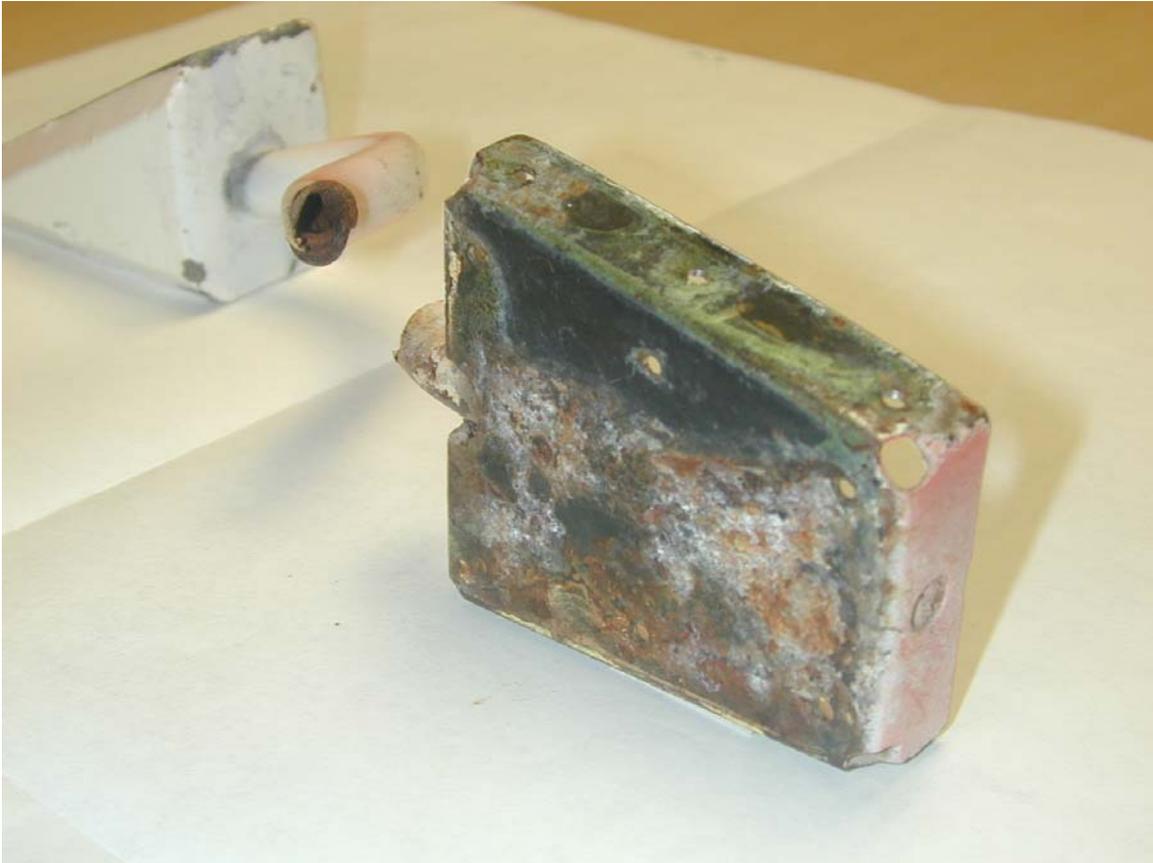
#### Piper: PA28 and-32; Corroded Aileron Balance Weight; ATA 5751

“This office received a report of a corroded aileron balance weight assembly on a 1964 Piper PA-28-235 (P/N 62369-00 or 62369-01). Based on the report and our research, the following is recommended: for those Piper PA-28 and PA-32 model airplanes that meet the applicability requirements specified in Airworthiness Directive (AD) 67-12-06, accomplish the actions specified in paragraphs (a) through (c) of the AD for the aileron balance weight assembly. Do this at the next annual or 100 hour inspection (whichever comes first) and repeat every annual inspection. Consider additional inspection of the faying surface—where the assembly attaches to the aileron end-rib. More corrosion may be found.”

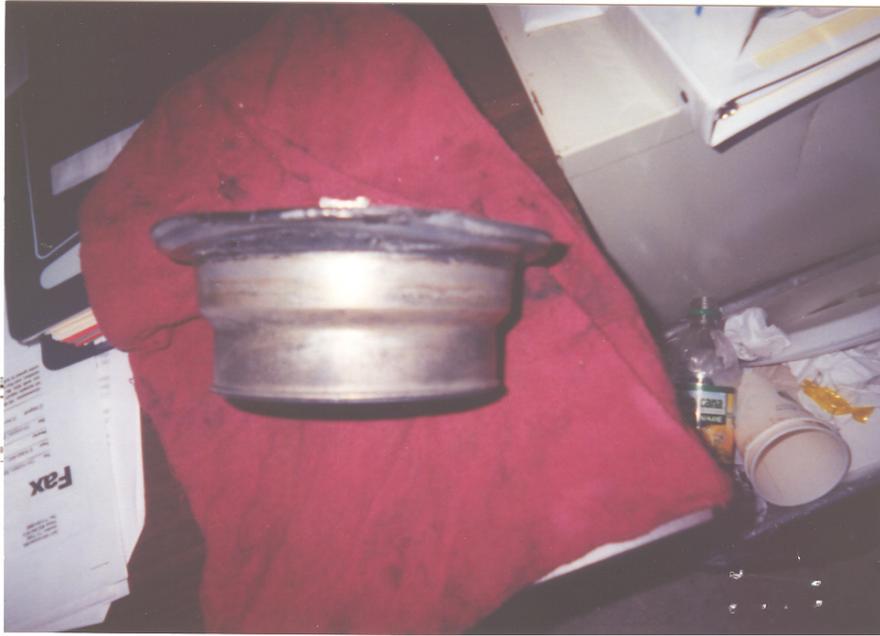
**Piper: PA32; Cracked Wheel Half; ATA 3246**

A mechanic describes this aircraft landing safely, with a subsequent flat tire developed during taxi. Fairing removal revealed the inboard wheel half (P/N 161-47) rubbing on the brakes. After disassembly and removal of the brake disk, "...the inboard wheel half (*was observed*) to be cracked three inches along the bead area and bowed out." The pilot reported this wheel's tire had been changed 6 months previously, leading the mechanic to speculate whether or not close inspection at that time could have detected this defect.
