U.S. Department  
of Transportation  
**Federal Aviation  
Administration**

## ADVISORY CIRCULAR

# AVIATION MAINTENANCE ALERTS

**ALERT  
NUMBER  
342**

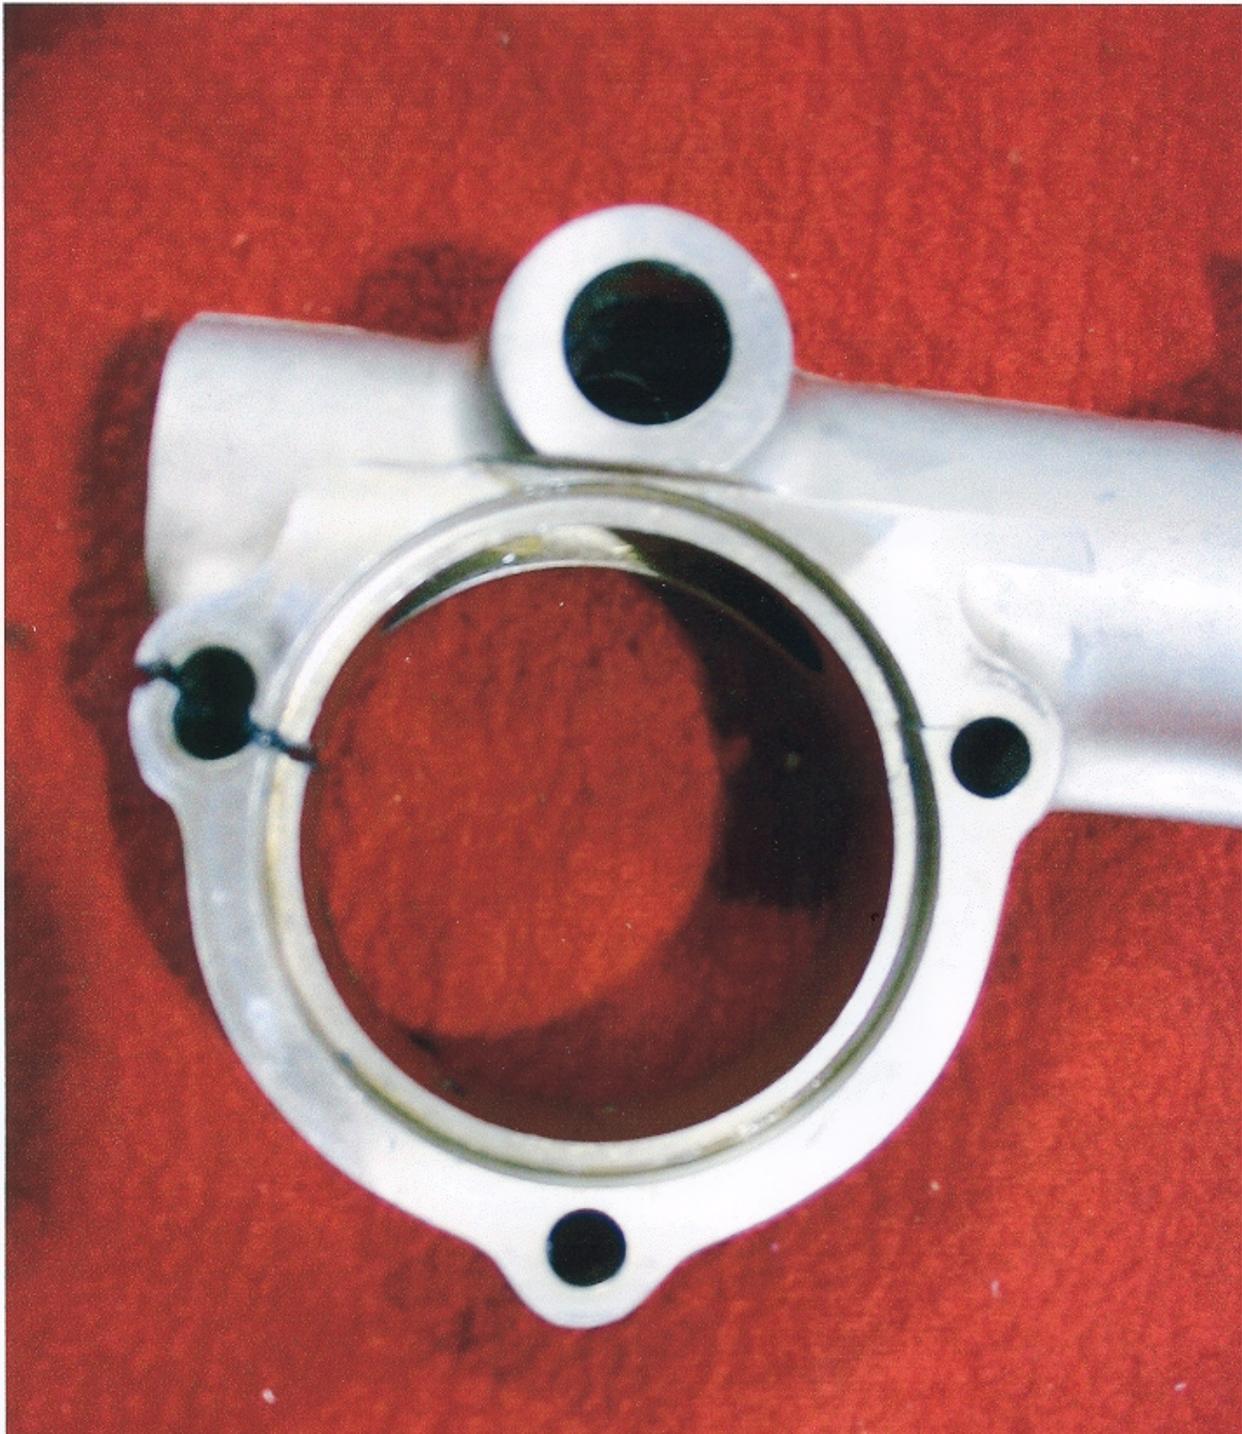
**CESSNA****Cessna: 172RG; Cracked, L/H Landing Gear Actuator; ATA 3233**

Two technicians from a repair station co-authored this discrepancy. “During flight, the L/H main landing gear failed to extend, but trailed—seemingly disconnected from the hydraulic system. The pilot was able to rock (*this L/H gear*) into the down and locked position and make a safe landing. Upon inspection it was determined that the (P/N 1281001-3) actuator body had cracked clear through the forward attach hole and half-way through the aft attach hole. (*This*) caused the actuator to separate when hydraulic pressure was applied, separating the piston gear shaft (P/N 9882004-1) from the sector gear (P/N 9882002-2) mounted to the pivot. The actuator’s attach bolts were found tight and their safety wire undisturbed. The actuator body was replaced with a new part (P/N 1281001-6). The actuator was resealed, reassembled, reinstalled and torqued per the 172RG Service Manual. (*We*) performed a hydraulic pressure switch check (*same ref.*) and found the pressure to be within limits.

“Damage to the actuator body is unrelated to the condition addressed in Cessna (*bulletin*) SEB01-2. (*We*) suspect failure of the actuator body may be attributed to shear stress on (*its*) attach bolt holes due to the high number of gear cycles over the life of the aircraft. Inspection of the R/H gear actuator body yielded no cracks or defects.” (*This actuator assembly, P/N 9882015-2, is located under the floor beneath the cabin’s back seat. A search of the FAA Service Difficulty Reporting System data base reflects 20 entries for this same part number since 1995.*)

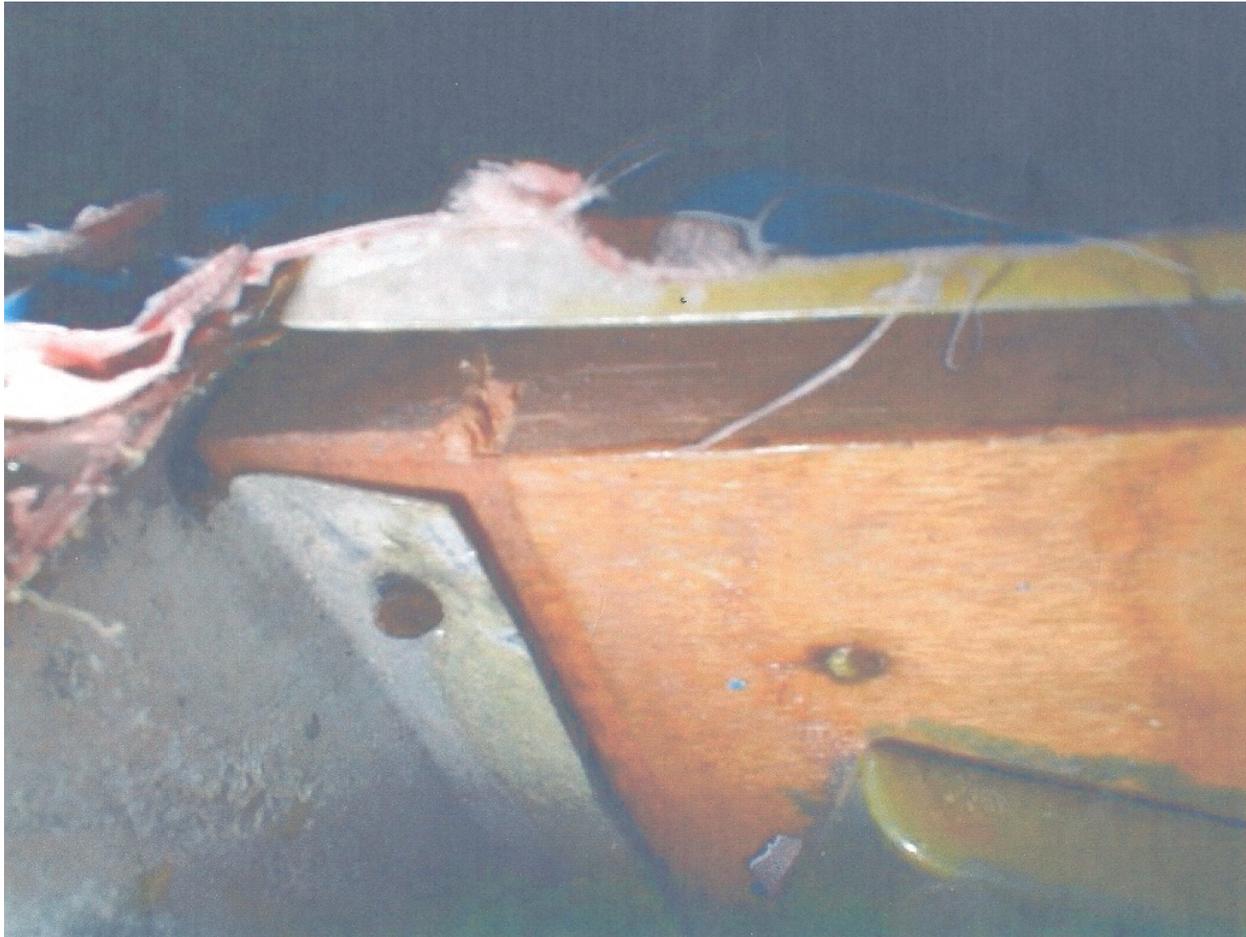
### Champion: 7ECA; Cracked Wing Spar; ATA 5711

A repair station technician writes, “A required inspection of wooden wing spars in accordance with AD 2000-25-02 revealed a compression crack in the left wing forward spar at the top, O/B of the wing-strut attach doubler plate.” (*The part number listed is 5-271L.*)

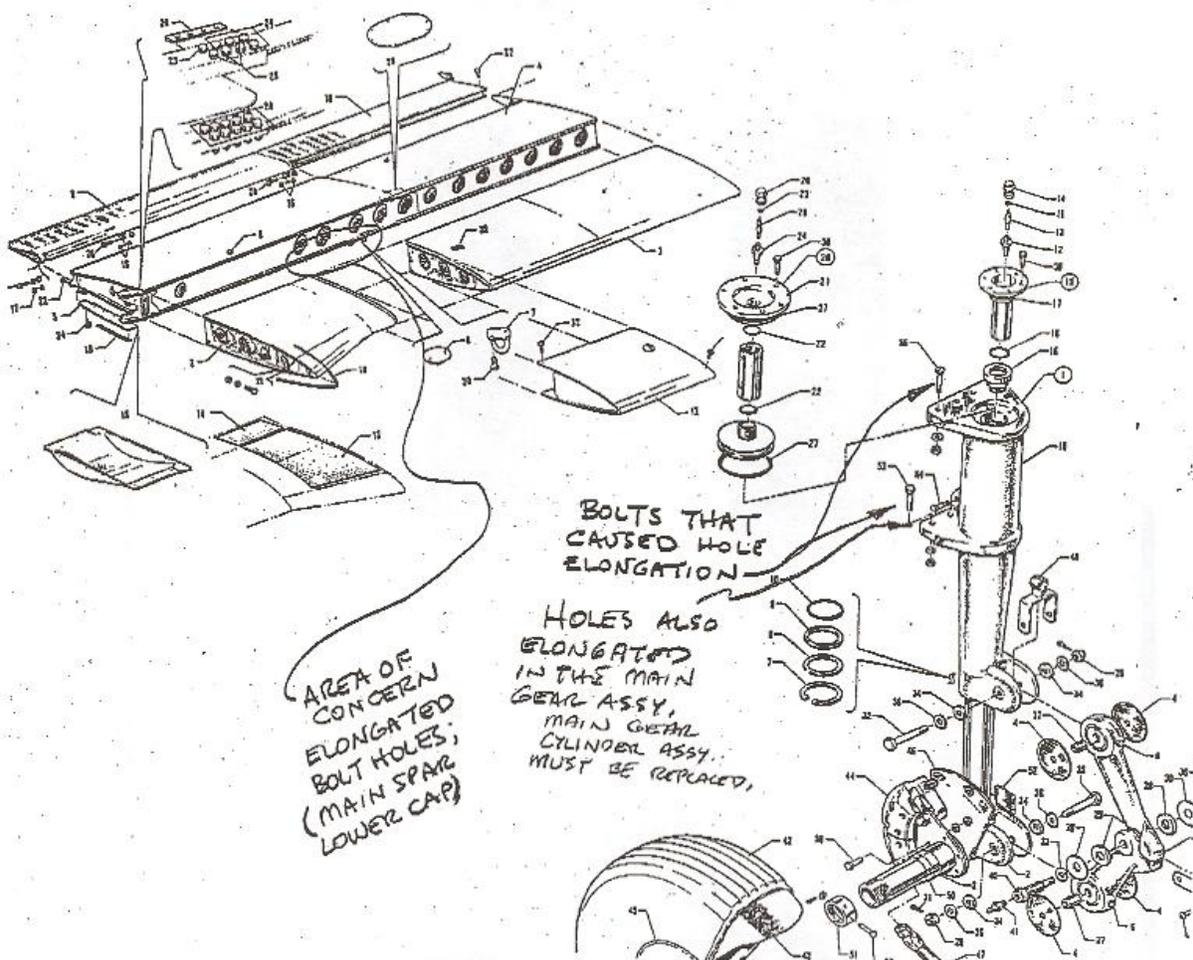
### Piper: PA28-140; Worn Landing Gear Mount Holes; ATA 3211

A Designated Airworthiness Representative (DAR) for a repair station describes the following defect. “During an annual inspection of the L/H main landing gear cylinder assembly (P/N 65319-04), it was found to be loose in the main wing spar. The L/H main landing gear was removed for further inspection of the main wing spar assembly’s gear attaching bolt holes and attach points. Close inspection of the wing spar showed the lower four bolt holes had been elongated. The holes in the landing gear cylinder were also found to be elongated. (Apparently, all the bolts were ‘shanked-out,’ leaving the assembly loose for some time.) The aircraft wing spar was repaired. The L/H main landing gear cylinder was replaced with a later model cylinder assembly from Piper since the original part was no longer available. (I) recommend close inspection of landing gear attach points during all inspections.”
