ADVISORY CIRCULAR

43-16A

AVIATION MAINTENANCE ALERTS

**ALERT
NUMBER
378**

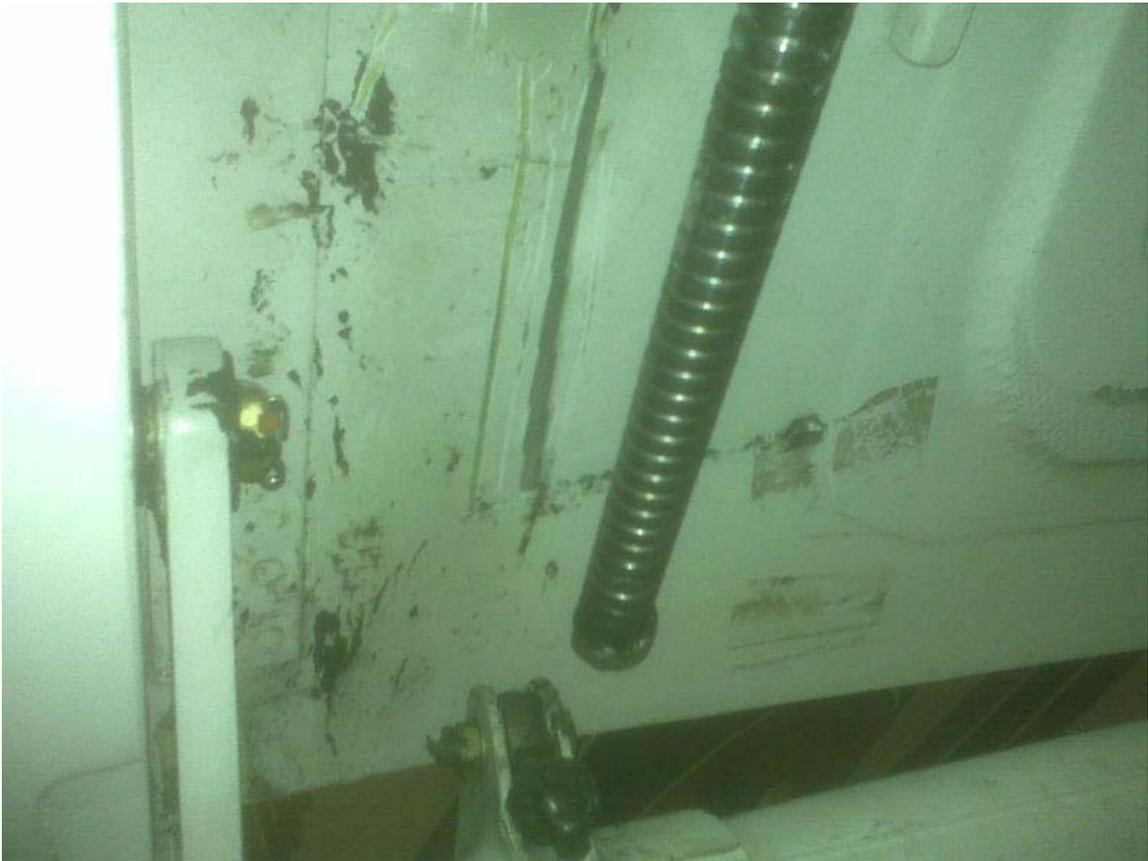
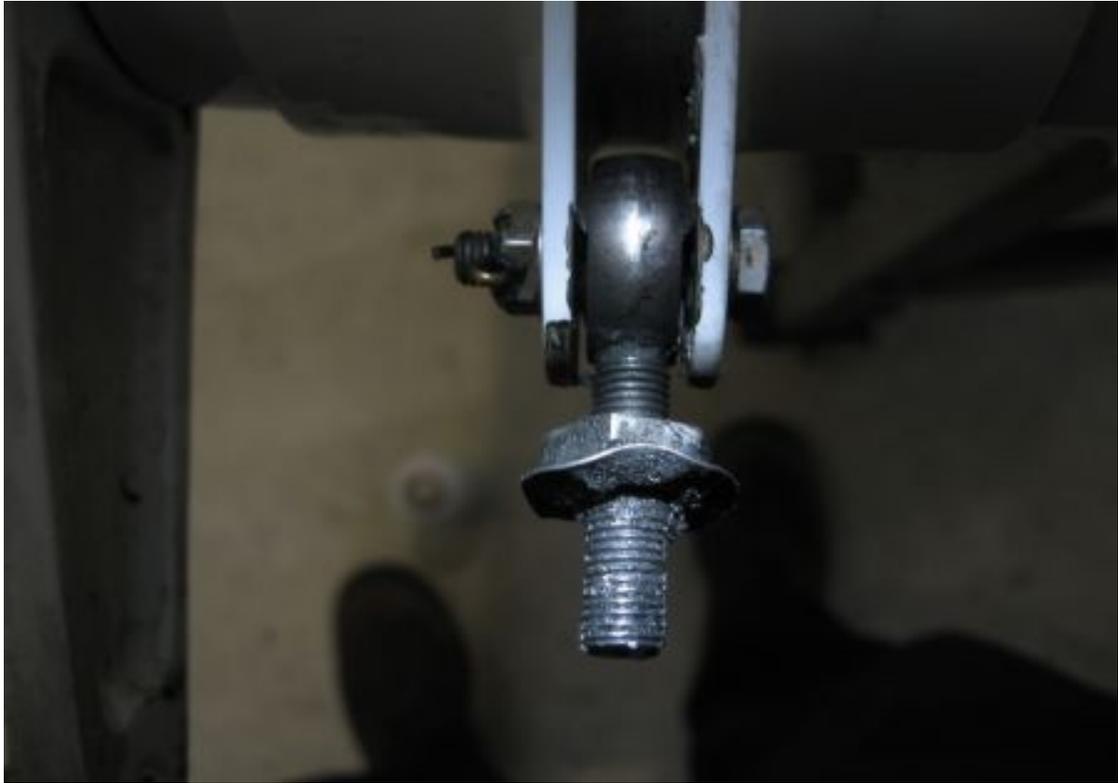
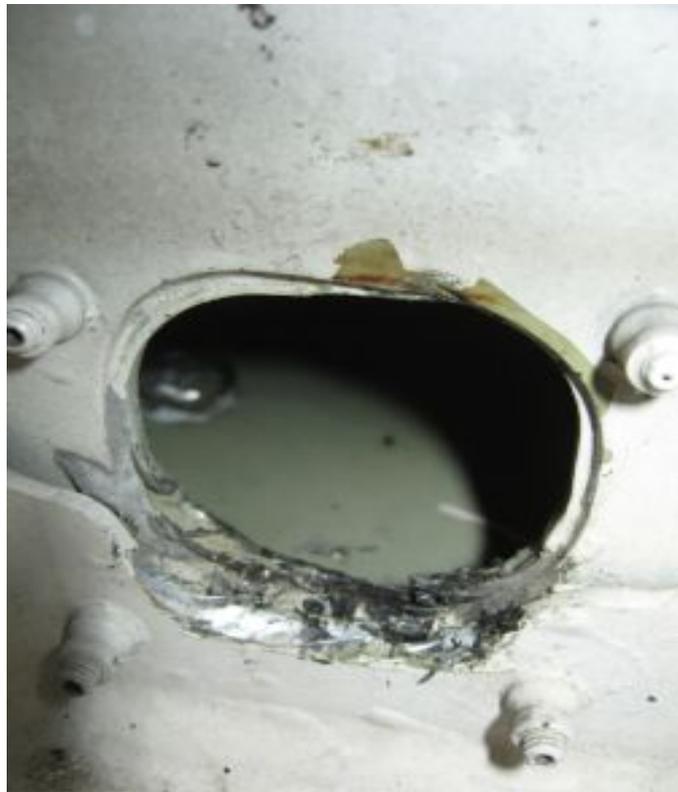
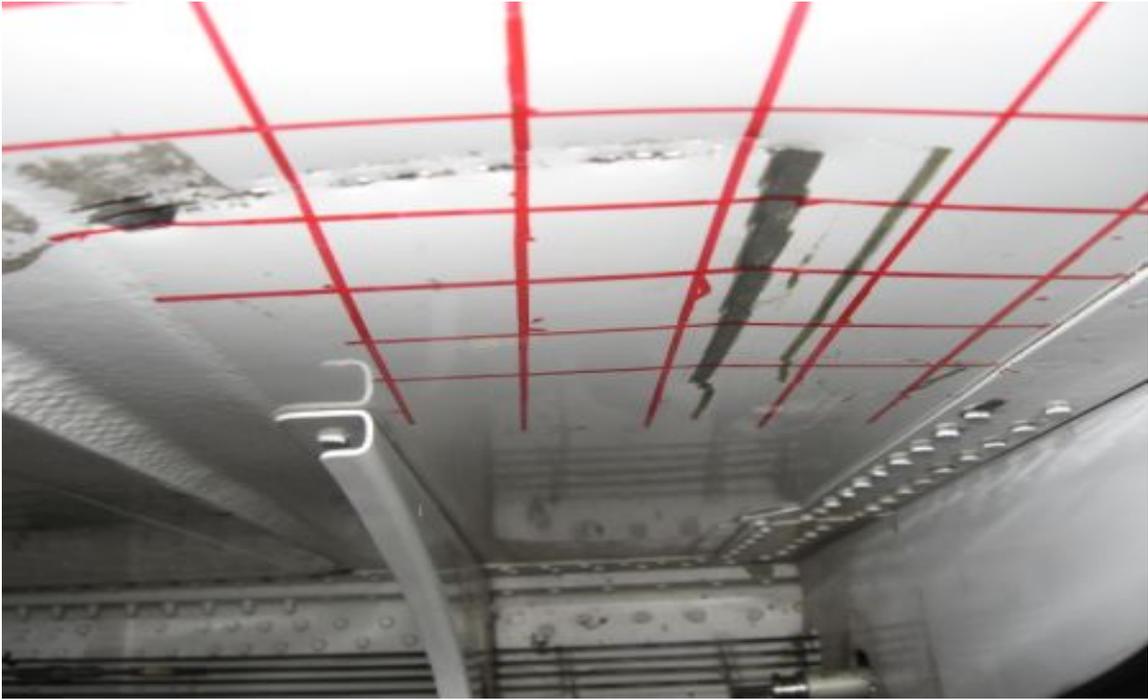
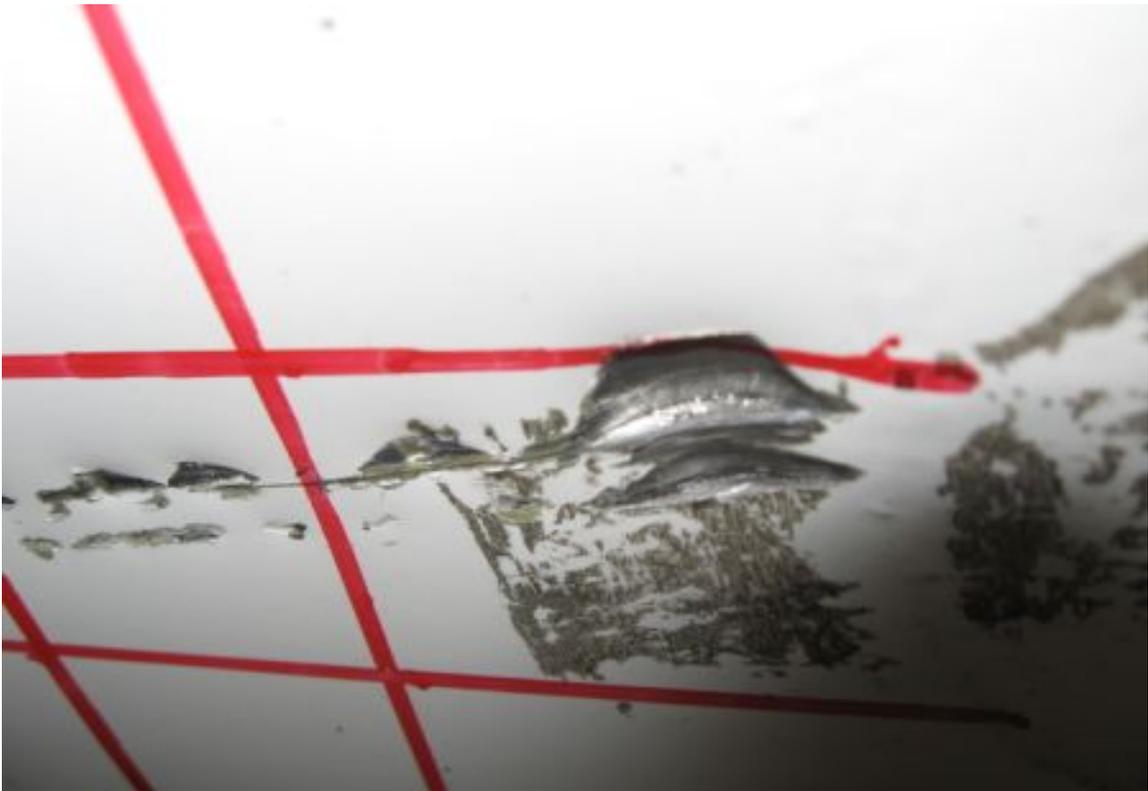
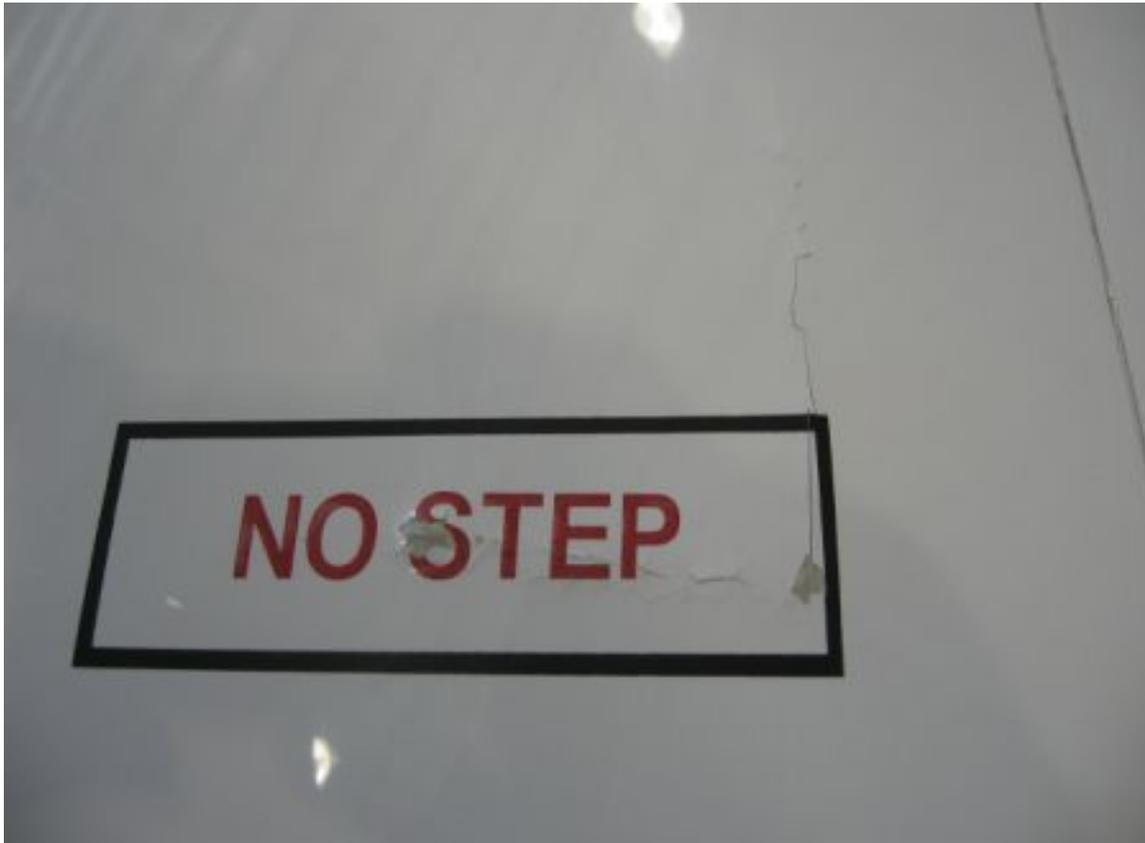
Cessna: CE750; Disconnected Flap Linkage; ATA 2750

An unidentified submitter writes, "On visual approach the copilot complained the aircraft was 'out of rig'—it wanted to roll right with flaps at 35 degrees. On post flight we discovered the right flap was extended full, and *(its drive)* linkage was not connected."

(Great.... I've got a detective's proverbial 'dead body'...but no plot. Does the male rod-end have mangled threads on the OTHER side? Is this mechanical or mechanic failure? Ouch! How are we going to repair that wing skin? YOU sent the scary pictures...so what do you think happened? Guess I have to buy the book—Ed.)

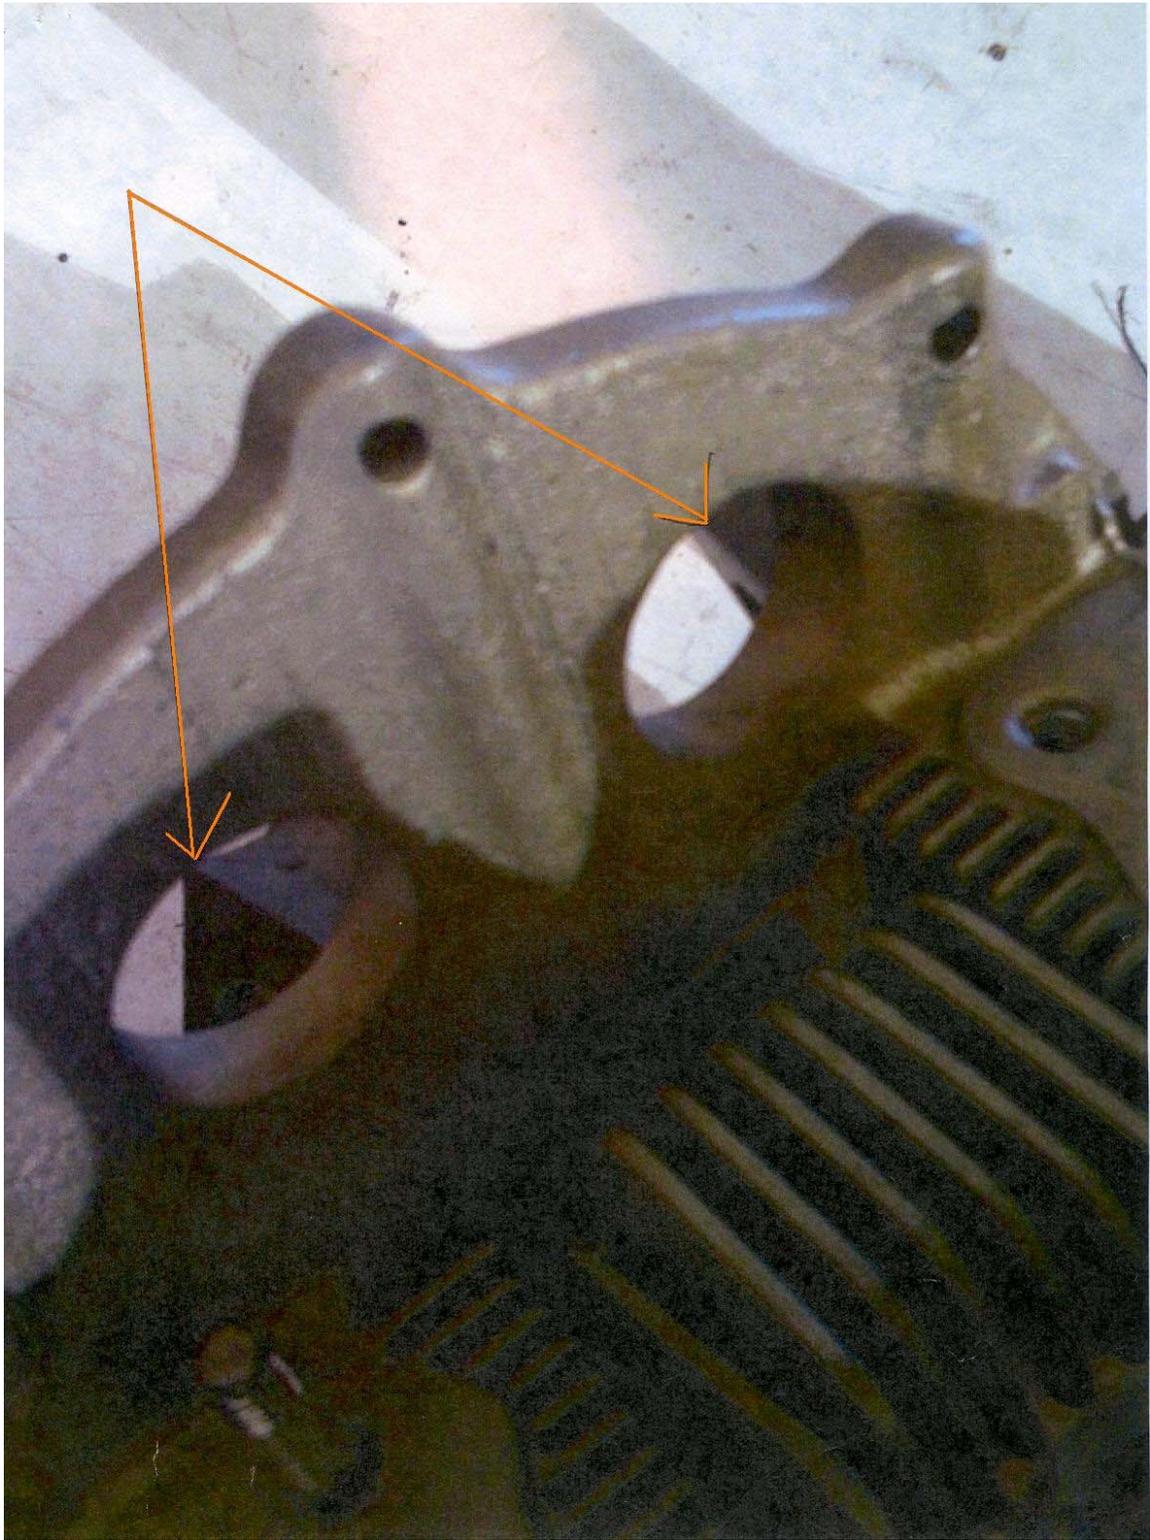
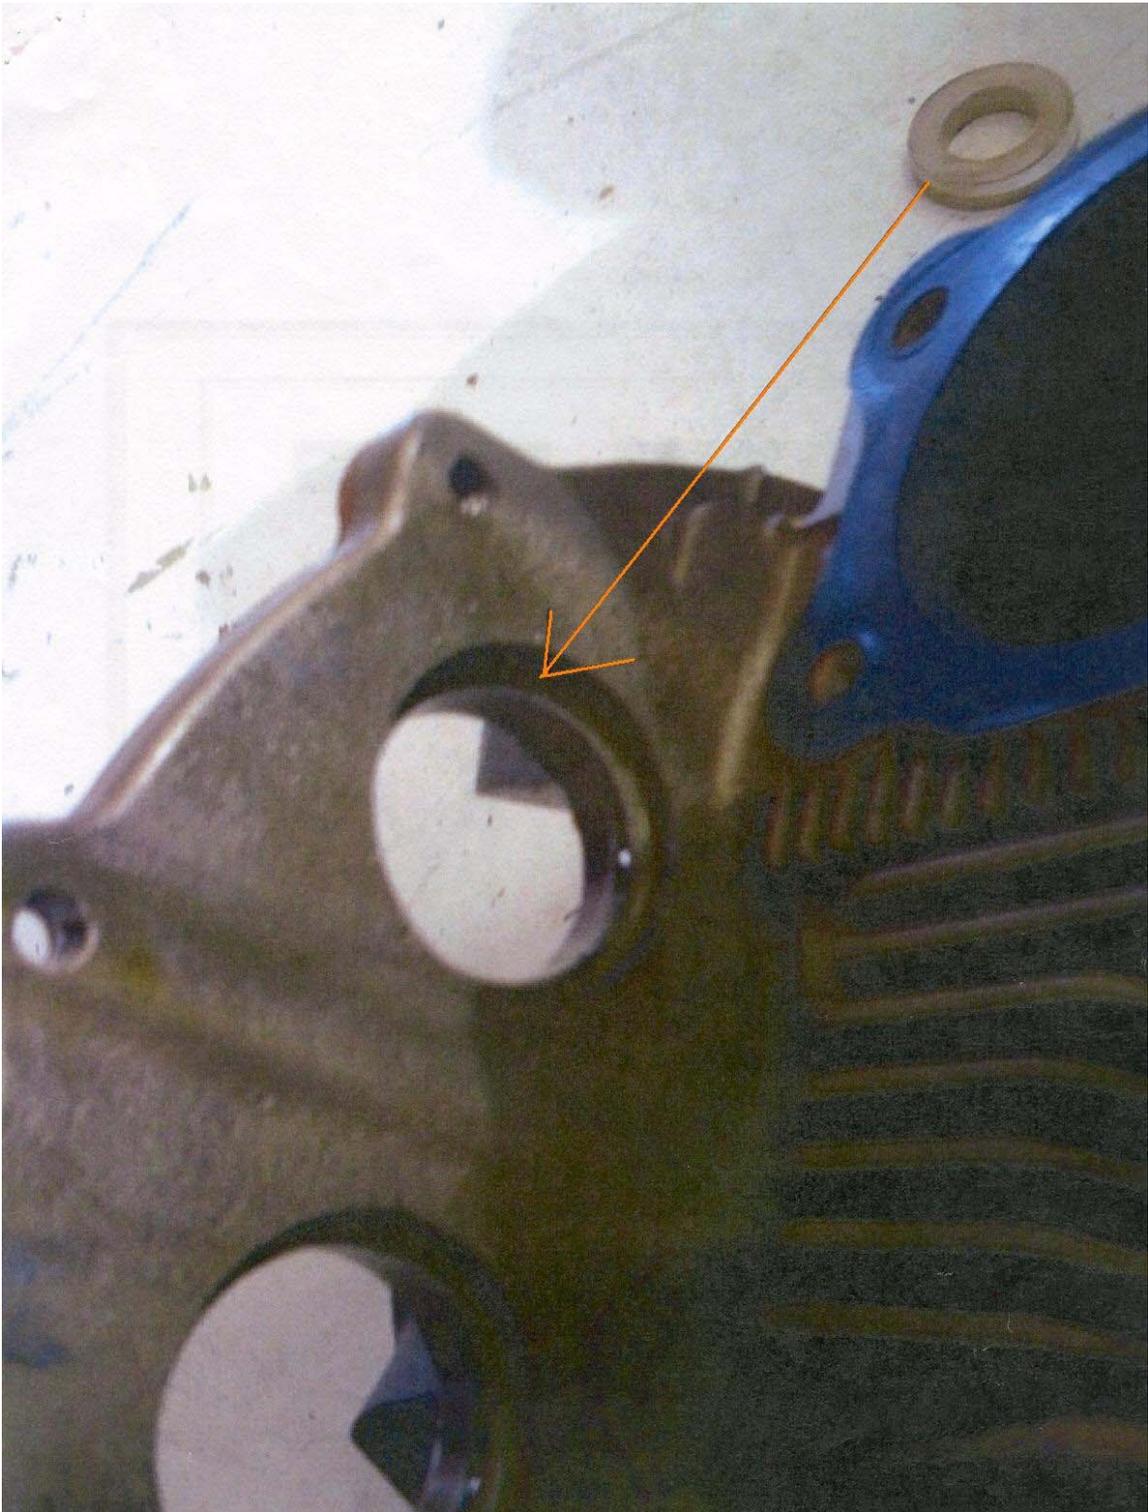
TCM Cylinder: 655484A5; Missing Seal Counterbores: ATA 8530

A repair station mechanic says, "While performing incoming inspection of a new TCM cylinder (P/N 655484A5) the cylinder pushrod housing boss was found not to have been machined for the pushrod housing seal during the manufacture of the cylinder." *(The first picture points to the area of the cylinder missing the counterbore. The second shows the counterbore areas and a typical seal on a correctly machined cylinder.)*

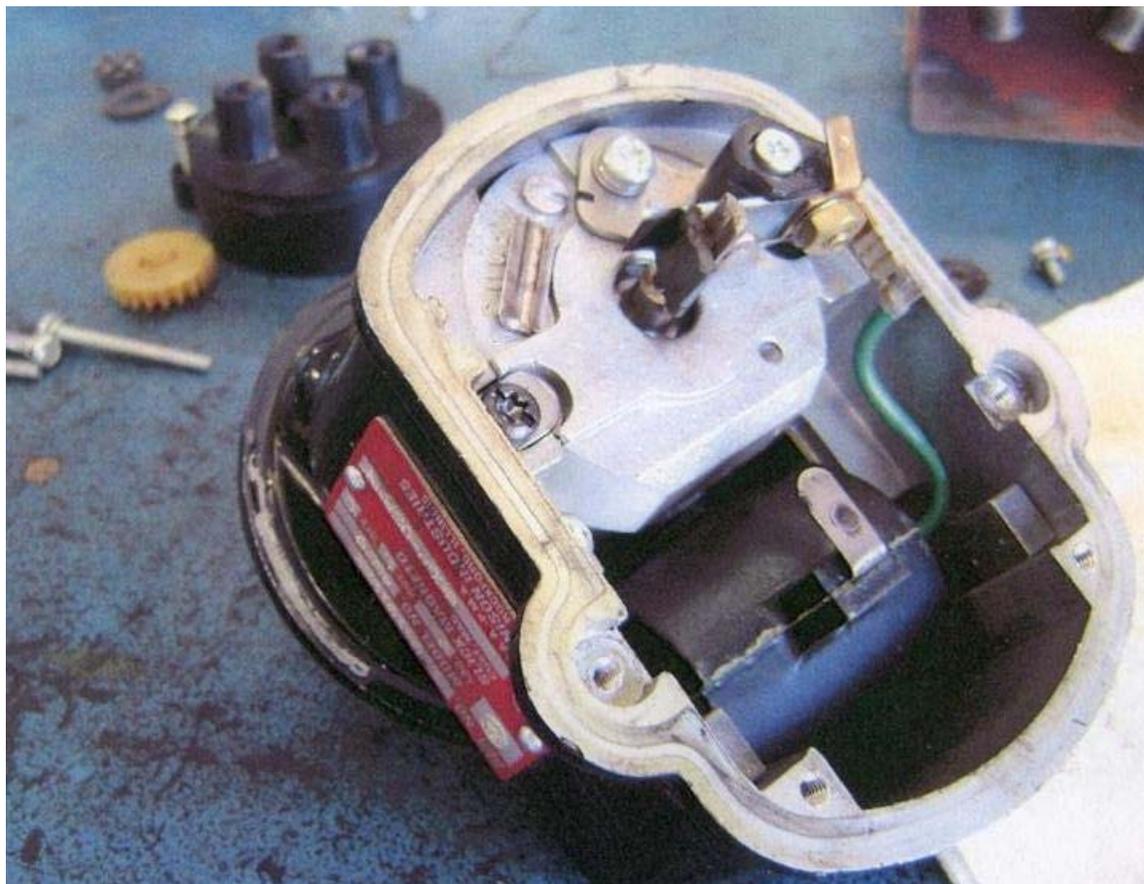
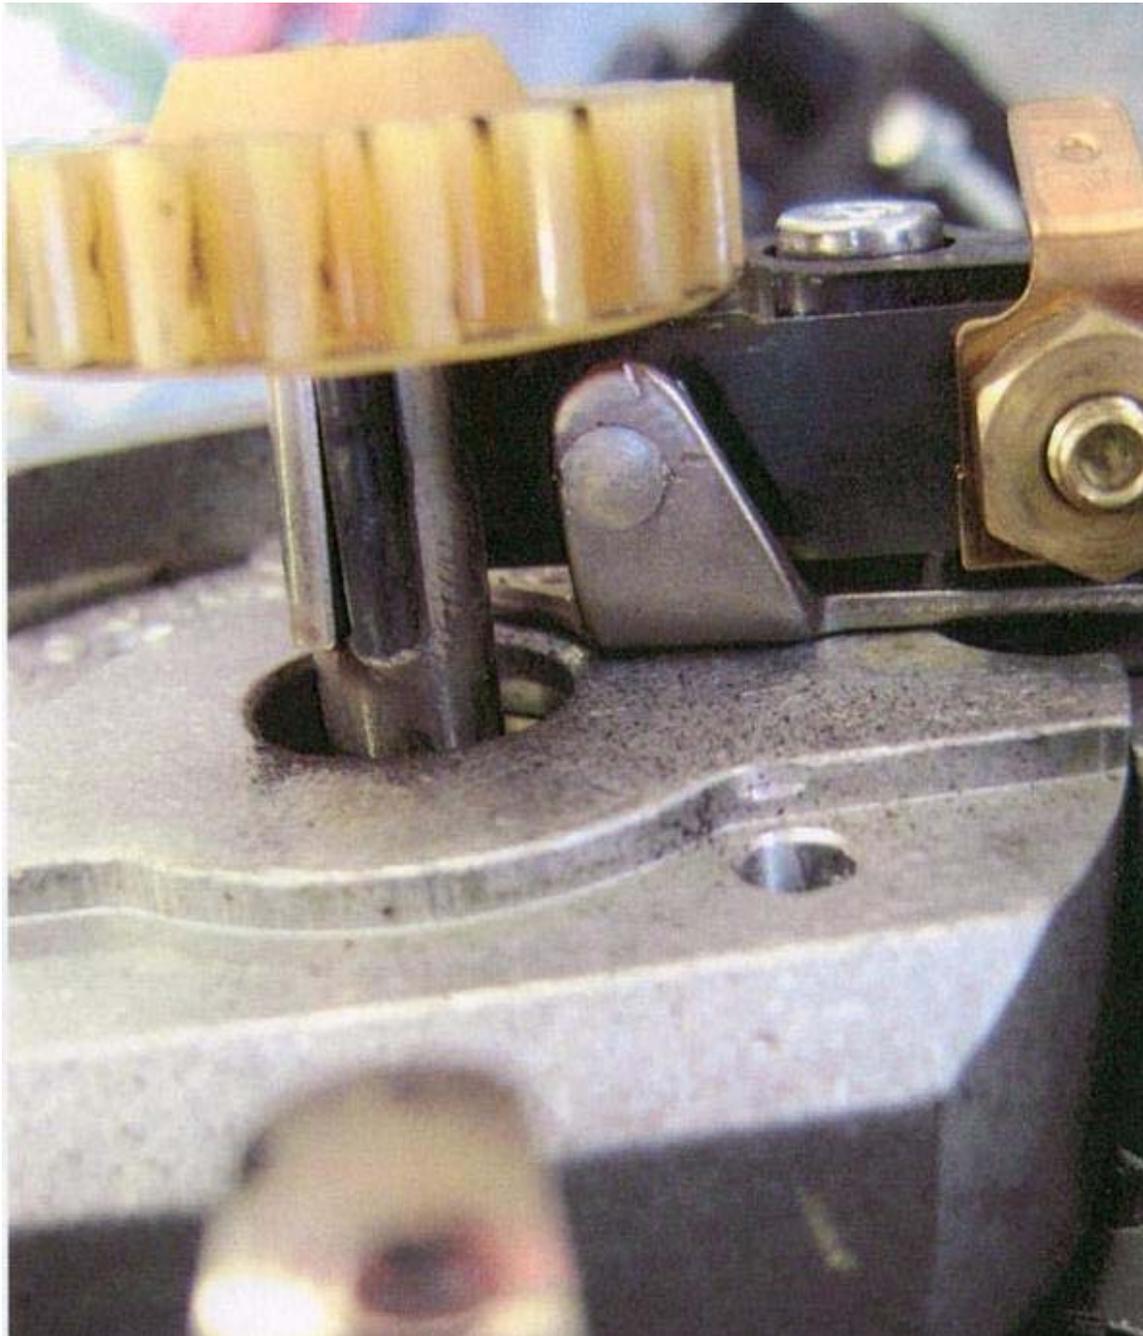
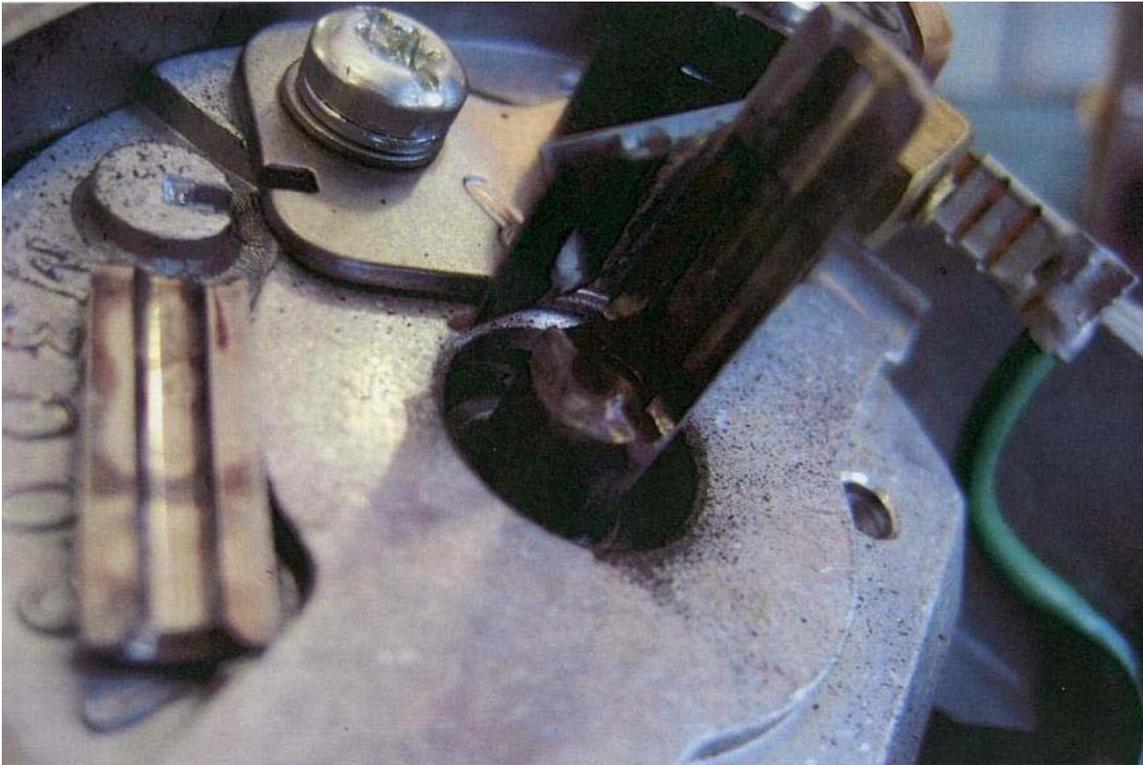
Slick Magneto: 4370; Failed Gear Shaft; ATA 7414

An unidentified submitter states, "*(This unit indicated...)* an excessive (*engine RPM*) drop. (*I*) removed the magneto for an internal inspection and found the shaft had failed at the base of the slot that retains the point cam. (*When I*) removed the shaft gear from the cam, one side of the shaft stayed attached to the gear."
