U.S. Department
of Transportation
**Federal Aviation
Administration**

ADVISORY CIRCULAR

AVIATION MAINTENANCE ALERTS

**ALERT
NUMBER
348**

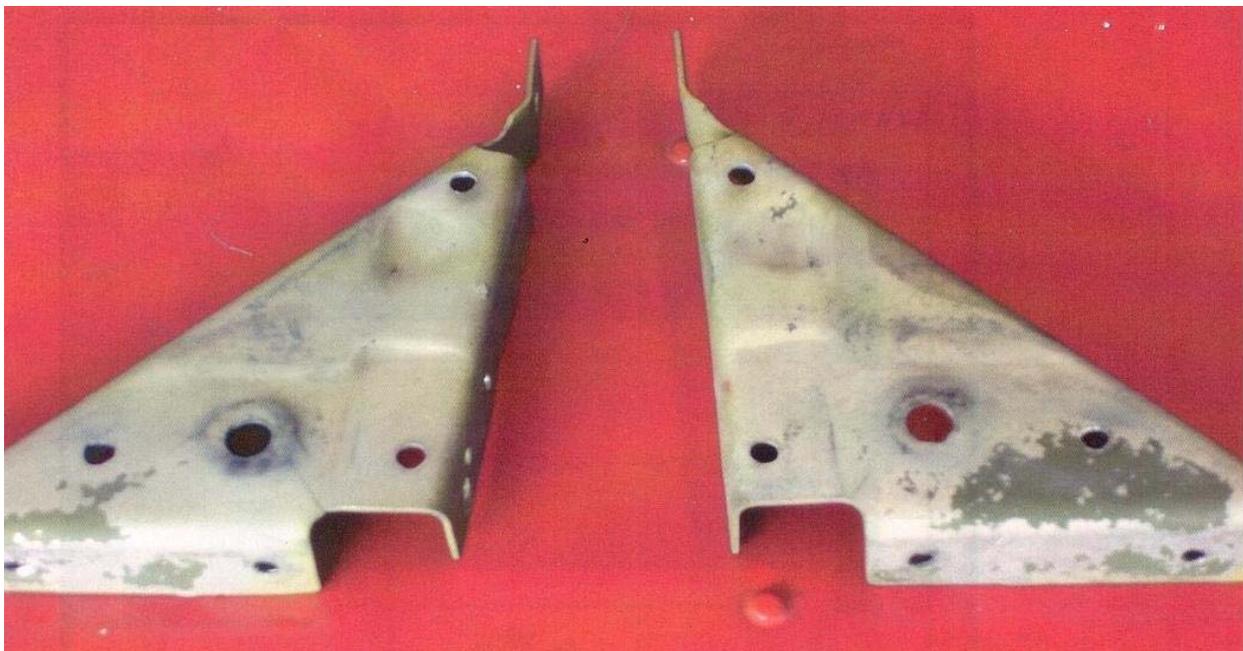
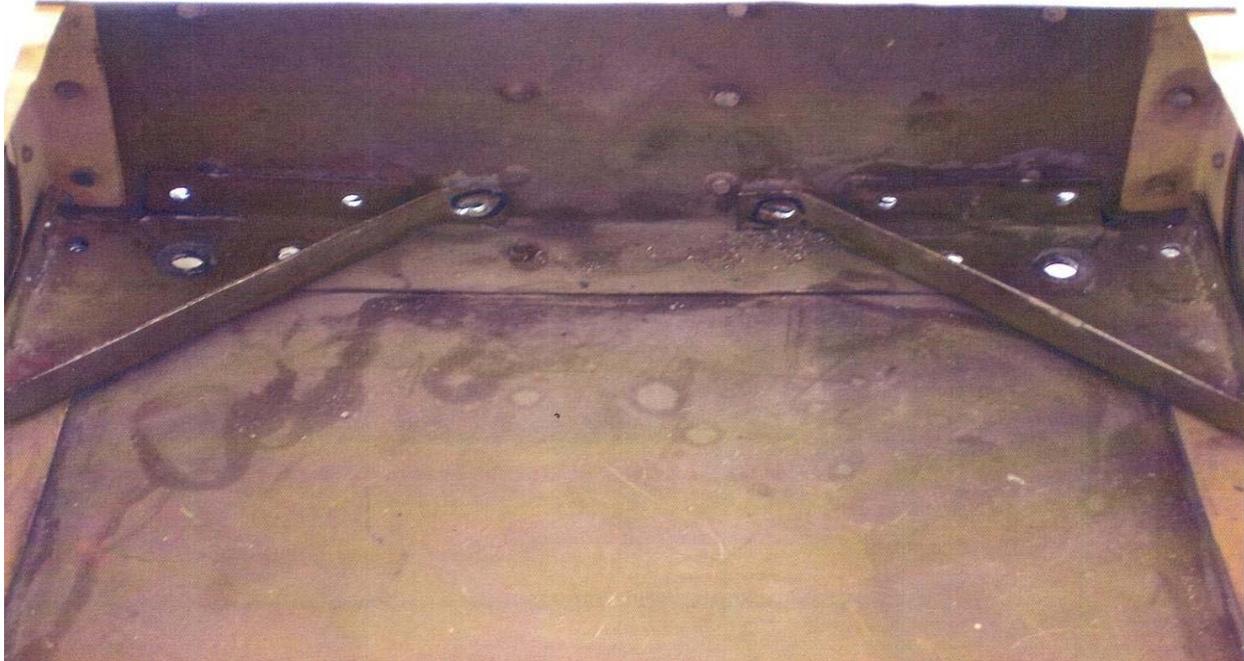
Cessna: A185F; Cracked Horizontal Stabilizer Brackets; ATA 5340

A technician writes, "The aft attach points of this 185 Horizontal Stabilizer are structurally reinforced with an internal reinforcement triangle bracket (P/N's 0732106 and 0732106-1). Cracks in these reinforcements were found around the washers of the attach hardware, and in the radius of the angle. Identification of this problem can be accomplished by *(noting)* excessive fore and aft movement of the horizontal stabilizer while observing the rear attach fitting. If the fitting shows signs of a gap between the skin and the fitting while testing the movement fore and aft, this is probably a cause for further investigation of the internal reinforcement triangle brackets.

"This area is most easily inspected by removing the elevators and using adequate lighting and a small mirror through the lightening holes in the horizontal stabilizer. Probable cause *(might be)* fatigue and over torquing of the attach hardware. *(For prevention I recommend)* inspection of these reinforcements and/or their replacement."

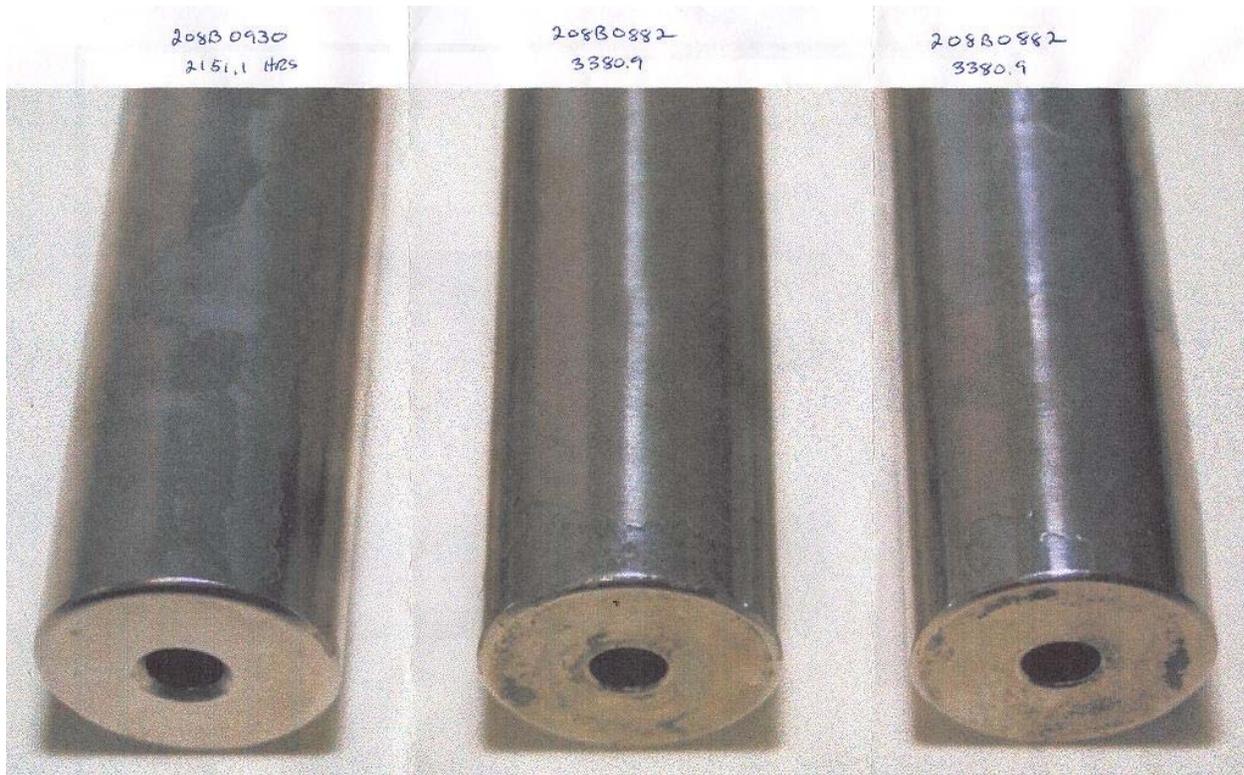
Cessna: 208B; Plating Delamination of Landing Gear Pins; ATA 3211

A technician states, “These pins are life-limited to 31,500 landings, but we remove them at intervals for corrosion inspection of the landing gear interface. We have never found the pins themselves corroded, but the pins on newer aircraft or newer spare pins are plated (earlier ones were not) and (*this plating*) is prone to peeling off. I suspect the chrome is damaged during normal assembly and is discovered on the next disassembly.” (*P/N listed as 2641008-2. The top numbers in the photograph are serial numbers.*)

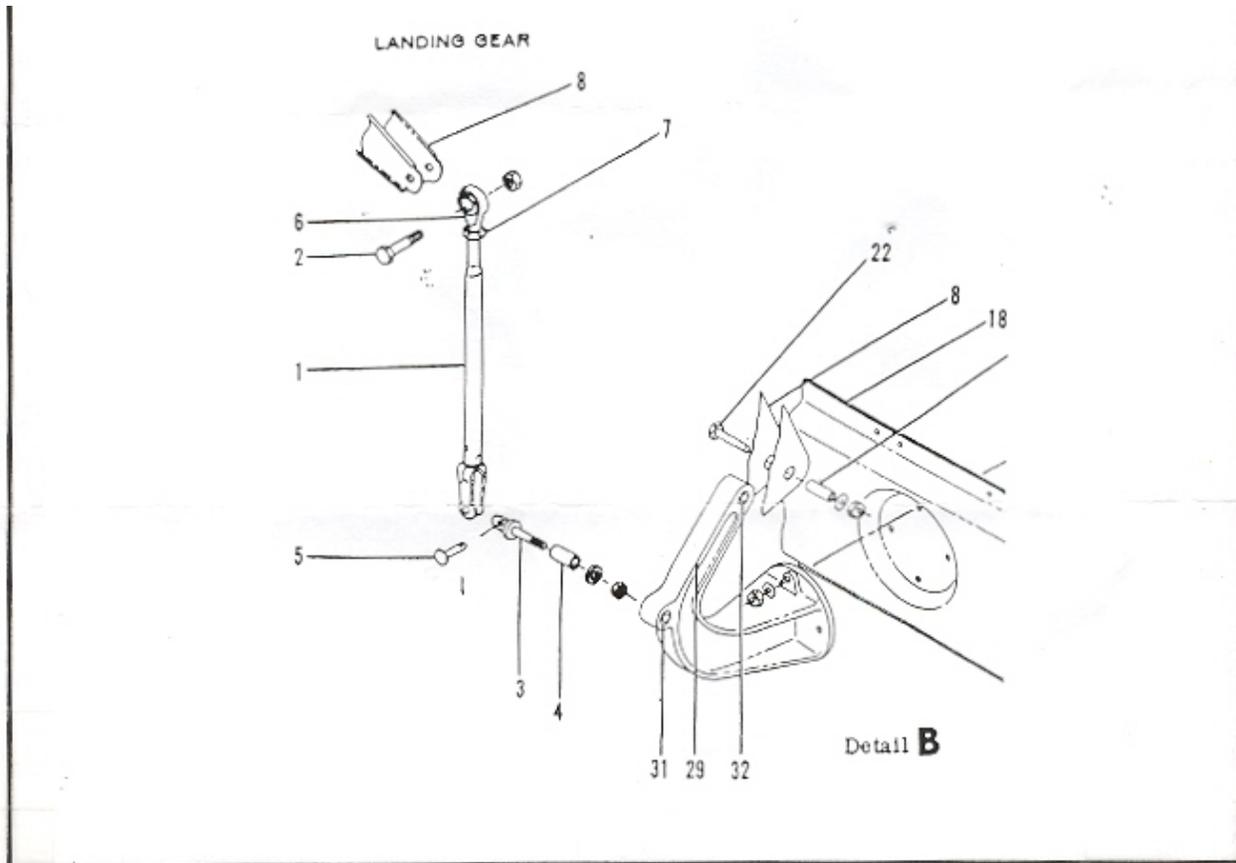
Cessna: 310Q; Failed Nose Gear Door Clevis Pin; ATA 5280

A mechanic for an air operator describes difficulty with his aircraft's nose landing gear door. "Either the cotter pin came out of the clevis pin (item #5) or the clevis pin failed—(these items necessary to attach...) the nose gear door push-pull tube to the eye bolt on the L/H nose gear door. On take-off the L/H door blew shut. When the gear was retracted the nose gear jammed half-way up, breaking the bell crank under the pilot's feet. The nose gear would not come down. Numerous high-G maneuvers were performed in an attempt to get the gear to drop (but it remained stuck). The aircraft landed on its mains, the (props) were feathered, and the aircraft came to a stop—sliding on its nose for approximately 200 feet. The nose was lifted and (its) gear extended and locked. (The aircraft) was then towed to the hanger." (Clevis pin P/N: MS20392-2011.)

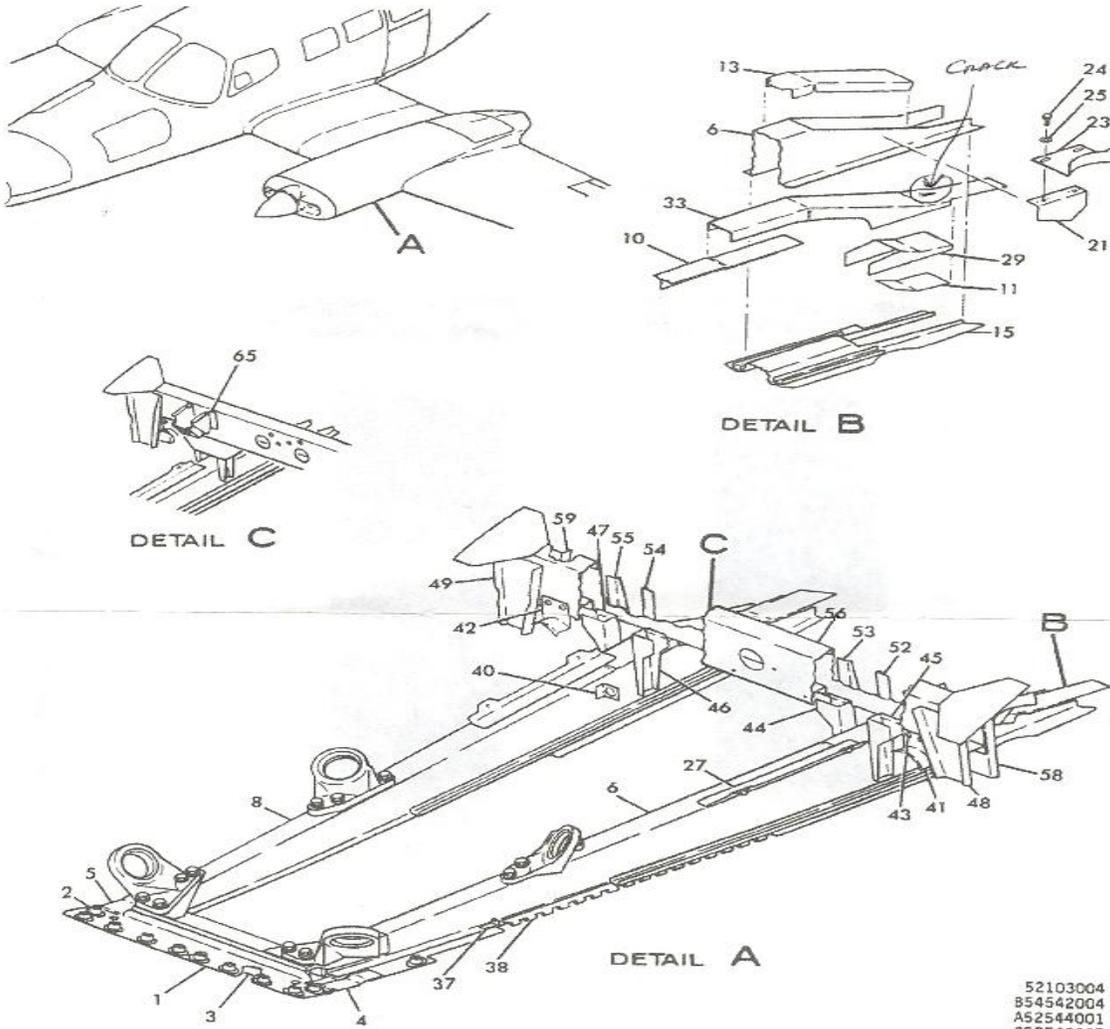
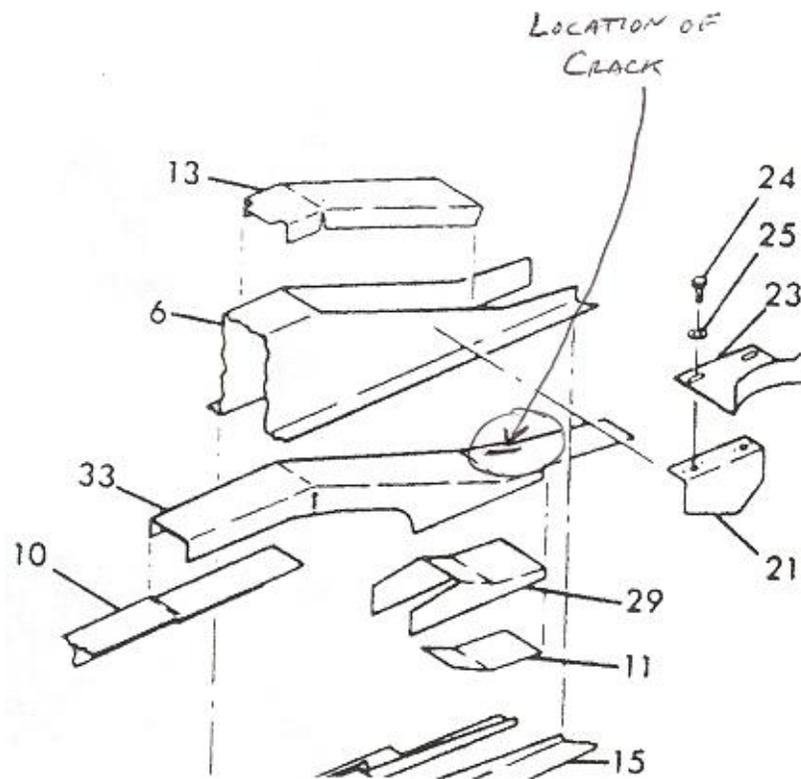
STRUCTURE-NACELLE
FIGURE 01 (SHEET 1)

A mechanic says, "During compliance with AD 2005-12-13 (installation of Cessna Spar mod, kit SK402-47B) it was discovered the left nacelle outboard engine support beam channel (P/N 5654111-1) had a 1.75 inch crack running longitudinally on *its* inboard radius. (See the two drawings for the crack location.) The area of this crack is in a location where that portion of the channel is to be removed and the new channel installed per SK402-47B."
