**Federal Aviation  
Administration**

## ADVISORY CIRCULAR

# AVIATION MAINTENANCE ALERTS

**ALERT  
NUMBER  
372**

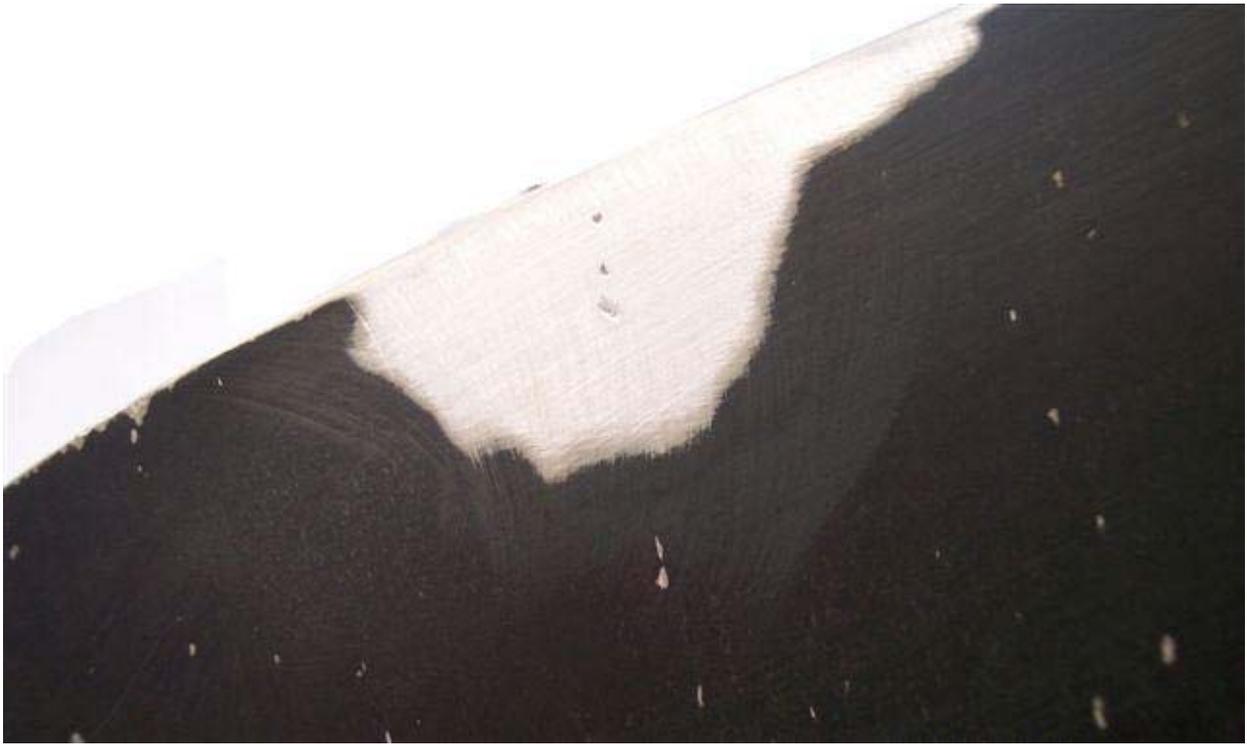
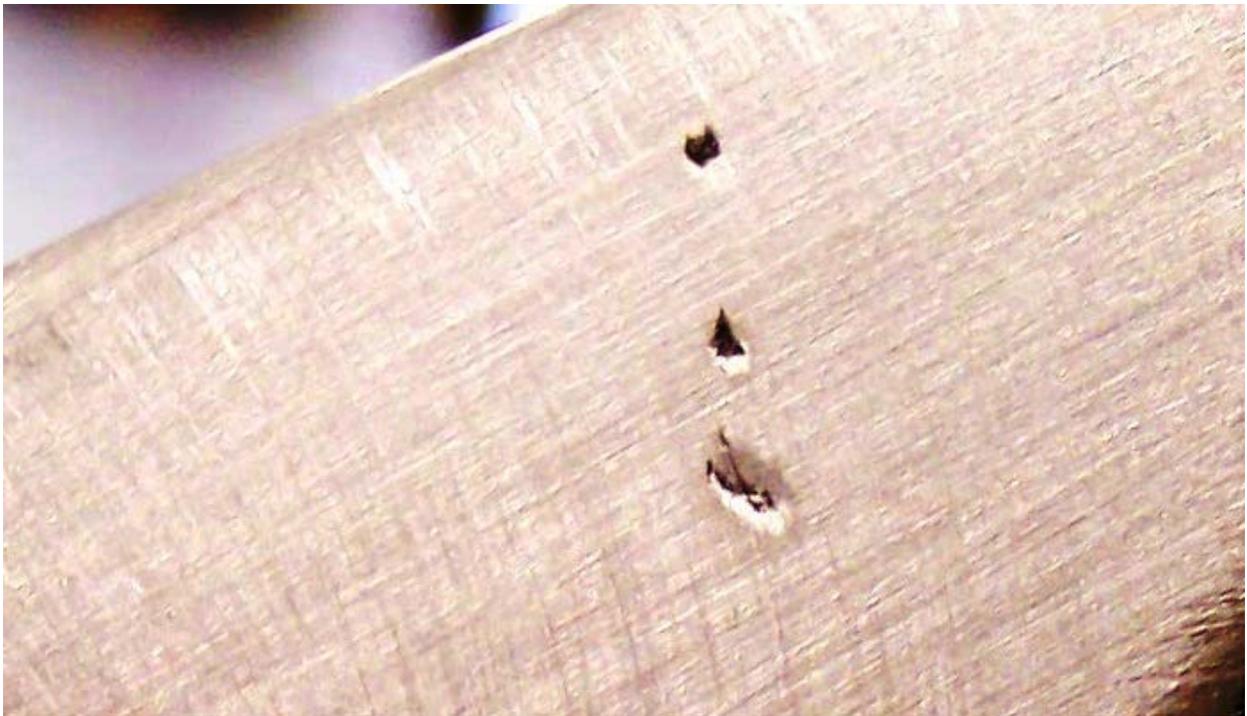
**Piper: PA44-180; Cracked Propeller; ATA 6111**

"During a routine inspection," writes a mechanic, "a nick (from rock or runway debris) was found in the face of one blade on the left propeller, 3.25 inches inboard from the tip. After minor dressing it was discovered to have three pits in the bottom of the nick. The third pit back from the leading edge was (*also*) found to have a crack. This crack was discovered from a digital picture that was enlarged. Even with a small magnifying glass and a strong light the crack did not show up very well."

*(Rather dramatic, isn't it? The propeller is a Hartzell HC-C2YR-2CEUF. Its time since overhaul: 304.5 hours. Thanks goes to the mechanic "he—who shall not be named" and Embry-Riddle inspector Pat Kelly for their submission—Ed.)*

Part Total Time: 4,696.5 hours.

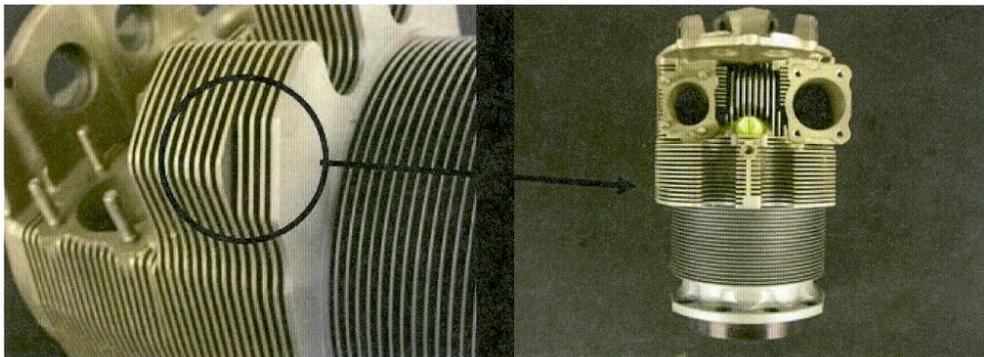
**FIGURE 1**  
Cylinder Head Casting Four (4) Fin relief Location

The EQ3 head casting cylinder assemblies are identified by a four (4) fin relief at the bottom lower left hand portion of the cylinder head (as installed on the engine) and a depression cast EQ3 in the cylinder head rocker boss (overhead) area as shown in Figures 1 and 2. These cylinders are to be replaced in accordance with the guidelines set forth in this bulletin and based upon applicable engine model and aircraft manufacturer procedures. All EQ3 cylinders must be replaced no later than December 31, 2009.

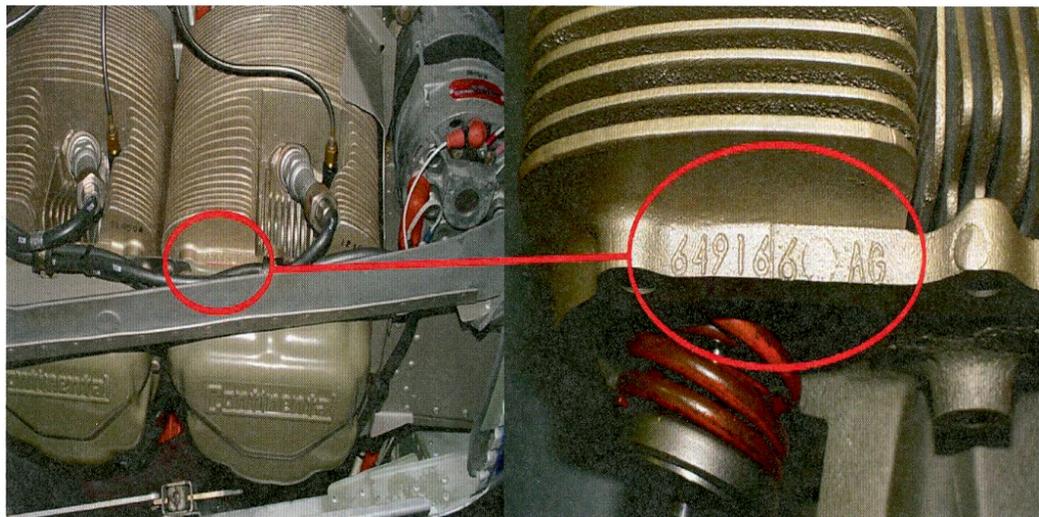
**FIGURE 5**  
**Rocker Arm Boss (overhead view of cylinder in mounted condition)**

2. Access the area of the cylinder head casting as shown in Figure 5. This area is visible as you look down at the cylinders in their mounted condition from above the engine compartment.

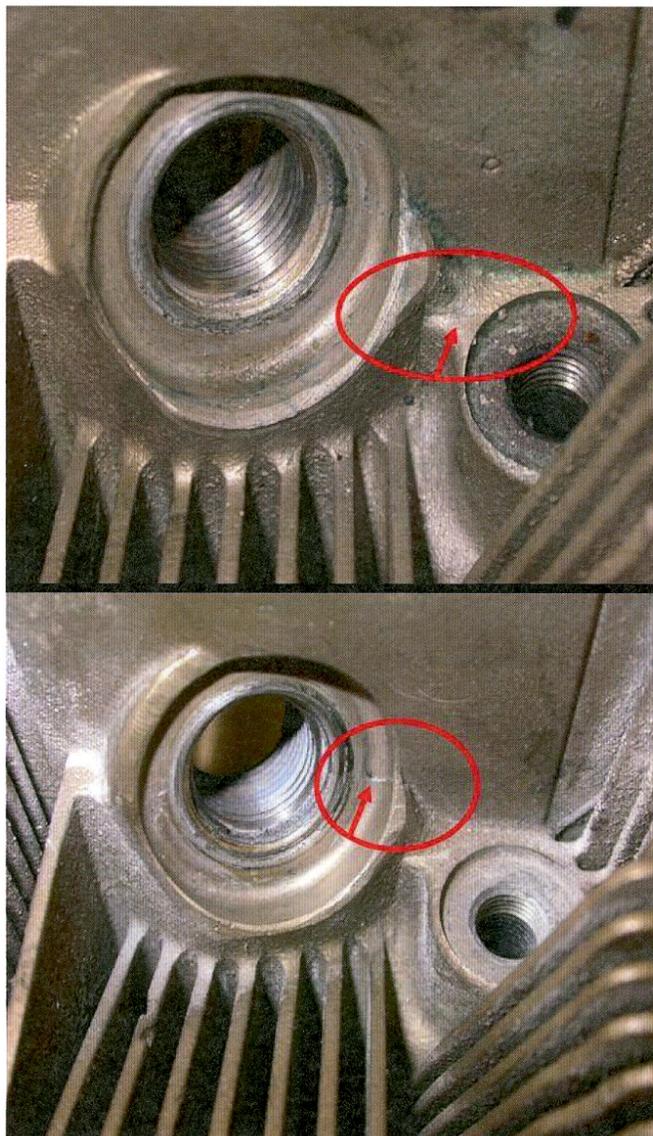
**FIGURE 6**  
**Typical Visual Crack Indications**

**NOTE: Visual evidence of a crack in the inspection area between upper spark plug bore and fuel injection nozzle/primer port as indicated in Figure 6 does not require further verification with a dye penetrant inspection.**

IF A CRACK IS PRESENT THE CYLINDER MUST BE REPLACED IMMEDIATELY. TO SUPPORT REPLACEMENT AT AN AUTHORIZED CENTER, A REPOSITIONING FLIGHT OF NOT TO EXCEED FIVE (5) HOURS IS AUTHORIZED IF NO FUEL OR COMBUSTION STAINING IS FOUND AT THE SUBJECT LOCATION. IF SUCH INDICATIONS ARE FOUND, CONTACT TCM BEFORE FURTHER FLIGHT.

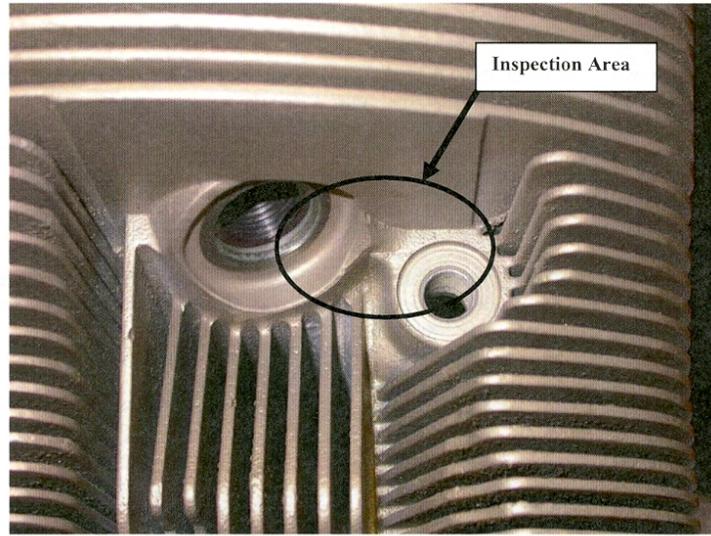
**FIGURE 7**  
**Inspection Area Between Upper Spark Plug Bore and Fuel Injection**  
**Nozzle/Primer Port**

9. Remove and clean the area in which the “Penetrant/Dye” was applied in accordance with the manufacturer’s instructions.
10. Spray the “Developer” onto the clean/dry area indicated in Figure 7. Allow the “Developer” enough time to dwell in accordance with the manufacturer’s instructions for the determination of the existence of a crack.

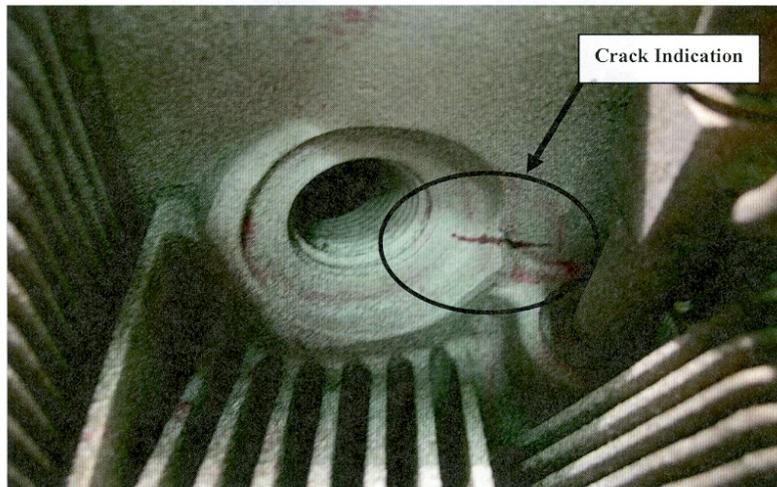
**FIGURE 8** Cylinder Head Crack Indication with Dye Penetrant

- a. If a crack is present, its appearance and location will be similar to that shown in Figure 8.
  - b. Refer to Step 12, below, for required actions in either a “No Crack Present” or a “Crack Present” case.

- b. Preceding Inspection Reveals Cracks
    - i. If a crack is verified and fuel or combustion staining was noted in the inspection area, contact TCM before further flight.

- ii. Contact TCM via one of the means listed below and on the Customer Information Form to schedule replacement of the affected cylinder(s).
    - iii. If a crack is verified but no evidence is found of fuel or combustion staining, then the engine may be operated for up to five (5) hours for the purpose of relocating the aircraft to a cylinder replacement location.
