ADVISORY CIRCULAR

43-16A

AVIATION MAINTENANCE ALERTS

**ALERT
NUMBER
384**

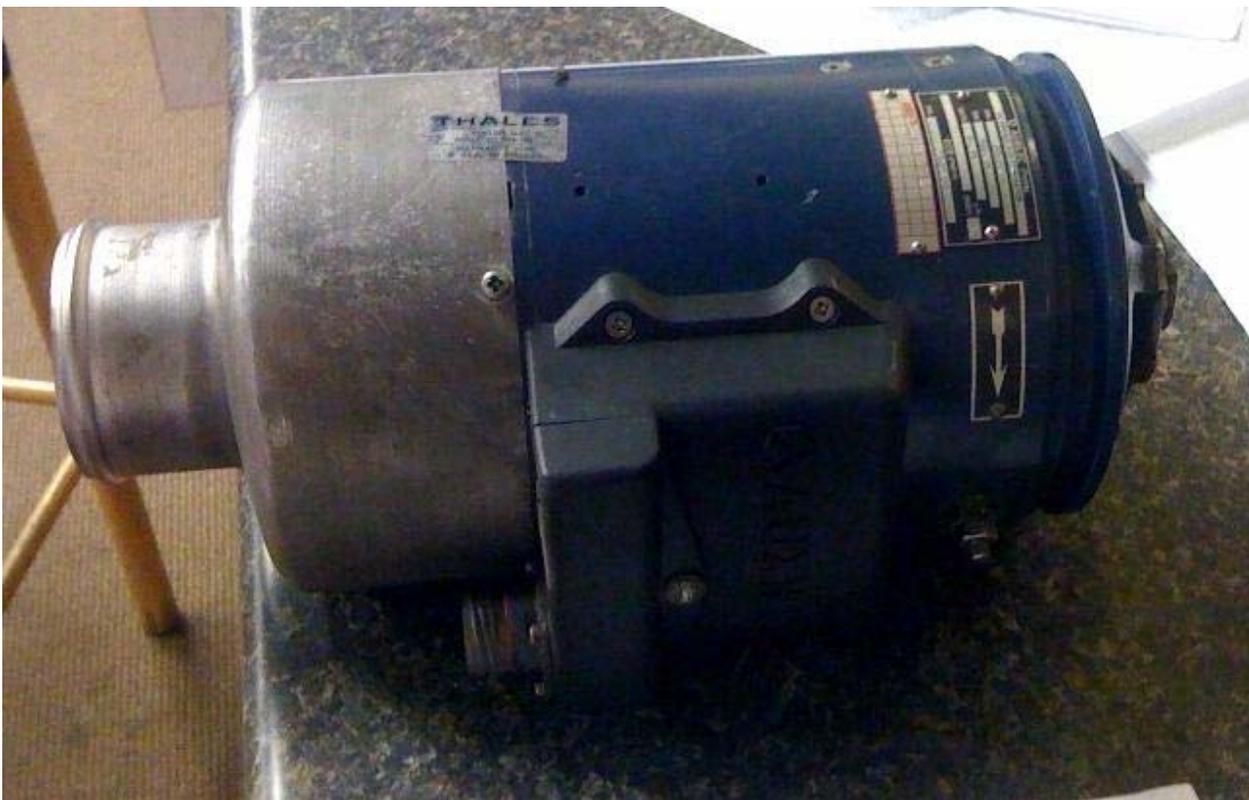
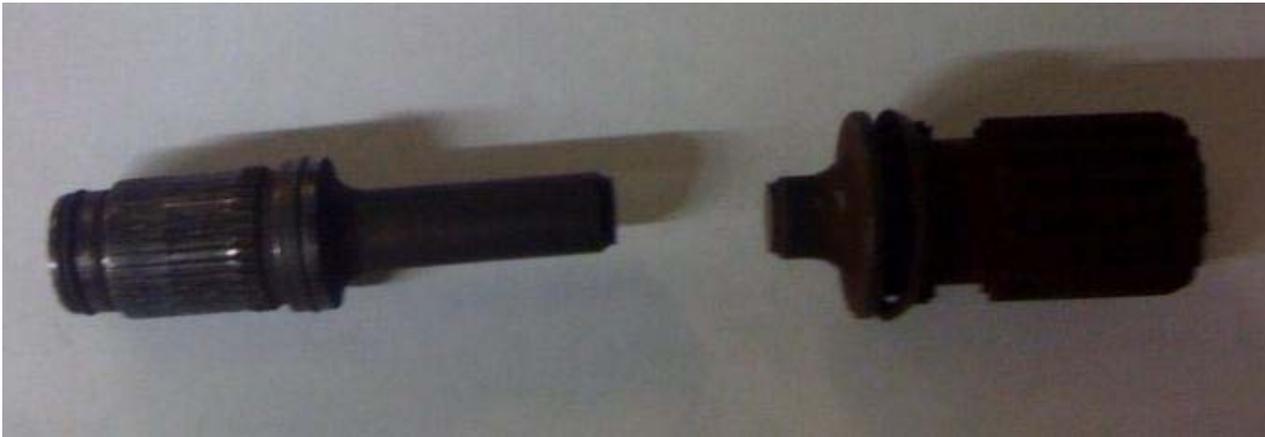
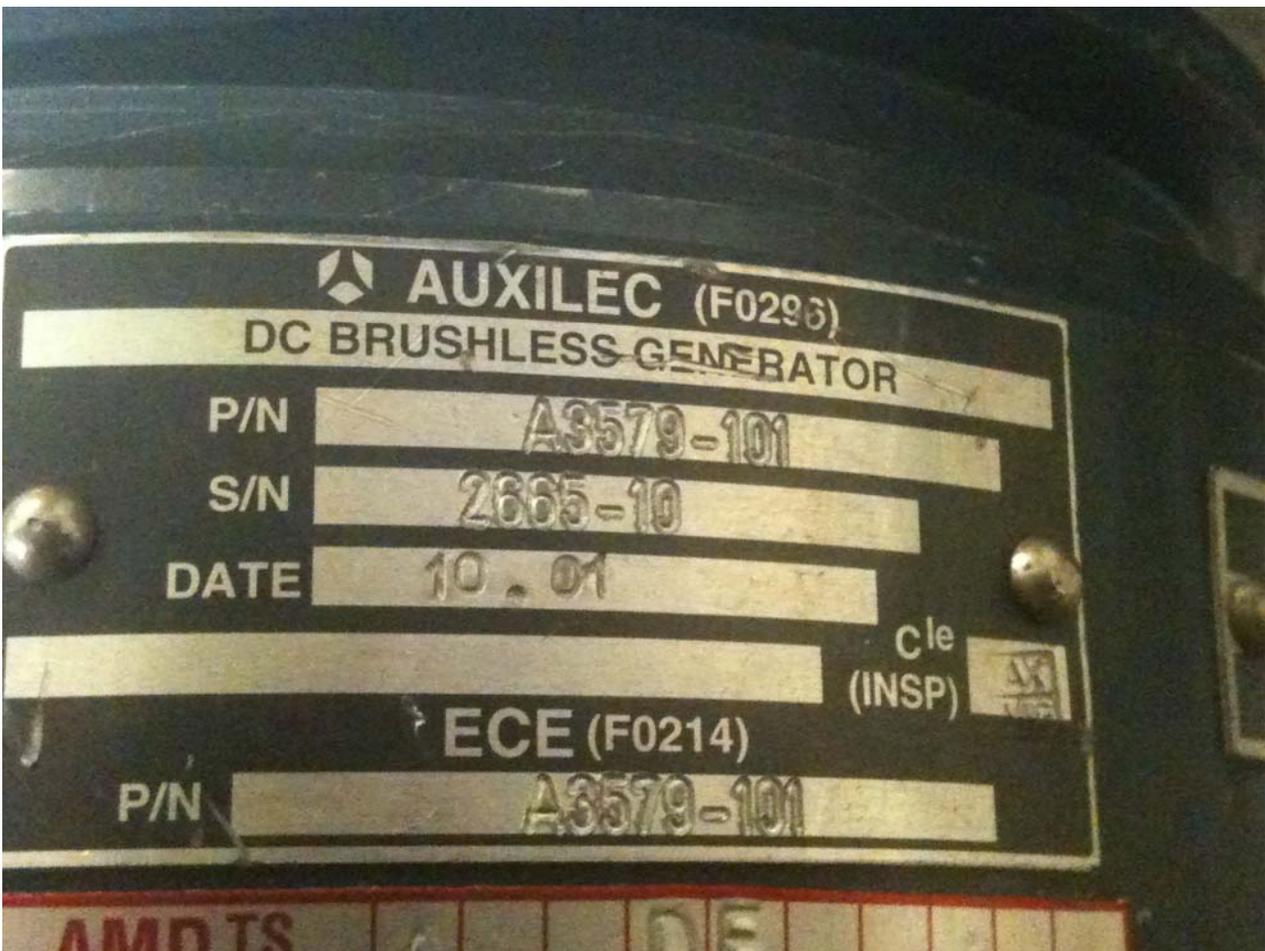
Bombardier: BD100-1A10; Sheared Generator Spline Shaft; ATA 2421

About this aircraft an unidentified technician states, "The APU (*auxiliary power unit*) goes off line as soon as it is loaded. The APU generator spline shaft (*was found*) sheared off."

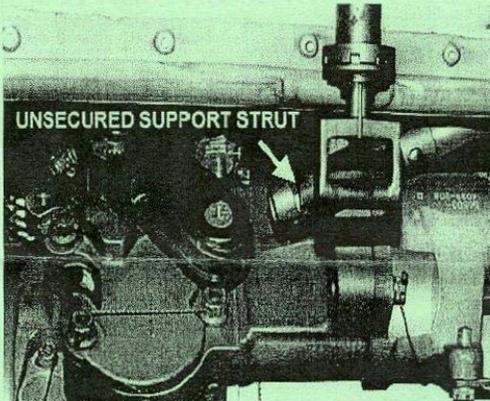
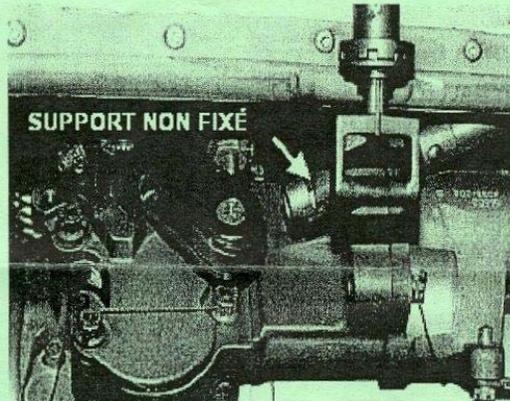
Figure 1. Fuel Control Link lever at 100% N1 Position

Even though the following figures represent aircraft post Service Bulletin (SB) CF34-NAC-71-013C and pre SB CF34-NAC-71-045A / -054, the possibility for a core cowl support strut/rod jam exists for any configuration.

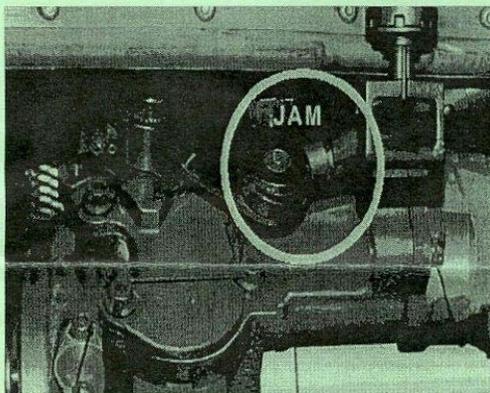
Figure 2. Fuel Control Link lever at 93% N1 Position

When the engine throttles are retarded towards the idle position, the MFC link lever can contact the support strut/rod and create a jam condition as seen below in figure 2.

In this condition the engine RPM cannot be controlled or reduced below 93% N1 and can only be shutdown by the operation of the applicable ENG FIRE PUSH switch.

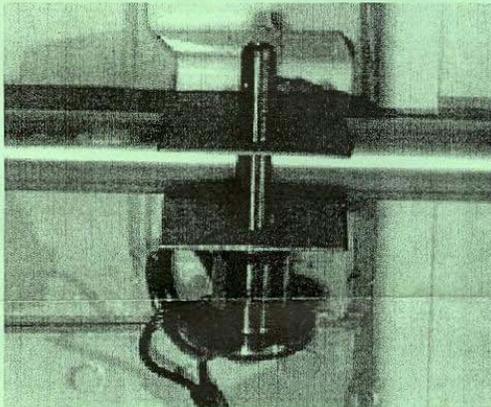
Figure 4. Secondary Lock Pin Correctly Installed as seen when the core cowl is in the open position

Note that the secondary lock pin will be inverted (pin pointing up) as seen in figure 4 when the core cowl is open, as normally seen during maintenance activities but will be positioned (pin pointing down), with the core cowl in the closed position. The AMM has been corrected, which was in error prior to TR 71-137, to stipulate this important pin configuration.

2. The stay support strut/rod secondary lock pin is correctly oriented as seen in figure 4;

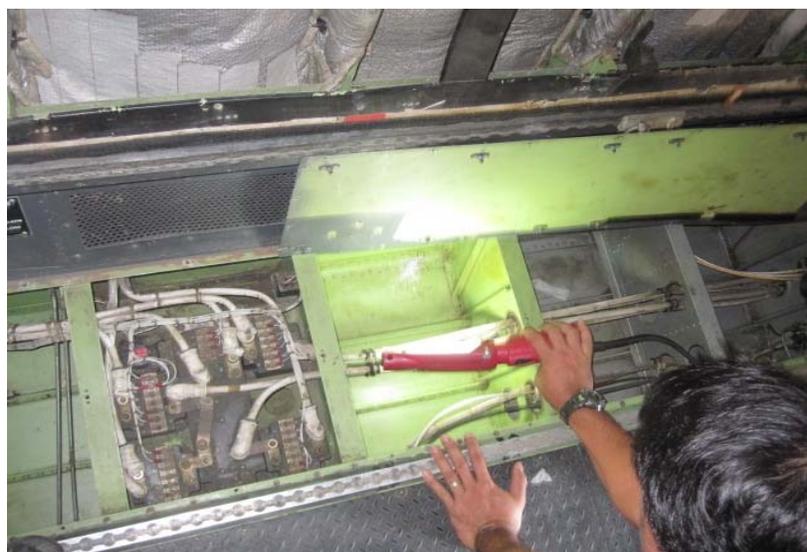
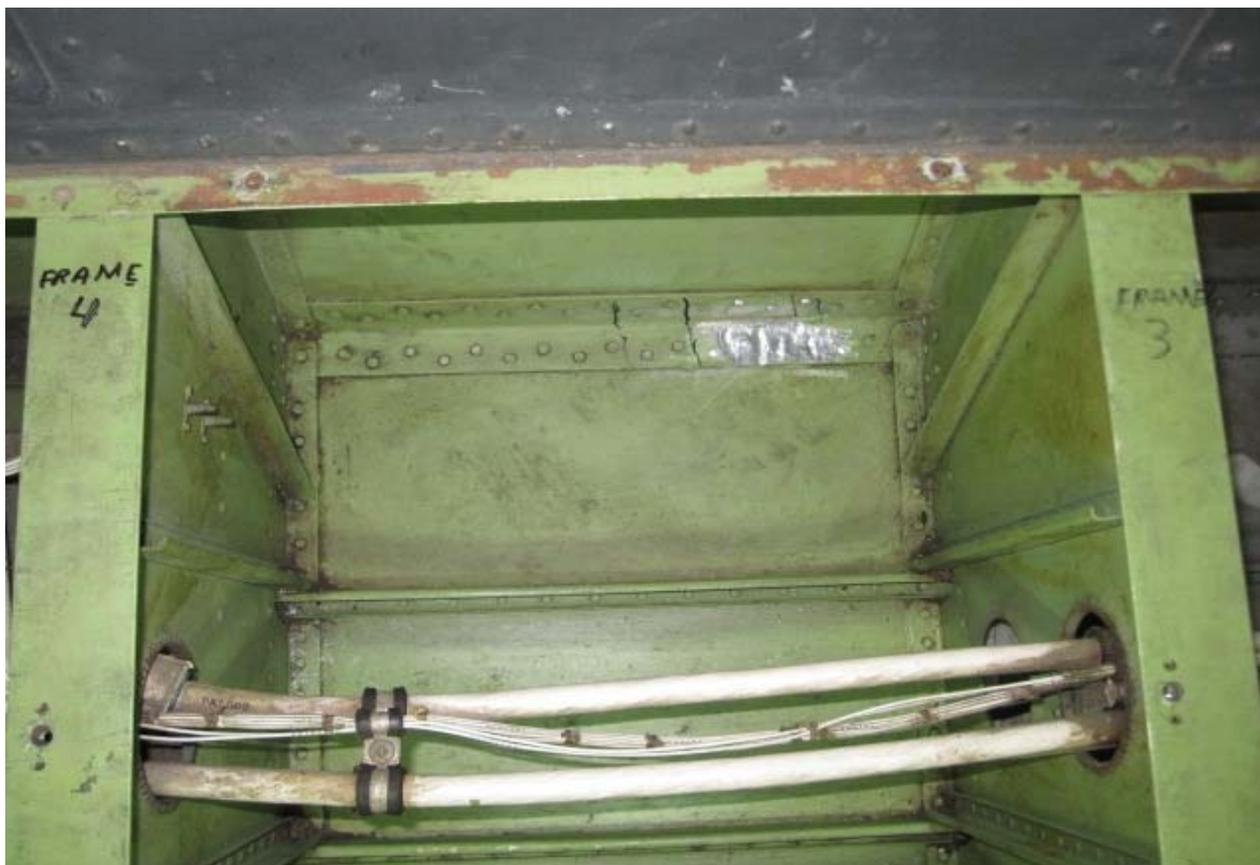
CASA: C212CC; Corroded Longeron; ATA 5313

An air carrier submission says, "The longeron that connects the left fuselage sidewall and belly has one spot of corrosion between frames 3 and 4 at approximate station 4100. The longeron is 3.2 MM thick, and is formed as an angle. The corrosion damage extends at least halfway into the beam (thickness) and moves into the bend radius. This (*corrosion spot*) is about 0.50 inches in diameter."

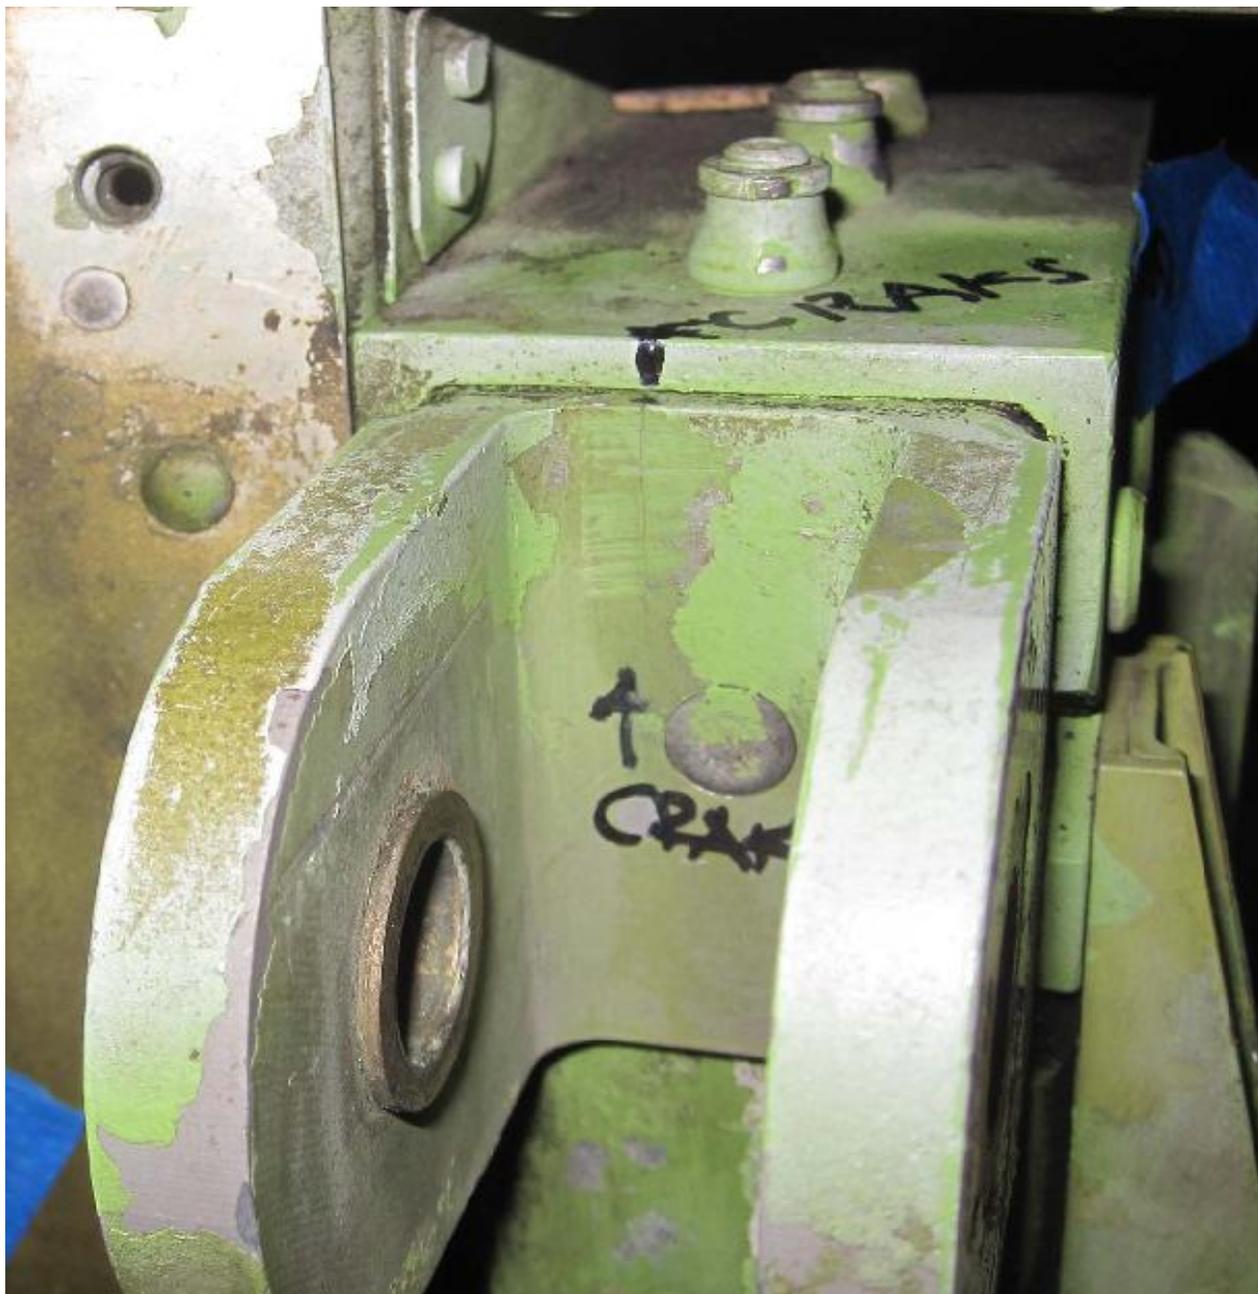
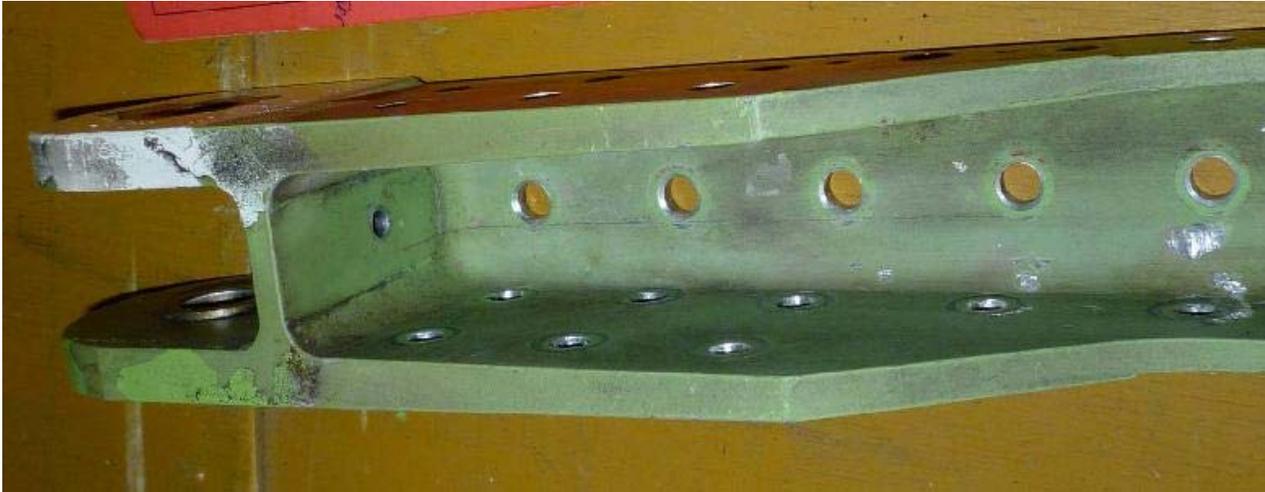
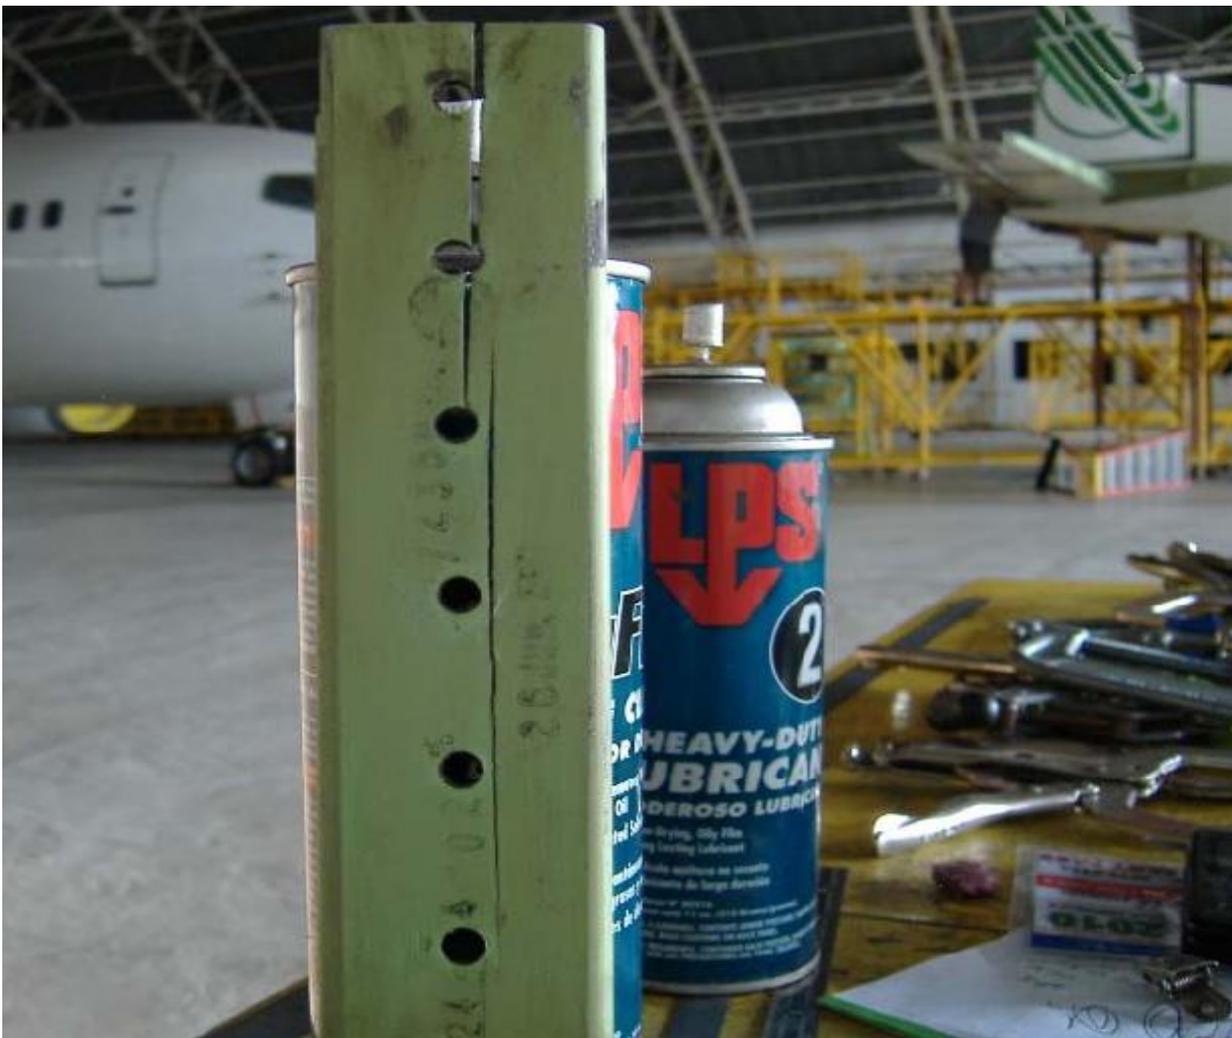
CASA: C212CC; Cracked Horz. Stabilizer Attach Fittings; ATA 5551

The previously reported aircraft has another defect. The submission states, "Three each horizontal stabilizer attach fittings (*fuselage side*) were found to be cracked, and three others were found with intergranular corrosion. Six of the eight (*fittings*) are beyond limits (*P/N 2122415XX*)."

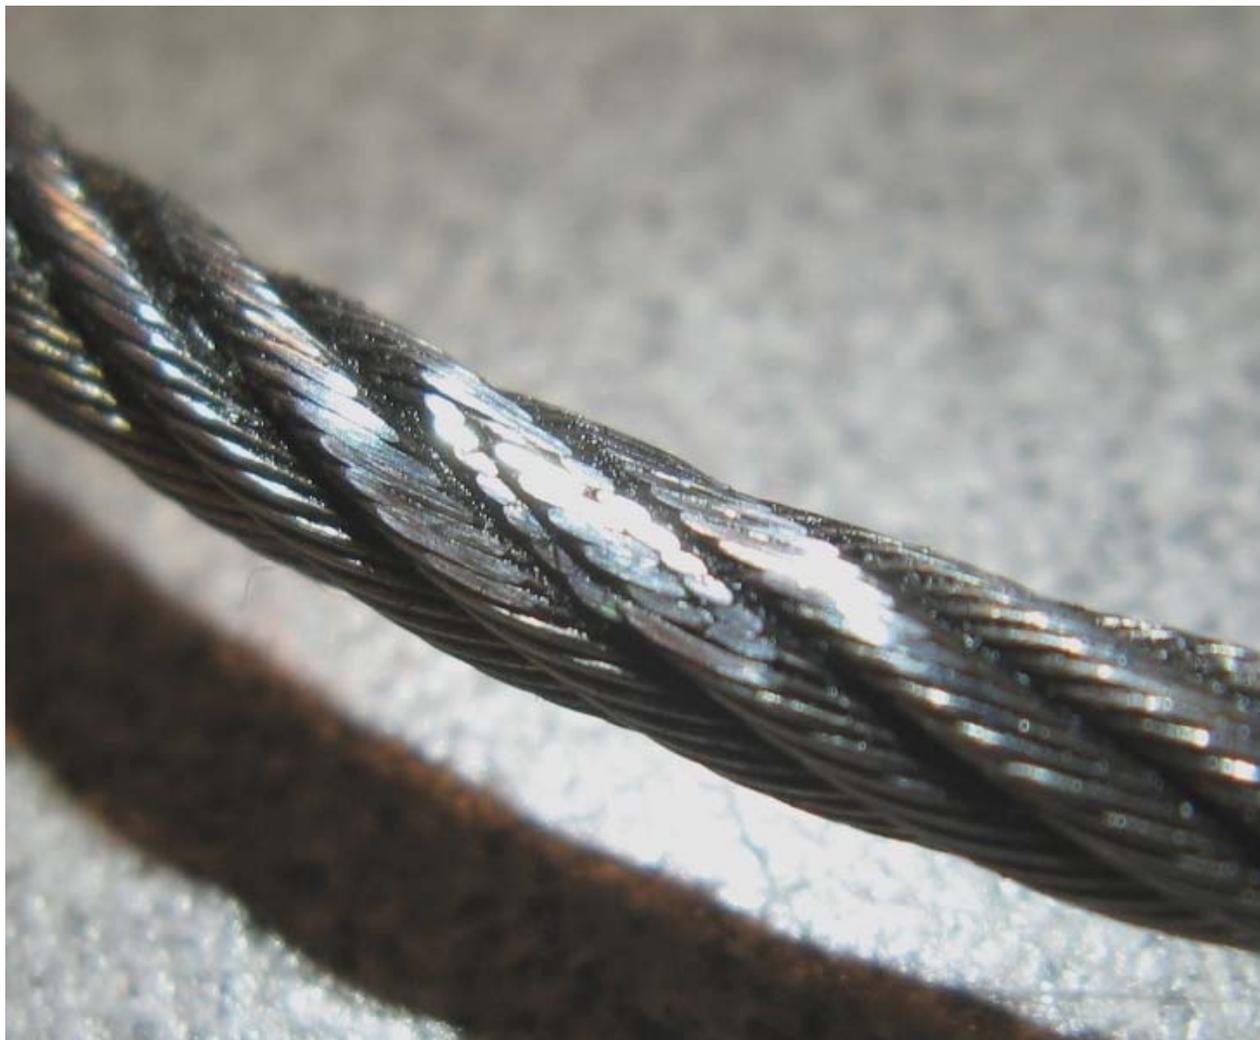
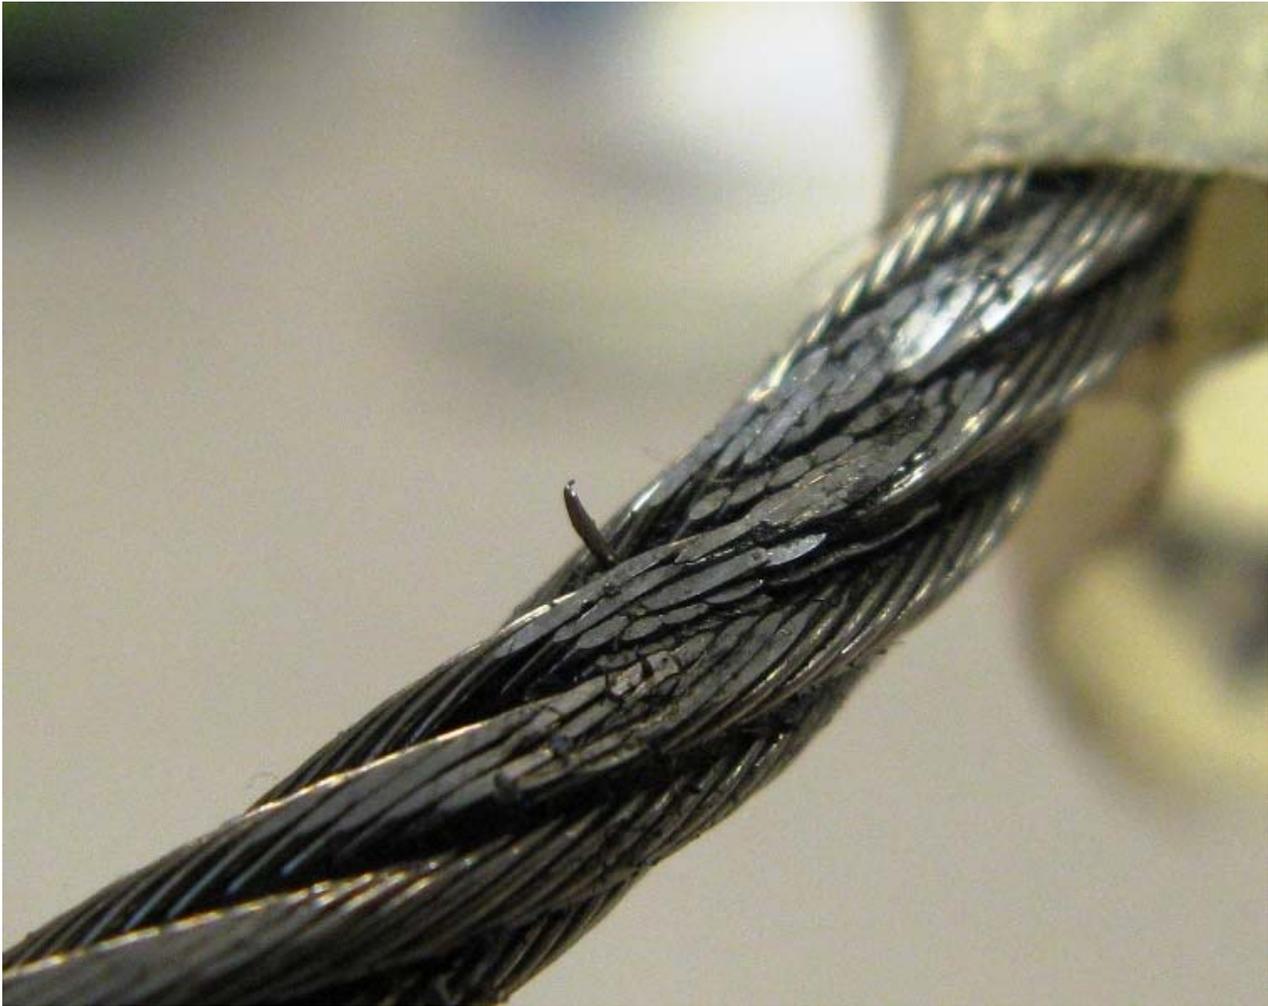
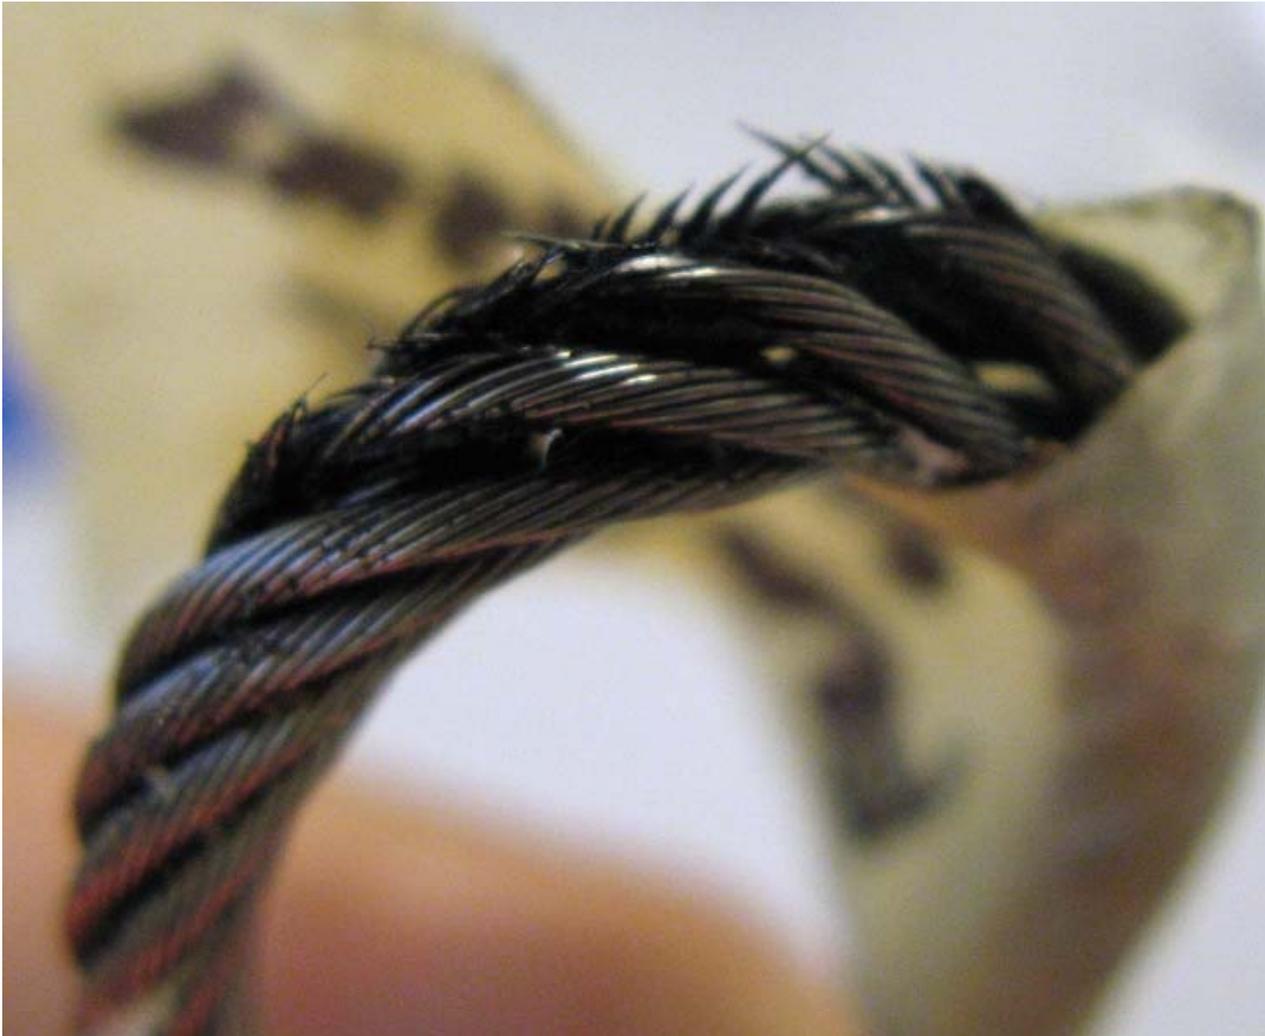
Cessna: 172S; Frayed Aileron Cable; ATA 2710

"During a routine inspection," says a flight school submission, "the aileron cable (P/N 0510105-364) was found shiny (*worn*) where it passes through the ceiling pulley cluster. When it was viewed through a strong magnifying glass many broken strands could be seen."

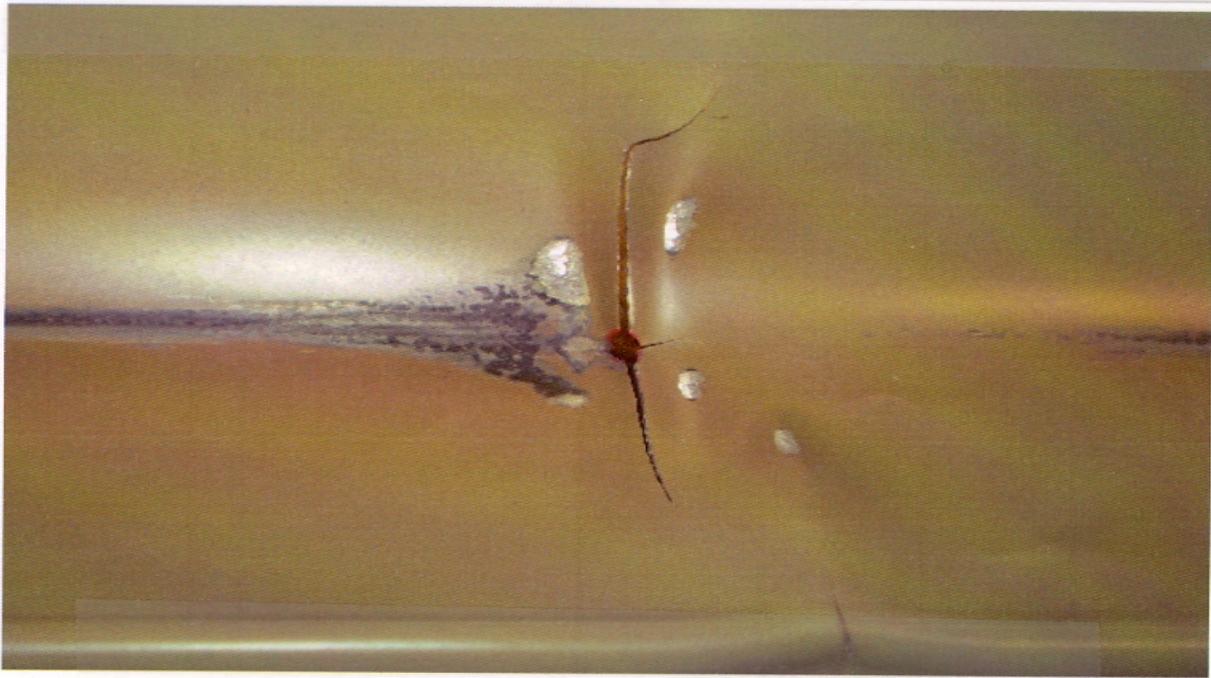
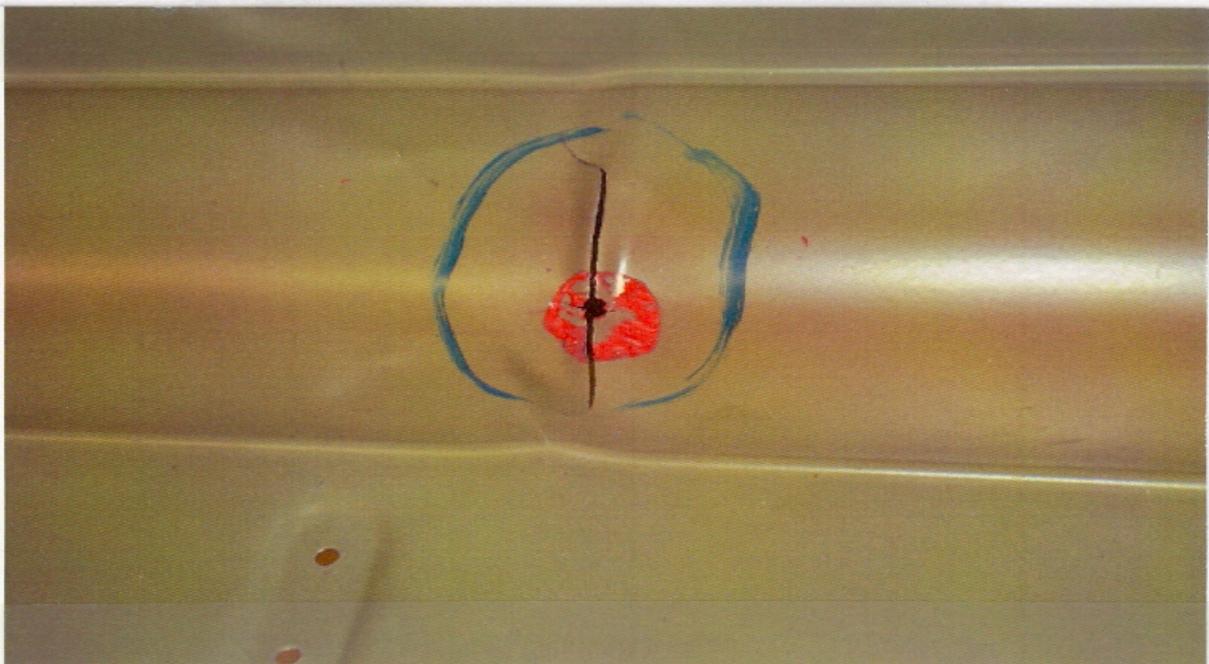
Cessna: 680; Cracked Diffuser Ducts; ATA 3010

A repair station technician describes a heat duct defect. "We have found these wing bleed air heated leading edge diffusers cracked or deformed on numerous aircraft. This (*particular*) discrepancy was found while performing A301001 Wing/Horizontal Stabilizer Bleed Air Anti-Ice System Detailed Inspection. Task 30-10-00-220 is part of Inspection Document nine—a 48 month inspection. This discrepancy was likely caused by thermal expansion and flight vibrations of the wing leading edge, anti-ice piccolo tube. The piccolo tube is hard mounted to the diffuser with no vibration dampeners or means to compensate for thermal expansion. The material for the diffusers is thin and bends easily. We have also found the piccolo tubes chafing on the diffusers. We recommend the diffusers be built with a heavier material and the piccolo tube mounting to be redesigned. This occurrence was corrected by replacement of the effected parts." (*Diffuser P/N's 6922520-53, -54, -55, and -56.*)

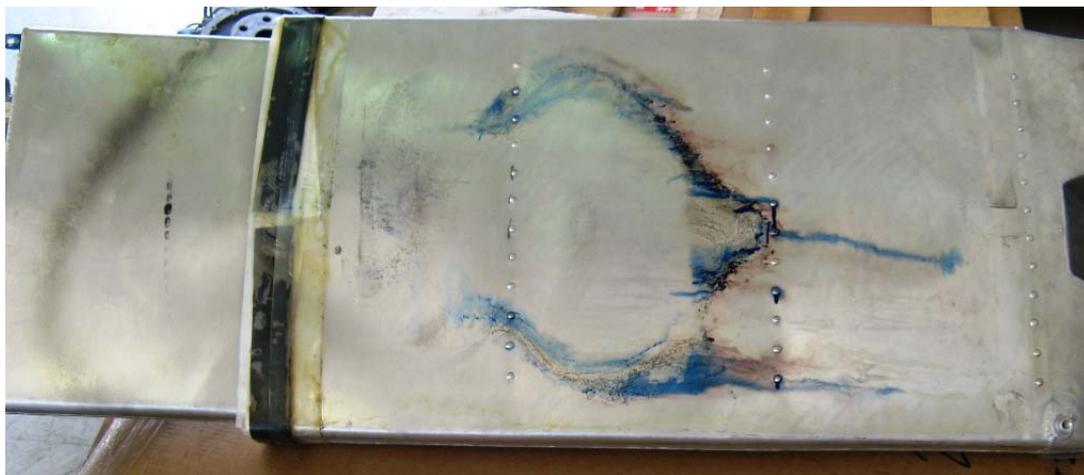
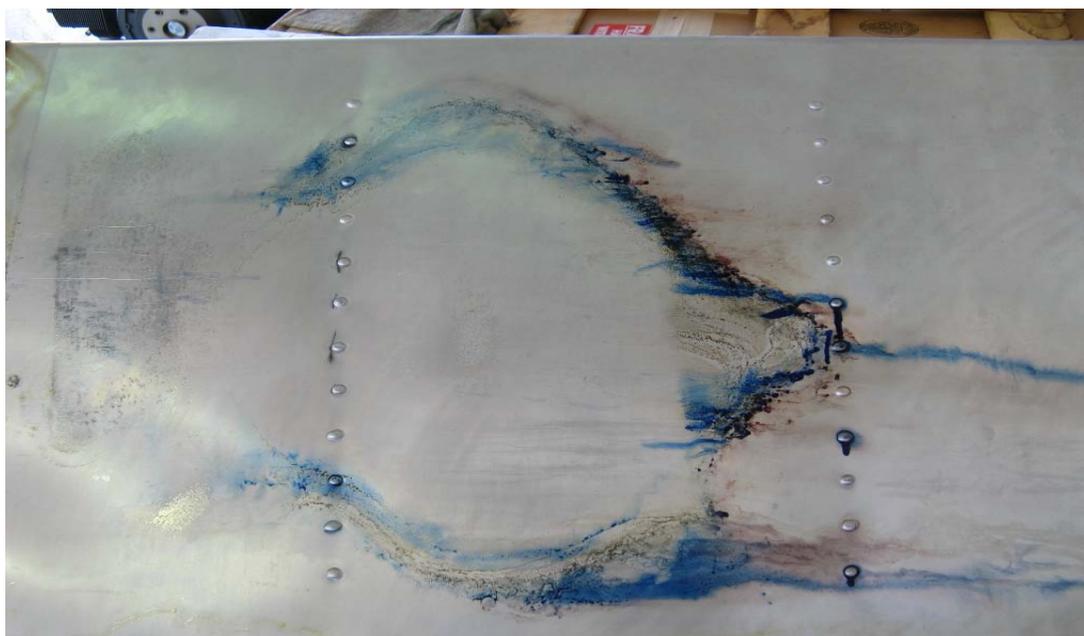
Diamond: DA42; Cracked Fuel Tanks; ATA 2810

A flight school reports, "During a routine inspection a fuel stain was noted in the left auxiliary tank area. The tank was removed and inspected. There were cracks found at several of the weld points where an internal baffle is welded to the bottom panel of the tank. A new tank (P/N D6028141100) was installed."

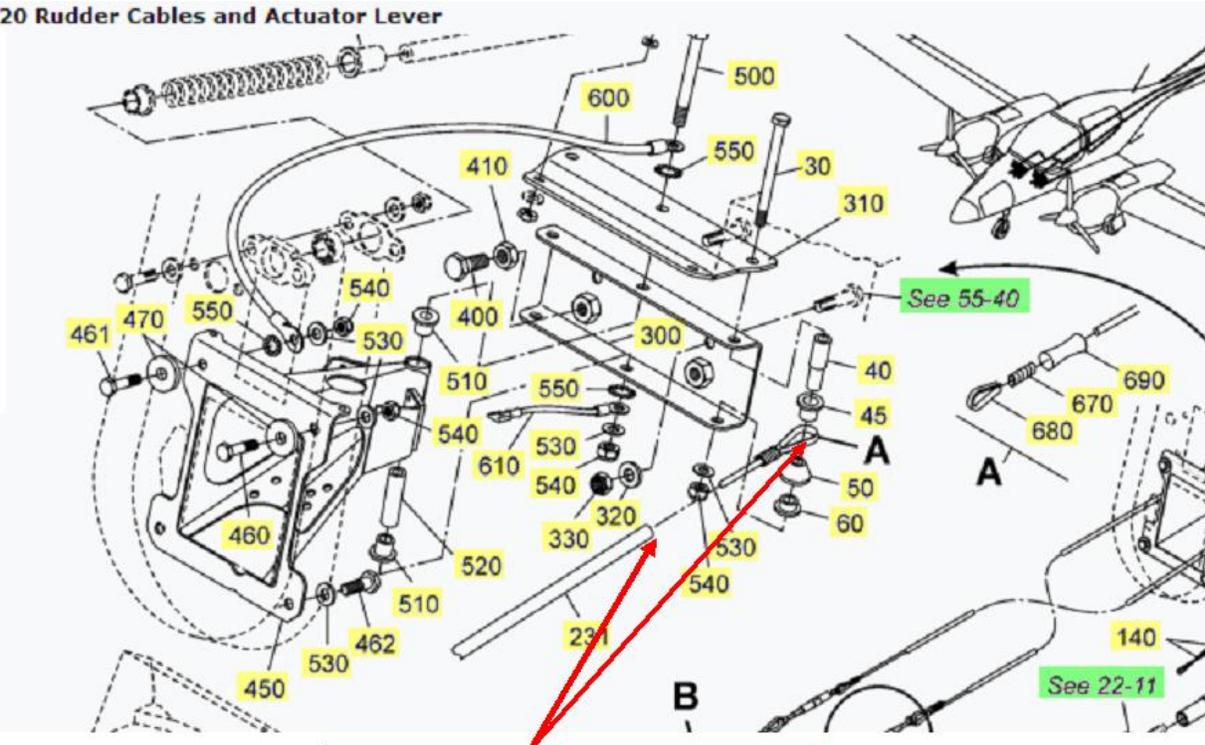
Diamond: DA42; Chafed Rudder Cable; ATA 2720

An unidentified submitter states, "During a routine inspection, the rudder cable (P/N CA13190) was found worn with broken strands where it exits the (*guide*) tube (P/N 157727) about two inches forward of the rudder bell crank. This is approximately on the rudder hinge line. Once the cable was removed, additional wear was found 33 inches inside the tube. Since both ends of the cable are swaged, this cable would never be removed to inspect for that wear (*occurring*) midway in the protective tube."

Left arrow shows location of wear. Rt. Arrow is where cable is attached to rudder Bellcrank.

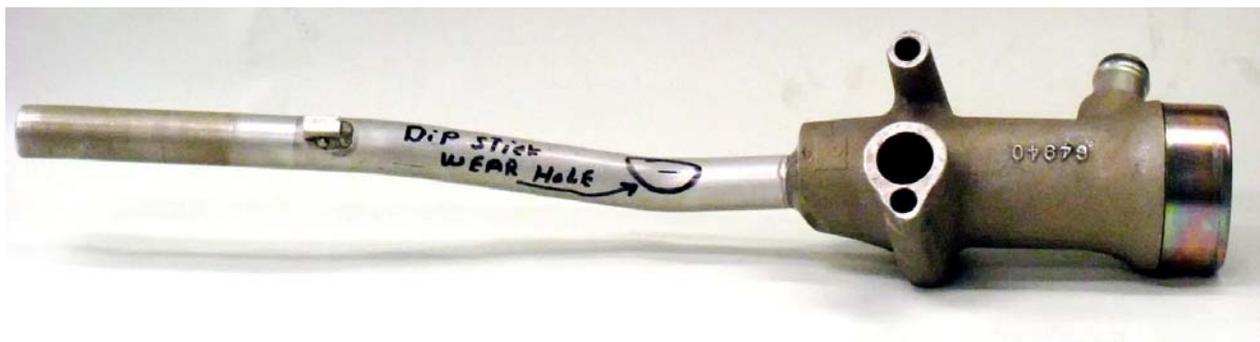
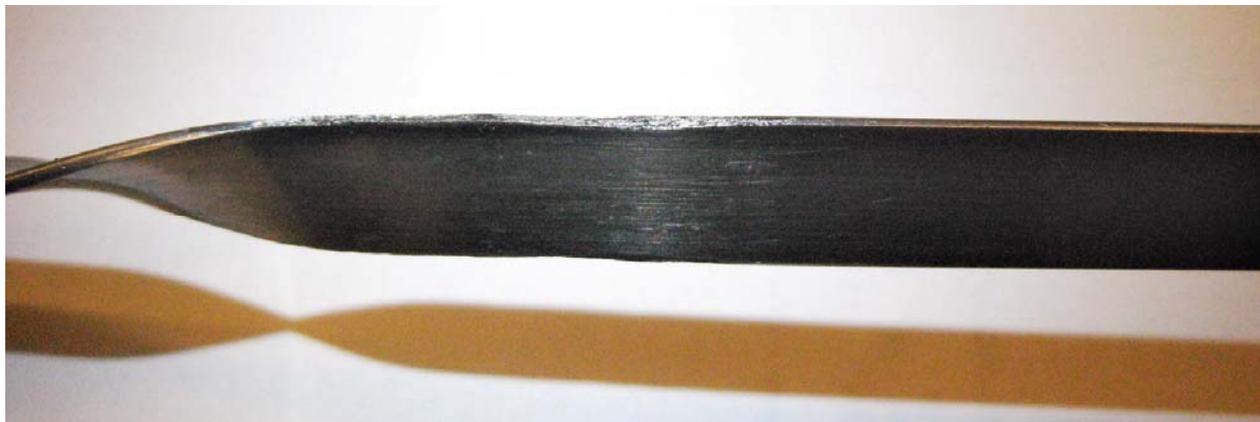
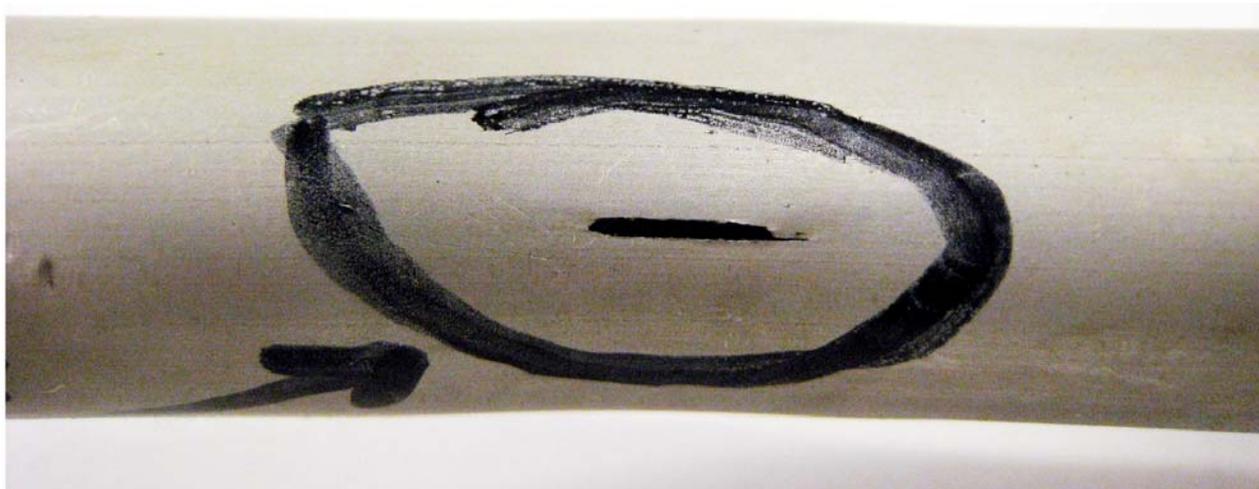
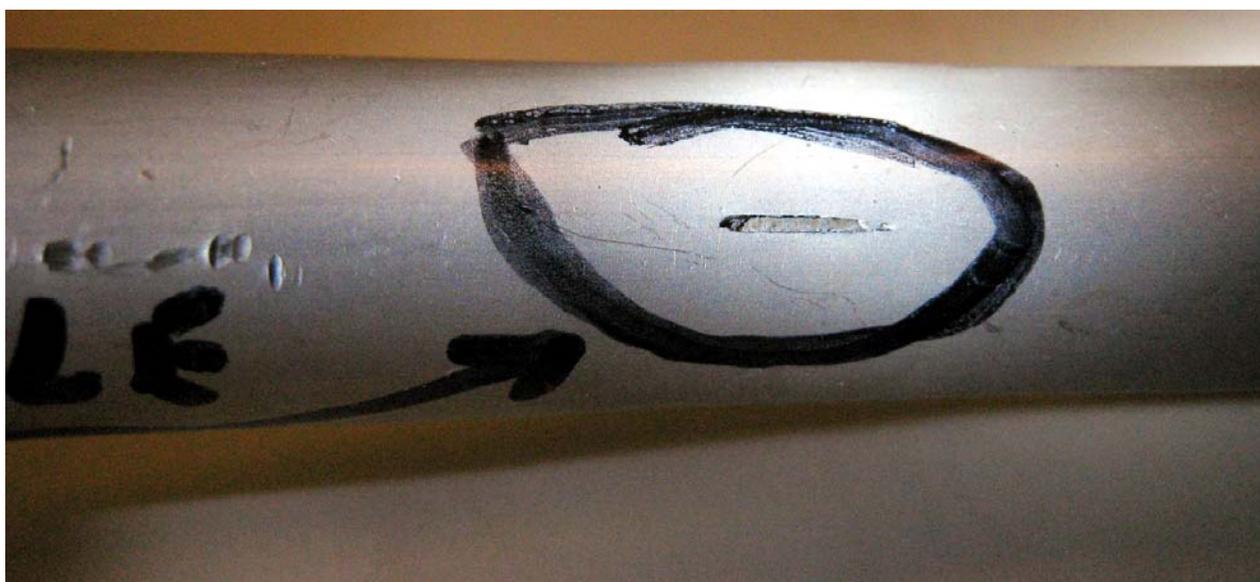
Continental: IO550C; Leaking Dipstick Housing; ATA 8550

A technician states, "During a routine oil change a puddle of oil was observed in the bottom of the cowling. No oil was spilled while filling the crankcase. Having seen this problem several times in the past, the mechanic immediately knew to look at the dipstick tube (P/N 6494061) in the chafed area. As in all the previous situations, the hole is located at the first inside bend below the filler opening. Even though the OEM says they are not aware of the problem, most of our in-service engines show some sign of chafing which can be observed by looking down the oil fill opening on the crank case side of the tube. Fortunately, once the dipstick is in place, it tends to fill the chafed opening and very little oil can escape through the hole. The attached photos show the dipstick through the chafed hole—it actually creates a decent seal."

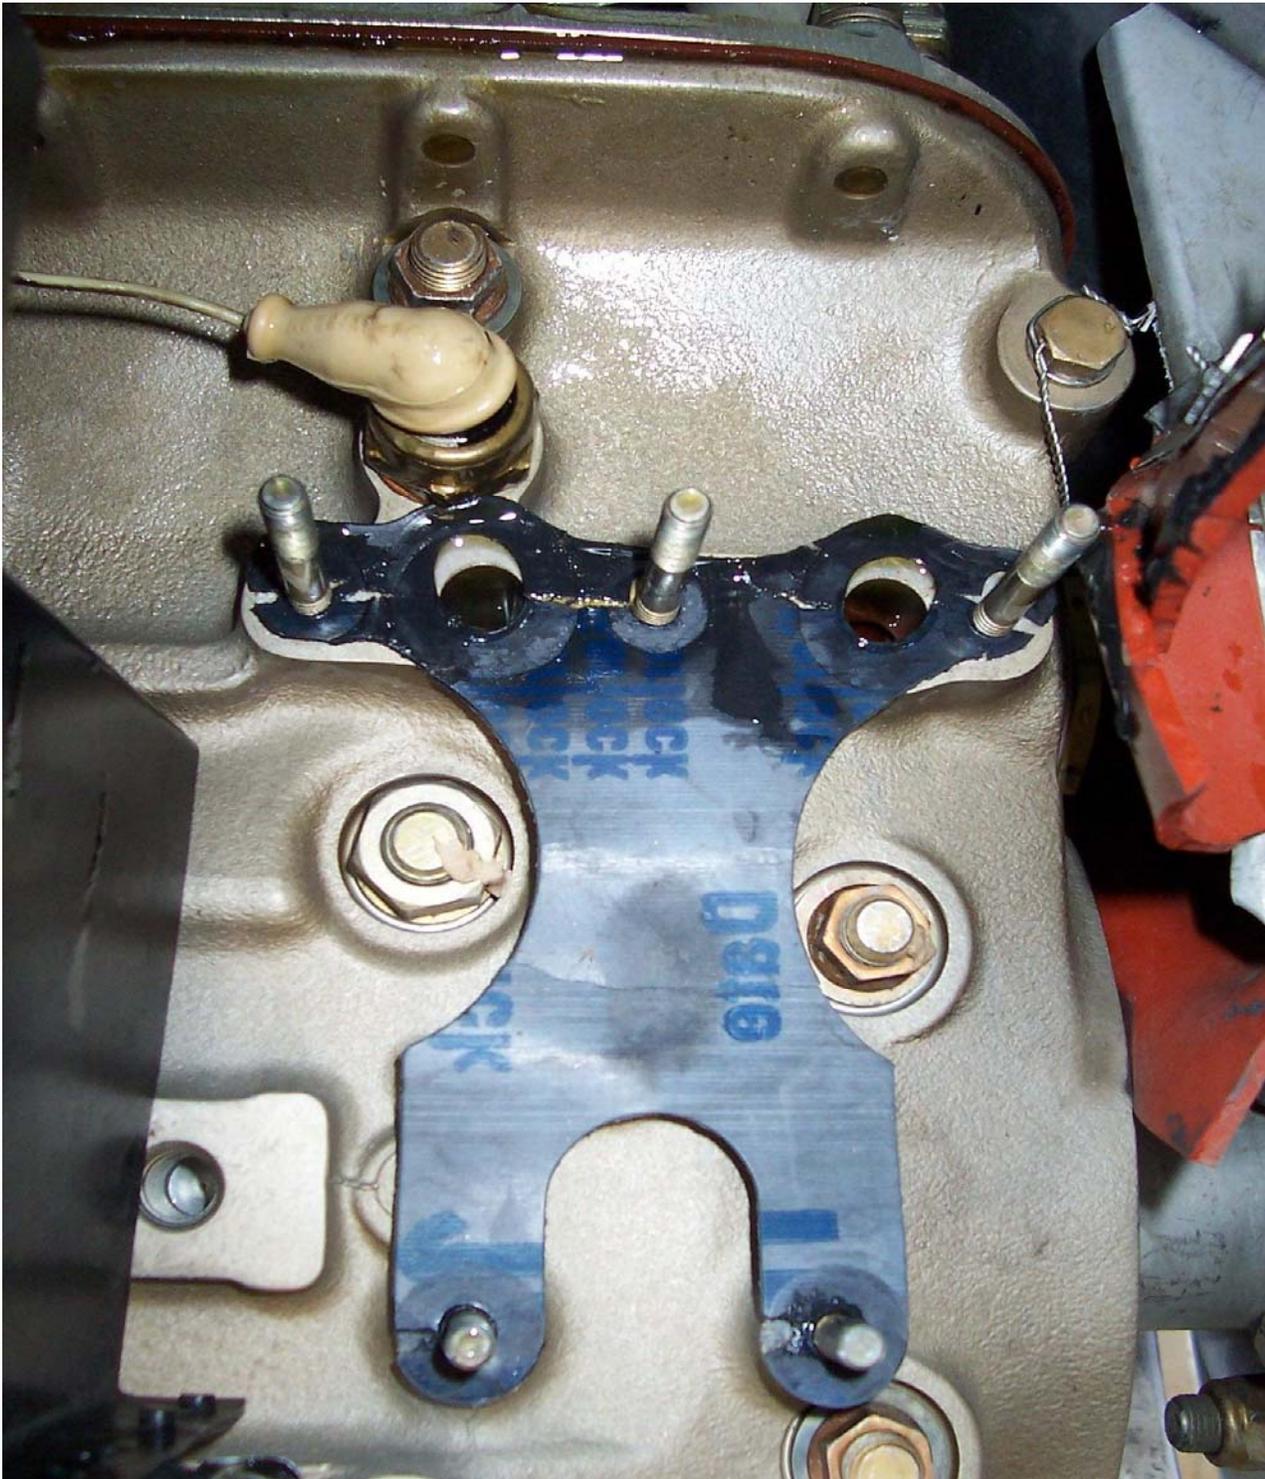
Continental: IO470N; Failed Oil Cooler Gasket; ATA 7921

A technician for an aviation company says, "The oil cooler gasket failed."
