43-16A

AVIATION MAINTENANCE ALERTS

**ALERT
NUMBER
335**

**JUNE
2006**

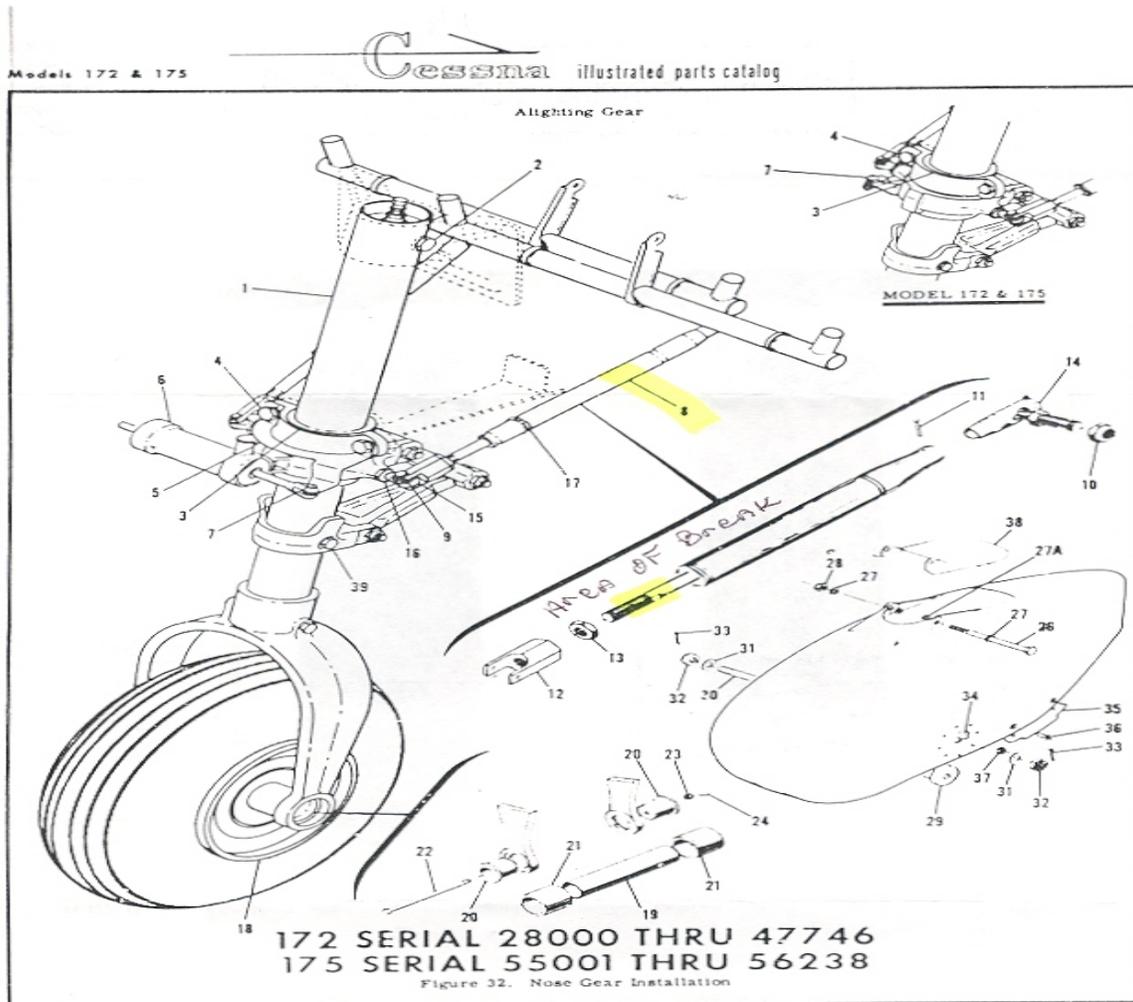
Cessna: 172A; Failed Rod-End, Nose Gear Steering; ATA 3250

An FAA inspector from Spokane, Washington, submitted this defect report, indicating the cause of the 172's accident. The attached drawing shows the failure point on the nose gear steering tube's rod-end (P/N 0543022-1). "The aircraft turned left and impacted an embankment. A small amount of rust was (*noticed*) on the threaded area (*of the rod end*)."
(*The attached drawing has been vertically compressed—fairly obvious!*)

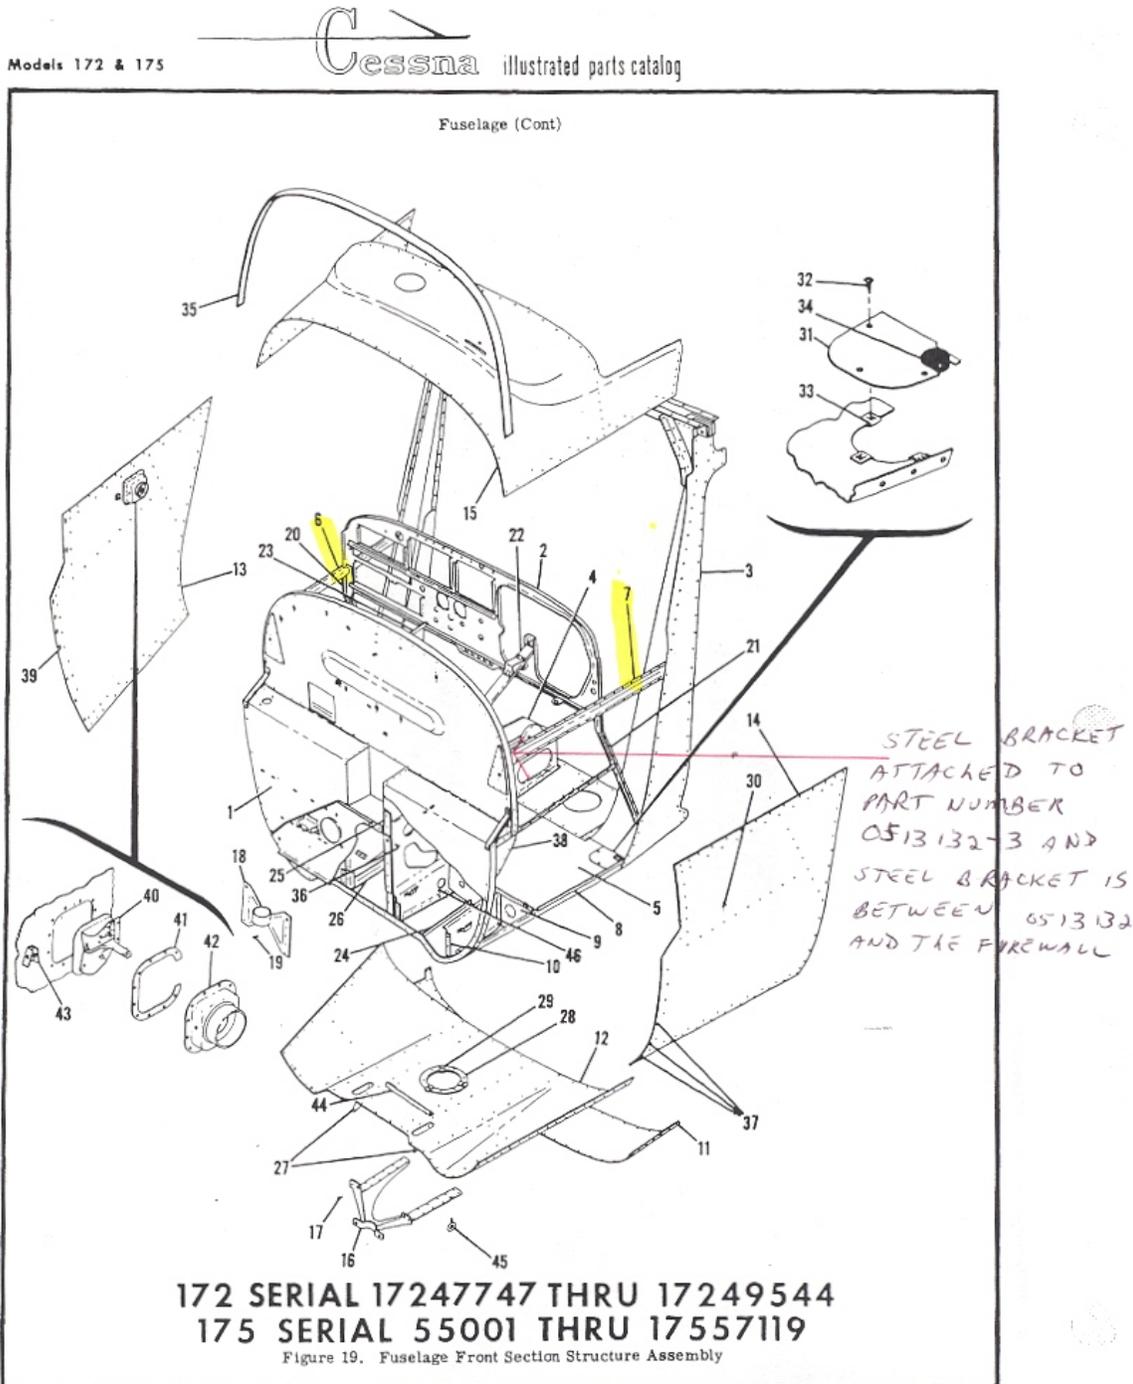
Cessna: 175B; Cracked Engine Mount Attach Brackets; ATA 5313

The submitter states, "This aircraft experienced a hard landing. During the landing the two top engine mount attach brackets failed behind the firewall, allowing the top half of the firewall to fail, pulling forward and down about 18 inches. (See the attached figure 19, items 7 and 6.) The part number 0513132-11 engine mount attach bracket fits onto the front of the hat channels (items 6 and 7). (*This same part*)--which has a hole in it for the

engine mount bolt to go through—had failed some time ago on the pilot’s top side...(as evidenced by rust being found in the break surfaces of two pieces). The bracket on the co-pilot’s top side had an existing crack in the center third—at the bolt hole. Rust was also (evident on these crack surfaces).” “This aircraft had an STC’d (Supplemental Type Certificate) Continental IO-360 engine installed....” (SDRS data base records 17 entries on this particular part number.)

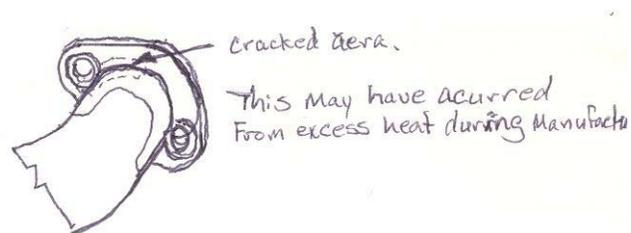
DIAMOND**Diamond; DA40-180; Cracked Exhaust Riser; ATA 7810**

A mechanic said he ordered a brand new exhaust riser for this aircraft’s Lycoming IO360 number two cylinder. “Inspecting the riser before installation, we found a crack at the weld radius of the mount flange and the exhaust pipe.

“This is the first crack seen on new risers sent to us, but we have had two in-service risers crack at 780.4 hours *(on one aircraft)...*” *(Another aircraft is mentioned as also having experienced two cracked risers, but the time was not noted. Exhaust riser assembly P/N DA40-3. Thanks for the effort on the hand drawing. It leaves no doubt where to focus attention. Three additional entries are found in the SDRS data base.)*

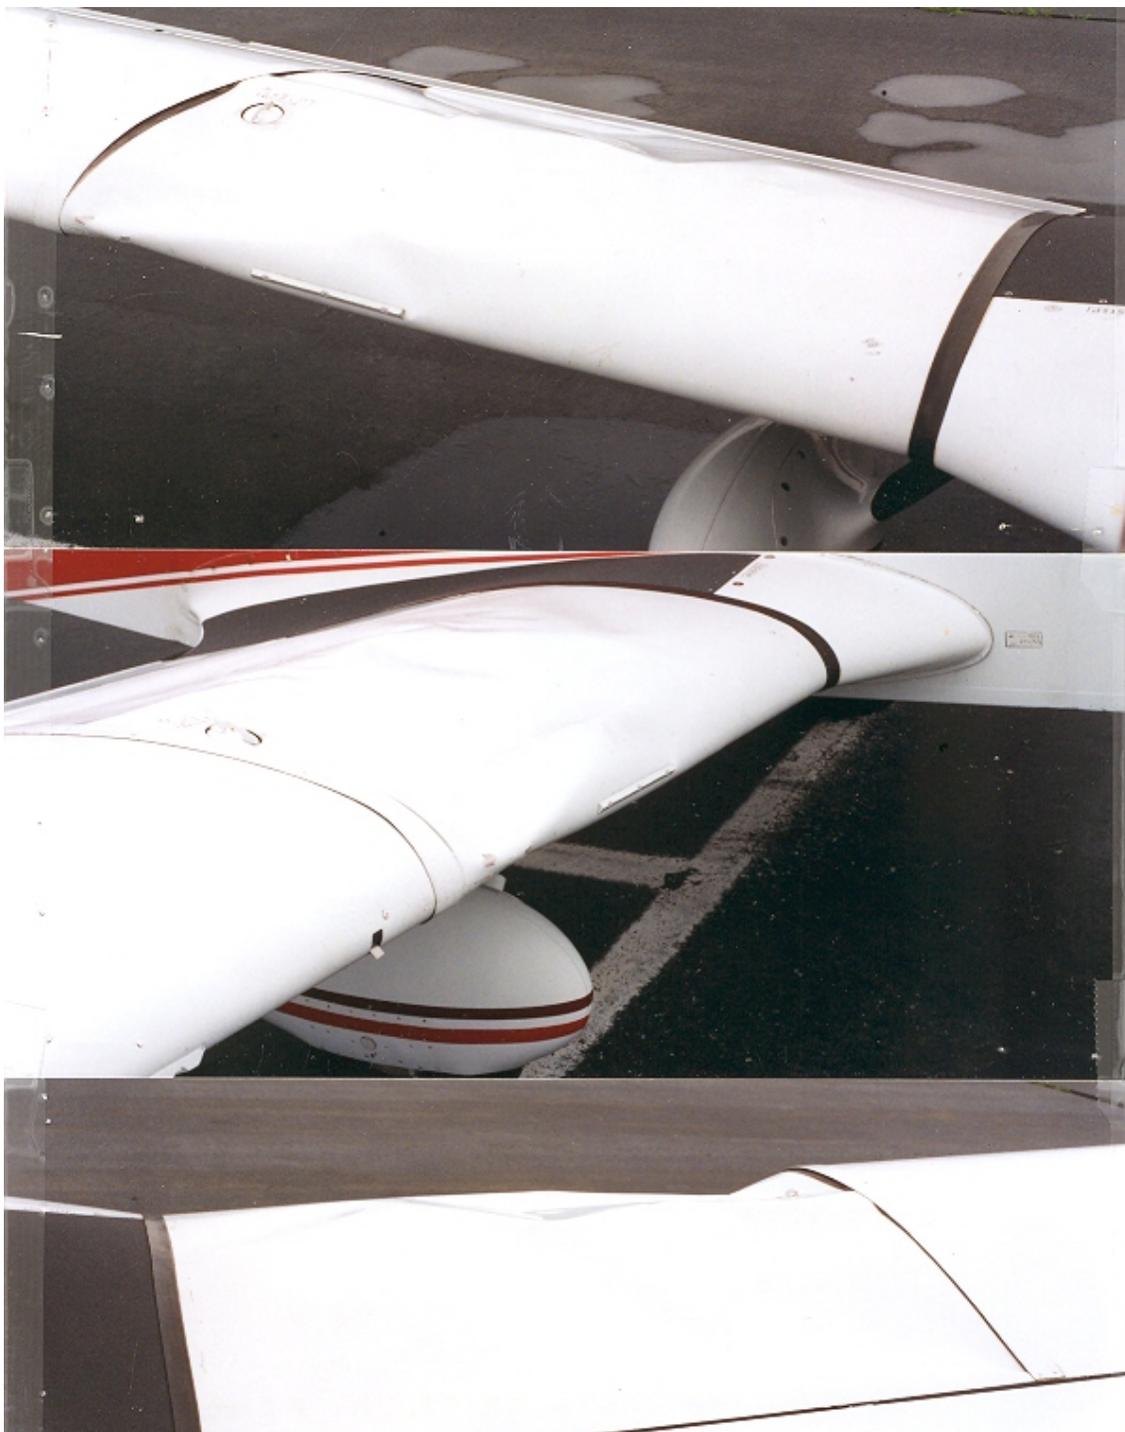
GRUMMAN**Grumman: AA5-A; Collapsed Wing Fuel Tank; ATA 2810**

“The right wing fuel tank collapsed during flight,” states a mechanic. “A safe landing was made. We found the fuel tank vent line plugged with insect debris. *(It is recommended to...)* periodically check fuel vents for obstructions, especially when tied down on grass.” *(If the following pictures don’t make converts of us all, nothing will.)*

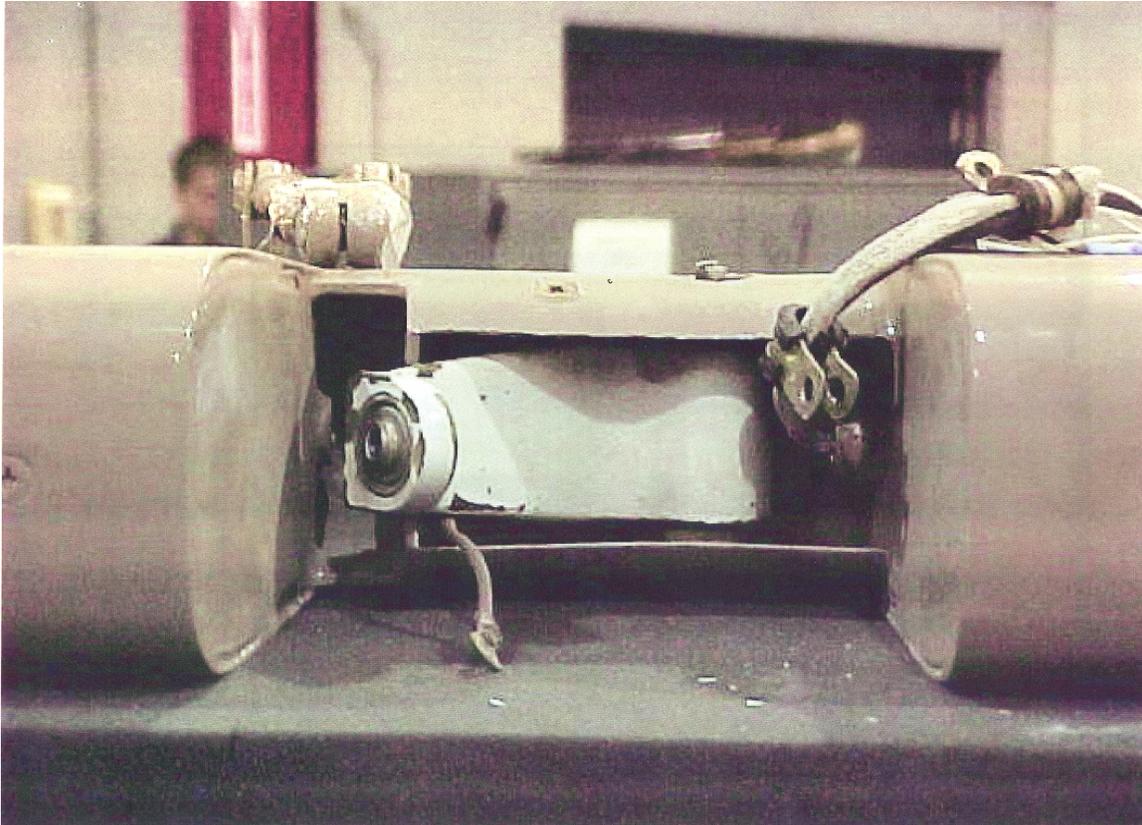
Lear: 60; Bent Aileron Drive Yoke Castings; ATA 2710

A repair station technician states, “An incoming inspection found the aileron drive yoke, attach casting—bent. Upon further inspection it was discovered the drive yoke’s upper (or lower) shims were not installed. (*However*), the drive yoke attach bolt was installed, causing the casting to be bent. (*Damage like this mandates*) replacement by OEM (*original equipment manufacturer*). This (*error*) could have been prevented by following maintenance manual installation instructions.” (*The part number given for the left aileron drive yoke attach casting: 2424000-258.*)

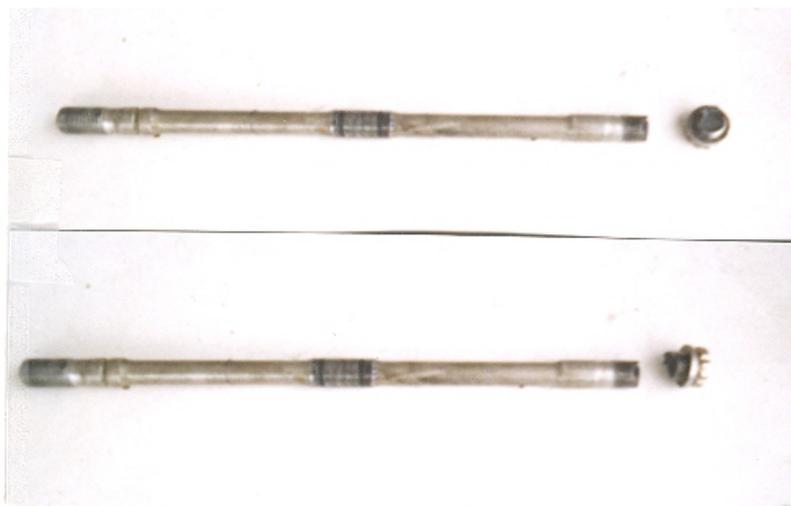
Continental: TSIO520 NB; Broken Through-Bolt; ATA 8520

“While checking the right engine over for oil leaks,” writes the mechanic, “I found the (*through bolt*) nut and part of the bolt (*originating*) from the top forward number two cylinder lodged by the oil filter tube. The break (*surfaces*) on the bolt appear to be old, (*indicated*) by dark colors. Removal of the cylinder was necessary to replace the bolt (P/N 641931-10.75).” (*The two images below depict the same bolt. Fourteen reports on these bolts are generated by the SDRS data base.*)
