43-16A

AVIATION MAINTENANCE ALERTS

**ALERT
NUMBER
347**

**JUNE
2007**

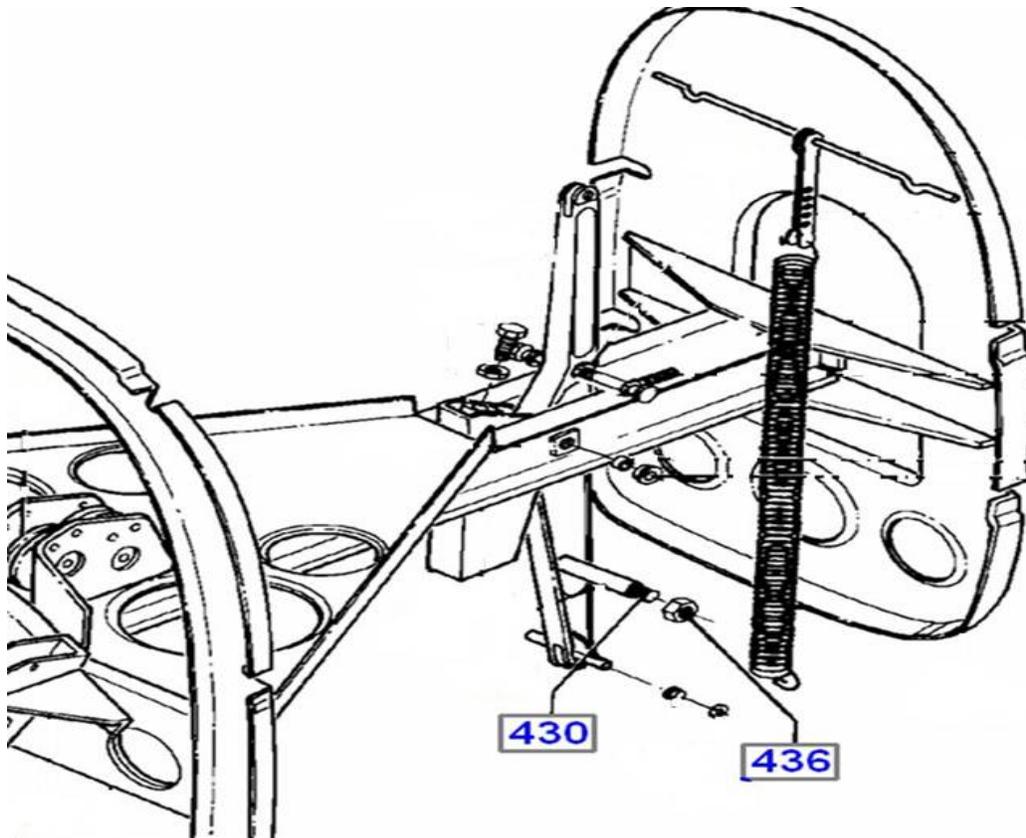
"The rod (elevator downspring limit bolt) identified in Alert number 345 was mistakenly identified by the submitter as part of the autopilot system. The limit bolt is an integral component of the downspring system and is required equipment on all model 36 and most model 33 Bonanza airplanes for static longitudinal stability. The limit bolt is a necessary part of the elevator control system and must be properly installed to meet airworthiness requirements.

"When inspecting for proper limit bolt installation in the 002-524024-51 elevator bell crank assembly, there must be at least two threads extending through the self locking nuts at each end. It is permissible to tighten the nuts to a maximum torque of 70 inch pounds.

"The limit bolt is not rigidly fixed to the bell crank (slip fit) and some axial and radial movement of the limit bolt is a normal part of the elevator bell crank assembly design.

"Item 430 in the following illustration is the elevator downspring limit bolt (as shown in the G36 illustrated parts catalog). Item 436 in the following illustration is the self-locking nut (two required). The washers are not shown, but are installed under each nut."

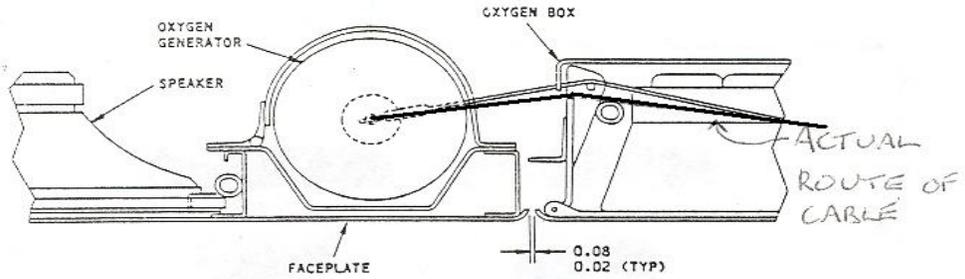
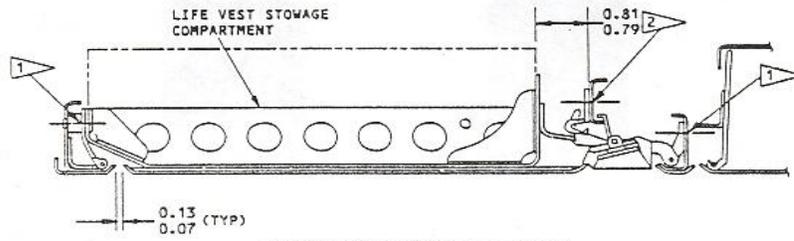
A submission from an English repair station describes an oxygen activation defect. "The actuating cables to the chemical oxygen generators on passenger service units were found to be incorrectly routed—under the support pin and resting on the plastic molding." (See the following diagram.)

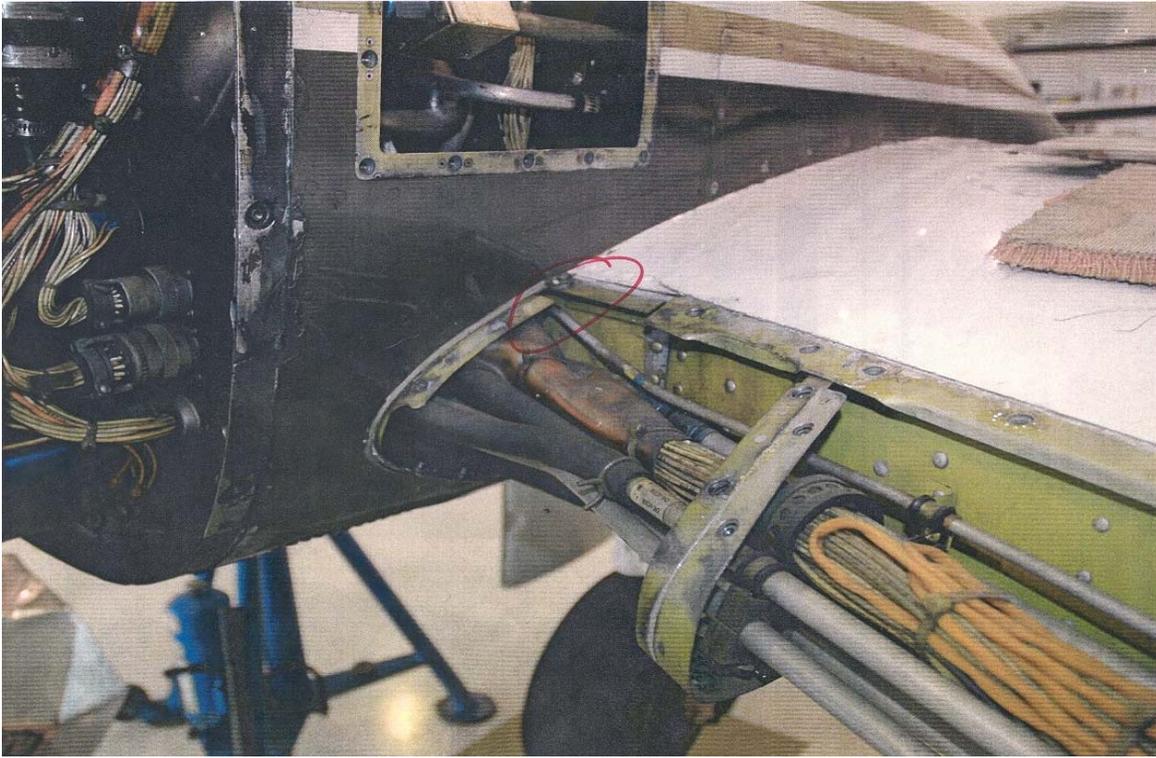
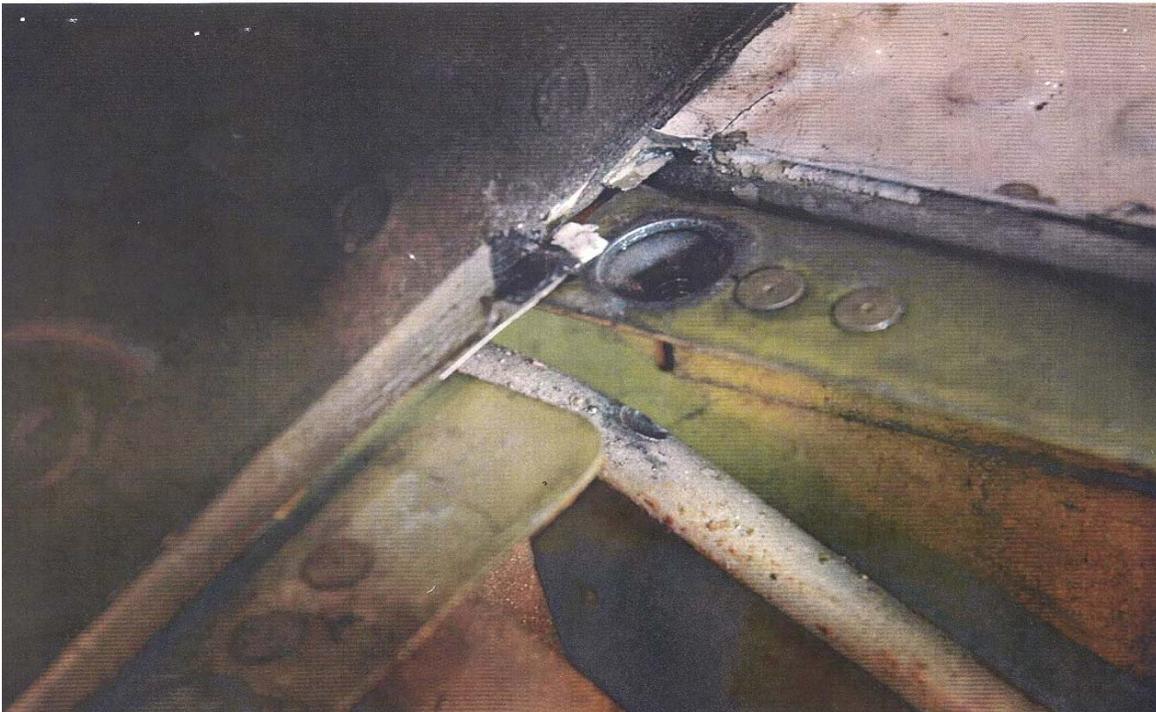
“The customer reported red fluid seep at the top, inboard (*area*) of the right wing,” states the submitter. “The (*wing’s*) inboard leading edges were removed. It was determined a leading edge retaining screw had chafed the right hydraulic pressure line (P/N 50157-001), causing a hydraulic leak. The line was replaced and the aircraft was returned to service. This area is not normally accessed during periodic inspections. It is suggested this area be inspected at 800 hour intervals.”

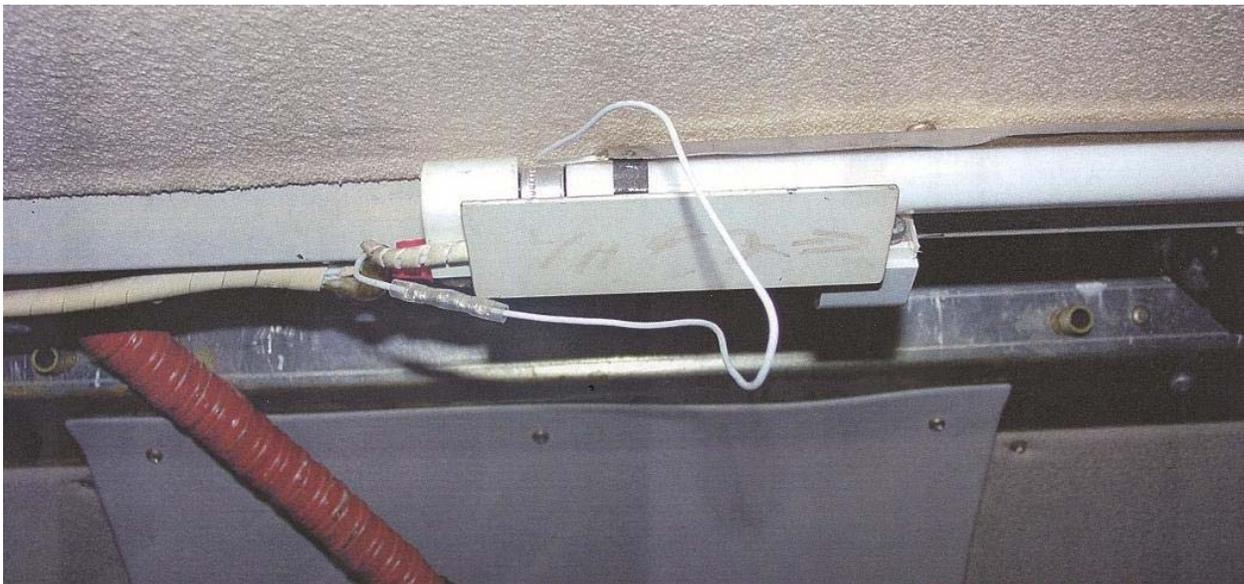
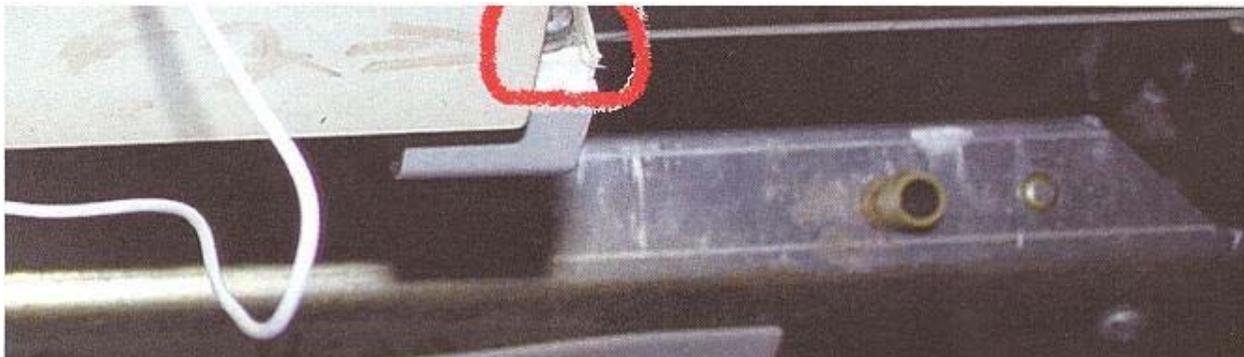
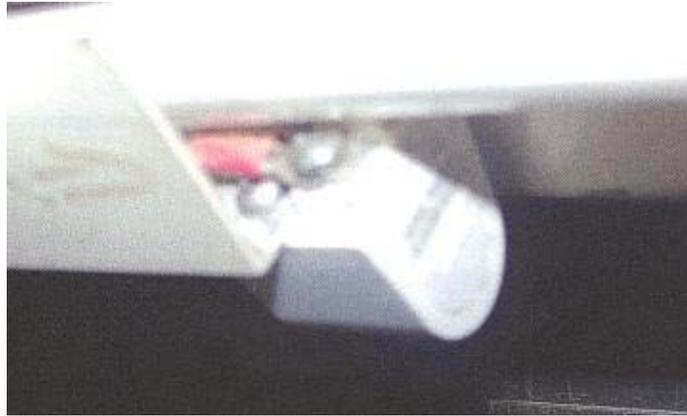
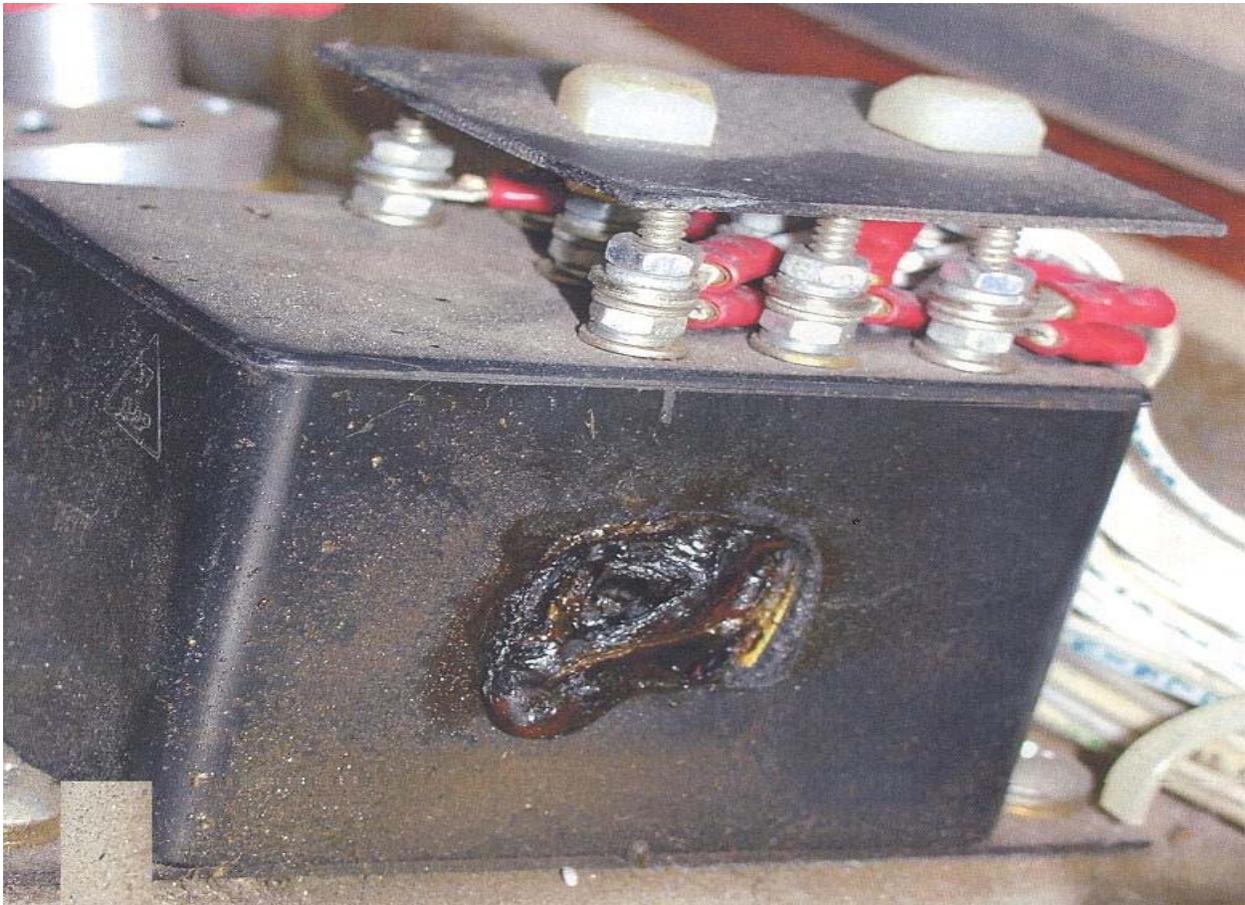
An unidentified submitter from a repair station writes, “The aircraft was disassembled for inspection. During re-assembly, we noted the grounding straps on the cabin valence lights were broken. The grounding straps were repaired, the aircraft re-assembled, and (*electrical*) power applied (*to the systems for operational checks.*) Power was on the aircraft for many hours.

“During turnover to second shift we noticed a spark in the overhead lighting. (*When*) we dropped the valence to investigate, the power supply blew up (*Day-Ray Products; P/N 61-21-3*). Upon further investigation we noticed silicone sealant was used to keep the grounding straps from rubbing on the lamp holders. This particular lamp holder’s (*sealant*) was worn down and the grounding strap was (*shorting to the electrically hot, lamp holder*). This caused the power supply to overheat and blow up. We readjusted the grounding straps to keep them away from the lamp holders. The power supply was suppose to shut the lights off in the event of a short, but this one did not. (*A search of the FAA Service Difficulty Reporting System data base revealed two additional entries having trouble with this power supply.*)
