U.S. Department
of Transportation
**Federal Aviation
Administration**

ADVISORY CIRCULAR

AVIATION MAINTENANCE ALERTS

**ALERT
NUMBER
359**

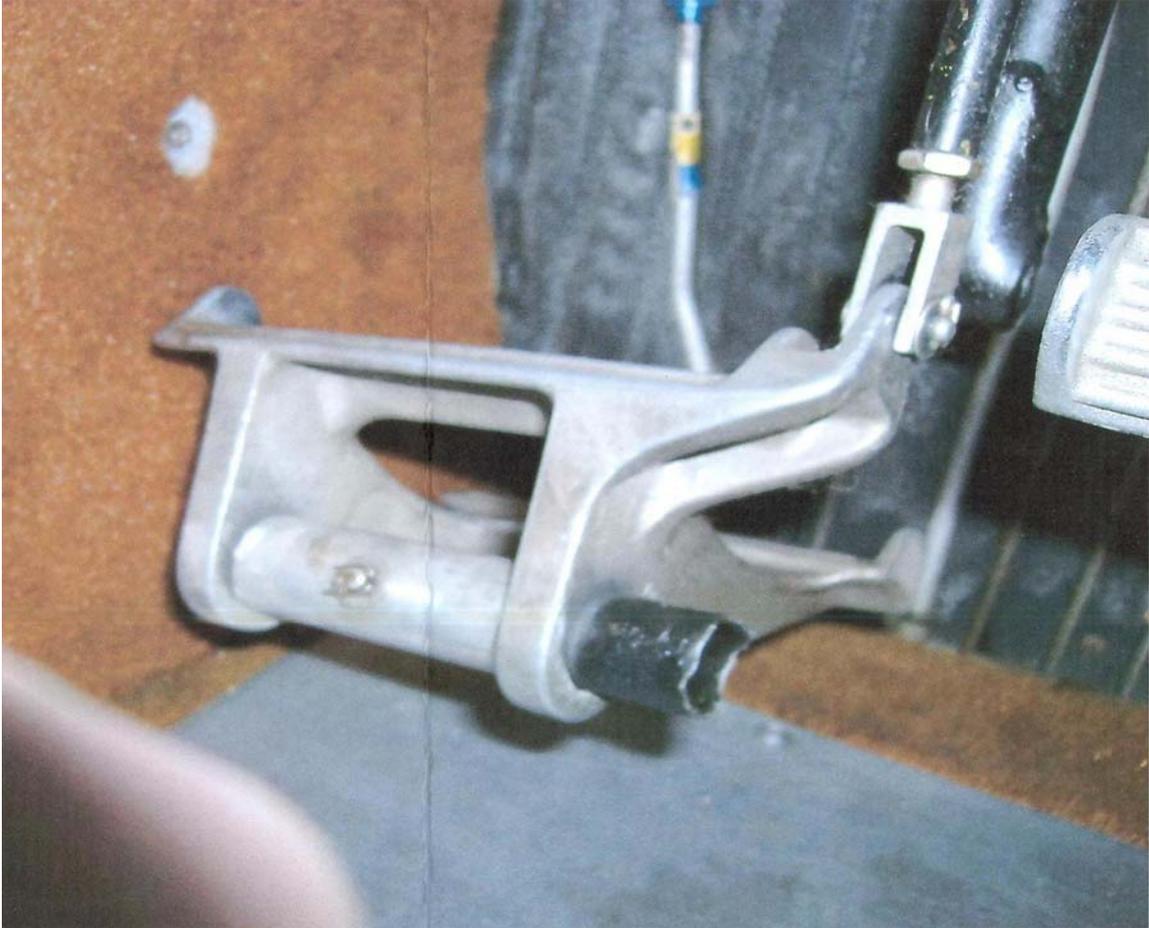
PIPER**Piper: PA24-260; Failed Rudder Torque Tube; ATA 2720**

An unidentified submitter states, “During maintenance run-up and taxi check (after maintenance) the left rudder torque tube broke off (*P/N 2223900*). It appeared to have been cracked for some time prior to failing during taxi. It is suggested the area be cleaned and inspected with a 10X magnifying glass. A borescope with a side view end could also be inserted in the tube to inspect if from the inside. If this had happened during landing and had broken at initial brake application, the aircraft would probably have departed the runway.

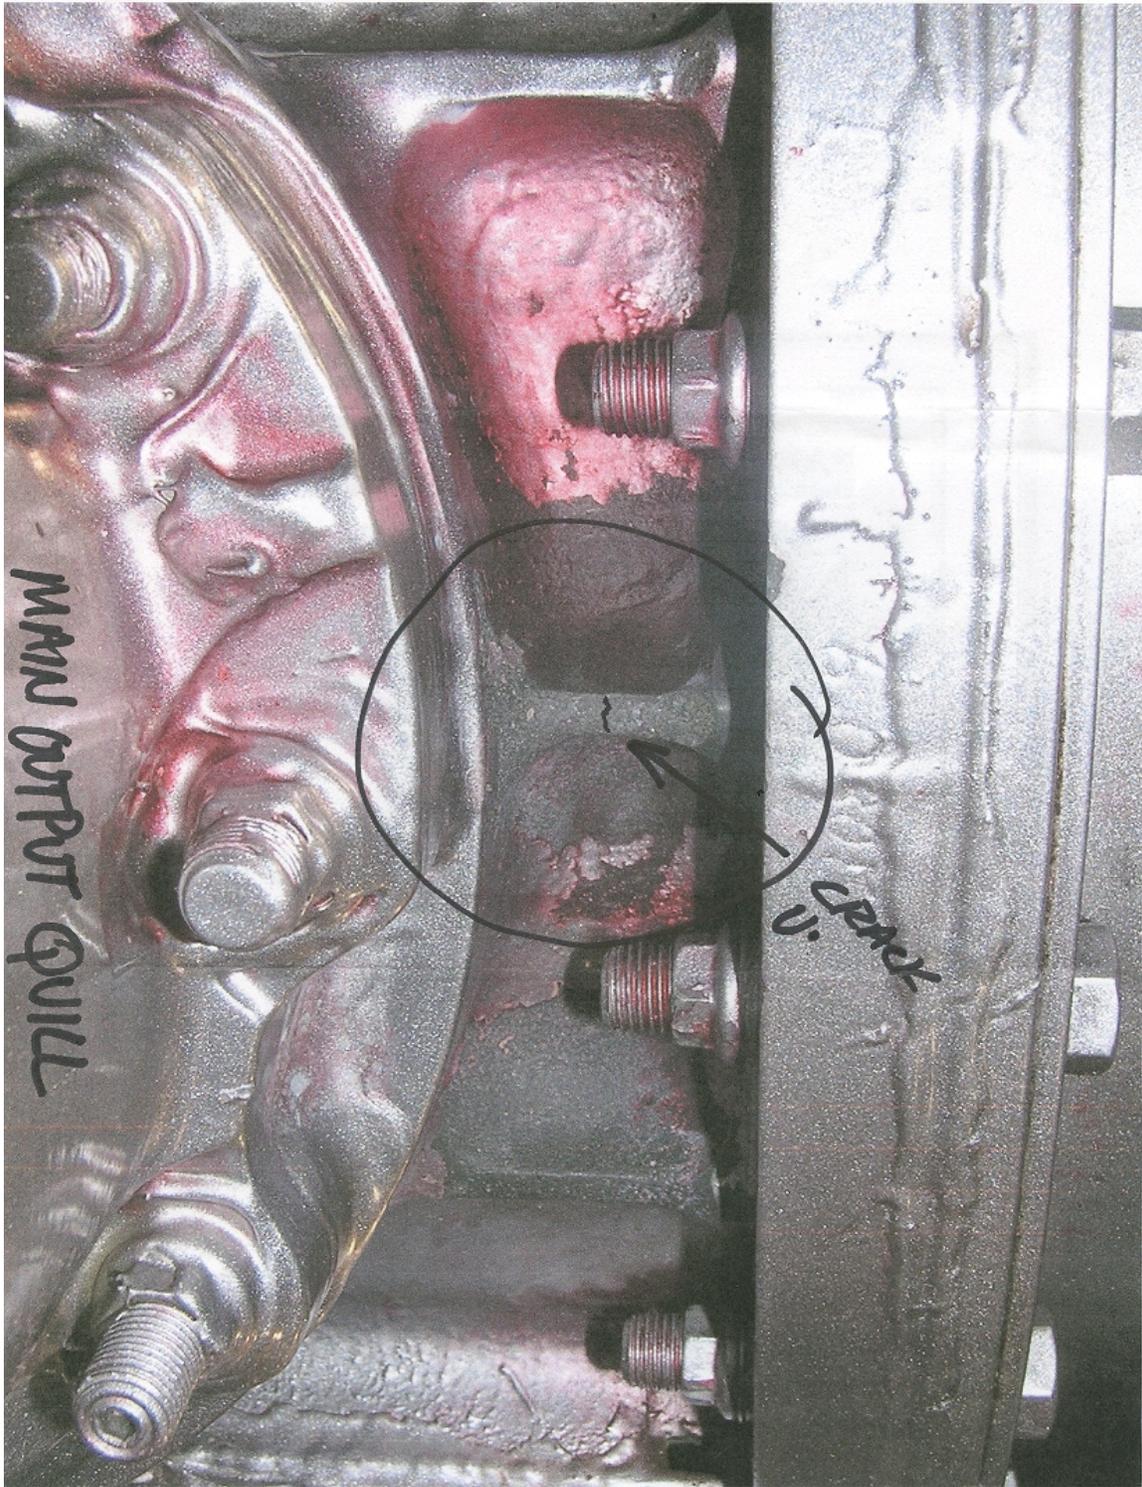
Bell: UH1F; Cracked Gearbox Web Casting; ATA 6320

A technician for a helicopter operator writes, "A crack was found on the main gear box (transmission) in the vertical cast webbing above the engine to transmission drive quill (P/N204-040-016-005). The military technical manual allows ¼ inch radius/polish into the webbing. This crack has been found on three transmissions on other aircraft, with one penetrating the gear box (*sufficiently*) to leak fluid."

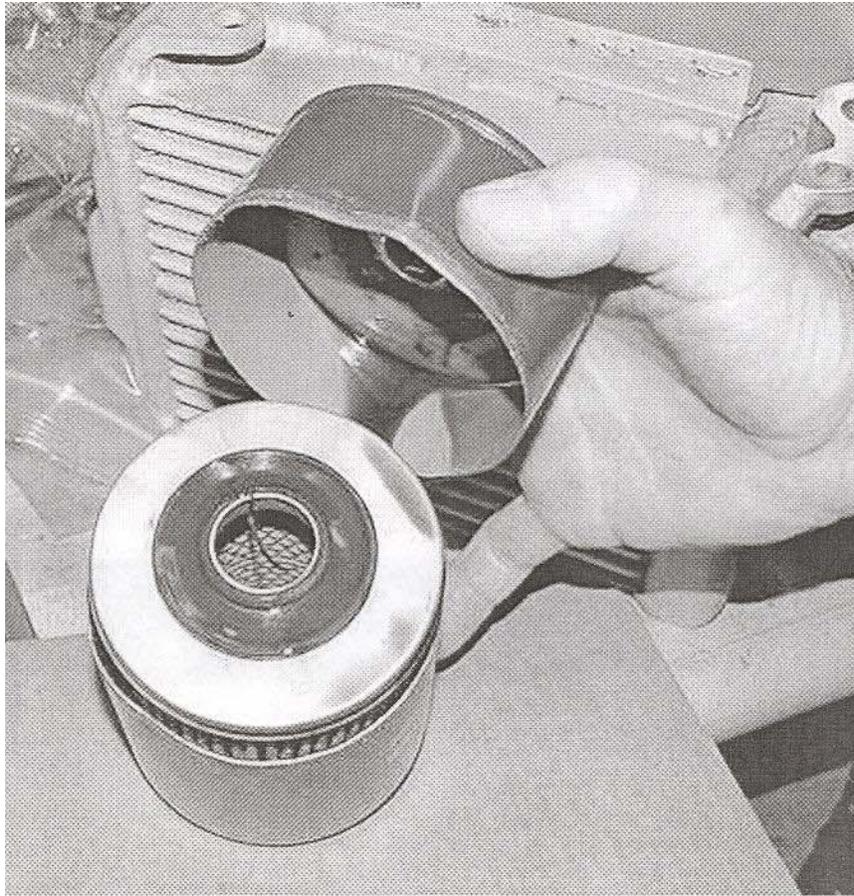
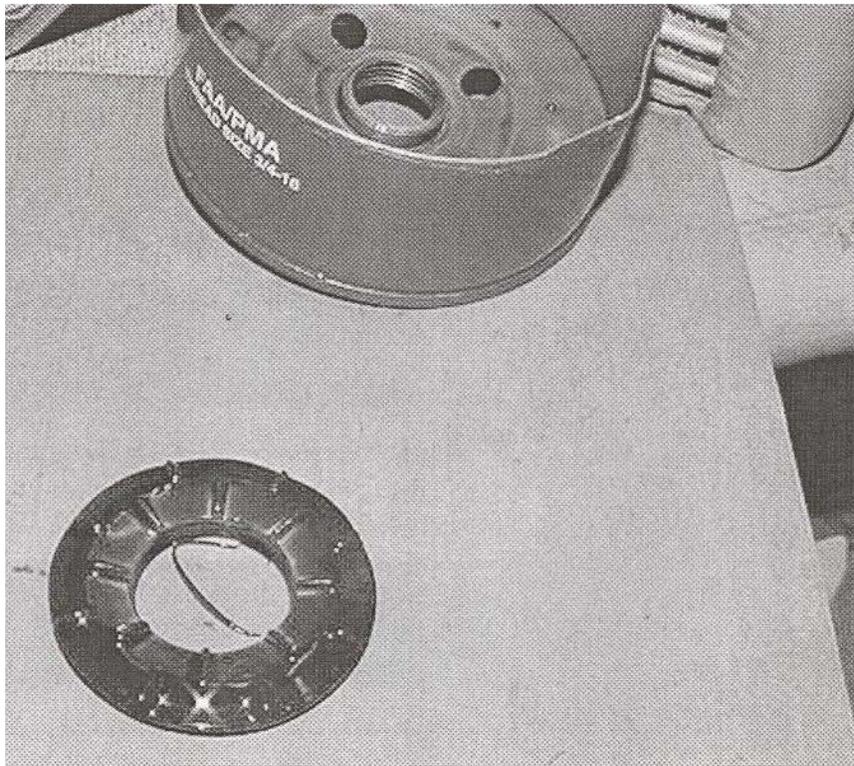
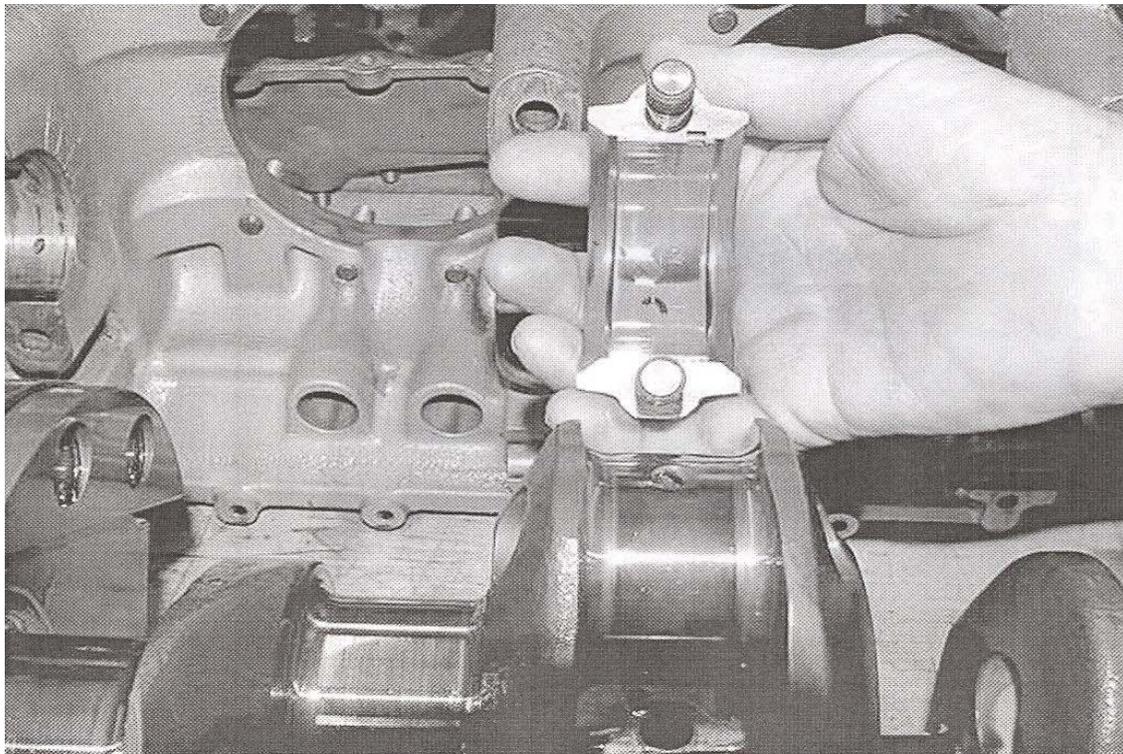
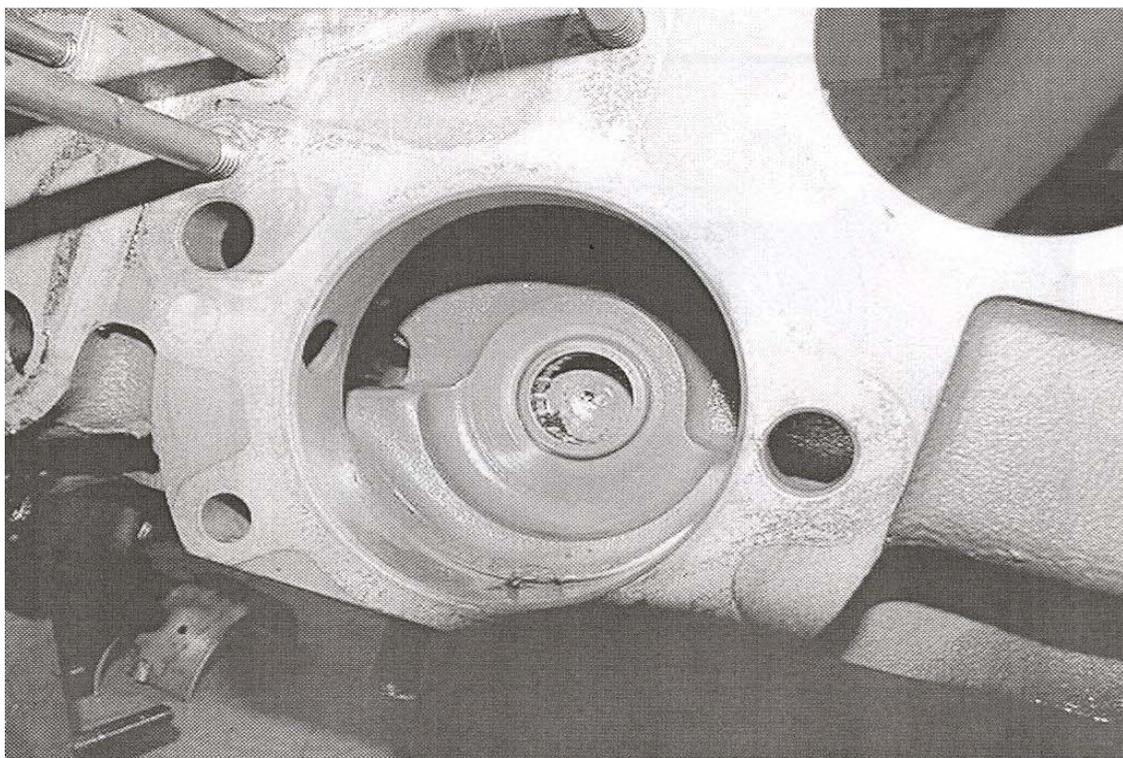
Kelly Oil Filter: ES48109; Defective Filter; ATA 8550

A technician for an operator writes, “On disassembly of this engine rubber debris was found in the oil passage that feeds the starter adapter pilot bearing—the passage was plugged. Upon splitting the engine case debris was found in the oil passage to the #3 main bearing. Both oil cooling jets to this bearing were plugged with rubber debris. The right (*jet*) was plugged with a piece 5/8 inch long, the left a piece 3/16 inch. One piece of rubber debris was located in the oil passage to the #5 bearing.

“This engine had utilized Kelly Aerospace oil filters (P/N ES48109) prior to the engine disassembly. (*Opening this engine’s Kelly filter indicated ...*) the top rubber seal within the filter was damaged—and this damage may have occurred at the time of the filter manufacture. (*Any debris*) from this filter would not be caught by the filter (*material*) because the rubber seal is located on the oil exiting portion of the filter. This debris...may restrict the lubrication to some parts of the engine and eventually result in an engine failure.”
