**Federal Aviation
Administration**

ADVISORY CIRCULAR

AVIATION MAINTENANCE ALERTS

**ALERT
NUMBER
371**

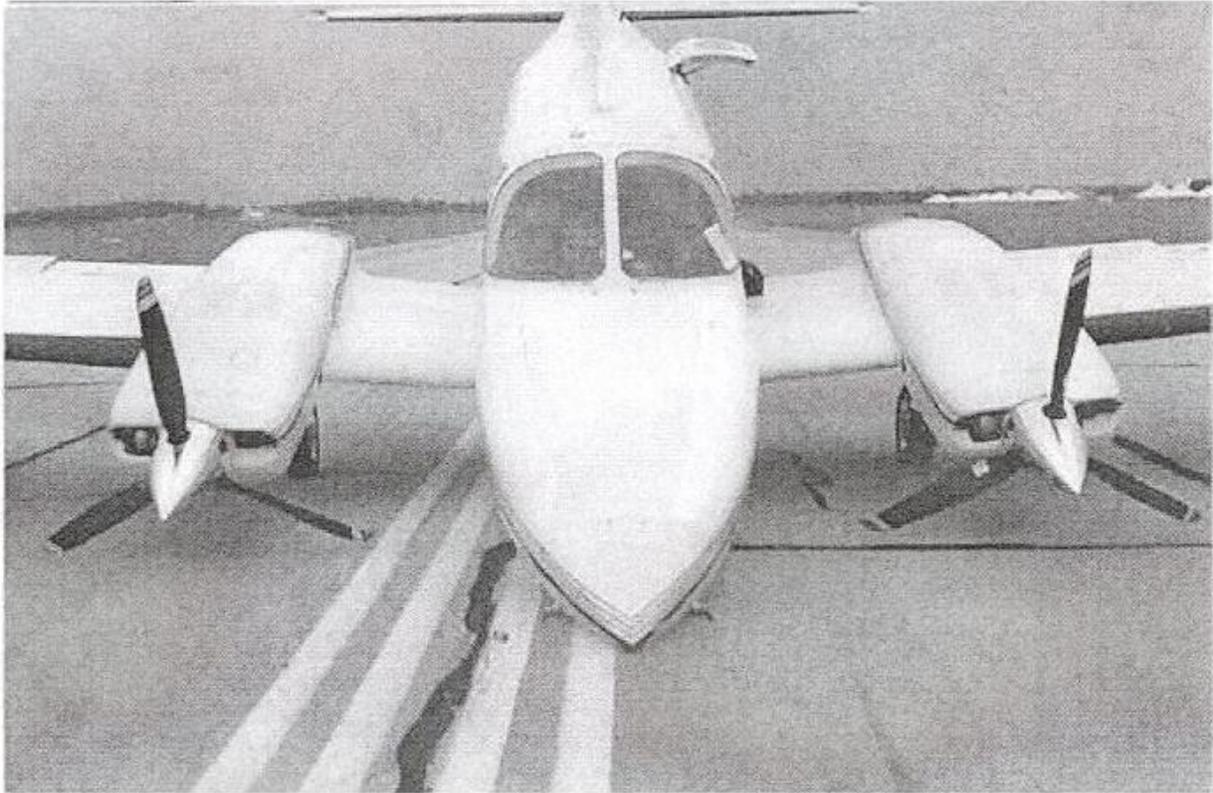
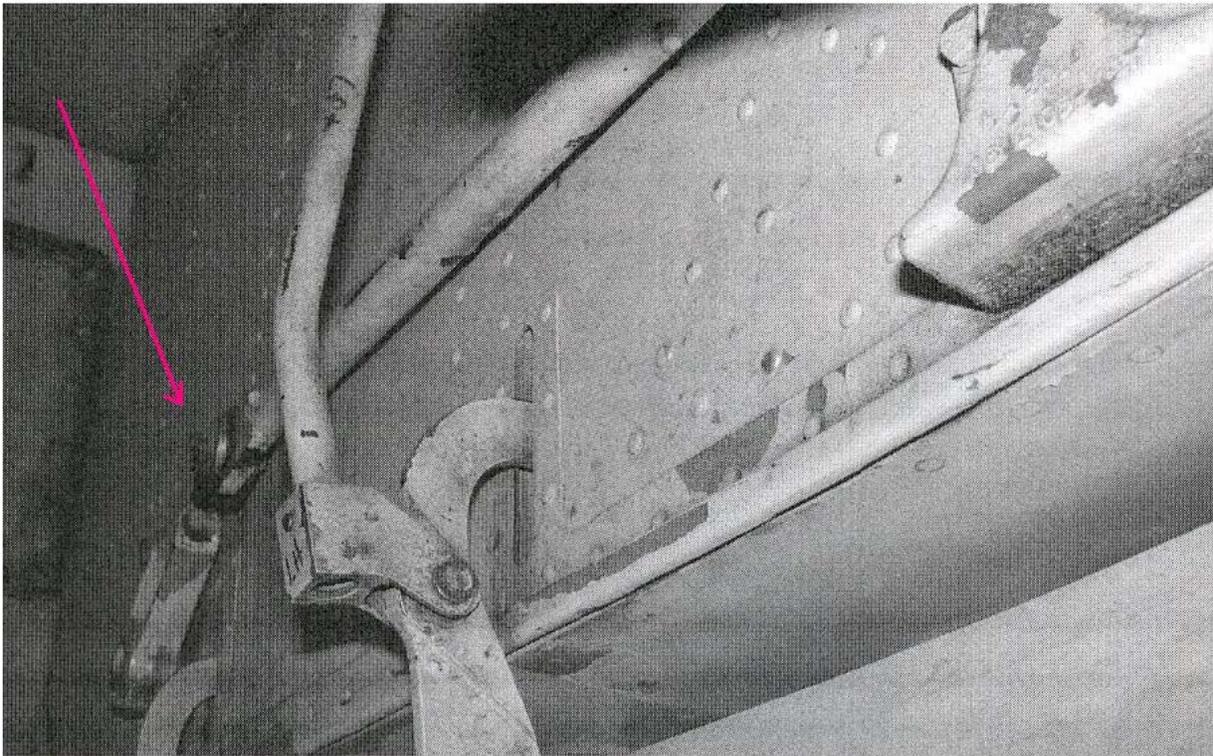
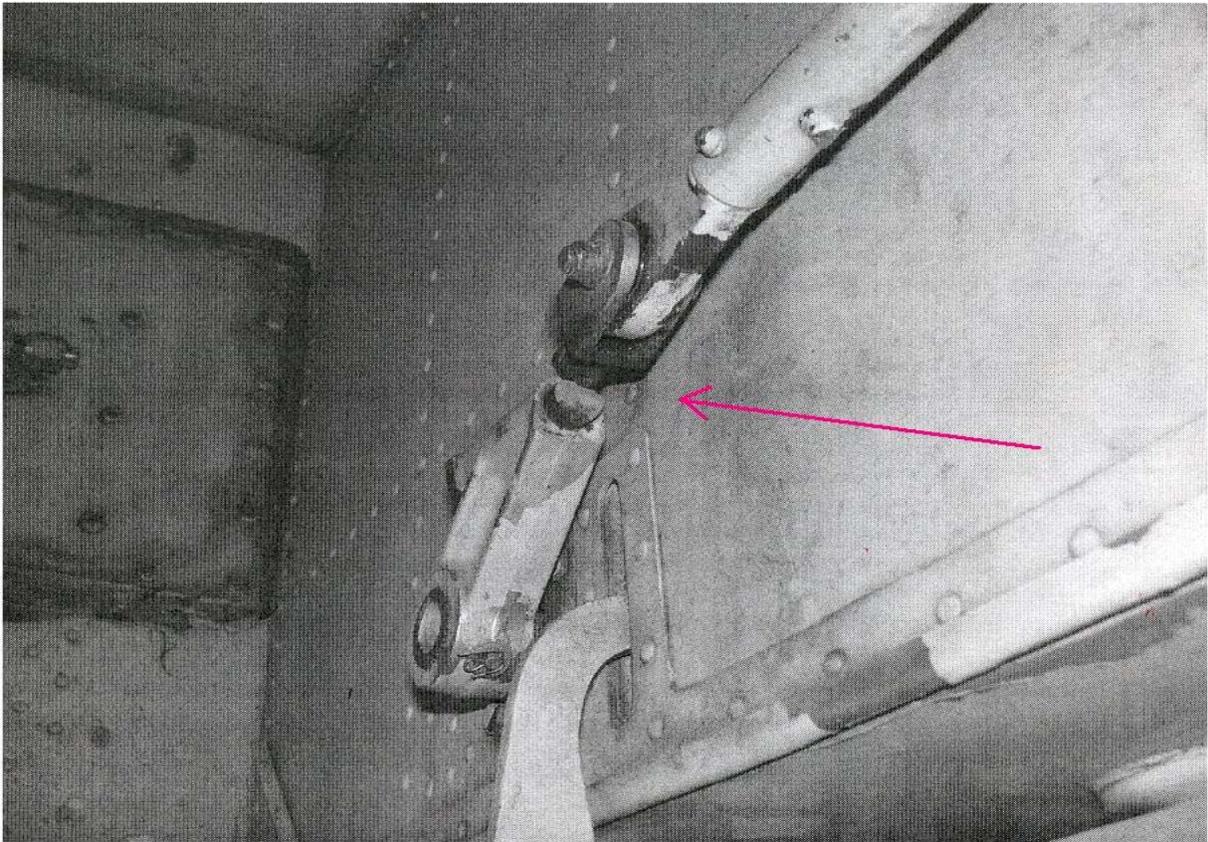
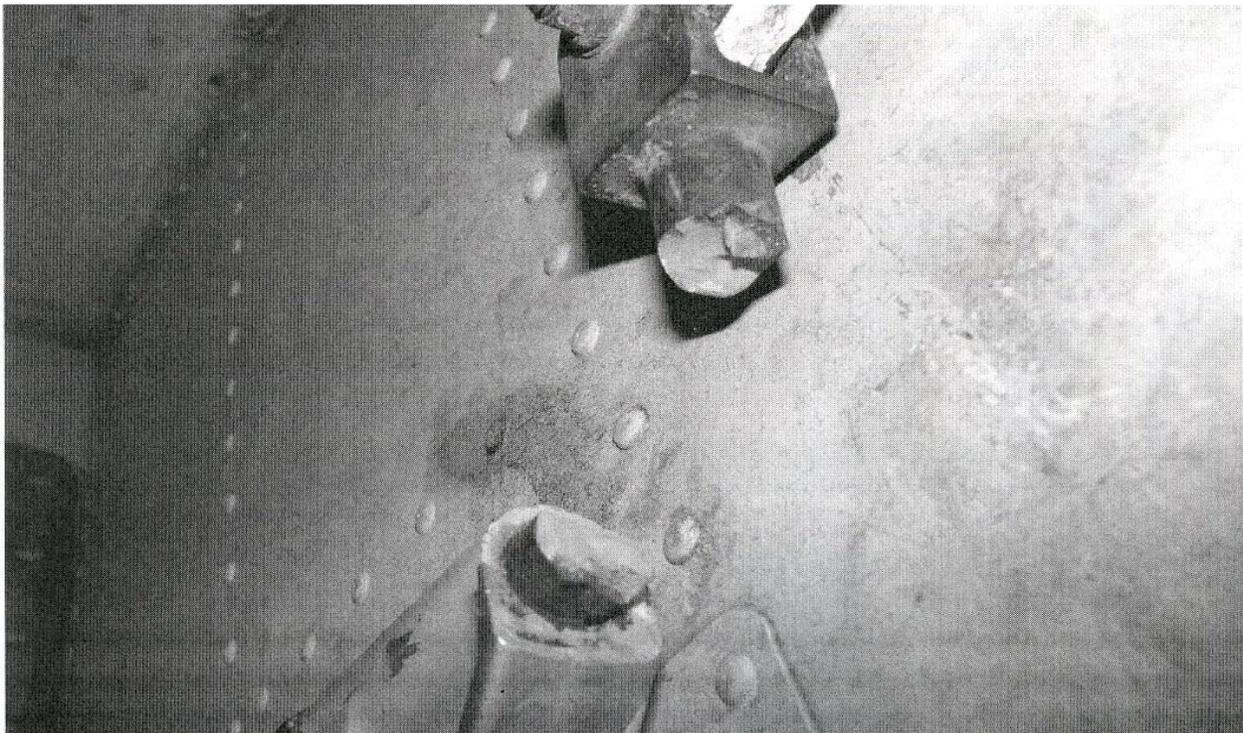
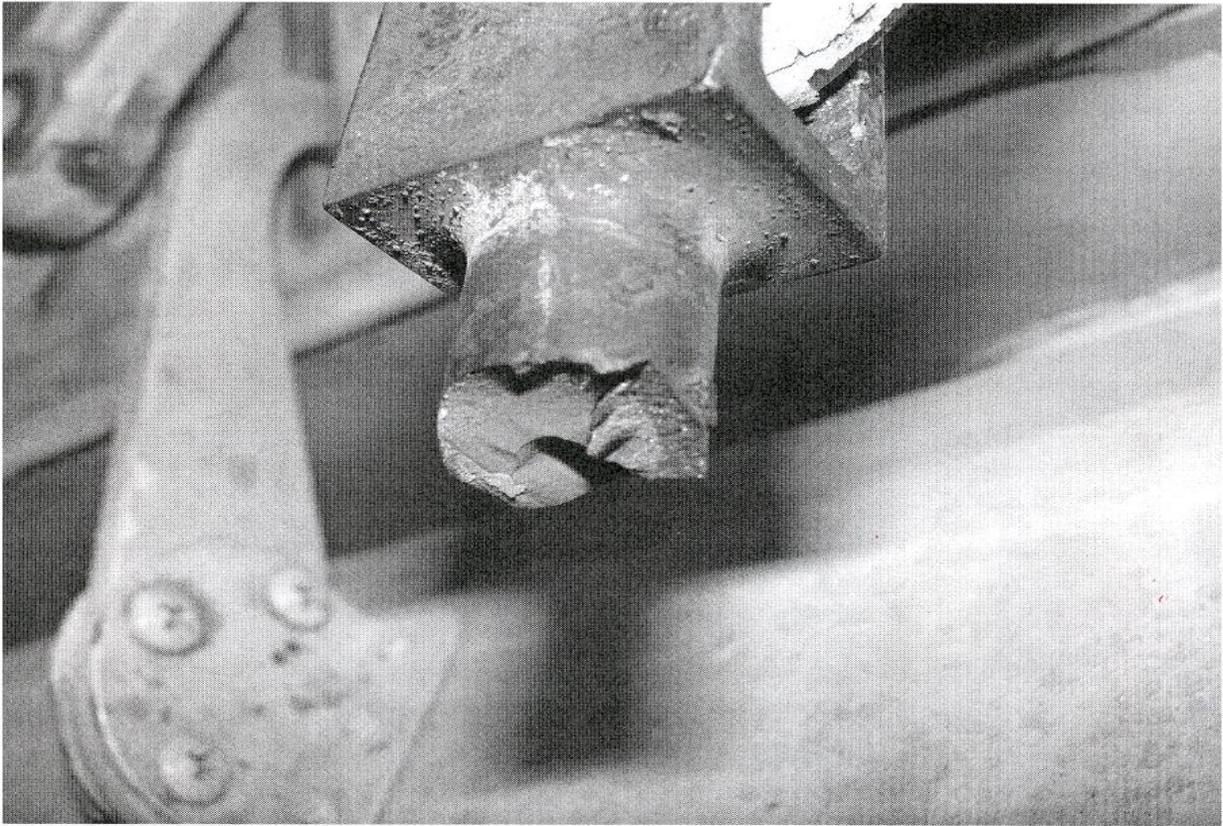
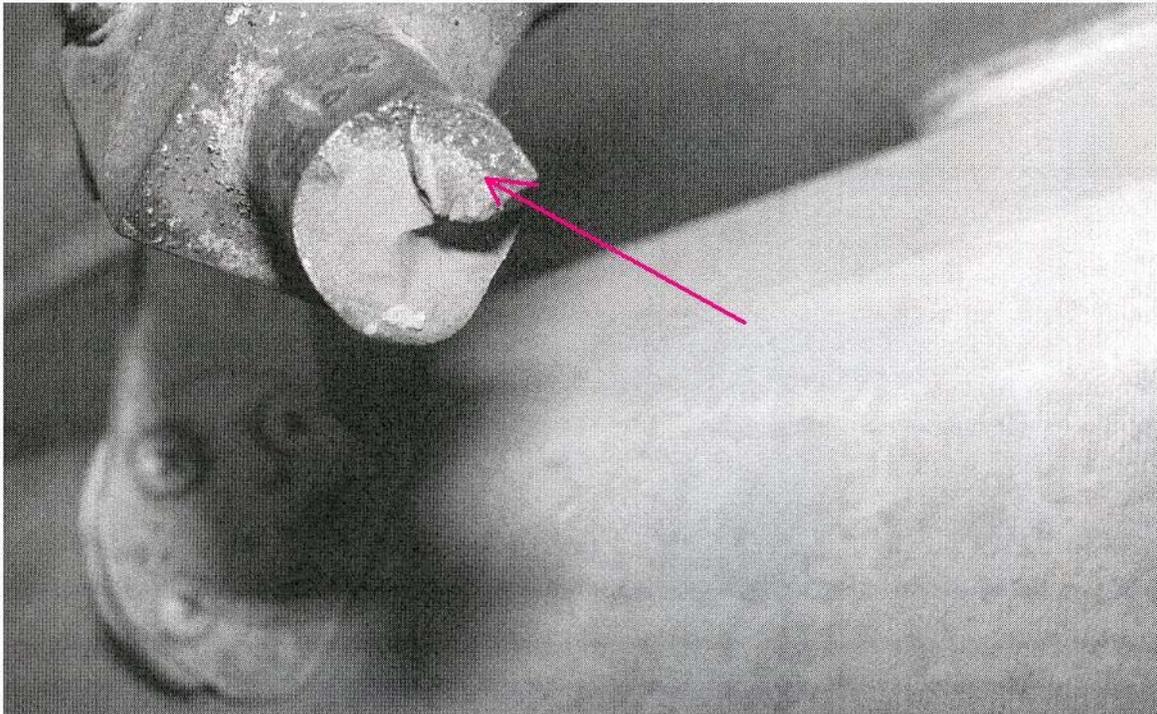
Cessna: 340A; Failed Nose Gear Linkage; ATA 3230

An unidentified submitter writes, "The landing gear 'down' actuation (*in this aircraft*) produced an *unsafe nose gear* indication light. An attempt at manual gear extension proved unsuccessful since the nose landing gear did not extend to a down and locked position. Subsequent damage resulted to the aircraft when the nose landing gear collapsed upon landing. An inspection of the aircraft revealed the nose landing gear linkage adjusting fork (*P/N 5045211-2*) fractured, thereby (*preventing*) the extension of the nose landing gear to a down and locked position. Evidence suggests this fracture was progressive in nature due to indications (*some*) degradation to the component's structure existed prior to failure." (*The following photos will make anyone cringe. The inserted red arrows and slight cropping distortions are artifacts of this editor.*)

(As indicated by the arrow in the last photo, the "time demarcation" is quite apparent. The submitter did not provide a part time with this report, but research indicates this airplane's age in excess of 32 years! It would be telling to compare the costs of new linkages to those of a damaged fuselage, engines, props—much less the experience of having "the bottom" fall out upon touchdown. Thanks for the detailed photographs. A search of the FAA Service Difficulty Reporting System (SDRS) database finds this part number at least six times, five of which are found on Cessna 402B reports: all are failures—Ed.)

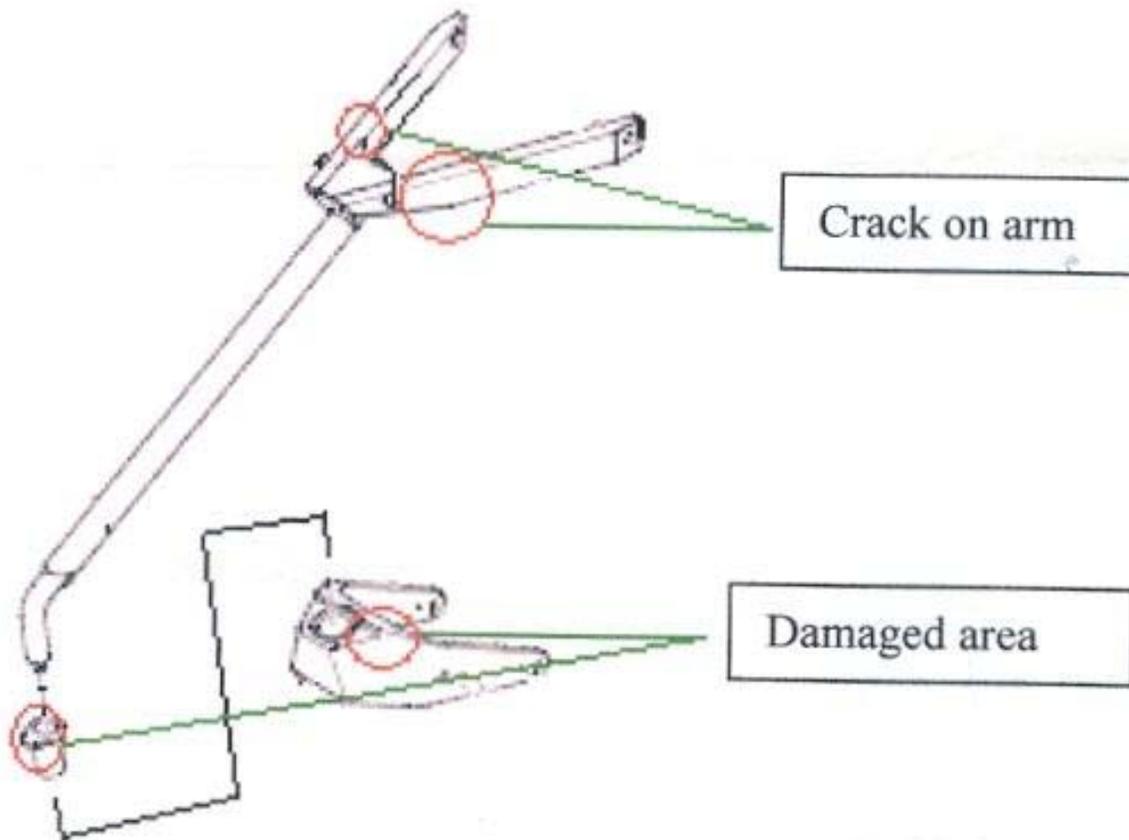
Cirrus: SR20; Cracked Nose Gear Strut; ATA 3222

"A report of 'nose wheel pant damage after landing' (*caused me*) to inspect this aircraft," writes a mechanic. "I found the upper left arm on the nose strut (P/N 11907-005) was seriously cracked. This crack ran from the top of the arm (just forward of the strut data plate) through the entire arm, and stopped at the bottom where a gusset was welded. This (*same*) crack continued to run parallel to the gusset for approximately 0.50 inches. (*I*) also found the nose wheel stop and nose fork were damaged.

"A possible cause (*for these discrepancies*) could be repeated, unreported hard landings. I would recommend all operators to inspect in this area after any hard landing or any excessive stress on the nose gear."
