**Federal Aviation
Administration**

ADVISORY CIRCULAR

AVIATION MAINTENANCE ALERTS

**ALERT
NUMBER
383**

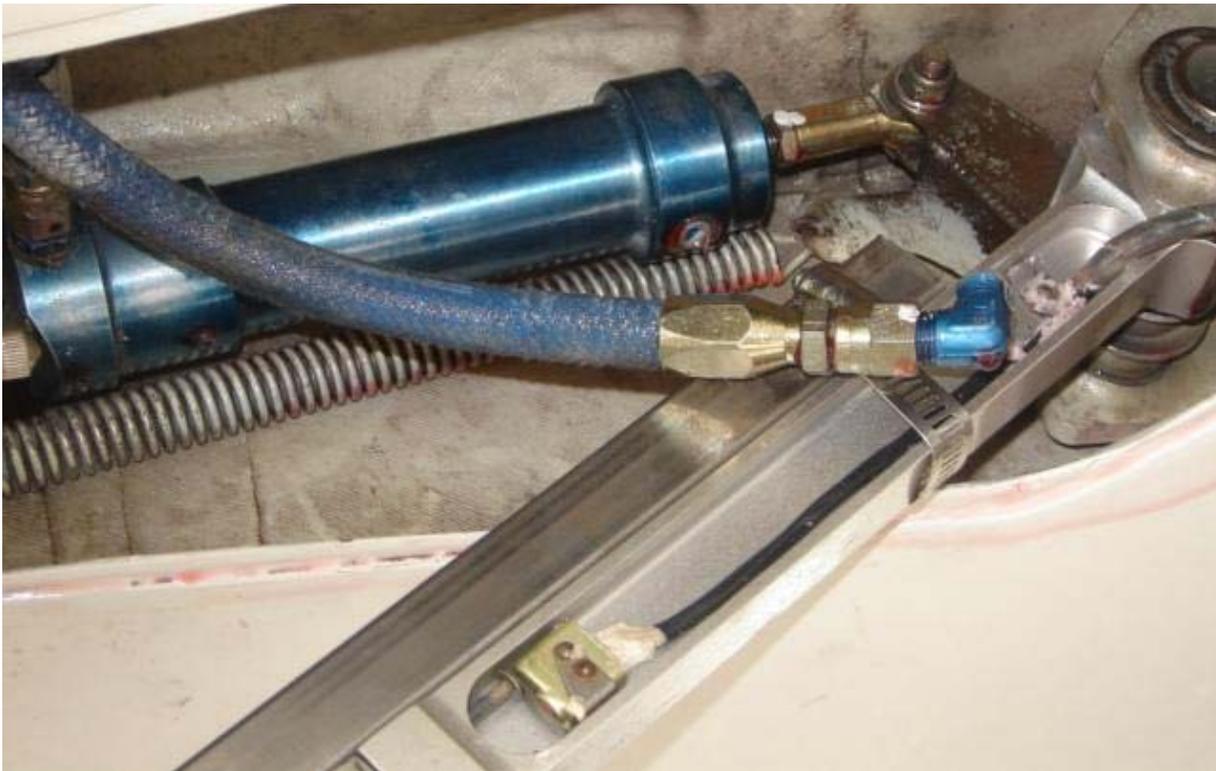
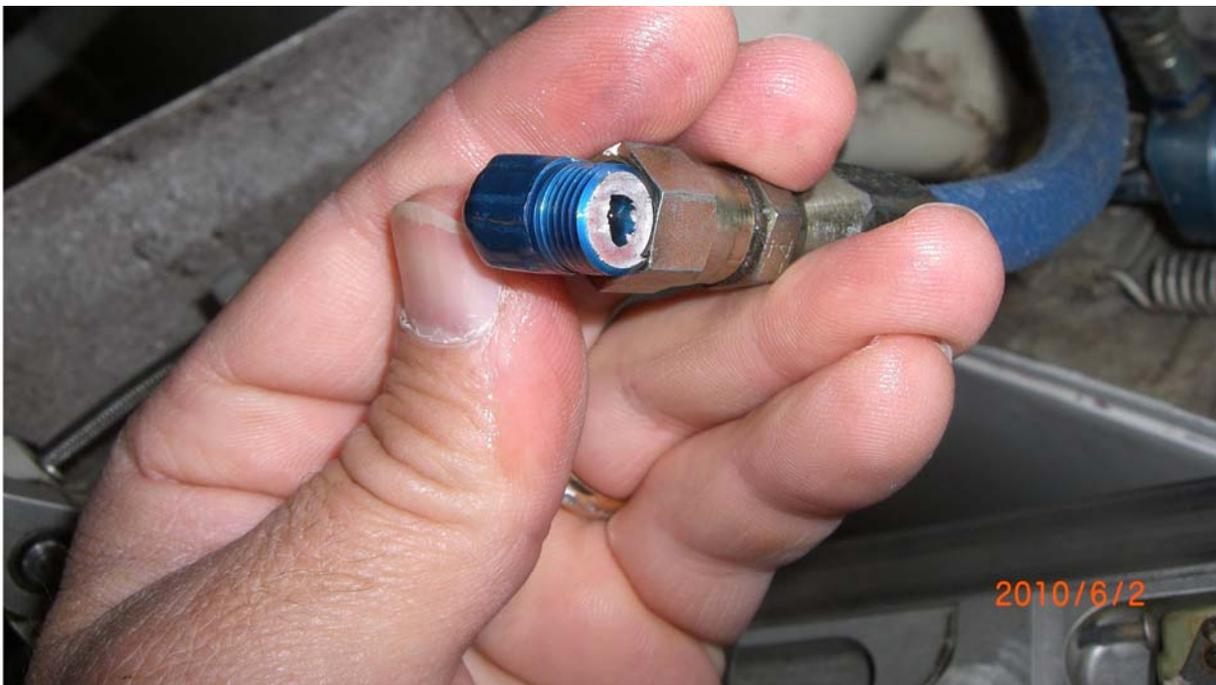
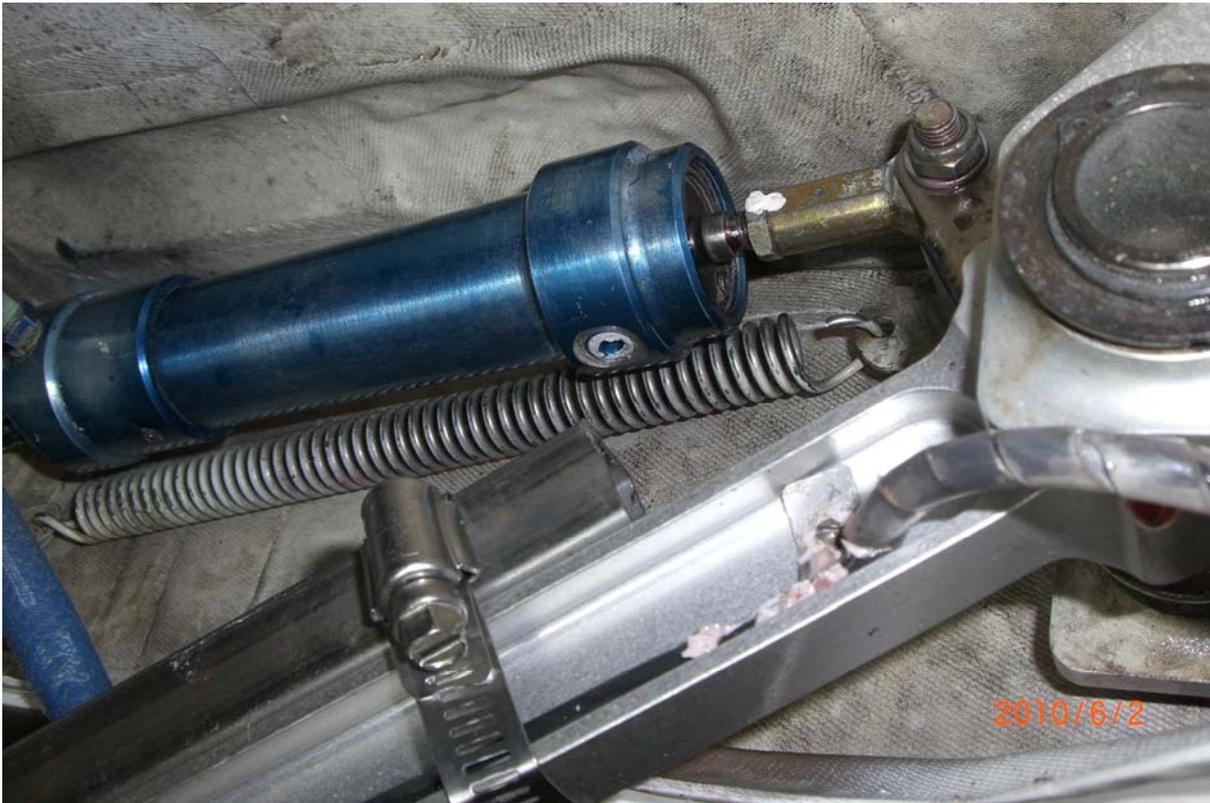
***(Amateur):* Glasair II SGR; Broken Hyd. Actuator Fitting; ATA 3230**

An unidentified submitter says, "The owner/pilot of this aircraft was performing 'touch and go' (*landings*). When preparing for the second landing he noticed he did not have a green landing gear down light for the left main gear." "The pilot elected to land with the landing gear (*positioned*) down.... A safe landing was made, (*sustaining*) minor damage to the aircraft and no injuries to the pilot. Upon examination of the aircraft after recovery, it was determined one of the left main landing gear actuator hydraulic fittings had broken off the actuator. This allowed the hydraulic system to lose a substantial amount of fluid, such that the left main landing gear leg would not completely retract or extend. Physical examination of the broken fitting shows it failed at a point flush with the actuator housing. The 90 degree elbow portion remained attached to the flexible hose assembly. Examination of the gear well and the general layout of the gear components show the flex hose may have been stress loaded while the gear was in the (*retracted position*). This may have...focused high loads on the hose elbow at the actuator housing. The gear actuator may also be rubbing against the top of the wheel well at the outboard edge. All of these (*observations*) were noted by both the owner and the airport's (*attending*) mechanic." (*Hydraulic fitting P/N: MS20822*).

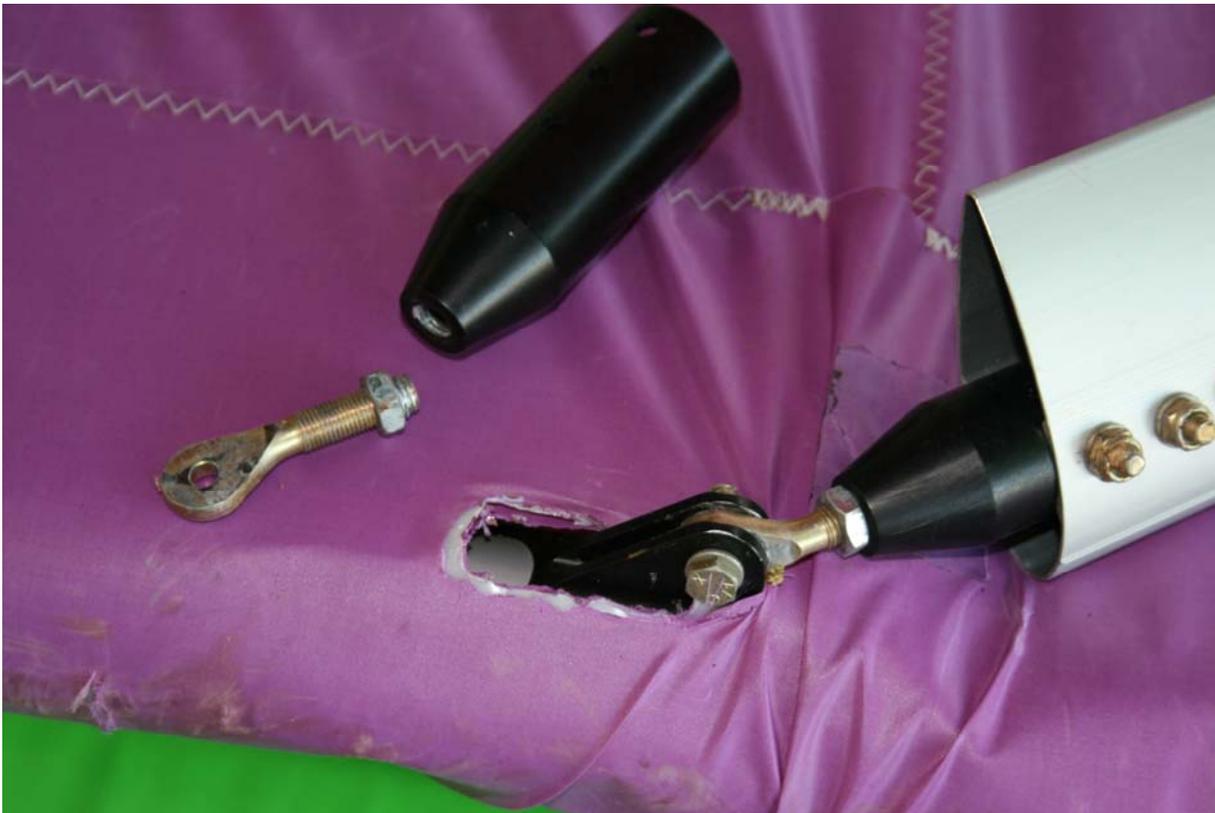
This aircraft was involved in a near disastrous event when the left hand, aft wing strut attachment eyebolt pulled out of the threaded lift strut fitting, resulting in loss of vertical control. Fortunately for the pilot/owner, he landed in a tree—breaking his fall to the ground. He walked away from this accident, but the 2S sustained substantial damage.

Post-accident investigation revealed the eyebolt was improperly installed in the lift strut fitting. The Sport 2S *Assembly, Maintenance and Parts* manual clearly provides detailed information on the proper assembly of this critical wing attach component. The manual specifies a minimum of 5/8 inch engagement of the threaded portion of the eyebolt into the fitting with 3 1/2 threads exposed. The accident eyebolt/fitting had 3/32 inch engagement with 16 threads exposed.

The following picture shows the failed eyebolt to lift strut fitting. It is positioned near the opposite wing's correctly assembled parts for comparison.

Any builder of an experimental aircraft is responsible for following all assembly instructions, including important notes and warnings. And any person inspecting or maintaining an experimental aircraft should be equally aware of these assembly specifications, checking for proper installation.

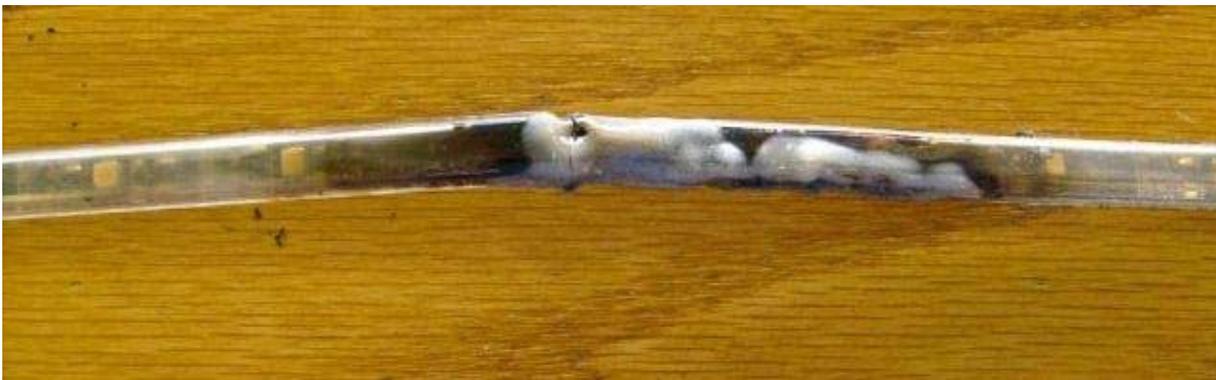
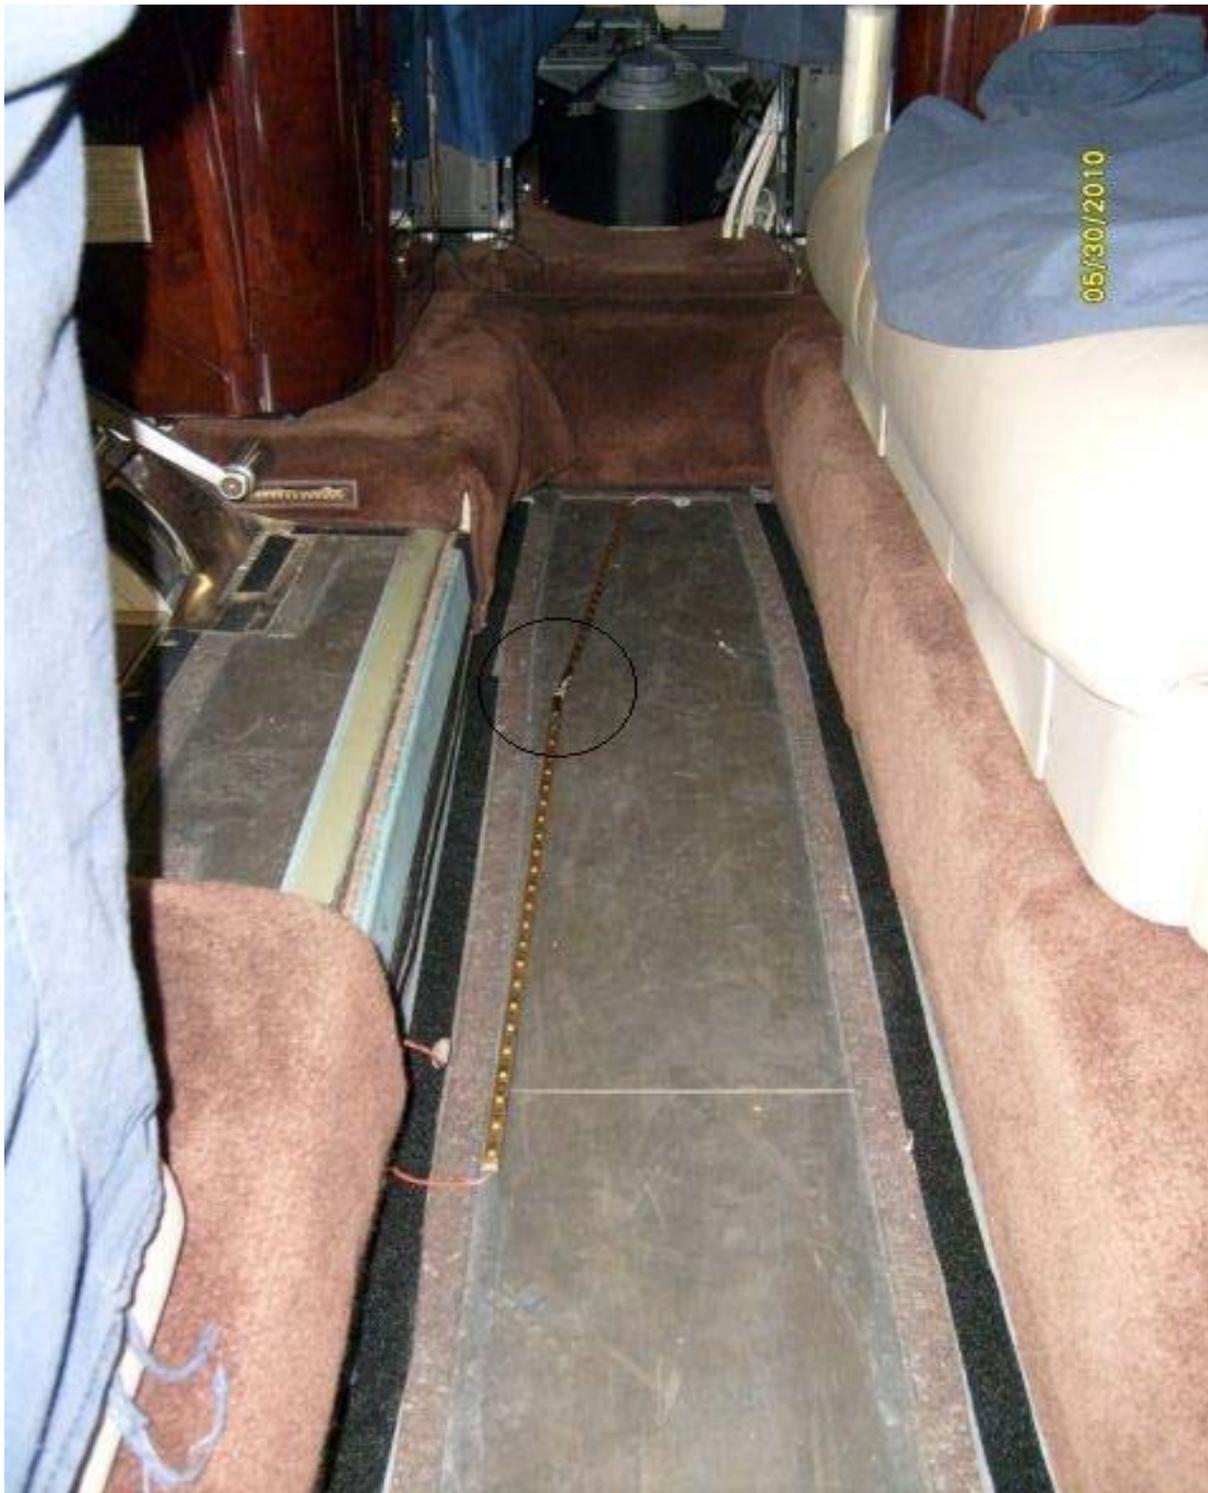
"During subsequent maintenance activity, personnel found a melted drop-isle lighting strip (P/N 9919040-26) which may be the root cause of the previously reported cockpit smoke."

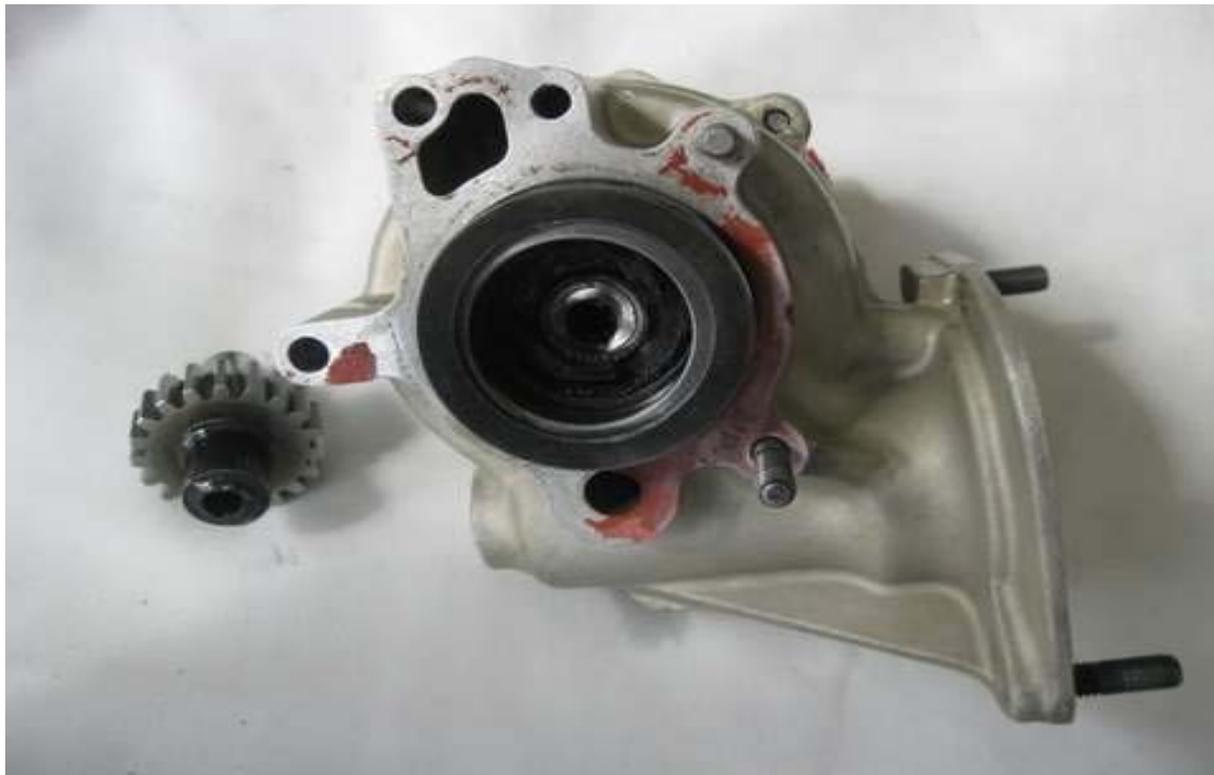
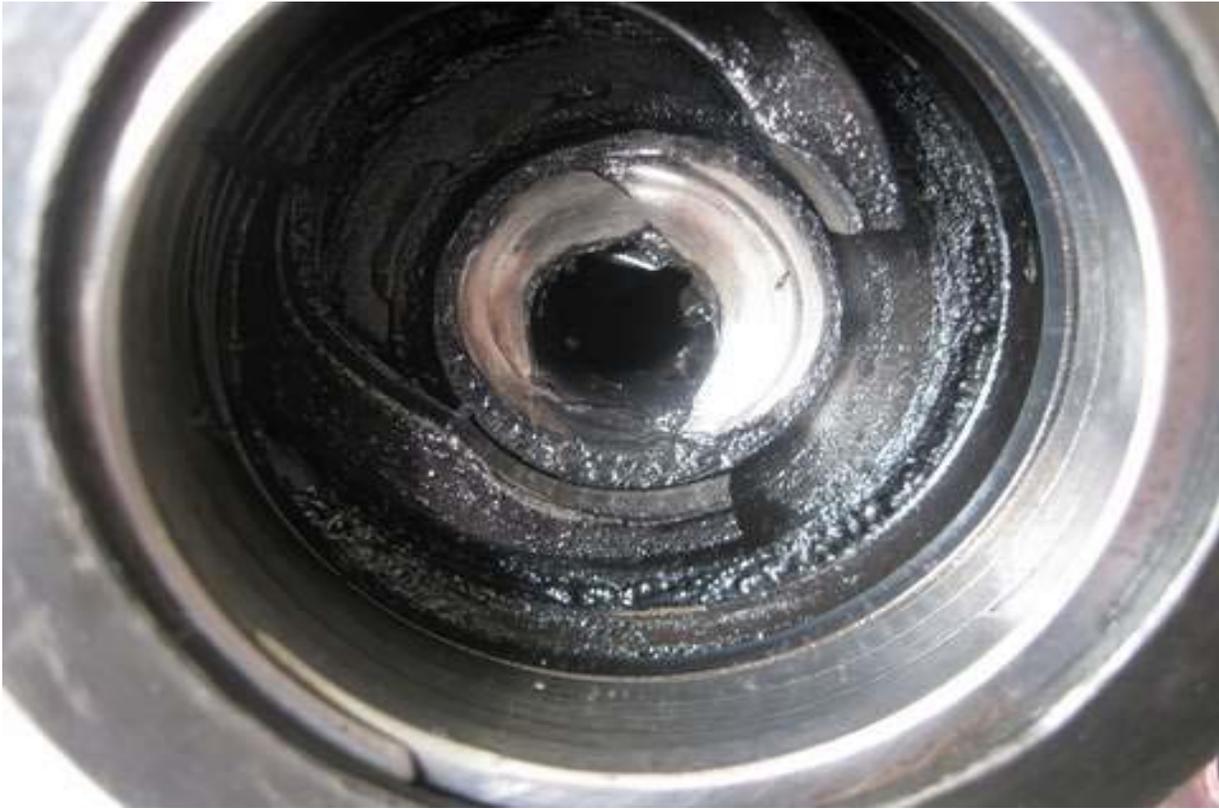
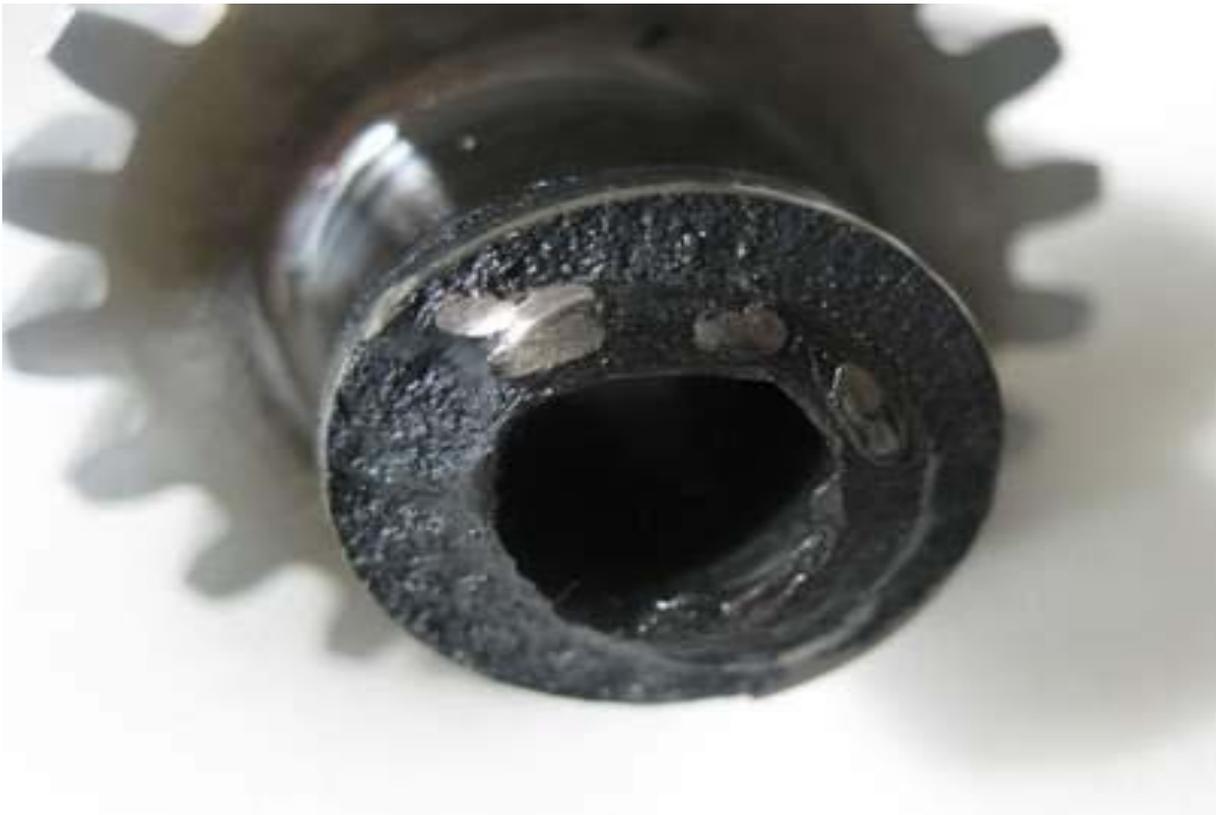
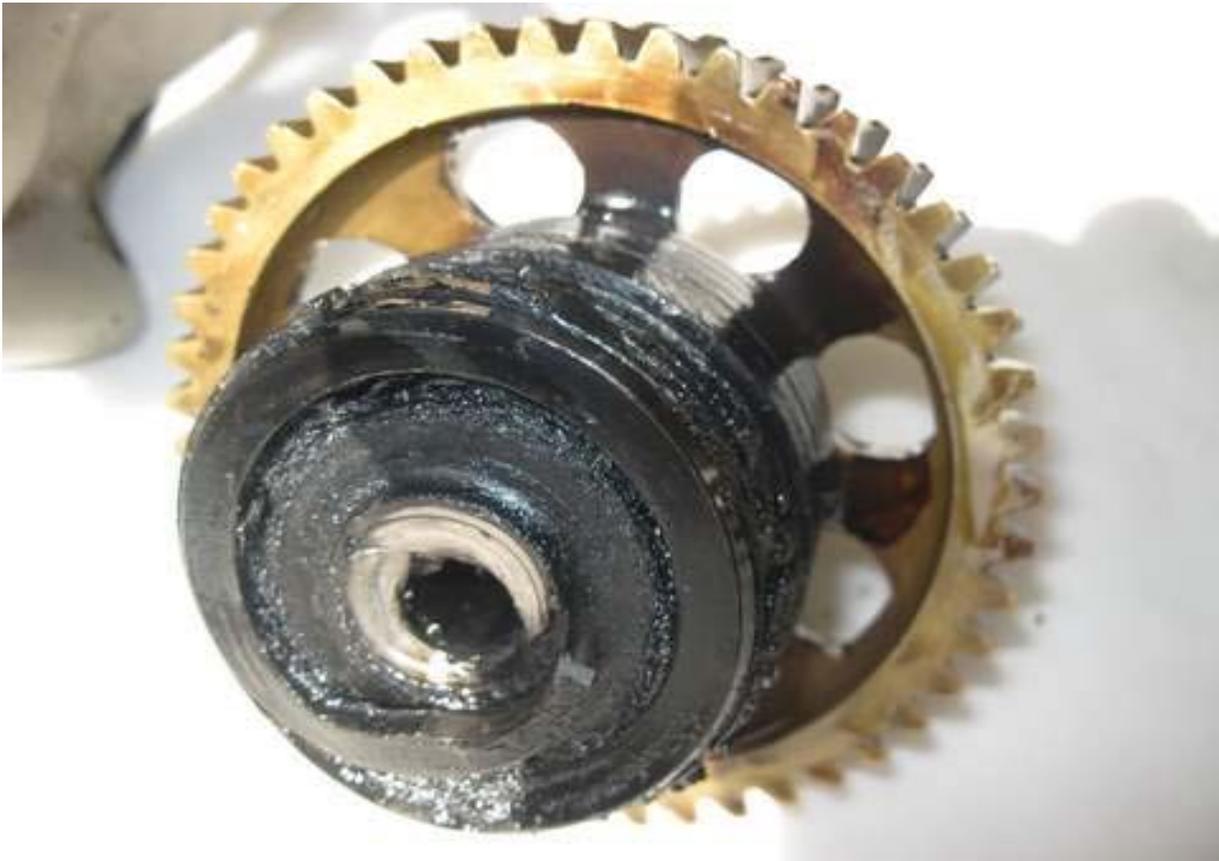
(Photos of adapter having less than five hours time.)

The unidentified technician states, "The newly overhauled starter adapter failed approximately five hours after installation (*1.4 hours for the second report*). Disassembly and failure analysis of the unit revealed an overheated and mangled clutch spring. The spring had a collapsed coil that wound around the shaft gear minor diameter, between the clutch drum and integral spur gear. The collapsed coil had overheated the shaft gear so severely that it twisted into two (*pieces*). Mangled clutch springs and separated shaft gears make in-flight engine re-start impossible. Both cause significant oil contamination. The shaft gear separation stops operation of the turbocharger scavenge pump, which could cause loss of oil past the turbocharger seals and possible engine oil starvation. A separated shaft could damage crankcase pilot and cam/crank gear teeth, (*resulting*) in possible engine loss.

"We strongly suspect starter motor run-on after engine start. Starter run-on can only be caused by a faulty aircraft starter switch or relay. Most starter relays are airframe parts not replaced at overhaul or repair of the engine or starter. If starter adapter failure occurs, we recommend troubleshooting and failure analysis of the entire aircraft starting system to determine the root cause(s). (*This may*) prevent recurrence of the failure. We recommend the aircraft starter relay be replaced every 10 years or 3,000 hours or every second engine change (whichever comes first), and whenever starter adapter failure or starter motor failure occur. Relay service information should include minimum spring force and contact gap. This is the fourth such failure (*we have*) seen." (*Starter P/N: 642085A17. Clutch Spring P/N: AS539800M015.*)

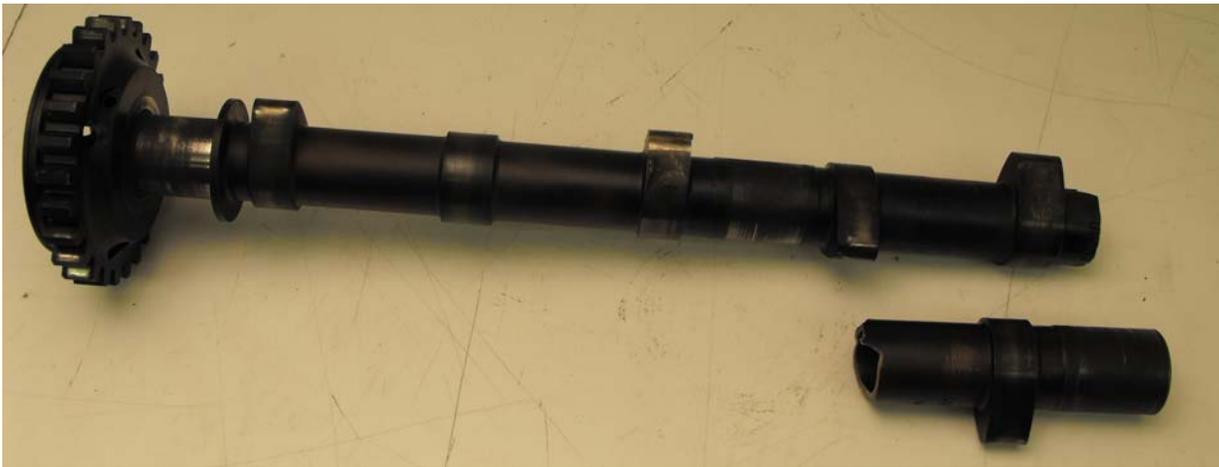
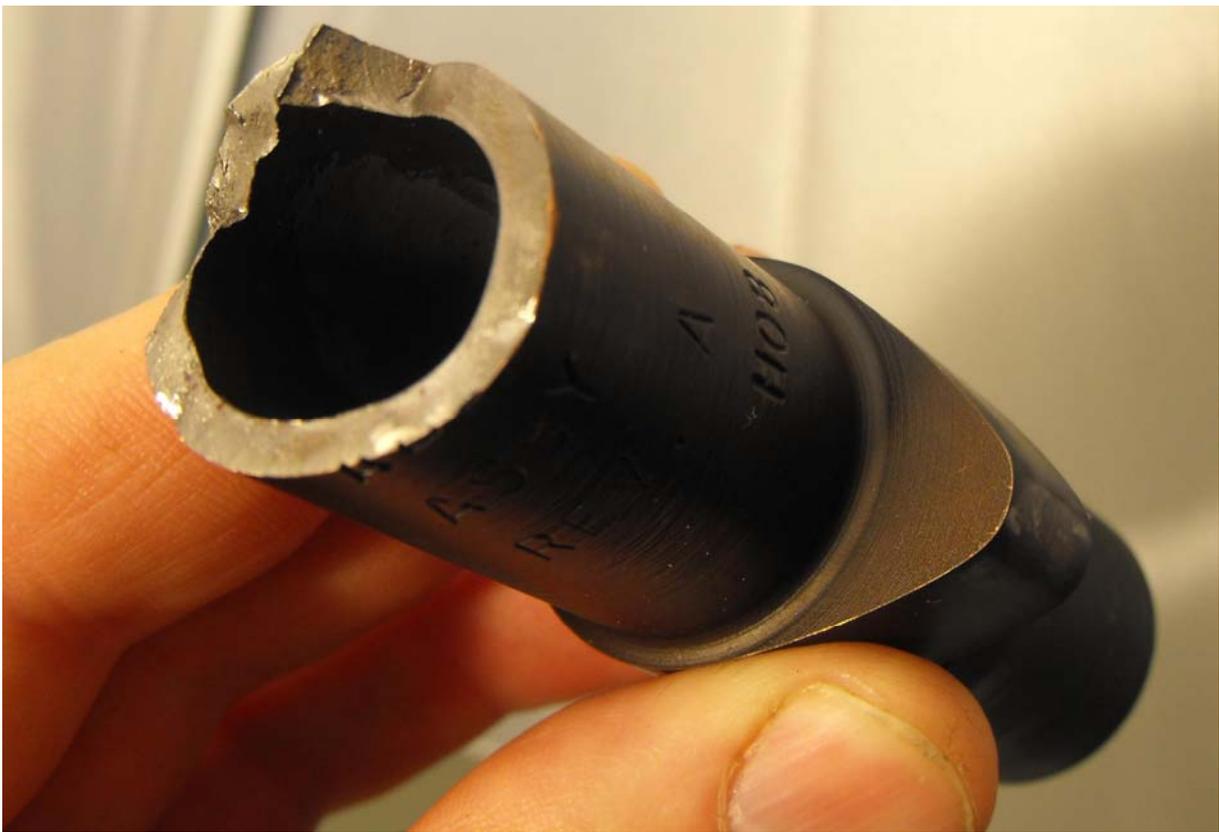
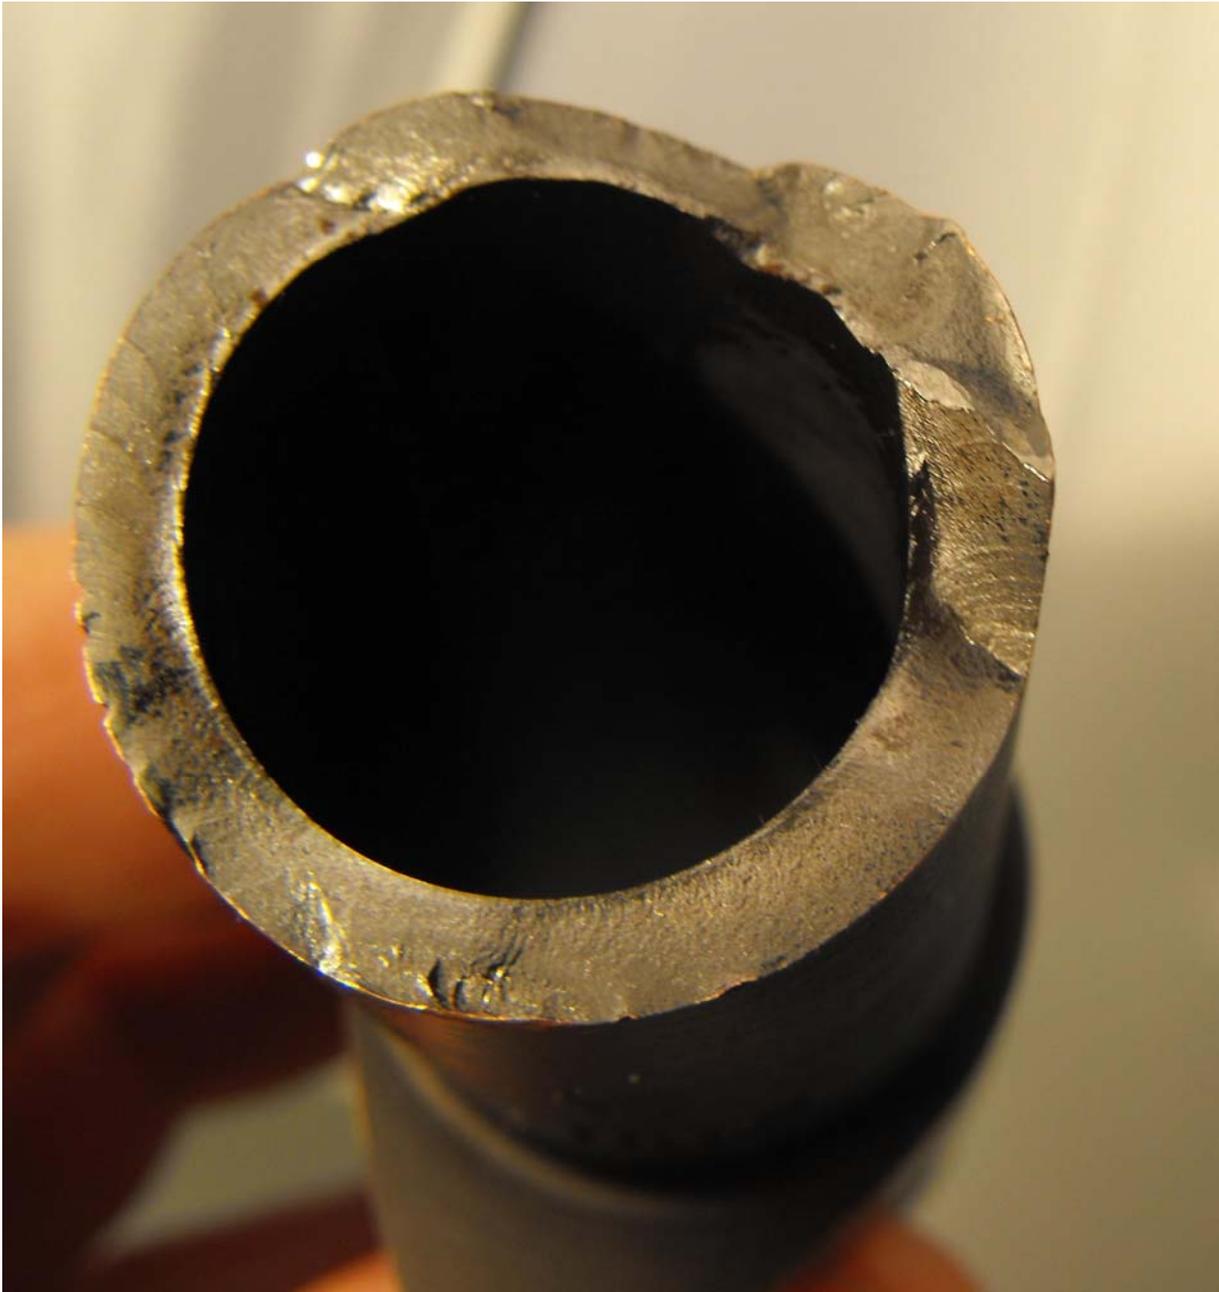
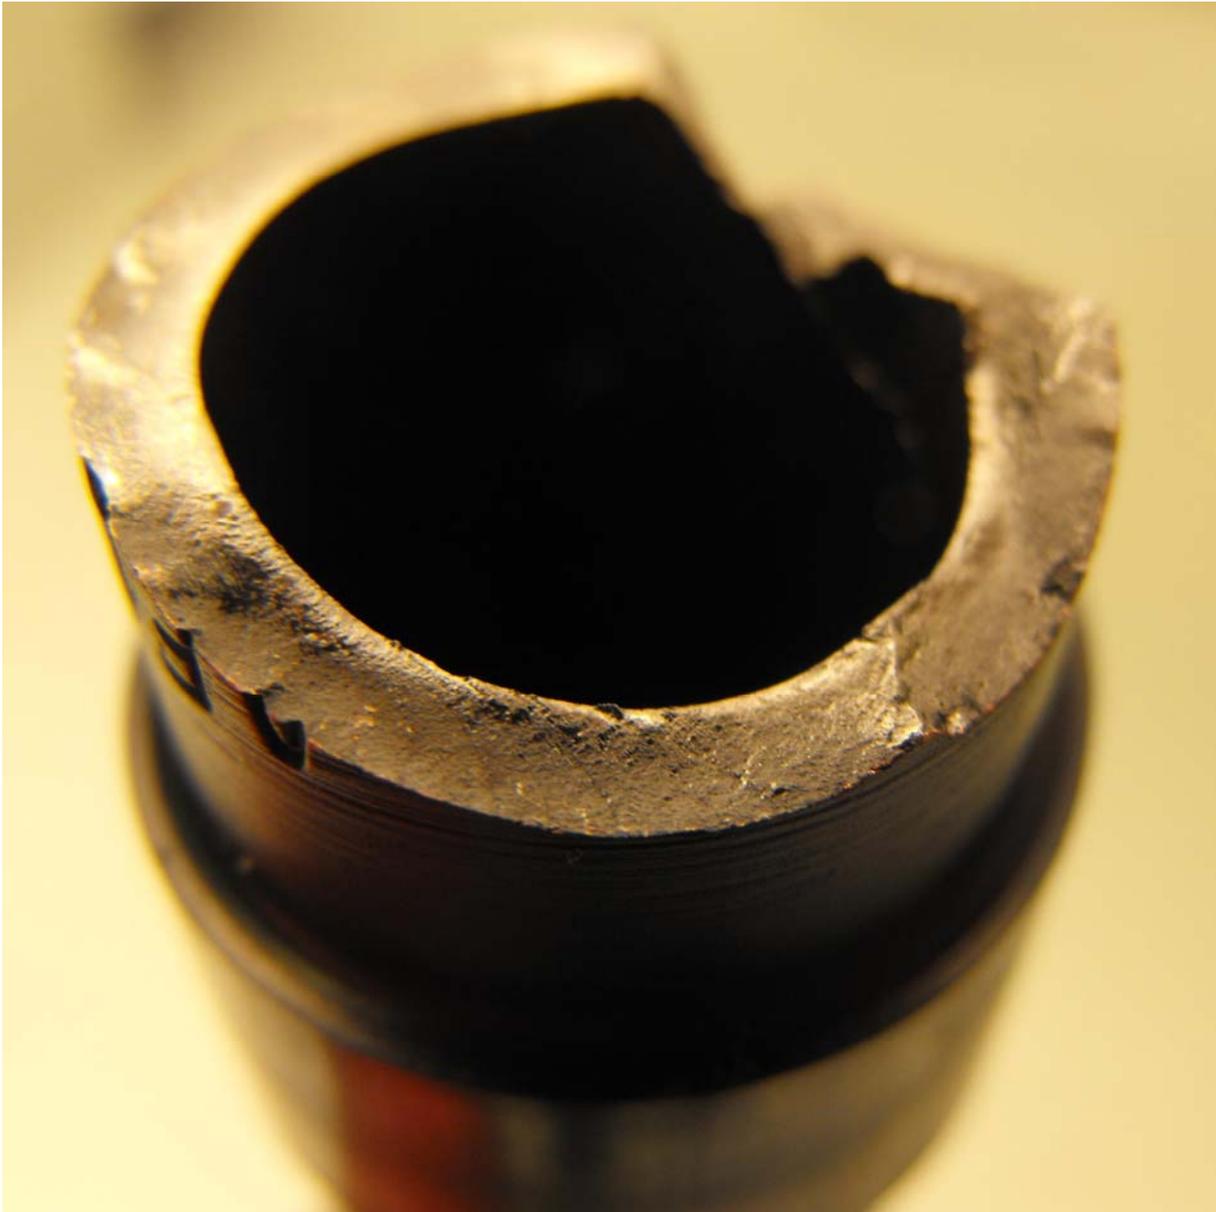
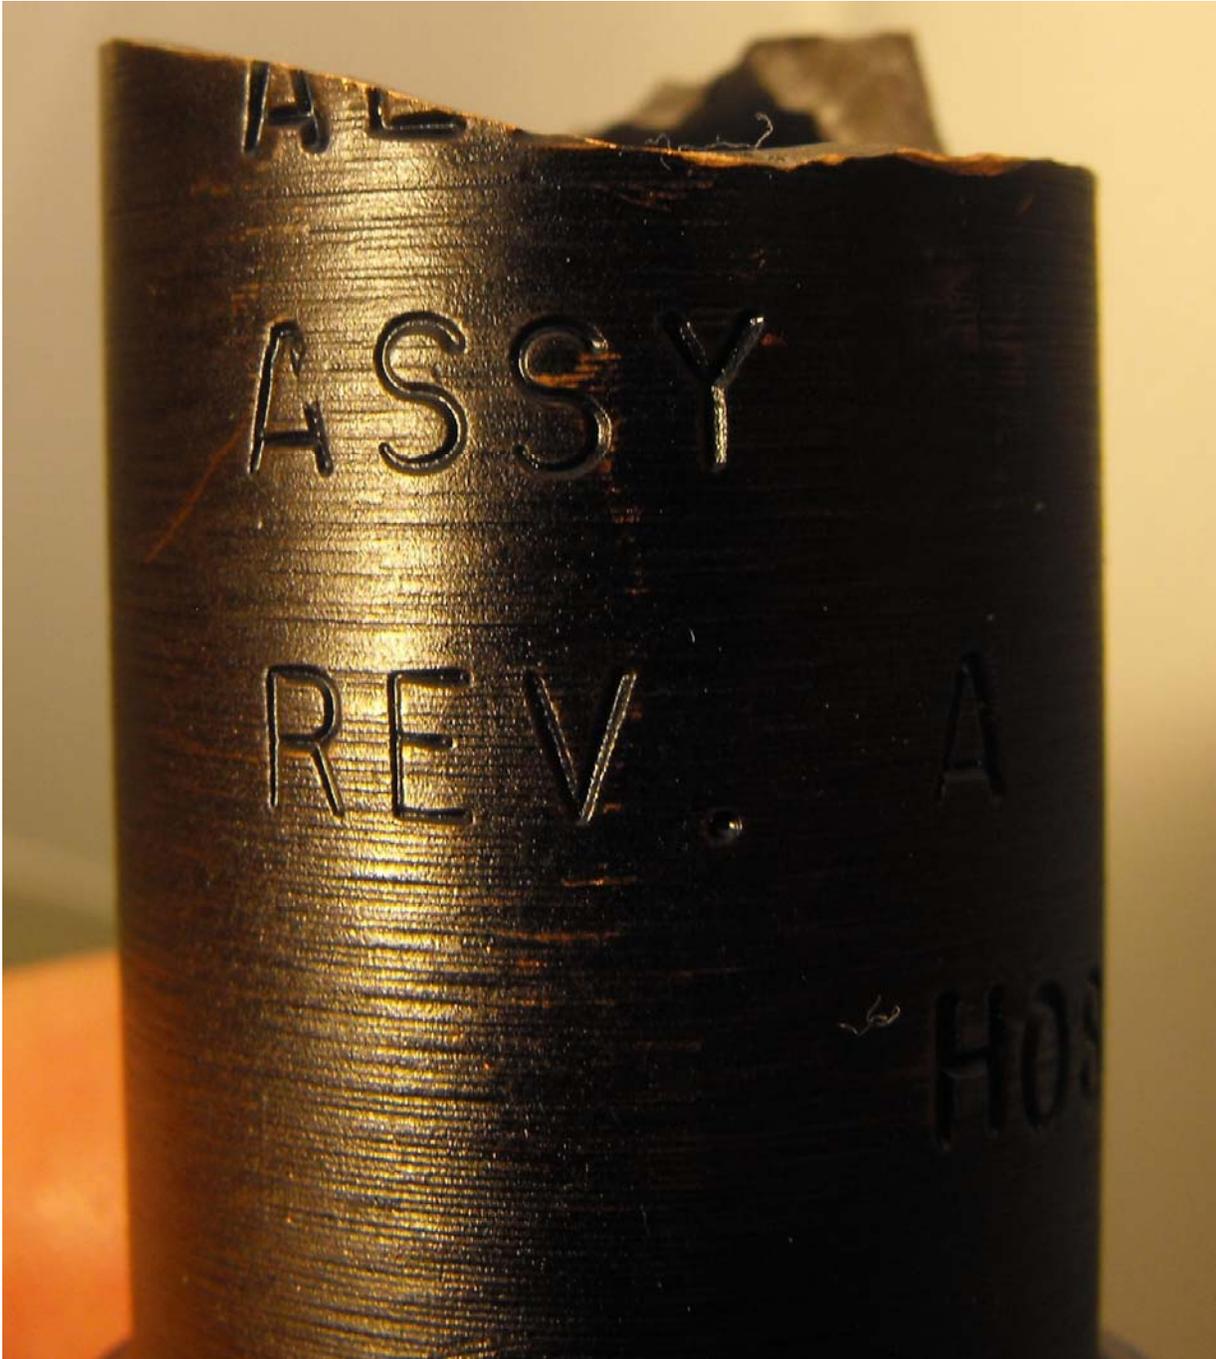
"The pilot stated the engine became rough after takeoff," says a general aviation submitter. (*He*) returned to the airport and landed. (*I*) found the number one cylinder to be colder than the (*others*). I pulled the rocker cover and noted the valves were not moving when the (*crankshaft*) was rotated. The rocker arms and pushrods were then pulled, but no problems were found. The engine was removed from the aircraft and brought to our repair station. We removed a cylinder and found the camshaft broken. The remainder of the engine was now disassembled. The valves moved freely in their guides and no other unusual problems were noted with the engine. The AEL18840 camshaft was installed new 236.48 hours previously with new (*P/N*) 72877 Lycoming lifters. The camshaft is broken about 3.37 inches from the forward end. While it will take a metallurgical evaluation to determine the exact cause of the fracture, the fracture appears to originate at the base of the letters "E" and "L" of the metal stamped part number, forward of the number one/two intake lobes."

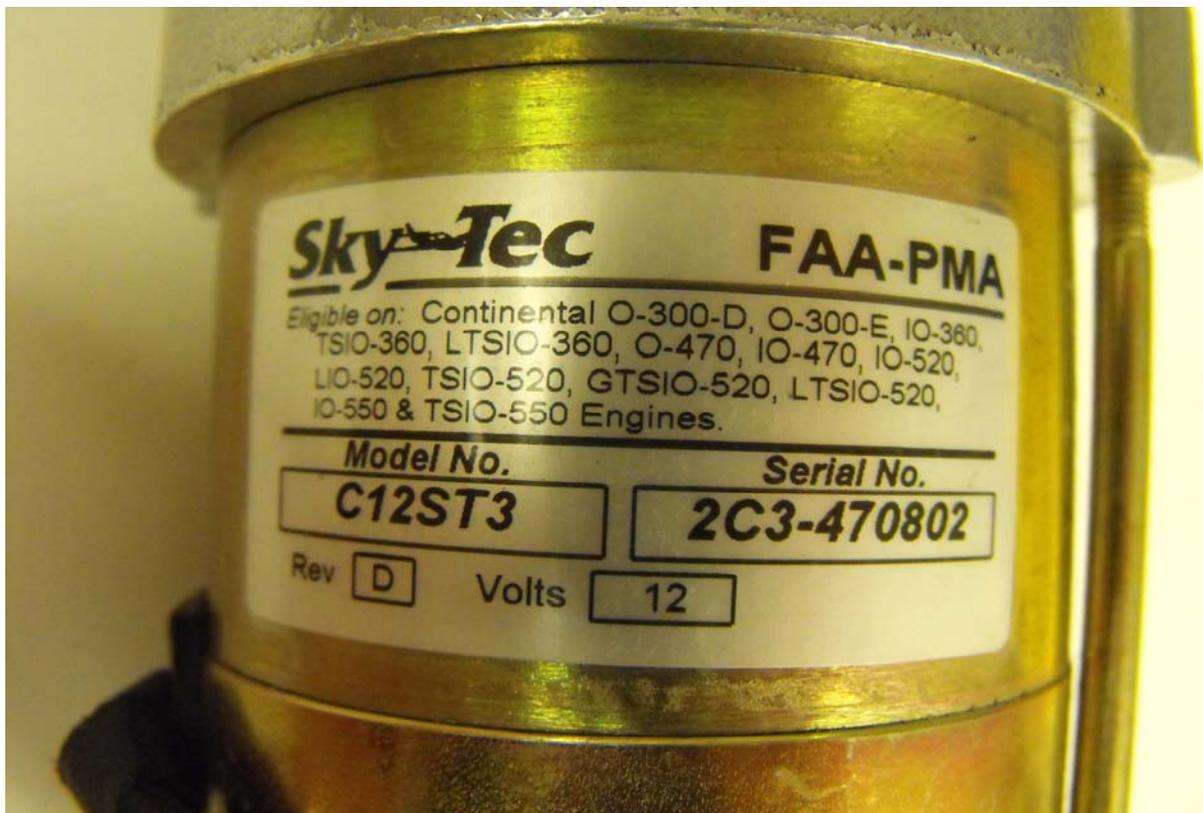
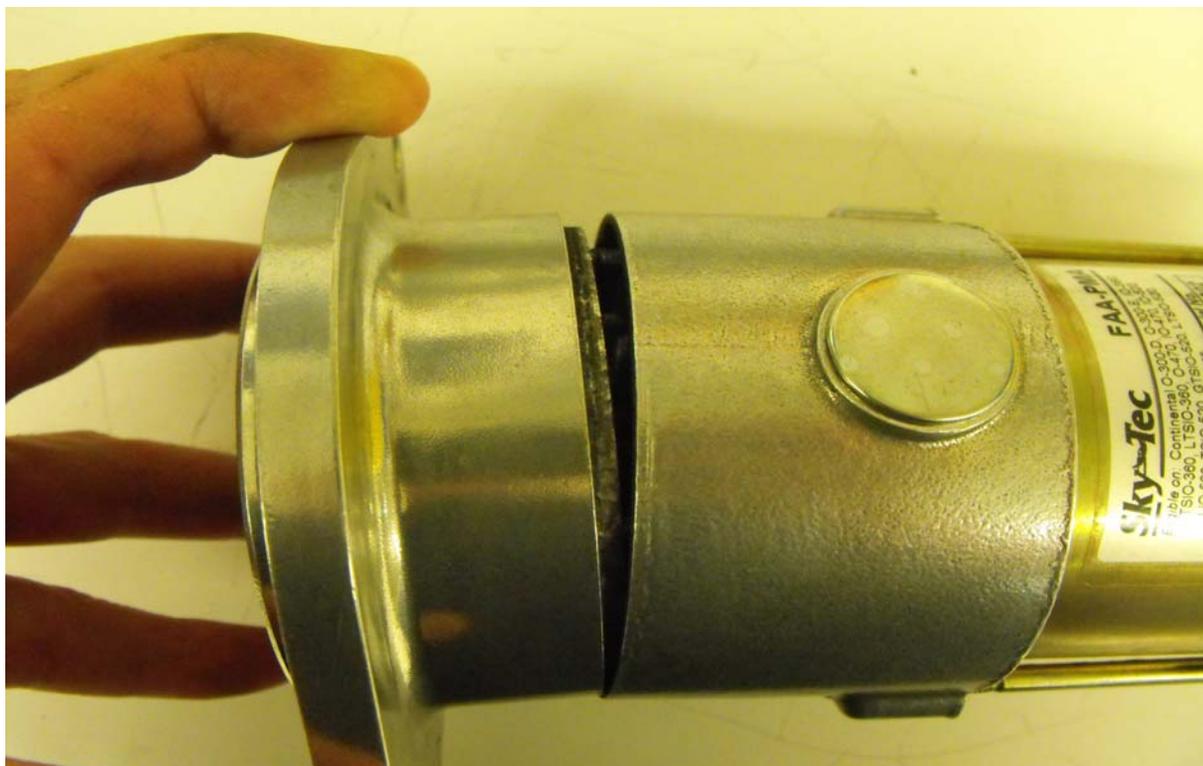
"The pilot reported starting difficulties--the problem visibly obvious *(upon inspection)*. The starter housing had a partial separation between the housing that attaches to the starter adapter and the main starter housing. Pictures are *(attached)*. The exterior bolts that secure the housings together are intact and tight. *(This)* starter was replaced *(P/N C12ST3 Revision D)*."
