**Federal Aviation
Administration**

ADVISORY CIRCULAR

AVIATION MAINTENANCE ALERTS

**ALERT
NUMBER
383**

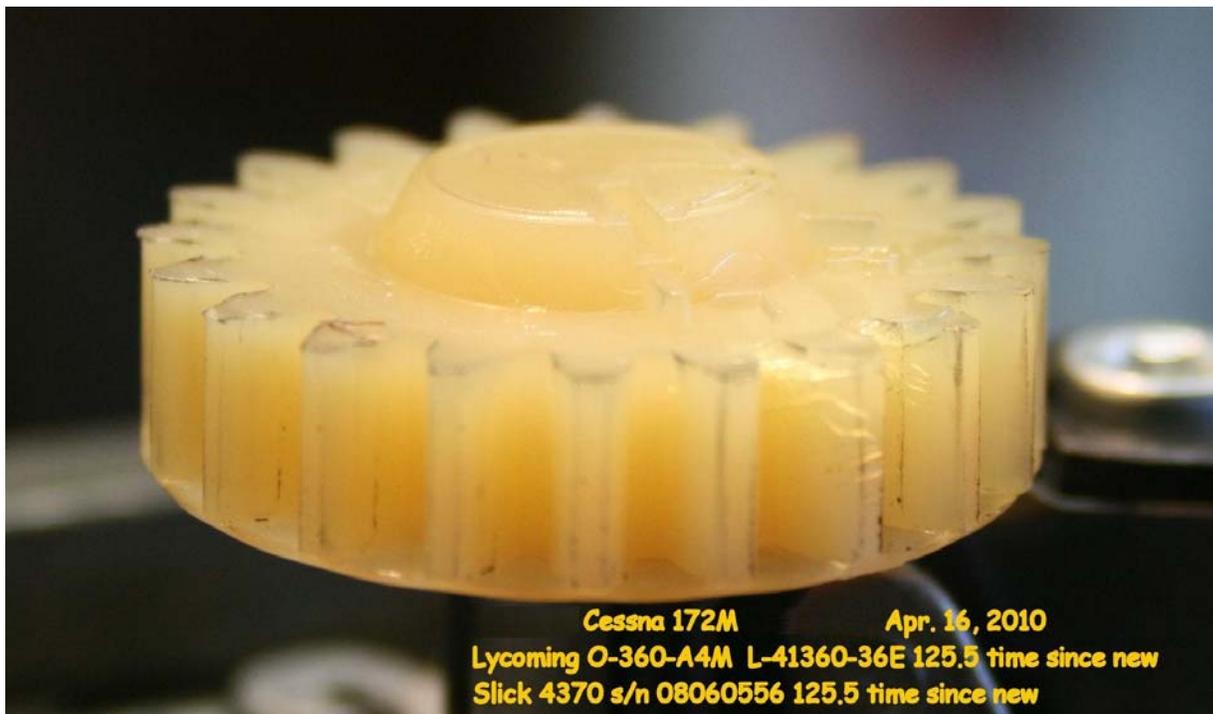
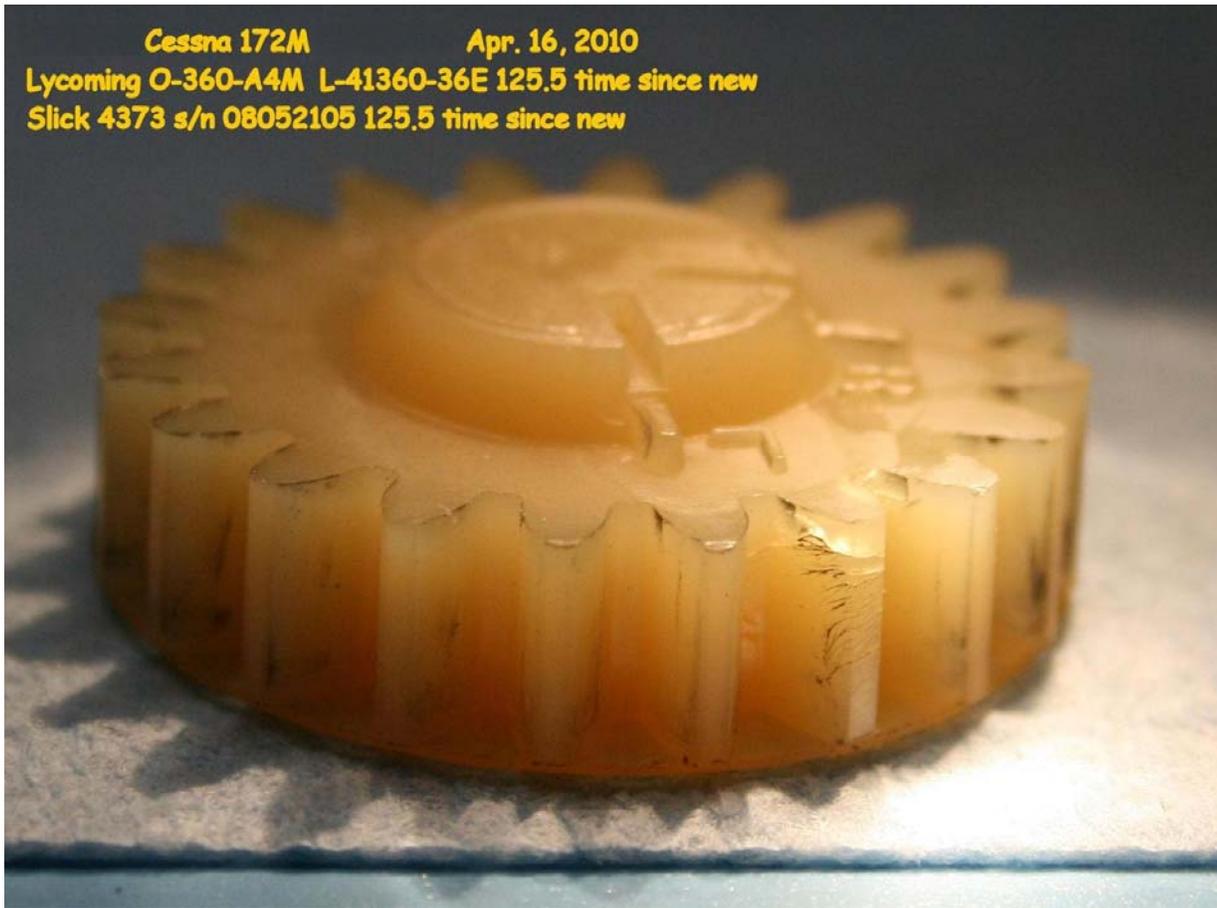
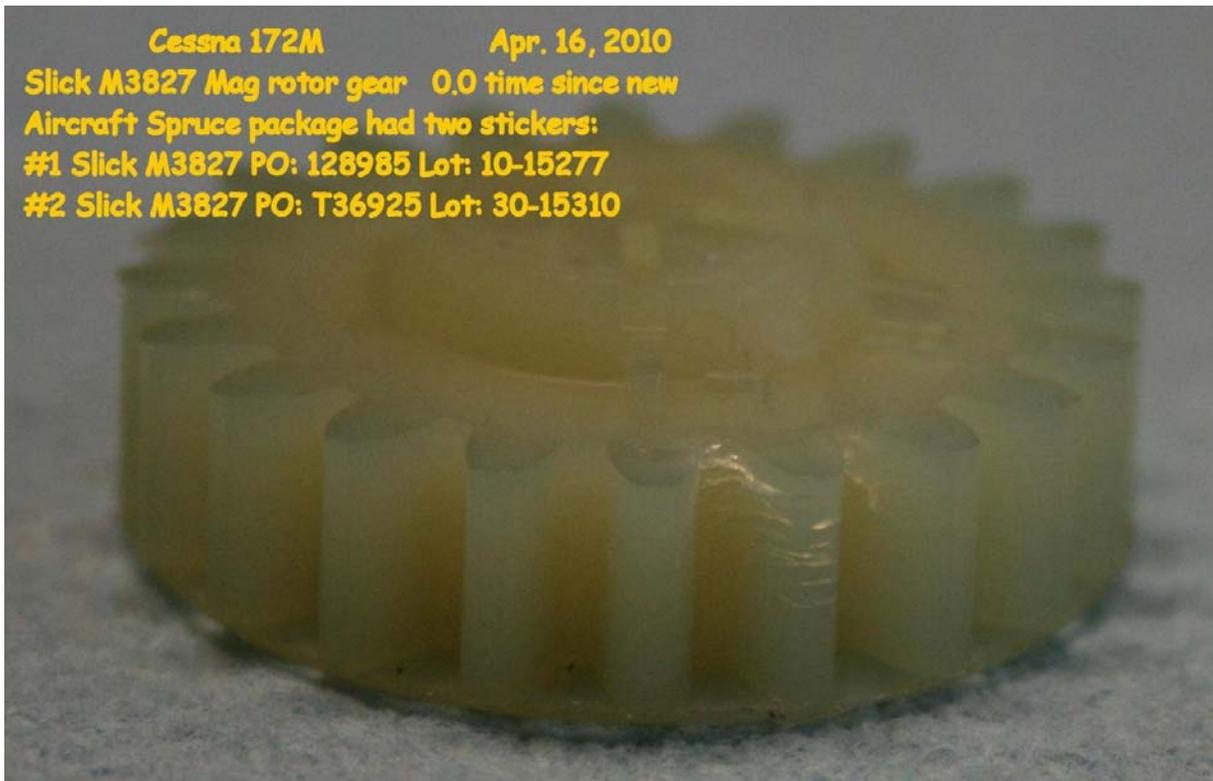
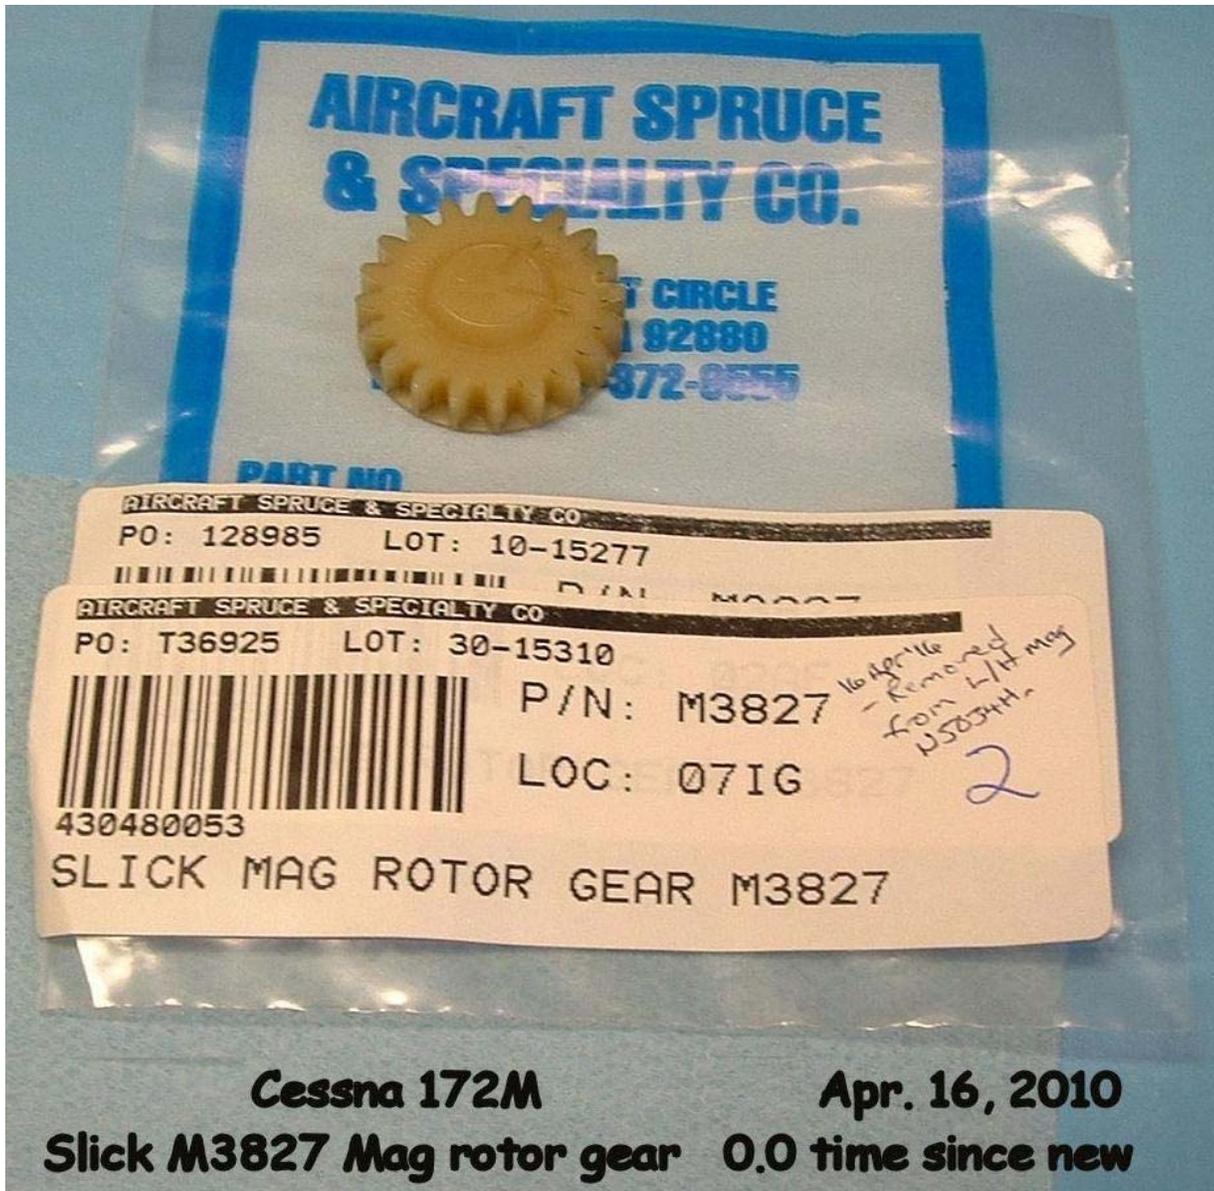
"Both magnetos were disassembled to comply with Slick (*service bulletin*) SB3-08A," says the submitter. "Prior to reassembly the mechanic noted the magneto rotor gears (P/N M3827) on both magnetos had numerous cracks in one of the gear teeth. (We) ordered two new gears and found numerous cracks in one of the new gears as well. All three gears had cracks in the same gear tooth. The gears are marked with a line for left and right rotation. There are three gear teeth between the left index tooth and the right index tooth. The cracks are (*visible*) from the top land of the tooth into the bottom land, and extend a short distance into the gear body. The left and right magnetos (Slick 4373 & 4370) each have 125.5 hours since new. The new rotor gear is from Aircraft Spruce; P/N M3827; PO T36925, Lot 30-15310; 0.0 hours since new. Both new gears were packaged separately, and both packages had the same information on the tags." (*This editor is responsible for removing the aircraft identification and "cropping" the enclosed photos. Readers should pay careful attention to the gear picture progression: used, used, new! That third "new gear" picture shows its cracks with eerie highlights. I cannot imagine more emphatic evidence for a defect report. I'll do my best to draw some attention to this, but backlighting these parts before installation seems a darn good idea. Thank-you for the tip and the excellent photo effort—Ed.*)

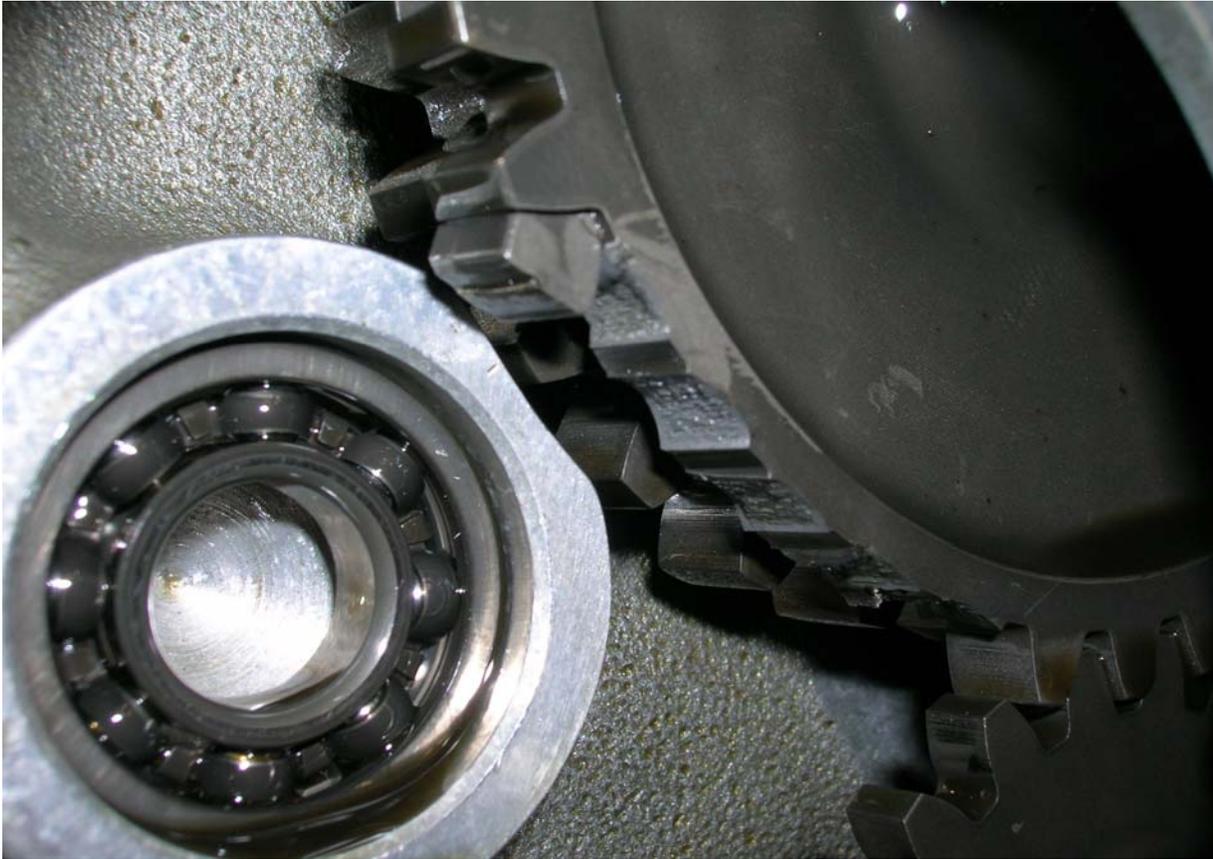
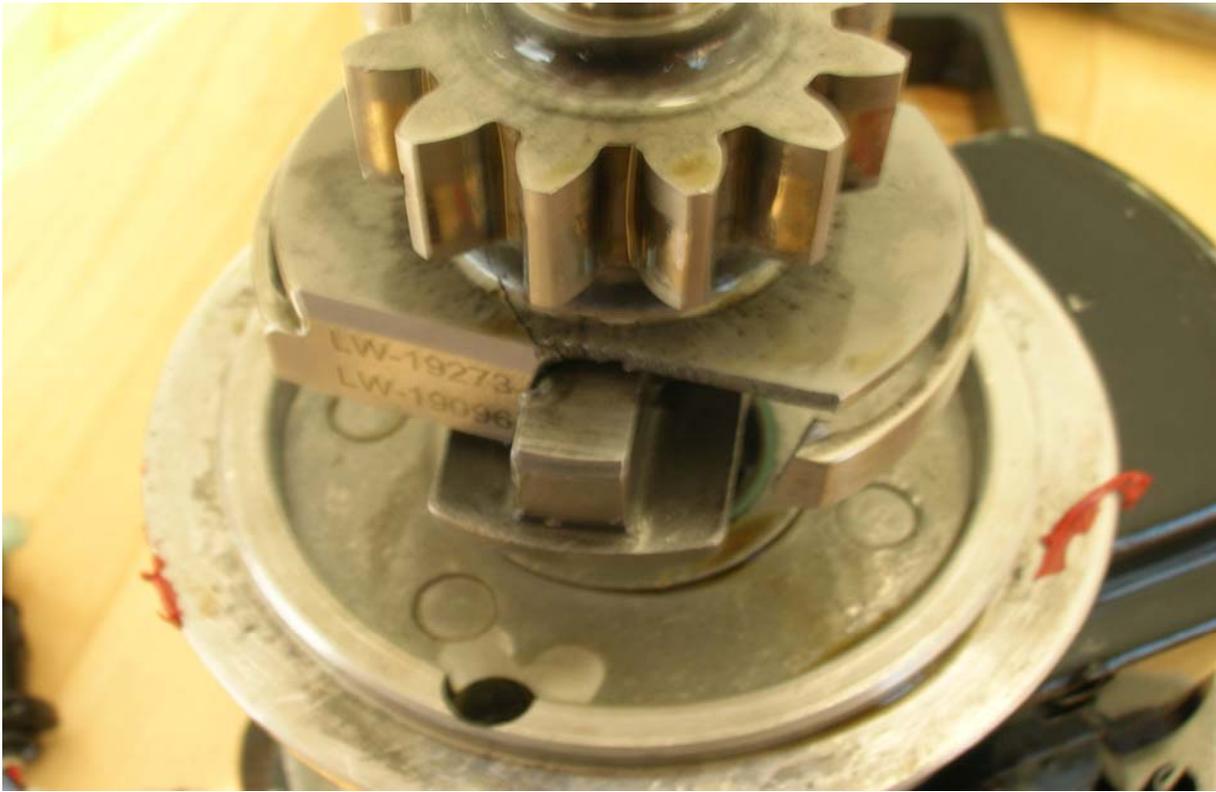
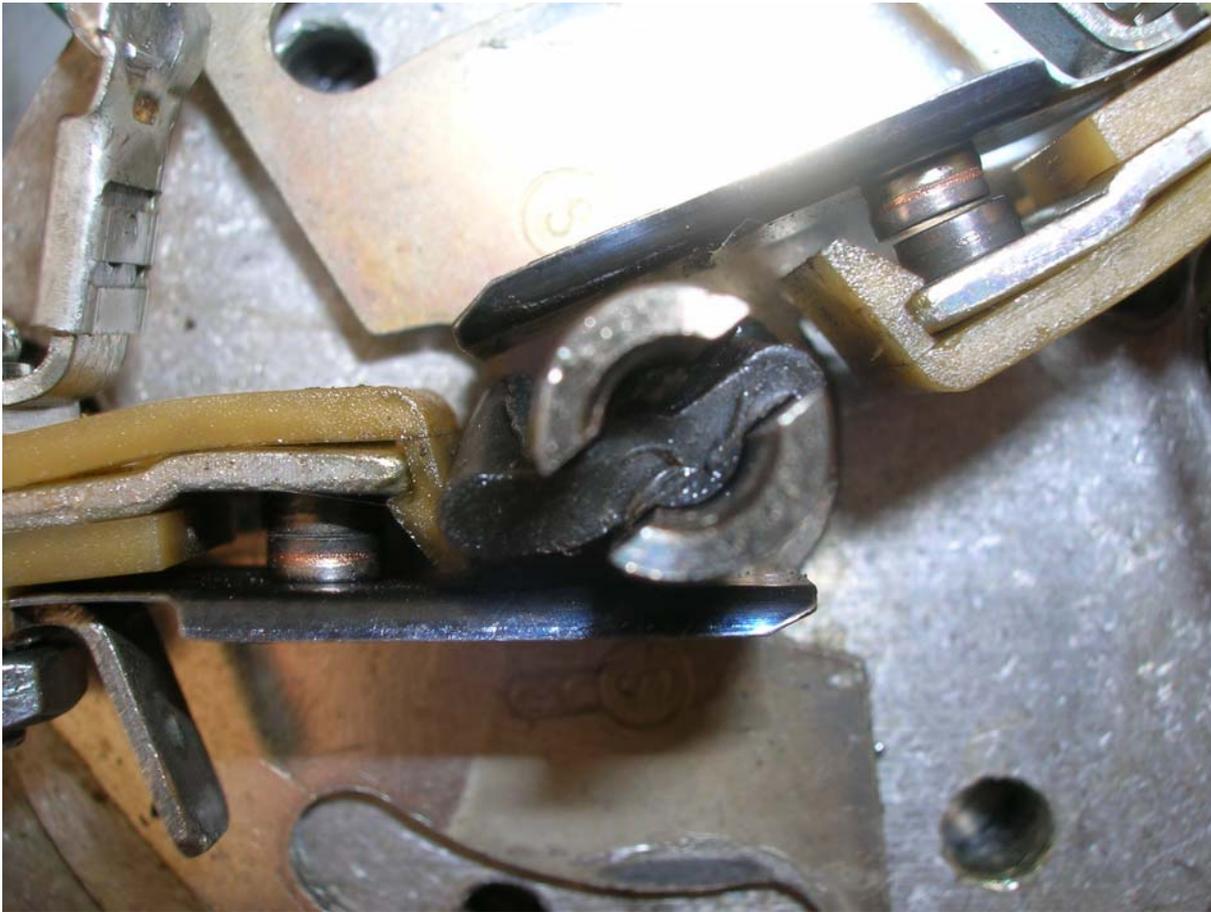
A general aviation submission states, "During a post maintenance run-up, the engine/propeller ceased to rotate. This occurred at or near the engine idle speed setting (approximately 850 RPM). (I) inspected the engine and found the left magneto dislodged slightly from its drive pad. I removed the left magneto and found the drive adapter distorted. The coupling 'paddle' had twisted the drive cushions 90 degrees in the drive retainer. The magneto would not rotate by hand. It was also noted that there were broken teeth on the camshaft gear. The right magneto was removed and no defects were noted. With both magnetos removed, the engine would (*still*) not

rotate by hand. I suspect the cause of the damage to be the failure of the left magneto shaft bearing. Further investigation will be needed to determine why this occurred. More importantly, why didn't the Woodruff key on the magneto shaft fail? Had this occurred as designed, the engine would not have experienced further damage. It is fortunate this (*defect*) occurred during ground operation and not during a critical phase of flight."
