ADVISORY CIRCULAR

43-16A

AVIATION MAINTENANCE ALERTS

**ALERT
NUMBER
308**

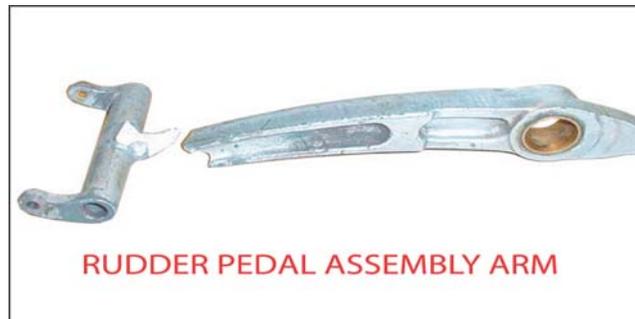
Beech; Model T-44A (C90); King Air; Cracked Rudder Pedal Arm Assembly; ATA 2720

While conducting a dye-testing inspection, the technician discovered a crack in the pilot's side right rudder pedal arm assembly (P/N 50-524326-25). He stated that the failed rudder pedal arm assembly was made of magnesium, but the replacement part was aluminum. (Refer to the illustration.)

The dye-testing inspection was performed as part of a Navy T-44A fleet-wide inspection after four rudder pedal assembly arms failed in a 3-month period. The inspections revealed 16 failures in a fleet of 54 aircraft.

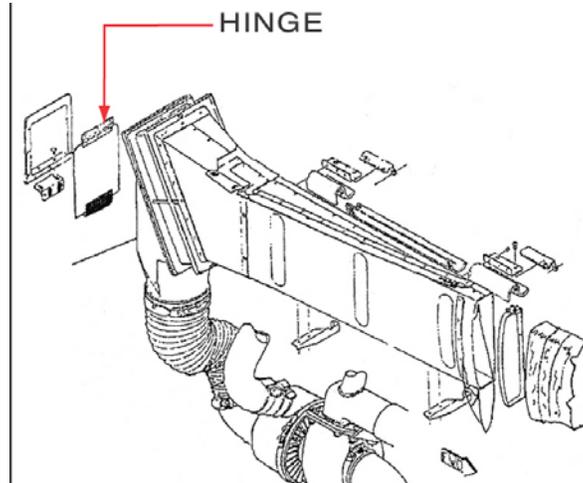
Cessna; Model T-210J; Centurion II; Failure of the Alternate Air Door Hinge Pin; ATA 7160

The submitter reported the original alternate air door hinge pin (P/N 1250839-12) was made out of aluminum. The pin had worn and dropped pieces into the intake system causing damage to the turbo charger. (Refer to the illustration.)

According to the submitter, the new hinge pin is made of stainless steel and secured in the hinge by crimping. He recommended routine inspections of this area and changing the aluminum pins to stainless steel pins.

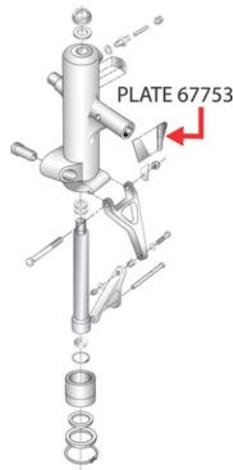
Piper; Model PA-28R-201; Arrow III; Failure of the Main Landing Gear Down-Lock System; ATA 3230

During a preflight walkaround, the pilot noticed the main landing gear down-lock spring (P/N 67203-00) was hanging down by one end.

Further investigation revealed the spring attach bracket (P/N 67753-000) had broken and the main gear down-lock spring was not attached to the trunnion. (Refer to the illustration.) The spring attach bracket is mounted to the trunnion underneath the squat switch and is attached by two bolts. The bracket failed at the attach point for the down-lock spring.

According to the submitter, the spring is the emergency-extension system backup if the hydraulic system fails.

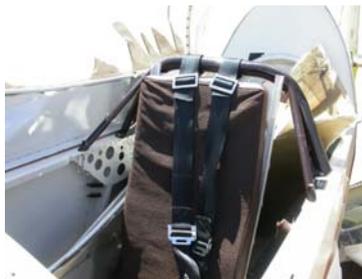
Applicable to all homebuilt aircraft with roll bar installation; fuselage, miscellaneous structure (roll bar); ATA 2560

The standard RV-4 aircraft kit was equipped with a roll bar which was to be installed directly aft of the forward pilot’s seat. The roll bar conformed closely to the inside dimensions of the canopy just aft of the forward pilot’s seat and was designed to protect the forward seat occupant in the event of a rollover/nose over occurrence. The owner/builder modified the roll bar in his RV-4 aircraft from the original “elliptical” design to a shortened, inverted “U” (refer to graphic image). The top of the modified roll bar reached only to the approximate height of the pilot’s shoulders rather than to the upper inside radius of the canopy.

On the evening of June 28, 2003, while the pilot was en route from Idaho to his home airstrip, the engine suffered a total loss of power and the pilot executed a forced landing to a field consisting of slightly rough terrain covered with 3 to 5 foot high grass. During the landing roll the tailwheel-equipped aircraft nosed over. Post mortem examination of the pilot revealed the cause of death as “multiple blunt force head and neck injuries” and “probably positional asphyxia as [a] contributing factor.” The pilot would very likely have sustained only minor injuries had the non-modified roll bar been installed.
