ADVISORY CIRCULAR

43-16A

AVIATION MAINTENANCE ALERTS

**ALERT
NUMBER
344**

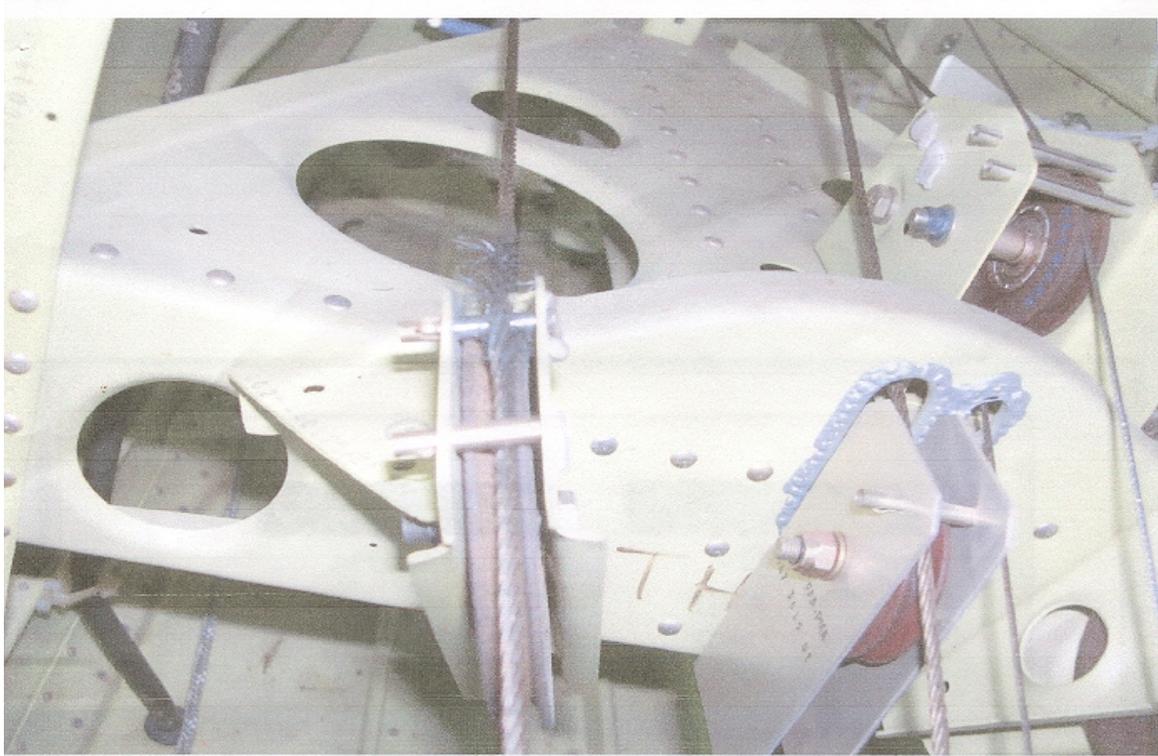
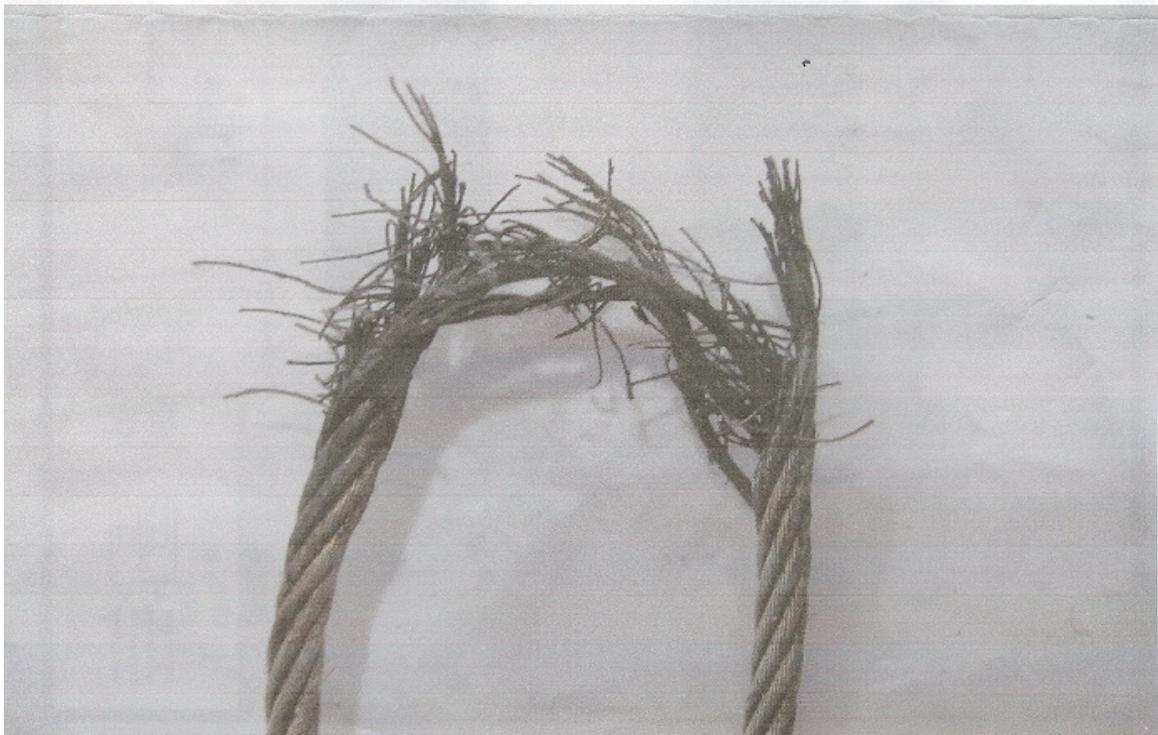
Beech: F33A; Frayed Elevator Cable; ATA 2730

A repair station technician states, "While performing an annual inspection on this aircraft, the right aft rudder cable was found frayed almost (*in half*). (*This*) cable was found routed over the top of one cable pulley guard pin and under another in the same location in the aft tail section. This cable appears to be the original cable installed in the aircraft at the factory. Log books did not reveal any evidence the cable had ever been removed or disconnected—(*an action which may have explained this improper routing, post production*). (*Estimating*) from the amount the cable was frayed, it had been rubbing on the pulley guard pin for quite some time.

"It is suspected this cable was routed incorrectly at the factory. Subsequent annual inspections were possibly done in a quick fashion, (*motivated, perhaps, by the aircraft's recent production...*) and low total time. (*I suggest*) inspecting the aircraft completely per the airframe manufacturer's recommendations or FAR 43 Appendix D...regardless how new the aircraft. This is the first time (*our organization has inspected*) this specific aircraft." (*Rudder cable P/N 002-524000-23.*)

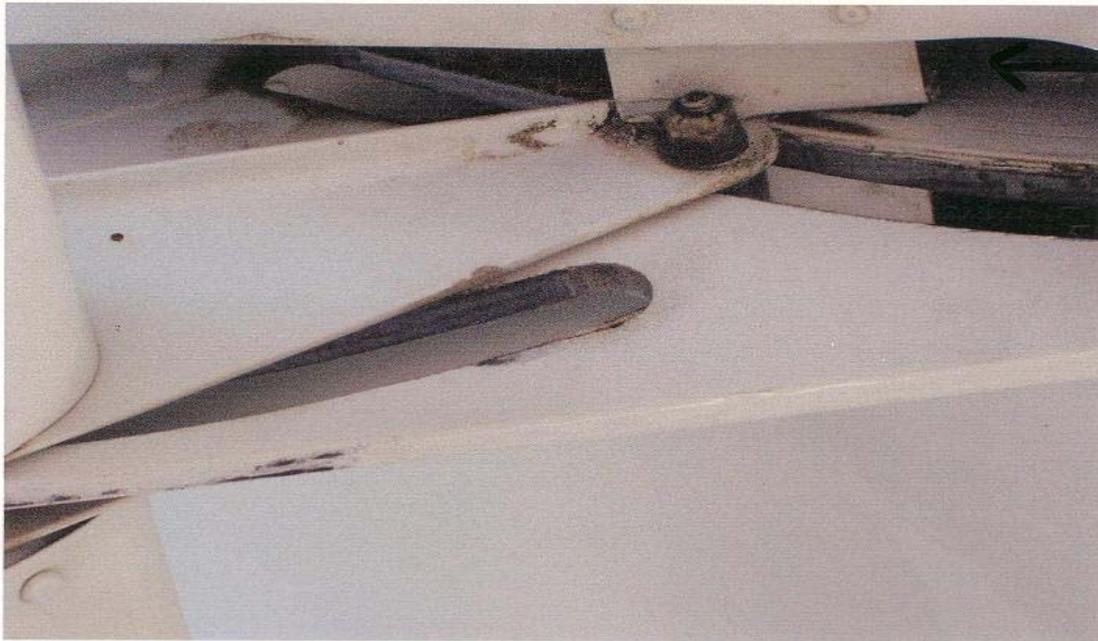
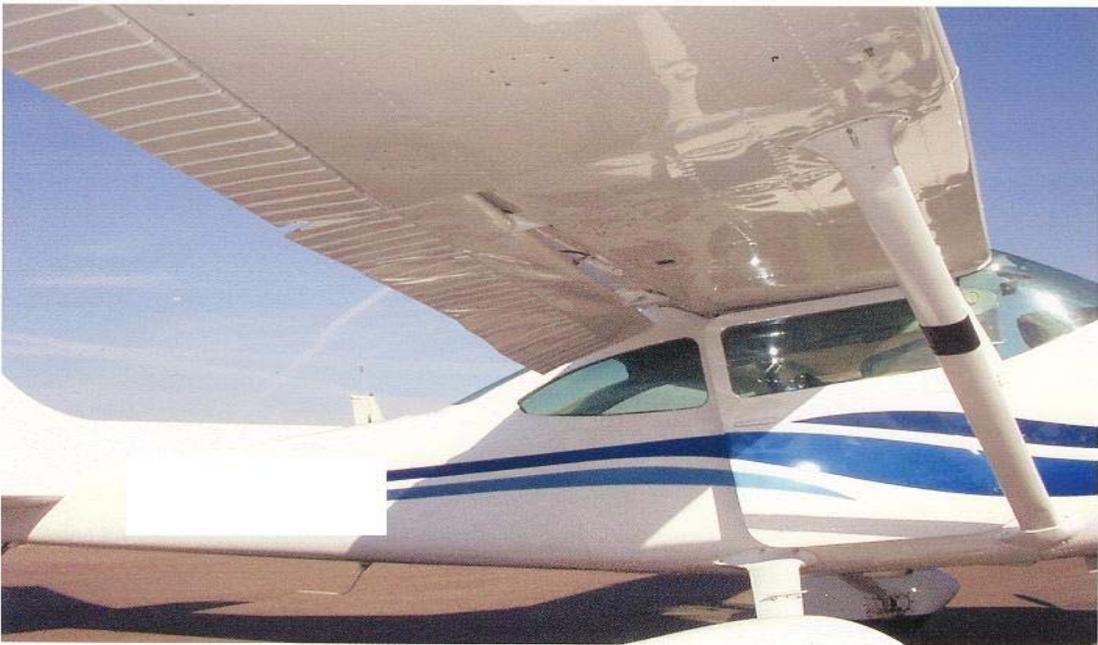
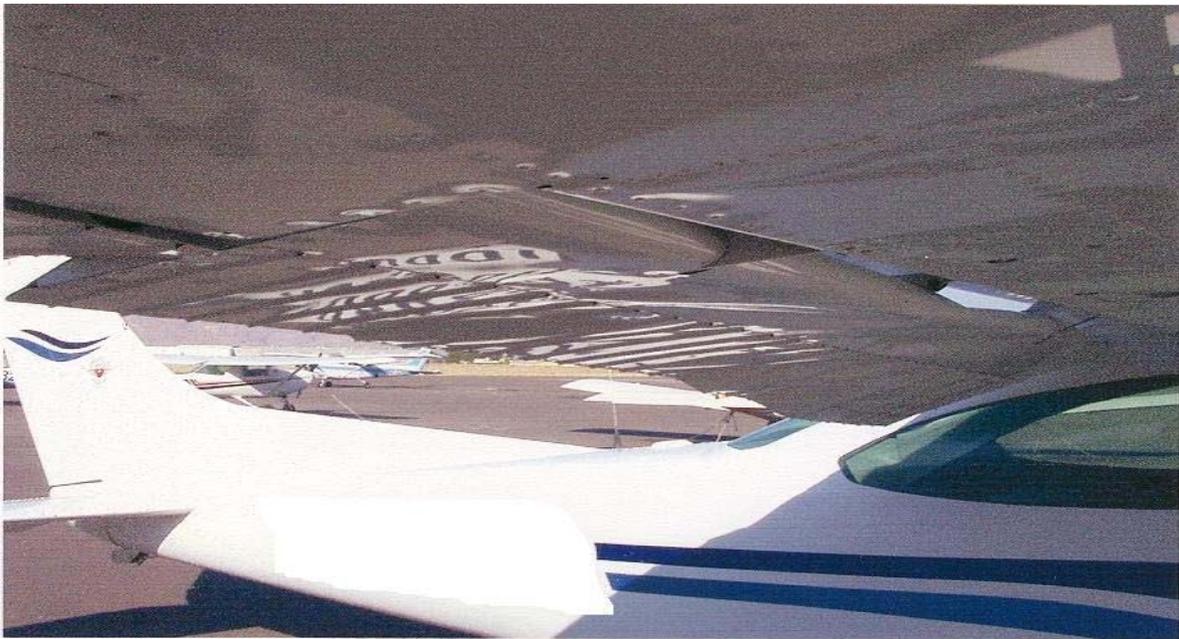
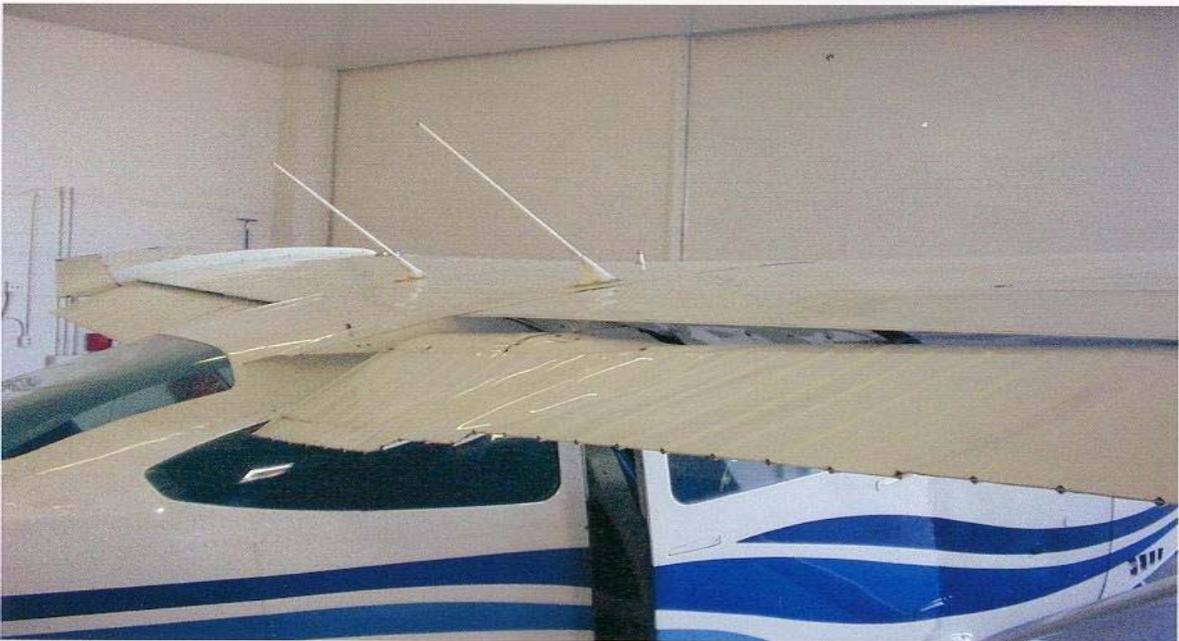
Subject Bracket

Cessna: 182P; Cracked T.E. Wing Skin Support Brackets; ATA 5753

A mechanic/D.O.M. (*director of maintenance*) writes, “The wing trailing edge skin support bracket cracked, causing flap interference and failure. This bracket is attached to each flap track rib inside the trailing edge of the wing. Its purpose is to support the trailing edge wing skin in the flap bay. This part cracked and allowed the flap support to get caught during flap retraction, consequently binding the flap. The flap structure failed before the flap motor caused the circuit breaker to trip. The resulting configuration of the flaps caused significant yaw in flight. Inspection of our fleet of Cessna 152, 172, 172RG, and 182 (*aircraft*) revealed similar conditions on many of these brackets and/or cracked wing skins at the bracket attach point. There is very little clearance between these brackets and the flap support rails by design. In addition, many of the brackets rest firmly against the upper portion of the flap support rails when the flaps are fully retracted and properly rigged. (*I*) suggest regular inspection of these brackets for wear and cracks. I’m unable to locate this part in any of the Cessna Parts Manuals. The bracket appears to be a sub-part of the whole rib assembly (P/N 1221010-15; Cessna 182P). Judging by the irregularity of the rivet holes in the brackets and the flap track rib, it appears these brackets may have been hand drilled by the factory.”

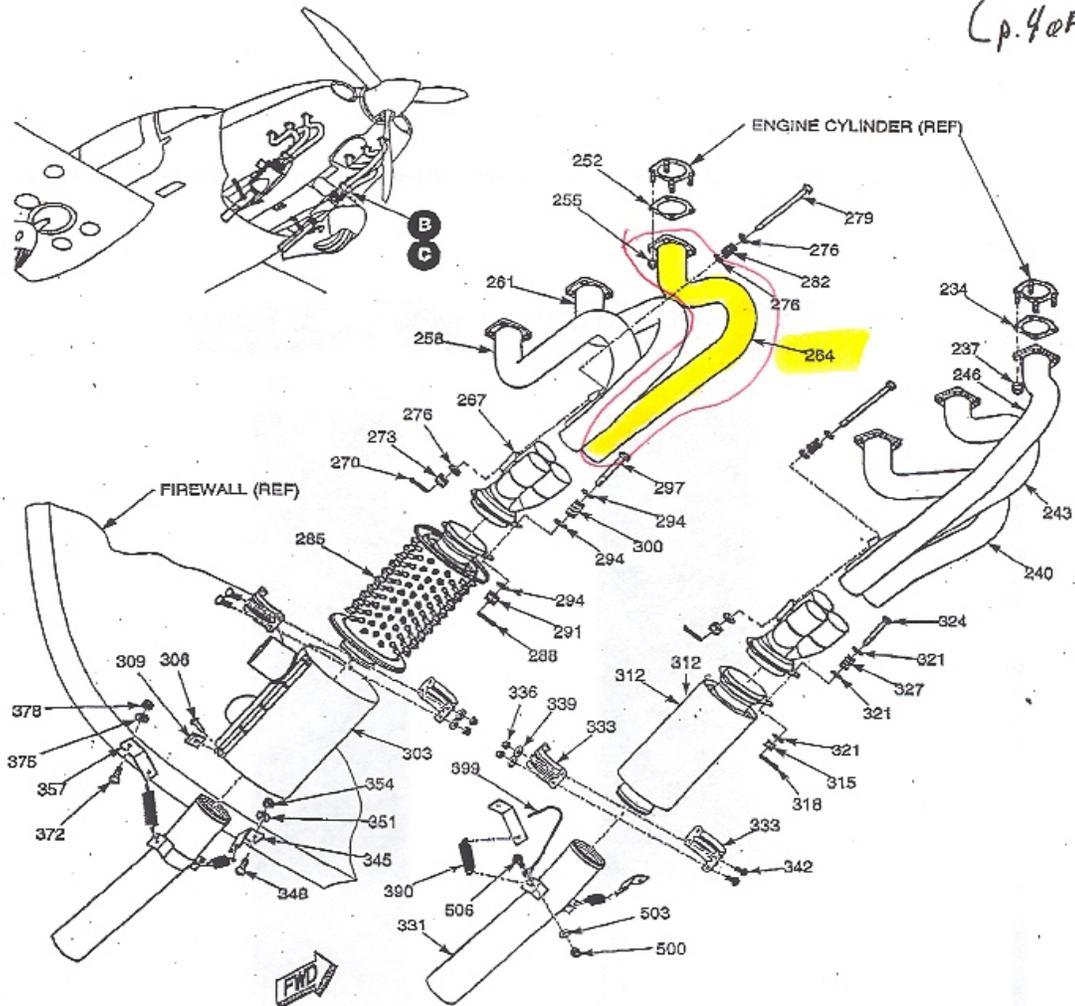
Figure 01
Exhaust System - Serials 0320 thru 0820 (Sheet 2 of 3)

Cirrus: SR22; Cracked Exhaust Header; ATA 7810

A technician from a repair station finds the same defects consistently on this model aircraft. “The number five exhaust header (P/N 15070-001) was found cracked at the cylinder flange just below the weld *(on three separate aircraft; 25.6, 33.7, and 254.3 hours, respectively)*. *(The first aircraft was also found with...)* the number six exhaust header cracked through its flange for a distance of about 1.5 inches, radiating out along the flange weld (P/N 15074-001). These headers need to be redesigned or given some sort of support. They are over-cantilevered for the stresses imposed upon them.”

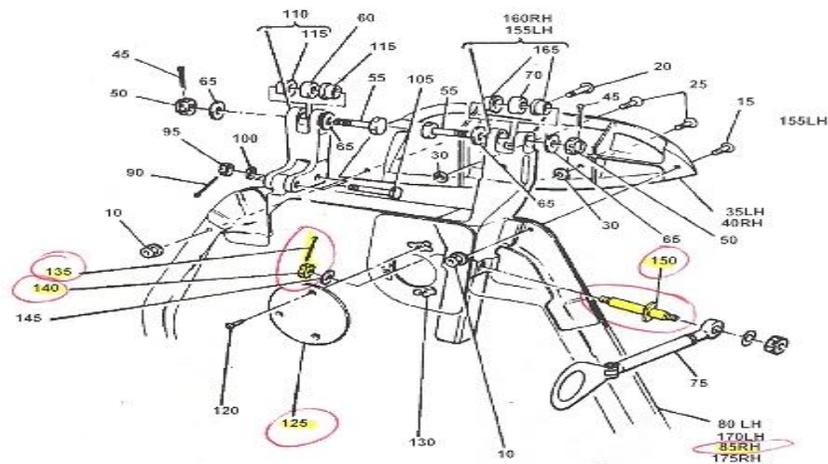
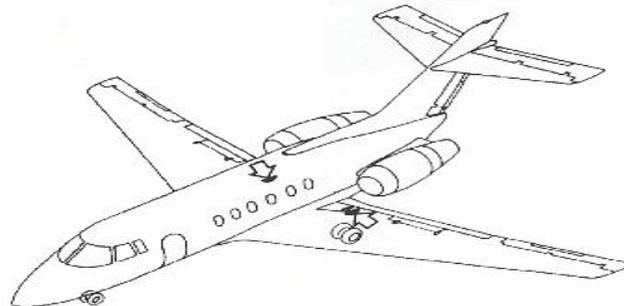
Hawker 800XP Illustrated Parts Catalog Fairing Instl - Main Gear

Raytheon: 800XP; Loose Main Gear Door Hardware; ATA 3231

Referencing this aircraft's R/H main gear outboard door a technician writes, "(I) found the door to gear strut attachment bolt (P/N 25UM775) backing out and loose. After removing the cover (P/N 25UM903-13) we found the nut (P/N A103GS) that was to secure the bolt was not safety (*wired*) and had backed off about three turns. If this had come loose the door would have dropped into the slip stream (P/N 25-8UD507-2A).

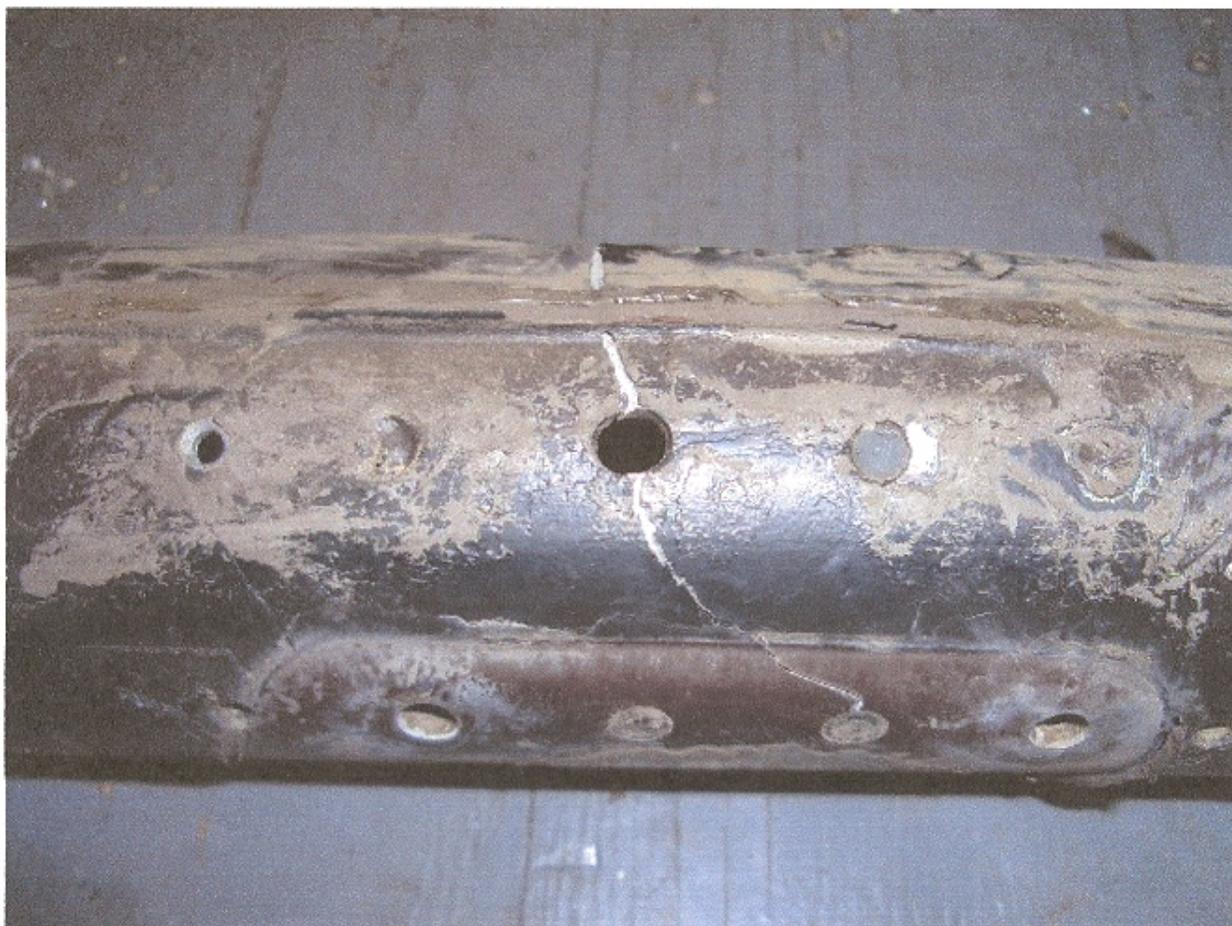
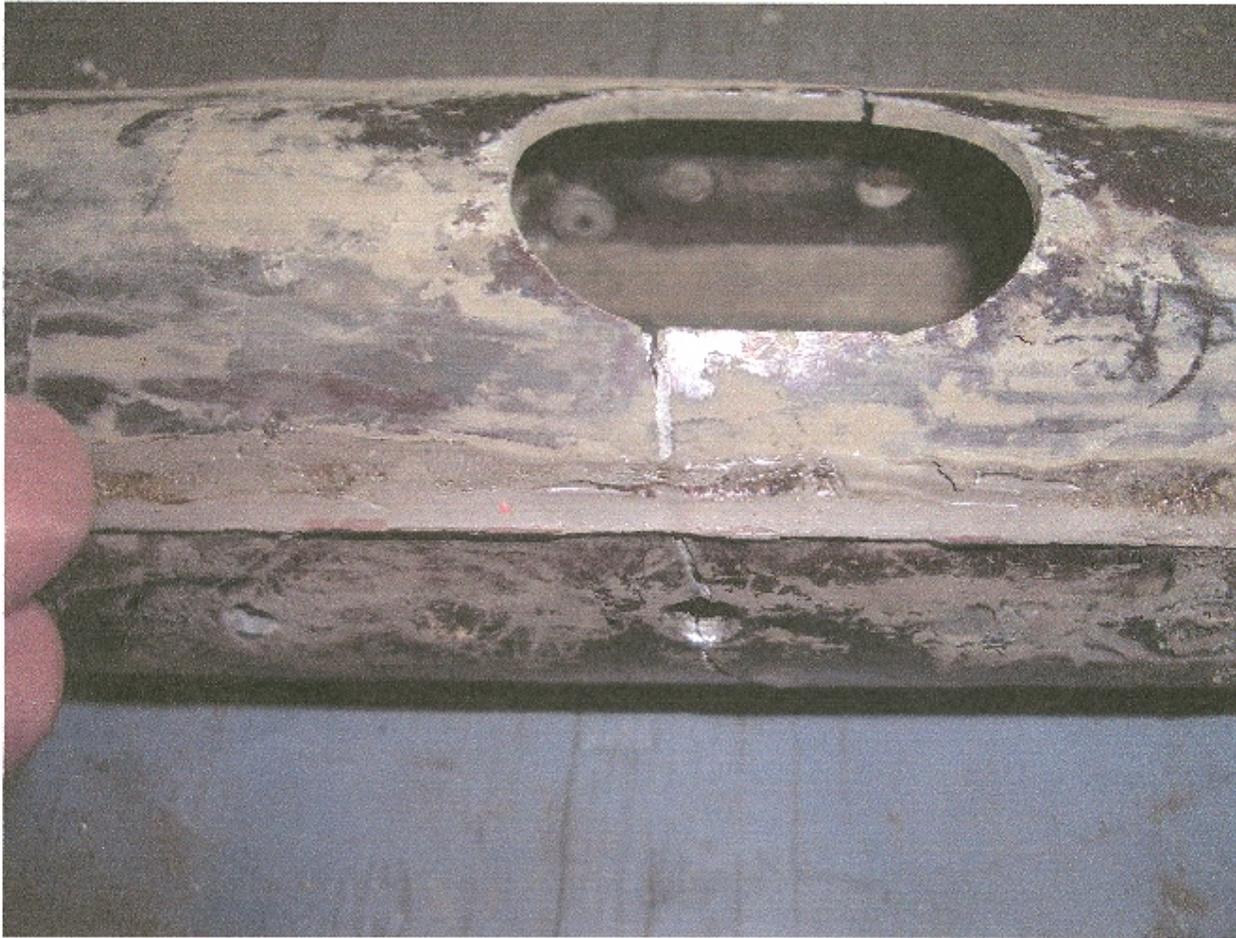
MD: 369D; Cracked Skid Tube; ATA 3246

The description states, "Upon landing a mechanic saw the forward left skid tube was angled up several degrees. It was discovered this tube was cracked under the forward foot and skid plate. The unit was replaced (P/N 369D292114-3)."

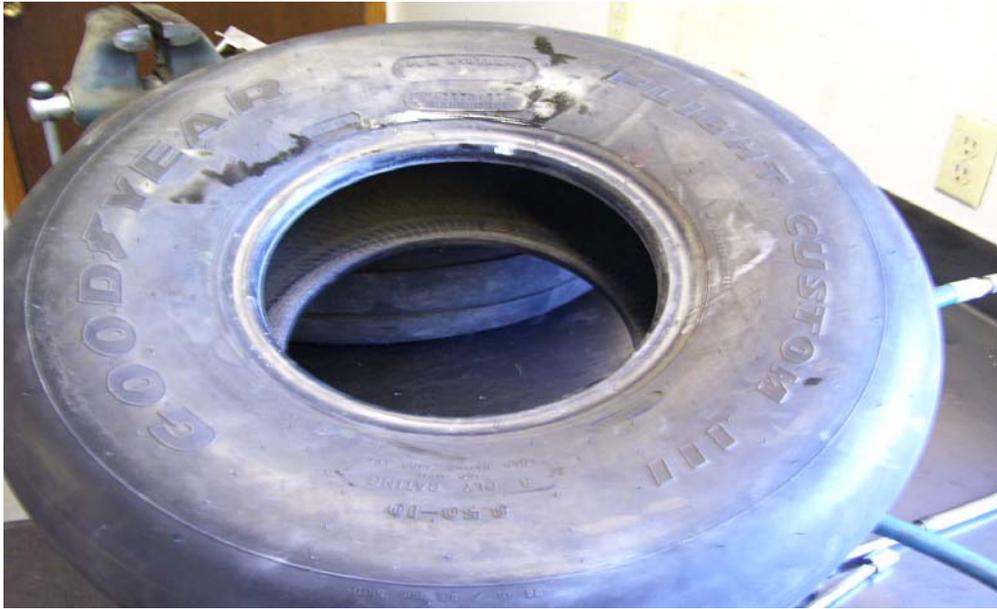
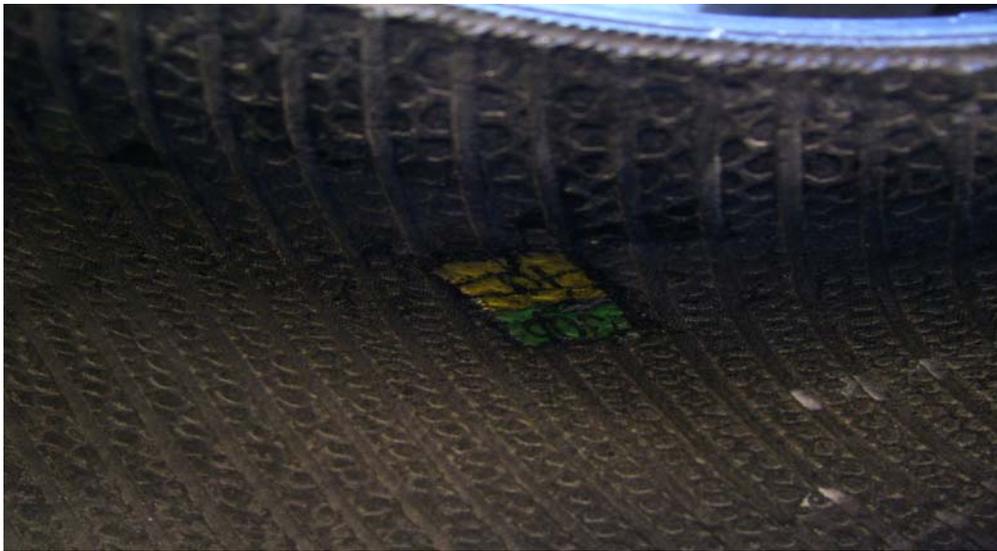
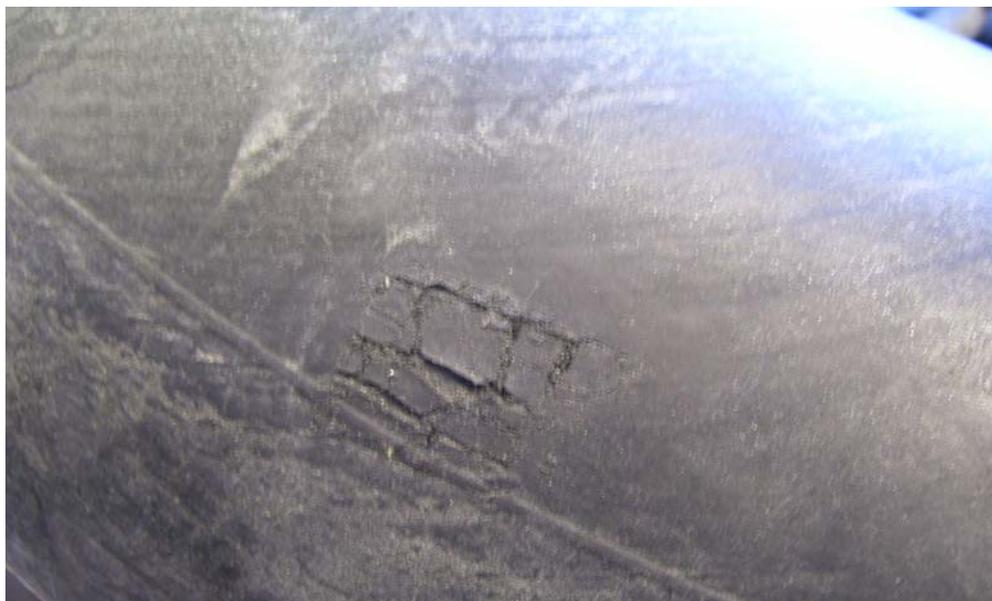
Goodyear: Inner-tube; Label/Adhesive Induced Deterioration; ATA 3245

A technician servicing a Cessna 208B describes his investigation into a tire/tube defect. "The R/H main gear tire (*on this aircraft*) was reported low (*on air pressure*). (*We*) removed the tire to check the tube—it looked old...(*so it was replaced with a new tube, size 8.50 x 10.00*). One week later this tire (*again*) was reported low.... We removed the tire and inspected the tube. The tube was leaking on one side and almost worn through on the opposite side. After further investigation we determined the stickers inside this 8.50 x 10.00 FC III tire (P/N 850T86-2) had caused the failure. This was the second failure on the same gear position with the second new tube in seven weeks." The submitter states he contacted Goodyear and the local Flight Standards District Office—both of whom responded quickly with information. He describes receiving e-mail from Goodyear indicating "...stickers are put in all of the tubeless tires...", but—their (Goodyear's) website and/or maintenance procedures clearly indicate these stickers are to be removed from tires when they are used with tubes. "(*I*) hope this information will help others in the field so they do not experience these same problems."

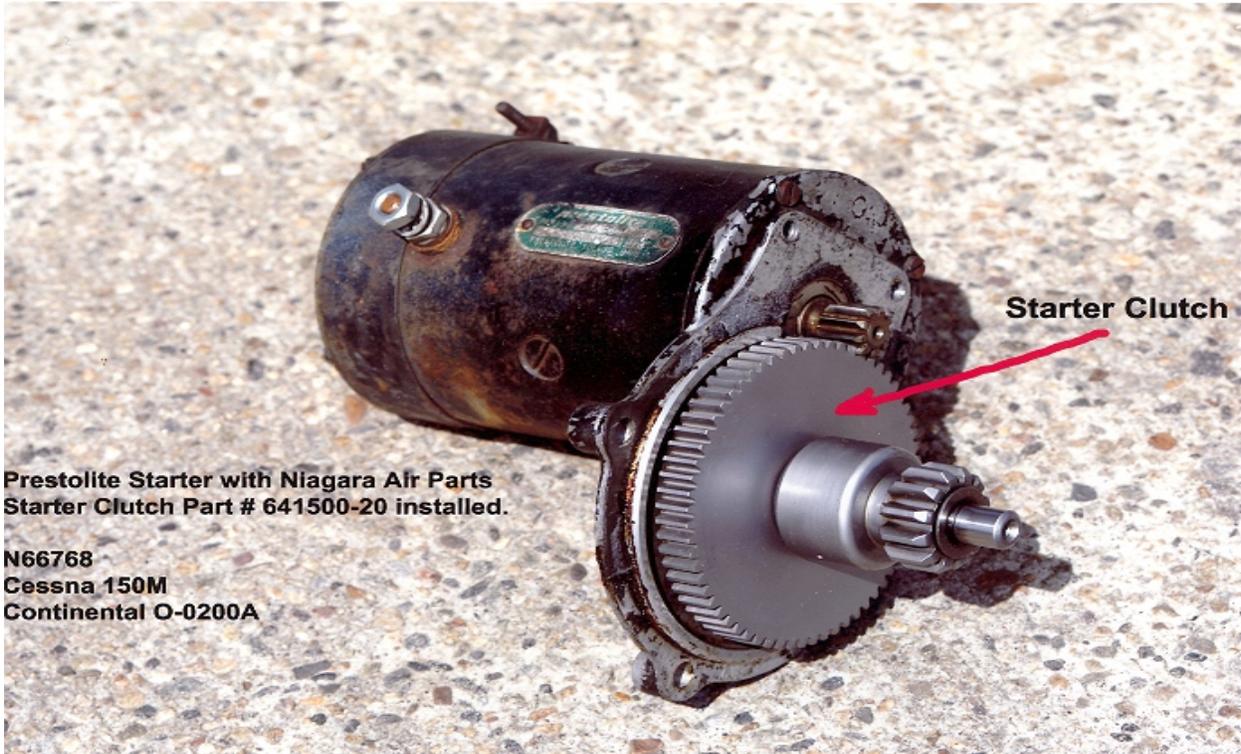
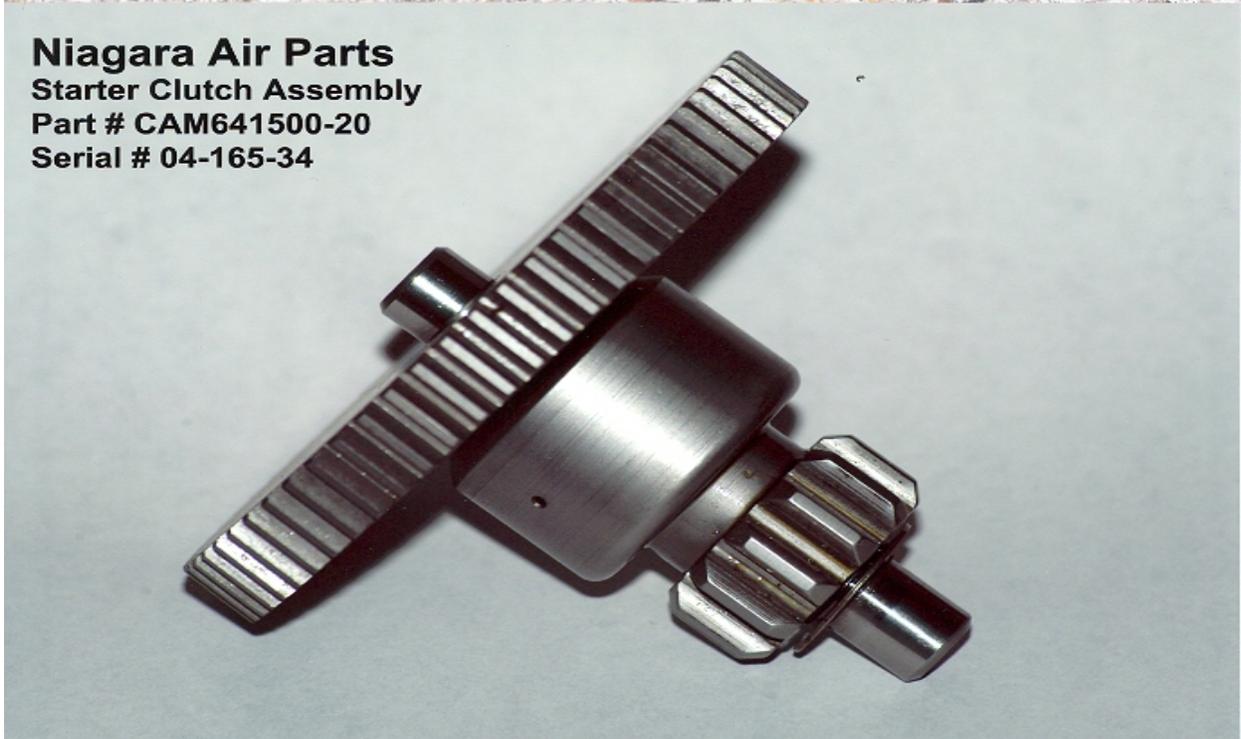
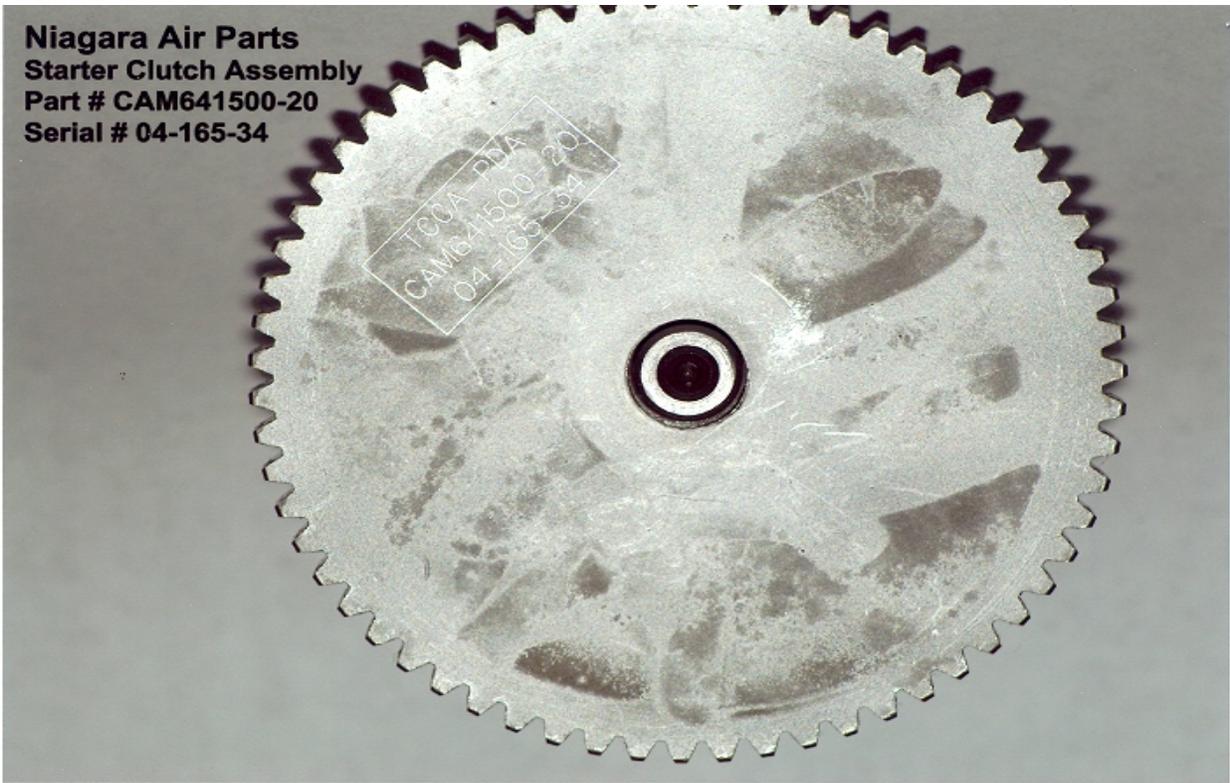
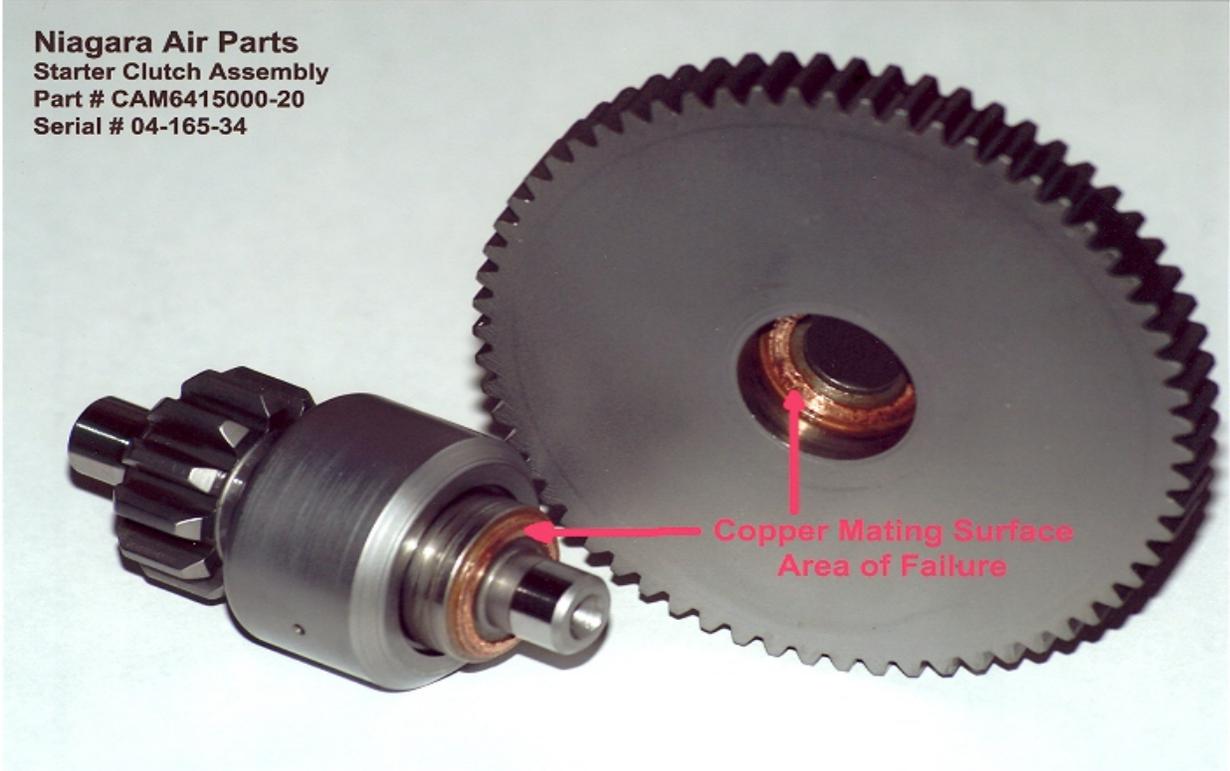
Niagara Air Parts: Starter Clutch; Failed Clutch/Drive Assembly; ATA 8011

“While attempting to start the engine the starter was heard spinning, but the engine would not crank. (I) disassembled and inspected the engine starter drive mechanism by removing the starter and clutch drive assembly from the rear accessory section of the engine. While inspecting the clutch drive assembly (Niagara Air Parts: P/N CAM641 500-20), (I) found the larger drive gear was separated from the shaft.” (This gear is (normally) driven by the starter, but would now spin freely due to its separation from the shaft.) “Upon closer inspection it appeared this drive gear was attached to the shaft by brazing, as the mating surfaces were brass or copper in color. Due to the high rotational torque involved in the starting process, it would appear this method of attachment (is) insufficient. (I) spoke with a representative of Niagara Air Parts who advised (a brazing type weldment) is the normal process of attachment of the drive gear to the shaft. He said they have tested the operating strength of this process to a four ton load rating without failure. (The representative further...) explained the gear and shaft are heated to approximately 1700 degrees with copper used as brazing material between parts. He (speculated) engine kick-back on start or shutdown may have caused this (gear/shaft separation). Niagara requested the part be returned for inspection and analysis of the failure.”

**Prestolite Starter with Niagara Air Parts
Starter Clutch Part # 641500-20 installed.**

**Niagara Air Parts
Starter Clutch Assembly
Part # CAM641500-20
Serial # 04-165-34**
