ADVISORY CIRCULAR

43-16A

AVIATION MAINTENANCE ALERTS

**ALERT
NUMBER
310**

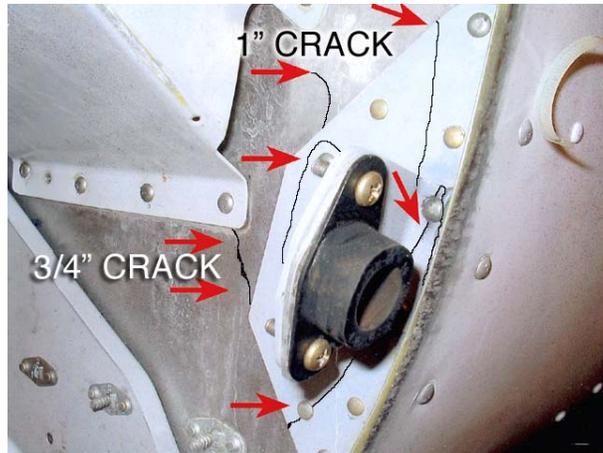
Cessna; Model 172R; Skyhawk; Cracks in Lower Firewall; ATA 5312

During an inspection, the technician found numerous cracks in the lower firewall (P/N 0553031-5) left side zone 124. The cracks radiated from the lower battery mount and cowling mount brackets. (Refer illustration.)

The submitter stated that he was aware of three additional like aircraft where the firewalls developed cracks in the same area.

A search of the FAA Service Difficulty Reporting Program data base contains 20 reports on Cessna 172R with firewall cracks. Most of the reports were generated while complying with Service Bulletin 98-53-02.

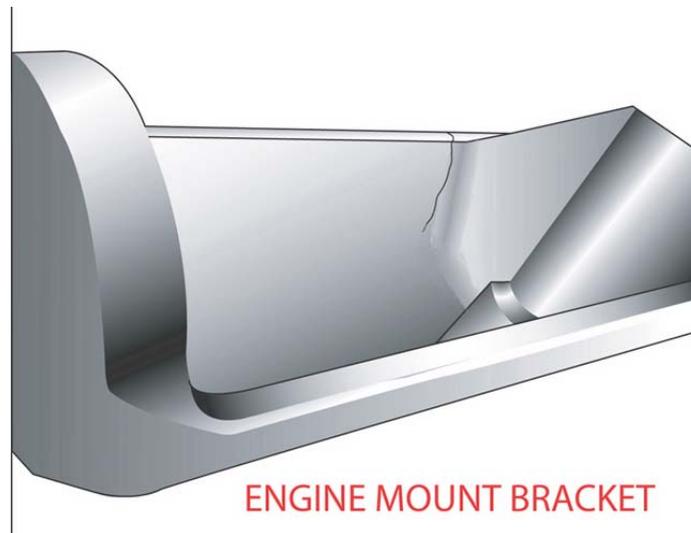
Cessna; Model T-303; Crusader; Cracked Engine Mount; ATA 7120

During an annual inspection, the technician discovered the inboard lower engine mount leg (P/N 643042) was cracked on the left engine.

The aircraft total time was 4,392 hours, and the engine total time was 685 hours since factory rebuilt. The crack was about 1-1/8 inches long and located at the lower edge 3 inches from the engine attach point.

The submitter also stated that it had a small porosity void 3/8 inch from the edge of the mount leg and in line with the crack. (Refer to the illustration.)

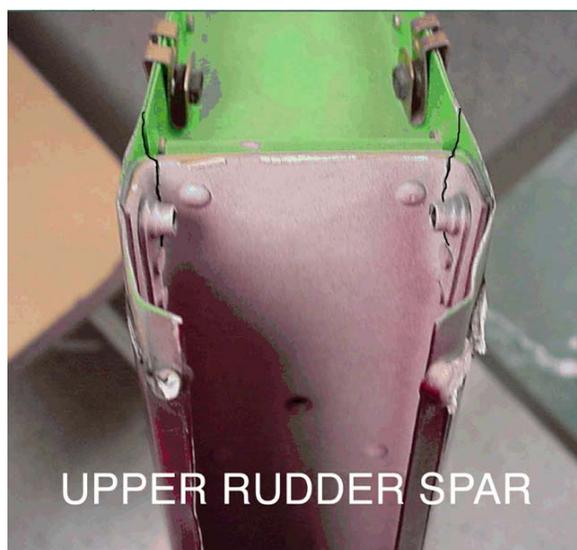
Piper; Model PA-28R-201; Arrow IV; Cracked Rudder Spar; ATA 5541

While inspecting the upper rudder spar (P/N 63543-00) and doublers (P/N 65341-00), the technician found cracks on both sides of the bend radius.

Both cracks were about $\frac{3}{4}$ to 1 inch in length from the top of the rudder to the nut plate. (Refer to the illustration.)

The operator inspected 13 additional PA-28R-201 aircraft in his fleet, and discovered two of the aircraft had spar cracks and four of the aircraft had cracked doublers.

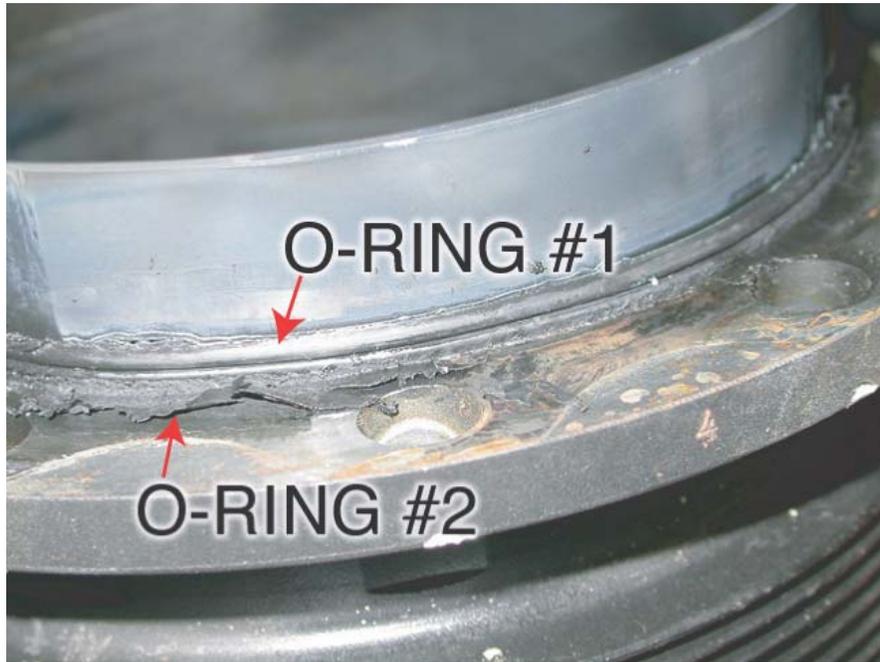
DUAL O-RING INSTALLED ON ENGINE CYLINDER BASE

During an annual inspection, it was discovered that one of the cylinder hold down studs had a missing nut. The nut was found lying in the cylinder baffling area. A torque check of the remaining nuts showed that several had become loose. The cylinder was removed to investigate. Upon removal, the mechanic found that the suspect cylinder had two cylinder base seals installed. The o-rings were deformed and compressed. Due to the two o-rings installed the original torque values had changed allowing one nut to come completely off and several remaining nuts to loosen. If not found it is possible that the cylinder could have eventually come loose from the crankcase causing severe engine damage or failure. The engine had 121 hours since new. (Refer to the illustration).

Maintenance personnel should take precaution when finding cylinder hold down hardware missing or loose. This incident is probably an isolated production error but demonstrates that further investigation into a problem can lead to discovery of additional problems that may not be apparent from a visual inspection.
