## ADVISORY CIRCULAR

43-16A

# AVIATION MAINTENANCE ALERTS

**ALERT  
NUMBER  
370**

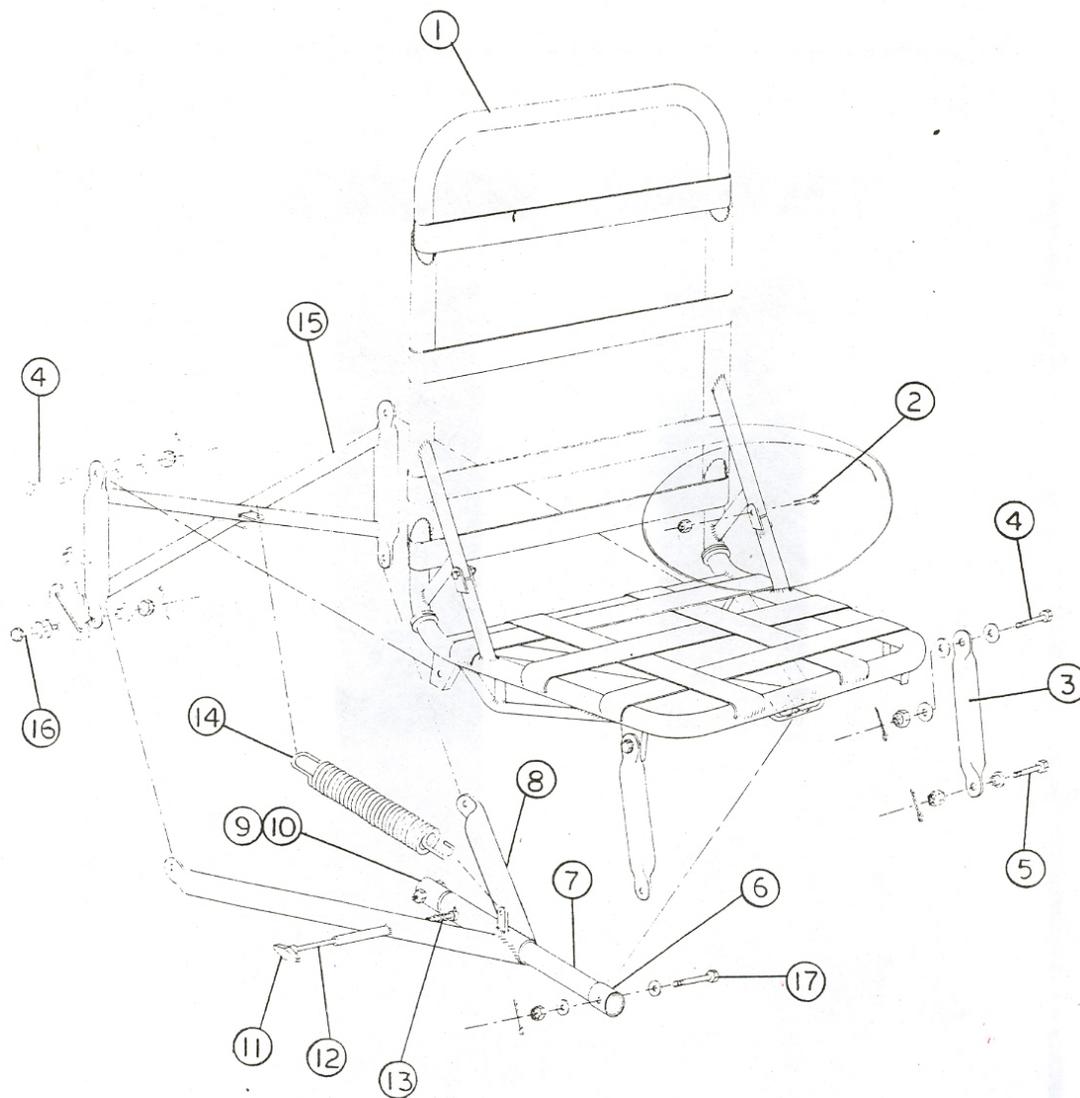
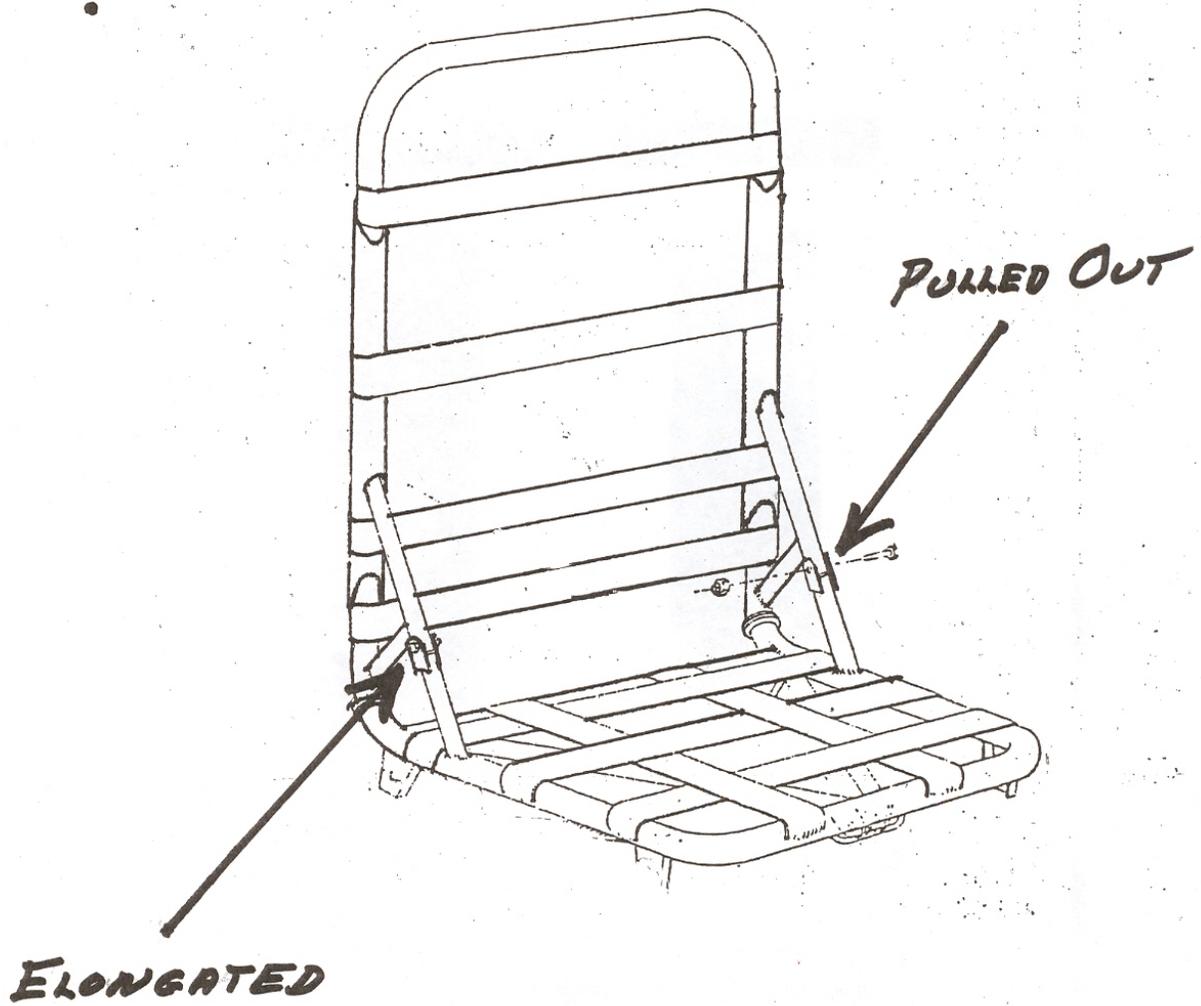
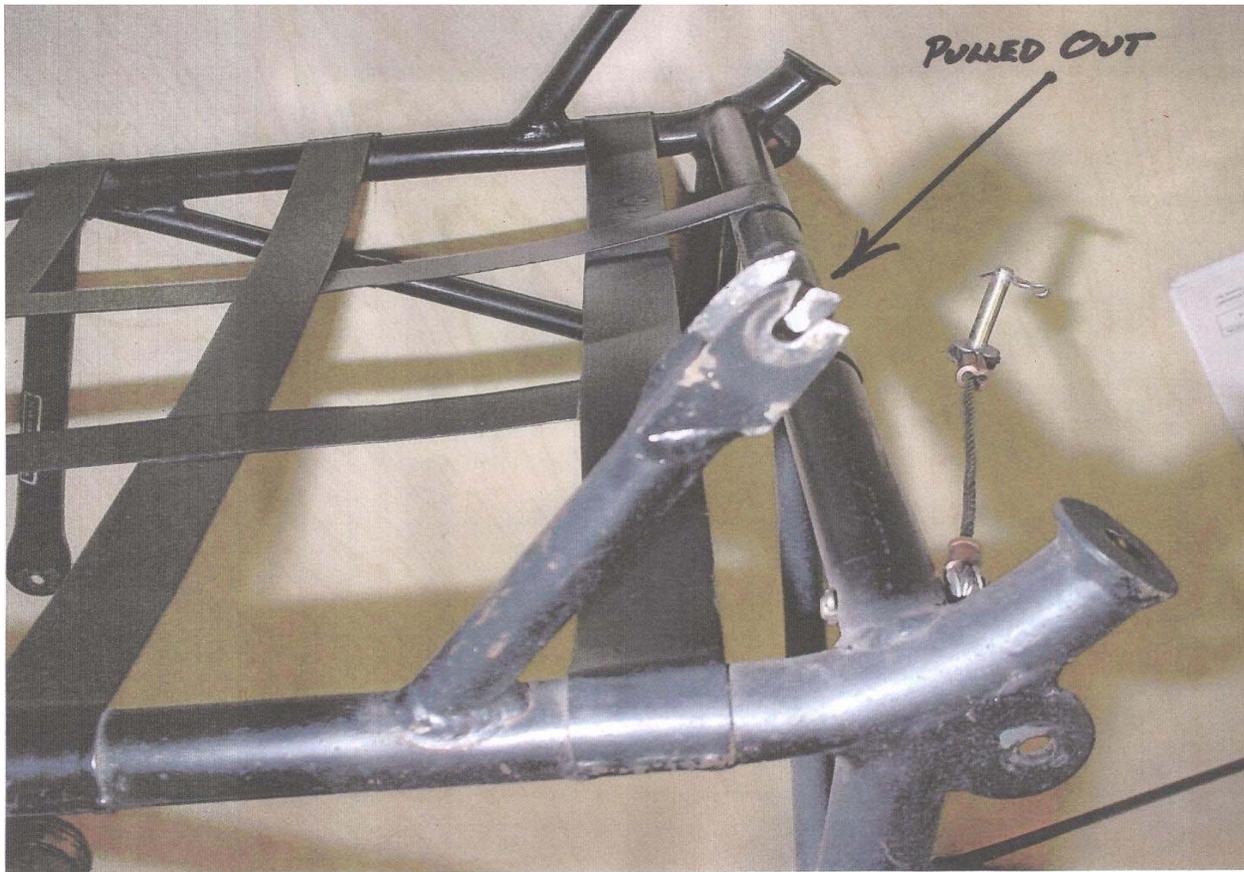
FIGURE 18  
INSTALLATION ADJUSTABLE SEAT

"The rear seat (P/N 7-1500; revision B) failed at the left hinge point. The AN3 series bolt pulled through the hinge lugs which are welded to the seat frame bottom. The right hinge holes show elongation, but remain intact. This aircraft was doing spin training at the time of the incident. I recommend the seat frame be modified to current standards as found on newer aircraft."

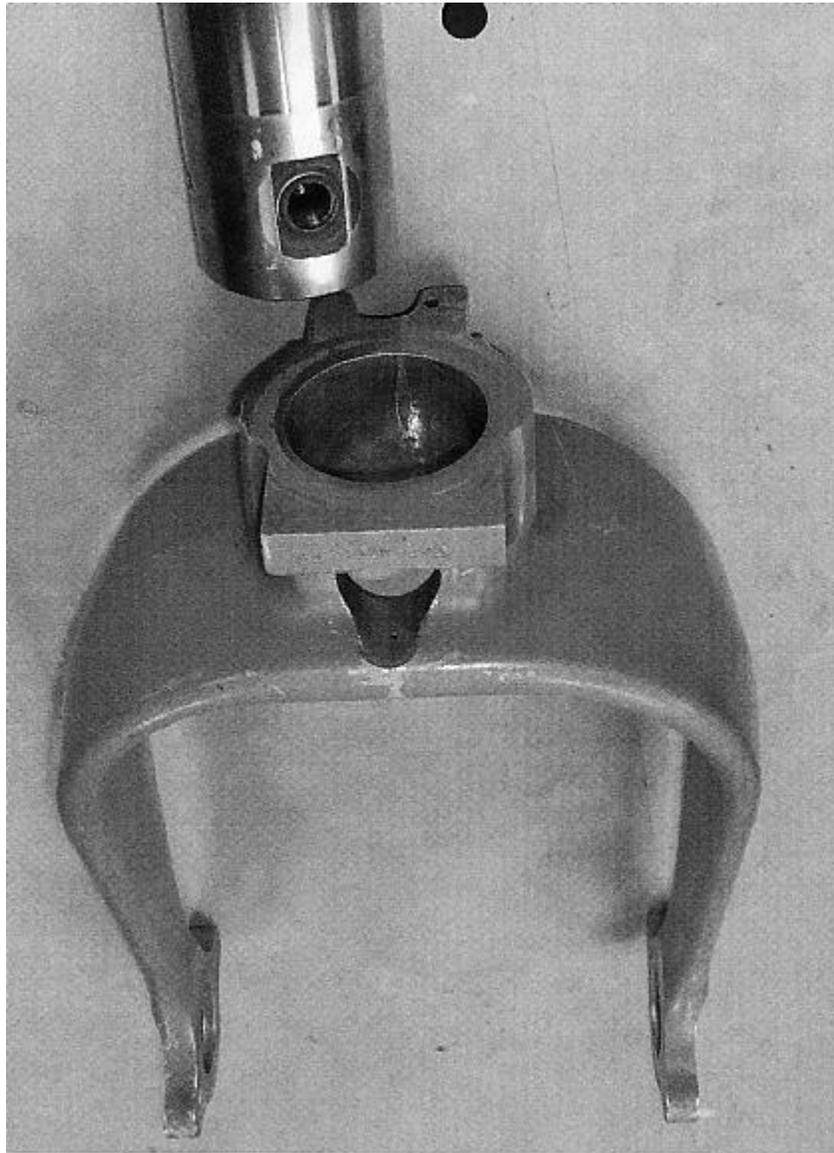
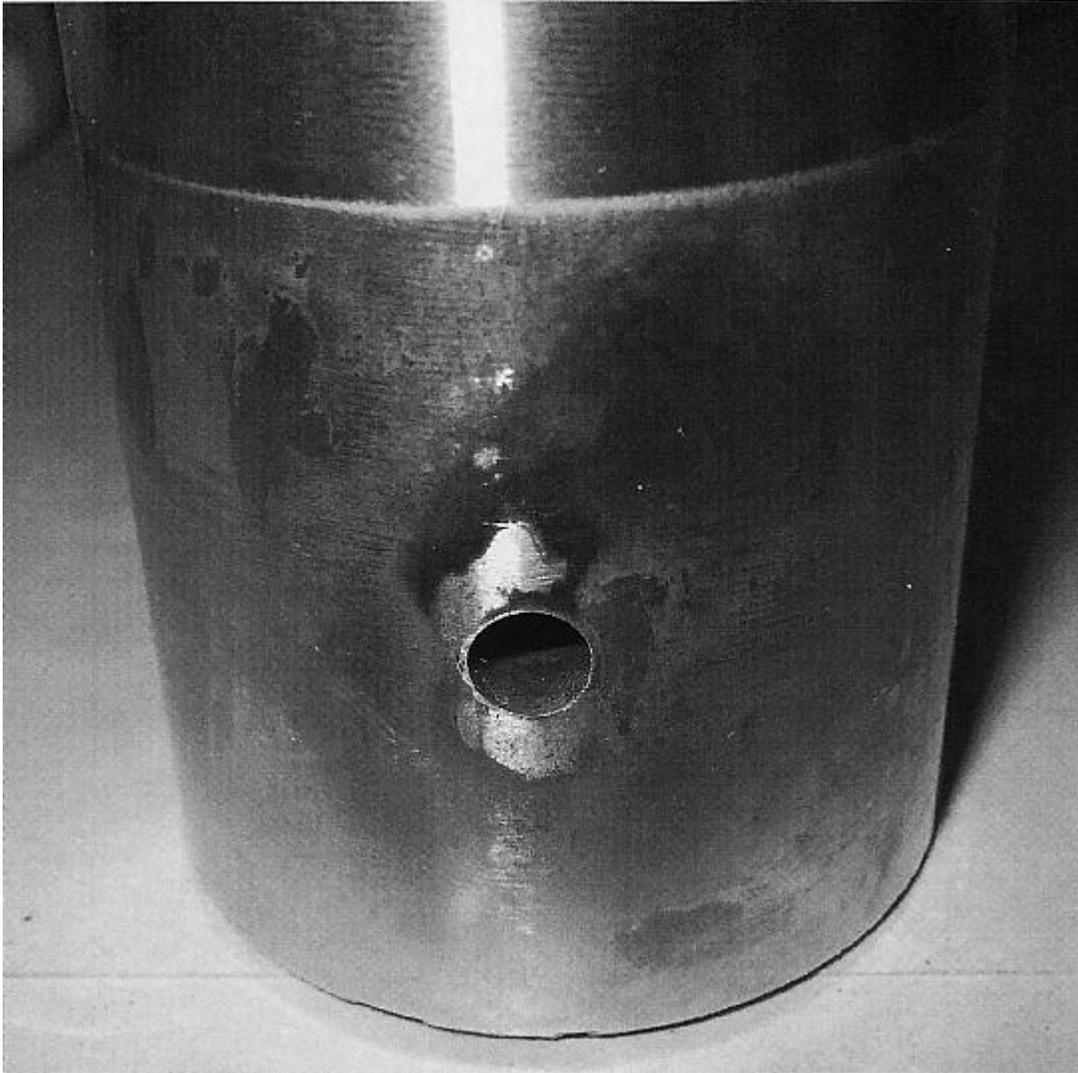
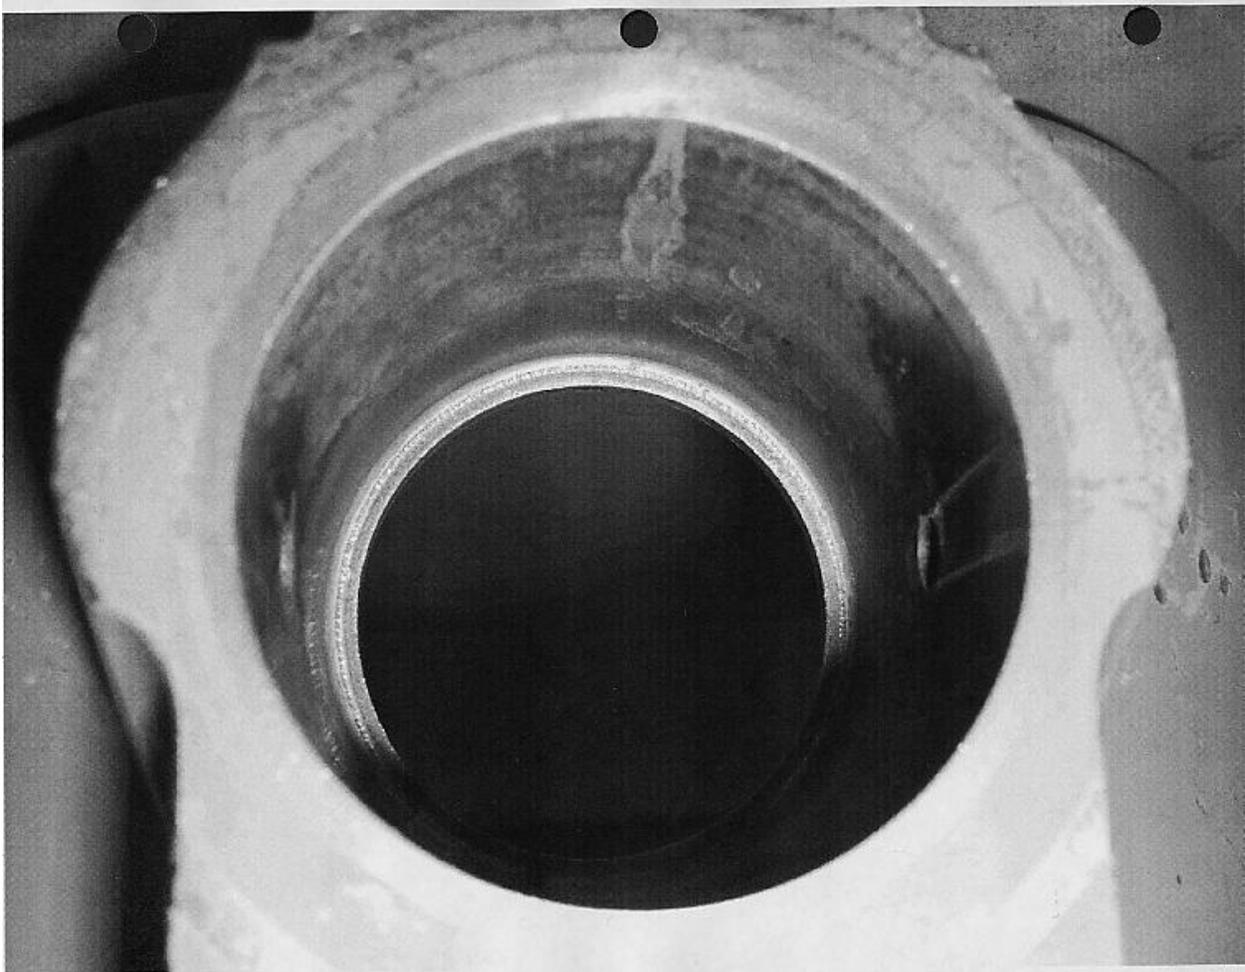
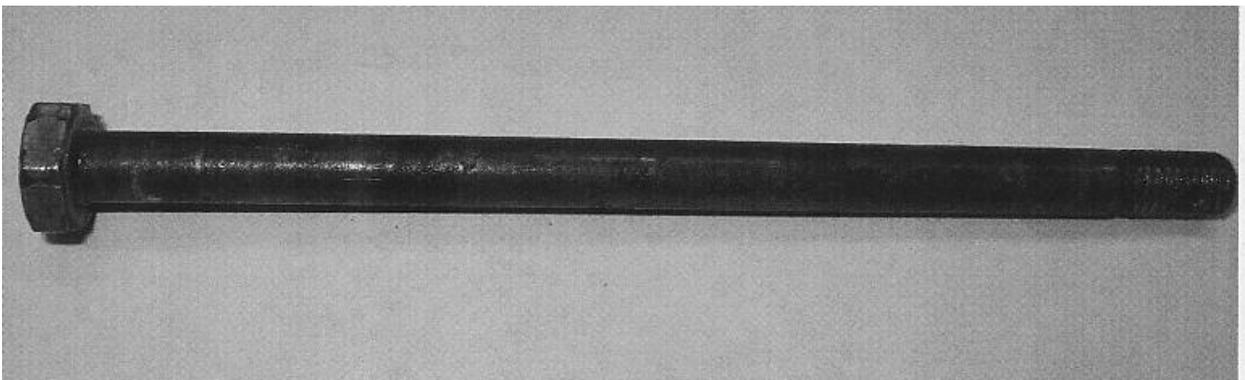
A repair station technician writes, "During a 1-5 phase inspection (we) found excessive (movement) in the nose gear forward and aft play-check. After further inspection, the nose gear fork was found loose on the piston. When the safety bolt was removed the fork fell from the piston—these (parts) should be an interference fit. (Given) this is a low-time aircraft, the (loose fork defect) appears to be a manufacturing problem." (Piston/fork assembly P/N: 6642000-3.)

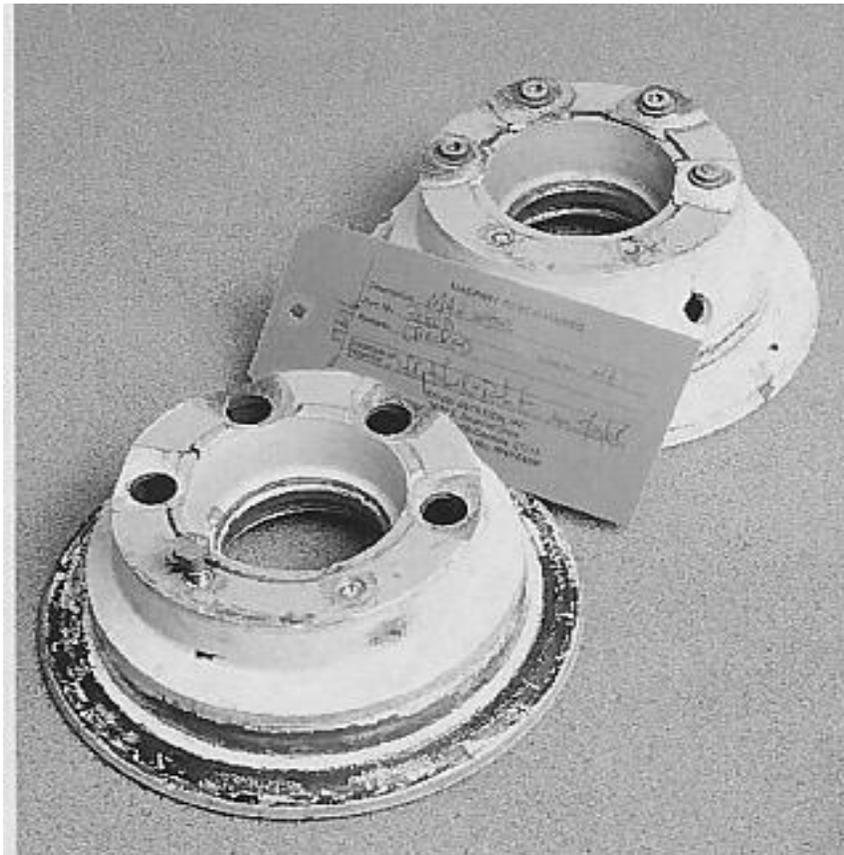
A repair station submitter states, "During a routine inspection, the *(mechanic)* encountered difficulty removing the L/H main gear wheel assembly axle retaining nut. He stopped and deflated the tire. The wheel was then easily removed. Following removal the wheel was found to be severely corroded and all but one wheel-half retaining bolt had failed. The log book entry indicated the wheel had last been disassembled 217 hours *(previously)*."

*(Cleveland Wheel and Brake Assembly P/N 3080D.)*
