## ADVISORY CIRCULAR

# AVIATION MAINTENANCE ALERTS

**ALERT  
NUMBER  
394**

**MAY  
2011**

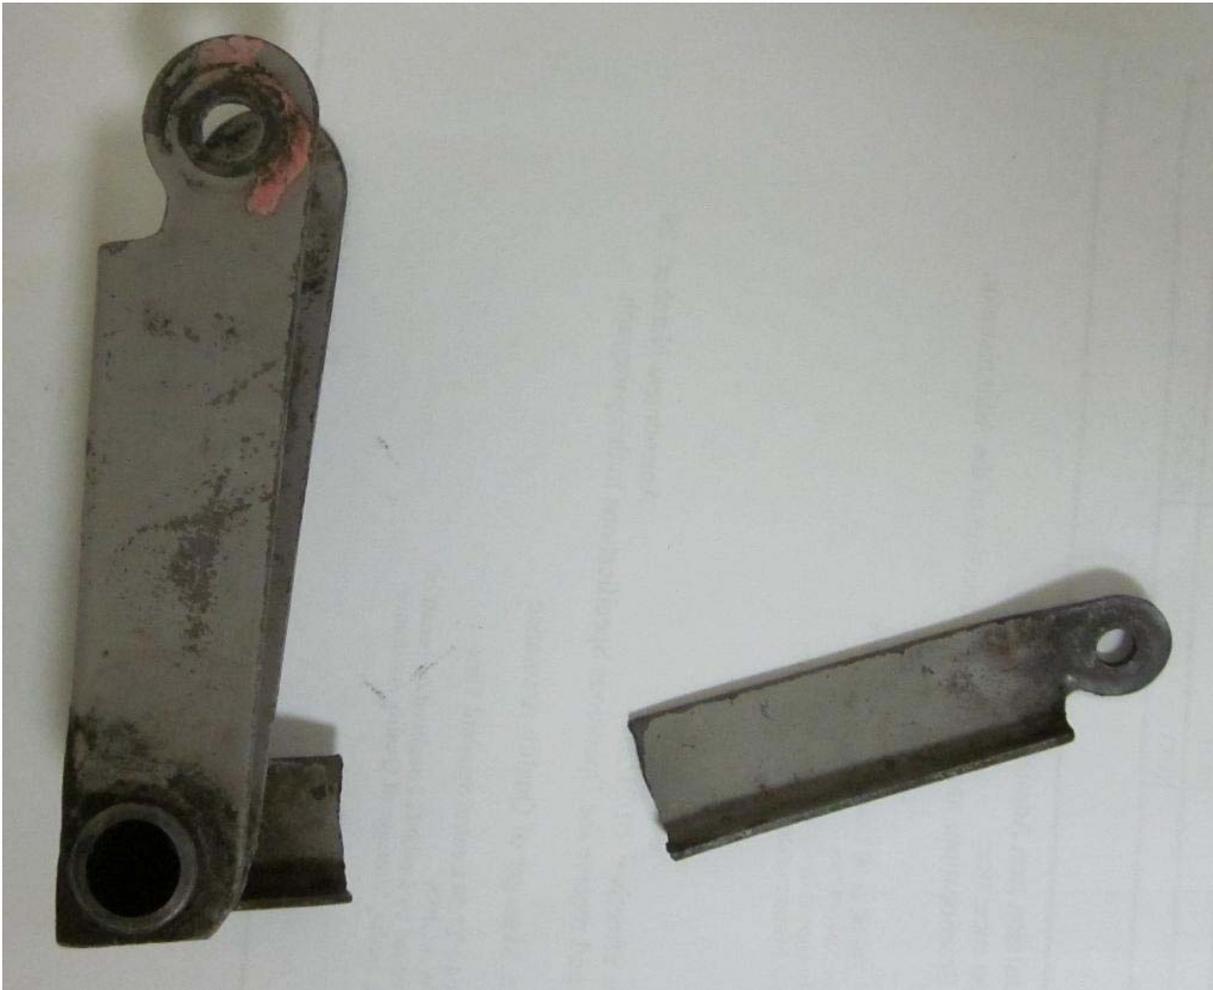
**Cessna: 177RG; Failed Nose Landing Gear; ATA 3230**

This submitter says, "The nose landing gear failed to extend when the gear was lowered for landing—a nose gear 'up' landing (*followed*). Examination revealed the up lock bell crank forward arm (that activates and disengages the up lock roller from the up lock hook) was found bent—and 90 per cent cracked (*through*). It would not allow the up lock to disengage. (The engine/nose gear mount was also found warped out of alignment—this was removed and repaired by a repair station. The probable cause: severe side loading during landing at an unknown time.)

"A new part was installed and a gear rigging check made per Cessna Manual, and no other problems were noted."  
(*Nose up lock P/N: 204303112.*)

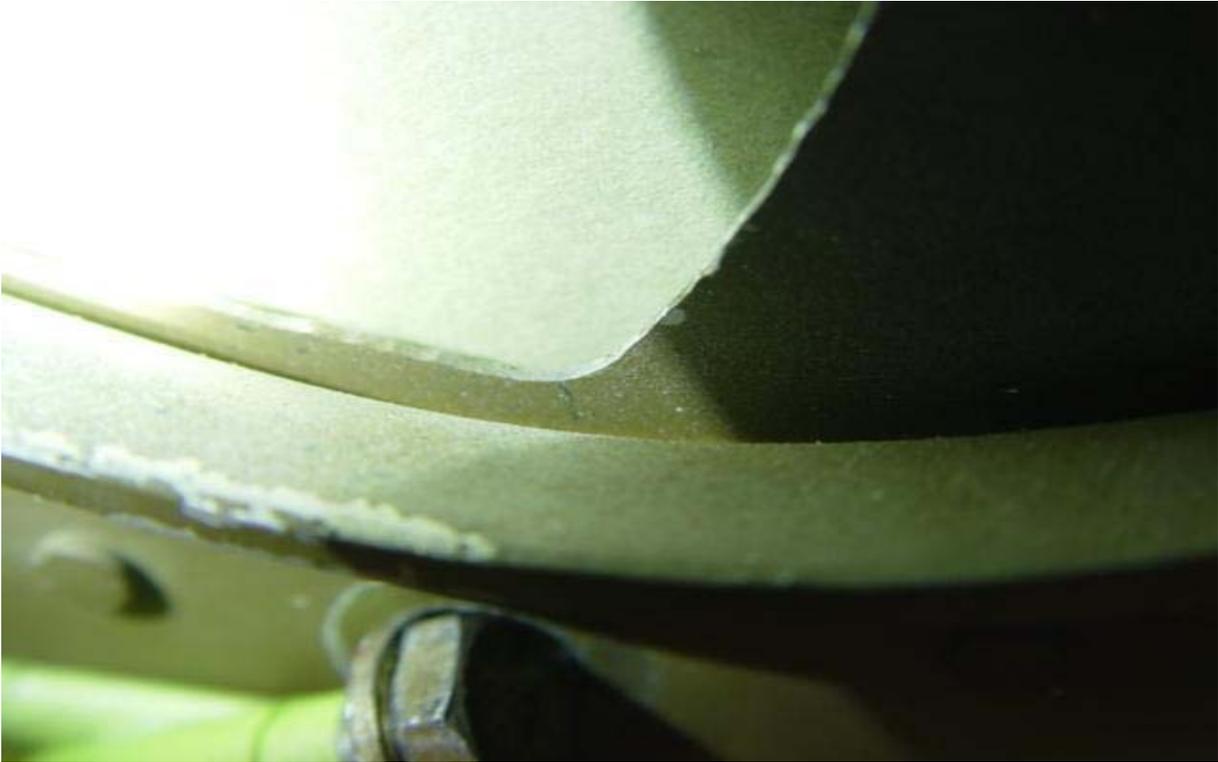
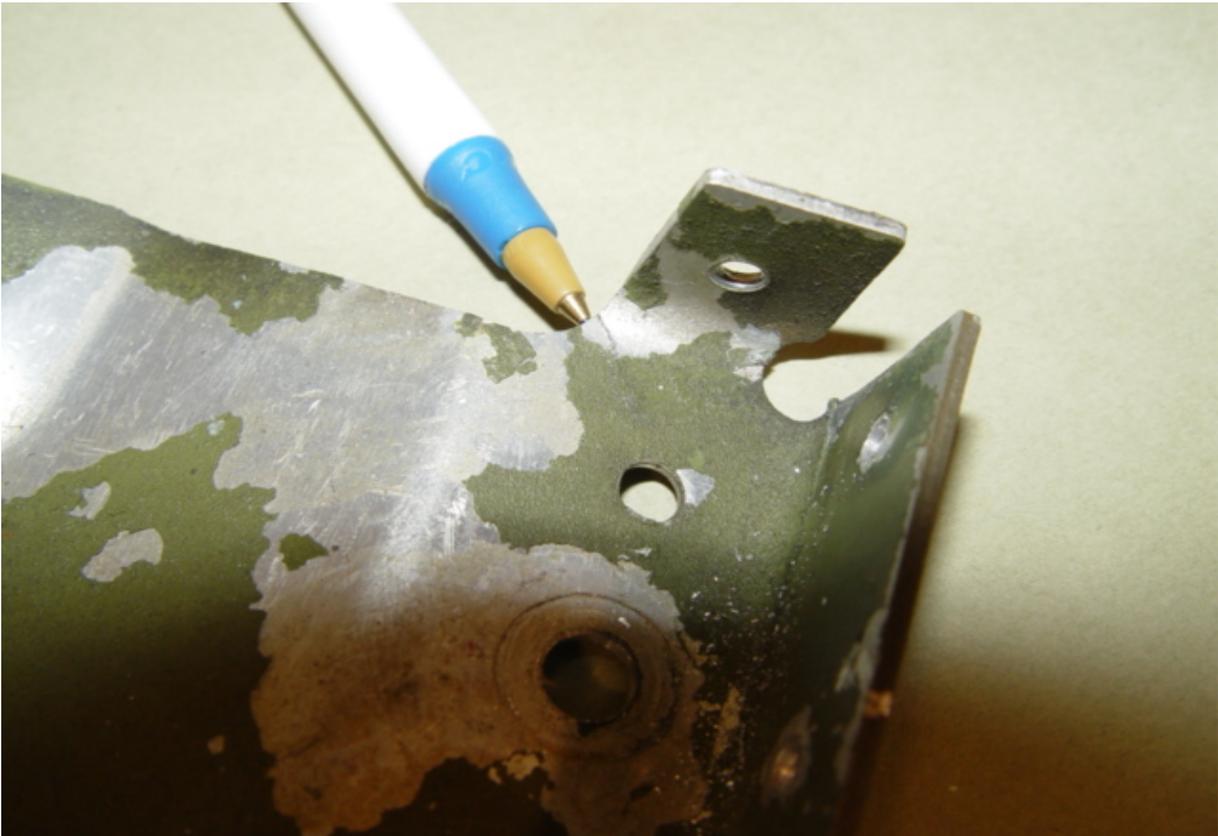
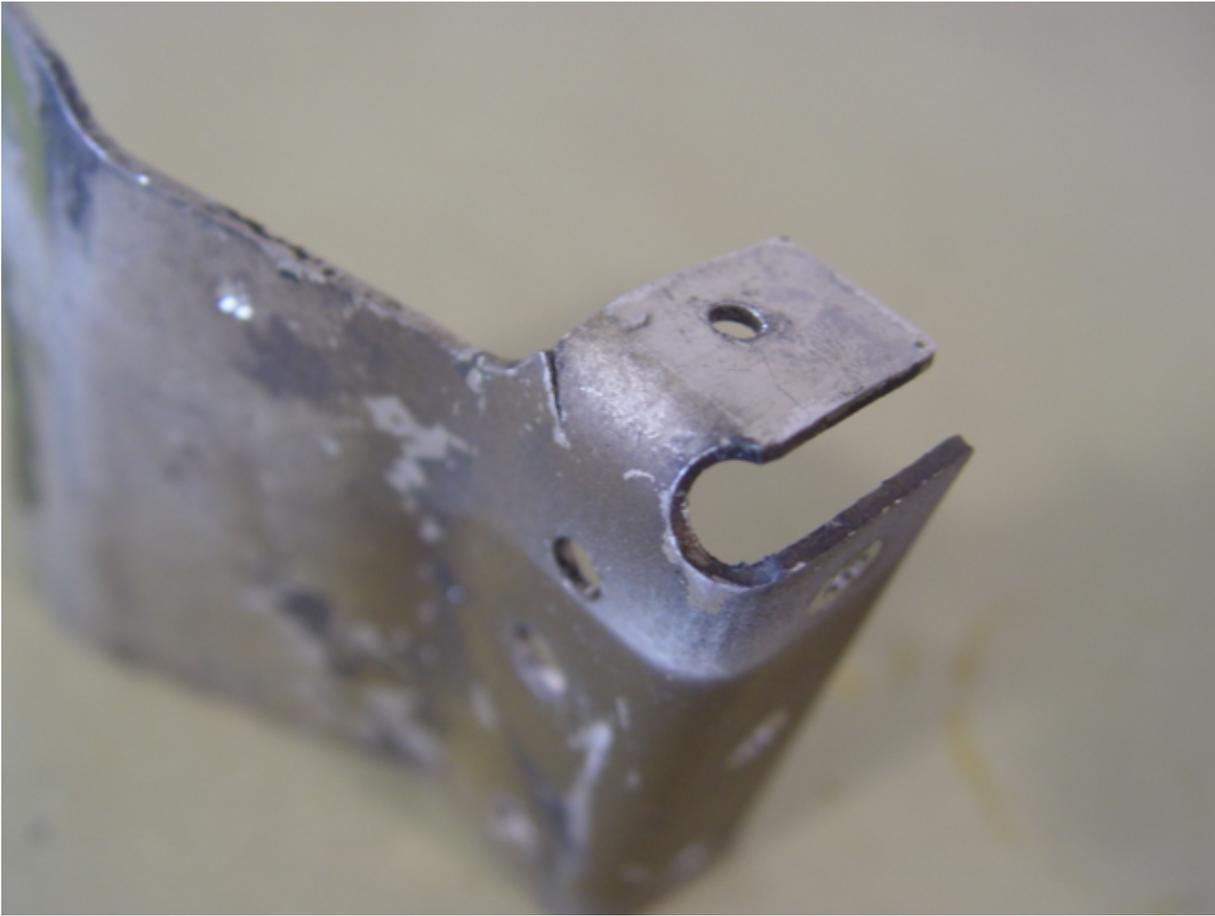
**Cessna: P206E; Cracked Bulkhead; ATA 5312**

A technician states, "During inspection per AD72-07-09 (10/17/1974) and Service Letter SE72-3, the aft bulkhead (P/N 1212858-2) was found cracked in both rudder cable cut outs. Upon removal of the aft bulkhead, the left and right stabilizer attach brackets (P/N's 0712629-3 and -4) were also found cracked."

*(The SDRS database reflects the -2 bulkhead part number at least five times.)*

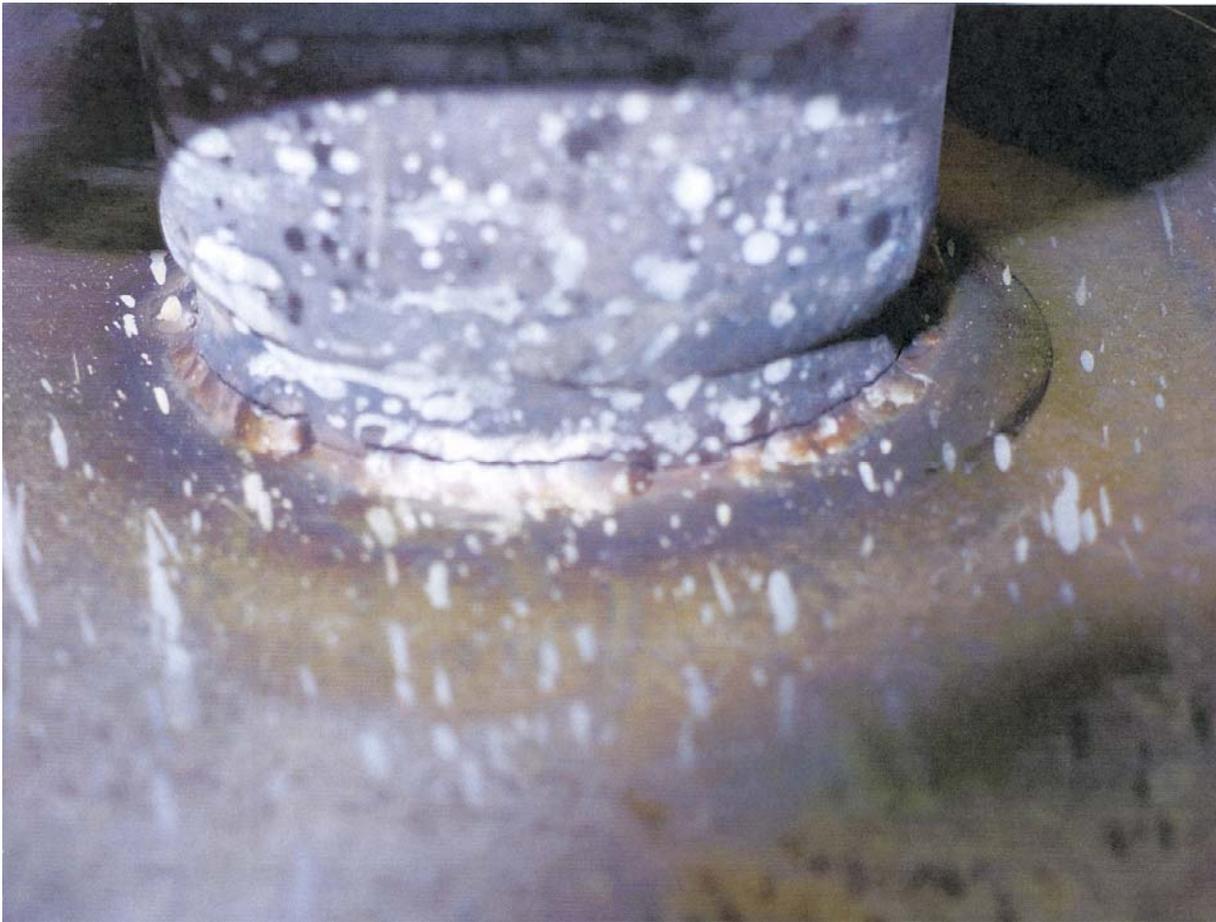
**Diamond: DA40; Cracked Heat Exchanger Exhaust; ATA 2140**

An unidentified writer says, "In accordance with Power Flow System's 'Continued Airworthiness Instructions' (dated 7/22/2008), paragraph 7.0 states, 'The exhaust system must be thoroughly inspected, especially within the heat exchanger section...'. During a 100 hour inspection of this airplane a crack was found in the chain weld at the exhaust exit ball and the heat exchanger cover. The cracks start at the finish point of the weld and continue through the center of the weld—to the start point of the weld segment. Paragraph 5.4.1 'Maximizing Service Life' states, 'Dynamically balance your propeller to below 0.2 ips (*inch per second*) every two years or 1000 hours (whichever occurs first).' This aircraft was manufactured in 2009 and has 398.6 hours since new." (*Heat exchanger P/N: 41303; Exhaust assembly component number: PFS15102.*)

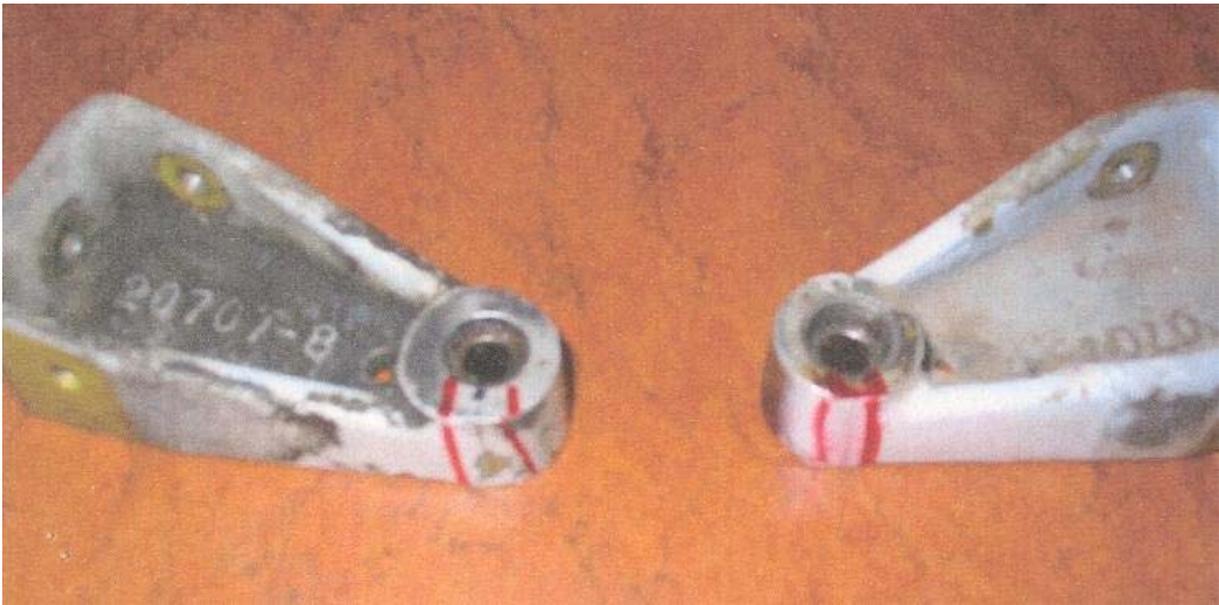
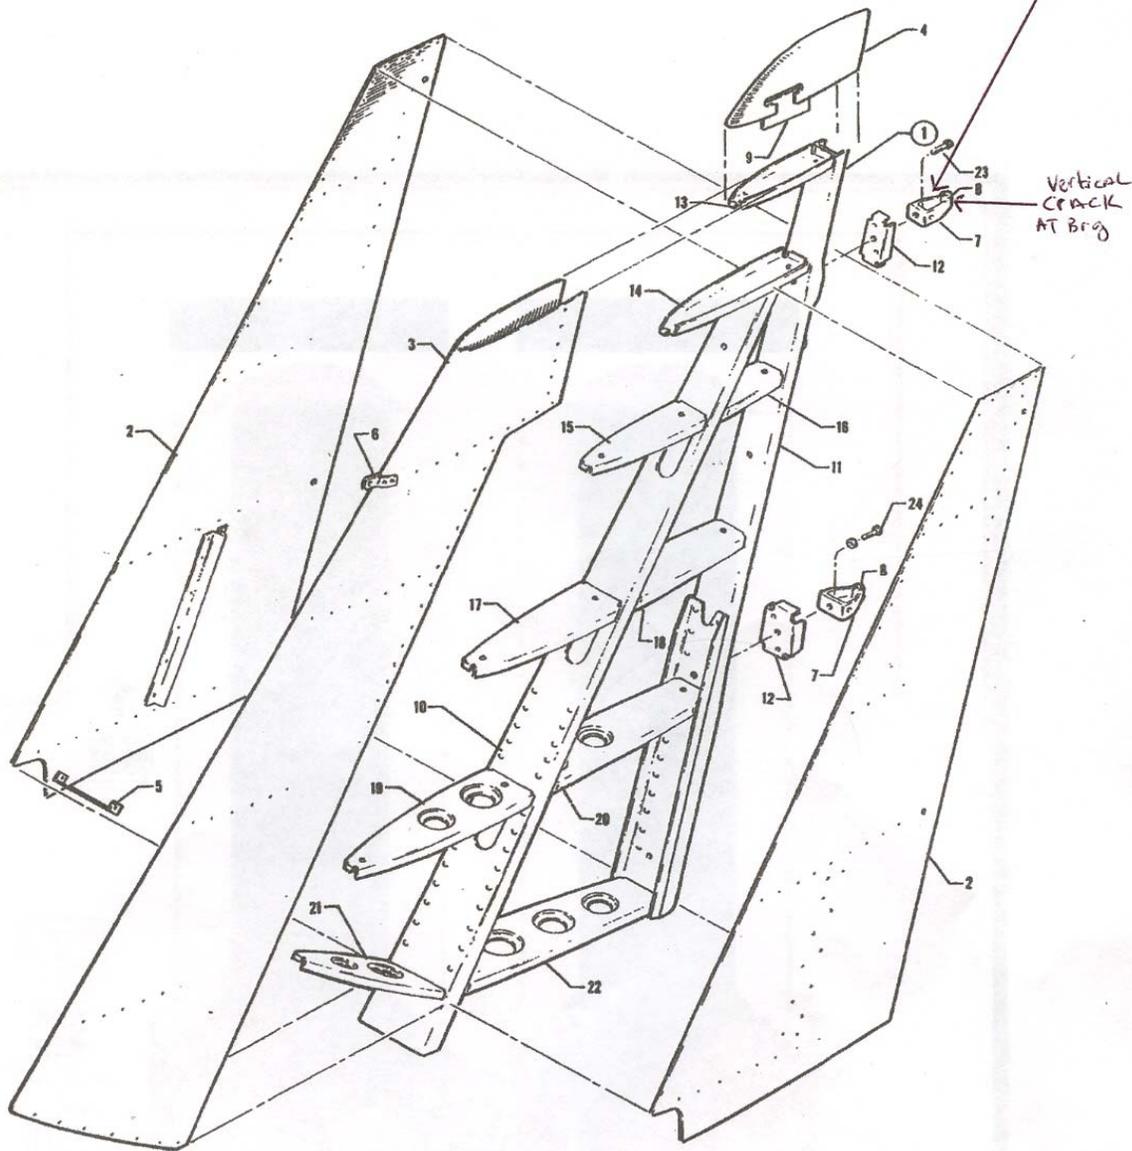
Figure 23F. Fin Assembly "180", "250" & "260"

**Piper: PA24-260; Cracked Rudder Hinge Castings; ATA 5540**

A mechanic writes, "The top rudder hinge casting is cracked at the roller bearing location." *(Displayed drawing and P/N for the 24-260: 20707-02. P/N for the 24-400: 20707-06; drawing is similar. A parts list might have resolved the mystery why the photo shows P/N 20707-8! However, the location and problem is quite clear; thanks—Ed.)*

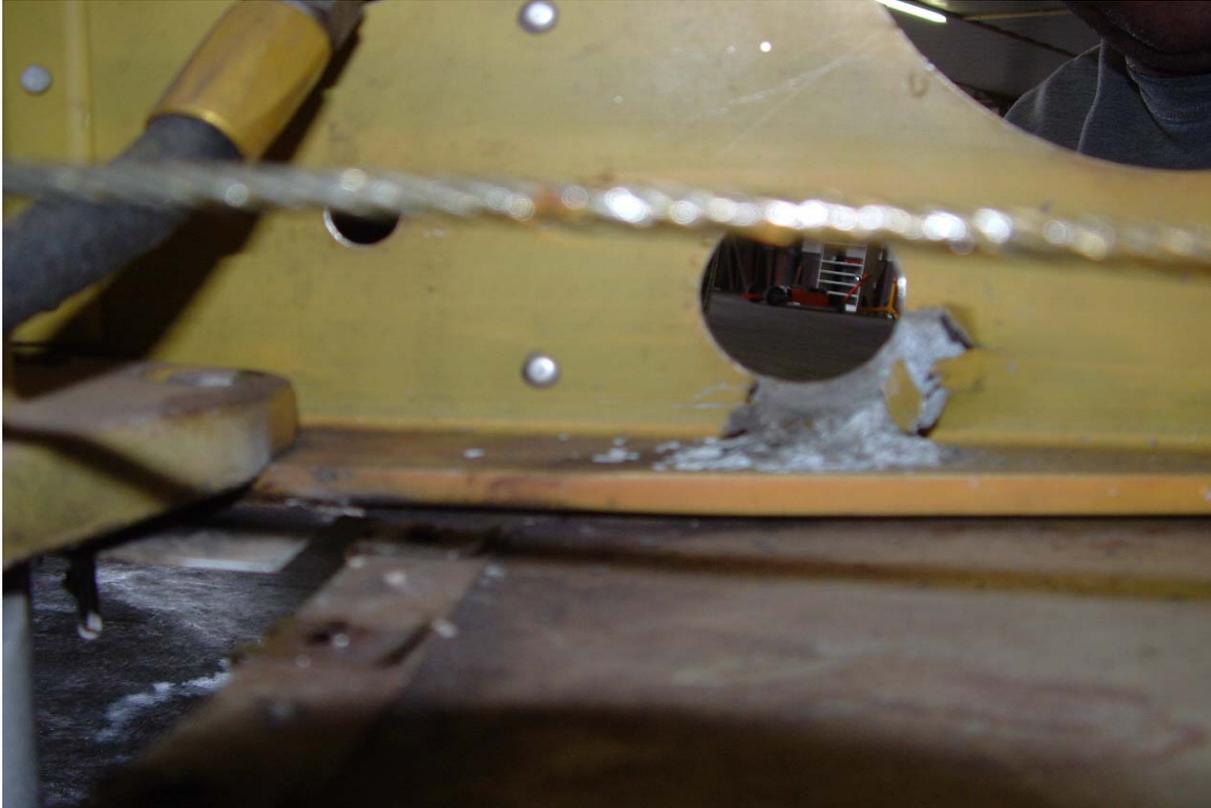
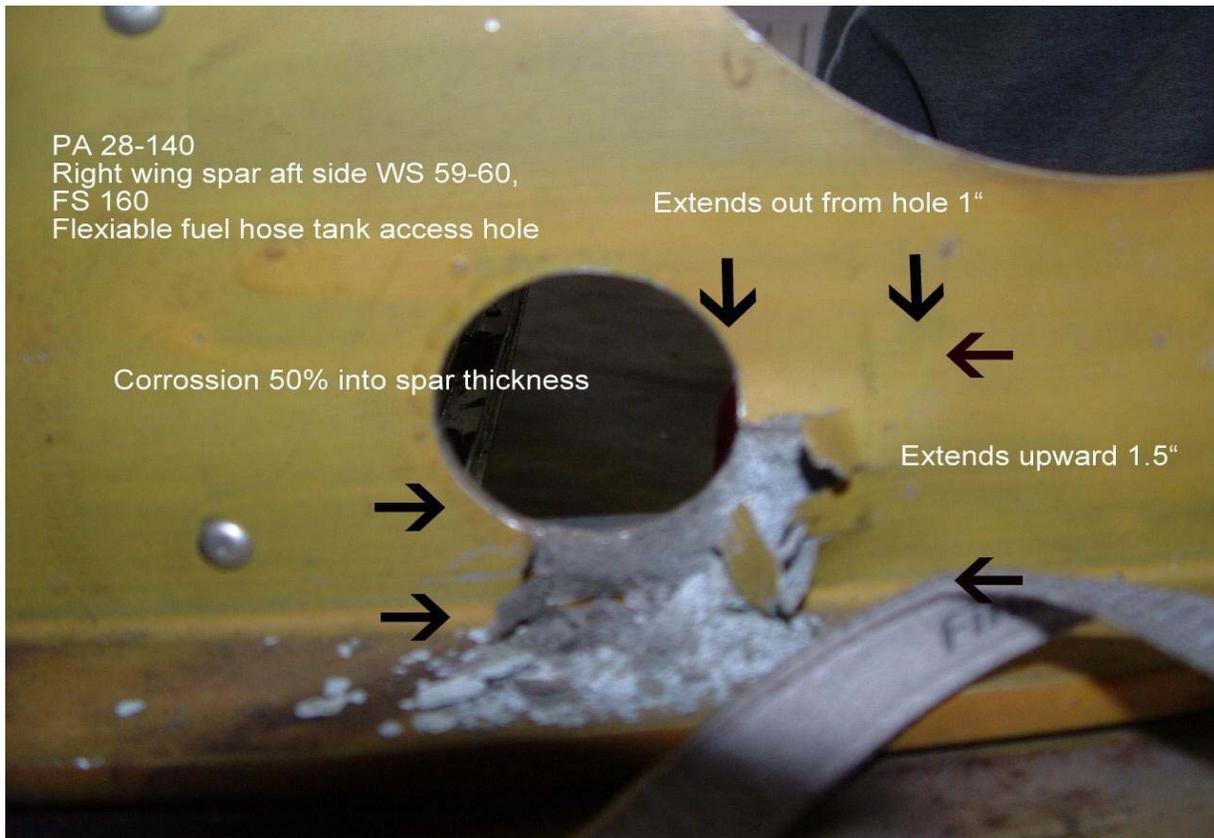
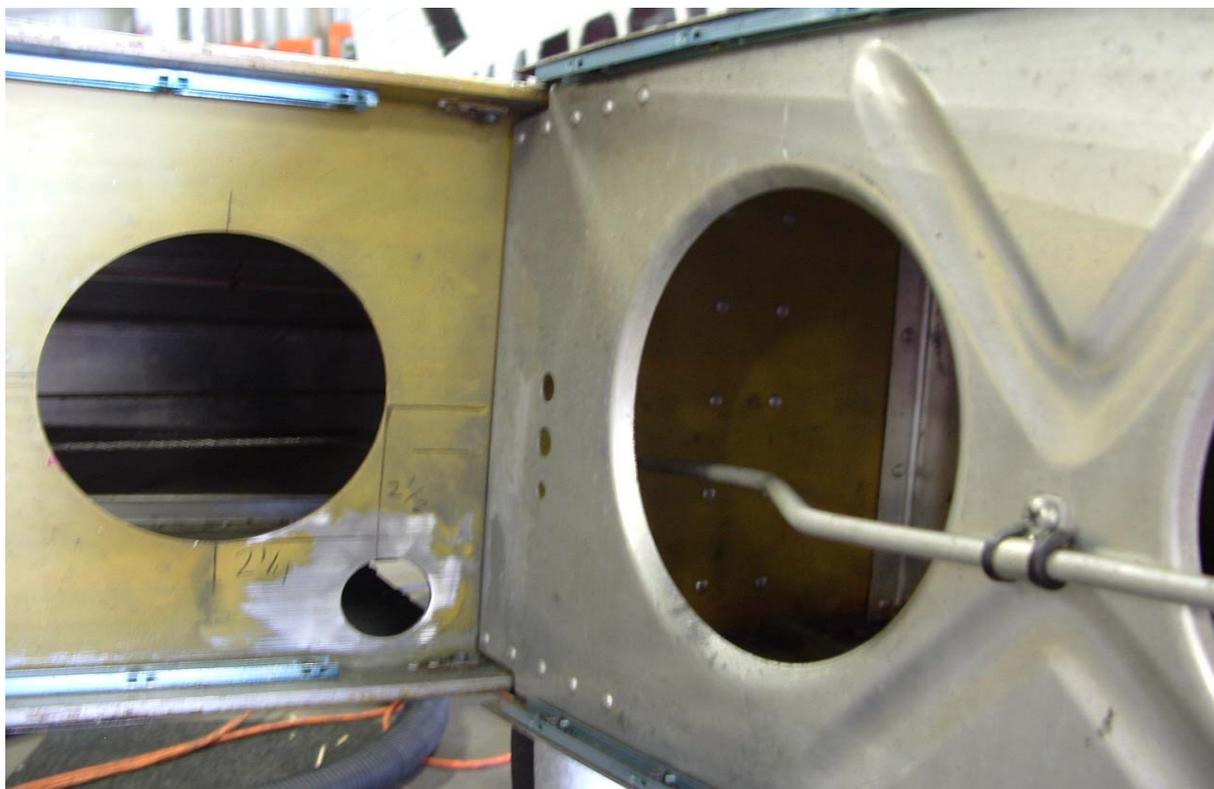
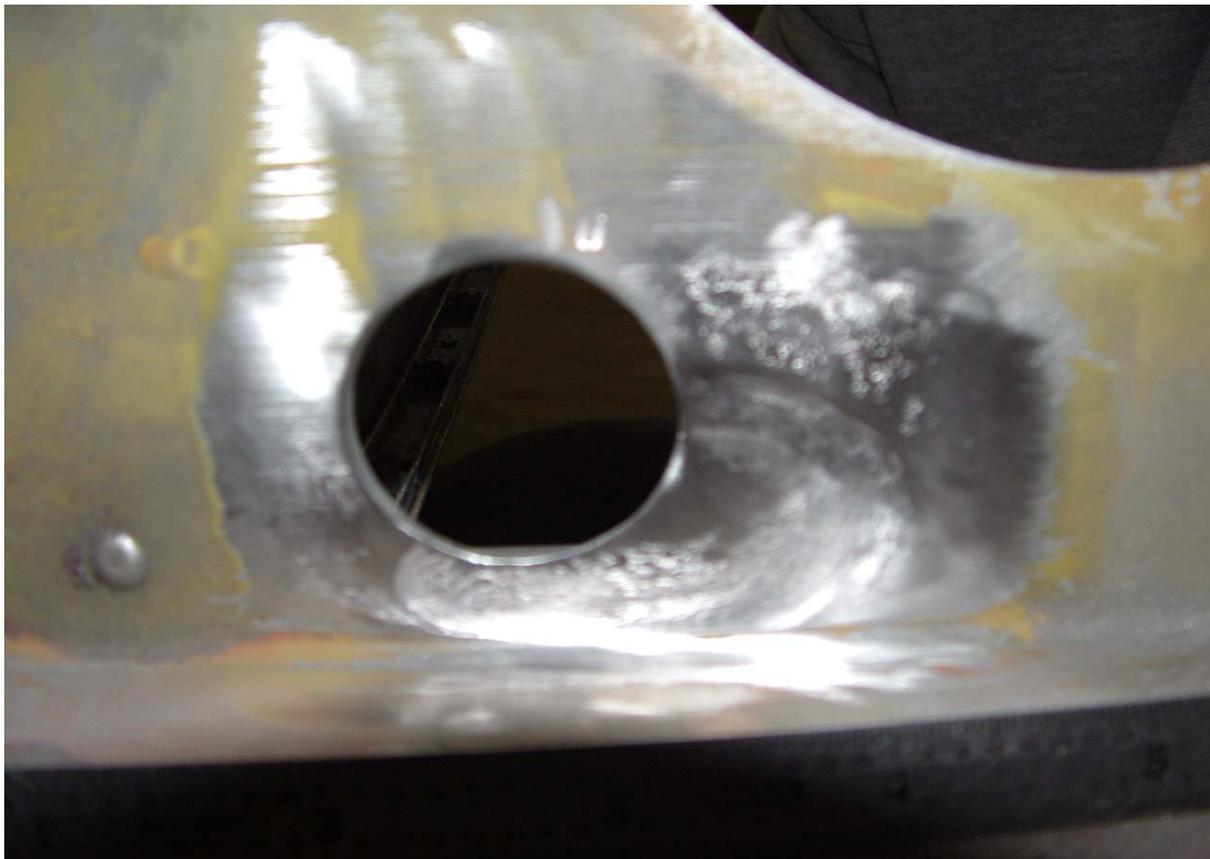
**Piper: PA28-140; Wing Spar Corrosion; ATA 5711**

"Corrosion (*has been found*) on the right wing spar aft side," says an unidentified technician, "at wing station 59-61 (*and*) the fuel tank flexible access." (*Wing spar P/N: 6207001.*)

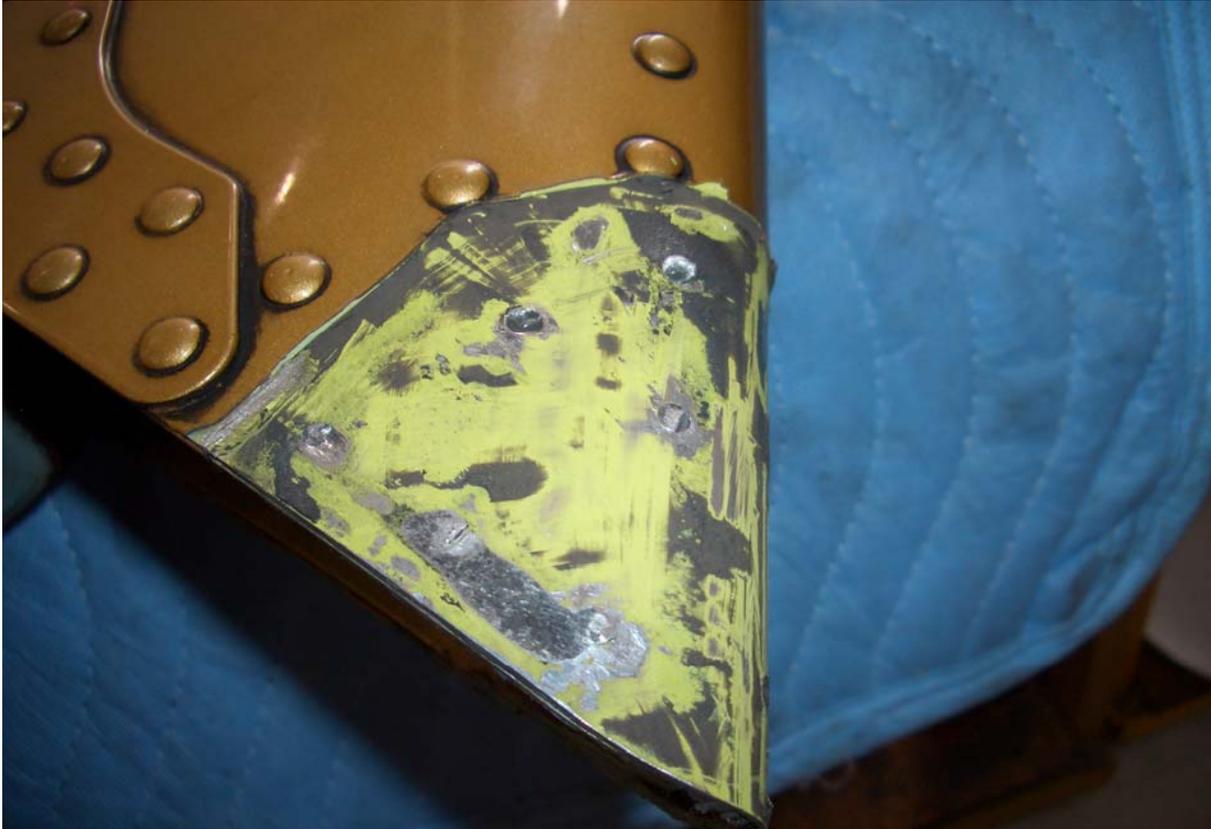
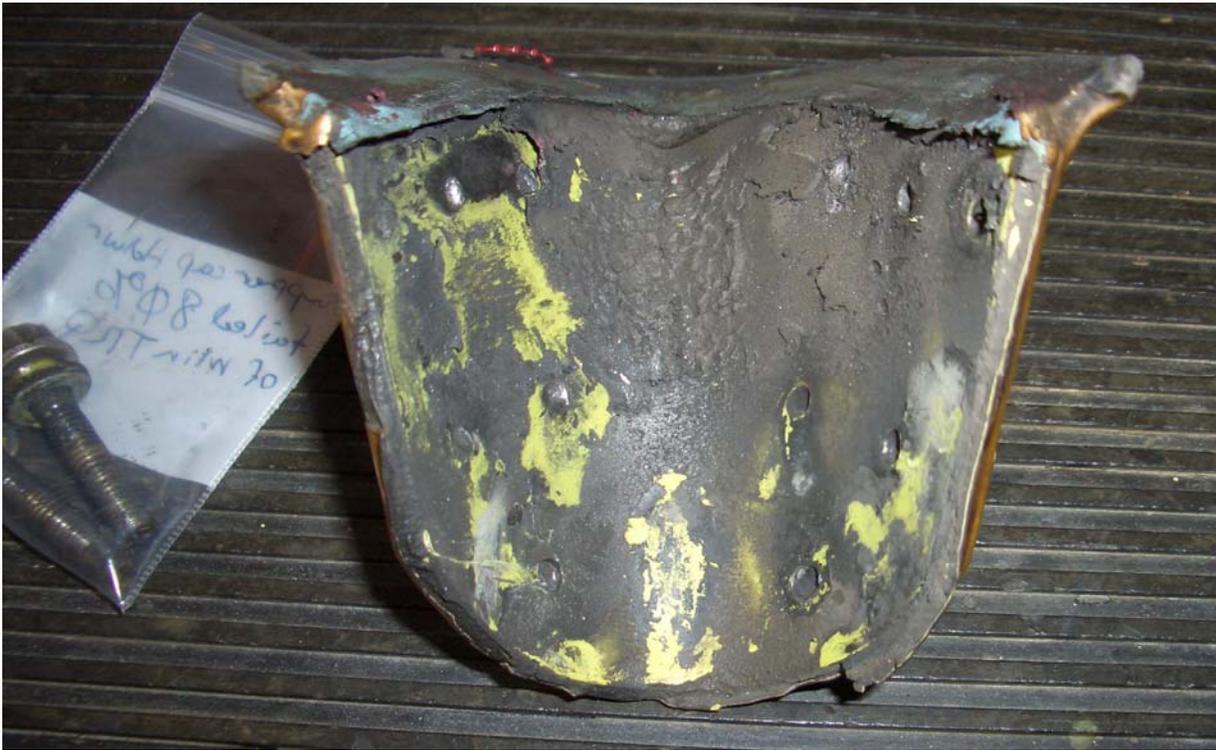
### **Eurocopter: AS350-B2; Vertical Stabilizer Rivet Failure; ATA 5302**

This submitter states, "Visual inspection of the vertical fin revealed leading edge movement. Removal of the attachment bolts (*exposed*) sheared rivets." (*Vertical fin P/N: 350A14201101. Total cycles: 15,403.*)

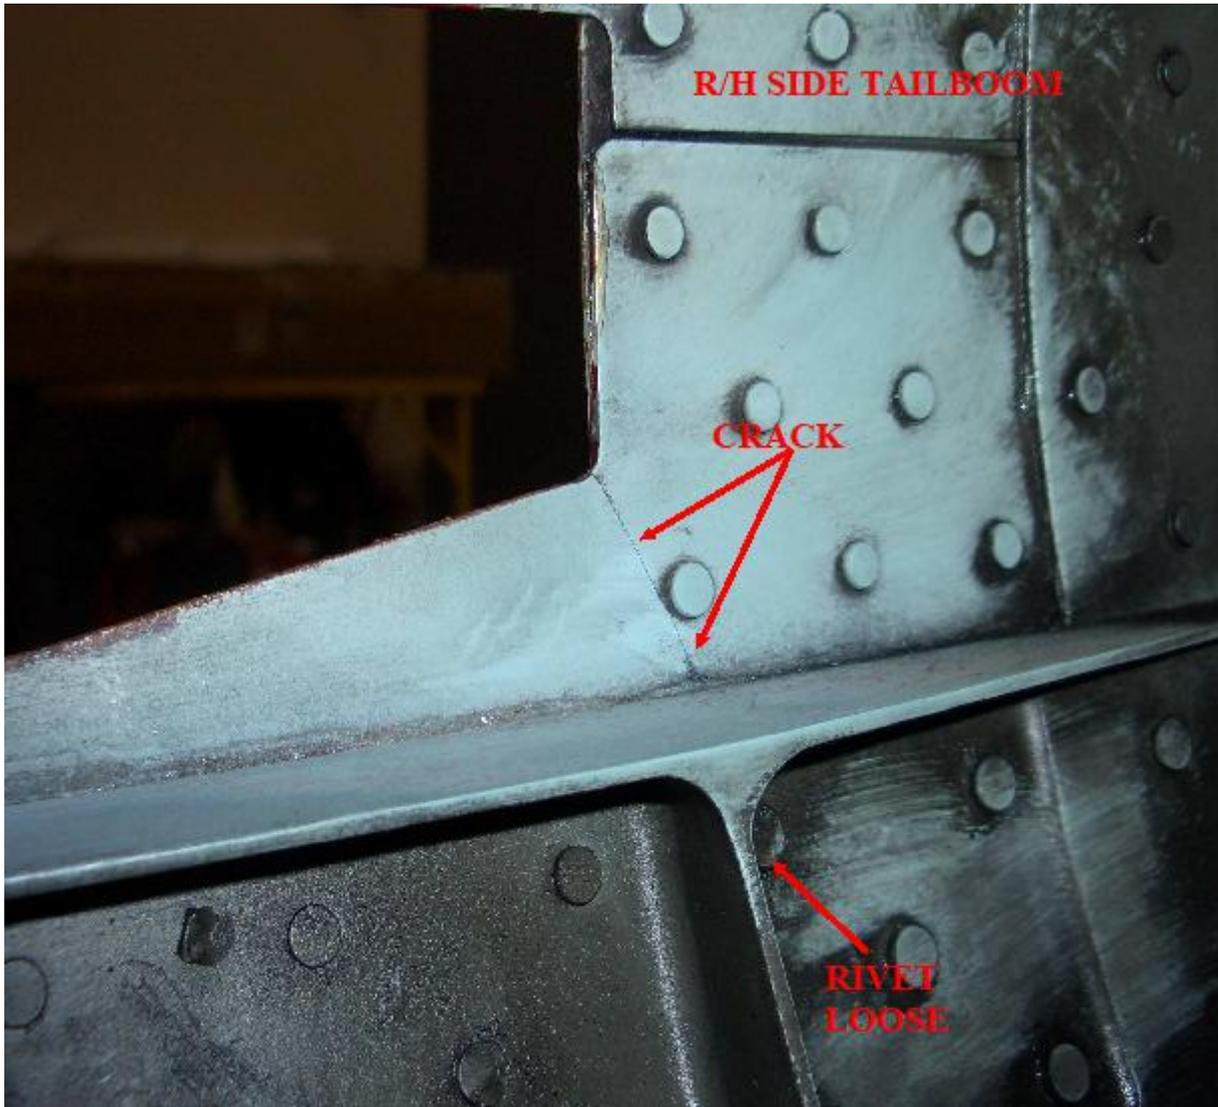
**Eurocopter: EC130-B4; Cracked Tail Boom Structure; ATA 5302**

*(About this defect our intrepid mechanic writes, "Cracked tail boom." He can be forgiven the lack of specific placement and detailed description because of the most excellent photo—folks who work this bird will know exactly where to look. Speculation as to cause of this crack would have been interesting. Listed total cycles are: 6,682—Ed.)*

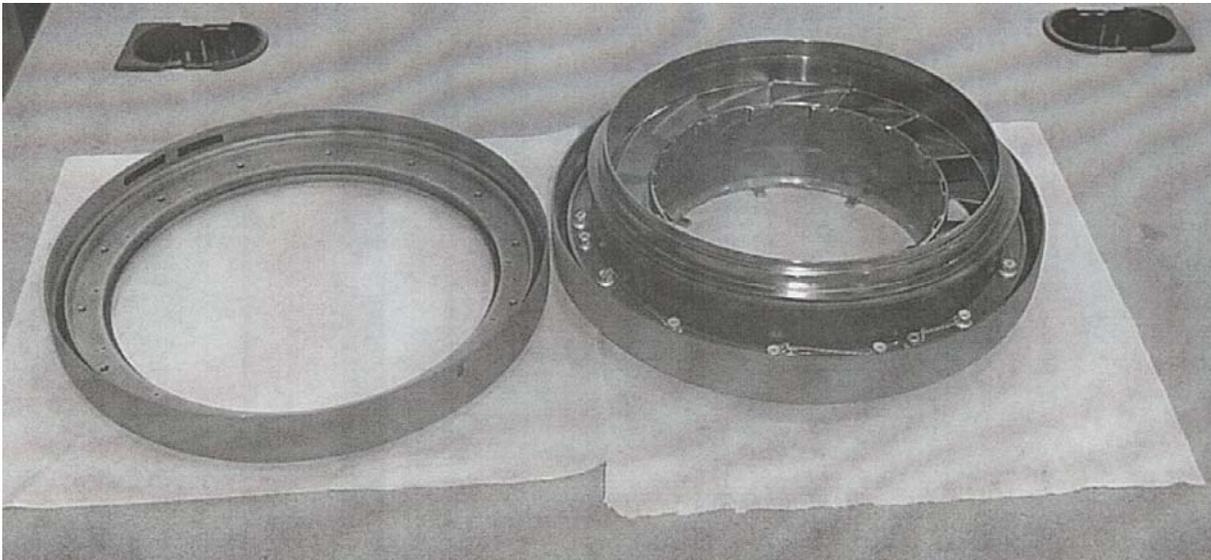
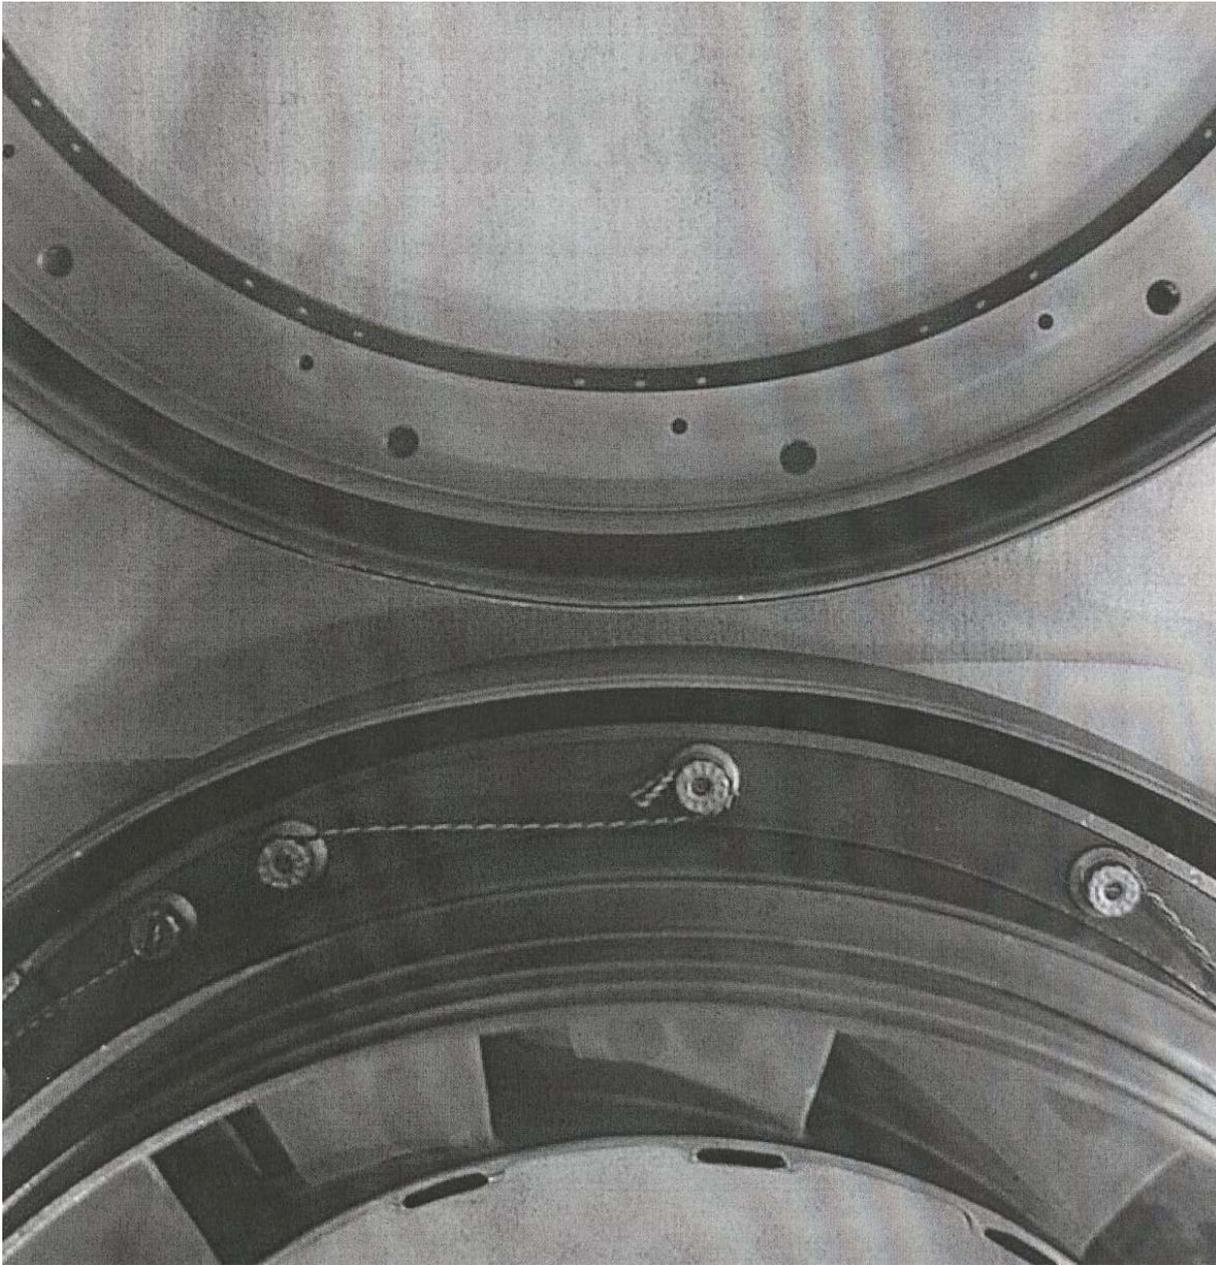
### Pratt & Whitney: PT6A-114; Defective Small Exit Duct; ATA 7240

A Chief Inspector for a repair station describes the following defect. "During a hot section inspection (*HSI*), the small exit duct (*SED*) required replacement. A replacement, overhauled *SED* with the same part number as the original *SED* was used in the build-up of the *I.E.* duct assembly. The *I.E.* duct assembly was installed in the engine, but when the technicians attempted to install the burner can it would not fit around the *SED*. After several unsuccessful attempts to install the burner can, the technicians removed the *I.E.* duct assembly and attempted to fit the burner can around the *SED* (*while*) sitting on a table. They were unsuccessful in the attempt. The assembly was then taken back to the vendor who had performed the *HSI*, and they found the inner wall of the *SED* had a gap between it and the outer wall as compared to a new unit. The vendor then changed out the *SED* for a new unit in their shop, which allowed the burner can to easily slip around the *I.E.* duct assembly. This new unit had no gap between its walls."

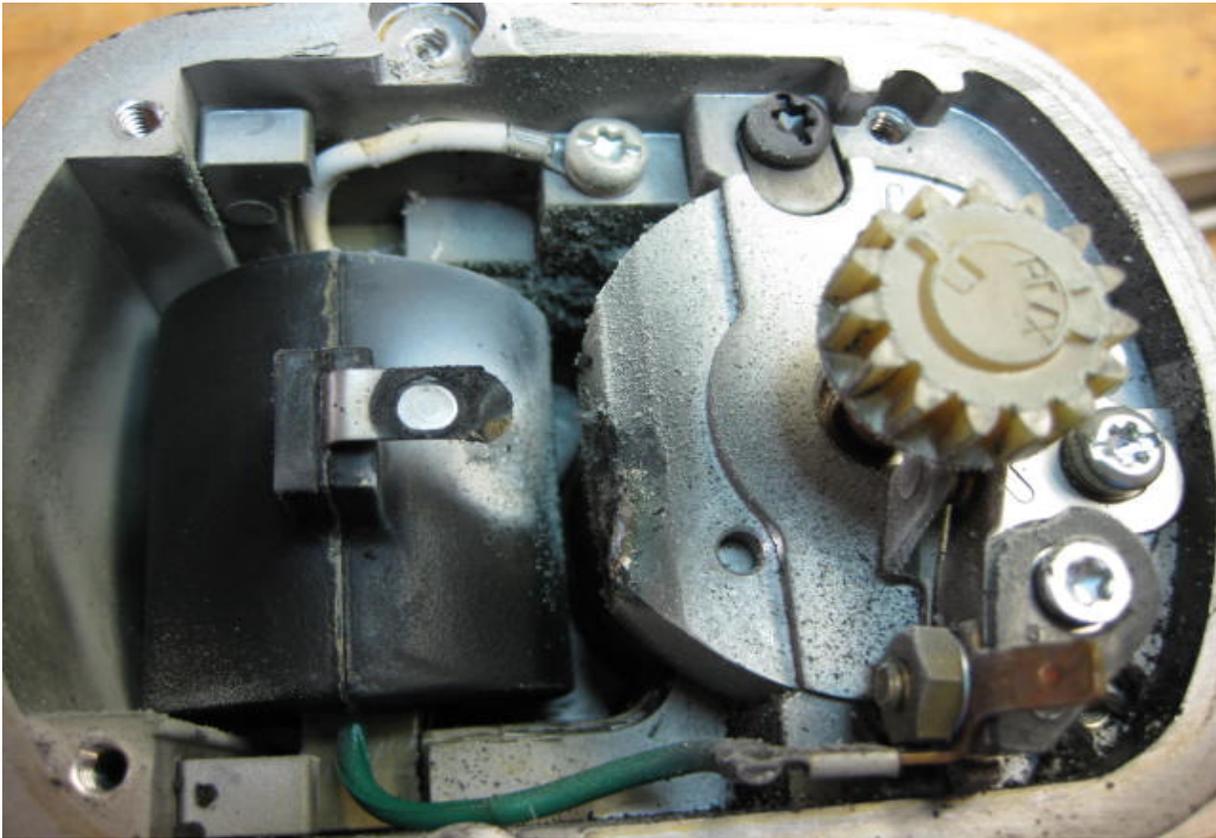
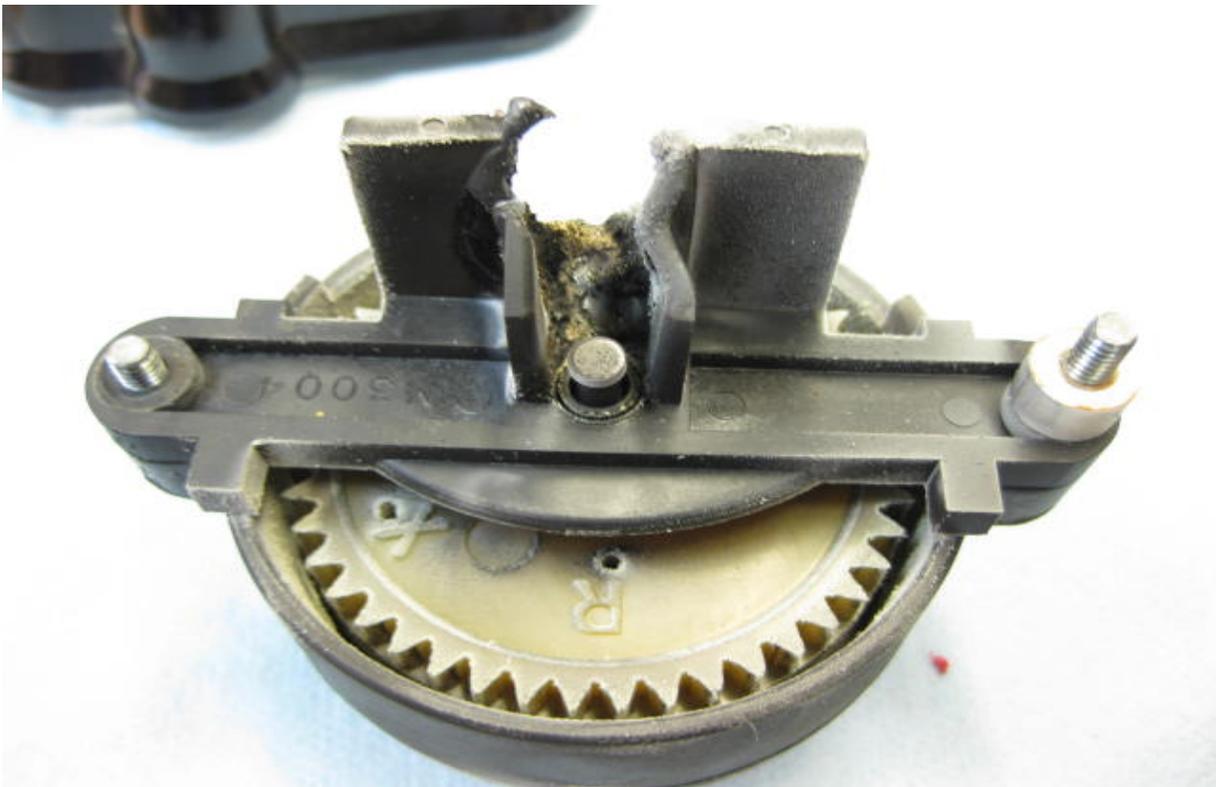
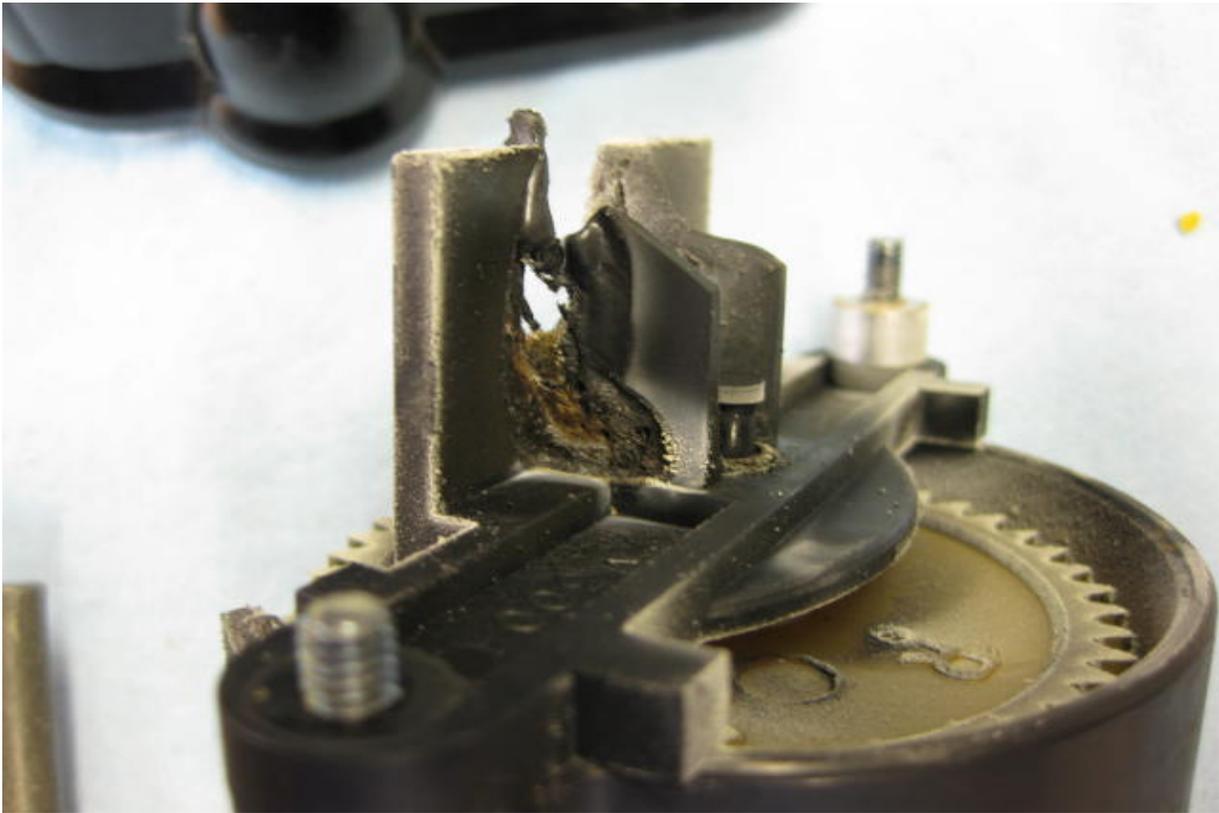
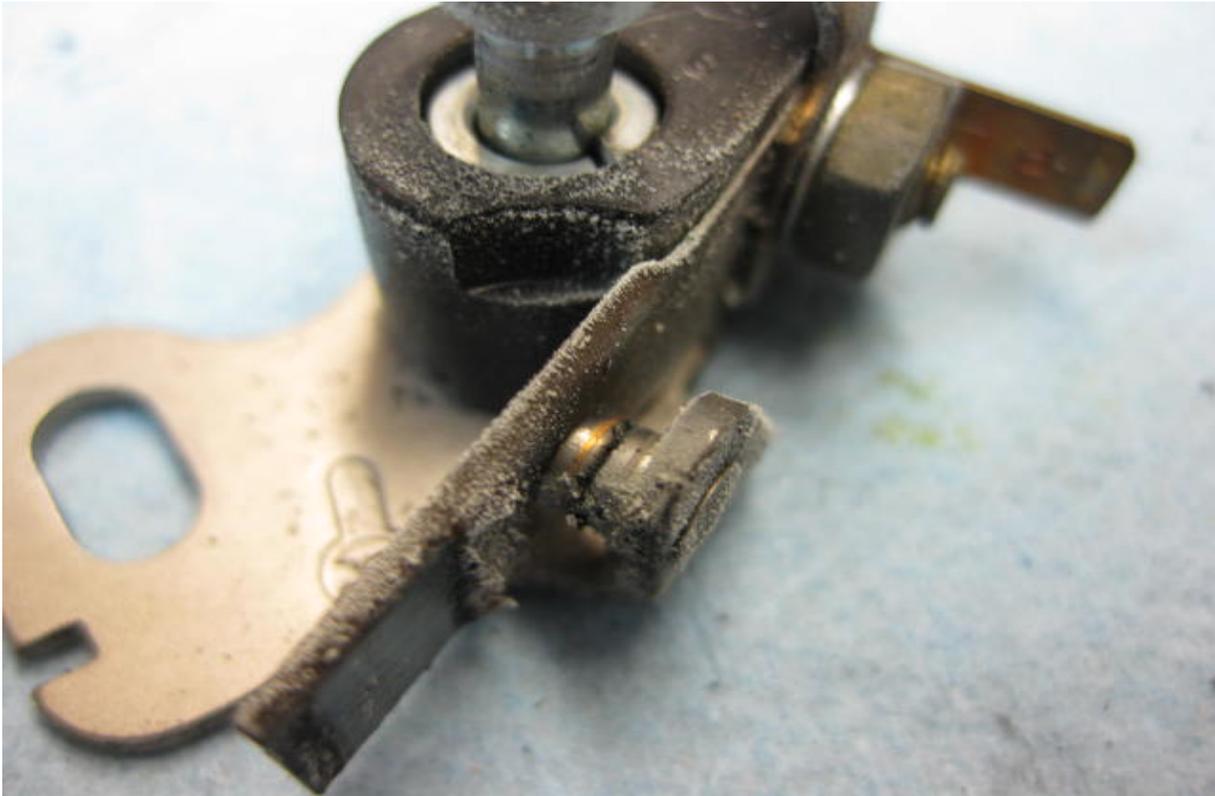
### **Slick Magneto: 6314; Overheat Failure, ATA 7414**

This writer says, "During a 500 hour inspection compliance of the Champion Slick 6314 magnetos, the left hand magneto showed signs of extreme internal heat. Slick SB (*service bulletin*) SB#-08A address the problem (*as*) caused by 'soft' carbon brushes packaged from September 1, 2004 through August 14, 2008. Champion Magneto Maintenance and Overhaul Manual (number L-1363E, chapter 3) lists a 500 hour inspection procedure and various other periodic inspection procedures. The total time of this magneto was documented as 1,672.8 hours. The magneto case screw had the factory applied torque seal in place. The breaker point assembly had plastic material melted around it. Further disassembly revealed the source of the melted plastic as material from the distributor block and gear assembly—the carbon brush was severely worn as described and illustrated in SB3-08A, page 2. I have included photographs in this report.

"I am surprised an Airworthiness Directive has not been issued for this component. I have seen two other magnetos in this condition, and many more with excessive wearing of the carbon brush in magnetos with far less time. There is no regulatory limitation in the L-1363E manual for the number of hours allowed to accumulate before any required inspection on this component."
