U.S. Department  
of Transportation  
**Federal Aviation  
Administration**

## ADVISORY CIRCULAR

43-16A

# AVIATION MAINTENANCE ALERTS

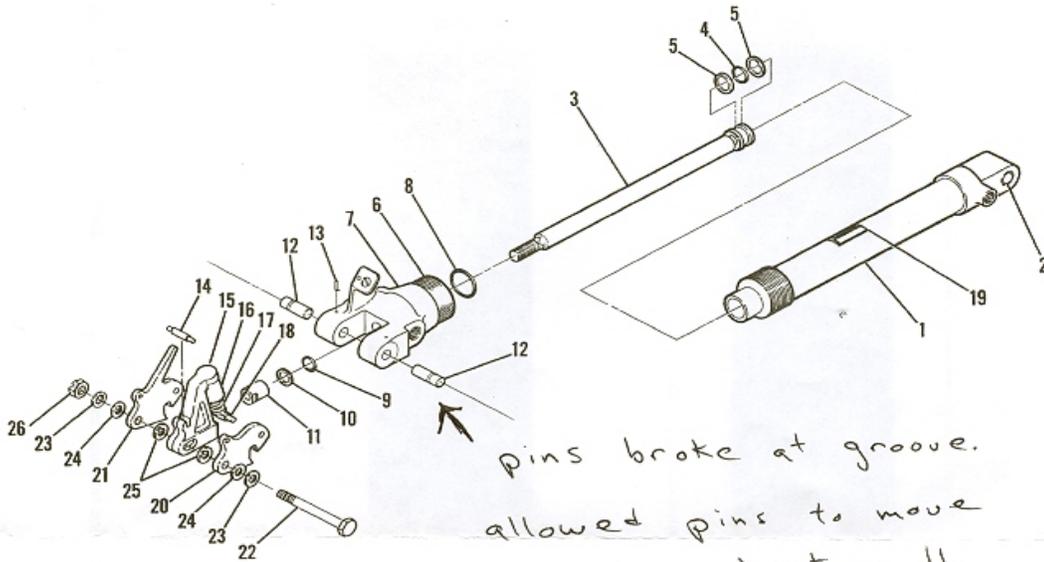
Figure 105. Nose Gear Actuator Assembly

A repair station technician describes the mechanical defect leading to this aircraft's accident. "The lockdown pins broke at the groove for the roll pins. This allowed the *(lockdown pins)* to move out of the actuator bearing's end to jam the actuator in the unlocked position. (See the attached parts manual illustration.) Cessna service bulletin SEB95-20 Actuator Downlock Pin Inspection says to check for loose pins. These pins were not *(noticeably)* loose in the end bearing until the part was thoroughly cleaned." *(New assemblies are referenced: they use a retaining key which passes through the lockdown pin—eliminating the need for a roll pin groove.)* The submitter ends with the suggestion that older style actuators still in use be removed, cleaned, and checked for integrity (P/N 1280514-9).

pins broke at groove.  
allowed pins to move  
in and contact no. 11  
Jam lock nut/collar. This  
would not let down lock  
(pin's 20 to 25) to engage  
to lock down pins.

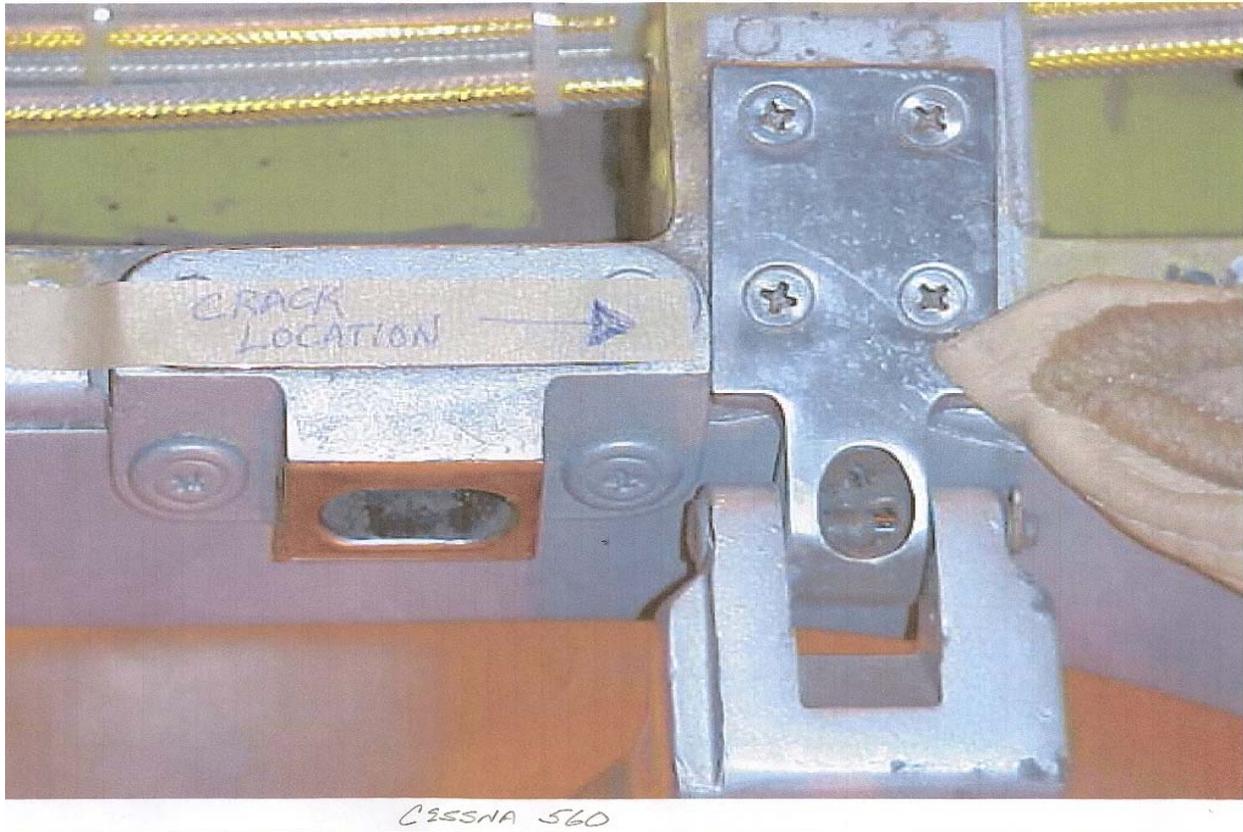
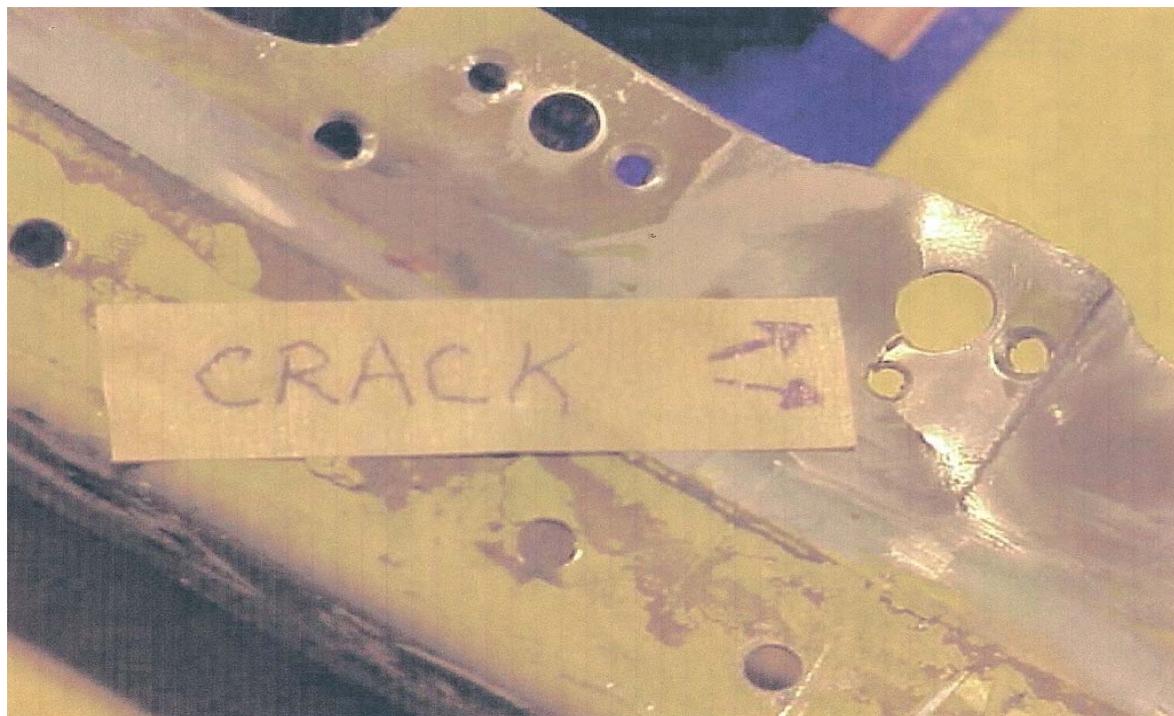
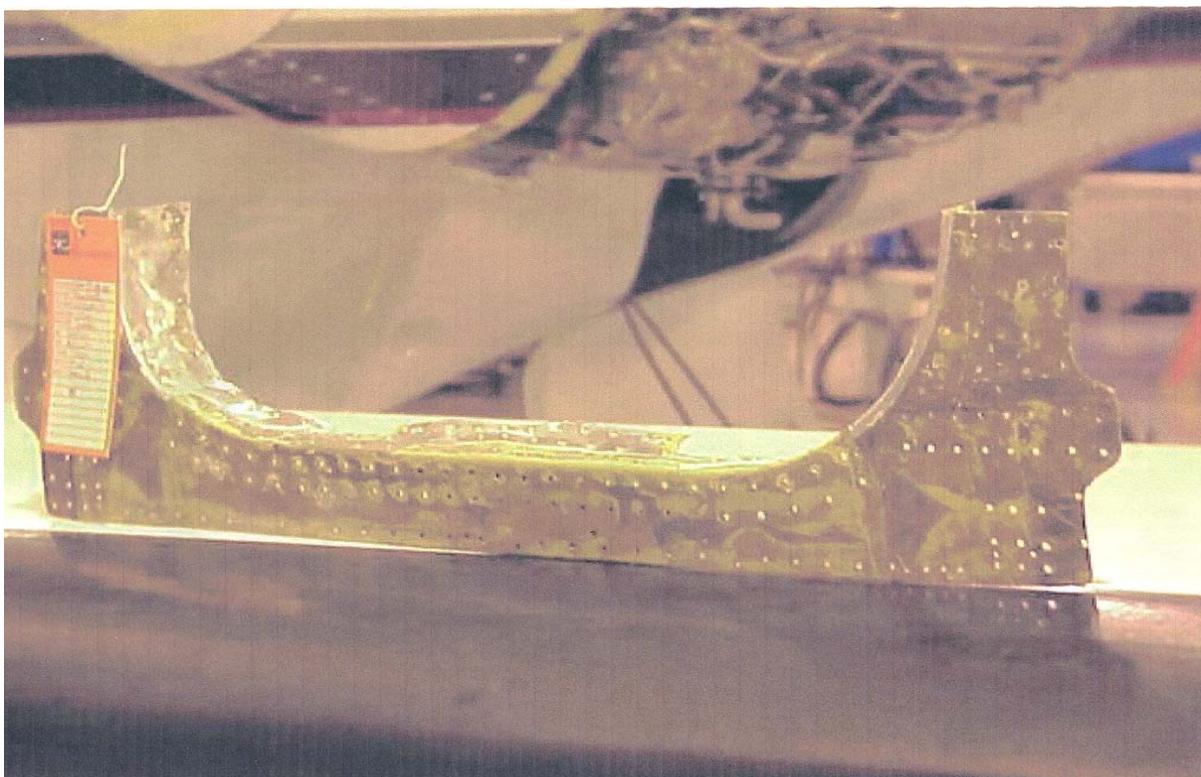
CESSNA 560  
CABIN ENTRY THRESHOLD  
PN 5511249-14

A repair station technician describes what has become a routine discrepancy on this Cessna jet. “The cabin entry threshold (*was found*) cracked at the aft step attach bolt hole. The probable cause (*may be*) a combination of the bolt hole having been located in the radius of the frame (*P/N 5511249-14S*) and the material thickness not sufficient to support the weight of personnel entering or exiting the aircraft. I recommend strengthening the structure by using thicker metal.” He notes approximately 75 percent of these model 560 aircraft are found with cracks in this threshold part.

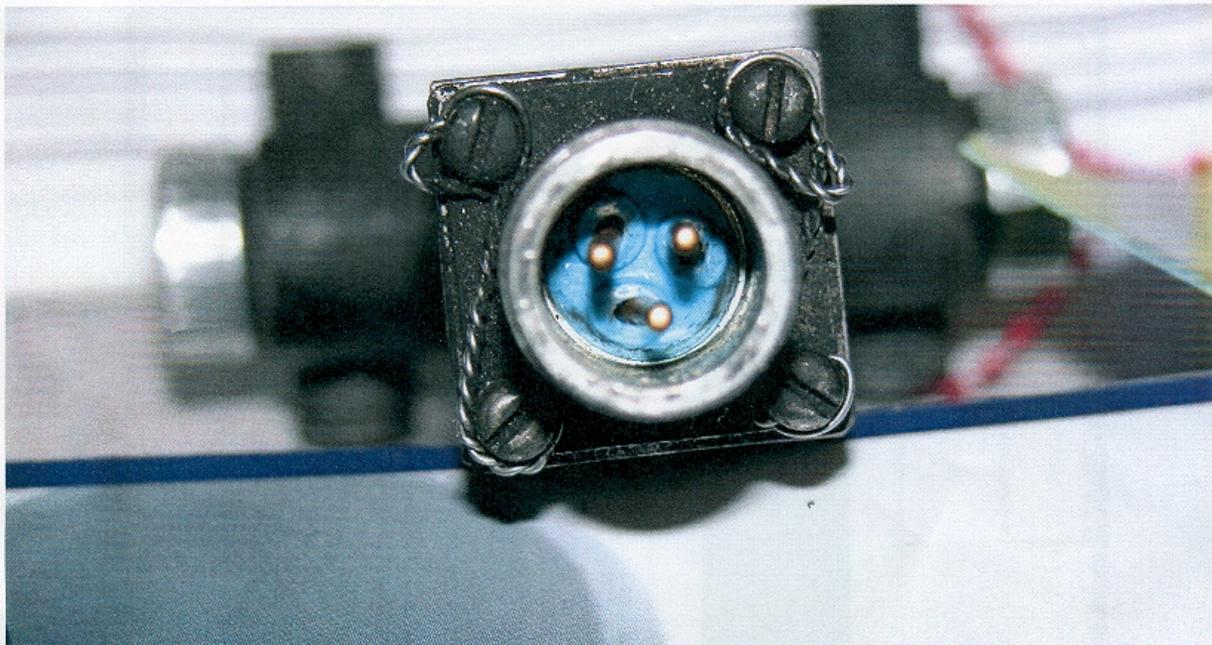
The submitter states, “The auxiliary power unit would not start. Troubleshooting led the technician to a bad fuel shutoff solenoid valve (P/N 34270-4140245-9). After removing the valve it was found not to have an alignment pin for the Cannon Plug, and (*its electrically connecting*) pins were badly twisted. This Cannon Plug did have (*an alignment pin*) groove, (*however*), there was no indication at all (like a painted line or stripe...) to indicate proper alignment of this plug to the valve’s connection. The loss of the alignment pin not only prevents the twisting of the pins—it also acts to correctly connect (*align*) the valve electrically. APU maintenance records indicate this part was original from installation.... a new valve was purchased with the correct alignment pin and installed—operational check was satisfactory.”

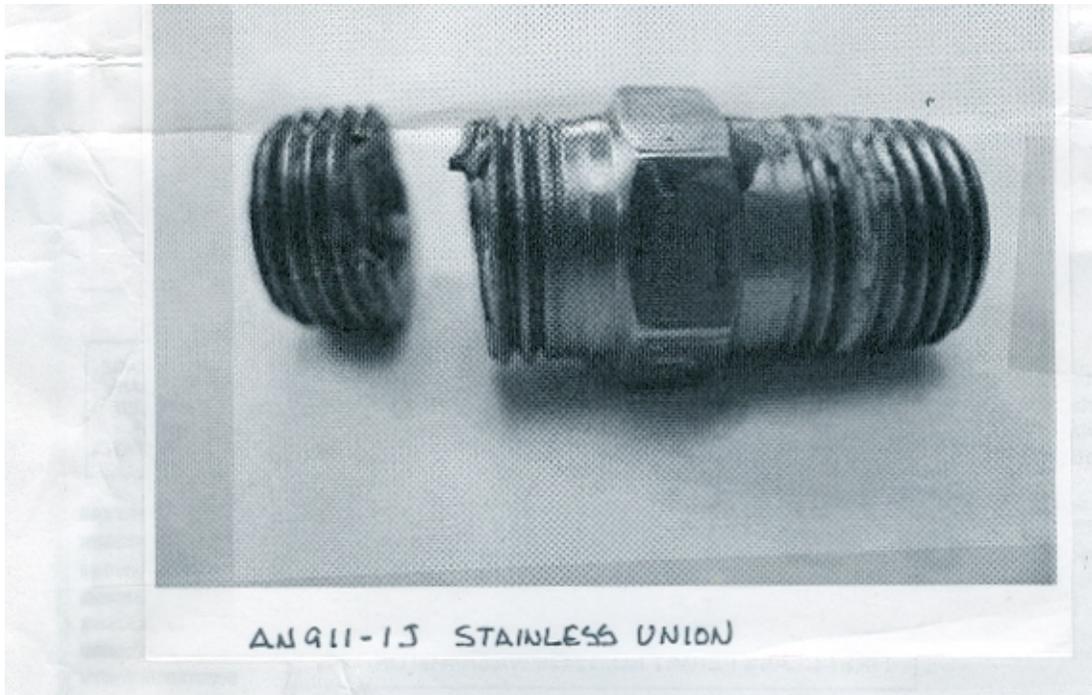
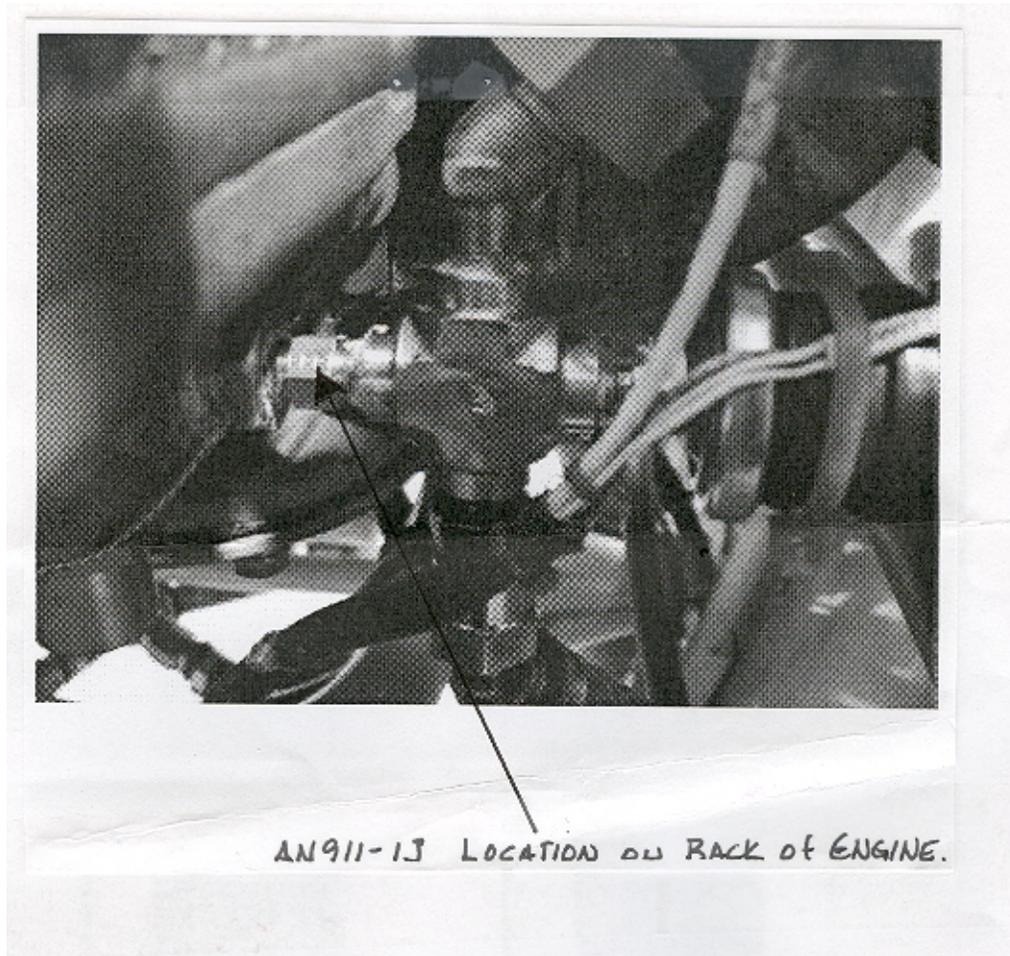
An AN911-1J union supplying oil to the oil pressure transducer and Hobbs pressure switch was found cracked. It is located in back of the aircraft’s Continental TSIO 550C5 engine at the base of the oil cooler. The mechanic states, “...(*this union*) was (*initially*) cracked at the pipe threads, and then broke in process of removing the part. The weight of the (*combined*) fittings attached to the union (hanging out as far as they are) and the vibration of the engine may have caused the union to crack at the pipe threads. The hardness of the stainless steel union could also have been part of the problem.

“This aircraft was scheduled to fly from Salem, Oregon to Olatha, Kansas that day, but the oil leak was noticed and investigated before the flight. (*It otherwise...*) would have ended with catastrophic failure of the engine due to oil loss.

“The (*short-term solution*) might be as simple as changing the union material from stainless steel—to steel or brass. The permanent solution may be to remotely mount the transducer and Hobbs switch ‘T’ fitting on the firewall or engine mount, and then (*route*) a flexible hose from the engine fitting to the ‘T’ fitting at its mounting point.”

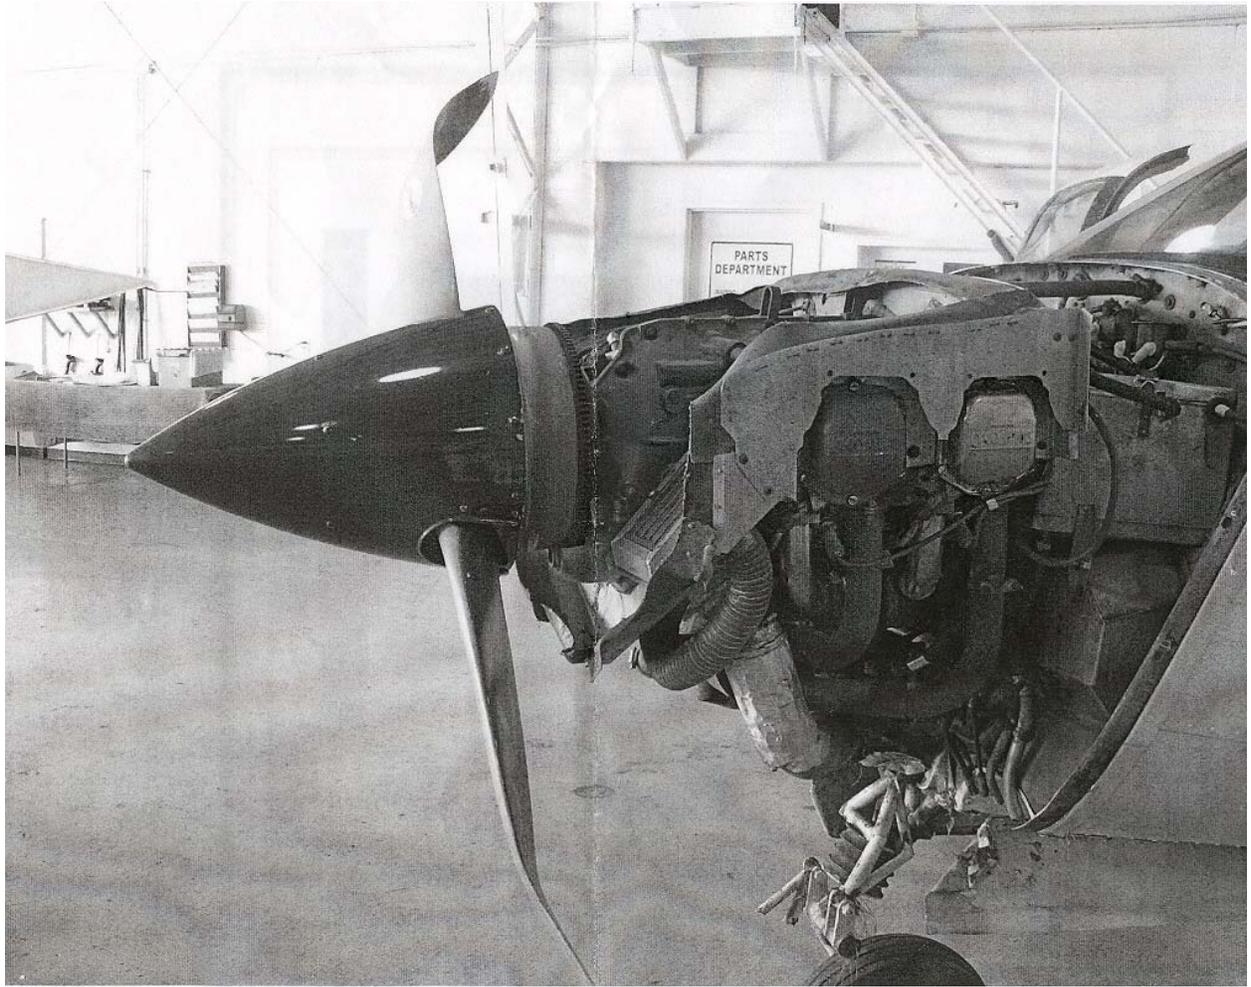
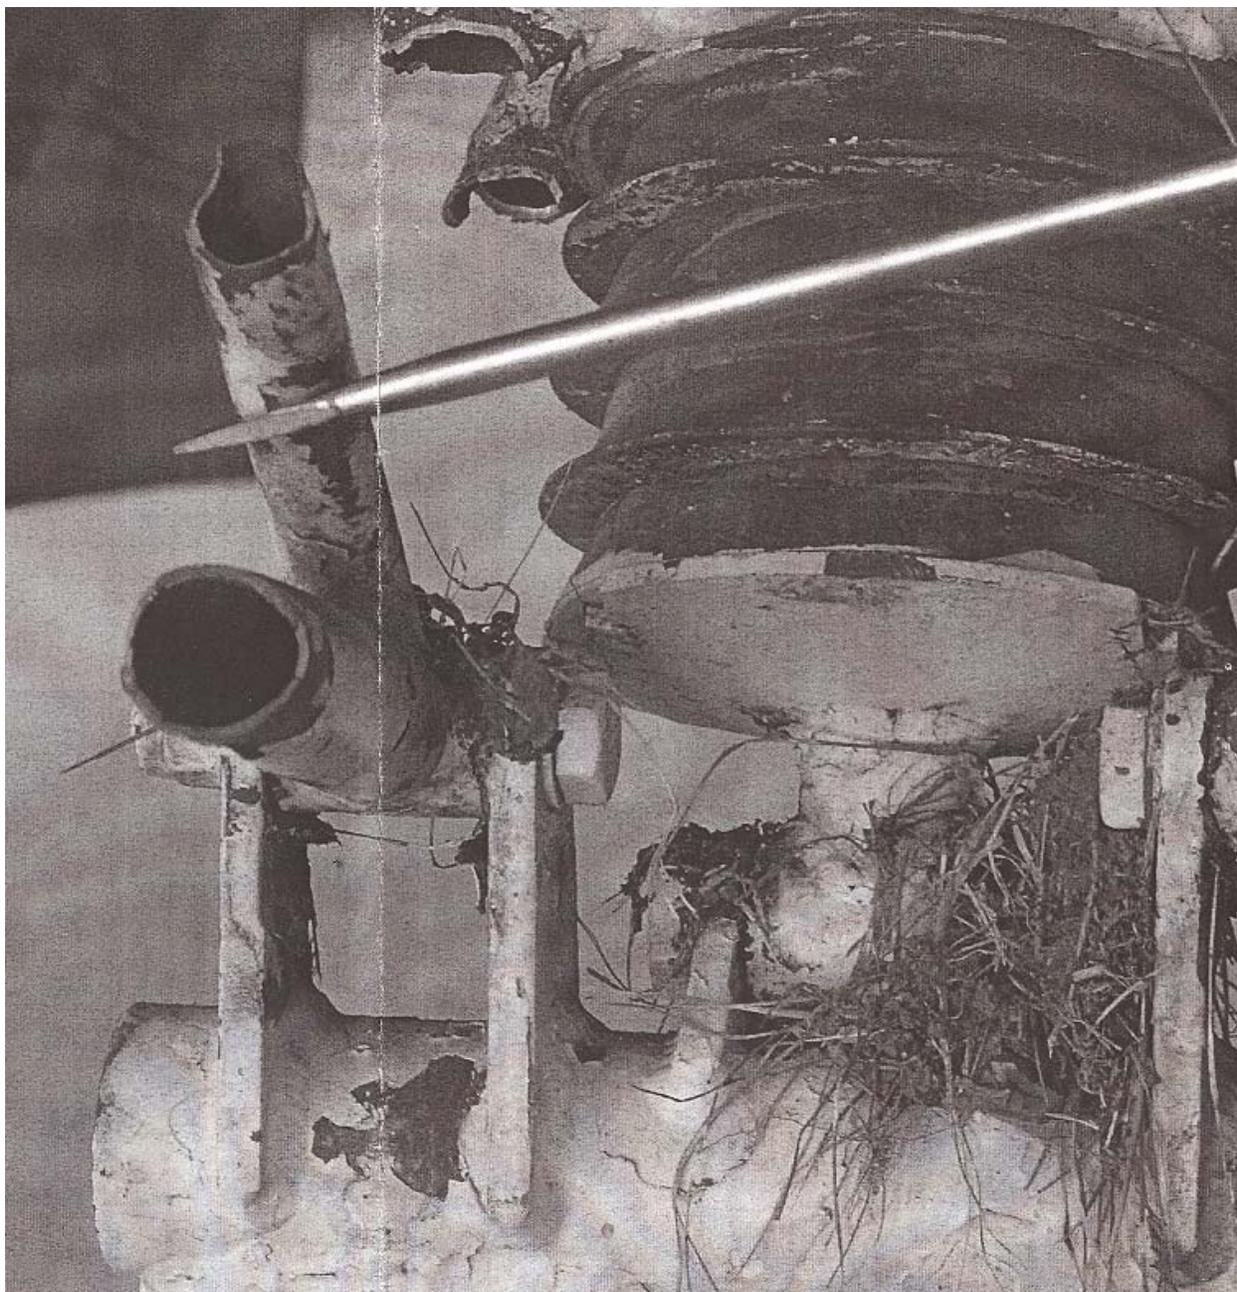
A submitter writes, “The nose gear (*on this airplane*) collapsed upon landing. An initial inspection found both tubes on the nose gear leg assembly broken (*P/N 540004*). The retract mechanism’s tubes were bent. (*I am...*) unable to determine which components were damaged prior to the incident. The pilot reported the landing gear was harder than normal to retract during the last take off and easier than normal to extend during this landing.”

*(A search of the FAA Service Difficulty Reporting System data base revealed 5 separate reports for this leg-assembly part number--one back to 1974!)*

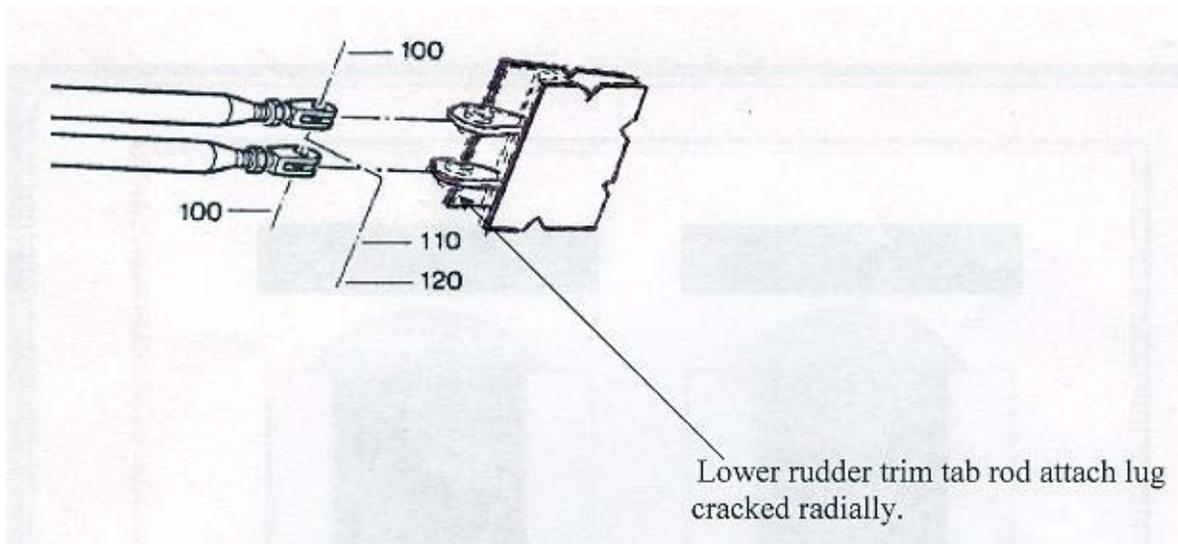
An unidentified writer states, “On post-maintenance walk-around, inspection found the rudder trim tab lower control rod attach lug radially cracked. The cause is unknown. No other damage or defects were noted.” (*Trim tab attach lug part number given as 80-483205-801.*)

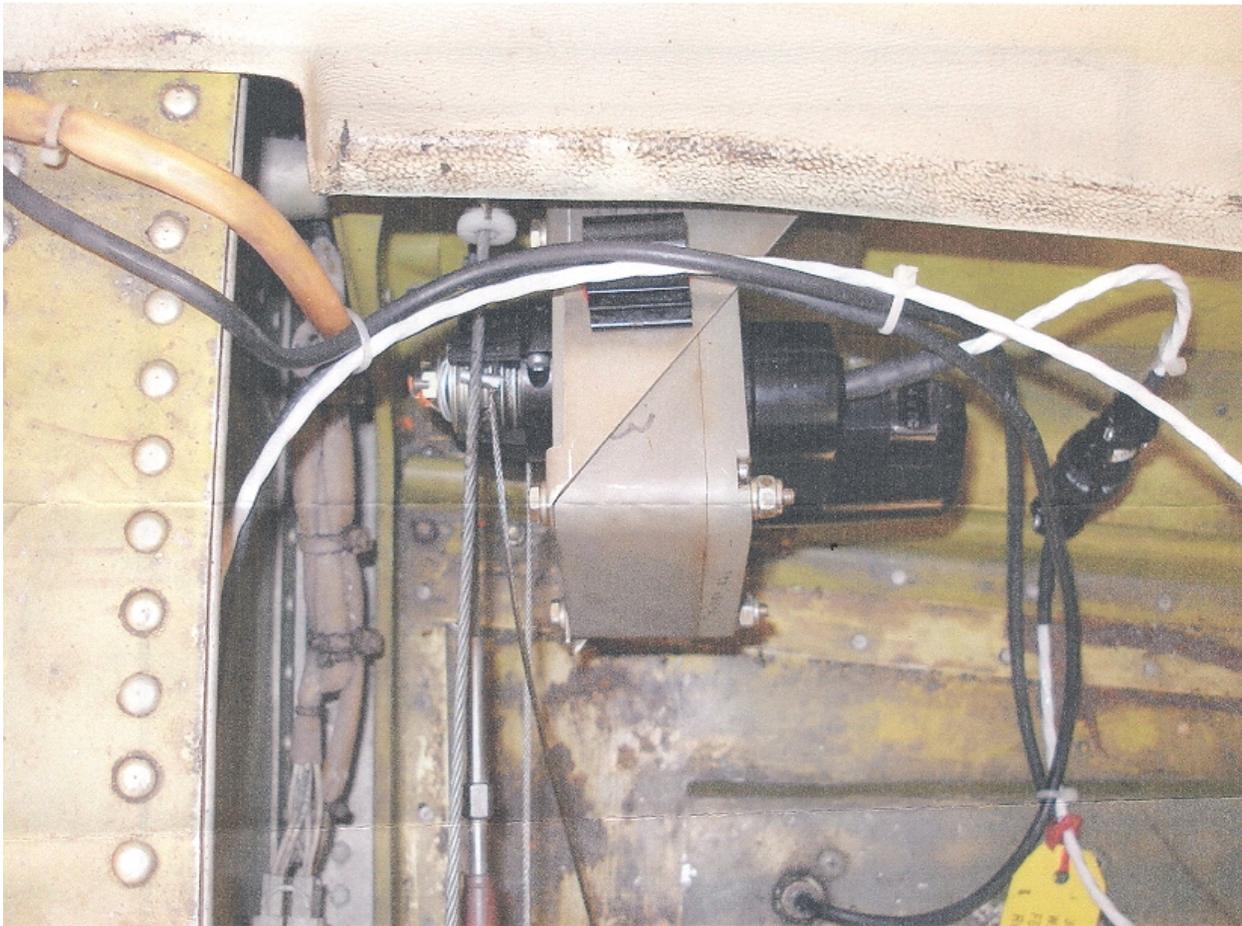
A repair station technician states, "The Century 2000 roll servo was installed and rigged incorrectly: the set was not tight on the bridle cable pin and the bridle cable was wrapped on the capstan incorrectly. This incorrect installation, in conjunction with the loose set screw, allowed the bridle cable locating pin to pull out of the servo capstan. The locating pin locked the ailerons at full deflection against the capstan guard. This condition occurred on the ground. In flight this condition would very likely result in an accident. I recommend the Century 2000 roll servo installations be inspected for proper installation and rigging. This condition (*defect*) has been corrected on this aircraft by installing and rigging the roll servo IAW Century Flight Document AK 1056." (*No part number was provided with this discrepancy.*)

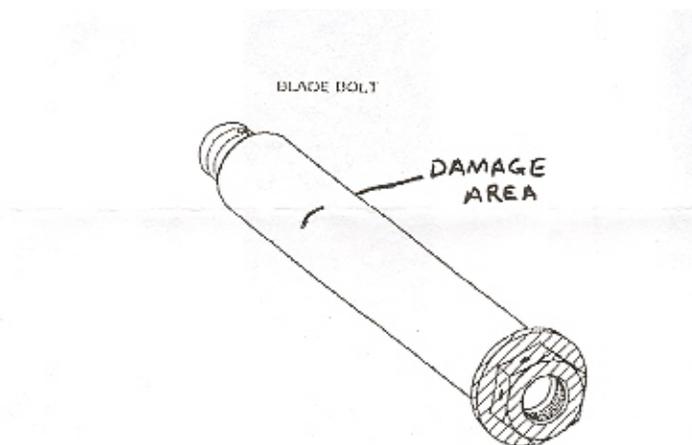
“Upon receipt of the aircraft (*for maintenance*),” says the technician, “the main rotor blades were removed for inspection. It was discovered one blade bolt (*P/N 3G6220A00251*) has a radial gouge mark at the lower blade-to-hub bushing location. The damage is outside of the permitted repair limits. The aircraft total time is approximately 58.4 hours. All of the blade bolts were previously changed approximately 8.5 hours prior to coming to (*our repair station*). Note: there are also typographical errors in the Agusta maintenance manual (see the millimeter-to-inches conversion in figure 2—*not provided here*): ‘Maximum Damage and Repair Depths.’ The figure calls out (mm/in) as 0.02/0.0080—it should be 0.0008.” (*Good catch! Two hundredths of a millimeter equals eight ten thousandths of an inch, not eight thousandths.*)

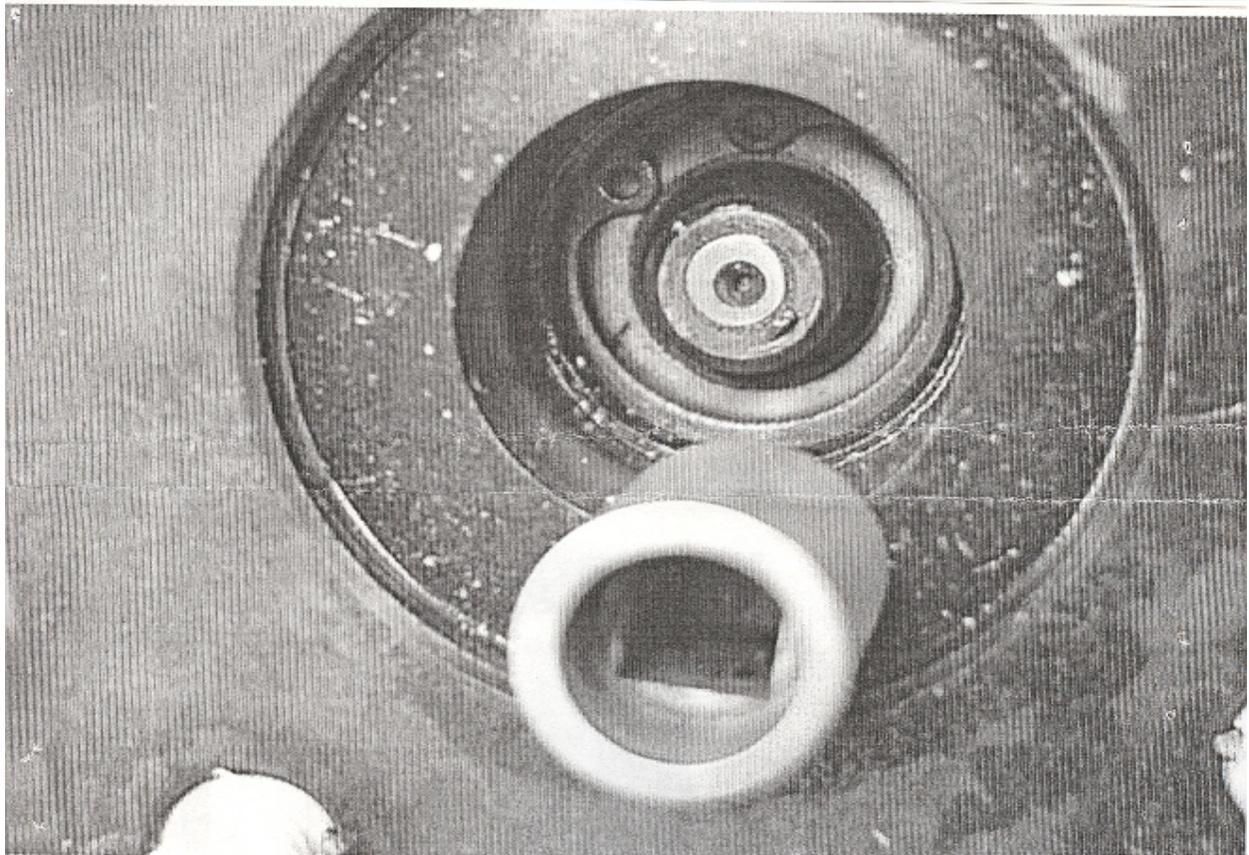
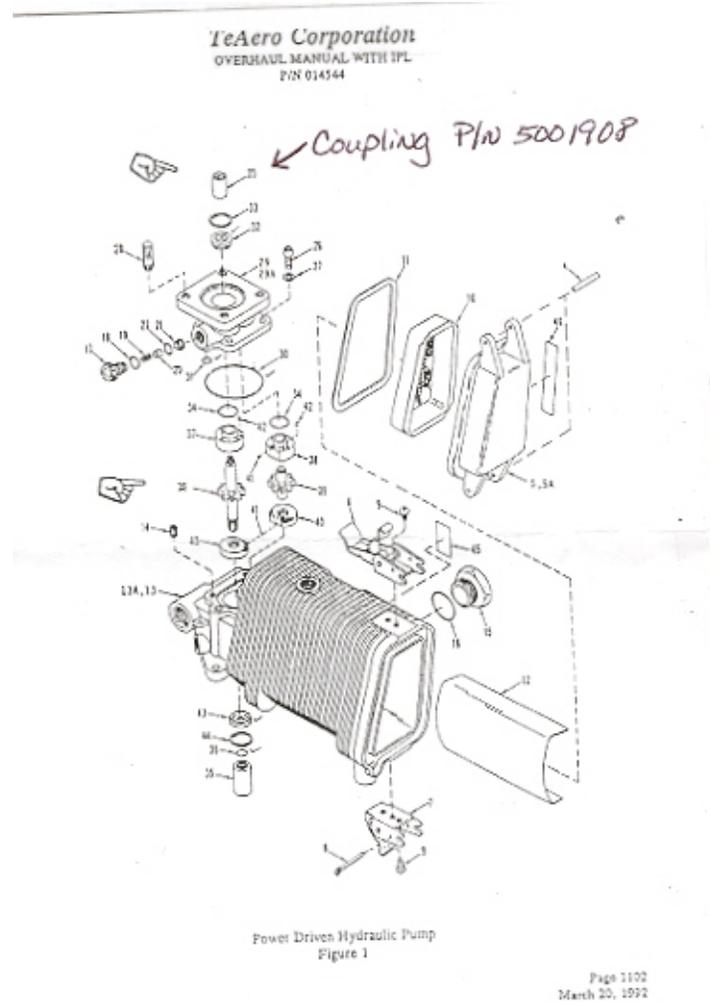
“The hydraulic pump’s tachometer drive coupling (braze welding) failed, causing the coupling to separate from the drive gear shaft. When this coupling fails, loss of rotor tachometer occurs. The manufacturer should check the strength of the braze after welding.”

*(A search of the FAA Service Difficulty Reporting System data base revealed four reports of coupling part number given as 5001908—separate total times are 106.3, 46.3, and 196.0 hours.)*

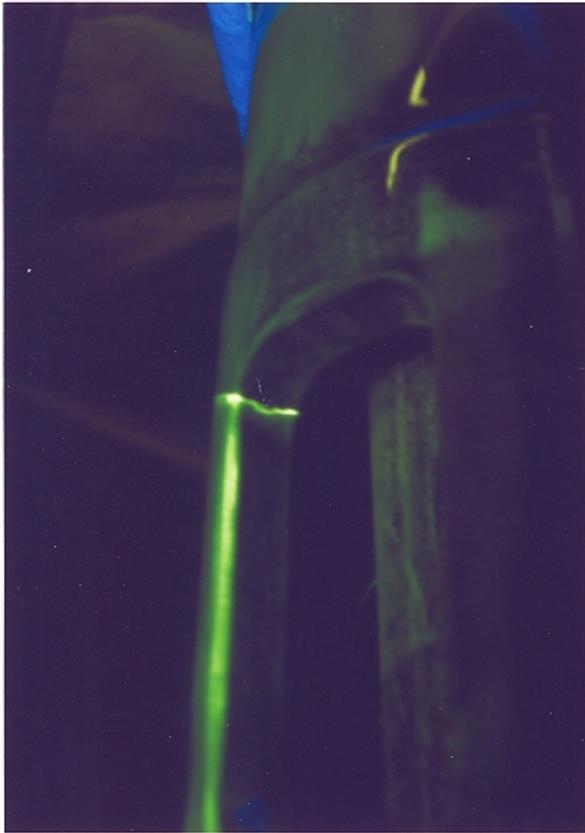
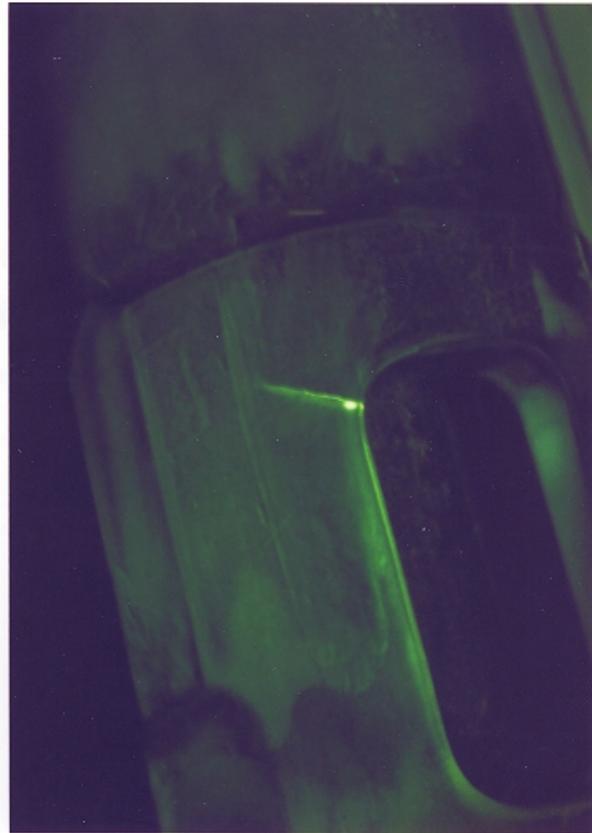
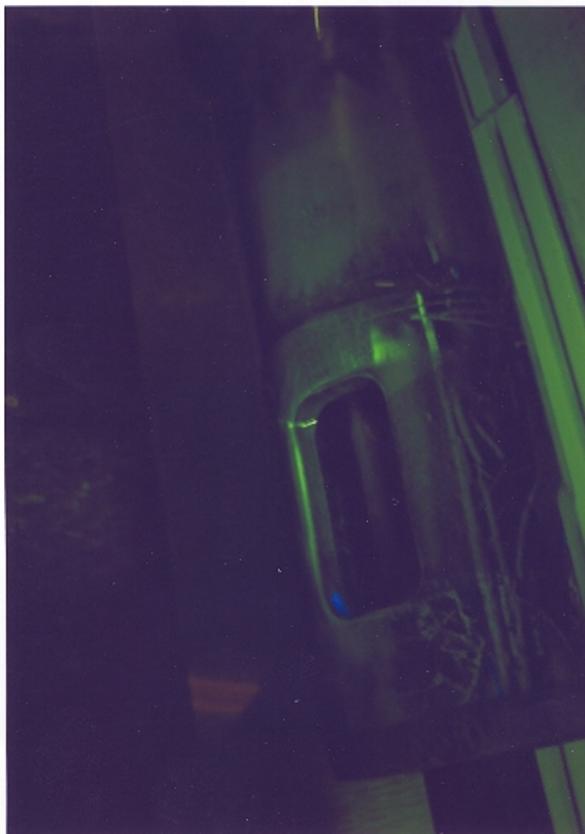
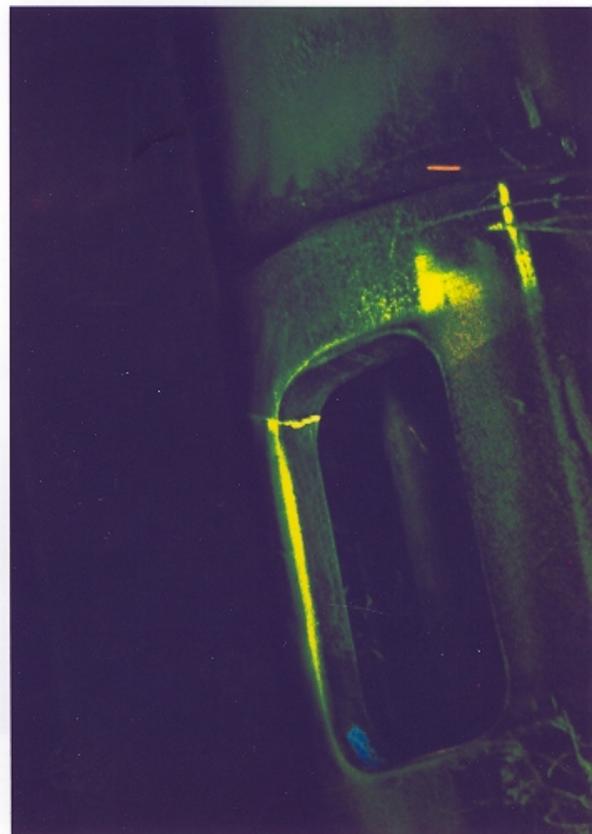
A repair station technician states, "During magnetic particle inspection, this shaft (P/N K774612-21) was found cracked at the upper end, where the rotor hub attaches to the shaft. The crack is approximately one inch long and located in the lower radius of the rectangle cutout. See the attached pictures."

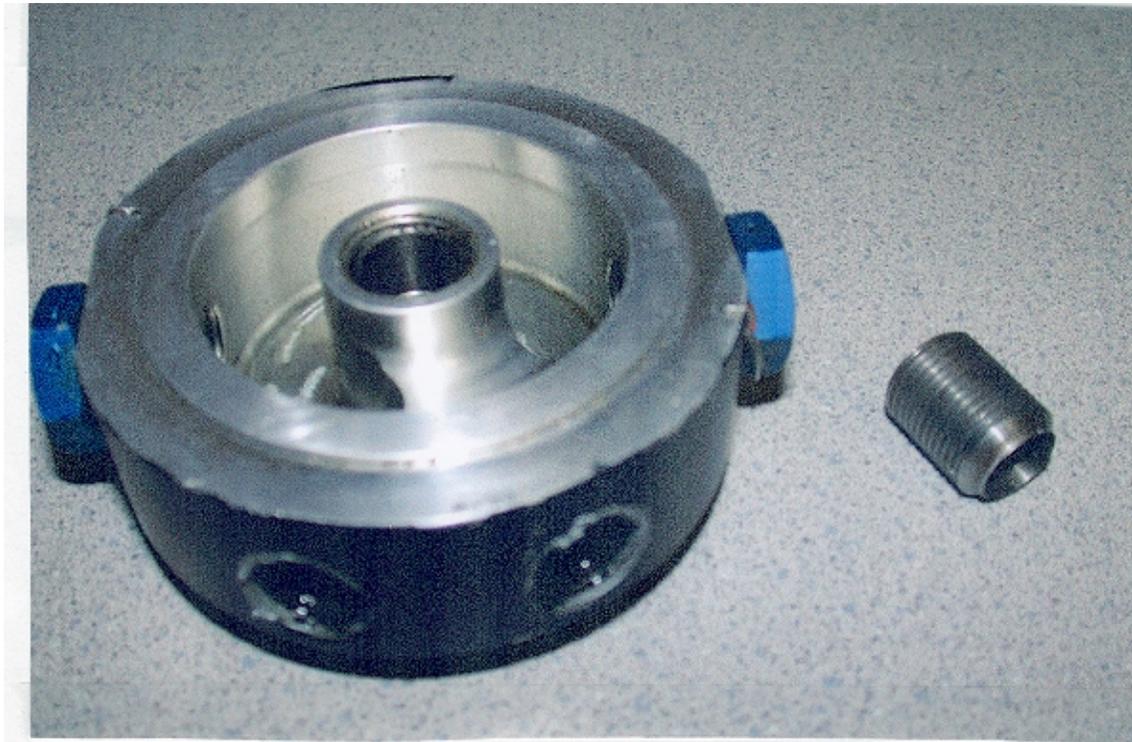
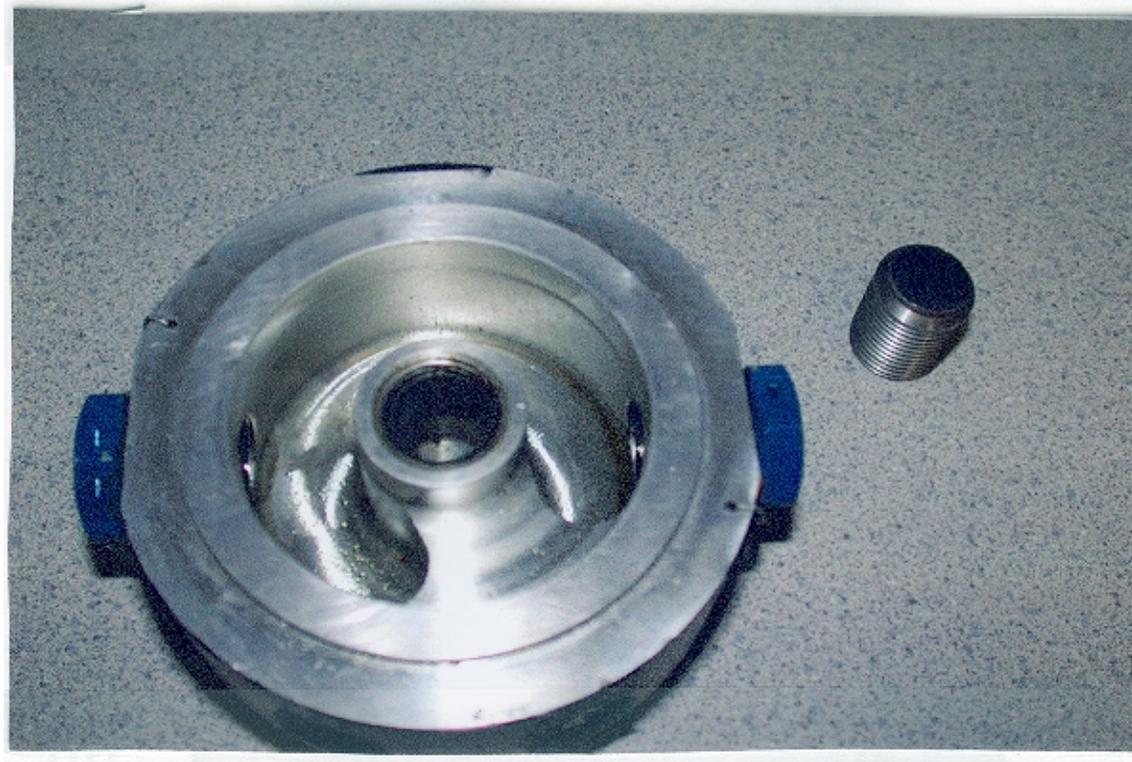
“While changing an oil filter during a routine 100 hour inspection,” states a mechanic, “the oil filter adapter’s center (threaded) shaft broke off, leaving half the shaft inside the adapter, and the other half threaded into the oil filter. This occurred with minimal rotational torque being applied. Inspection of the shaft revealed the machined center section of the shaft at the shear point was machined too deep, leaving only a maximum wall thickness of 0.20, and probably much less at the sheer line judging by the knife edge condition of the break point. The cause appears to be a manufacturing defect due to design or poor quality control. Recommendation: *(there should be...)* further investigation at the manufacturing level *(and/or)* a possible Airworthiness Directive if other units currently in service have the same defect condition.” *(The adapter’s P/N is 50001-1, manufactured by Aviation Development Corporation.)*

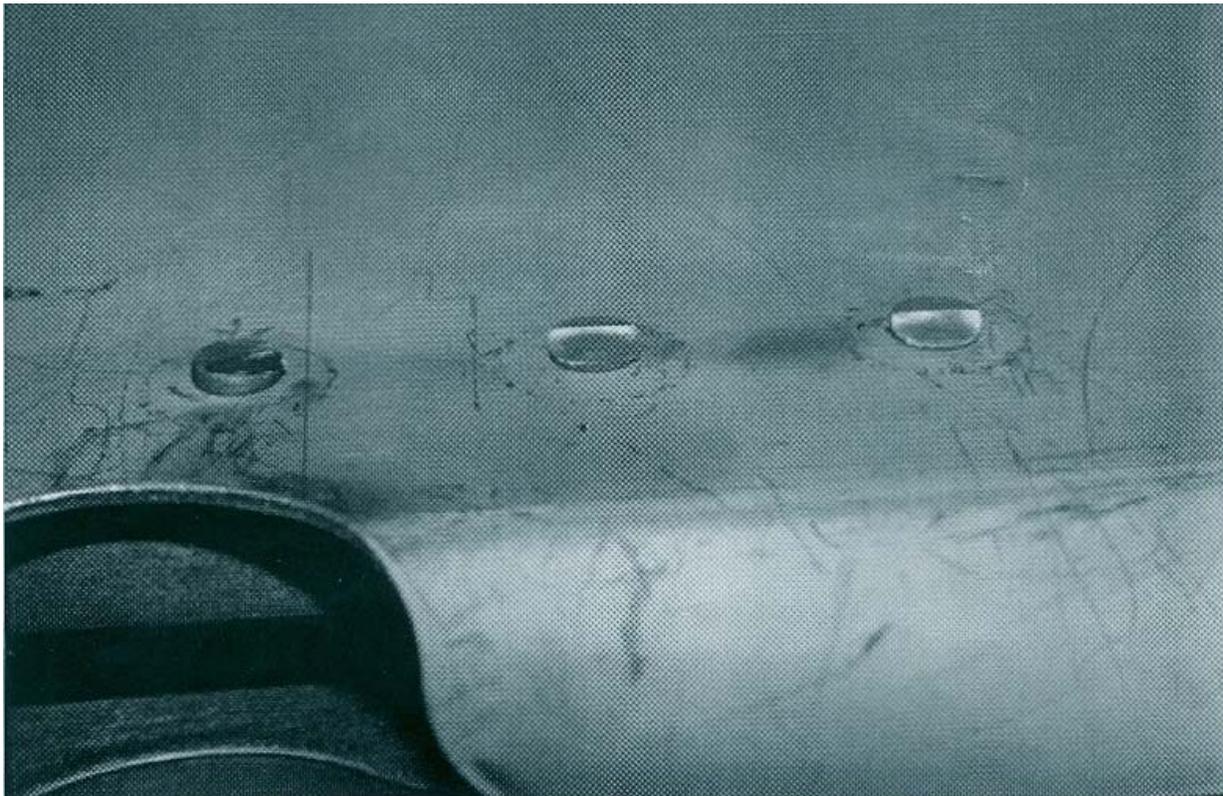
A repair station technician describes damage found on this engine which had been removed from a Boeing 737. "...Fretting damage was found in three locations on the number three position fuel nozzle drain tube (P/N 9387M34G01; Illustrated Parts Catalog 72-41-00-06 figure 30). The deepest...(*fretting damage measured 0.016 inch*). The root cause of the fretting has been determined (*to be*) contact with rivets on the deflector assembly (P/N 332A1908-39)." "It was noted the position of the number 3 fuel nozzle drain tube was protruding further from the case than the remaining installed drain tubes. Further investigation established the position of the fuel nozzle outer cap can be adjusted, (*which then allows...*) the position of the fuel drain to be altered. GE Wales has made a recommendation to CFMI that an amendment to the manual should be put in place to eliminate the possibility of a re-occurrence. The recommendation is to check (*during*) module assembly for (1) that the fuel drain tubes are not protruding past the fuel nozzles, and (2) also to check that there is sufficient clearance when fitting the deflector assembly post test. This (*defect*) occurrence could also be prevented through the application of Service Bulletin 73-116 which calls for the deletion of the drain manifold and associated drain tubes."

ASSOCIATED FRETAGE TO RIVETS ON DEFLECTOR ASSEMBLY.

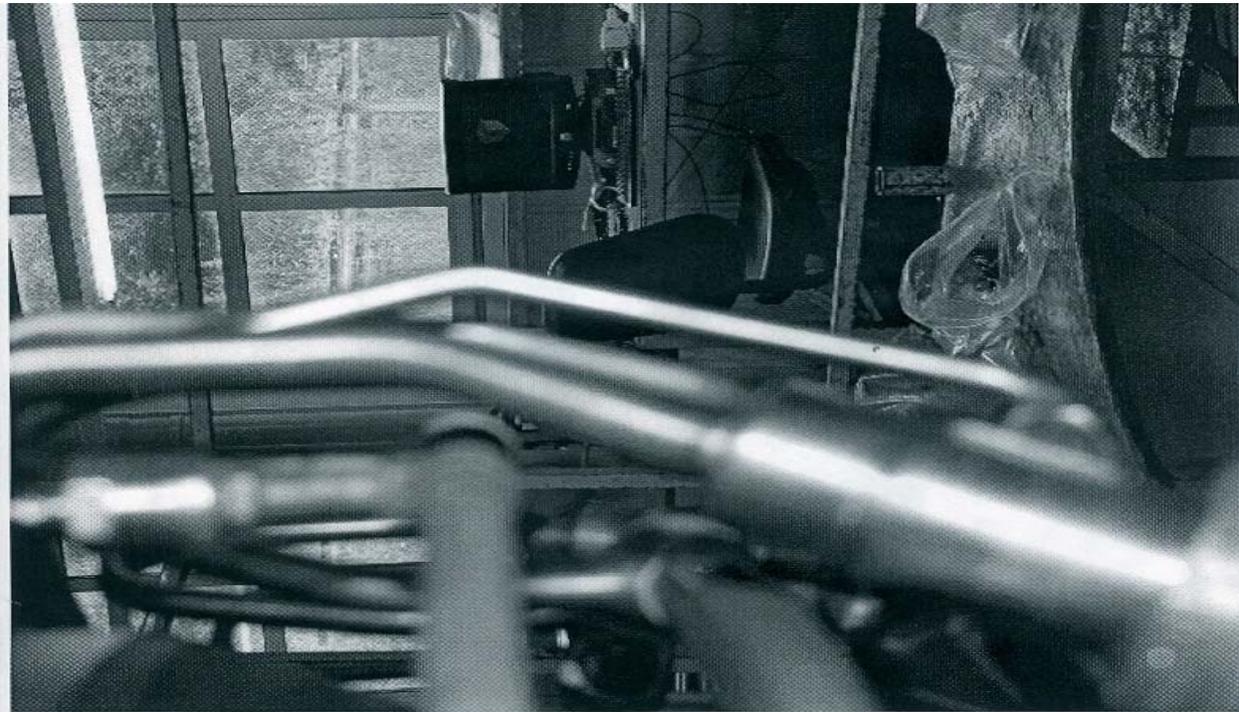
ANGLE OF PROTRUSION OF DAMAGED TUBE

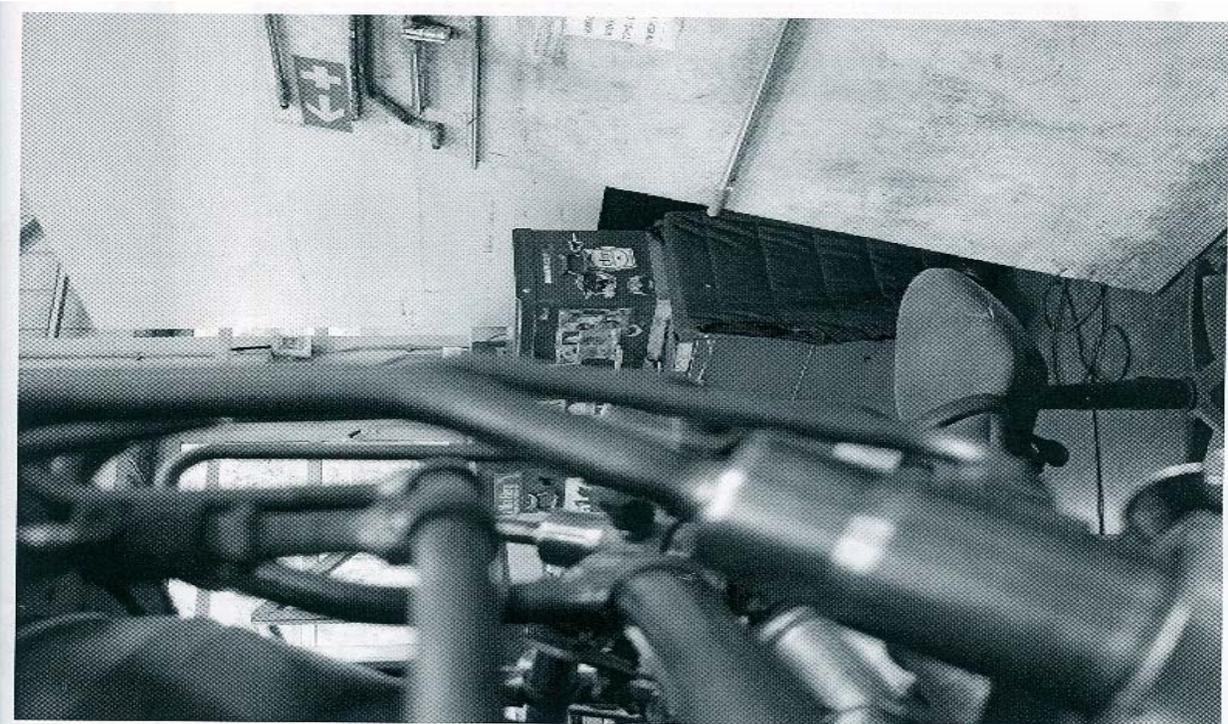
ANGLE OF PROTRUSION ON UNDAMAGED TUBE

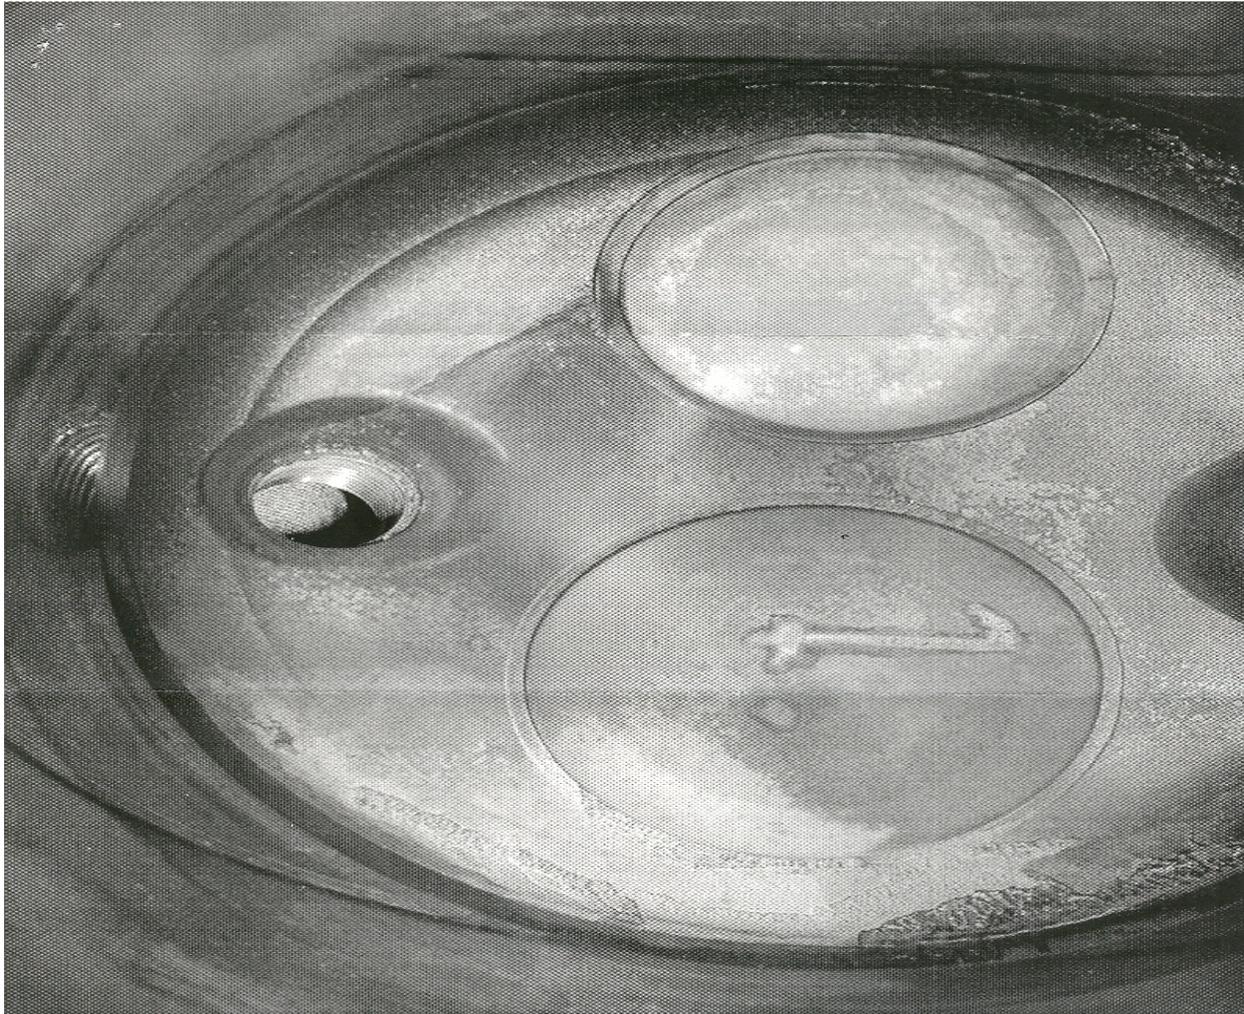
An unknown submitter writes, “418.6 hours (*have passed*) since compliance with AD2004-08-10 on (*this aircraft’s*) ECI cylinders (*P/N TISN71.2BCA-221*). The left engine’s number two...and the right engine’s number four cylinders were both found cracked through, from the upper plug hole to the exhaust valve. Both cylinders have identical cracks on relatively new heads.”
