U.S. Department  
of Transportation  
**Federal Aviation  
Administration**

## ADVISORY CIRCULAR

43-16A

# AVIATION MAINTENANCE ALERTS

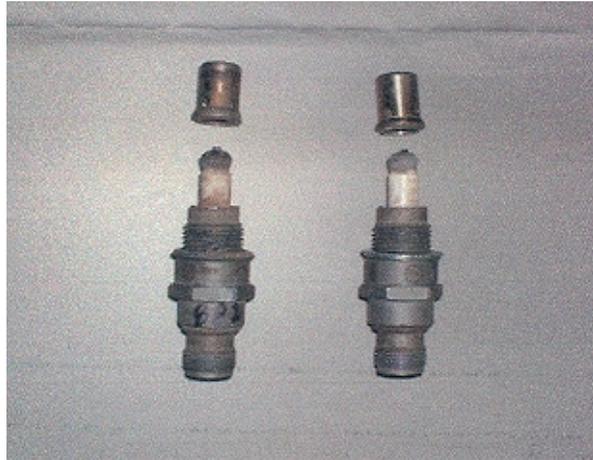
“The part of an igniter plug that surrounds the electrode separates—and shorts against the electrode, causing the APU not to start. This part could possibly enter the combustion area of the APU.” *(Igniter plug P/N: 304634-2; manufacturer number: CH34549. Part times were 489.2 and 792.24 hours, respectively.)*

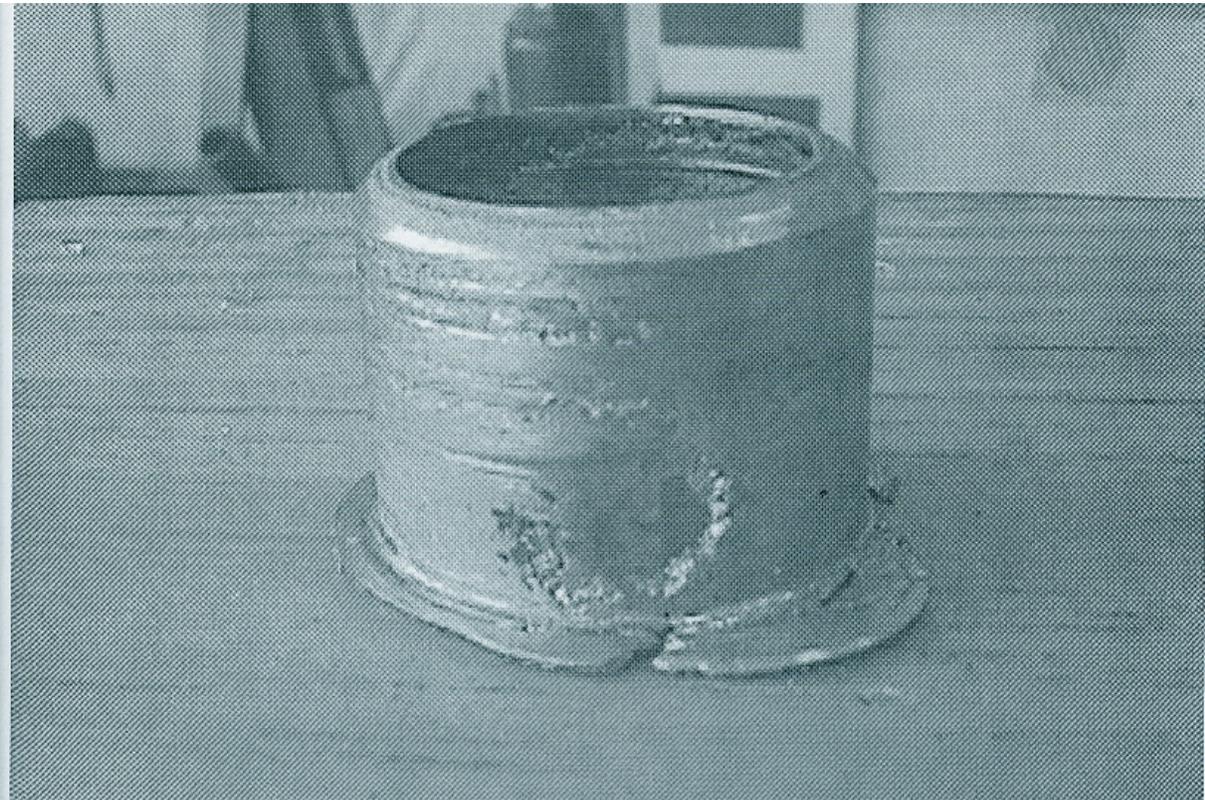
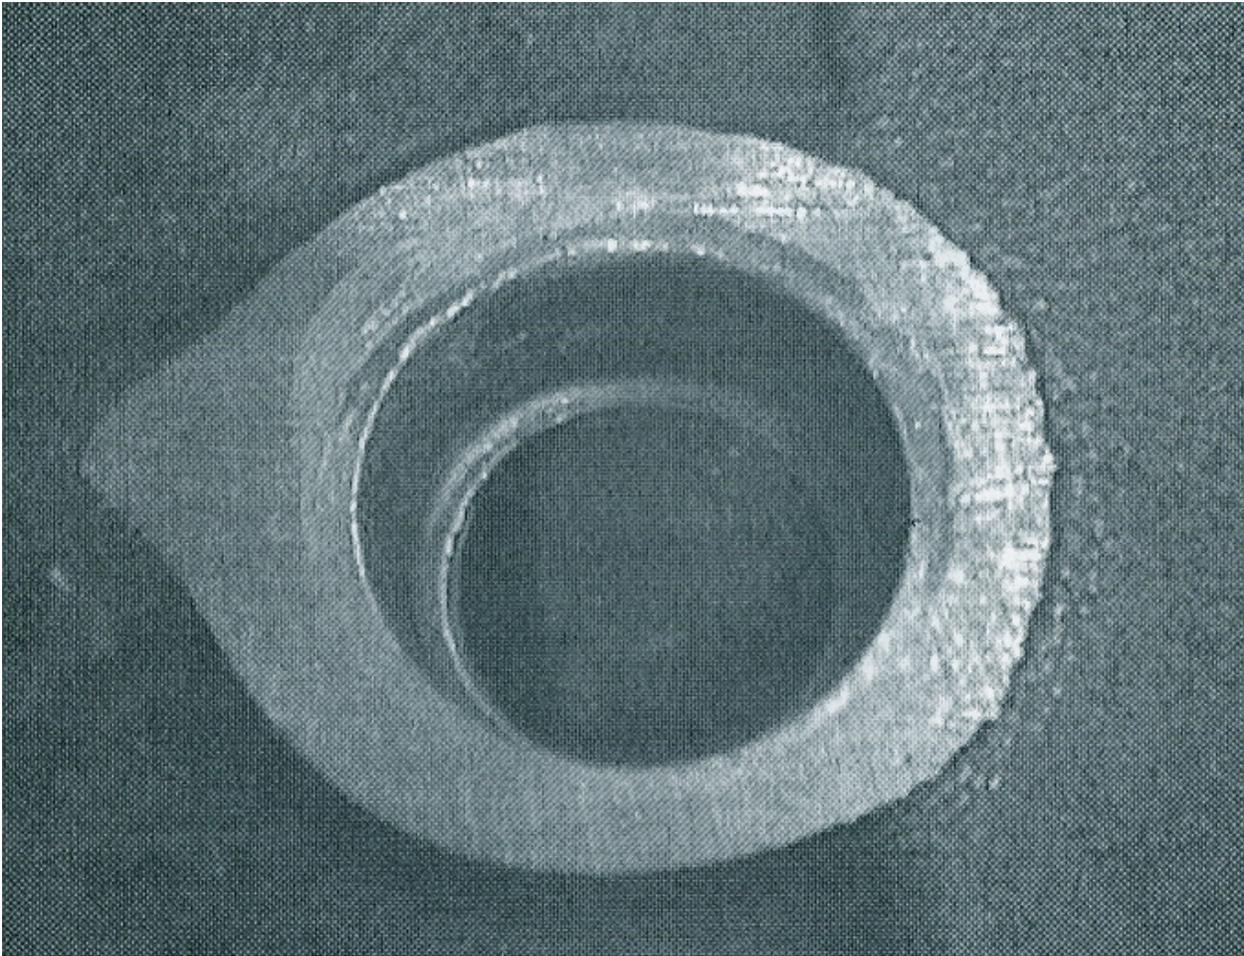
A repair station submission provides this defect discrepancy that was discovered during an annual inspection. “An aluminum bushing that was located in the accessory case—where the magneto drive gear is located—had become loose in the case, and spun. *(This problem was noticed...)* because we were not able to install the magneto correctly.... *(At times, the impulse coupling would not engage.)* We found that during the last overhaul the accessory case had been sent out to ECI. *(Conversations with the technician who performed the teardown stated installation of an aluminum bushing is an approved repair...)* and if done correctly, there would have been a drilled hole in the bushing for lubrication. But there was no hole, thus not allowing for any lubrication to the bushing area. This allowed for excessive wear and part failure. We recommend *(...eliminating the aluminum bushing repair, leaving the only other approved alternative...)* which is by *(...welding a new boss and drilling a new hole).*”

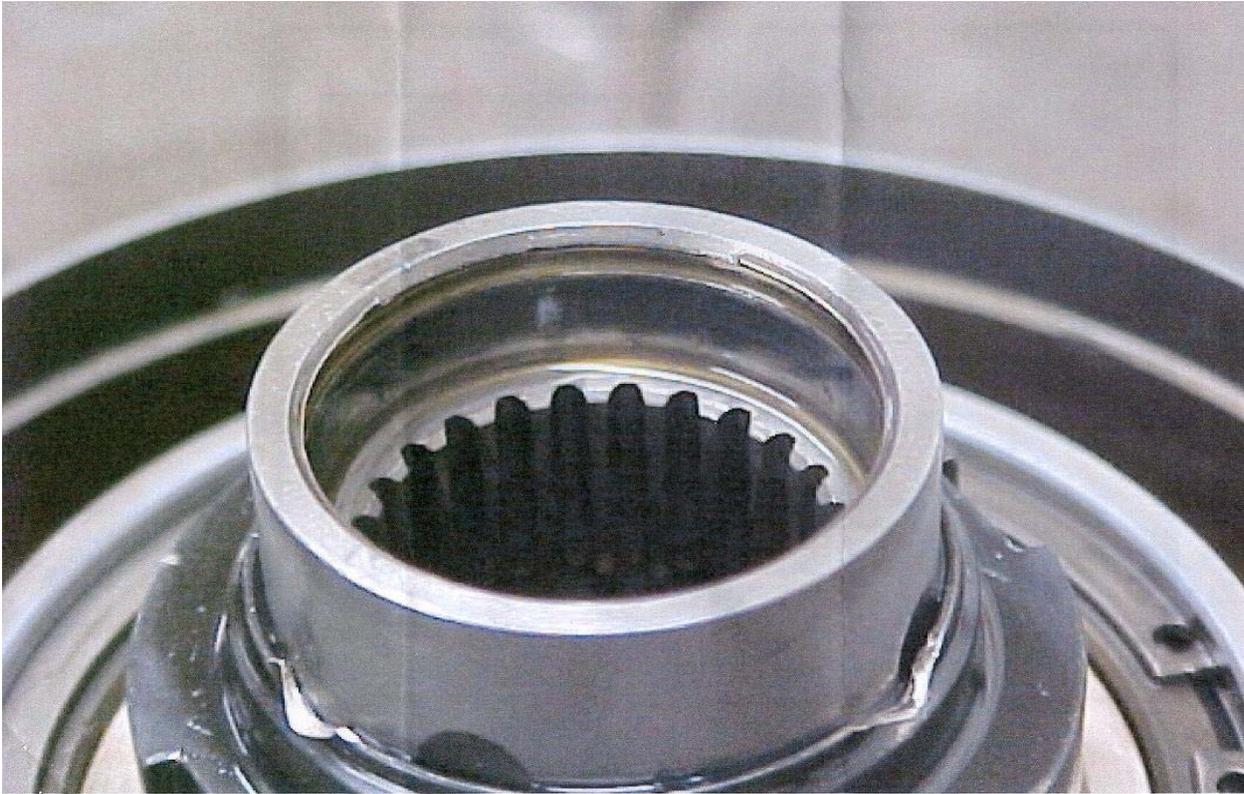
A repair station submitter writes, “During replacement of the SAG shaft it was discovered the outer land of the snap ring groove was very thin and the inner edge was lifting—two 3/8 inch pieces came off the land when the snap ring was removed (*impeller P/N: 6876873*). The groove for the snap ring seems to be of normal dimensions.”

*(A single inquiry to an outside source having a great deal of experience with these engines indicates--this defect is really a maintenance practice error. Those who have faced similar mechanical operations can easily deduce the series of actions which may have led to the breaking of the snapring flange. Nonetheless, whoever has to pay for this expensive part might vote for a few thousandths of an inch more support for an obvious design vulnerability. A search of the FAA Service Difficulty Reporting System data base for the above part number revealed six reports since 1988.)*
