ADVISORY CIRCULAR

43-16A

AVIATION MAINTENANCE ALERTS

**ALERT
NUMBER
364**

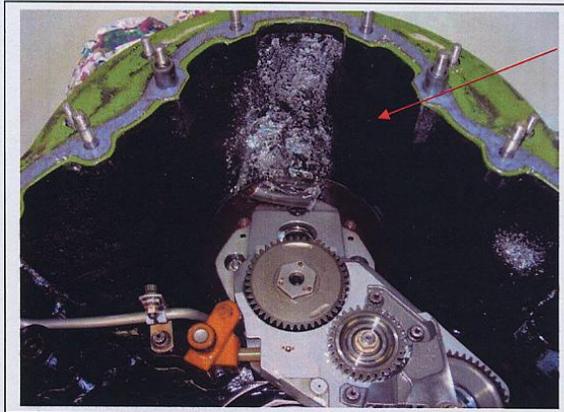
Gear Box Cavity

Preliminary Findings	Engine received with broken feather valve, nose cone nuts loose, rotation of engine rotating components found clunky and seized. Magnetic plug contaminated with fine metal particles		
Findings	Nose cone and diaphragm removed to investigate cause of failure. When diaphragm assembly was removed big chunks of metal noticed at the gearbox cavity identified as bull gear pieces. High speed pinion gear helical teeth broken off and crunched. Several bull gear teeth broken off. Big piece (2 – 3 inch) of gear rim missing and found trapped between diaphragm housing and scavenge pump causing a rupture of the pump housing The preliminary reason for the gear box failure is believed to be caused by a bull gear failure.		
Qty	Part Number	Name	Description of Defect
Preliminary Conclusion	The reason for the gear box failure is believed to be caused by a bull gear failure. The separation of the bull gear rim has caused a sudden stoppage of the gear train to the propeller resulting in the damage of the HSP helical gear. Honeywell has been contacted and further investigation will be required to confirm preliminary conclusion.

Metal particles and chunks of metal

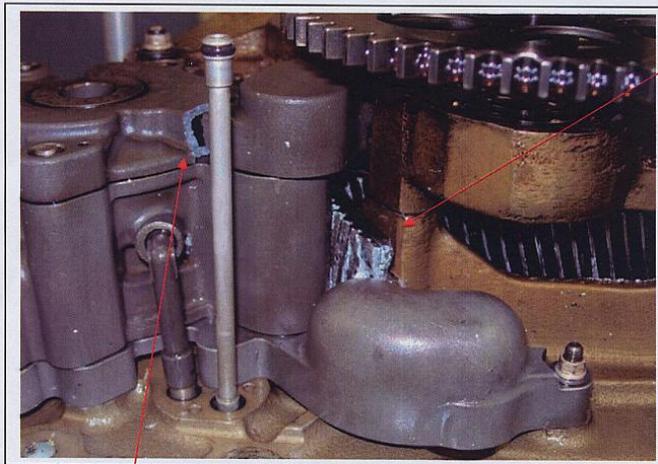
Scavenge Pump

Missing bull gear piece trapped between housing and scavenge pump

Scavenge pump housing broken

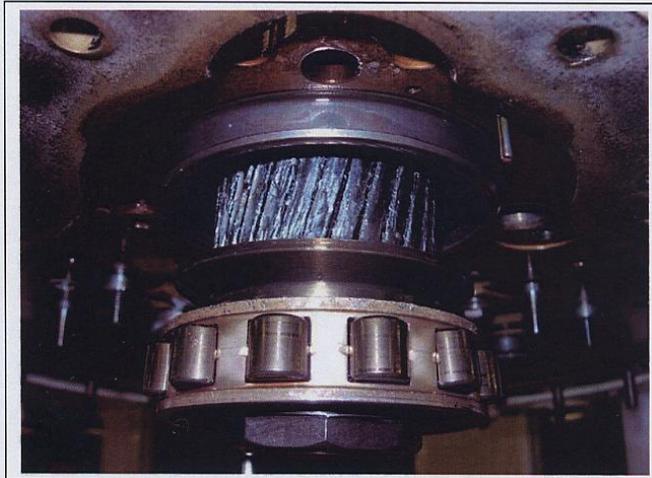
High Speed Pinion Gear

HSP gear helical gear damage

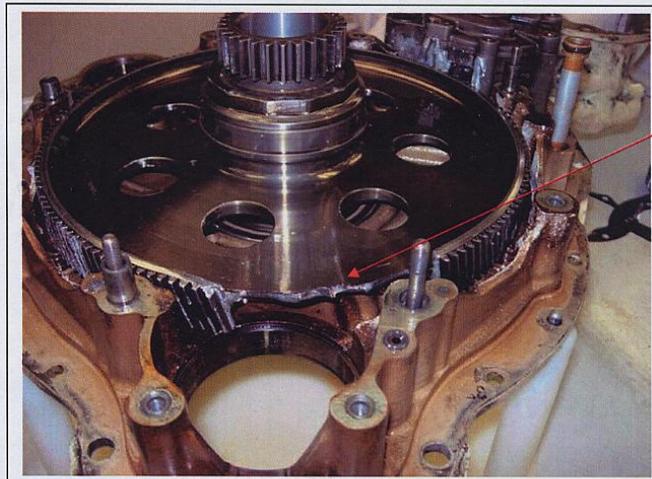
Bull Gear

Rim separation

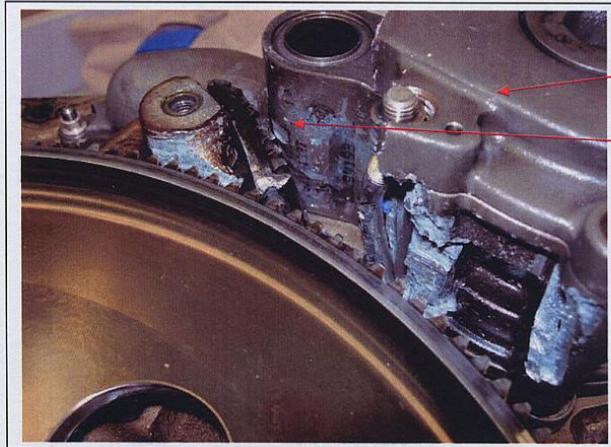
Trapped Bull Gear Piece

Scavenge Pump

Bull gear rim piece

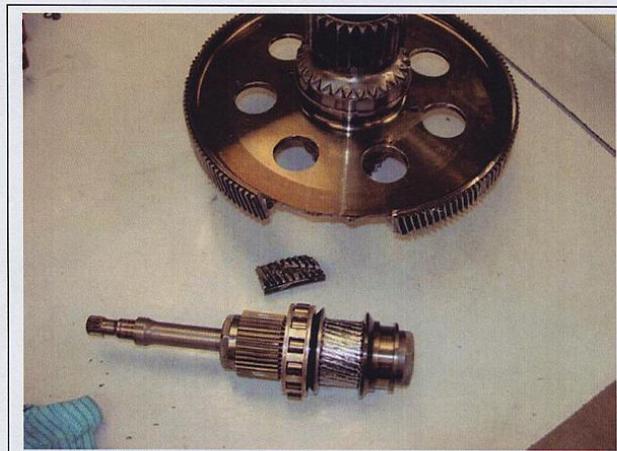
Bull & HSP Gear

Damaged bull gear
& HSP assembly

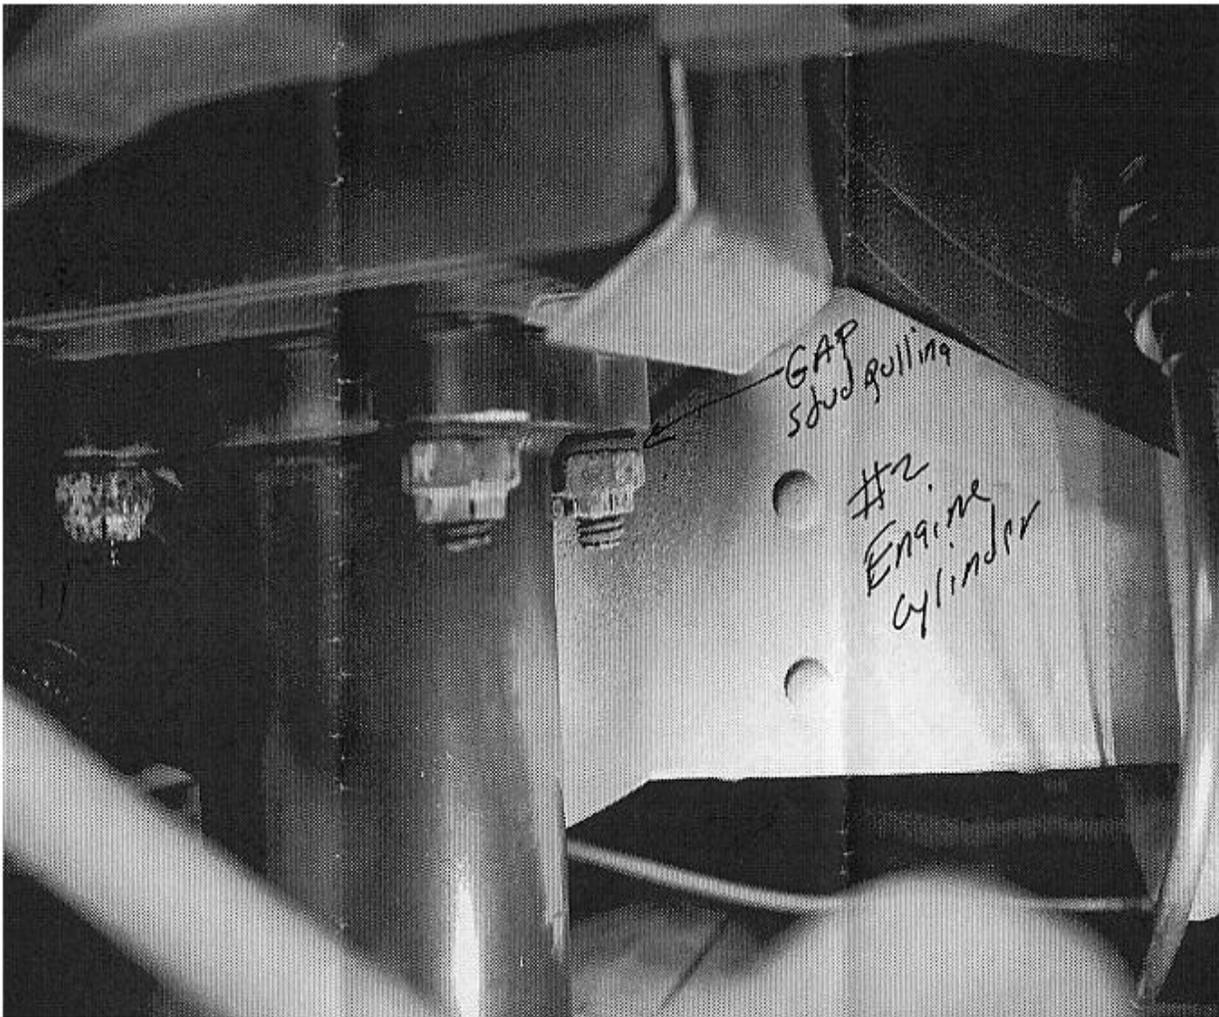
A repair station technician states, "During a Cessna 100 hour inspection, we found the exhaust stack at the number 2 cylinder pulled down approximately 1/16 inch. Further investigation found the number 1, 3, 5 and 6 engine cylinder exhaust stacks also pulled down, but not as much." "During the engine cylinder removal process we found the lower forward, 3/4 inch stud nut under torqued. Further investigation revealed the forward 2 studs (*each*) below Lycoming's recommended driving torque for cylinder hold-down studs in the case. We installed new, oversized studs (0.003") as per the engine manufacturer's recommendations. We installed the new, number 2 engine cylinder and new exhaust crossover pipe as required (see pictures). Note: tightening the exhaust flange nuts does not stop the leak on all of the studs; on some of the studs the nut bottoms out on the threads. After tightening, the previously effected exhaust flange areas have come loose again after 50 hours time in service." (*Exhaust assembly P/N: 40B222318.*)
