ADVISORY CIRCULAR

43-16A

AVIATION MAINTENANCE ALERTS

**ALERT
NUMBER
376**

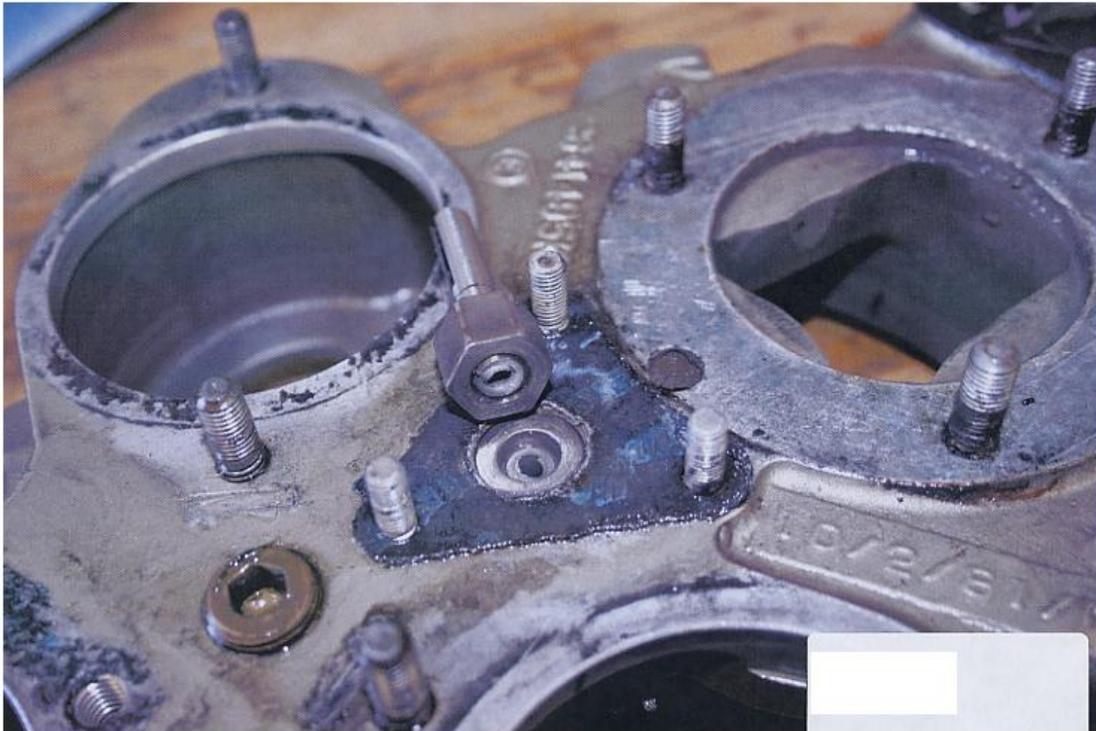
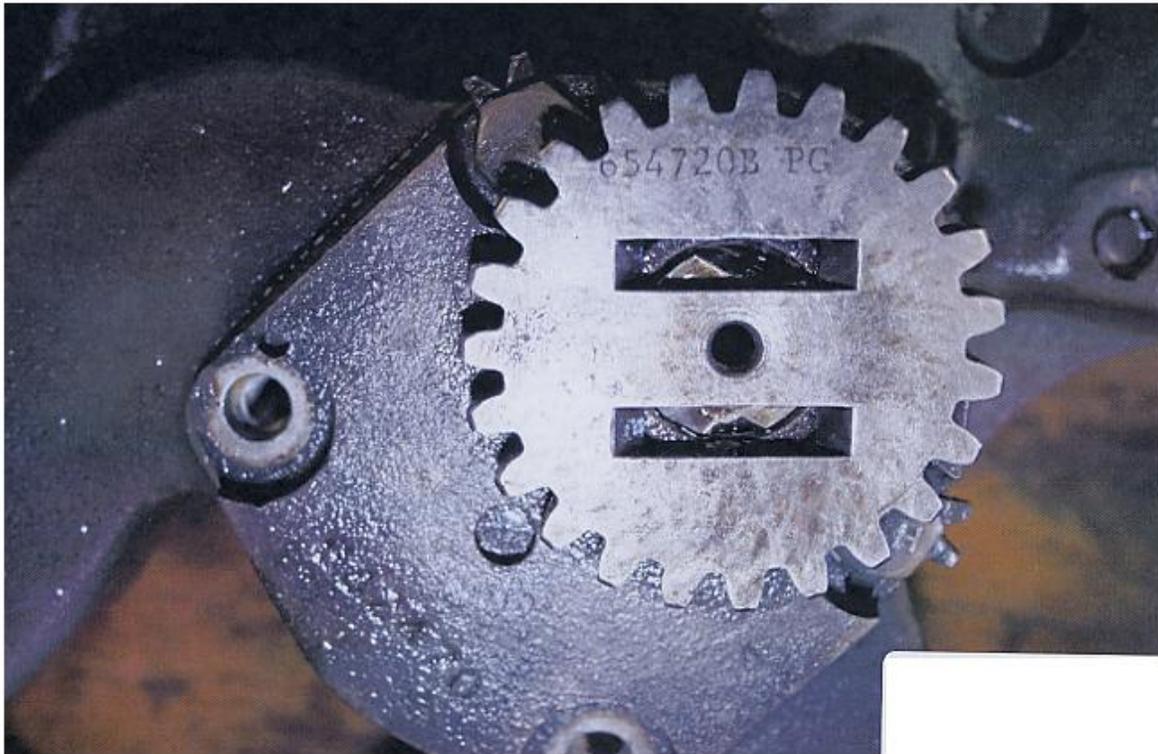
Continental: TSIO360; Failed Oil Pump Drive Shaft; ATA 8550

An unknown submitter writes, "*(There was...)* an in-flight failure of this engine due to a shaft shearing on the oil pump drive gear (*gear component P/N: 654720BPC*). (*This occurred*) while the pilot was at cruise altitude of approximately 4,000 feet MSL. He made an unscheduled landing at an airport."

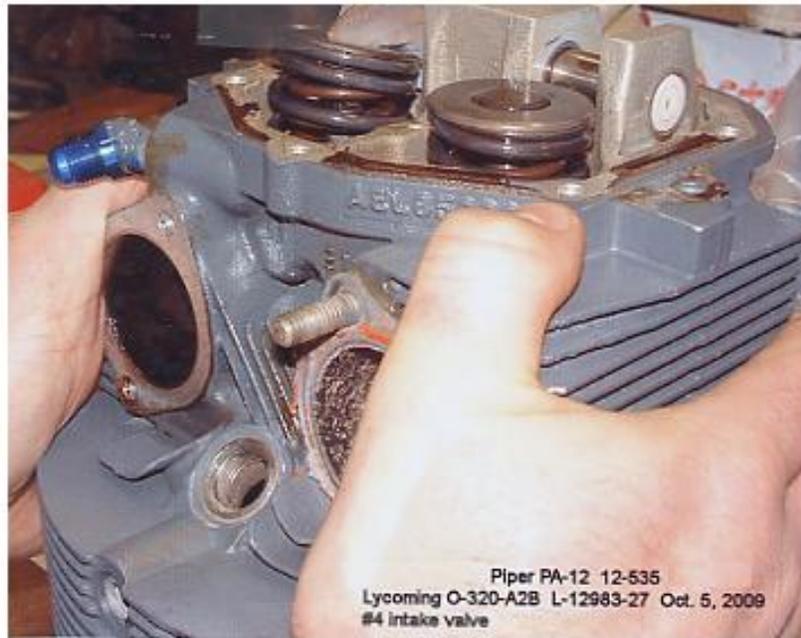
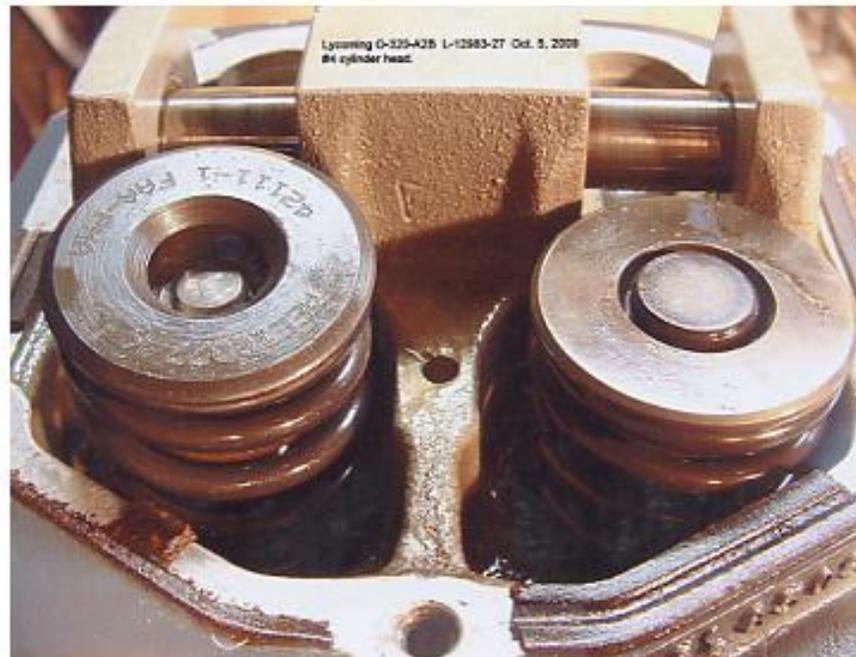
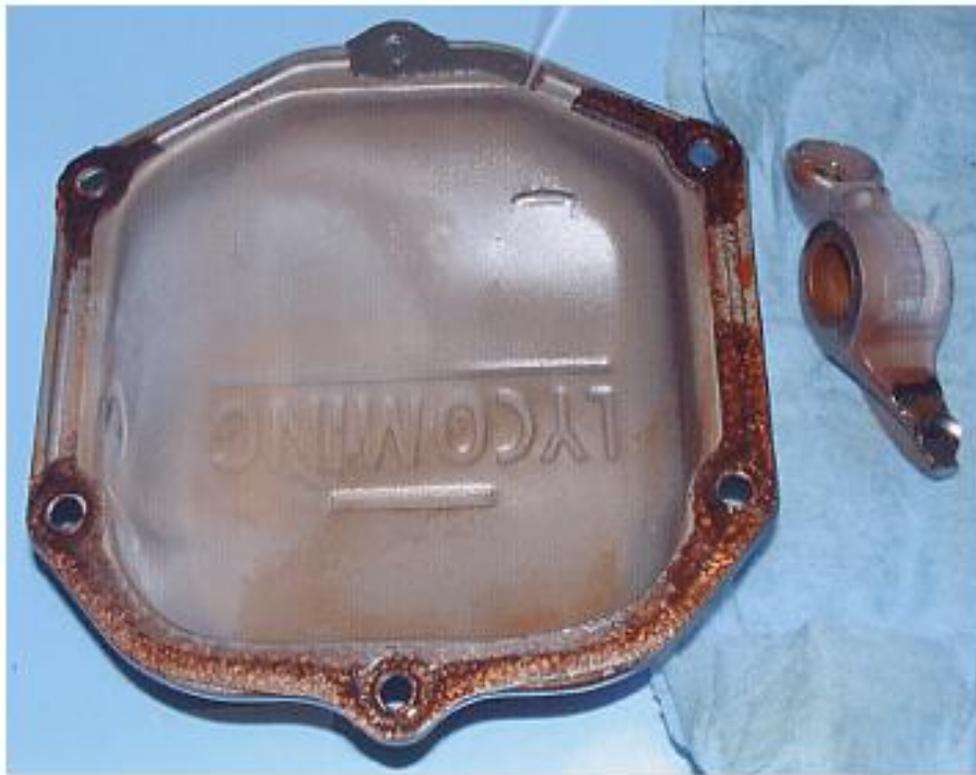
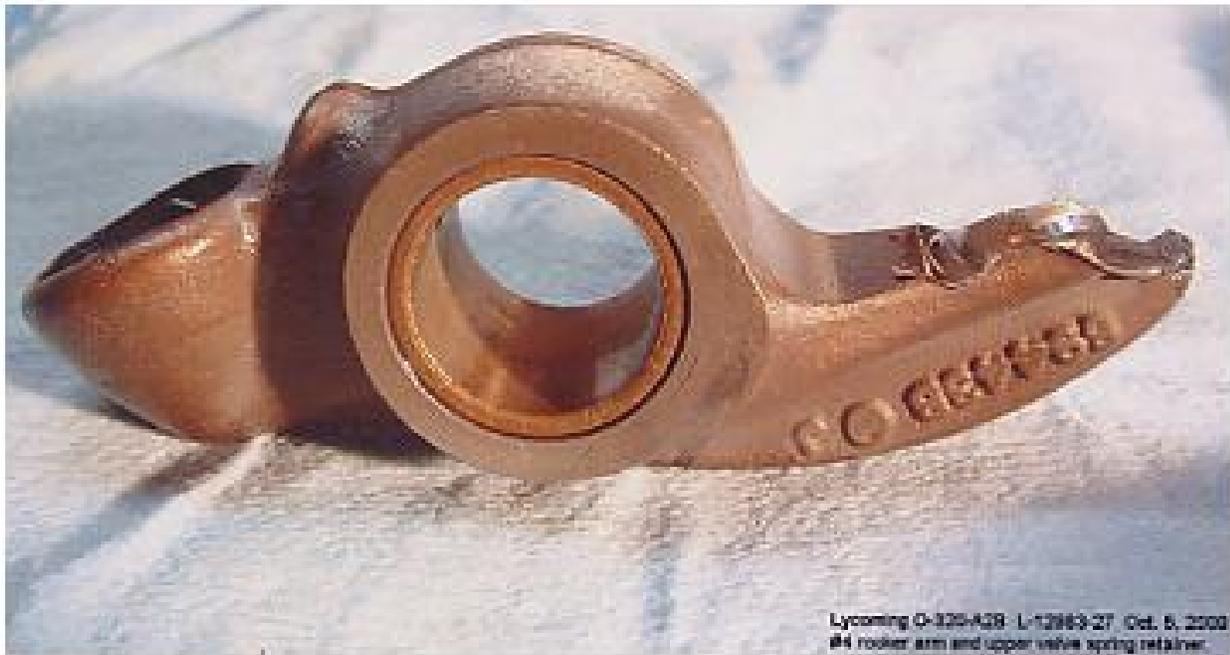
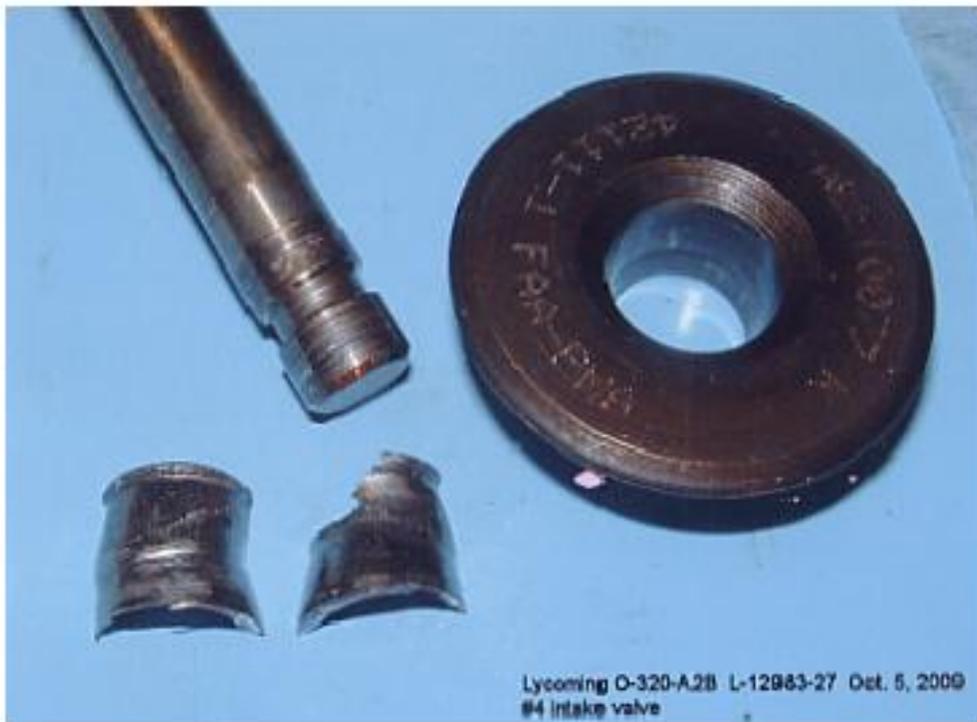
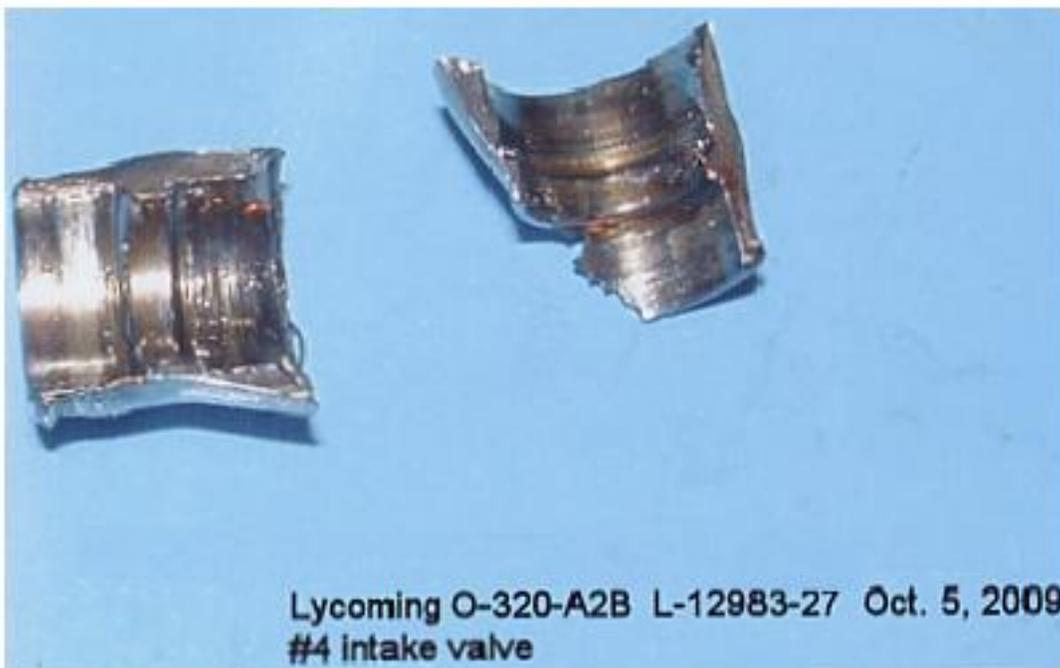
ECI Cylinder: TIST06.0CA; Failed Intake Valve Keys; ATA 8530

A mechanic holding an IA (*inspection authorization*) states, "This engine was overhauled in March of 2007 and currently has 237.3 hours since overhaul. The material at the lower end of the intake valve keys wore away, allowing the upper valve spring seat to move too high on the valve stem. This caused the rocker arm tip to wear abnormally, resulting in most of the rocker arm tip wearing away or breaking off. The upper valve spring seat continued moving up the valve stem until it began to make contact with the neck of the rocker arm. This caused the spring seat to tilt at an angle, eventually tilting enough to make contact with the rocker cover, wearing a ½ inch cut through the cover. The pilot did not notice any roughness in the engine's operation. He said that it felt like the engine might have been a little underpowered and not reaching full RPM at takeoff. The engine normally doesn't make full takeoff RPM on the first flight of the day if it has not had enough time to warm up and the oil is still cool." "*(The pilot)* assumed this was the case and continued with the takeoff. The engine ran smoothly throughout the flight. Upon landing, he noticed an oil streak running along the side of the aircraft. After opening the cowling, he found the cut that the upper valve spring seat had worn through the rocker cover. Because the aircraft was not at location where tools and supplies were available, we decided to replace the entire cylinder assembly. The cylinder was returned to ECI for warranty consideration."
