**Federal Aviation
Administration**

ADVISORY CIRCULAR

AVIATION MAINTENANCE ALERTS

**ALERT
NUMBER
400**

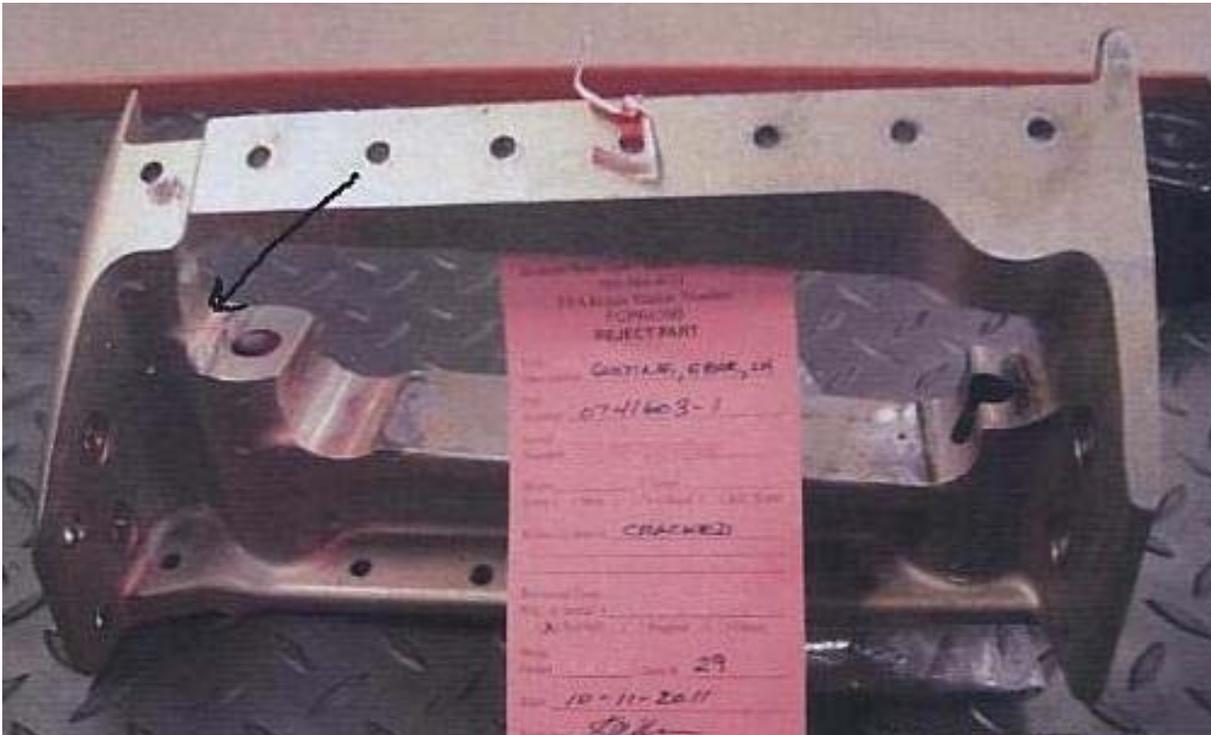
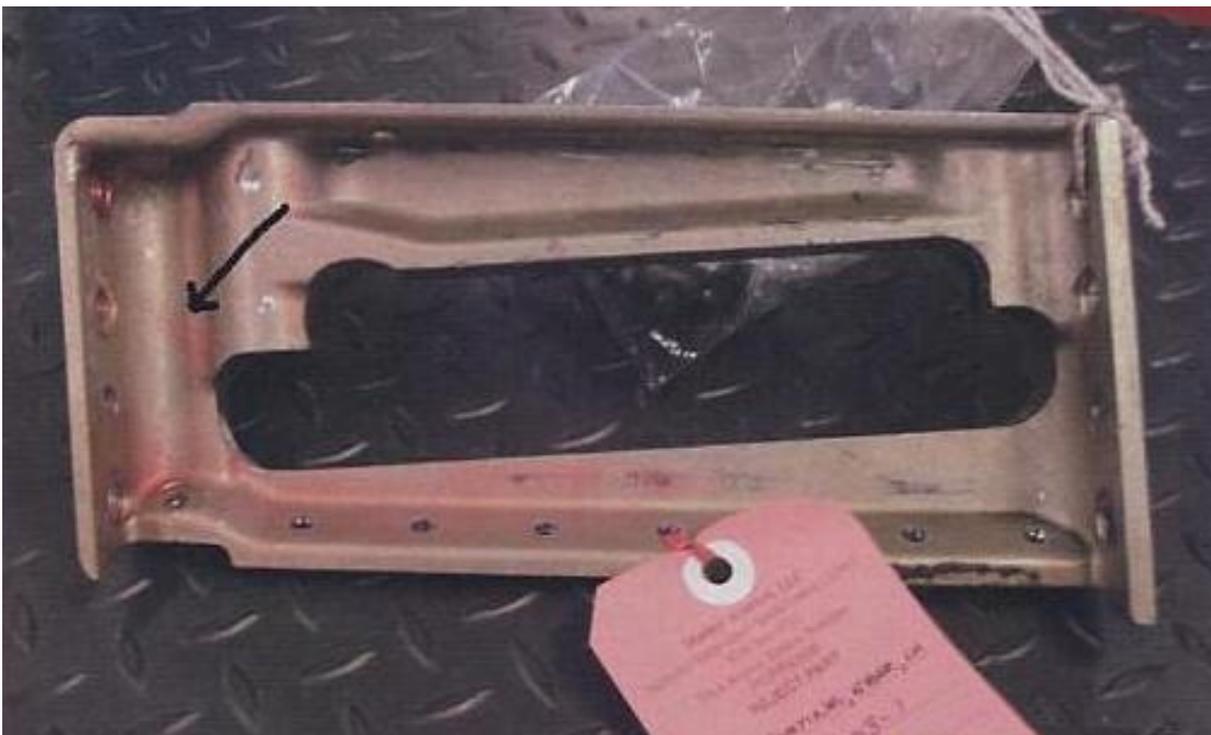
Cessna: Cracked Main Landing Gear Casting; ATA 5343

"The (*main landing gear attach*) casting crack was found by visual inspection," says the repair station technician. "The crack is located on the forward end of the support casting, and (*starts*) 0.25 inches from the mount holes on the outboard side (*and extends*) to within 0.25 inches of the mount holes on the inboard side of the casting (*P/N 07416031*)."

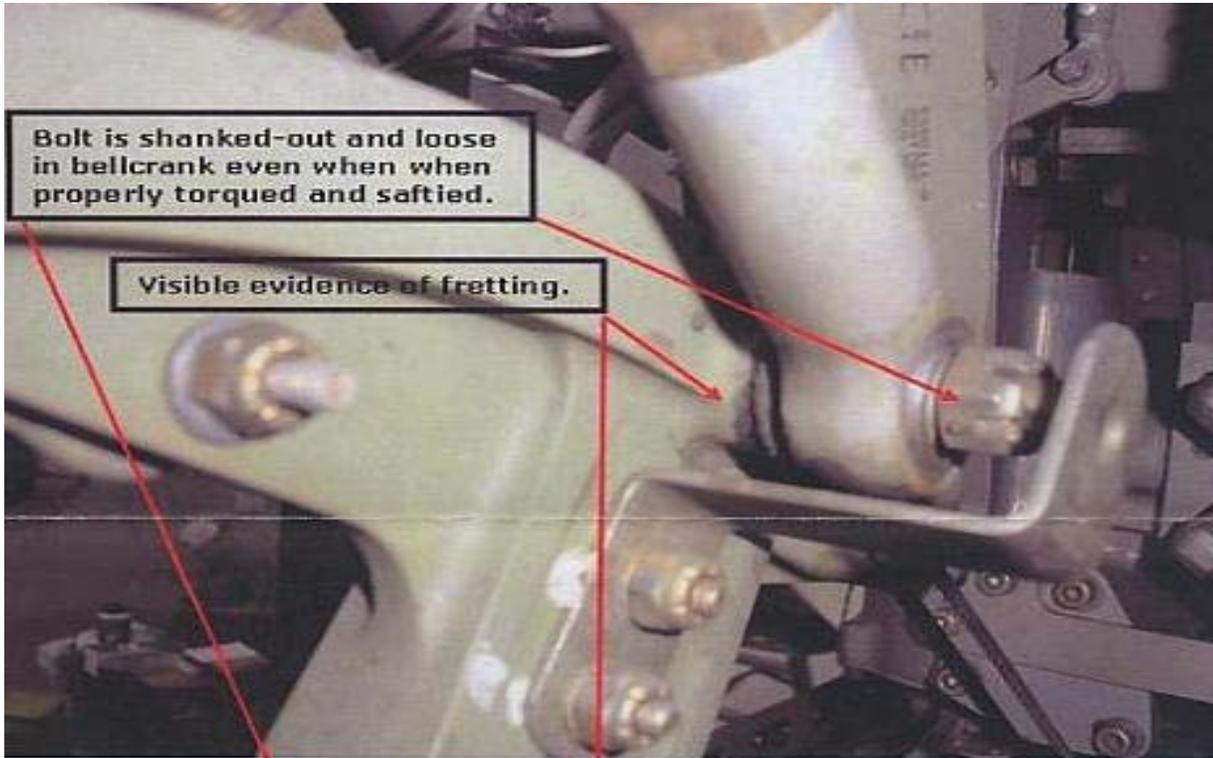
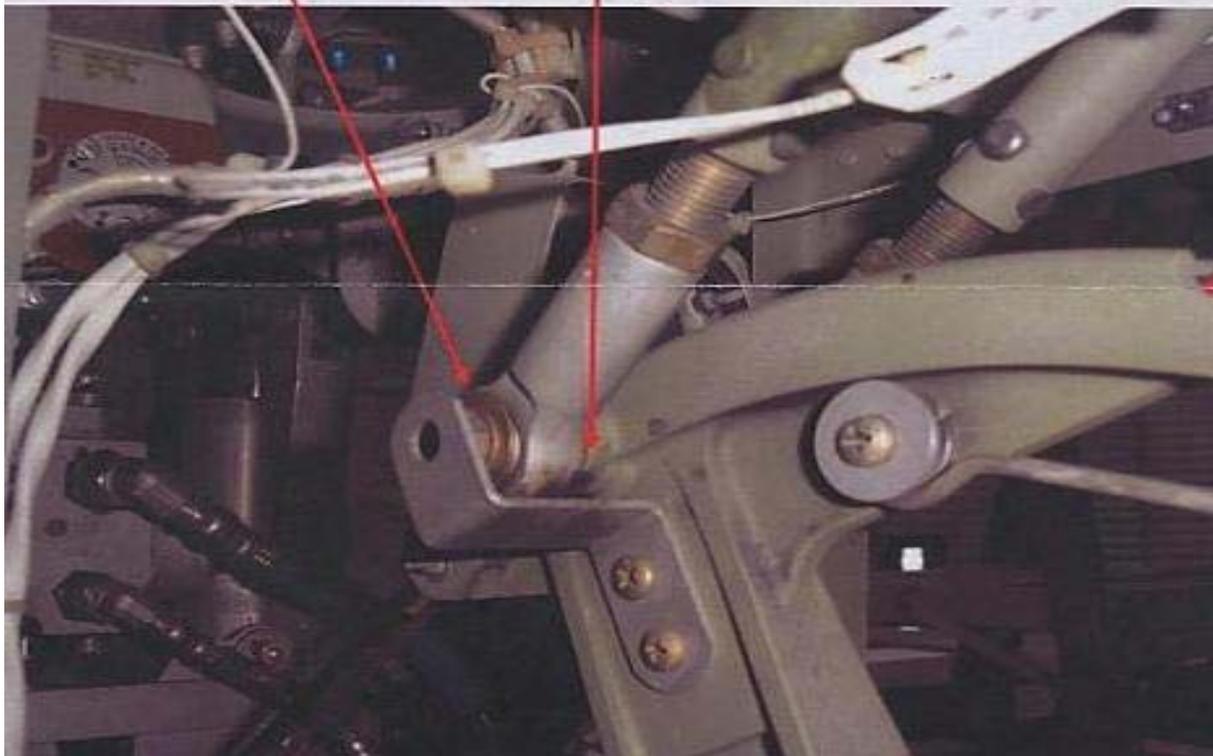
Cessna 560XL SN 560-5805 @ 2347.0 Hrs TT LND 1802

Cessna: 560XLS; Loose Elevator Push-pull Tubes; ATA 2730

"(Note: *the location of this defect...*) is the rear of the aircraft in the compartment below the horizontal stabilizer attach point," says this repair station technician. "Two push-pull tubes that attach to the aft elevator bell crank (*have nuts*) that shank-out on the bolt. This allows the bolts to be rotated by hand, causing wear in the bell crank attach hole." "(Now) the bolt begins to rock back and forth in the hole, resulting in chafing between the attached parts.

"Recommendation: When installing hardware, assure the nut does not shank-out on the bolt. Replace the bolt if worn, and add washers as required to prevent the nut from (*bottoming on the bolt's shank*)."

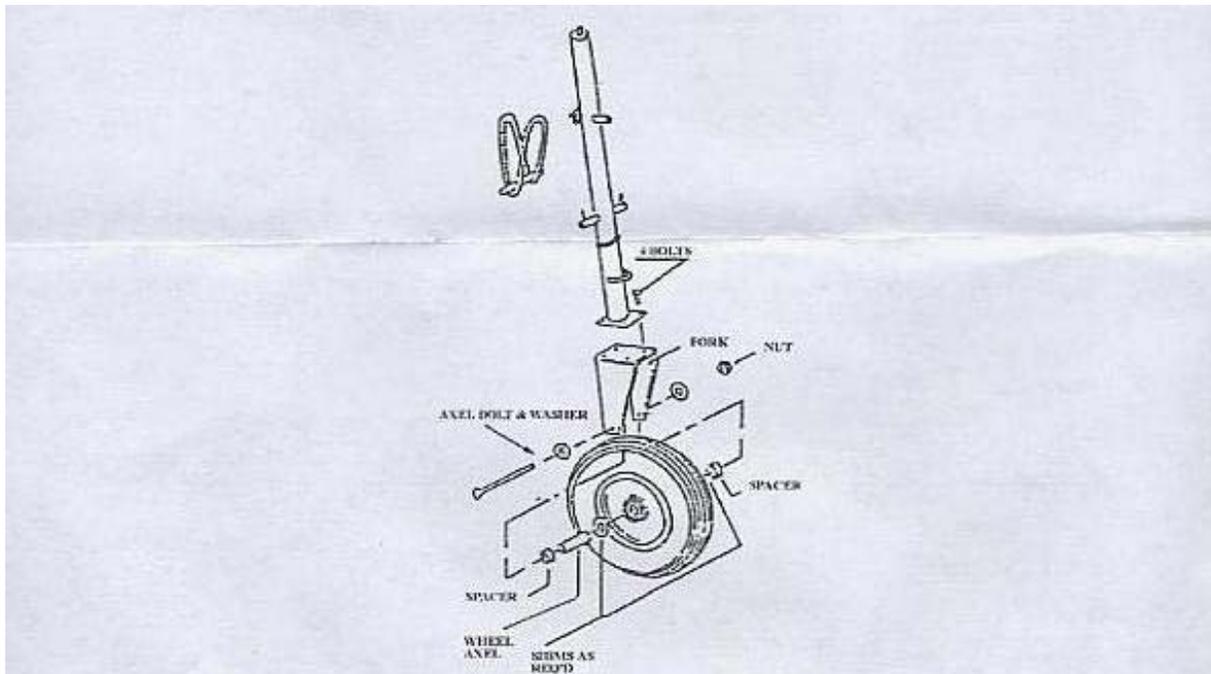
Photo 1: Nose Landing Gear Assembly

TCCA strongly recommends all affected owners and operators pay close attention to the NLG weld area both during scheduled maintenance activities and following every hard landing per Zenair Ltd. Service Manual instructions.

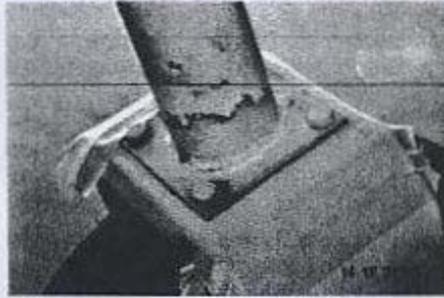
Additionally, the operator found cracks developing in the weld of another CH2000 aeroplane's NLG (Photo 2).

Photo 2: Cracking on the NLG leg and plate weld

A review of Service Difficulty Reports did not find additional occurrences. An investigation by Zenair did not reveal a root cause. It is believed that the weld cracking is due to "excessive hard NLG landing, exceeding the design limits. The nose wheel fork may flex and bend the square steel plate welded to the structure resulting in possible metal fatigue and eventual cracking."
