U.S. Department
of Transportation
**Federal Aviation
Administration**

ADVISORY CIRCULAR

43-16A

**ALERT
NUMBER
339**

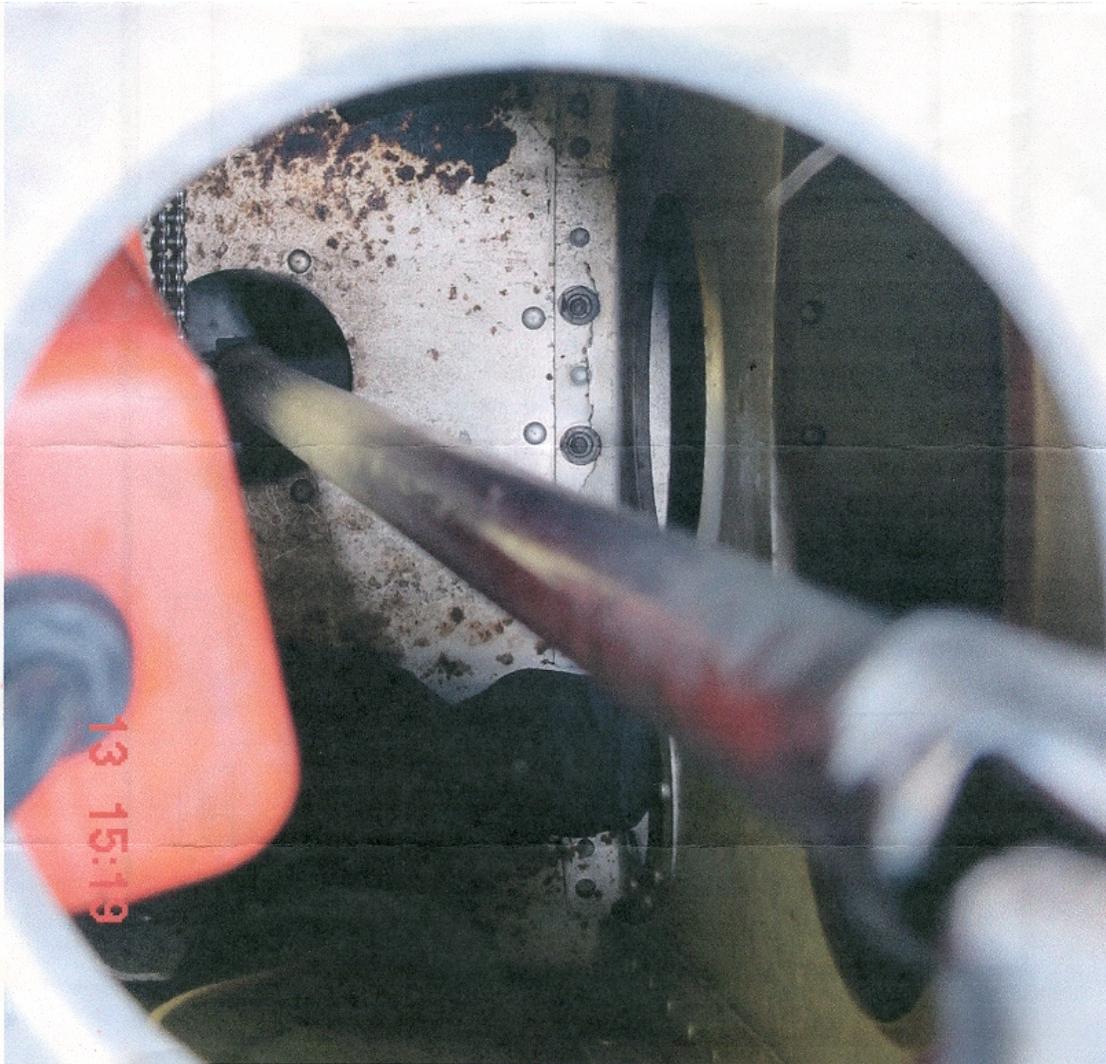
Cessna: 182A; Cracked Bulkhead Flange; ATA 5312

A mechanic writes, “(*This*) bulkhead, P/N 0712205-10, was found cracked at the tie-down hole. Bulkhead 0712206 (*was found cracked*) at the bolt holes where the attachment-to-elevator bell crank support mount is located. (*The included photo “frames” the topic quite nicely. Yes—the missing capacity for “attachments” to electronic defect report submissions has been voiced by this editor, and yes, I know it is 2006. Be assured this feature will be added to the SDRS system...soon. Meanwhile, thank-you all for the trouble and expense of physical submissions—they are appreciated.*)

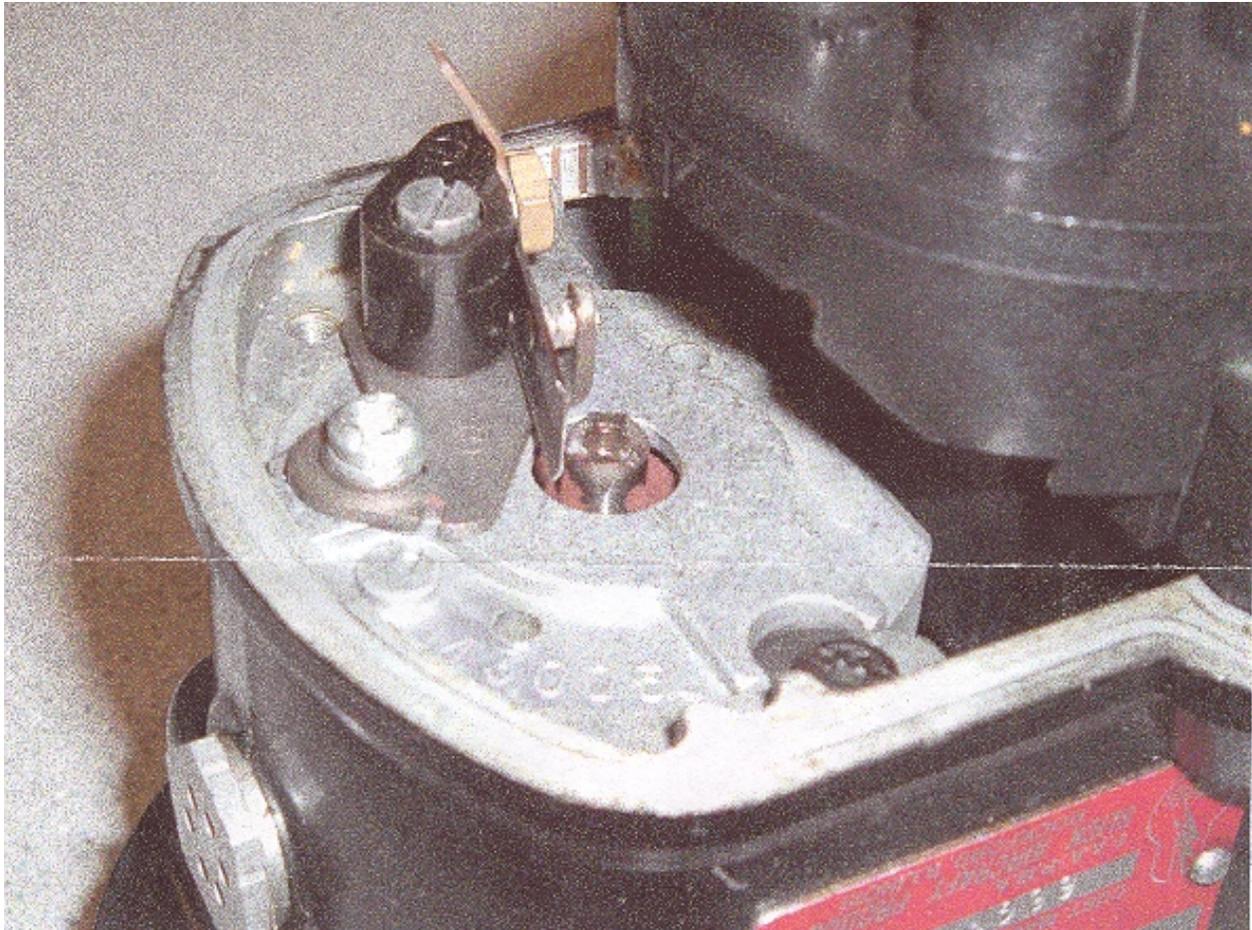
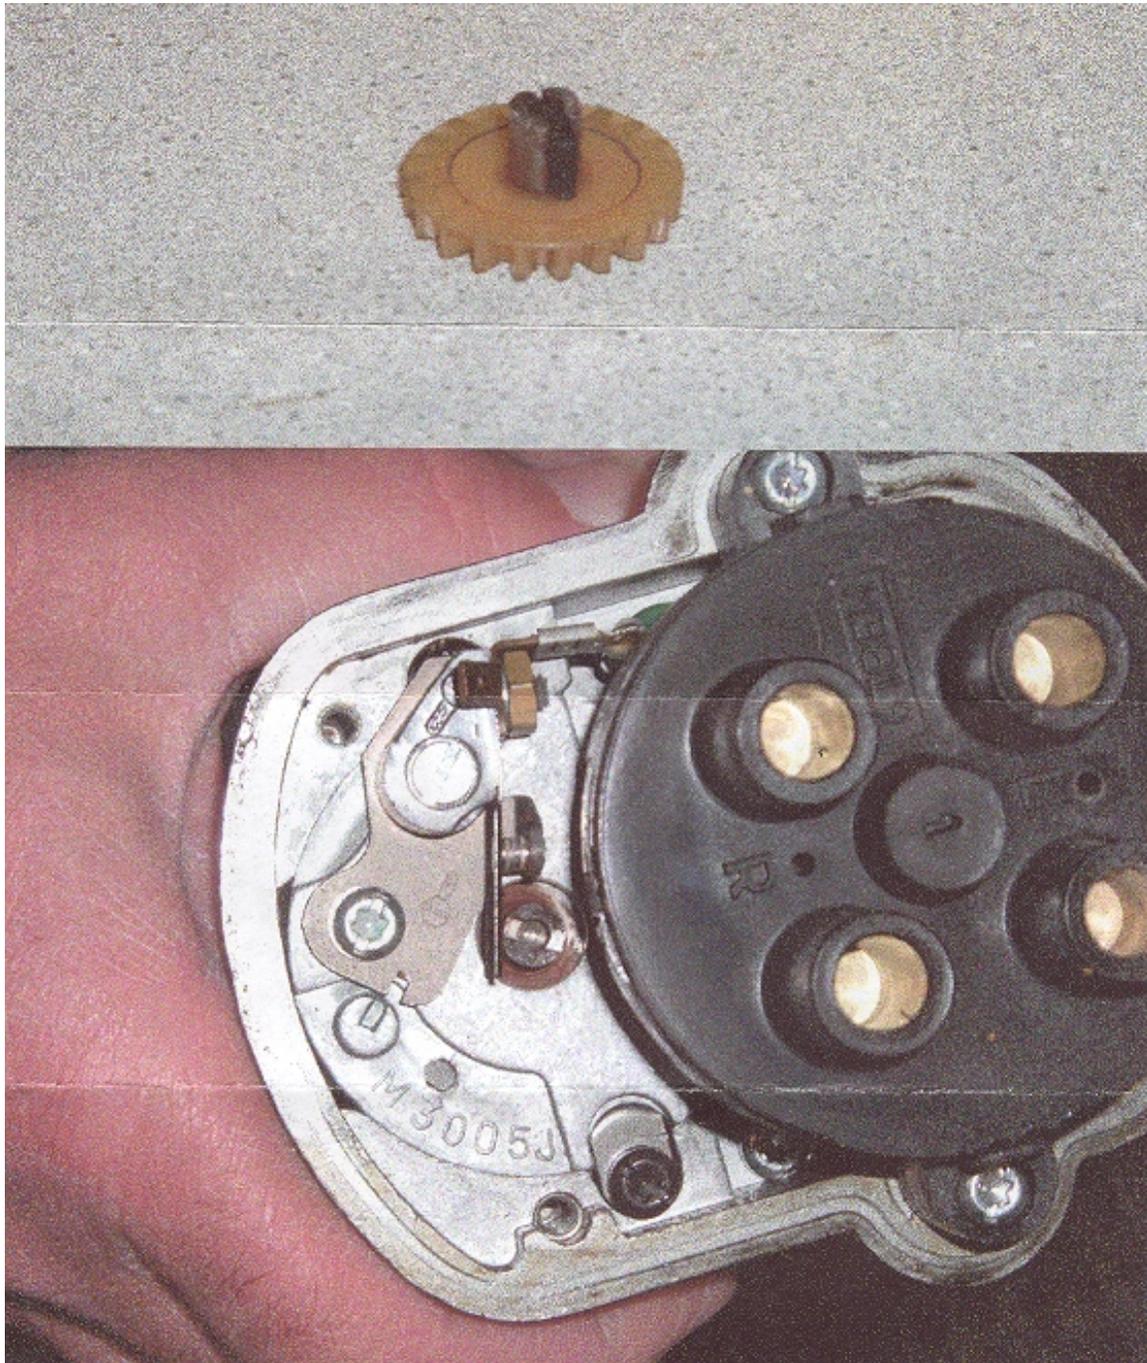
Slick Magneto: 4370; Sheared Rotor Shaft; ATA 7414

A mechanic writes, “The pilot noticed a lack of power and roughness after takeoff. Returning to the field, he discovered an inoperative R/H magneto. Disassembly revealed the rotor shaft had sheared flush with the bottom of the cam cut-out. The remaining rotor and distributor both rotated freely. (*There was ...*) no evidence of problems with either gear. The probable cause (*may be related*) to a defect in manufacturing (possibly bad metal or a stress crack from machining the cam slot).” (*This magneto was bolted to a Lycoming O-360-A4P. The rotor part number is M3548—reflected 20 times in the SDRS data base.*)

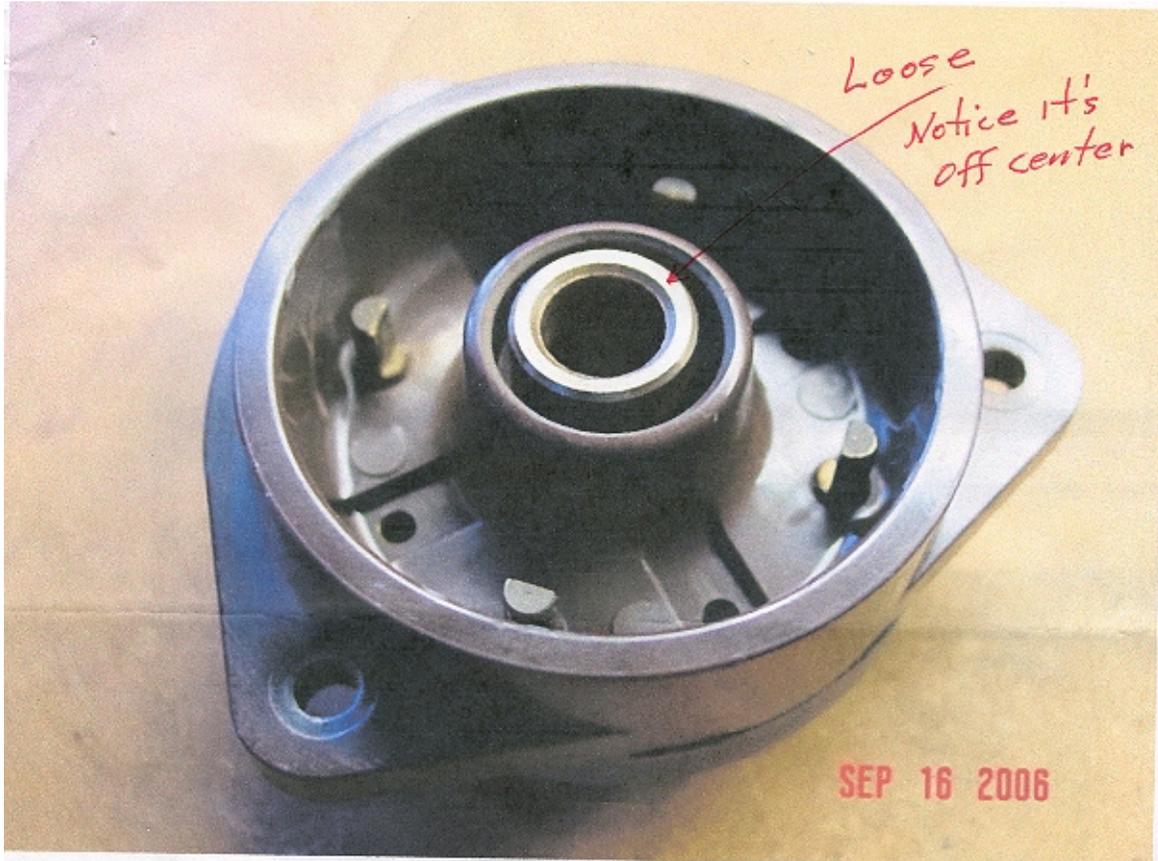
TCM Magneto: S4LN-200; Broken Distributor Block; ATA 7414

Another mechanic experiences magneto difficulties. "During a 500 hour inspection and service, the bronze bushing in the distributor block was found broken-loose and free to (move) around. (This unit is mounted to a Lycoming O-320-B2C. The new distributor part number is 10-52949, reflected 13 times in the SDRS data base; the old number is 10-357424 with 8 data base entries.)
