U.S. Department  
of Transportation  
**Federal Aviation  
Administration**

## ADVISORY CIRCULAR

43-16A

# AVIATION MAINTENANCE ALERTS

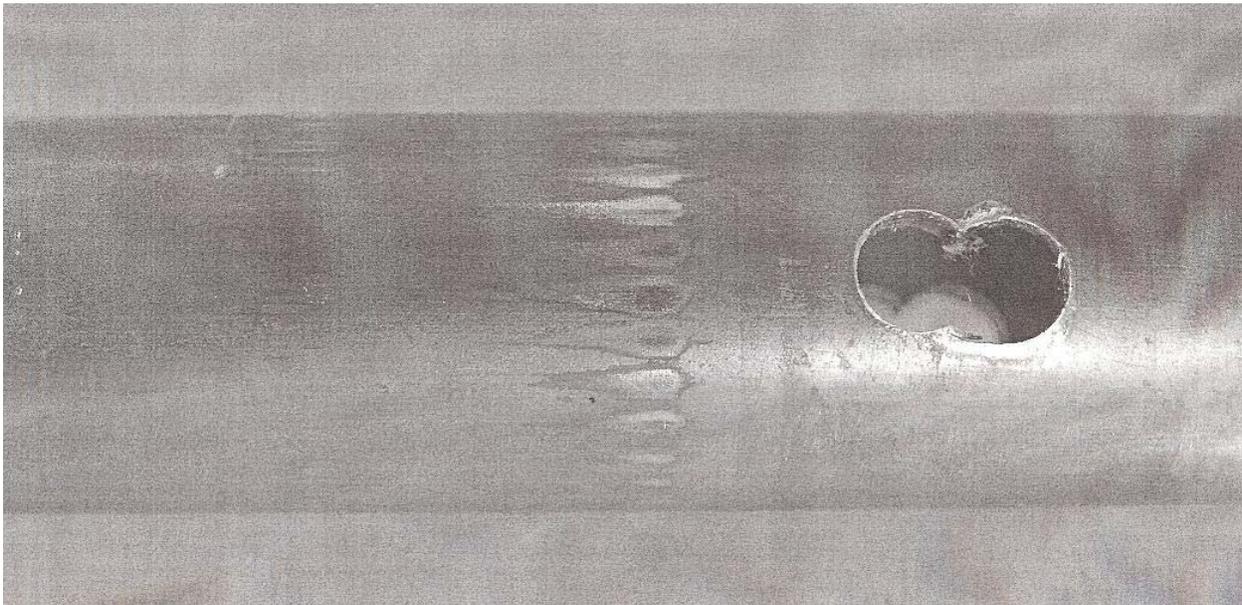
**Beech: A36; Loose Rudder Pedals; ATA 2720**

A repair station technician writes, "Upon investigating a loose rudder pedal (*discrepancy*), the (*controls*) were disassembled. (*We found*) that the shaft had been double-drilled with the holes overlapping. This aircraft was certificated in January of 2002; it now has 1,015.4 hours time in service." (*Pilot's rudder pedal assembly: P/N 002-524040; left rudder pedal shaft: P/N 002-524016-5*).

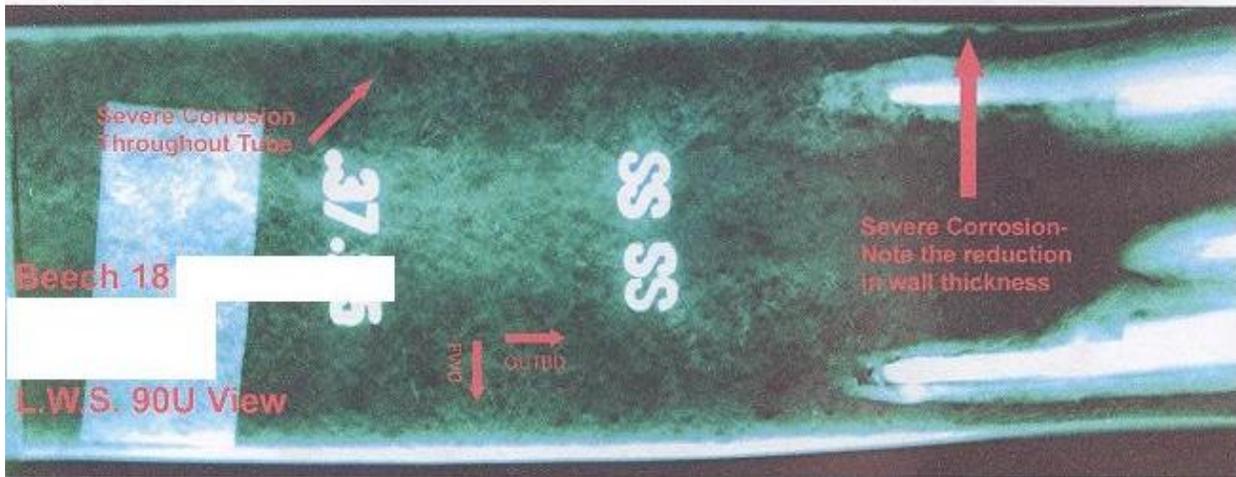
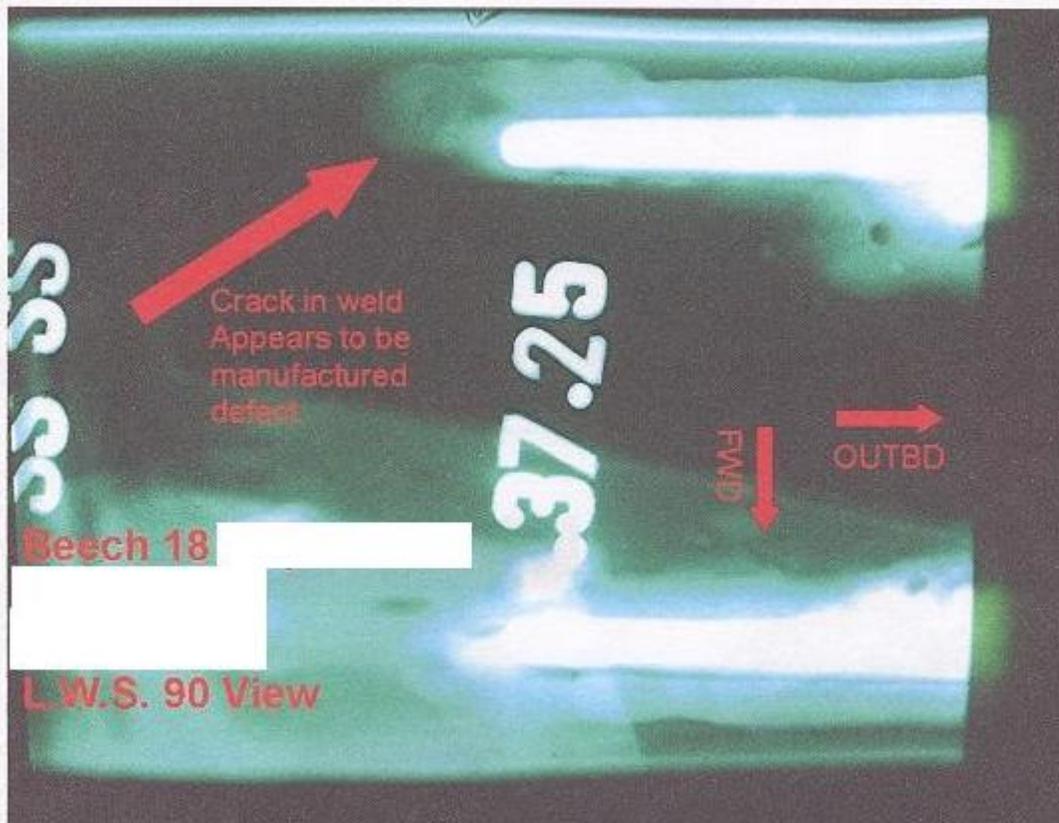
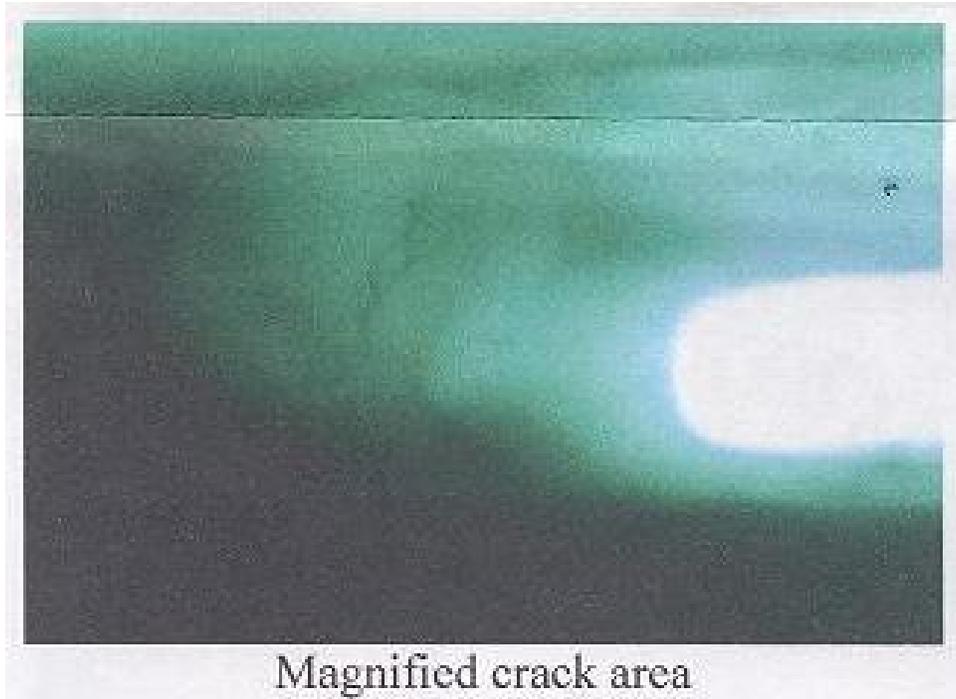
**Beech: G18; Wing Spar Corrosion; ATA 5711**

An unknown submitter states, “This defect (*describes*) severe corrosion in the L/H spar tube at wing station 90. The probable cause is exposure to moisture over an extended period of time. My recommendation to prevent recurrence would be to seal and fill (*the spar tubes*) with linseed oil. A further recommendation would be to (*perform*) visual and dye penetrant inspections of this area at 25 hour intervals up to the first 100 hours. If no fatigue cracks are noted, extend the inspections to every 100 hours—or each year—whichever occurs first.”

*(No part numbers were provided with this report. Uninitiated readers should not interpret the technician’s use of the words “...fill the spar...” literally. He means “to add a liberal quantity.” Reference the practice in steel tubing structures.)*

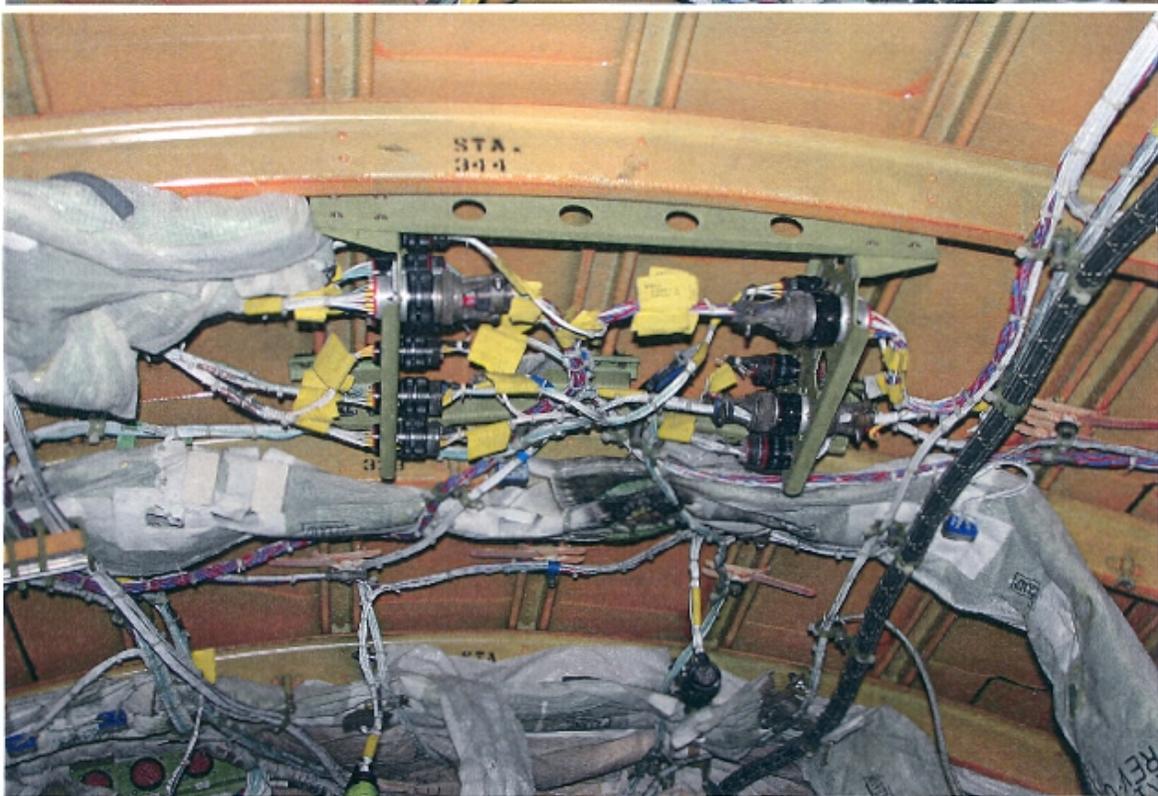
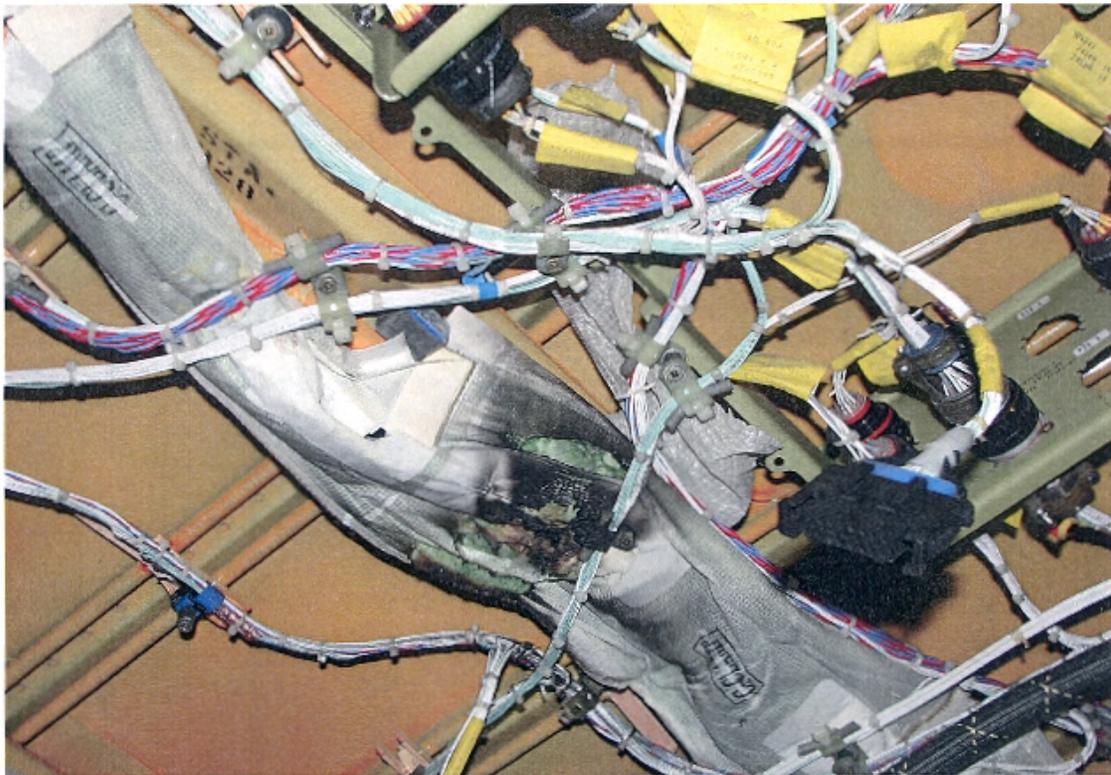
### **Boeing: B737-7Q8; Overheated Light Ballast; ATA 3320**

*This “one-liner” from a repair station technician doesn’t describe very much: “The passenger cabin light ballast overheated, burning the insulation blanket at bulkhead station 328.” Of course, the following photographs say a great deal! (Light ballast P/N: S283U008-16. See SDR control number DL764020075 for a similar event on a 767 using the same part number.)*

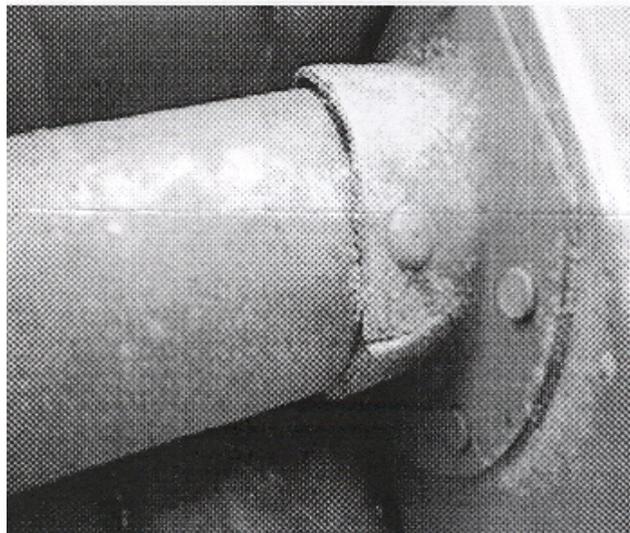
### **Cessna: 172, 180, 182,185, 188; Elev. Torque Tube Corrosion; ATA 2730**

The Australian Civil Airworthiness Safety Authority (CASA) has issued an airworthiness bulletin (AWB 53-006) recommending inspections for corrosion damage on the elevator torque tubes (P/N 0532001-31) in Cessna model 172 airplanes. This part has been installed on Cessna model 172's since it was introduced in 1956, and it continues to be installed on new Cessna model 172 production airplanes. The part is an aluminum tube exposed to wheel spray during landings, or spray from floats during water landings. The tube is oriented horizontally, so it tends to retain water. Exposure to moisture (particularly in coastal regions) over many years leads to corrosion damage.

No SDRs were found for P/N 0734110-7 where corrosion was an issue. However, two SDRs for the same airplane (one SDR for each side) were found for a Cessna model 170 in 1995 where the torque tubes were found rusted and pitted. The new parts had to be locally fabricated from a drawing. The submitter recommended the tubes be inspected on the airplane. The P/Ns were identified as 0334106 and 0334206.

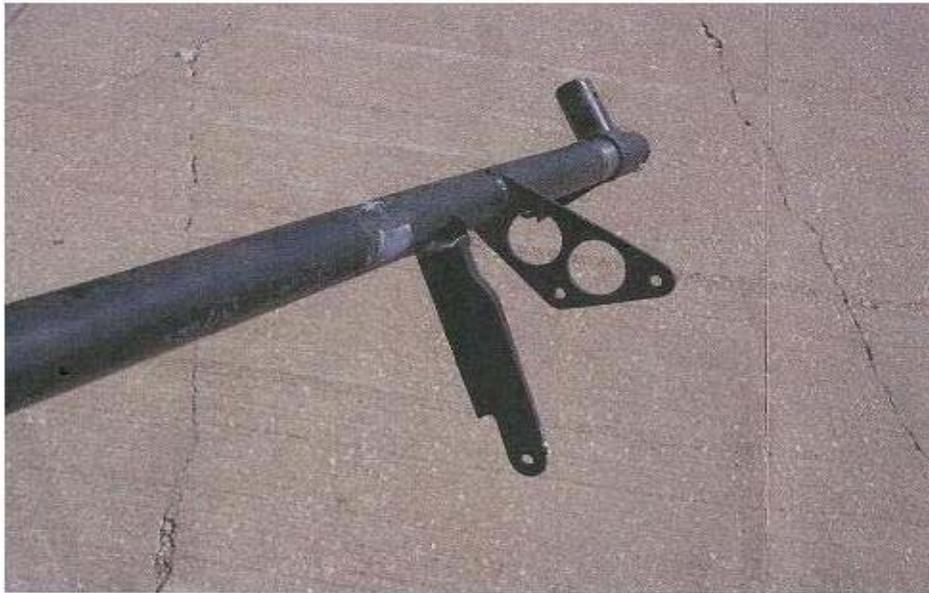
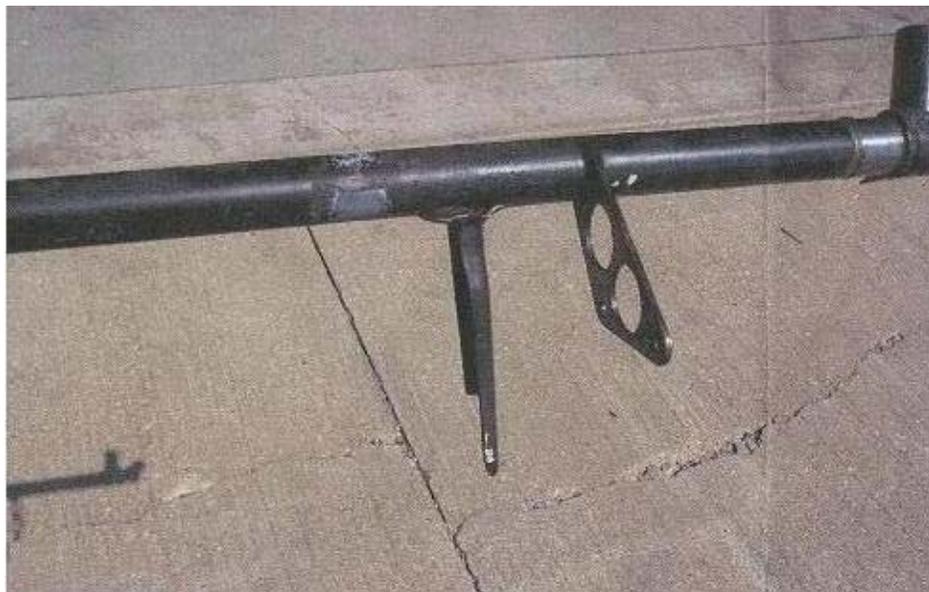
**Cessna: 310Q; Cracked Rudder Torque Tube; ATA 2720**

A mechanic writes, "The rudder torque tube (P/N 0813013-16) ripped at the rudder cable bracket. Inspect the area next to the weld."

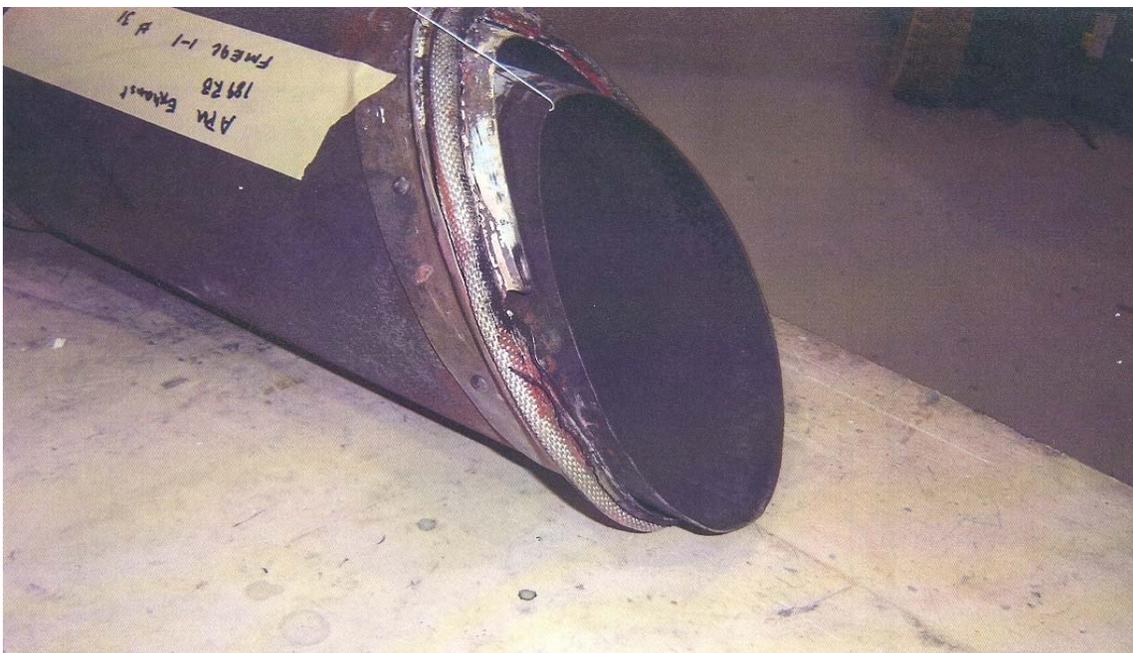
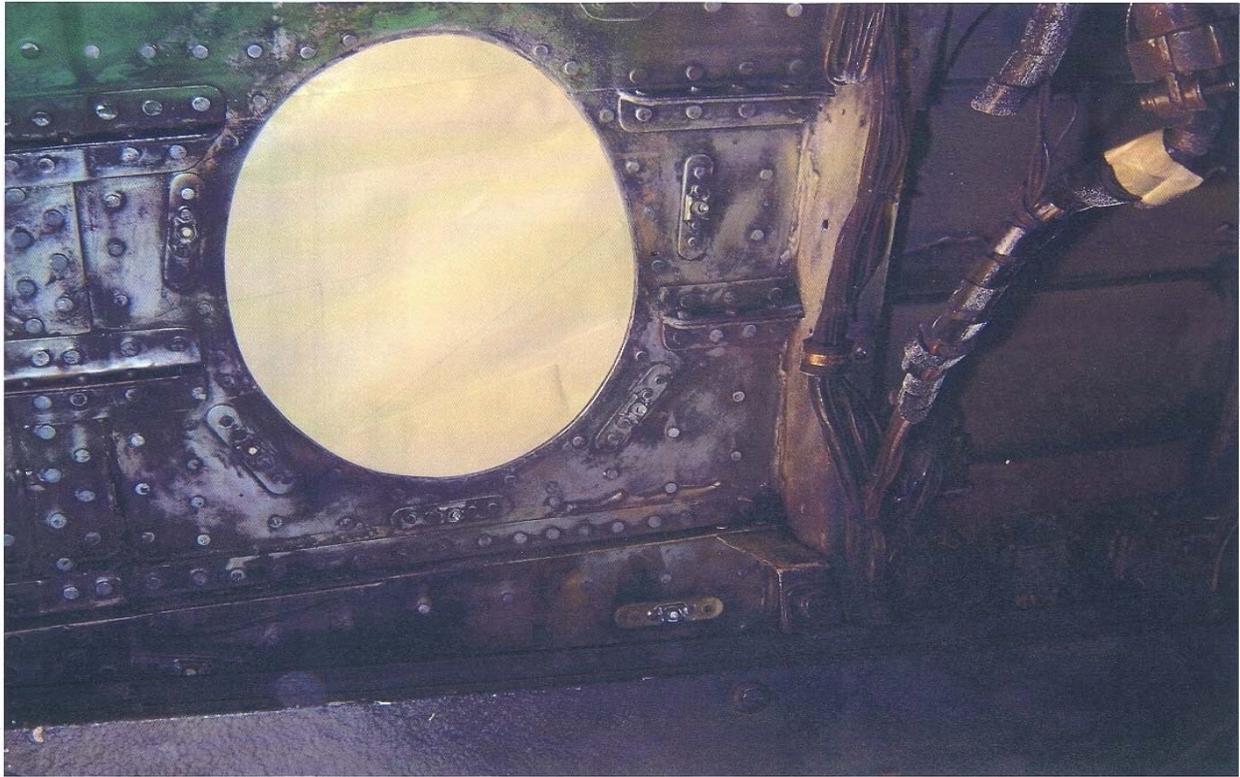
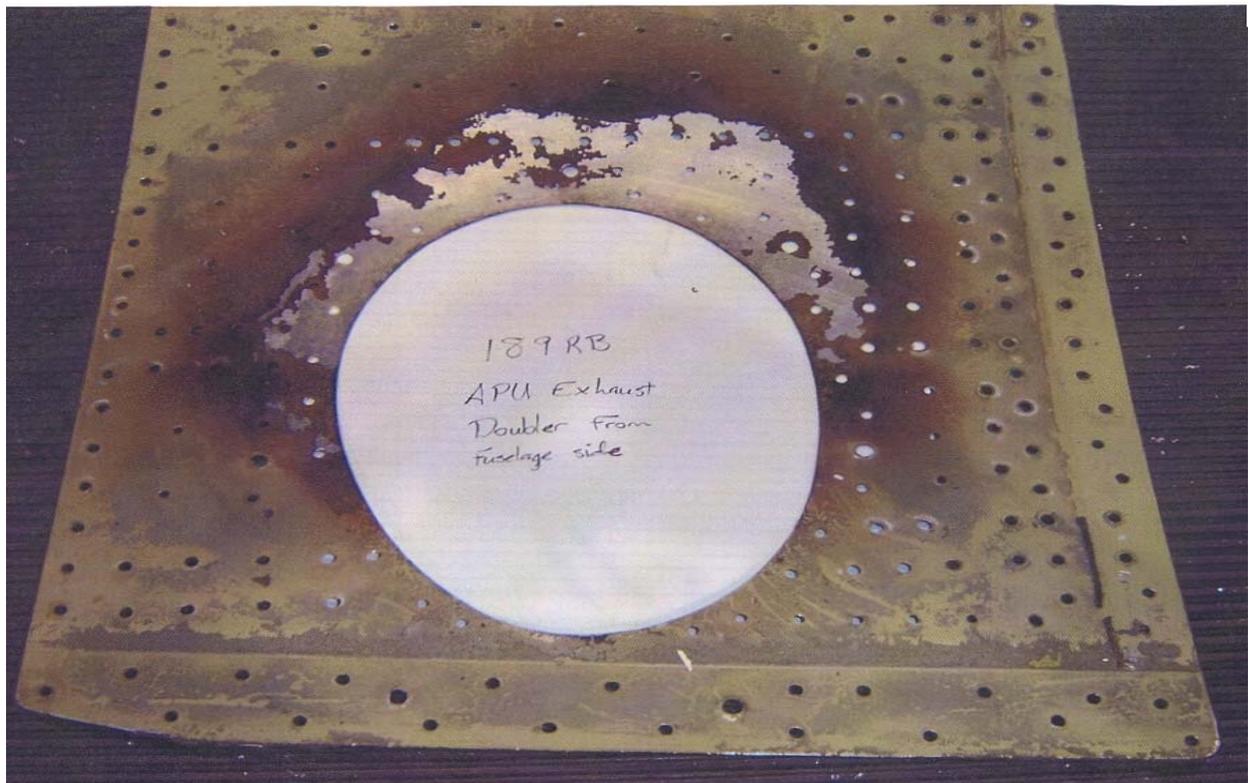
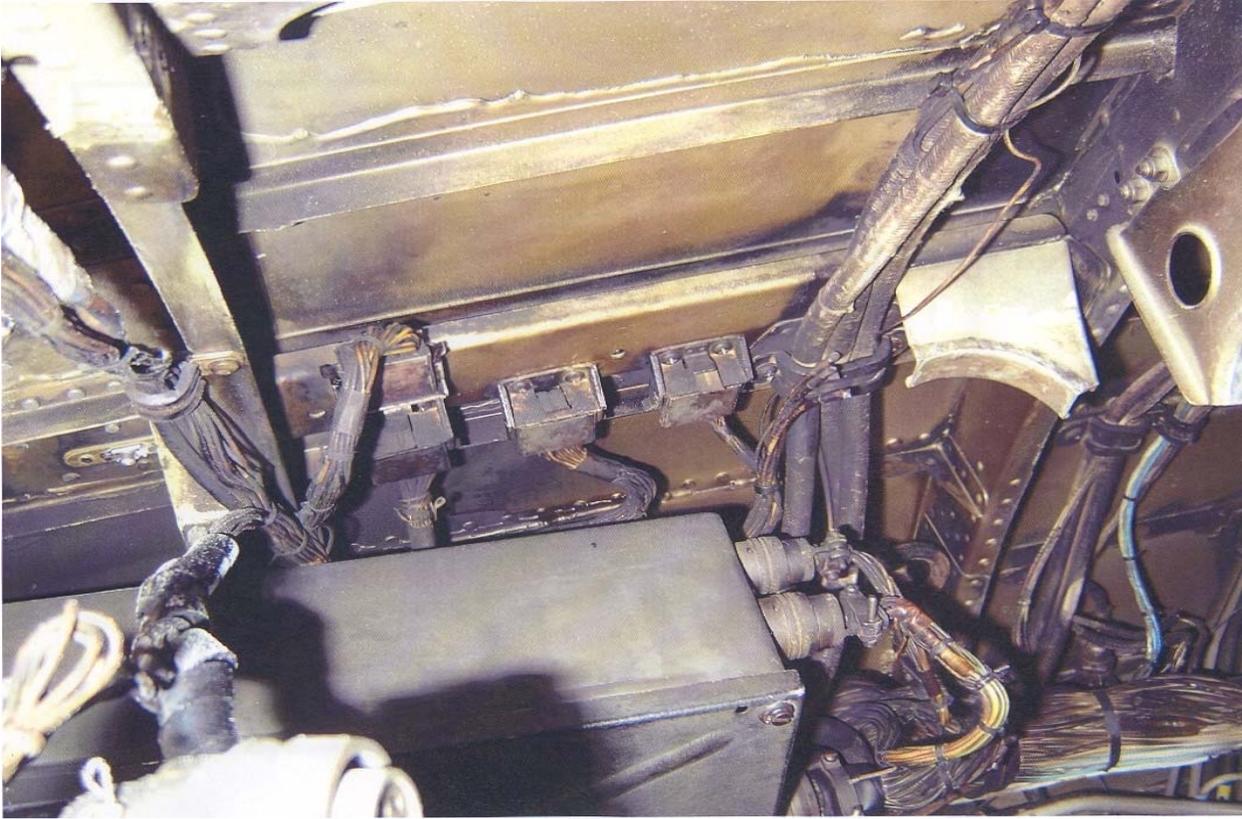
**DASSAULT****Dassault: 20-F5; Deteriorated APU Duct Seal; ATA 4980**

A repair station technician says, “A deteriorated APU (*auxiliary power unit*) exhaust duct seal (*P/N MY20240035005A3*) between the duct flange and the aircraft skin allowed hot exhaust gasses to enter the tail cone area, resulting in heavy soot build-up and heat damage to wire bundles and electrical connectors and structural components adjacent to the APU exhaust opening. Ultrasound inspection revealed heat damage to the aircraft skin above the exhaust opening, the APU exhaust opening doubler, and stringers adjacent to the opening. Periodic inspection of the APU installation—including this seal—is required at every ‘A’ check per the Mystere Falcon 20-F5 Maintenance Manual: chapter 5, section 49-002.”

*(The listed APU name is Sahpir; model 42, manufactured by Microturbo. Not shown here are another half-dozen pictures similar to the above—an excellent documentation effort!)*
