ADVISORY CIRCULAR

43-16A

AVIATION MAINTENANCE ALERTS

**ALERT
NUMBER
363**

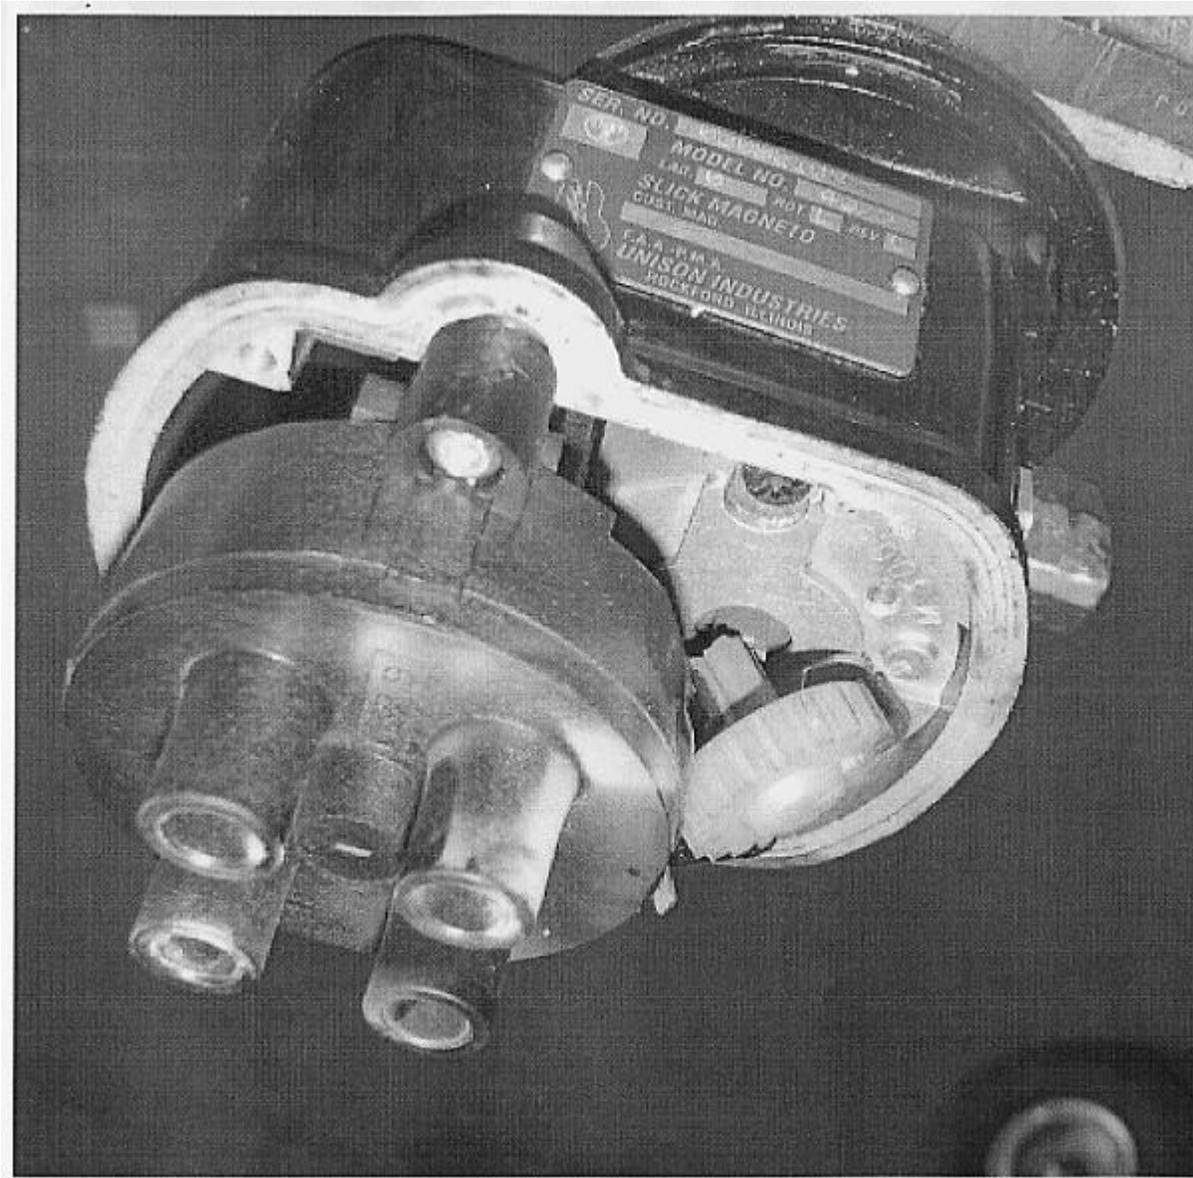
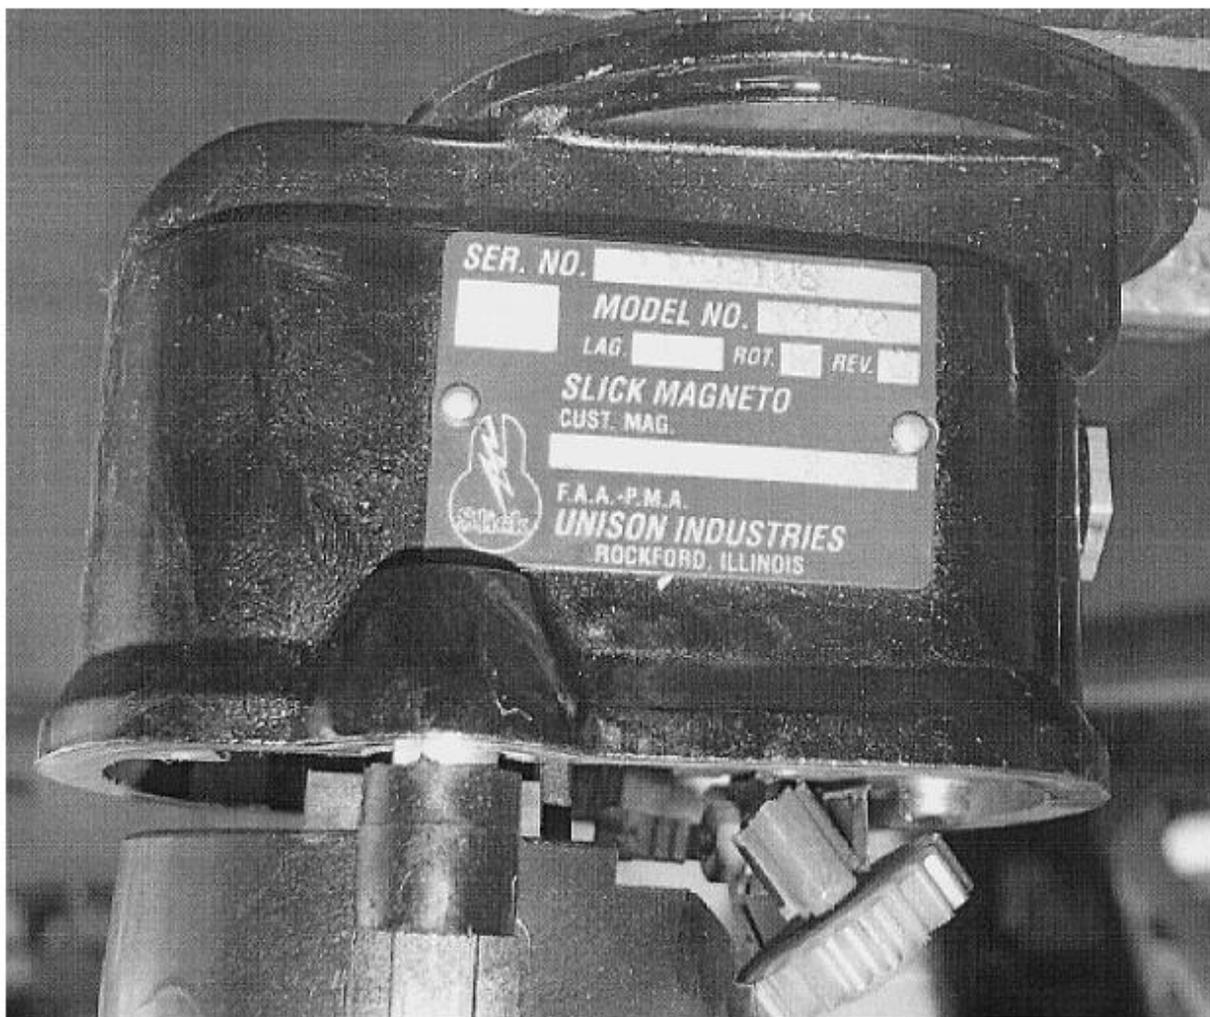
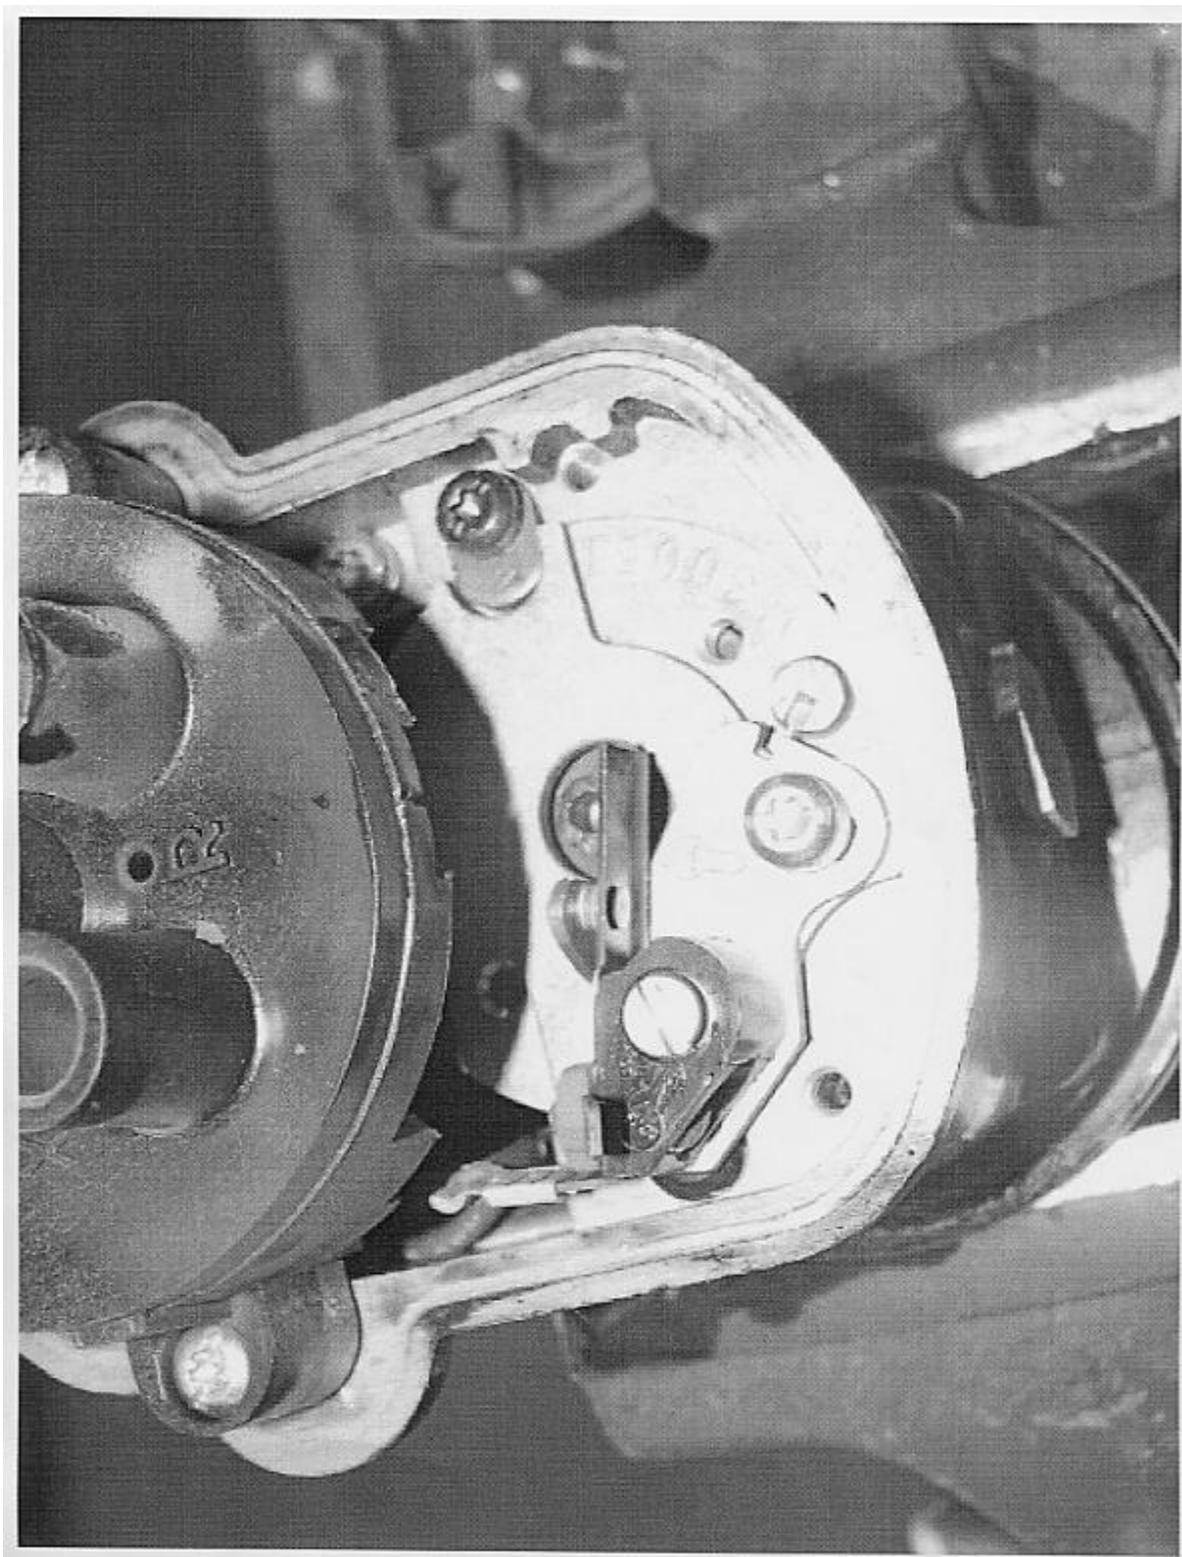
SLICK**Slick Magneto: 4370; Broken Point-Cam Shaft; ATA 7414**

(The following magneto defect was found on a Piper PA28R-200 sporting a Lycoming IO-360-C1C. Any missing verbal description is replaced with the photographs!)

The submitter says, “*(This engine’s magneto)* distributor/point cam shaft broke flush with the upper magneto gear inner race, causing total magneto failure. *The part was returned to the owner.*” *A search of the FAA Service Difficulty Reporting System data base includes 11 additional reports for the 4370 magneto.)*

Part Total Time: (unknown).
