U.S. Department
of Transportation

ADVISORY CIRCULAR

AVIATION MAINTENANCE ALERTS

**ALERT
NUMBER
387**

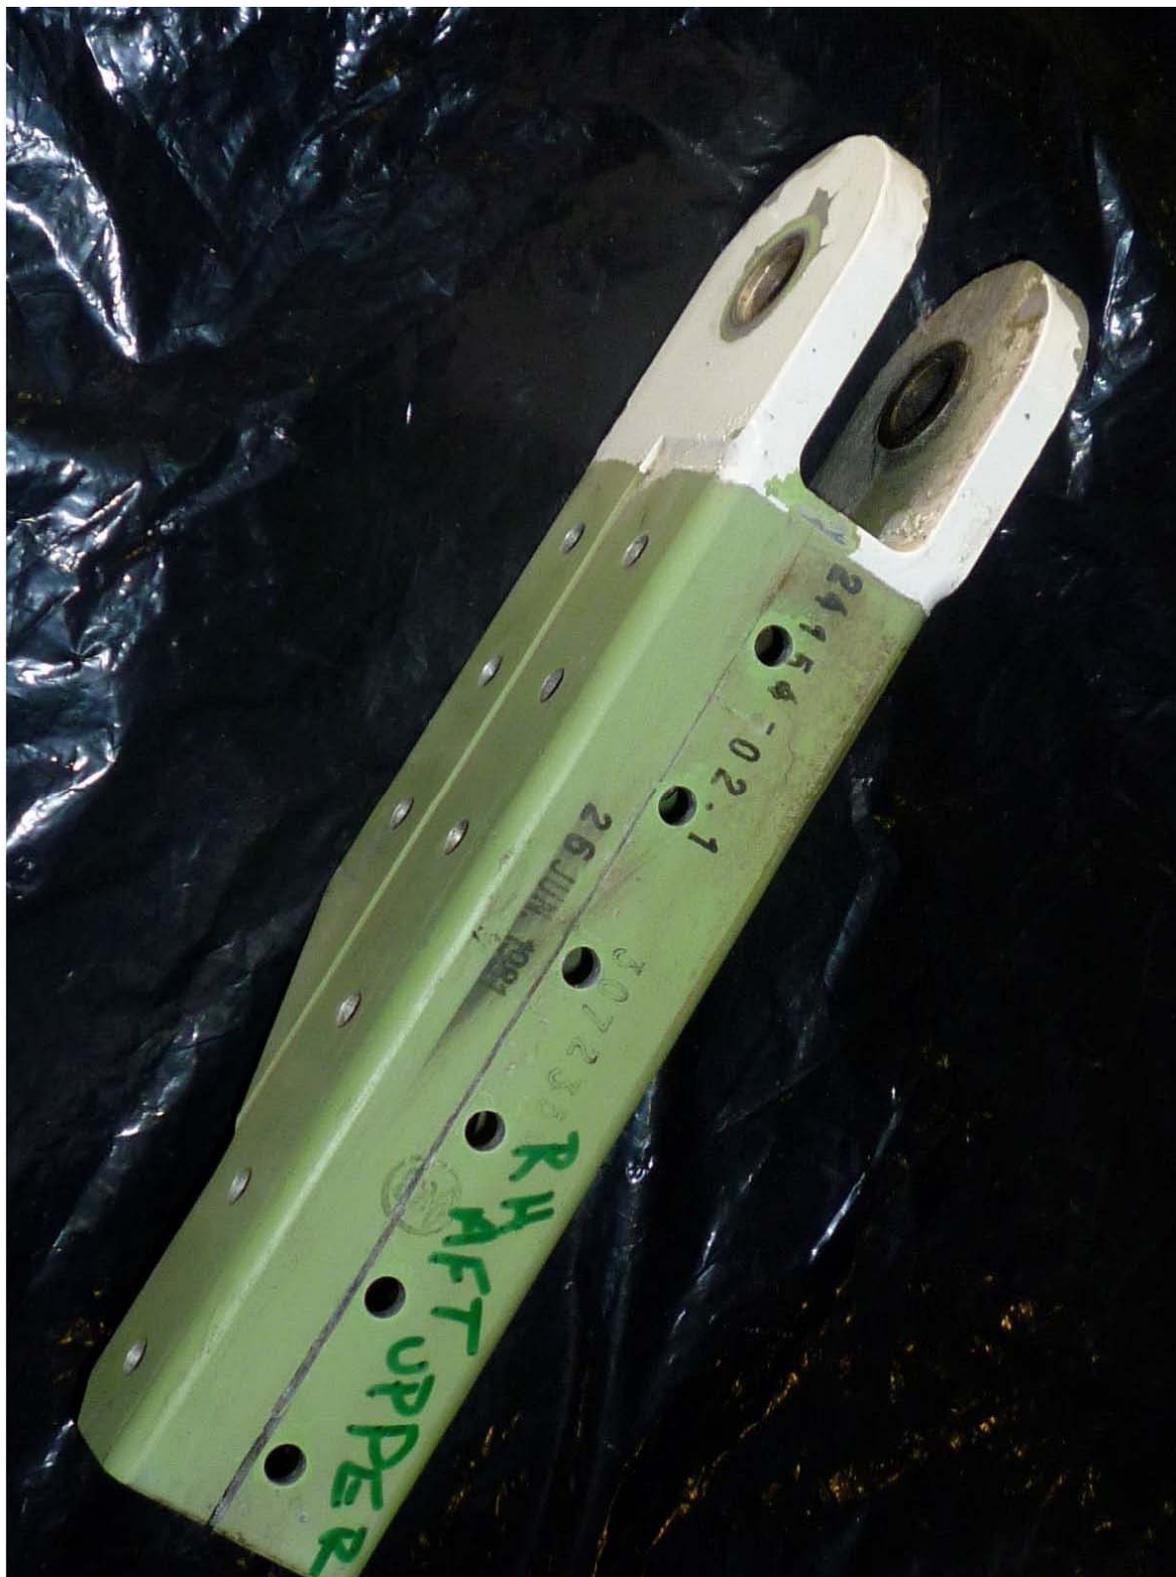
CASA: C212CC; Cracked Horizontal Stabilizer Fitting; ATA 5551

About the following this submitter states, "*(This provides)* supplemental information to SDR number 2010FA0000729 (*see also July Alerts for discussion of same*). The sixth (of eight) airframe side horizontal stabilizer fittings was removed and found to be cracked." "This aircraft is going through a combined 1, 2, and 4 year corrosion inspection." (*Attach fitting P/N: 21224154XX.*)

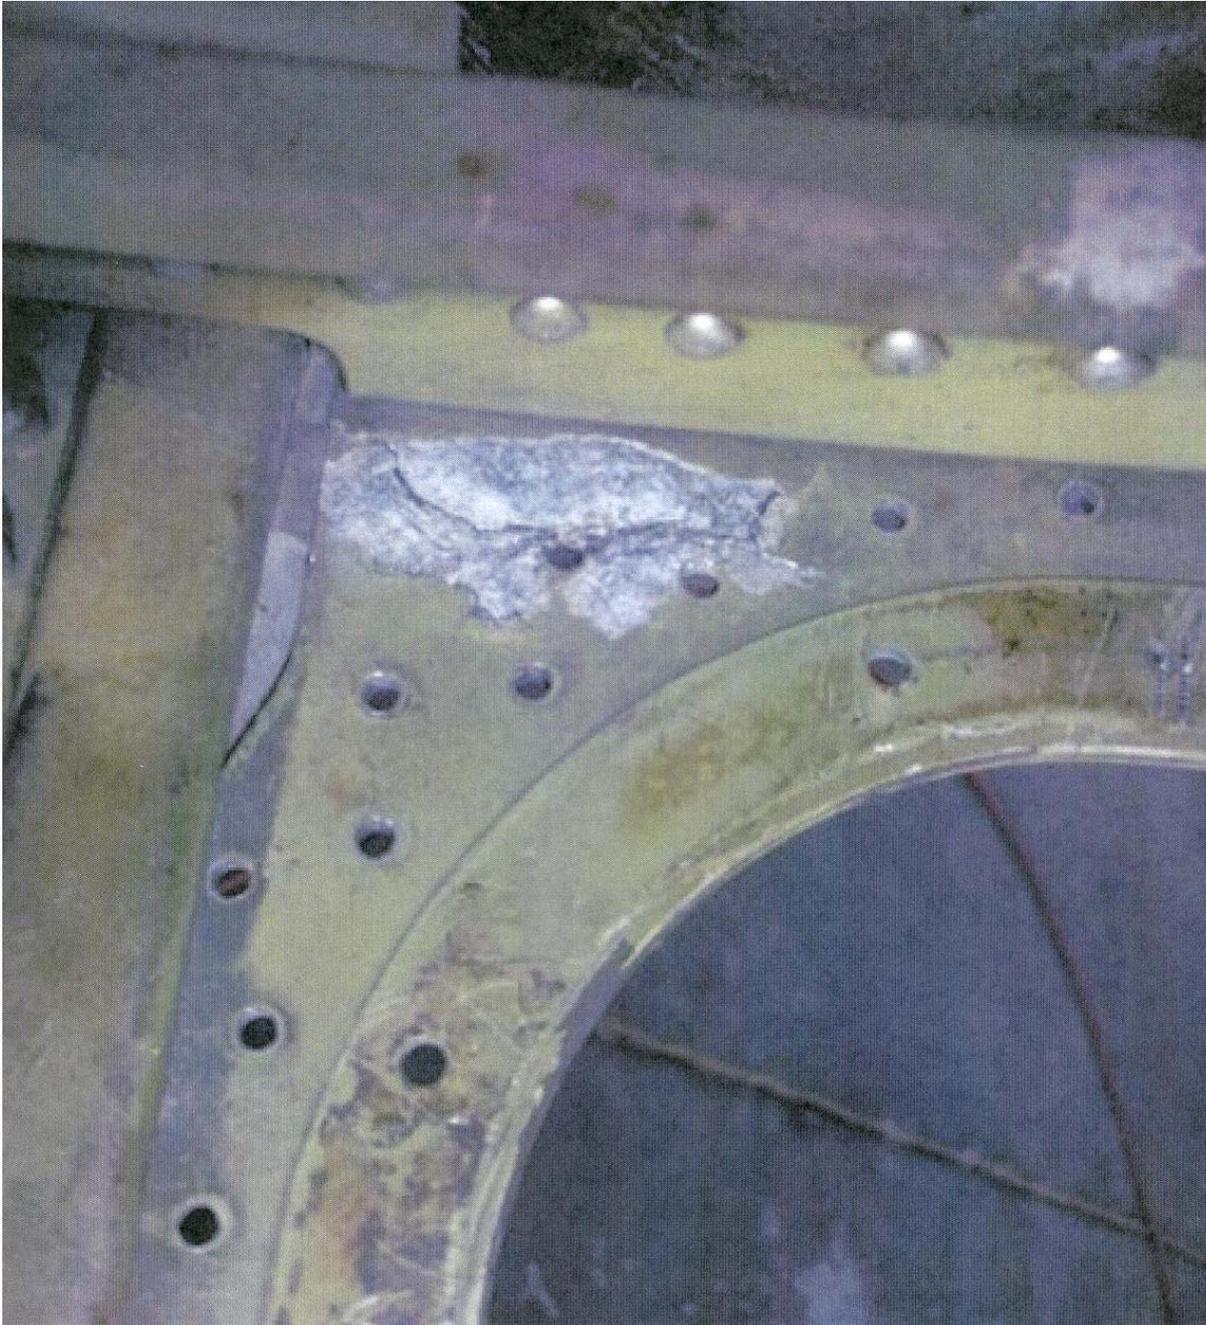
Douglas: DC915F; Corroded Outflow Valve Doubler; ATA 5320

An unidentified submitter writes, "During an "A" check, maintenance found two rivets with missing heads forward of the Lavatory Service Door. Upon investigation, inspection found the Cabin Air Outflow Valve Doubler (Plate) corroded beyond limits at station 786; longeron 23L. Maintenance installed a new doubler IAW DC-9 Structural Repair manual 51-30-2. This included the replacement of the two rivets that were missing. The aircraft was returned to service. Reference SRM 53-30-0, page 11, item 30; and SRM 53-30-0, page 14, Item 30 for the location and detail of the doubler (plate). This item was found during an "A" check, but it is normally inspected as part of the CPCP program (*corrosion prevention*) which was not due at this time. This is not a Principal Structural Element (PSE)." (*Doubler P/N: 59145581. Note the SDRS database records 6 such P/N's.*)

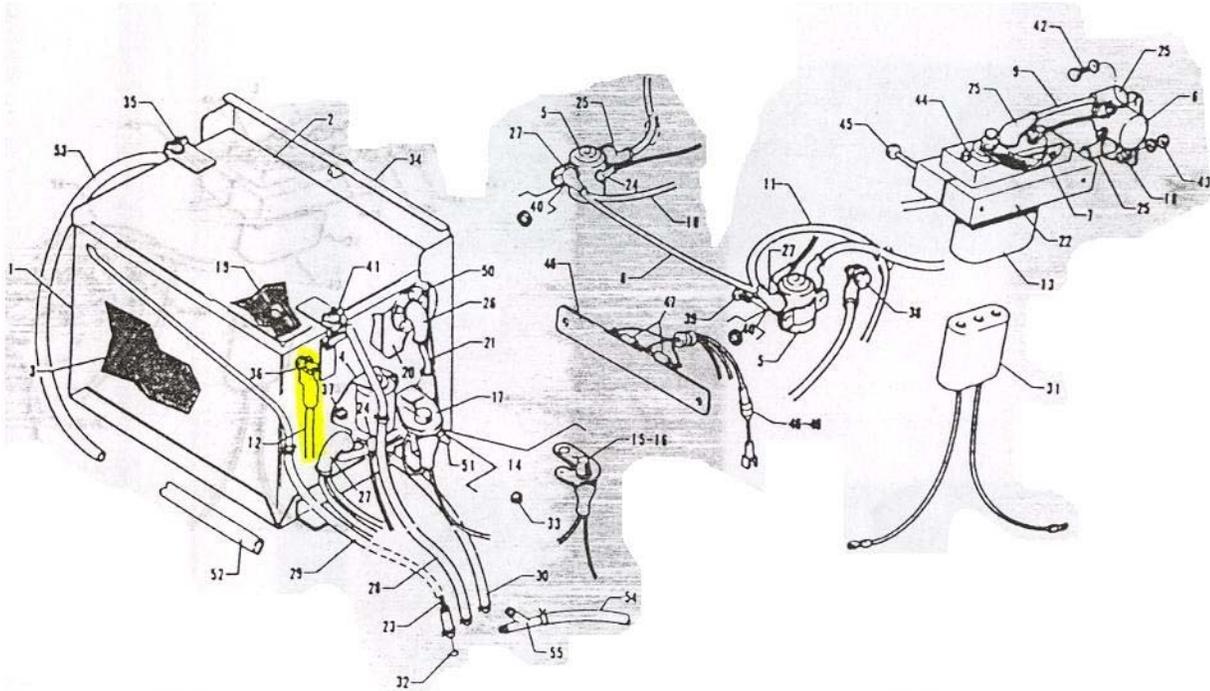
Piper: PA31-350; Electrical Power Failure; ATA 2432

Another FAA inspector writes, "Loose battery cables led to a complete loss of electrical power while in flight—IFR flight level 13,000 feet. Loose cables (P/N 80009-04) caused the loss of the aircraft battery (*power*). When the alternators were unable to carry the load, it resulted in a total electrical loss."

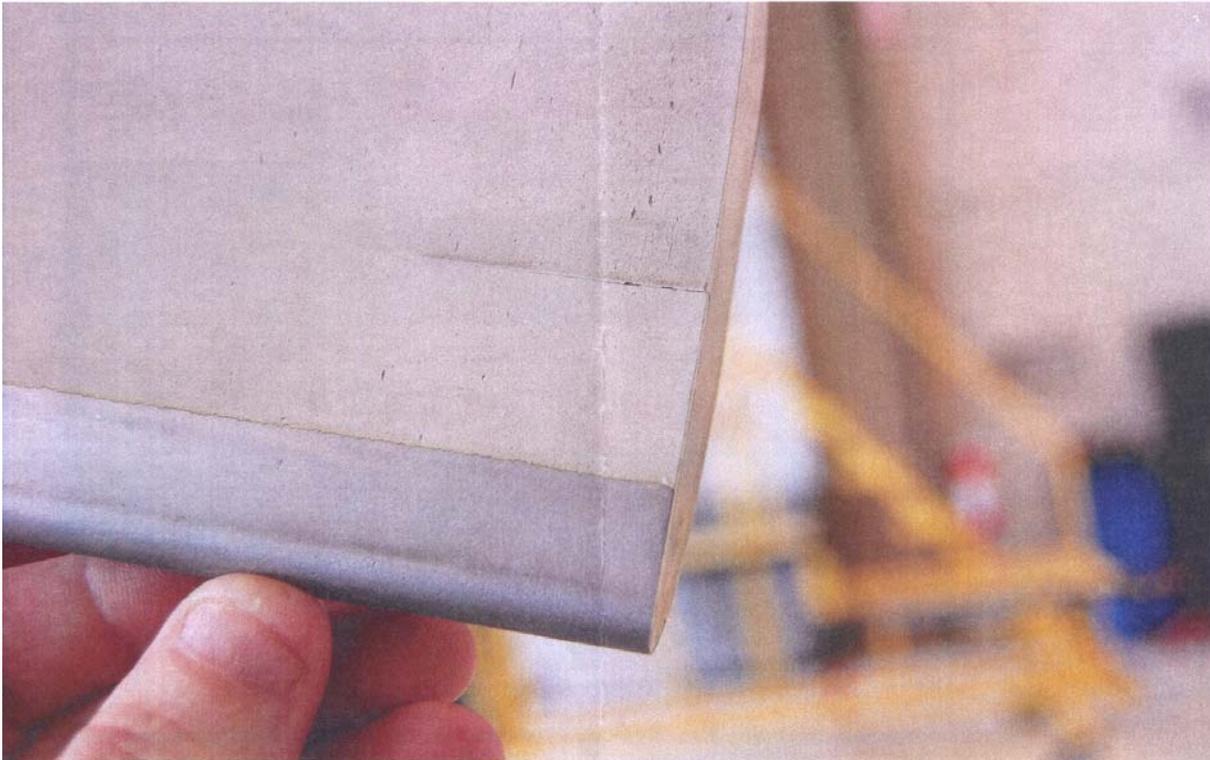
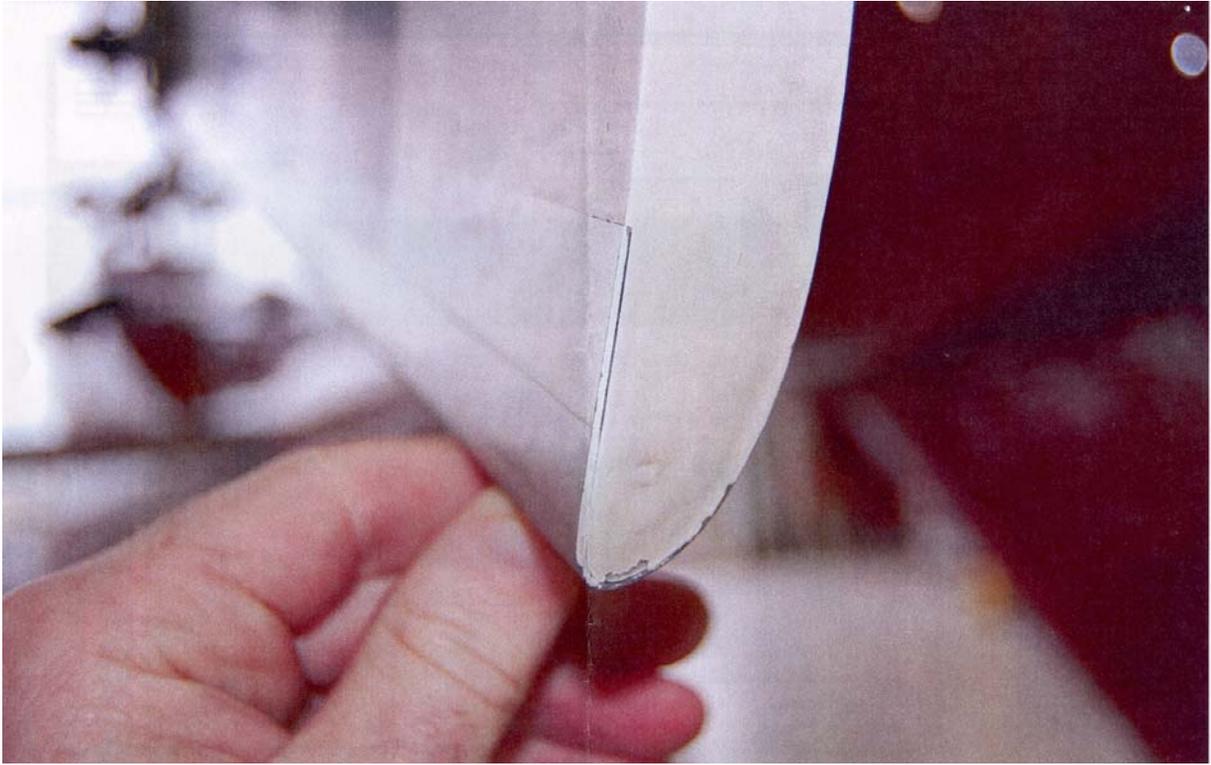
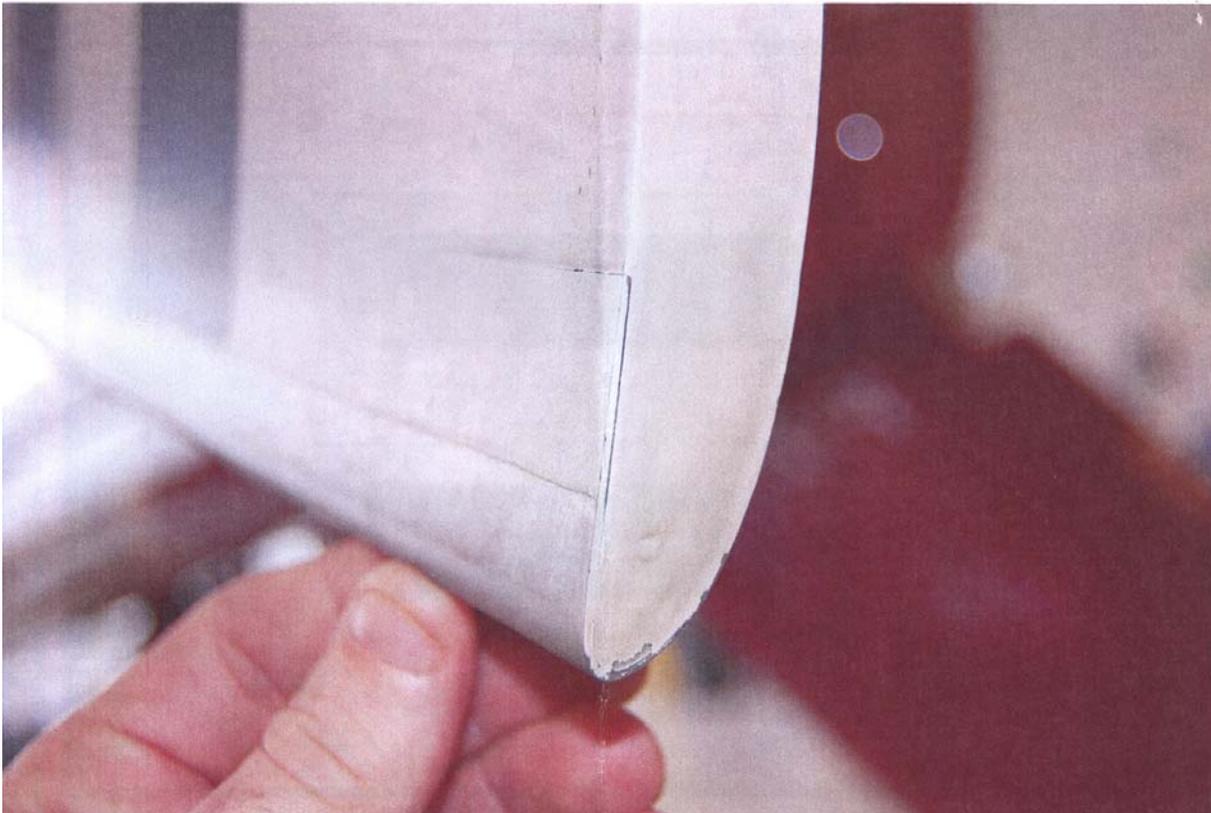
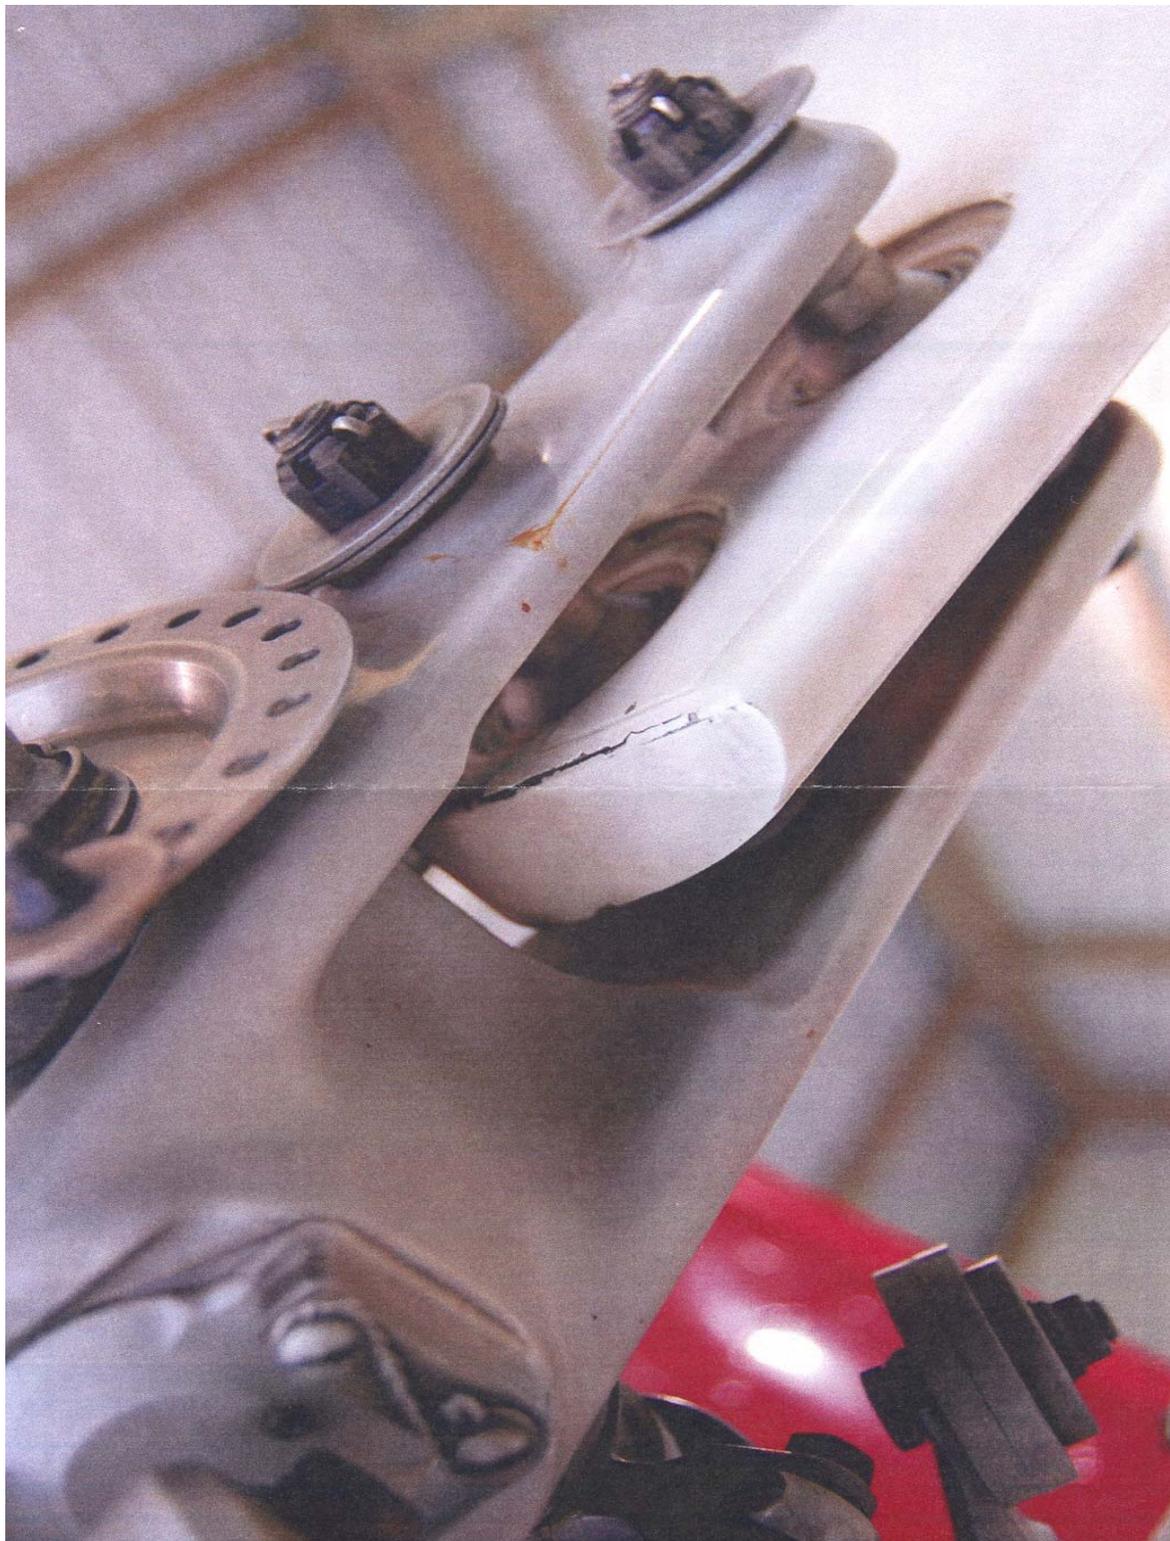
Bell: 430; Cracked Tail Rotor Blade; ATA 6410

A chief inspector for a repair station states, "This aircraft was flown to our facility and the operator reported '...debonding of the tail rotor blade leading edge—at the tip of the blade.' Upon further investigation of the blade, it was discovered that the root end of the blade had cracked and the skin was separated from the blade end. Photographs are included with this report. Information has also been submitted to Bell Helicopter Textron, product support engineering. Probable cause is unknown at this time. This aircraft is operated under Part 135 compliance." (*Tail rotor blade P/N: 222-016-001-131. Tail rotor hub and blade P/N: 222-012-701-125. Photos list as tip views 1-3, then root view 1. Quite dramatic; thanks for the photo effort—Ed.*)

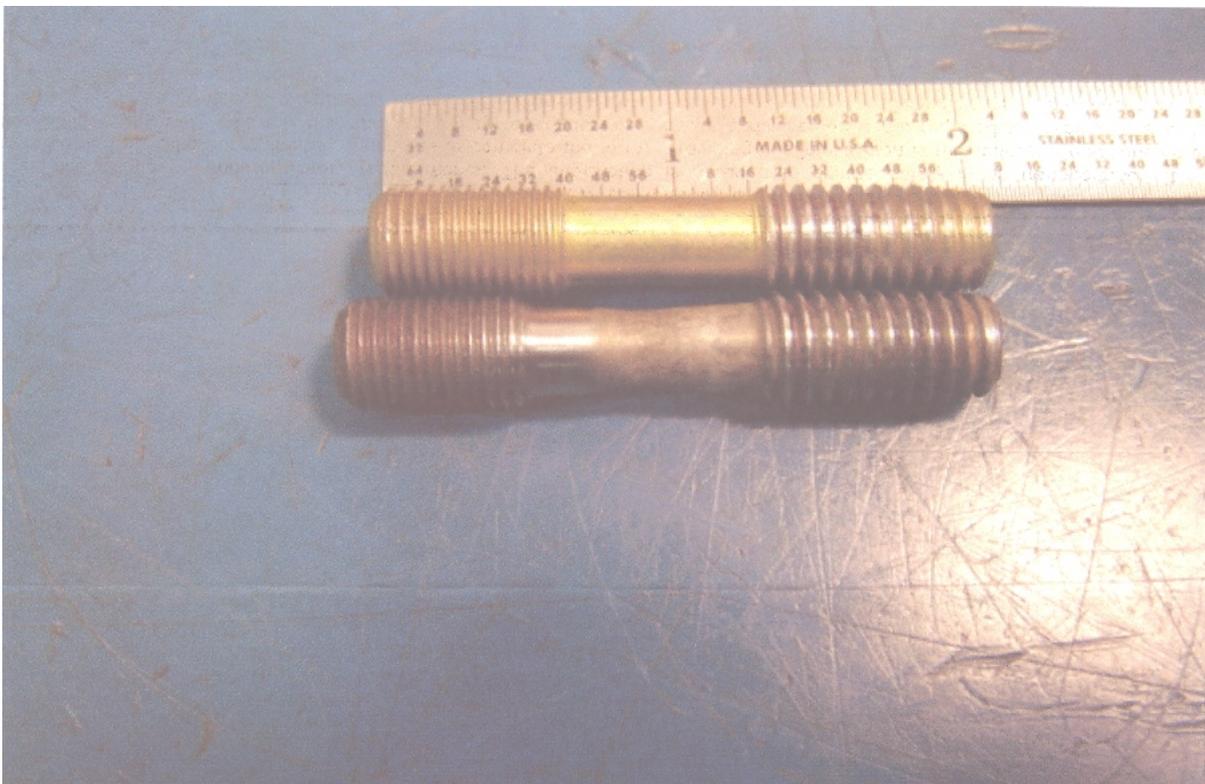
Continental: IO360G2B; Stretched Cylinder Studs; ATA 8520

"During the torque sequence for the engine overhaul final assembly, says a repair station submitter, "fasteners on the engine case were brought to half their final torque values (*with no problems*) as per the current TCM IO360 overhaul manual and pertinent service bulletins. Then, while attempting to reach final torque values we noted many of the studs seemed to be pulling from the case, rather than reaching torque. We then removed a cylinder to investigate (*and found*) the studs were stretching. We removed two studs to examine the threads in the case—no damage was found. These studs center portions were obviously elongated and narrowed. Requests to the manufacturer and other technical advisors for probable cause (*provided*) speculation the studs may have been over torqued at some point—moving them from an 'elastic' state to 'plastic.' (Note: the studs were stretch between 220-350 inch pounds of torque, well under final torque value.)" (*Stud P/N: 643651-1—this number found three times in the SDRS database.*)
