ADVISORY CIRCULAR

43-16A

AVIATION MAINTENANCE ALERTS

**ALERT
NUMBER
399**

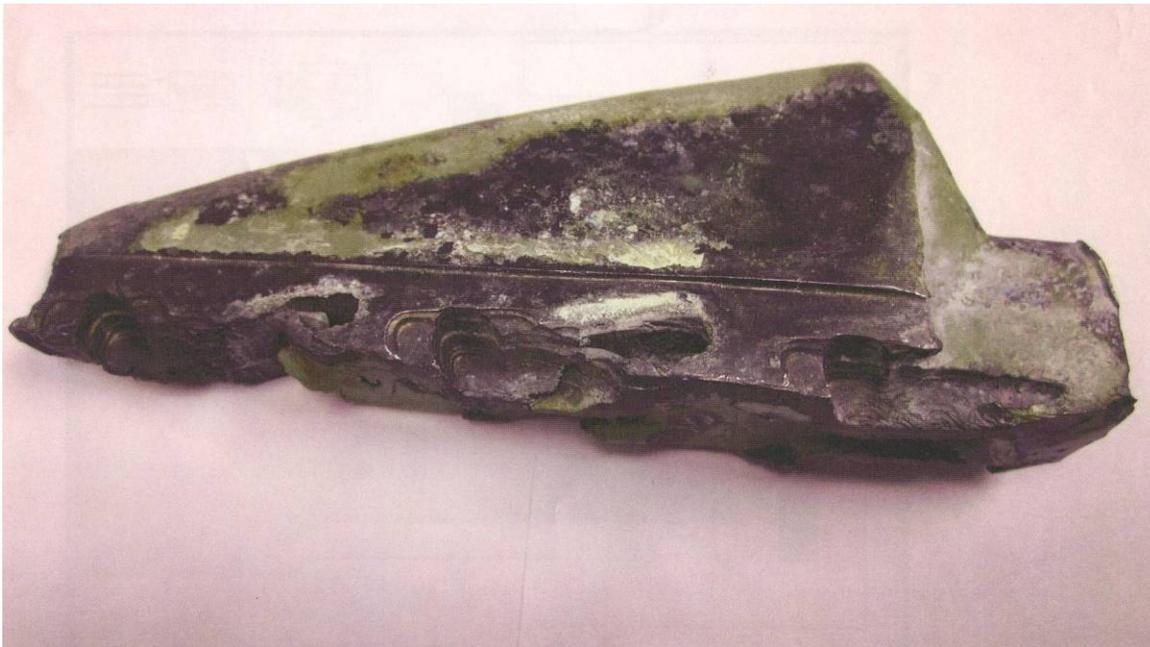
Beechcraft: B58; Broken/loose Elevator Balance Weights; ATA 2730

A repair station mechanic states, "During an Annual Inspection, (I) found the L/H elevator balance weight (P/N 96-610022-7) detached from its mount. The R/H elevator balance weight was found (both) broken and loose on its mount. The detached L/H weight was able to shift position inside the elevator and cause an out of balance condition. This damage appears to be caused by vibration." *(That—and toss in a ton of corrosion, too—Ed.)*

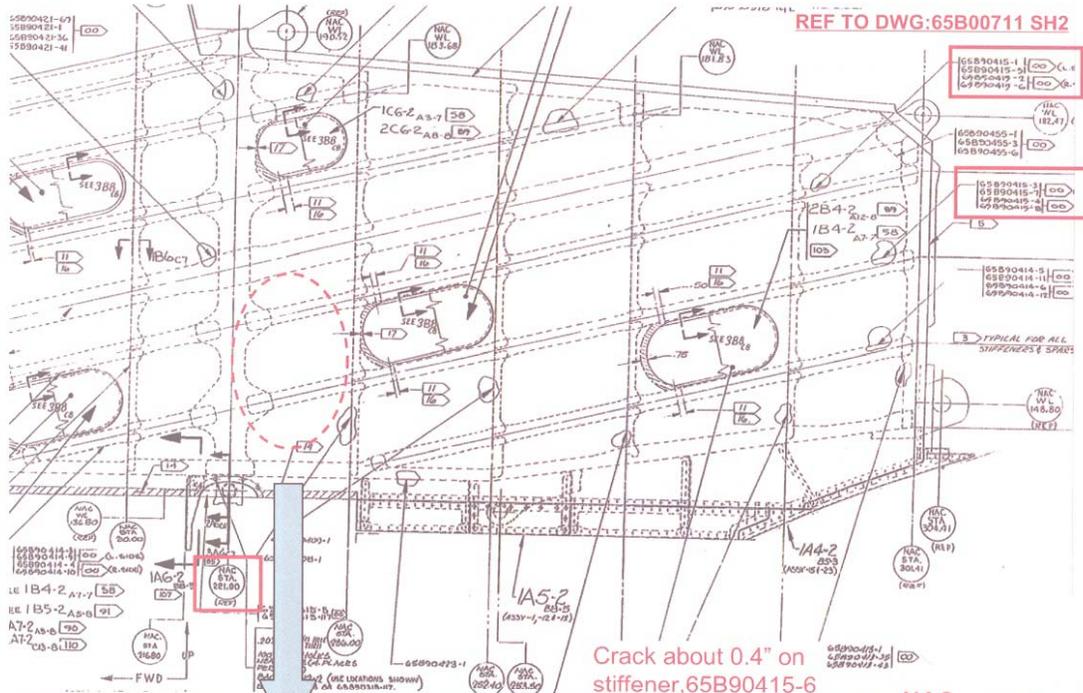
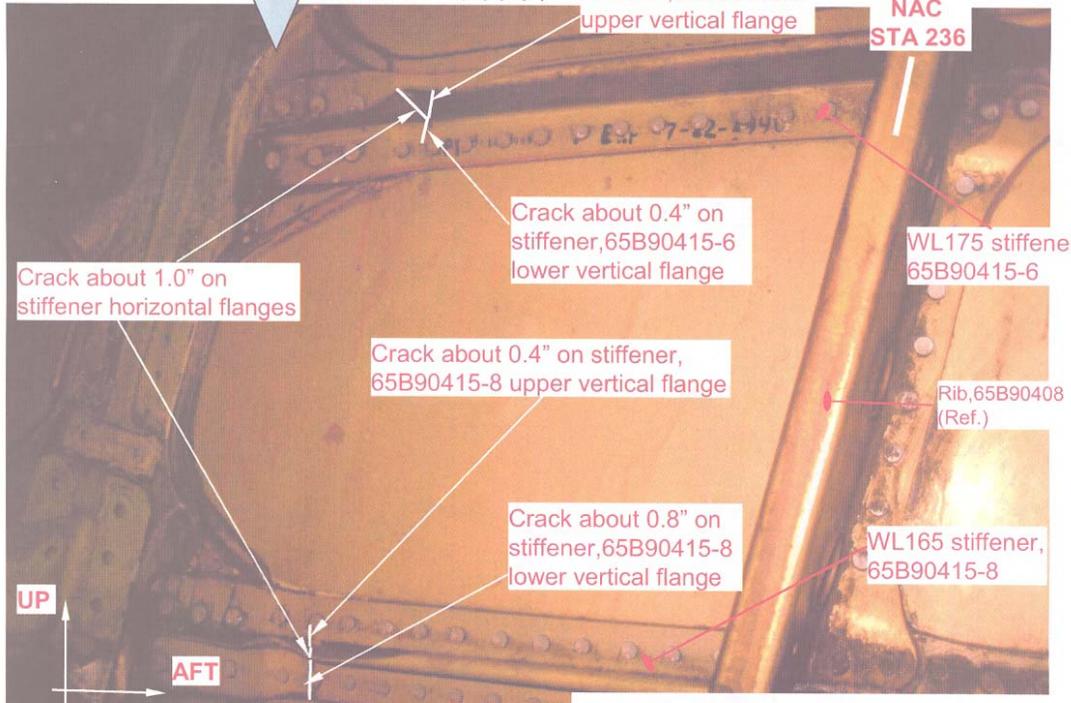
Figure 1 Damage Report

Boeing: 747-200F; Cracked Pylon Stiffeners; ATA 5400

A technician from a repair facility in Xiamen, China states, "During inspection, cracks were found on the R/H vertical and horizontal flanges of number two (*engine*) pylon near station 228. Following removal of the damaged stiffener section, the bulkhead strap (P/N 65B90412-38) was found cracked at a stiffener fastener hole. While (*effecting*) the repair, two each existing 2/16 inch diameter rivet holes in the skin common to the new upper repair angle (of stiffener P/N 65B90415-6) were found oversized to 8/32 inches."

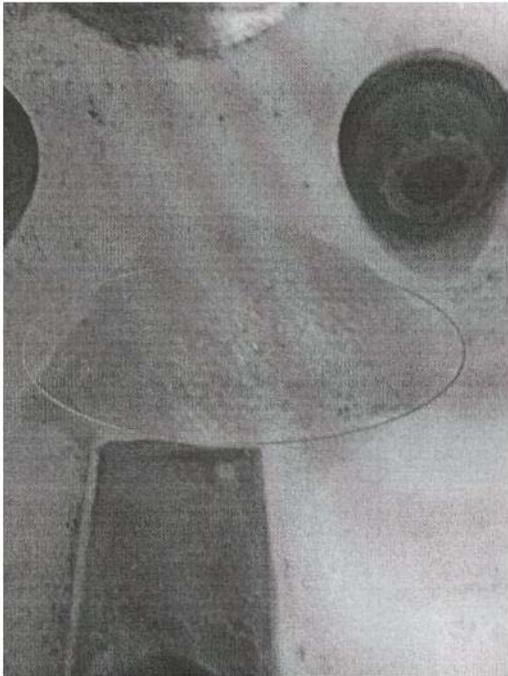
Figure 1: Soapy Water Liquid Test

A Director for Quality Control at a repair station states, "This main wheel hub half (P/N AH08901)...was noticed to have air leakage after one day's service. The main wheel assembly (P/N AHA1648) was returned to the (source) location for warranty evaluation. A large crack was visually confirmed in the inboard ring area of the wheel hub half, pictured in figure 1 and 2...."

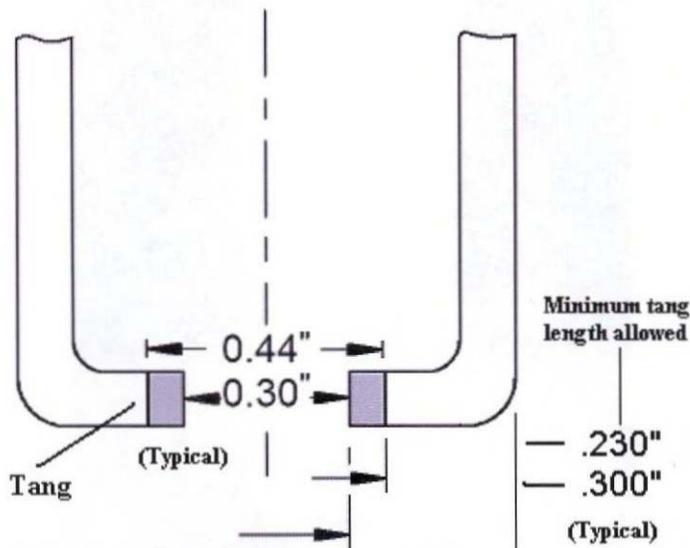
Figure 4. Closeup of seat roller housing and tang gap width

(6) Due to wear or deformation of the tangs, inspect the tang length from the inner edge of the tang to the outer edge (the bend area) of the roller housing (see figure 4).

(i) The minimum measurement allowed for the remaining tang length is 0.230 inches remaining on either of the tangs, from the inner edge of the tang to the outer edge (the bend area) of the roller housing. If the measurement is less than 0.230 inches on either of the tangs, before further flight, replace the roller housing.

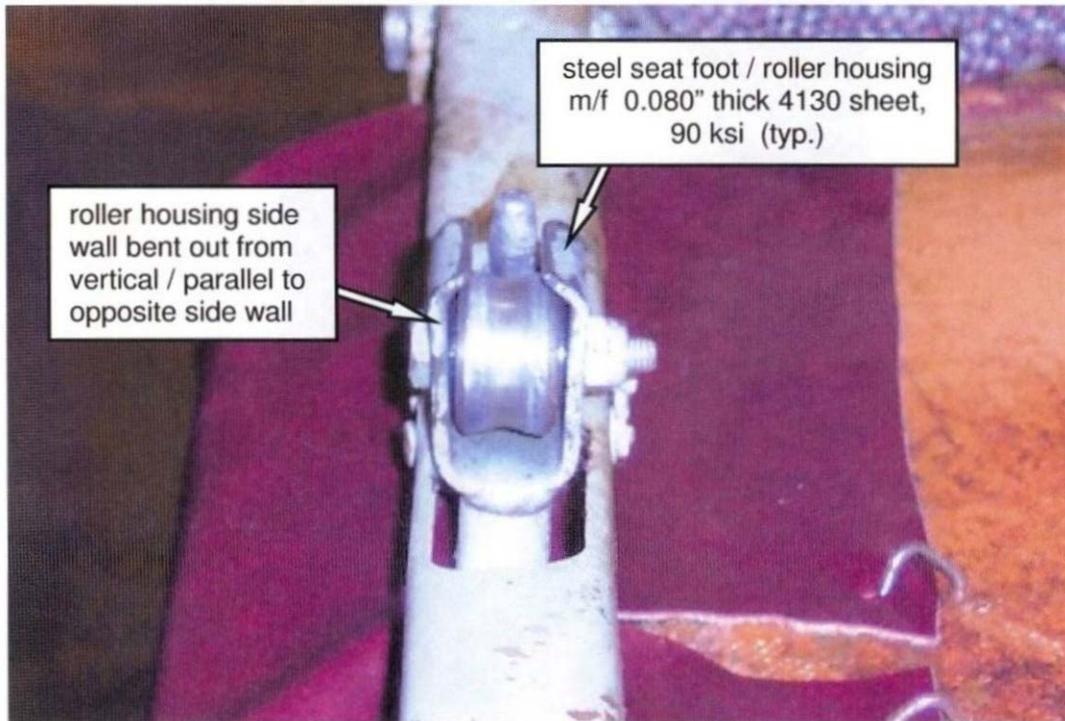
FIGURE 2.0-2 DETAIL OF BENDING / DEFORMATION OF SEAT ROLLER HOUSING SIDE WALL

In the case of seats which use steel roller housings (e.g. as defined by Cessna drawings 0311310 "Roller, Pilot Seat", and 0514016 "Housing Assy – Seat Roller"), the tangs may not meet the dimensional requirements set forth in the AD due to primarily to deformation or bending of the seat feet, rather than being caused by actual wear / loss of material. Ref. Figures 2.0-2 and 2.0-3 for examples of this type of deformation / bending of roller housing geometry.

Read the entire service document prior to beginning the repair; contact Cessna Customer Service if the repair cannot be performed as described below. Steel seat roller housings may be gently formed (or "bent") back to a configuration conforming to specifications as shown in Figure 3.2-1 below and AD 2011-10-09, followed by an NDI inspection (as identified in paragraph 3.2.4) for any cracking. Note that this is a cold forming operation. No heating is to be done for this operation.

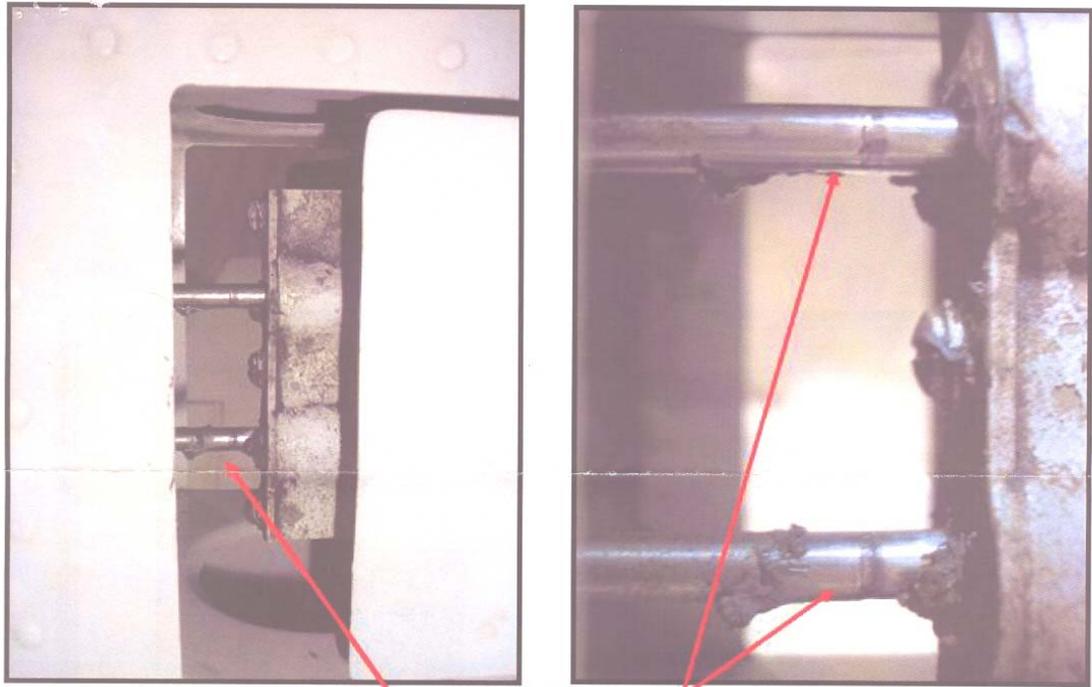
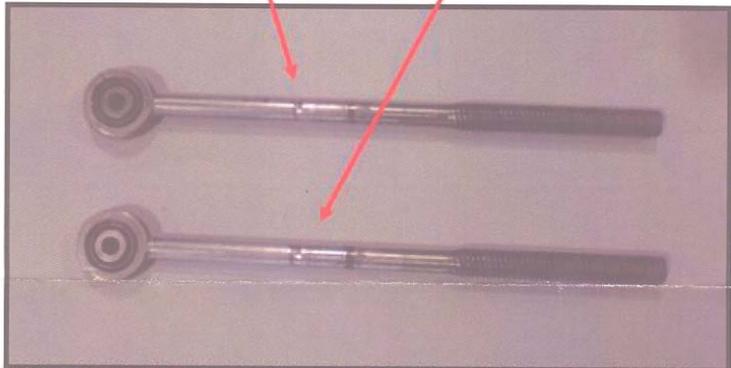
A repair station submitter says, "(I) found grooves worn into the shaft of the two screws (P/N 6660251-52) that enter into the rudder actuator assembly. Probable cause: the aircraft is set for cruise configuration. During flight the tail vibrates, causing grooves to wear into the shaft of the screws at the point where they enter into the actuator."

Note wear rings.

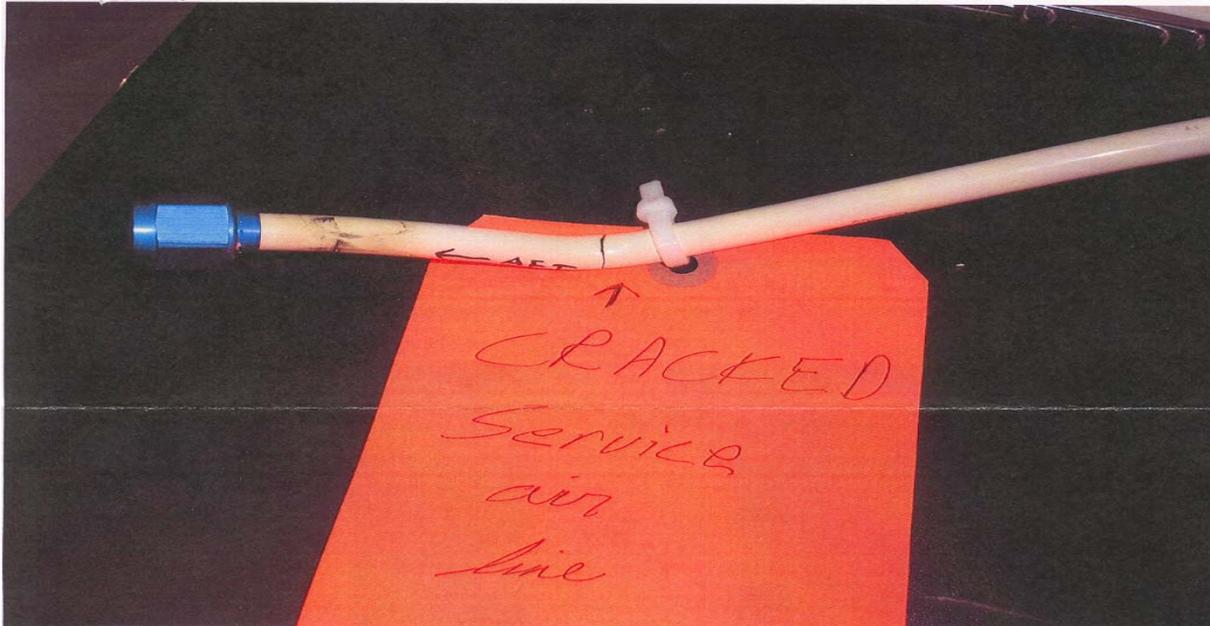
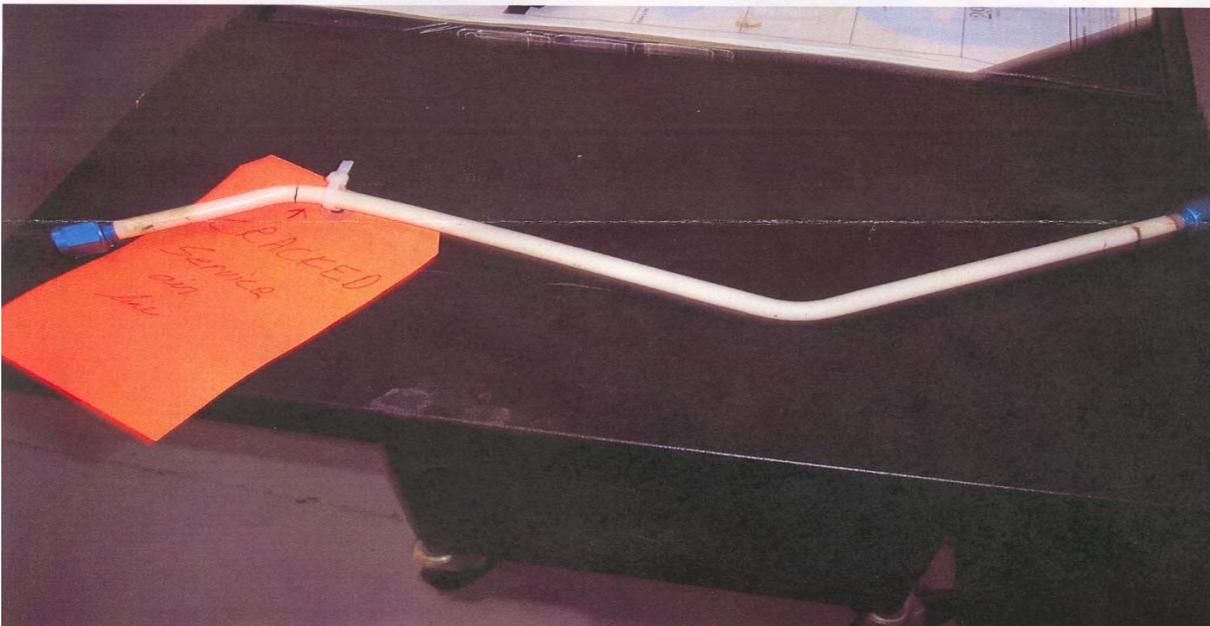
A repair station submitter says, "(I) found the service air tube assembly cracked in the bend radius that leads to the rudder bias actuator in the tail cone." (Tube assembly P/N: 6914040-37.)

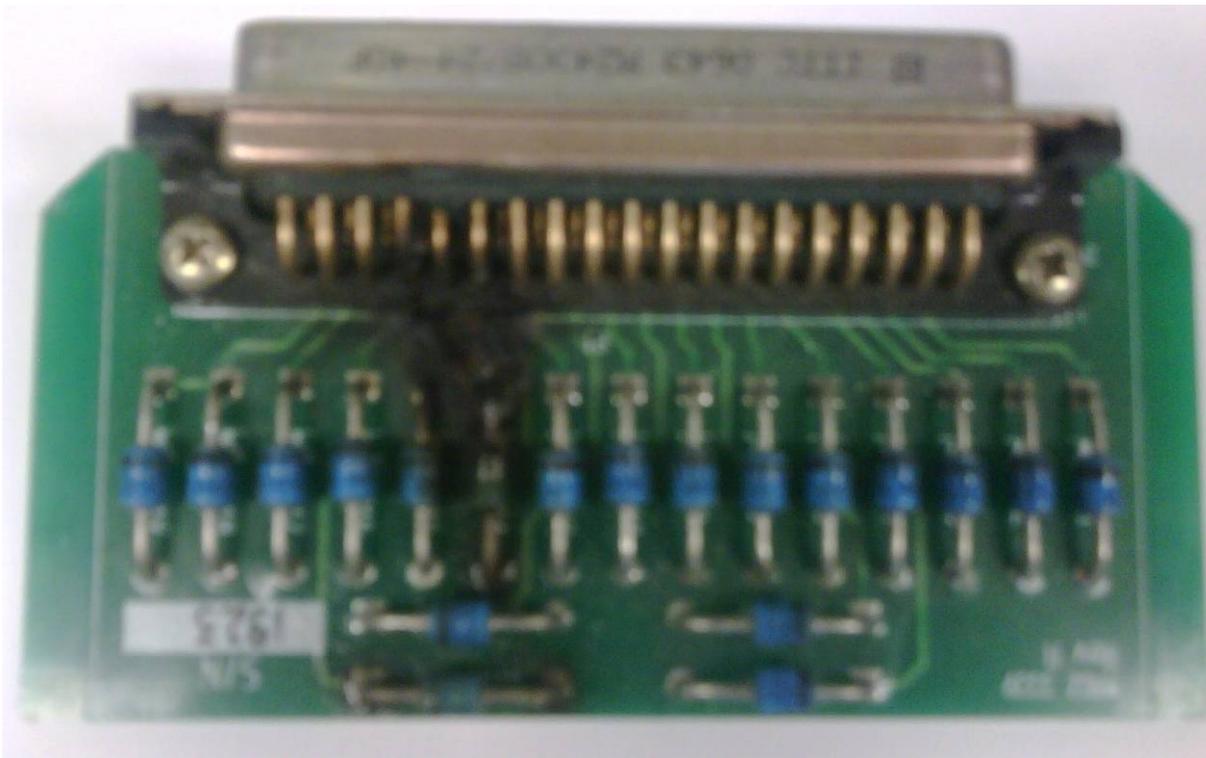
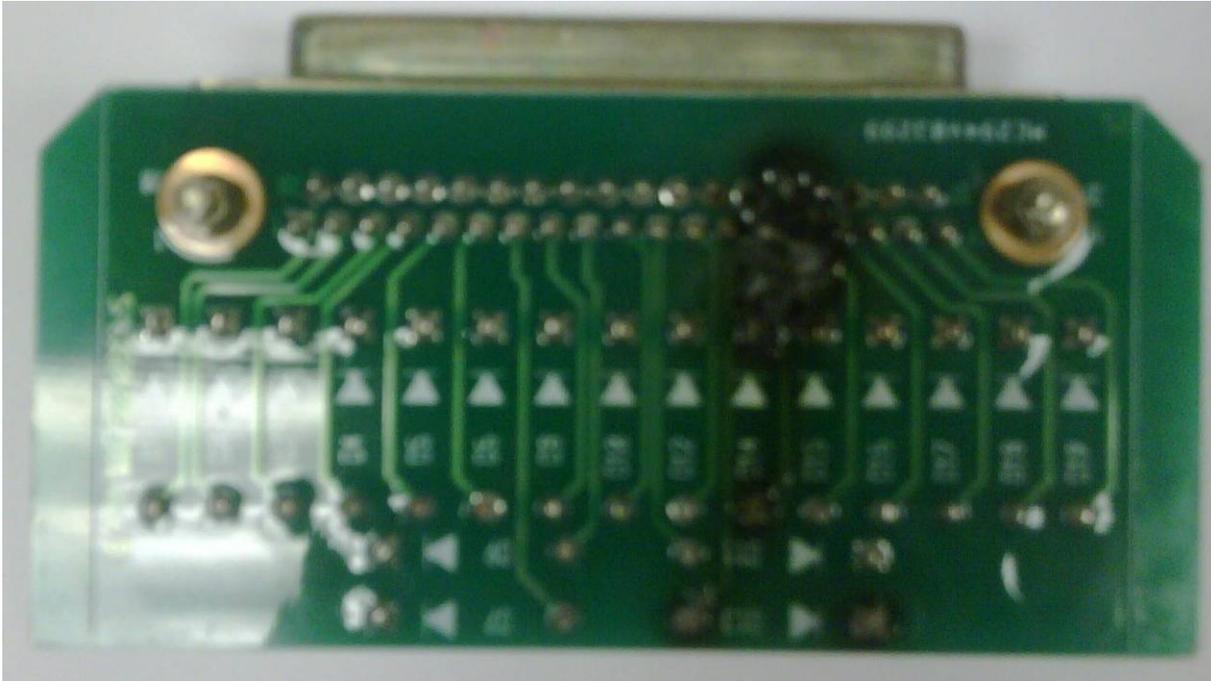
"After takeoff," states an unknown technician/pilot, "(I) noticed a very slight electrical smoke odor. After climbing through 24,000 feet, and the left and right 'Ice Detect Fail' EICAS came on simultaneously (*Engine Indicating & Crew Alert System*). These lights came on for about thirty seconds, then disappeared. Annunciators appeared about thirty seconds later (for a few seconds) around (approximately) 20,000 feet. They remained extinguished for the rest of the flight. No circuit breakers tripped, and everything looked normal on the electrical and secondary EICAS pages.

"After landing, the odor appeared to be coming from wires from the avionics box located behind the pilot's seat—on top of the potable water controls. I found the ice detectors to fail the self-test and the system test. The system would heat normally, but no EICAS indication would (*generate*). We verified the ejector valve heater blankets had not failed by performing resistance checks at relay 350H in the right relay junction box. We investigated this right relay junction box for faults and damaged components. We found the PC diode card 82P to be discolored and displaying burn marks. We removed and replaced card 82P with a new unit. Operational check was good. No further faults were noted." (*Circuit card P/N: SPE3508005001.*)

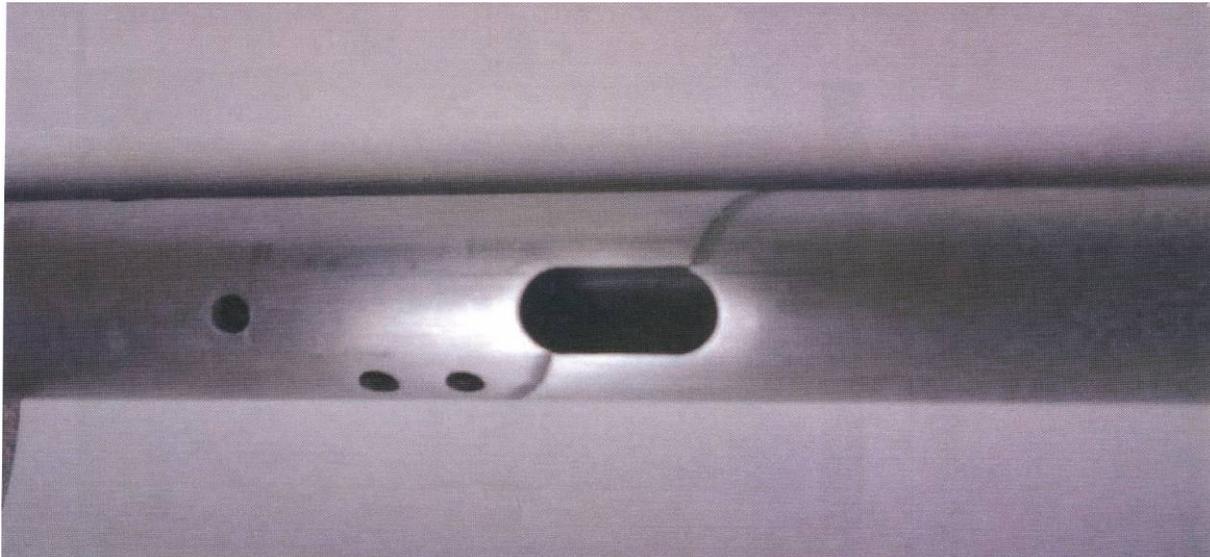
"The co-pilot's seat was removed for recovering," states a submitter. "During the recovering (*process*) it was noticed the seat height adjustment torque tube was cracked (*P/N 2A0590174*). The technicians working on the seat said this was not an uncommon failure."

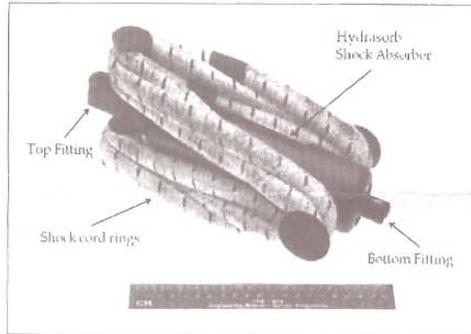
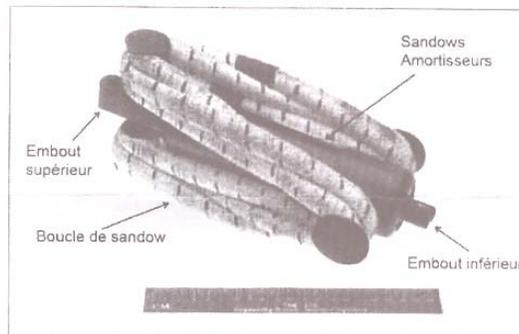
Shock Strut Assembly.

Initial examination determined that the right main landing gear Hydrasorb shock absorber had failed at the bolt hole in the lower fitting, resulting in separation of the upper end of the right main landing gear vee assembly. Subsequent dye penetrant inspection (DPI) determined that the lower fitting on the left Hydrasorb shock absorber was also cracked through the bolt hole. The Hydrasorb shock absorbers, in combination with shock chords, absorb and dissipate landing loads within the shock strut assemblies.

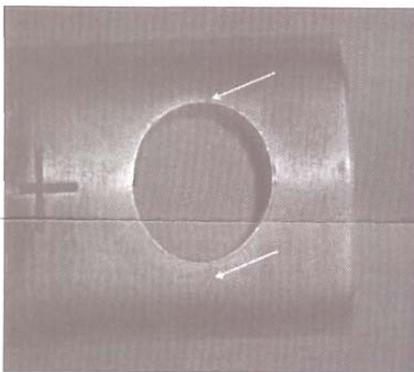
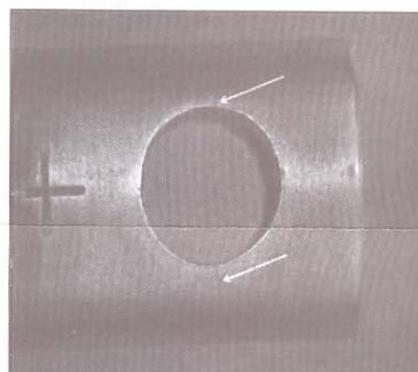
Photo 2. Fatigue crack in end fitting

Both main landing gear shock strut assemblies were submitted to the TSB Laboratory for metallurgical examination. It was determined that the right Hydrasorb shock absorber had failed due to the instantaneous overstress extension of a high-cycle fatigue crack through the bolt hole in the bottom end fitting (see Photo 2).

A similar fatigue crack was found on the bottom end fitting of the left Hydrasorb shock absorber (see Photo 2). In both cases the fatigue cracking had initiated from multiple origins located at the sharp edge of the bolt hole and at residual tool marks on the bolt hole surface which had acted as stress risers. Examination showed that the lack of a chamfer on the bottom end bolt holes and the use of non heat-treated steel were contributory to the fatigue failures of the bottom fittings.

Univair Revision A of the OEM specification, dated 30 September 2003, required the sharp edges on the top and bottom end fitting bolt holes to be chamfered. Univair Revision B of the OEM specification dated 14 October 2009, required heat treatment of the top and bottom fittings. The top and bottom fittings on Hydrasorb shock absorbers manufactured to Univair Revision A and Revision B specifications are expected to be more resistant to fatigue cracking.

The Design approval holder, Laviasa of Argentina, is aware of these shock absorber end fitting failures and has developed Service Bulletin (SB) 25-32-04 that introduces a safety cable to prevent spread or lateral movement of the main landing gear and also helps prevent wing damage should the landing gear collapse.

TCCA strongly recommends that all affected owners and operators pay close attention to the main landing gear shock absorber assembly, both during scheduled maintenance activity and during post and pre-flight inspection. To prevent unnecessary damage in the event of a failed Hydrasorb shock absorber assembly, it is recommended to incorporate the Laviasa SB 25-32-04, or at a minimum, incorporate the cable installation as per the Service Bulletin.

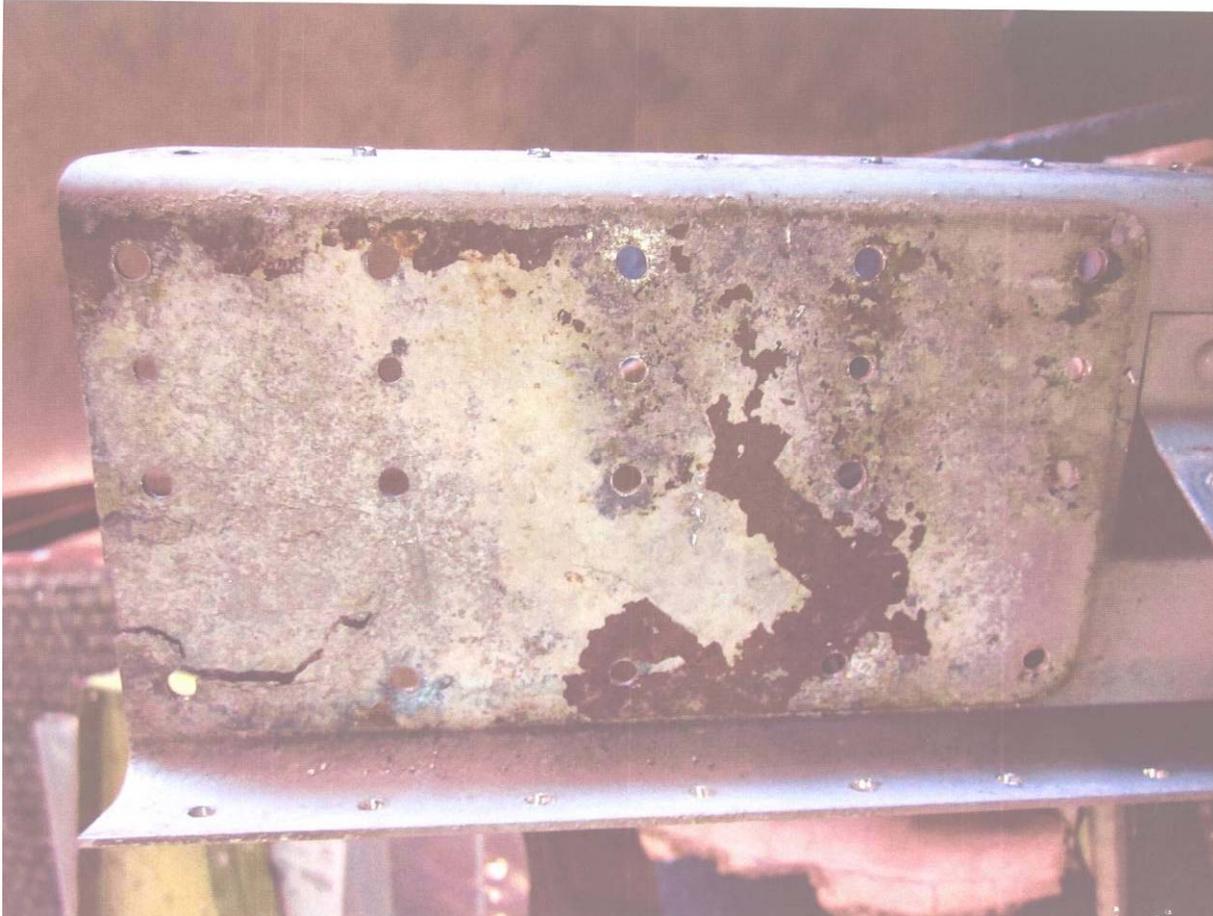
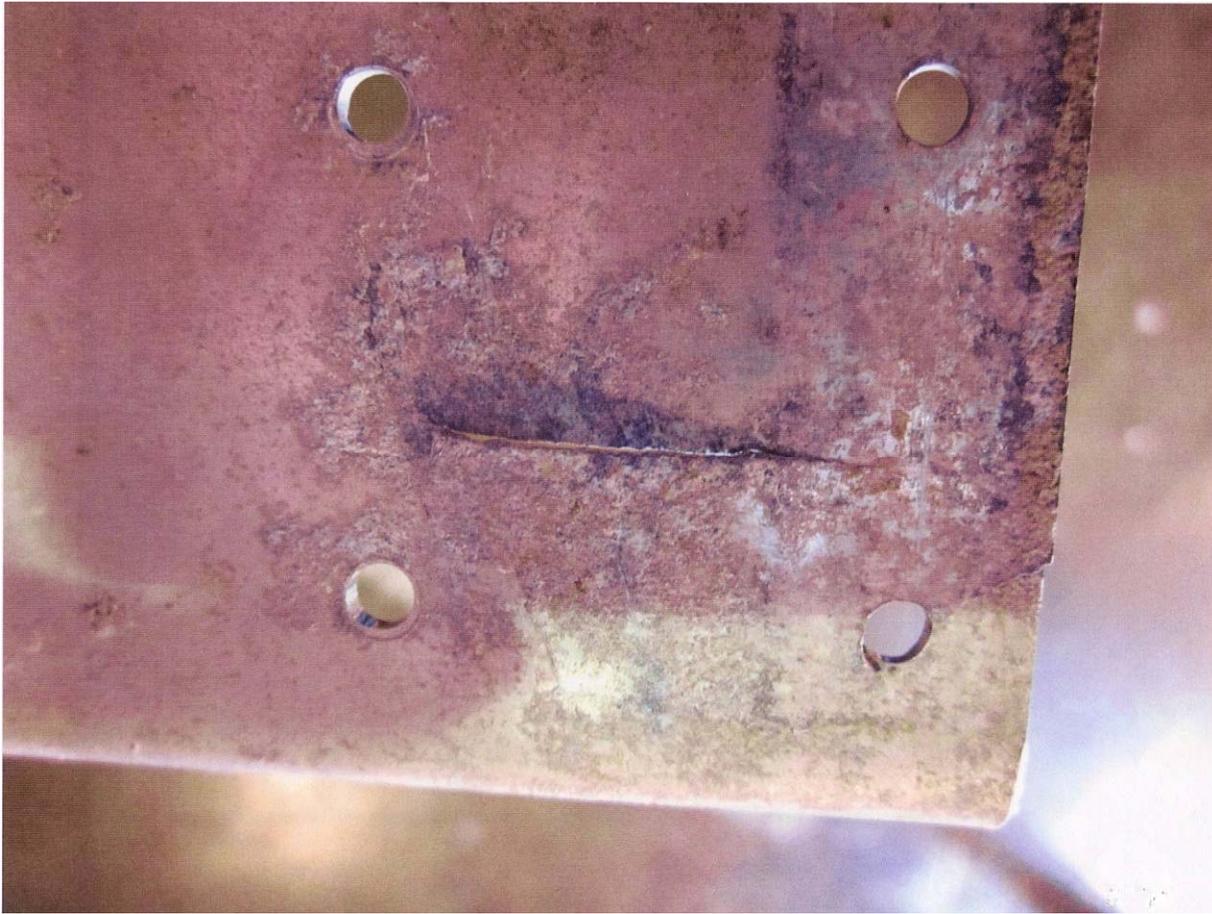
A mechanic writes, "During repair of the L/H wing, the aft spar attach fitting was removed. Severe corrosions was found under the fitting. Possible cause is trapped moisture, lack of a preventing treatment(s), and lack of proper inspection of the area." (*L/H Aft Spar P/N 62054-000. This number is found three times in the SDRS database—and several more times as the trailing zeros are removed in the search.*)
