ADVISORY CIRCULAR

43-16A

AVIATION MAINTENANCE ALERTS

**ALERT
NUMBER
338**

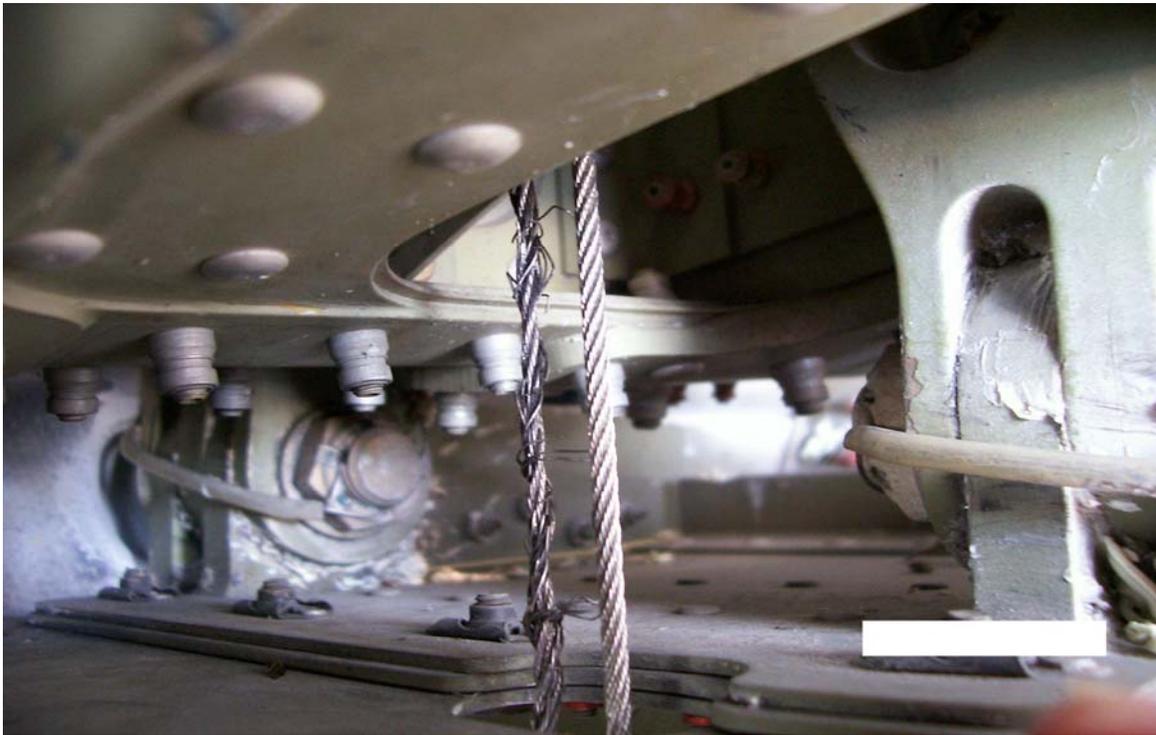
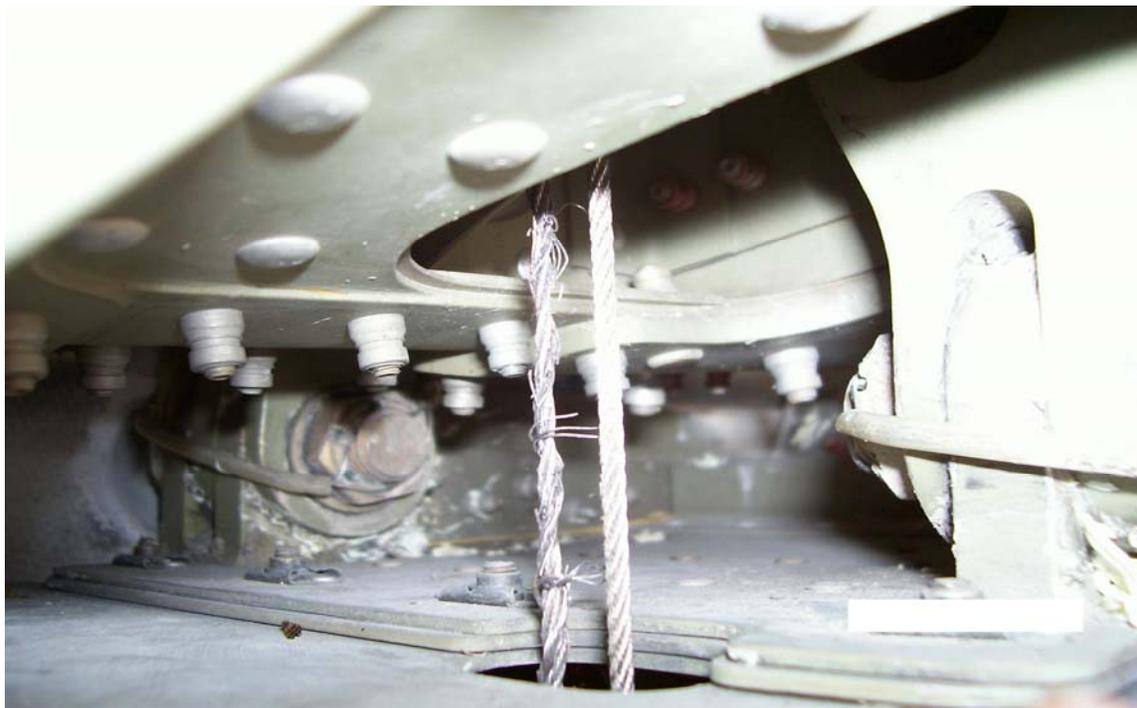
A technician for a repair station states, "During a phase 1-4 inspection the elevator trim cable assembly (*P/N 6660001-34*) was found to be frayed where it passes through the horizontal stabilizer. The cable appears to have been installed properly and it does not look as if it was damaged during installation. A report has been submitted to Cessna..." (*A search of the SDRS data base yields 33 responses to the base number 6660001—almost all Cessna cables. At least 5 additional reports of frayed elevator trim cables can be found on this same type aircraft. Their times ranged quite close: from 5,253 to 5,558 averaging 5,427 hours for six aircraft. Additional inquiry confirms the second cable shown—P/N 6660001-33—has also been found frayed. Both of these cables are of stainless steel composition. The following two photos have been slightly compressed in the vertical dimension. Greatly appreciated, they provide all necessary arguments for preemptive cable replacement!*)

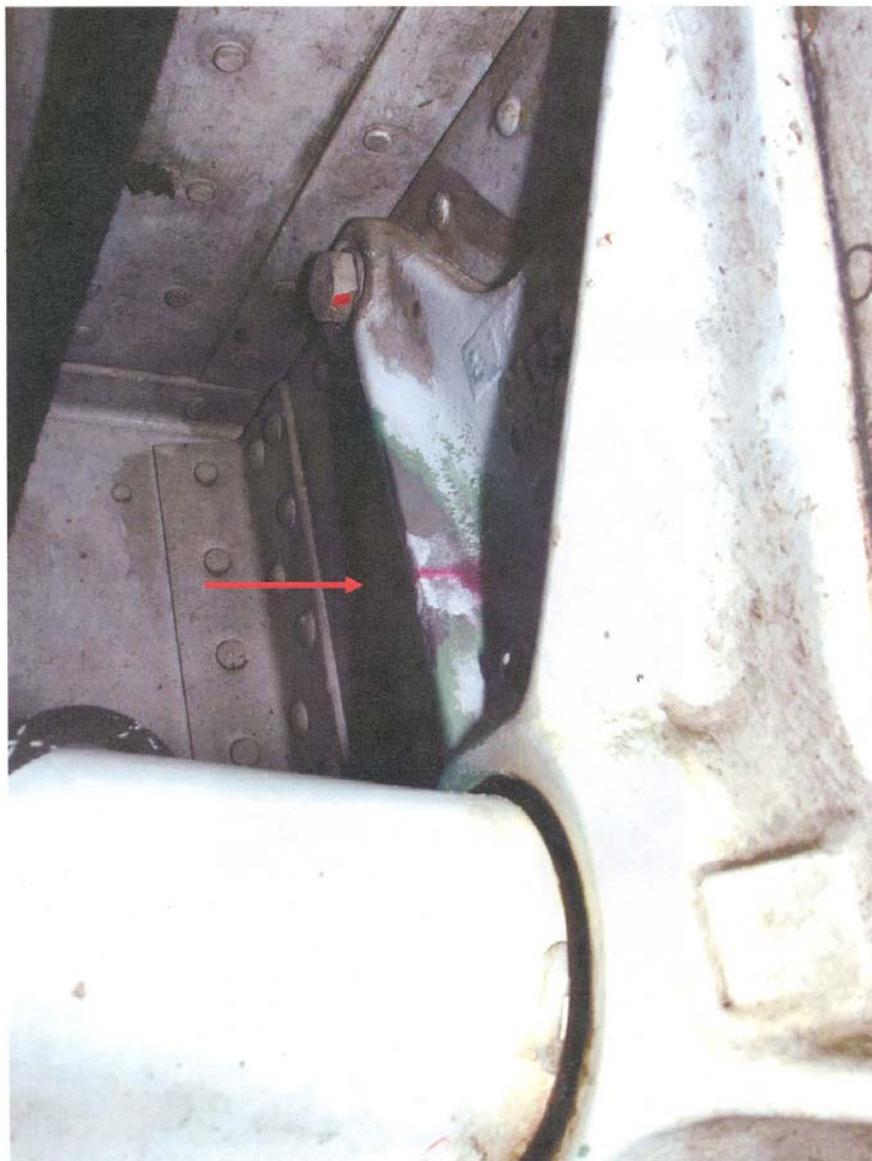
Figure 1. A crack was found on this MLG trunnion assembly. The dye penetrant highlights the crack.

A crack was found on the MLG aft trunnion assembly of a Piper Seminole aircraft, Figure 1. The aft trunnion is item #7 in the New Piper Aircraft Airplane Parts Catalog, Figure 2. The trunnion assembly is shown "as received" by FAST in Figures 3 - 5. The crack is widest at the top surface (arrow in Figure 5.) This is the crack initiation point.

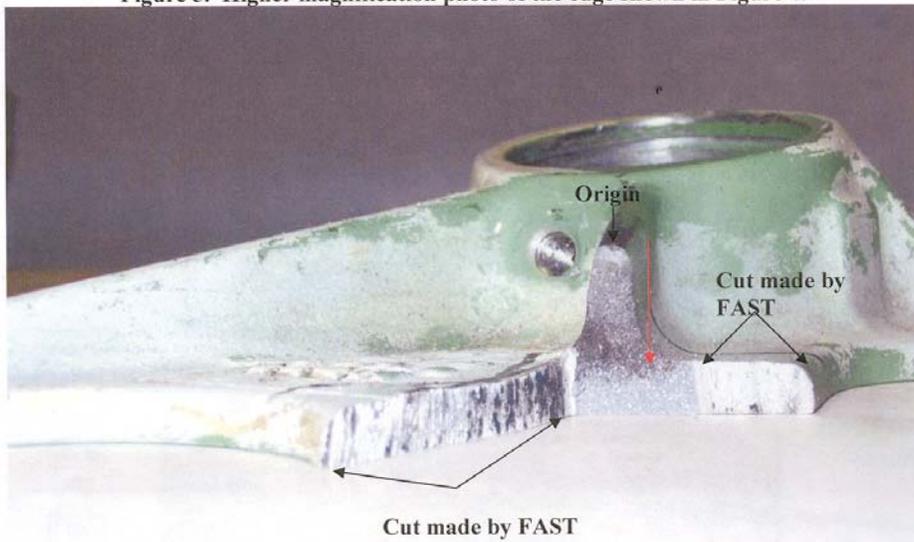
It was necessary to cut the trunnion assembly to expose the fracture surface. Cuts were made as shown in Figure 6. The crack initiated at the top of the inverted "T" section of the trunnion, and traveled to the main thickness of the trunnion. Notice the lighter color in the main thickness of the trunnion, below the red arrow in Figure 6. The lighter colored area is the freshly exposed crack surface that was impact overloaded by FAST. The other side of the fracture, which was

Figure 6. Cuts were made to the trunnion as shown to expose the fracture surface of the crack. The red arrow shows the crack growth direction and distance for which the crack traveled. The area below the red arrow, which is a lighter color, is the freshly exposed surface that was overloaded by FAST.

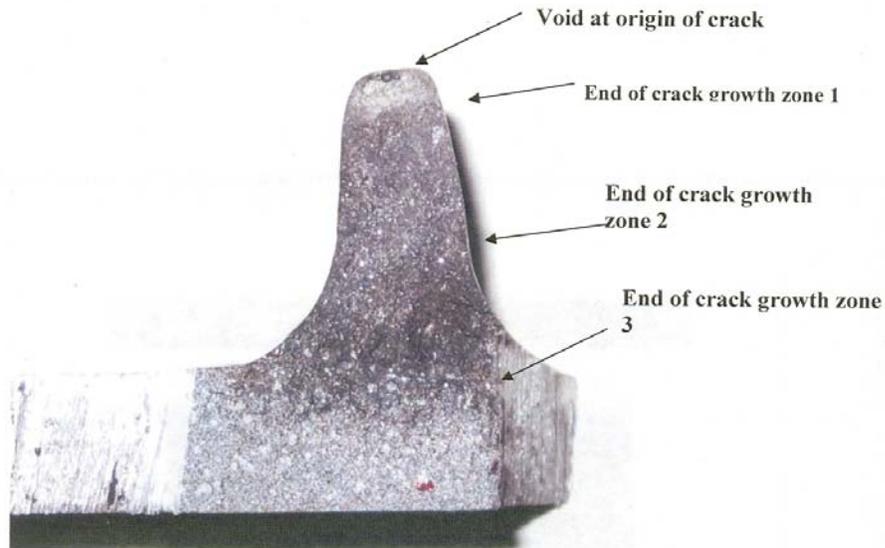
the section used for analysis in the scanning electron microscope (SEM), is shown in Figure 7. There are three distinct zones of coloration as indicated by the arrows. These are areas crack growth stoppage. There is also a void at the origin of the crack. The features on this surface are a mirror image of those shown in Figure 6.

Figure 7. This surface was analyzed in the SEM. Notice the color changes in the crack growth area as indicated by the arrows. There are three separate crack growth areas. Notice the void at the origin.

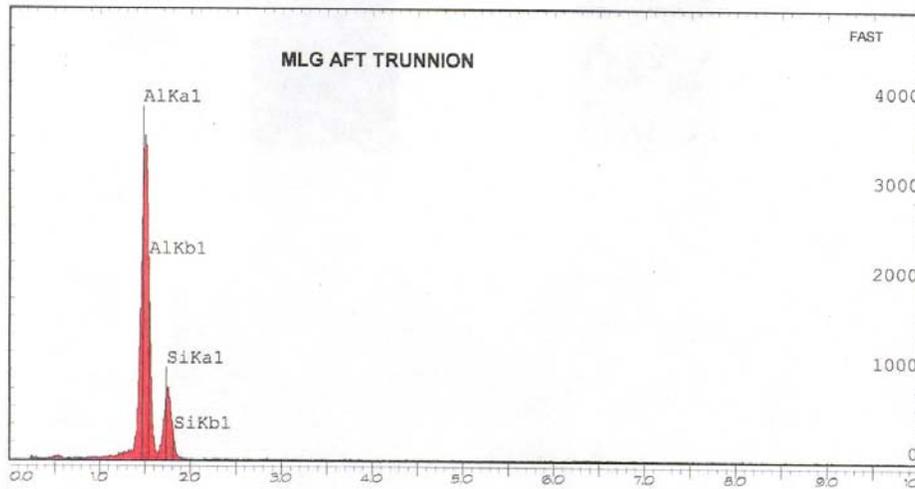
Figure 8. The aft trunnion is made of cast aluminum.

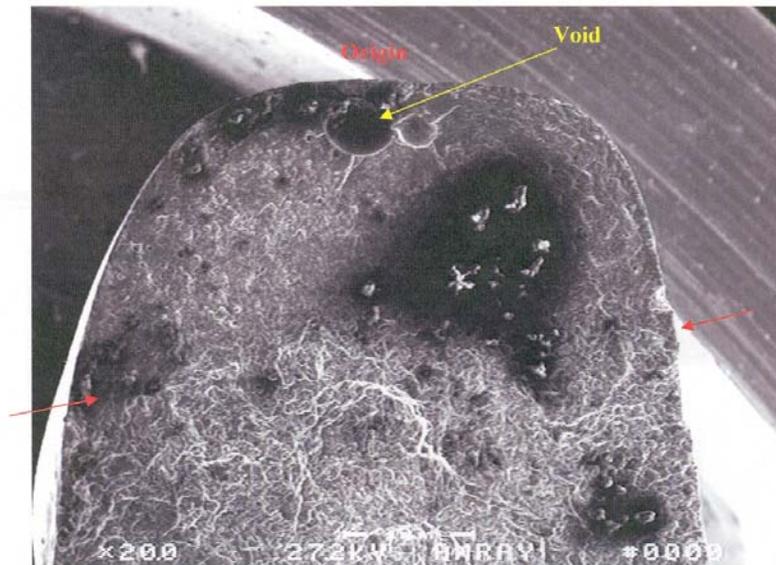
The trunnion is made of cast aluminum, Figure 8. A 20X SEM photo of the trunnion shows the crack origin and a line of coloration change, Figure 9. The initial crack growth traveled from the tip of the trunnion to this line. There is a void at the top which is the initiation point for the crack. An 80X SEM photo of the origin shows the void to be roughly spherical with a diameter of approximately 0.5 mm, Figure 10.

Figure 9. 20X SEM photo of void at the crack origin. Notice the color change on a line between the arrows. The initial crack traveled from the top to this line of discoloration.

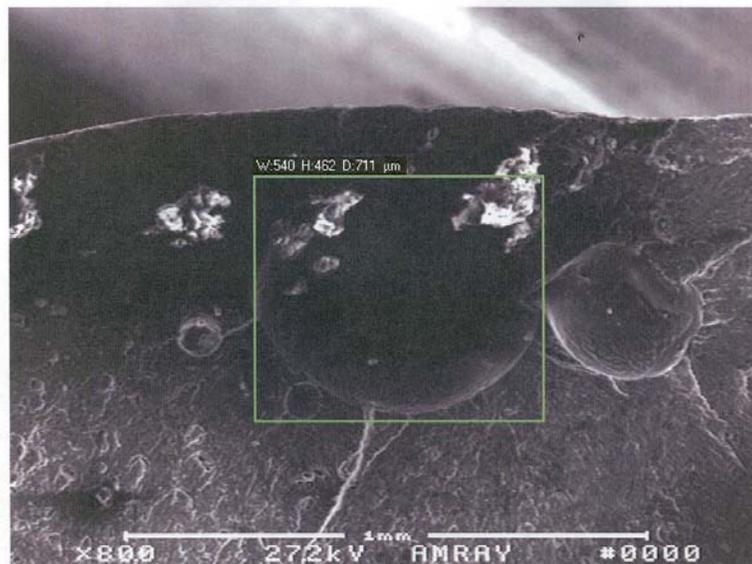
Figure 10. An 80X SEM photo of the void shows it to be roughly spherical with a diameter approximately 0.5 mm.

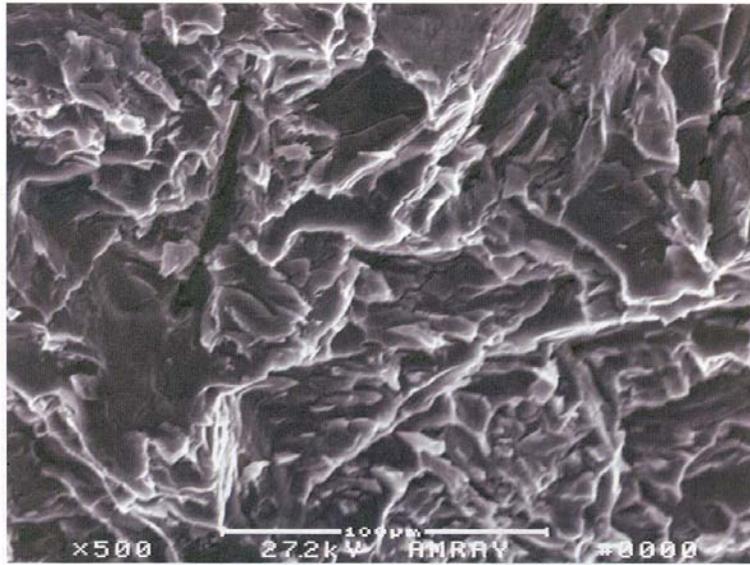
Figure 11. A 500X SEM photo of the fracture surface created by FAST. These are fracture features caused by impact overload.

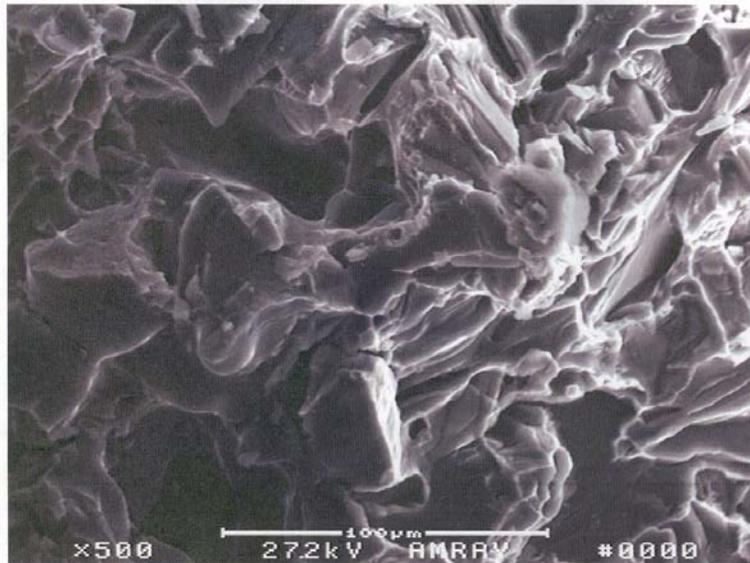
Figure 12. A 500X SEM photo of another area of the fracture surface created by FAST.

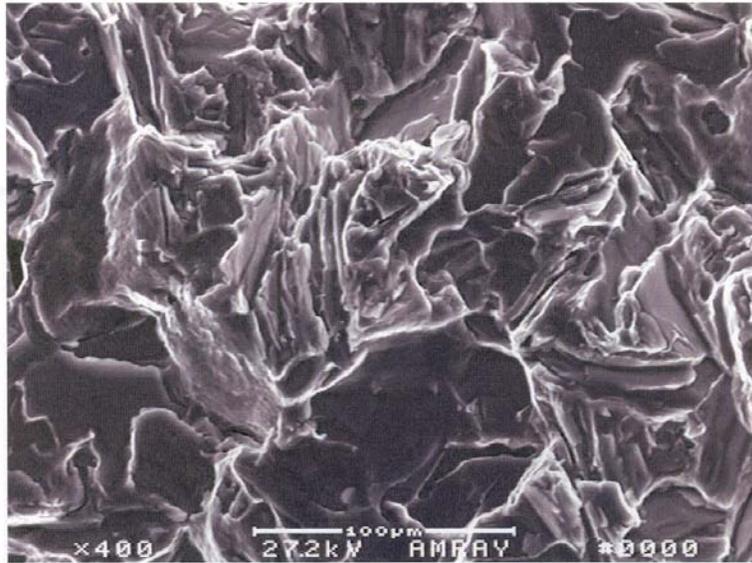
Figure 13. A 400X SEM photo of the initial crack growth area reveals features characteristic of impact overload.

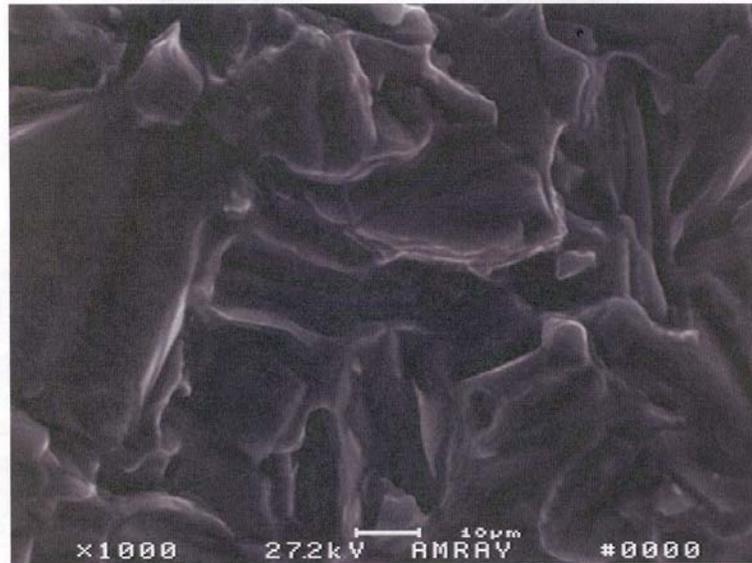
Figure 14. A 1000X SEM photo in crack growth zone three showing features characteristic of brittle overload.

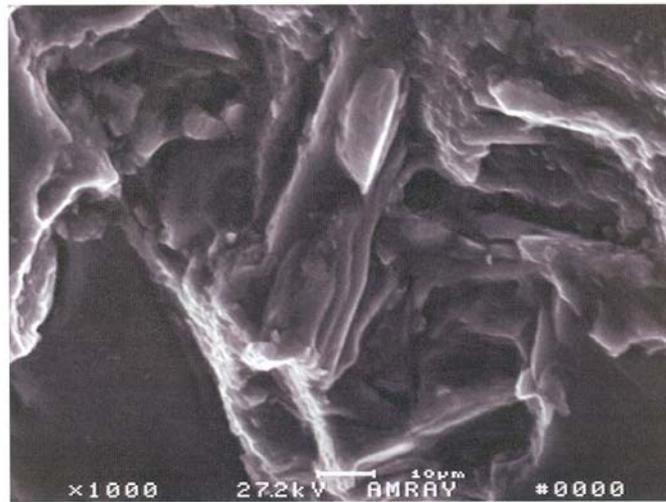
The physical evidence is conclusive for impact overload. The crack initiated at a void in the thinnest section of the trunnion. There were two more impact overloads (color changes in the fracture surface) to the trunnion which took the crack growth slightly into the trunnion where the trunnion thickens. One item of note is that the submitted trunnion has the grease nipple in a location different from that indicated in the Airplane Parts Catalog. (Compare Figures 2 and 4.) Please contact me if further assistance is required.

Figure 15. A 1000X SEM photo revealing brittle overload fracture features.

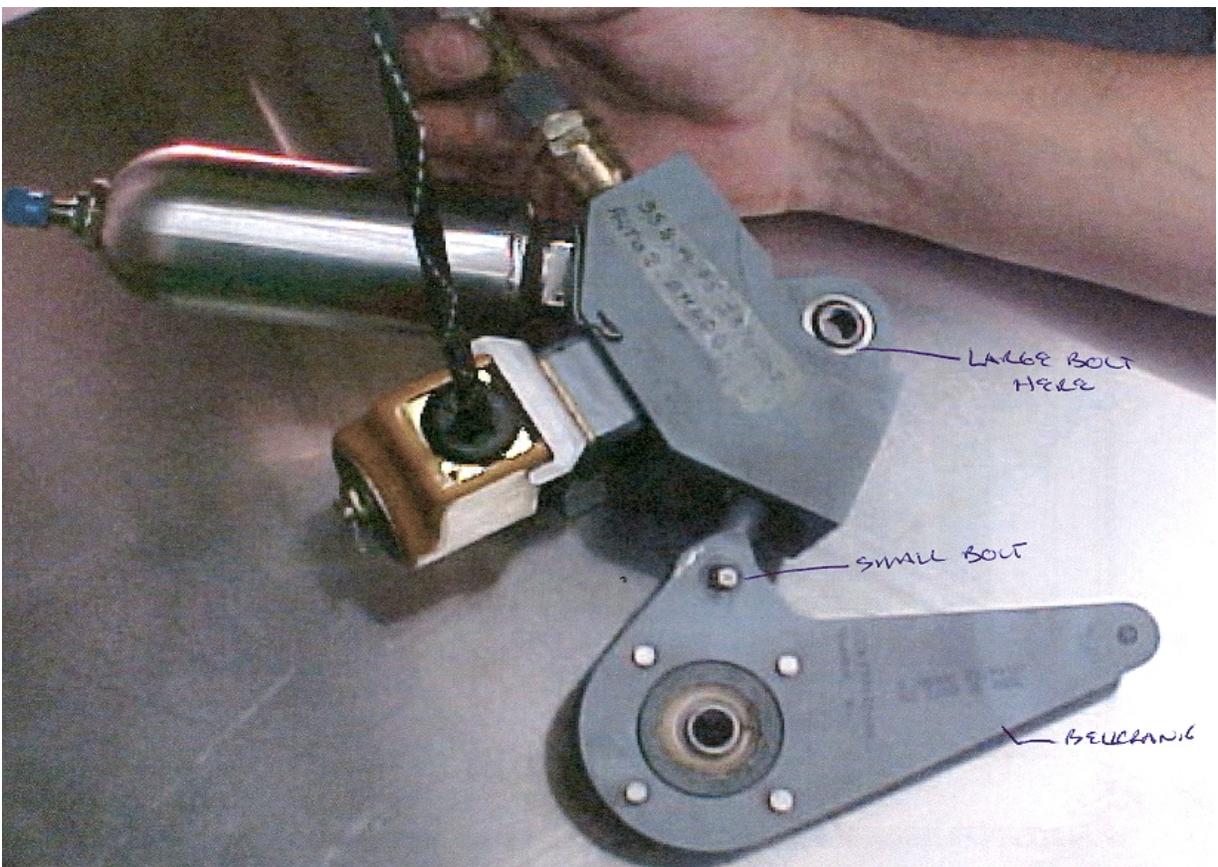
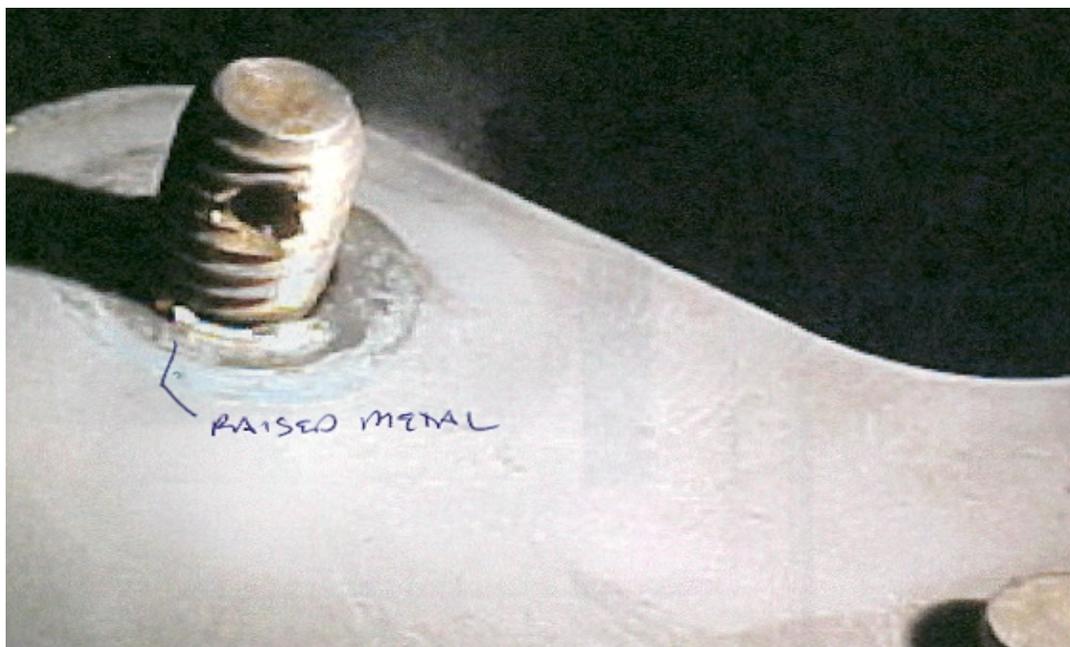
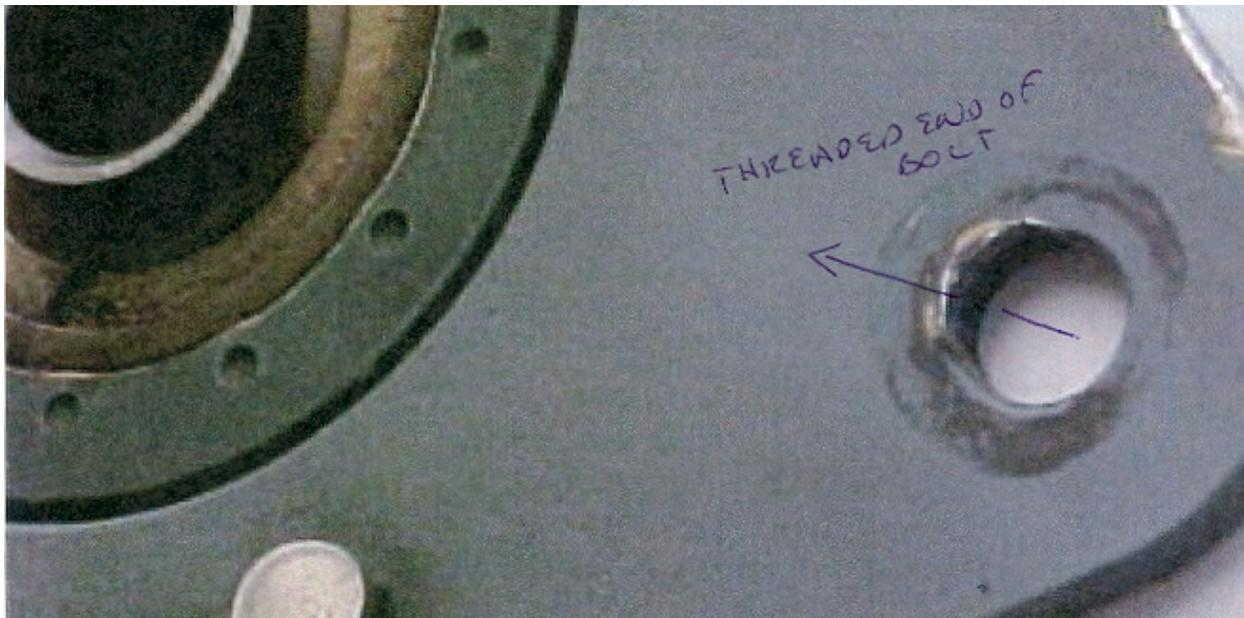
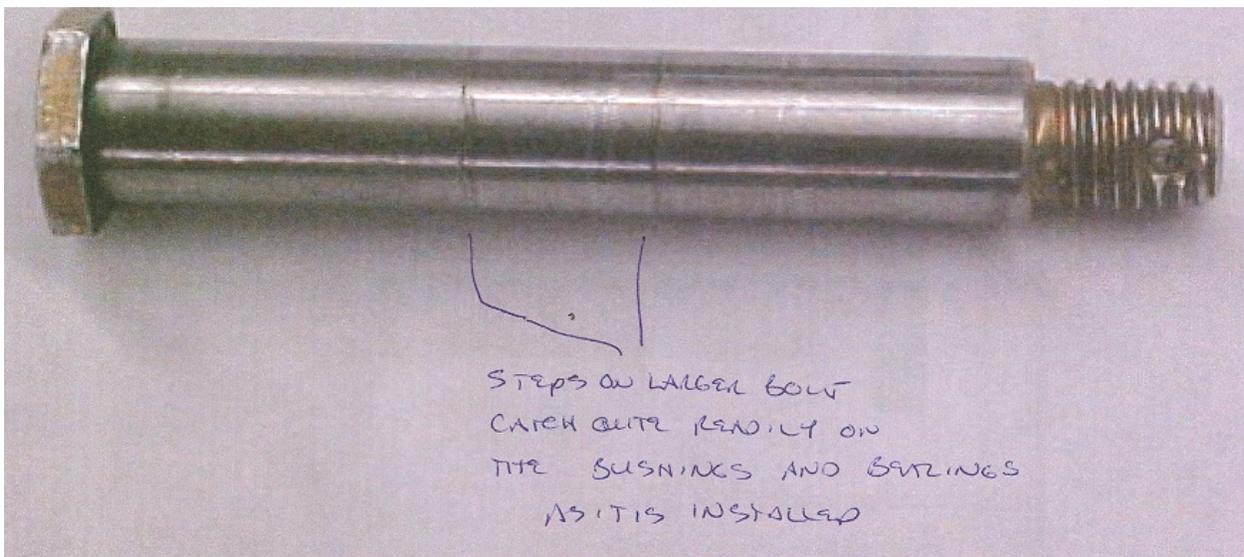
A repair station mechanic describes damage found to the tail rotor’s servo mounting structure. “During a 500 hour inspection and (subsequent) removal of the tail rotor over-center mechanism, it was discovered the main support bolt and the bell crank pivot bolt were obviously hammered in—evidenced by the raised metal (a deformed edge) and elongated hole—see photos. (I) replaced the bell crank (P/N 355A27.00720001) and both bolts.” (Four of seven submitted pictures are shown here, slightly cropped and/or vertically compressed. Meaningful effort is obvious in the care taken to show the negligent damage. The submitter’s documentation makes apparent his conclusions. Thank-you.)

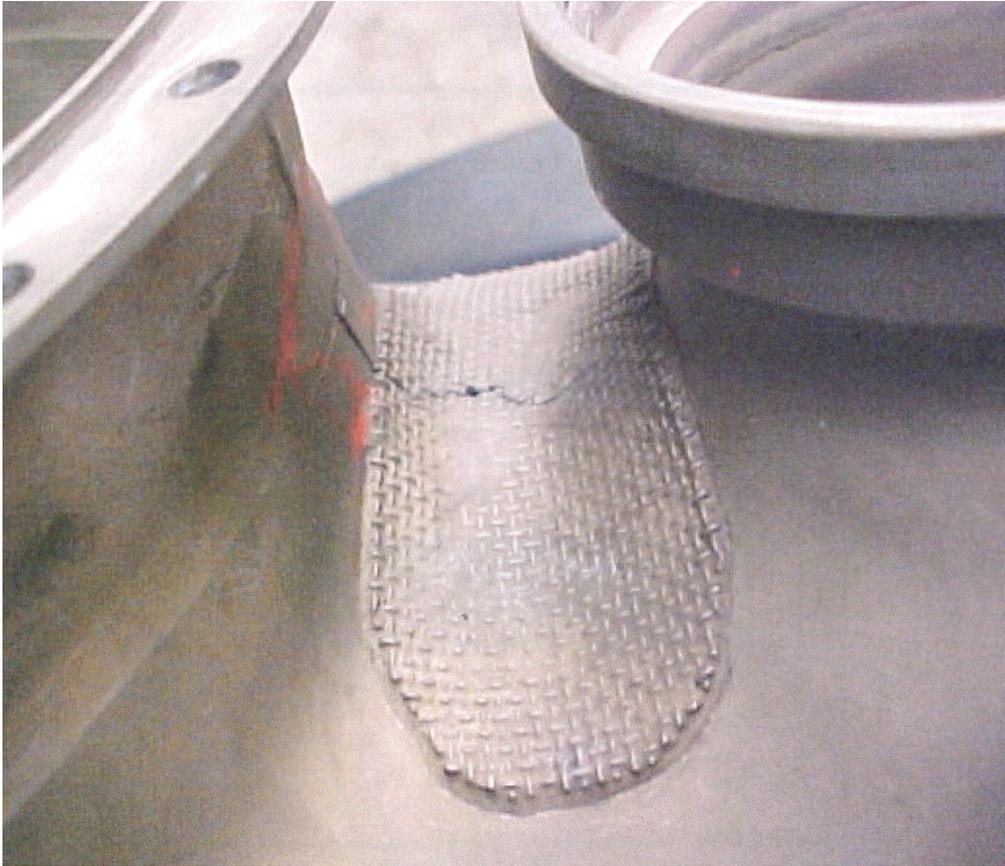
A technician states, “During an inspection for high TOT (*turbine outlet*) temperature the outer combustion can (P/N 6870992) was found to be cracked in the left ‘armpit’ (see photo). This unit was replaced.” *(The aircraft is an MD 500D helicopter. The part number returns 27 entries from the SDRS data base for similar discrepancies.)*
