U.S. Department
of Transportation
**Federal Aviation
Administration**

ADVISORY CIRCULAR

43-16A

AVIATION MAINTENANCE ALERTS

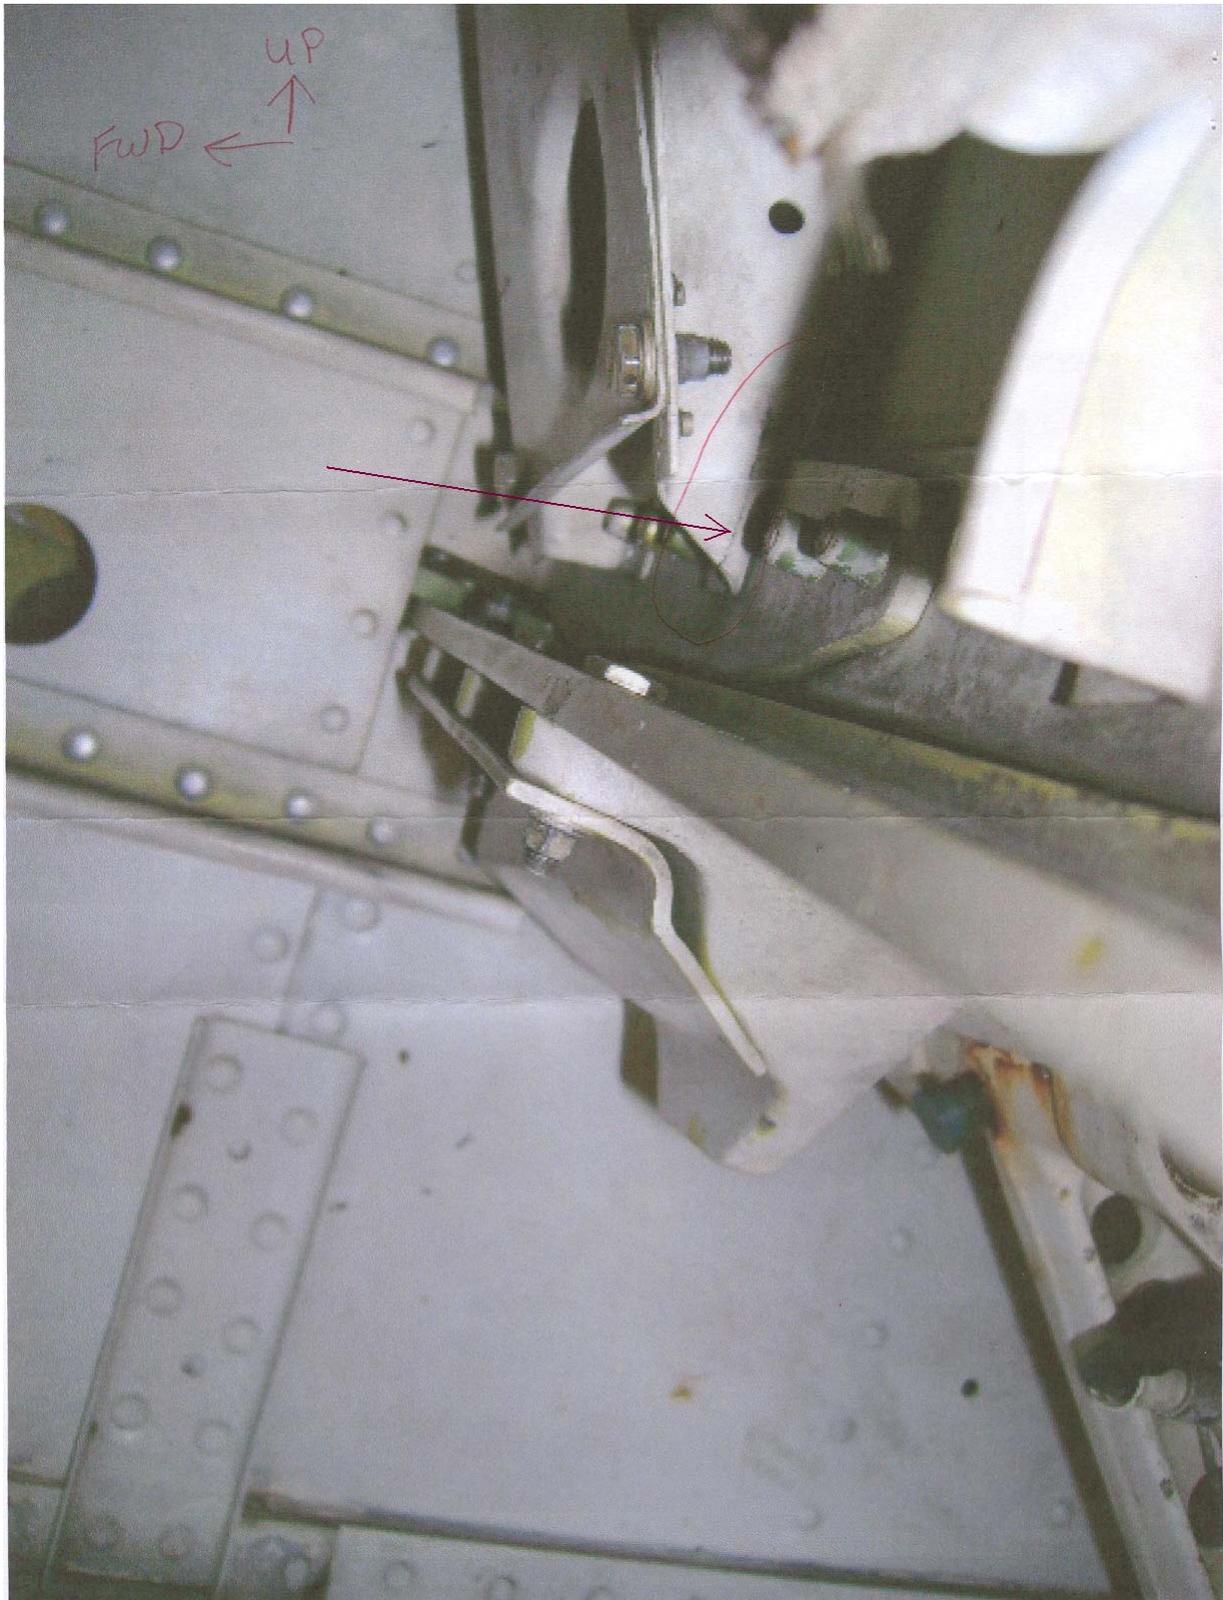
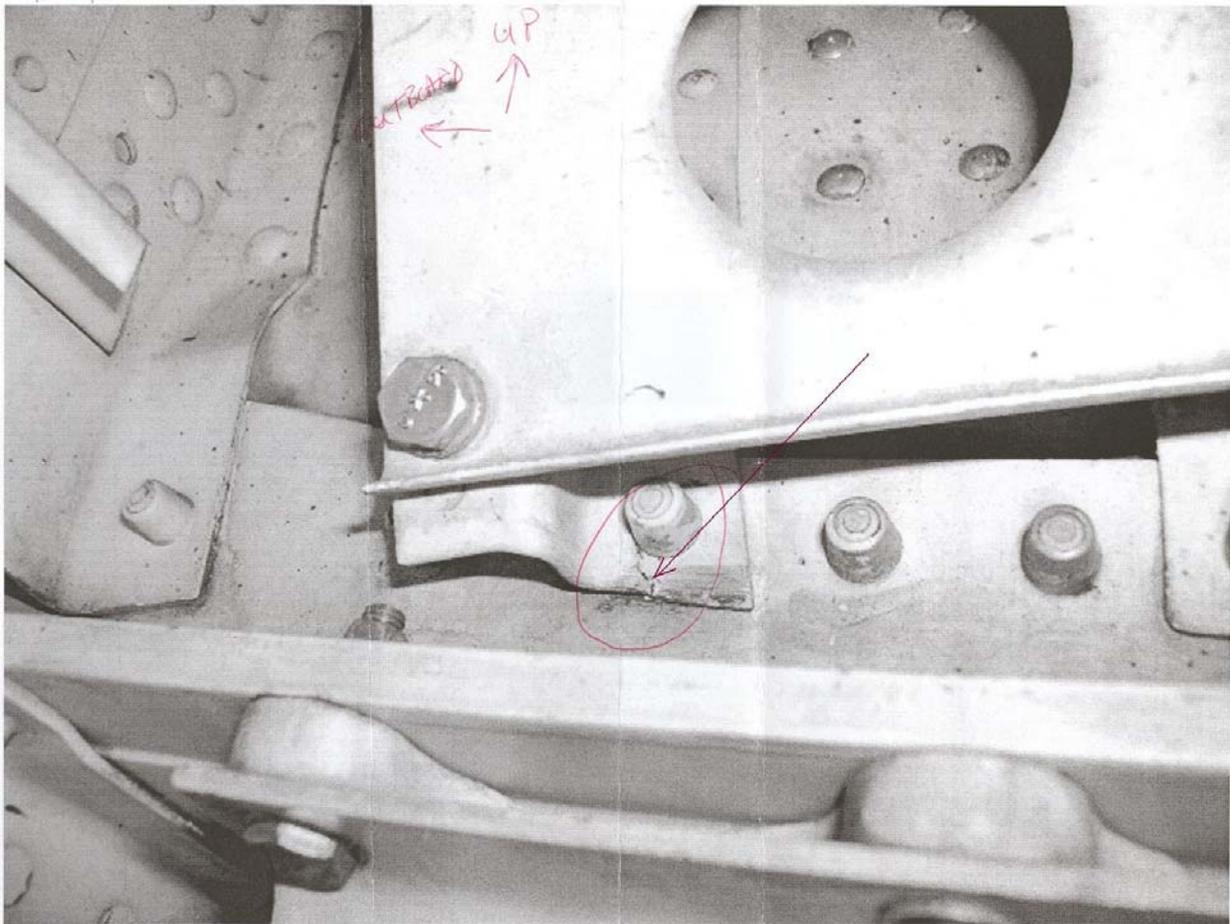
Beech: C90; Cracked Drag Leg Support Brackets; ATA 5740

A repair station technician states, "The drag leg support brackets (*P/N 50-120077-16 & -17*) were found cracked on both left and right sides during a routine inspection. (*These*) cracks are most likely (*caused*) by fatigue or a rough landing."

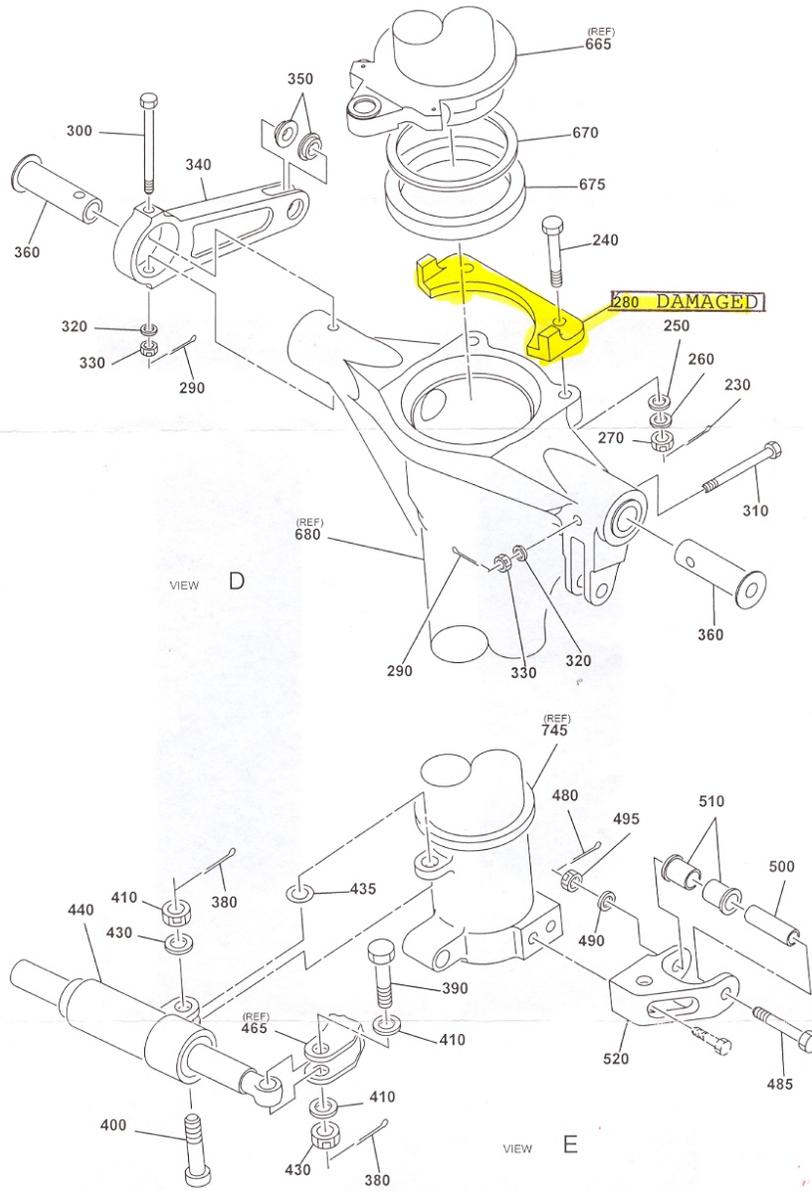
Premier I/A Model 390 - Illustrated Parts Catalog
NOSE LANDING GEAR ASSY

Beech: 390; Distorted Nose Gear Stopper Assembly; ATA 3230

A technician describes an all too frequent problem for many airplanes. “The pilot reported (*having*) a ‘landing gear unlocked’ indication after selecting gear retraction (*subsequent to*) takeoff. We found the nose gear stopper assembly damaged, preventing the gear assembly from centering and (*properly*) engaging the uplock assembly. The stopper assembly was replaced after gear disassembly and inspection—gear operations then (*checked*) normal. It was reported this aircraft was previously towed with the nose gear torque links connected. The flight crew, ground operations personnel, and technicians should be aware of correct Premier towing procedures as specified in the 390 Maintenance Manual, section 9-10-01-201.” (*Stopper Assembly P/N: 390-820001-0001*)

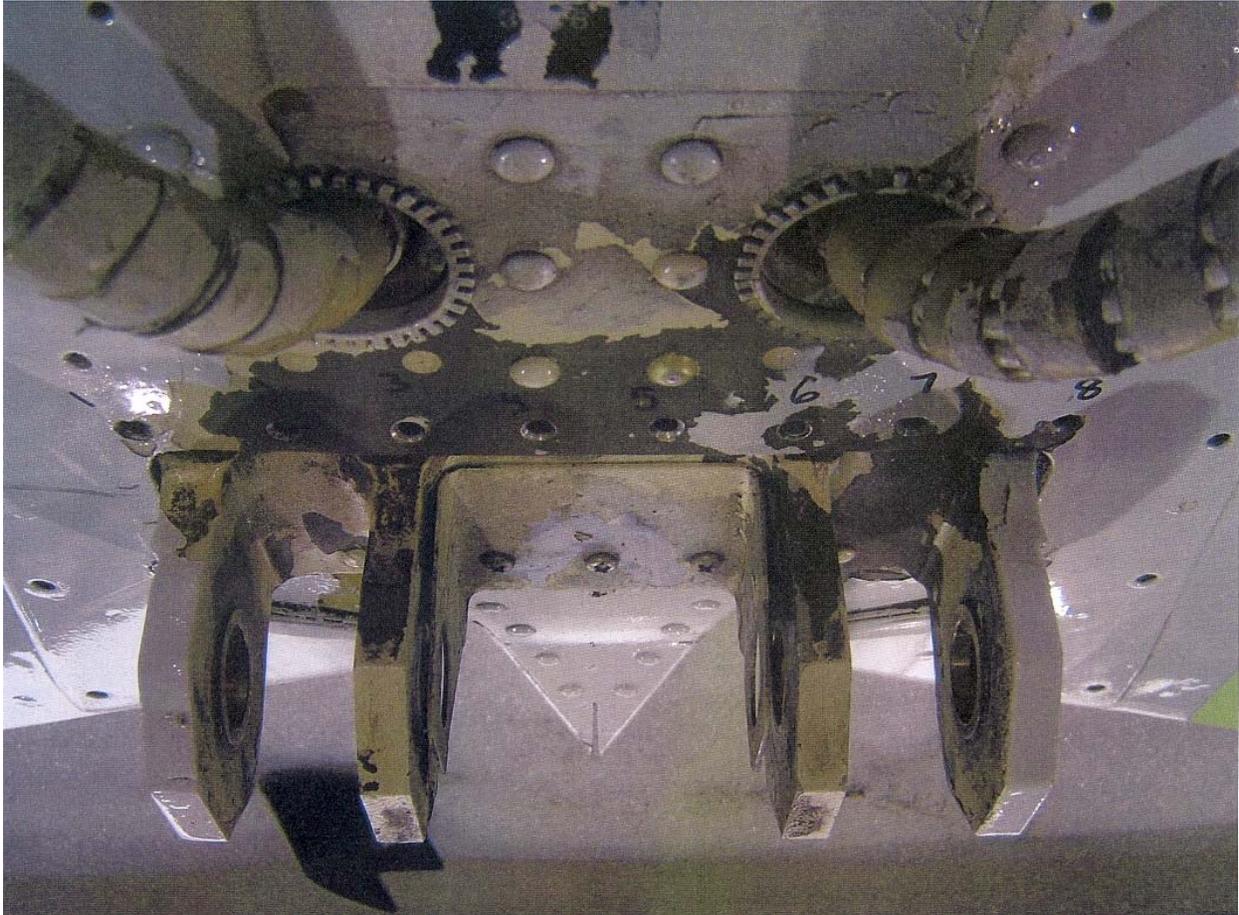
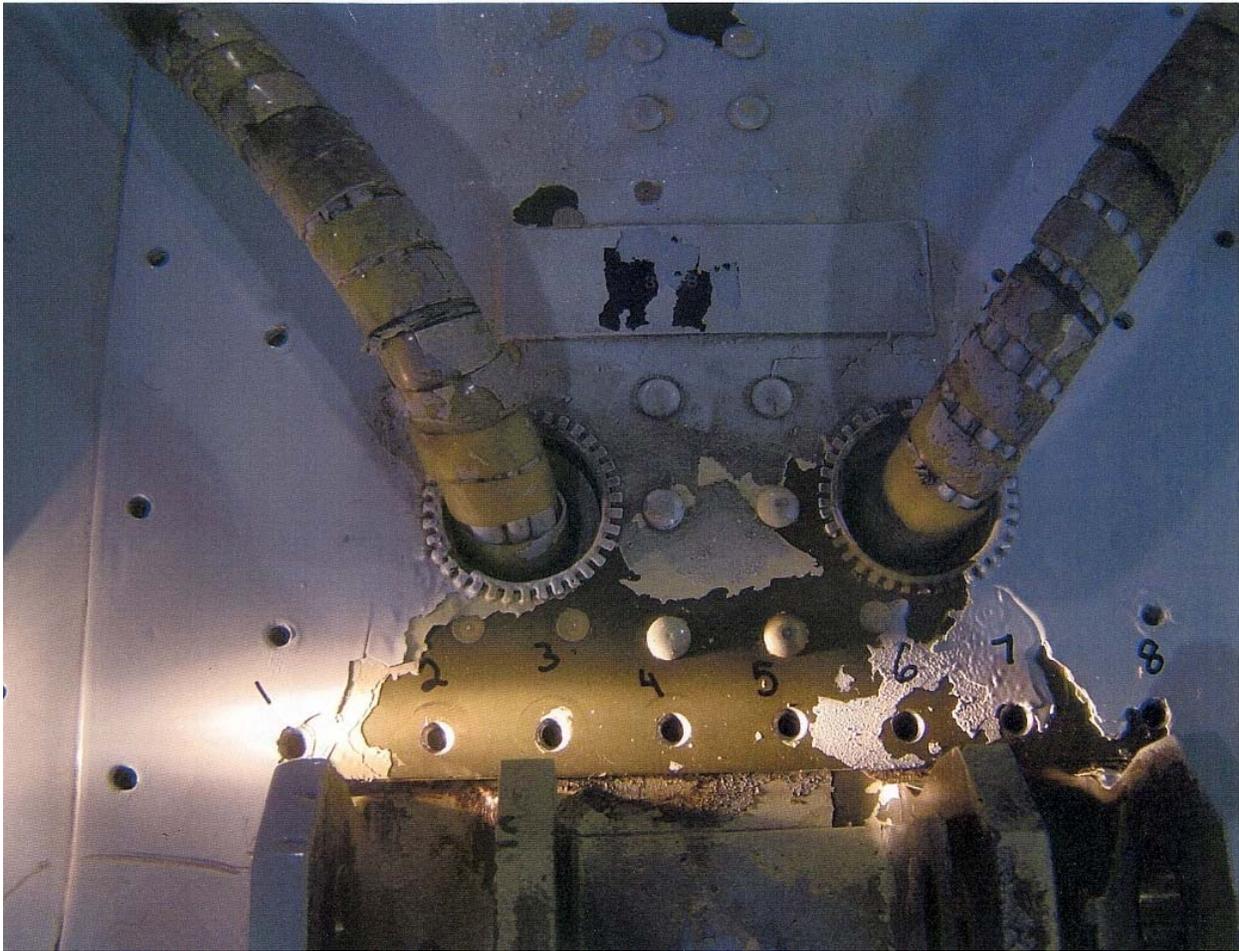
Beech: 400A; Sheared Rivets in Horz. Stab. Pivot Fitting; ATA 5510

“While performing a scheduled A-D inspection, eight sheared rivets were found in the forward rivet line of the attachment pivot fitting (P/N 45A21183-11) on the bottom of the horizontal stabilizer. It is suspected the missing rivets failed from fatigue. Recommendations are to inspect this area thoroughly at each inspection and to contact Hawker Beechcraft for repair options.” *(Horizontal stabilizer P/N 45A21002-41.)*

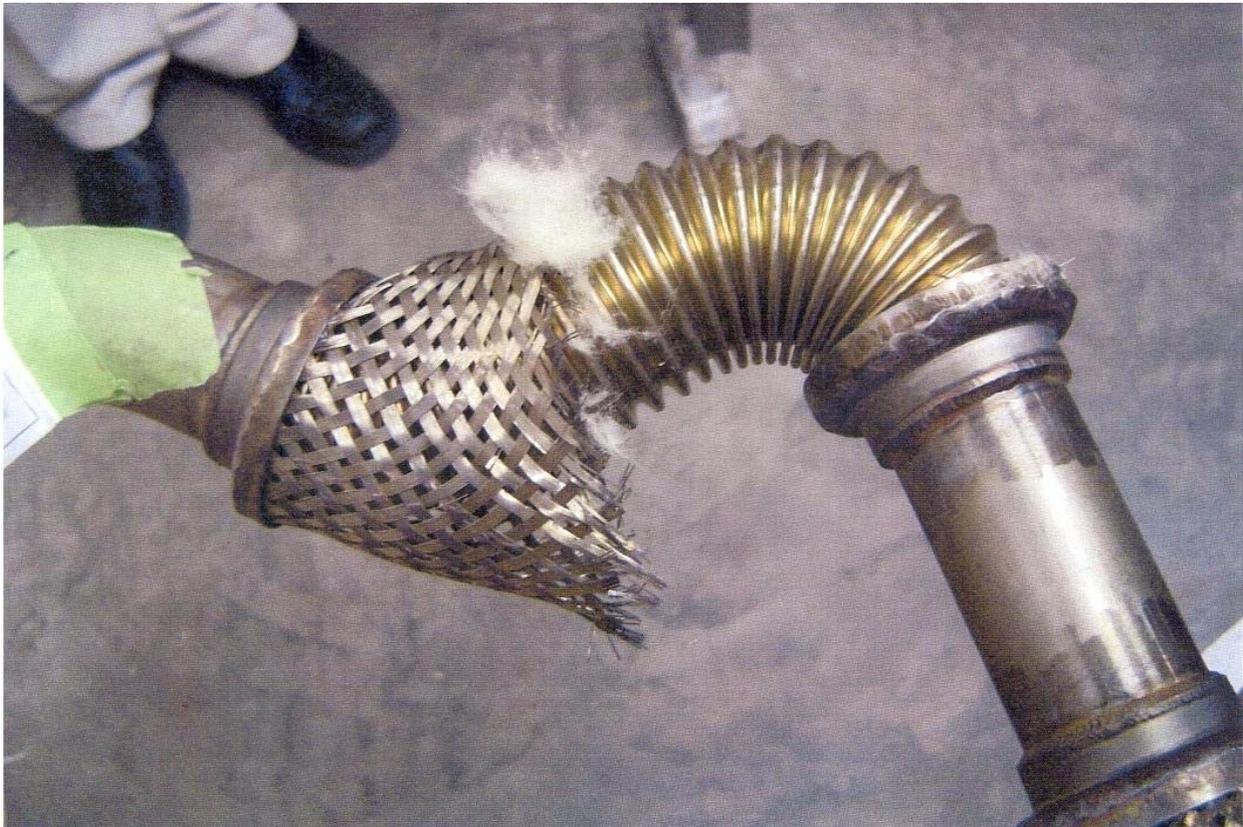
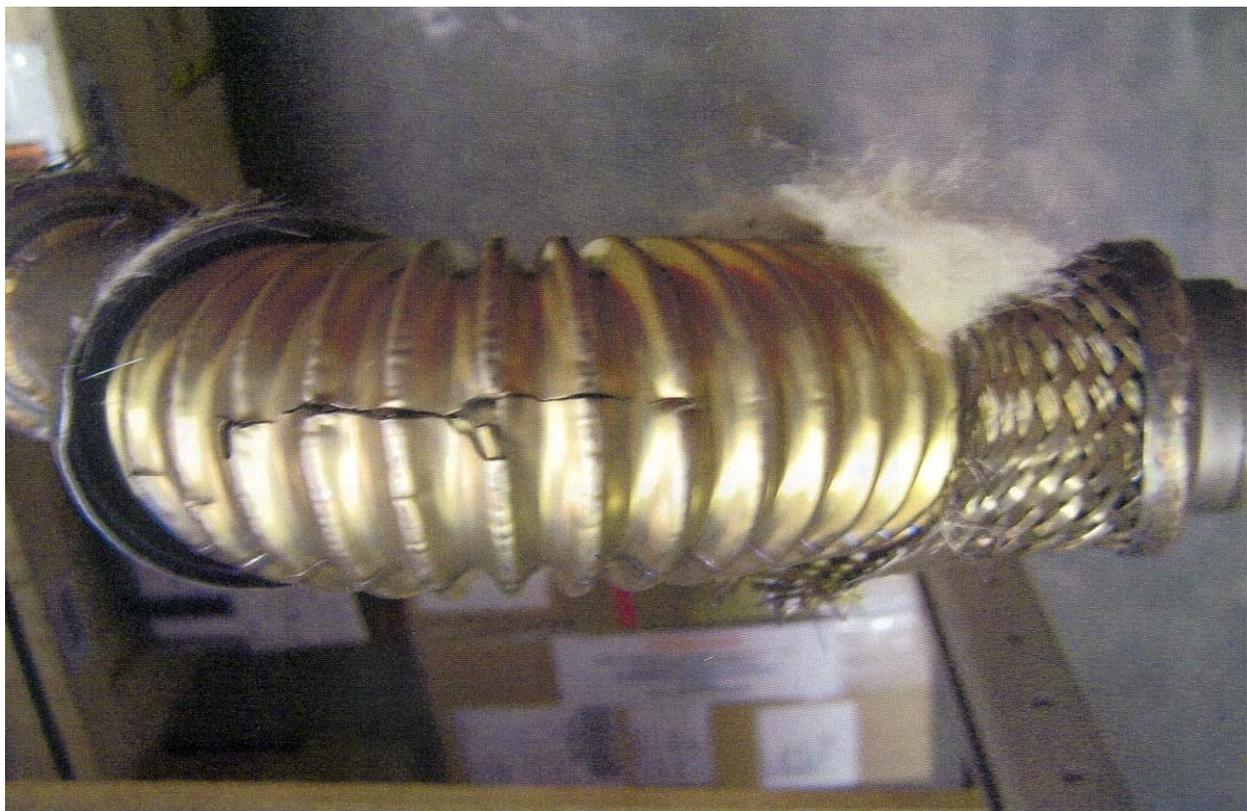
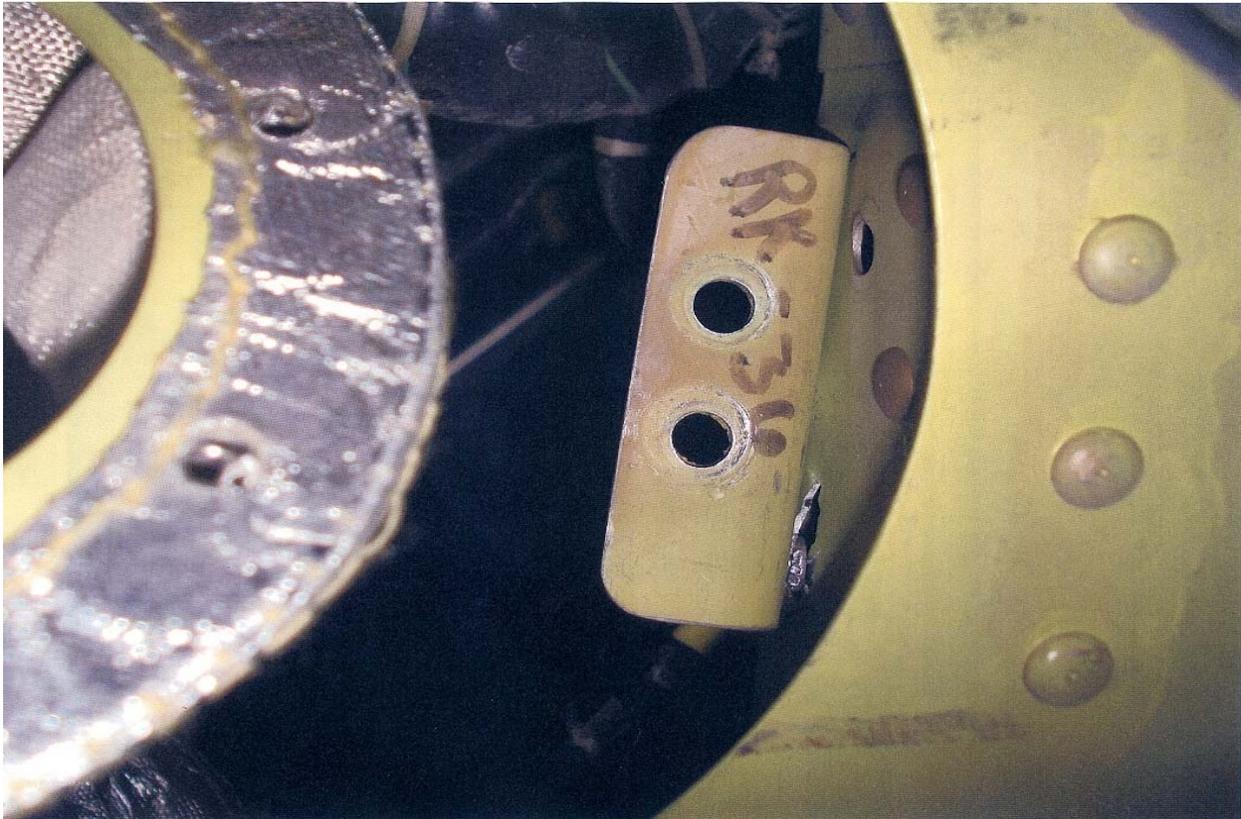
Our technician states, “While performing a scheduled A-D inspection, the left aft fuselage bleed air line bellows (P/N 45A63517-073) was found blown apart. The right aft fuselage bleed air line bellows-braiding (P/N 45A63517-075) was found fraying. When the left bleed air line blew apart it cracked a fuselage bulkhead at upper frame station 329.92 and BP 29.92L. I would recommend that detailed inspections of these bleed air lines be performed at scheduled intervals, and the upper frame station in the areas around the bleed air lines be carefully inspected for damage. It is suspected both bleed lines failed due to fatigue or time in service.

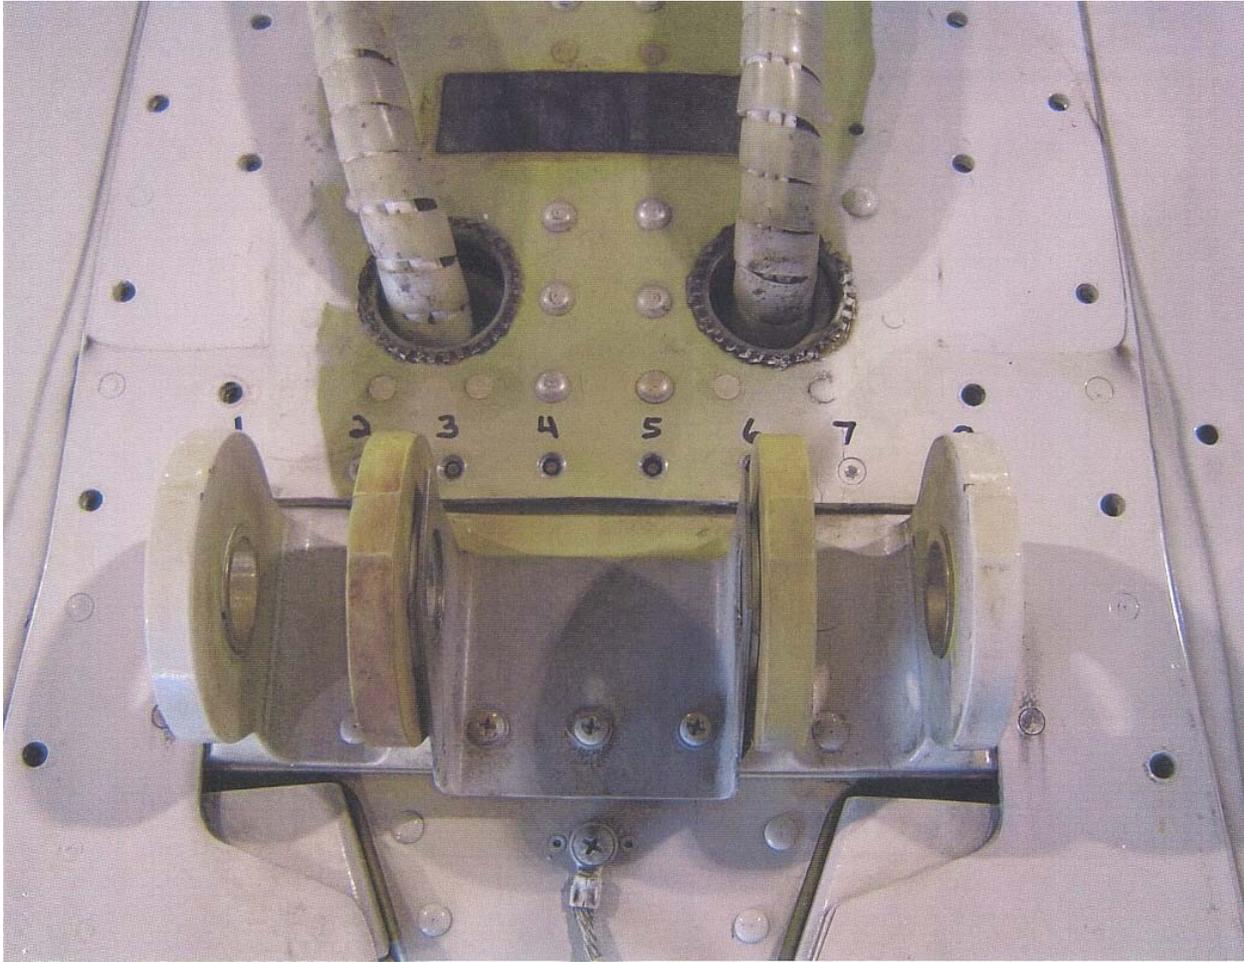
“While performing a scheduled A-D inspection, six sheared rivets and two loose rivets were found in the forward rivet line of the attachment pivot fitting (P/N 45A21183-11) on the bottom of the horizontal stabilizer. It is suspected the missing rivets failed from fatigue. Recommendations are to inspect this area thoroughly at each inspection and to contact Hawker Beechcraft for repair options. This is the second aircraft this same discrepancy has been found.”

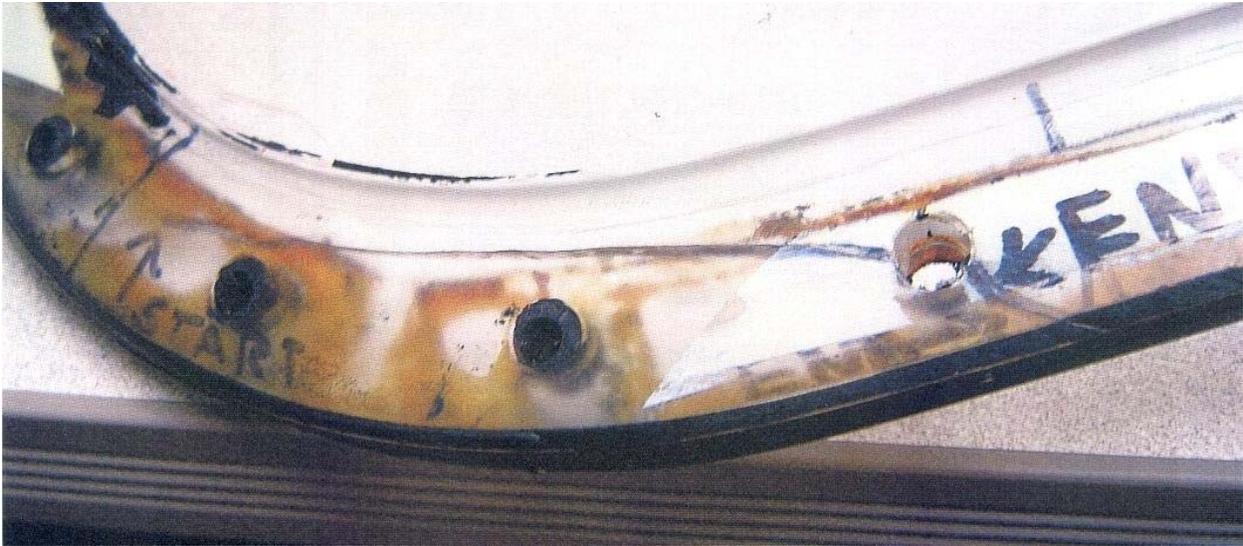
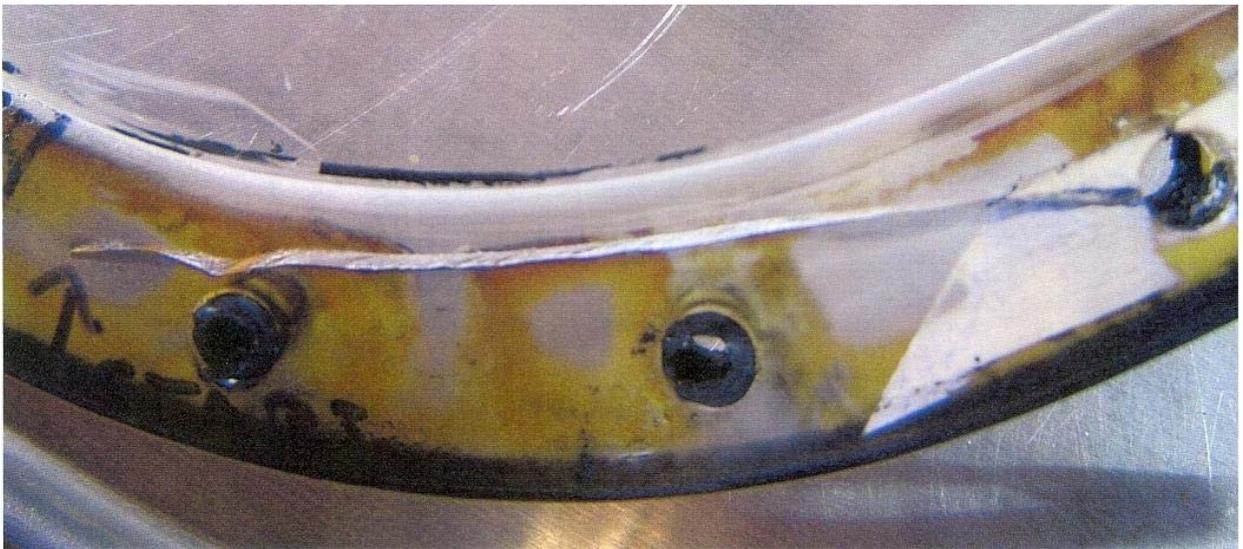
Beech: 400A; Cracked Copilots Side Window; ATA 5610

“While performing a scheduled A-D inspection, I found the copilot’s cockpit side window cracked using the prism inspection method. The ‘D’ inspection requires both windshields be inspected by removing the windshield retainers or using optical prism inspection (*criteria*). There is no statement in the aircraft or in the A-D inspection checklist that requires one to inspect the cockpit side windows in the same manner as the windshields. All of the windows in the cockpit area are installed or fastened in the same manner as the windshields. It is suspected the copilot side window cracked from fatigue, or total time installed. This window was manufactured in May of 1997. It is recommended inspections of all cockpit windows with a prism be completed at scheduled intervals.”

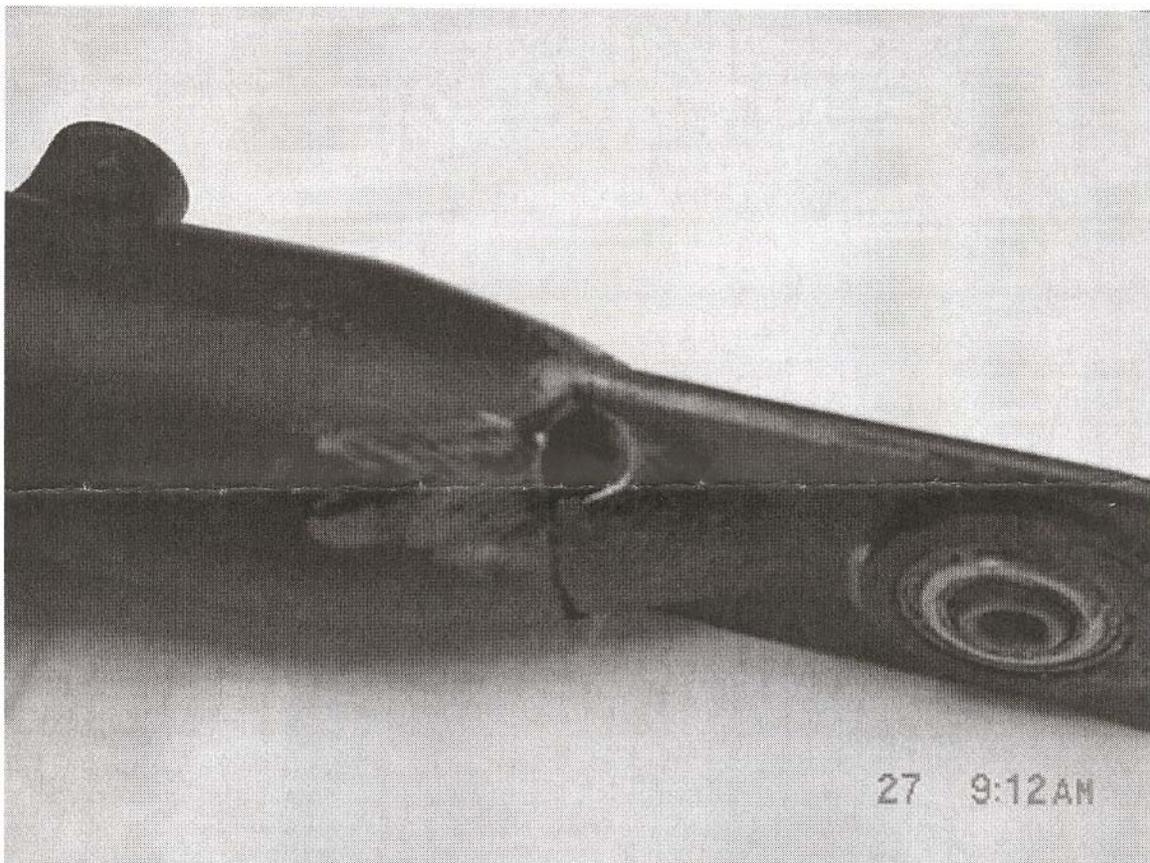
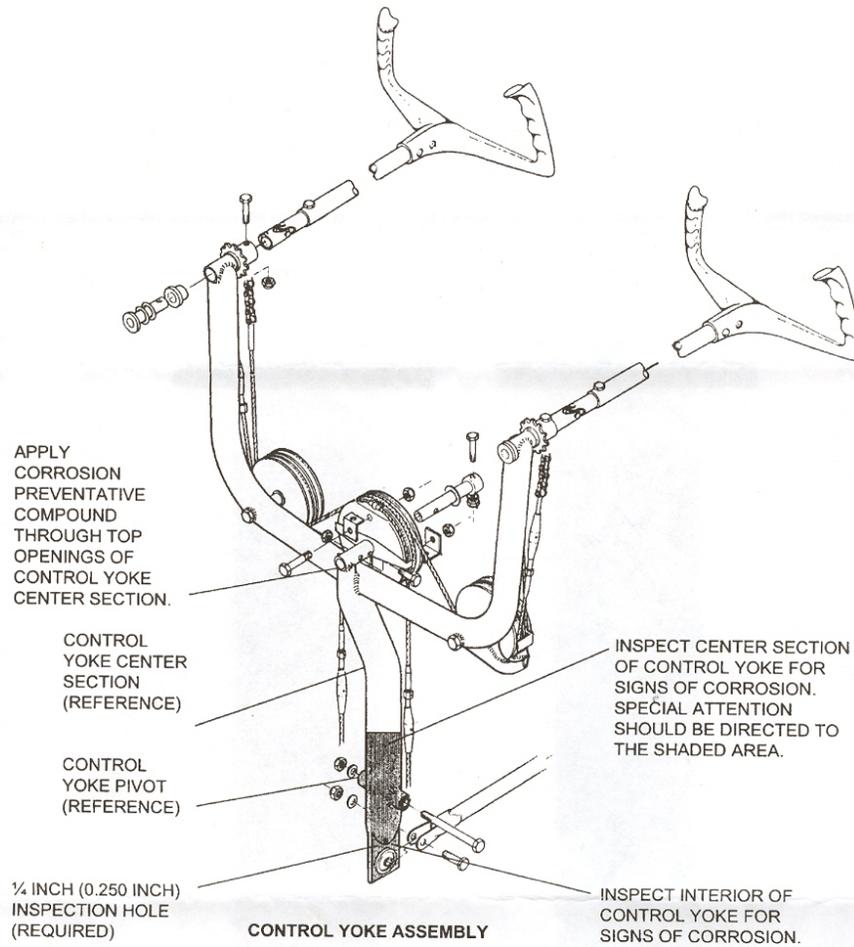
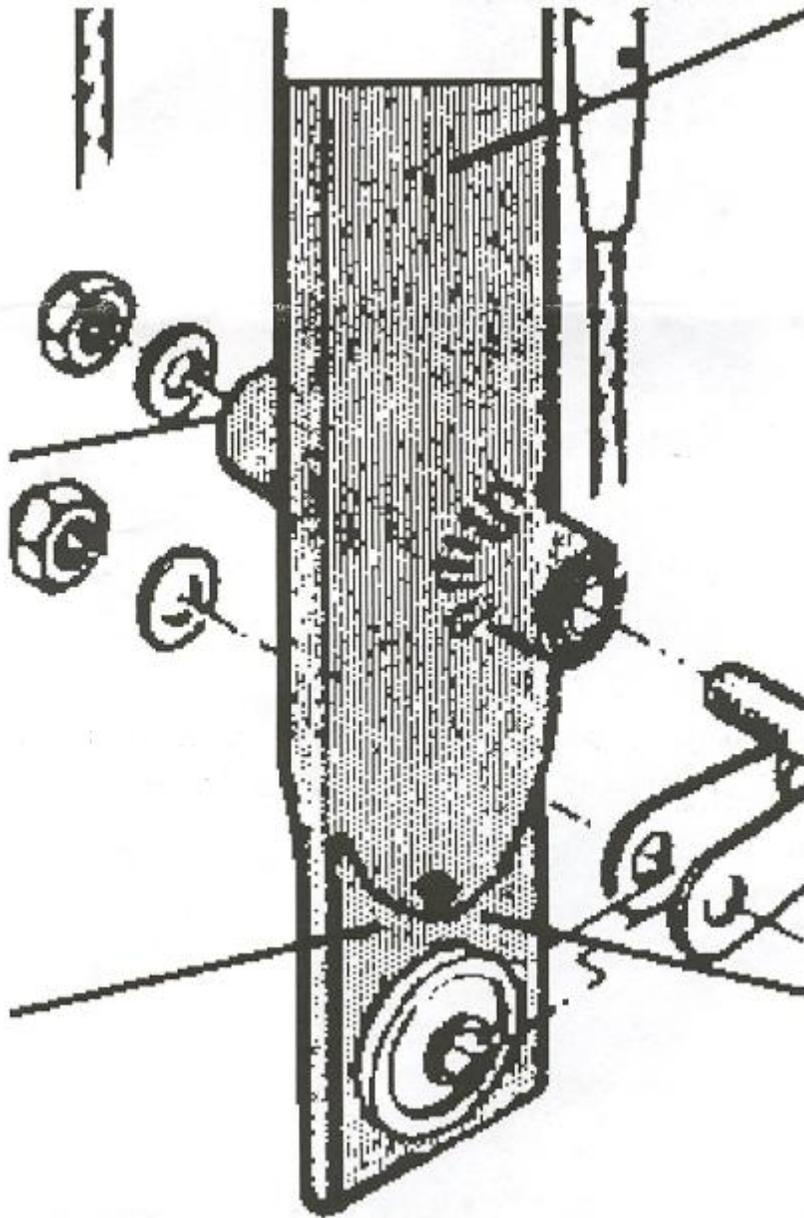
Figure 1. Control Yoke Inspection

“The FAA recently proposed in a safety recommendation to issue an Airworthiness Directive to comply with Cessna SEB01-3R1. The purpose for this service bulletin is given as follows: ‘Reports have been received of some control yokes corroding internally resulting in failure of the control yoke below the pivot attach point. The control yoke shall be inspected, and if required, replaced as described in this service bulletin. Non-compliance with this service bulletin may result in failure of the control yoke which could cause complete loss of elevator control.’

“The safety recommendation was issued because of a reported failure of a control yoke that was found while complying with the service bulletin on a 1985 Cessna 172P in Anchorage, Alaska during April 2008. As shown in the photograph, the drain hole appears to be larger than ¼ inch diameter and is mislocated. The correct position is shown in the enclosed Figure 1 from page 11 of SEB01-3R1. The FAA has determined that this alteration from the service bulletin weakened the tube structure, and may have contributed to the failure.

“For additional information on maintaining the control yokes, we suggest that you review the FAA Special Airworthiness Information Bulletin (SAIB) CE-04-03, Cessna Service Bulletin SEB01-3R1, and the article published in the Cessna Pilot Association (CPA) in September 2002 on pages 6308 through 6311 entitled ‘CPA Comments to the Airworthiness Concern Sheet dated 5/31/02’.”
