U.S. Department  
of Transportation

## ADVISORY CIRCULAR

# AVIATION MAINTENANCE ALERTS

**ALERT  
NUMBER  
386**

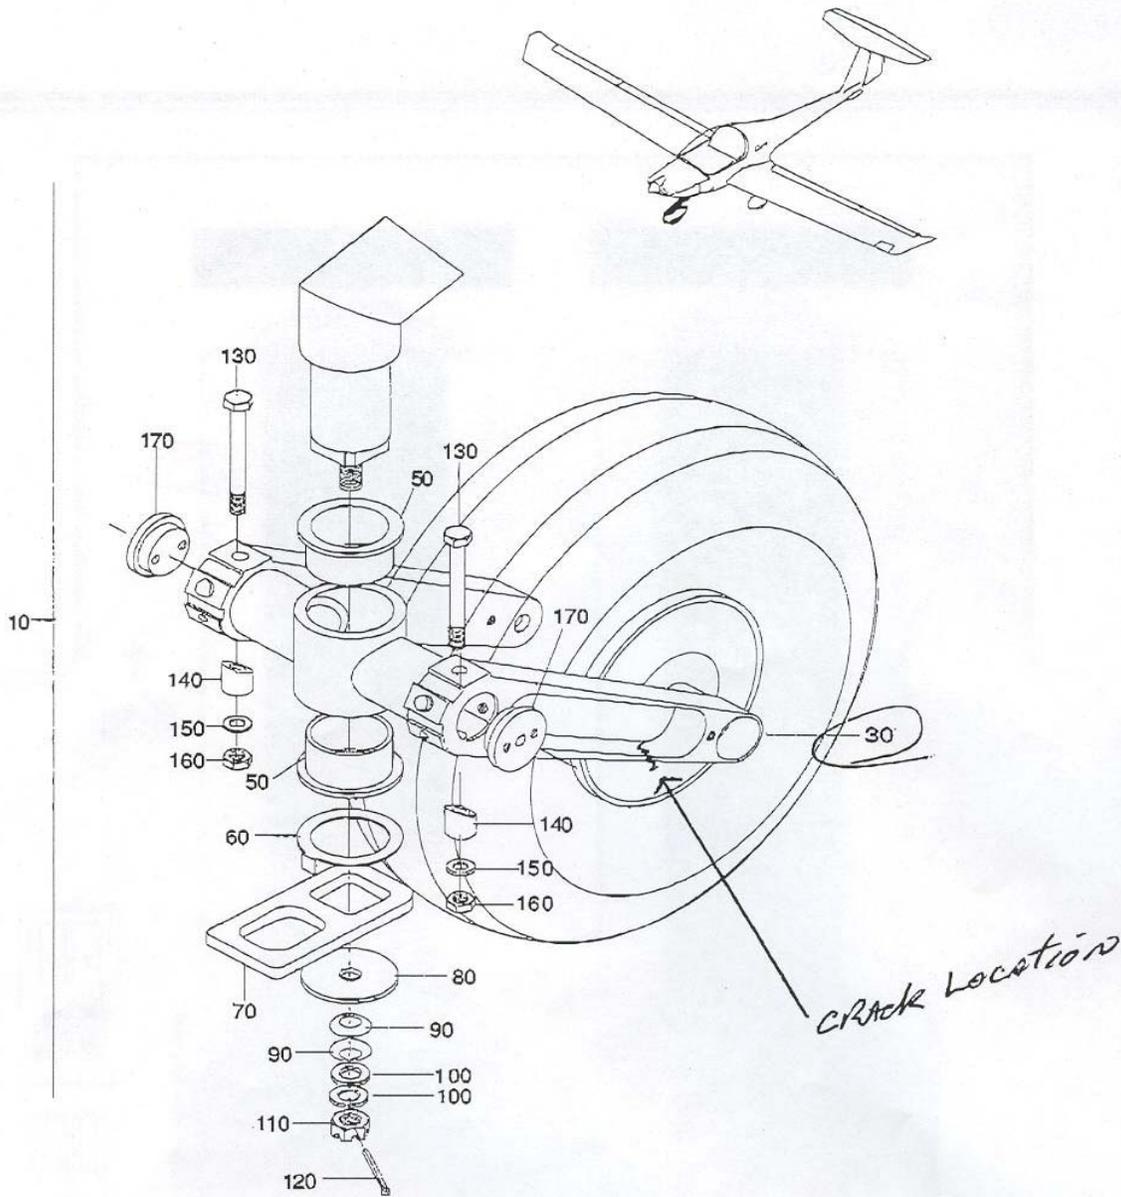
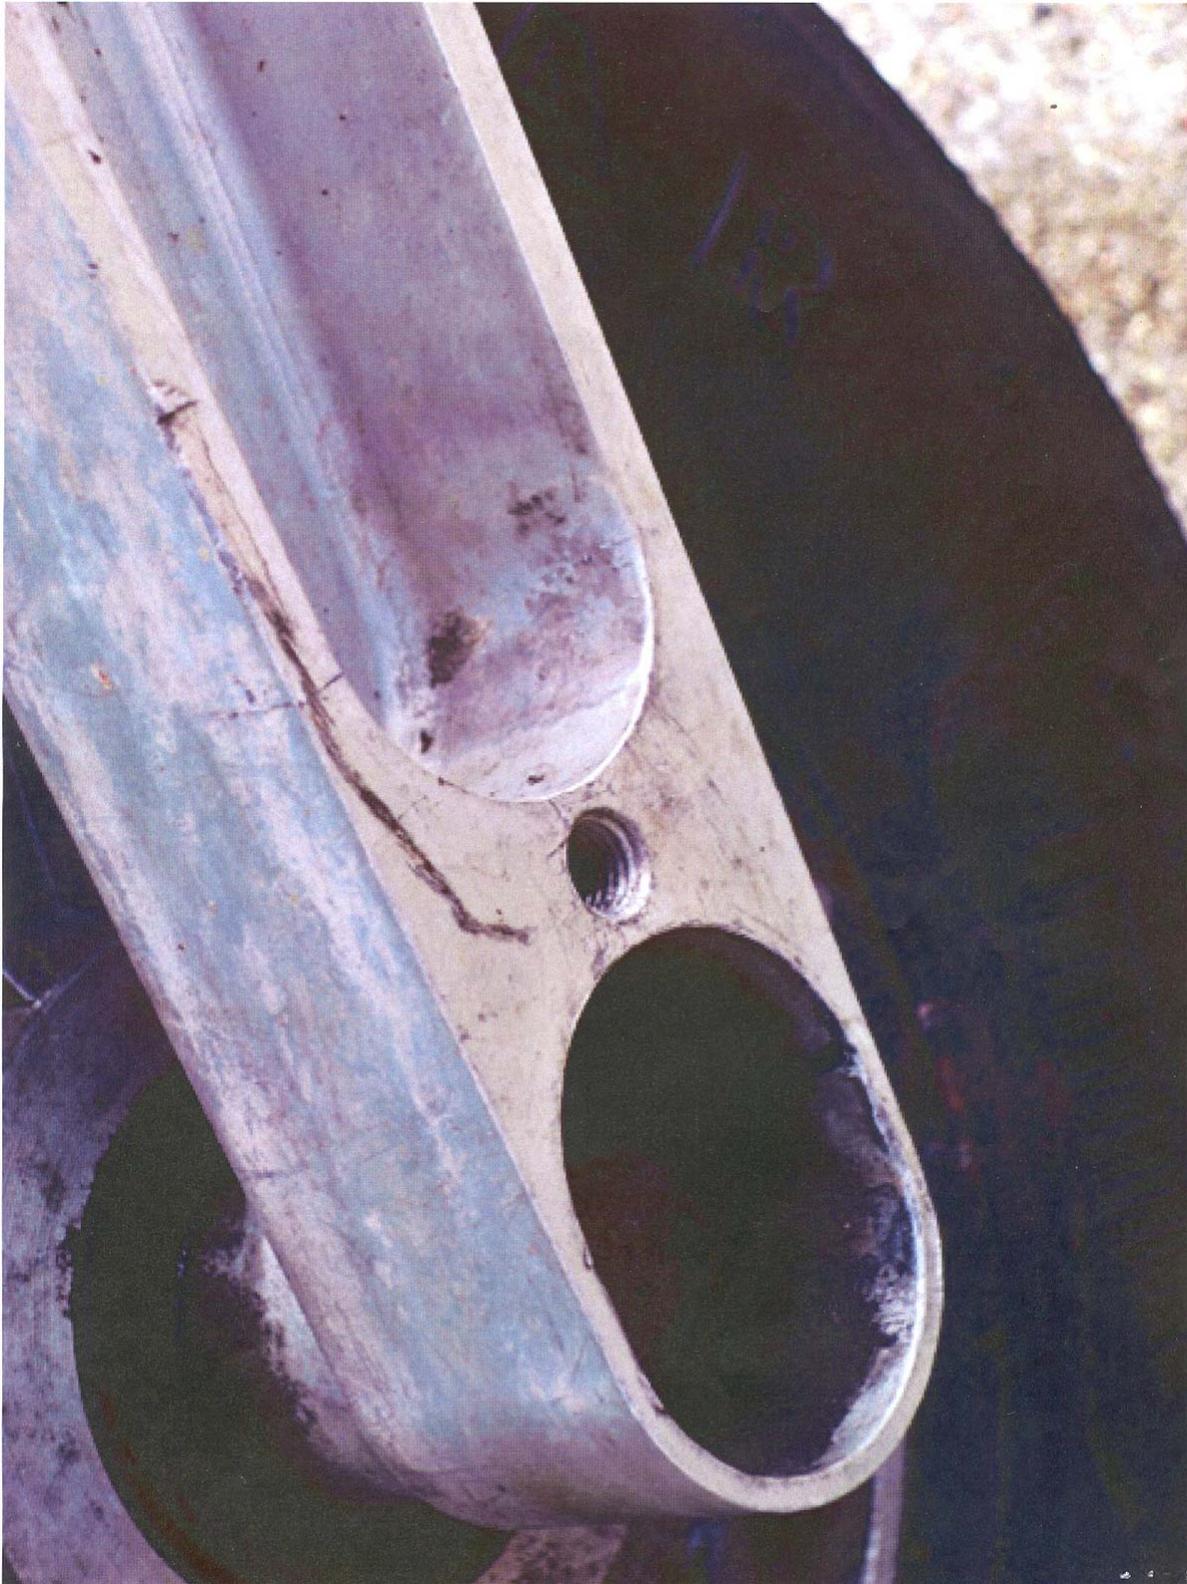
**Diamond: DA20-C1; Cracked Nose Gear Fork; ATA 3222**

A repair station submitter says, "The nose landing gear fork cracked on both left and right sides." (Nose Landing Gear Fork P/N: 20-3220-08-00. The SDRS database records at least five such discrepancy reports.)

Part Total Time: 1,926.7 hours

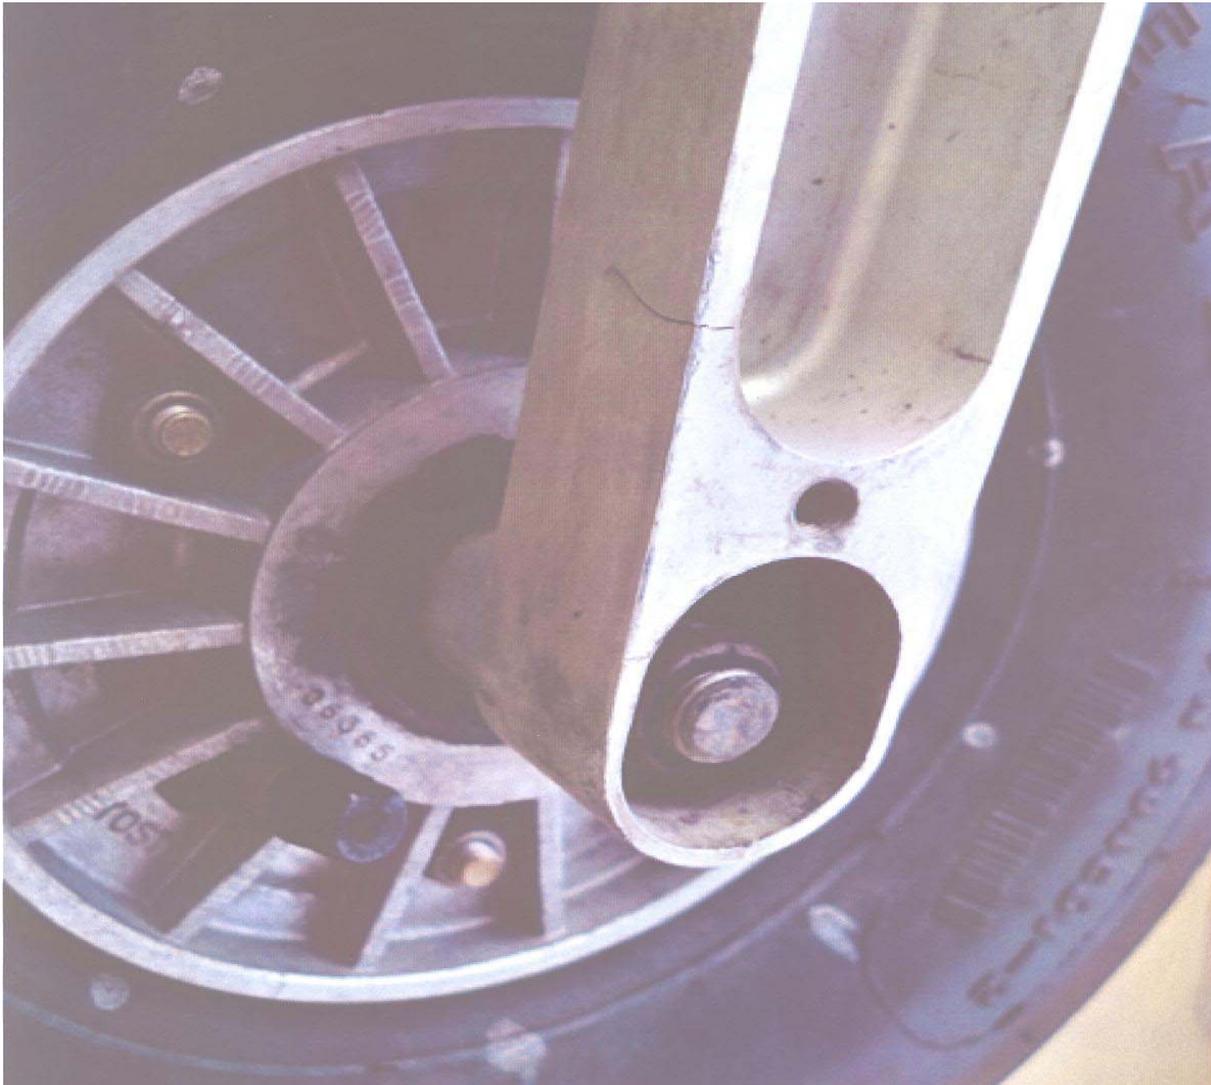
First Report: April 2009. "The nose landing gear fork cracked on both the left and right arms."  
(P/N 20-3220-08-00.)

Part Total Time: 1,306.0 hours

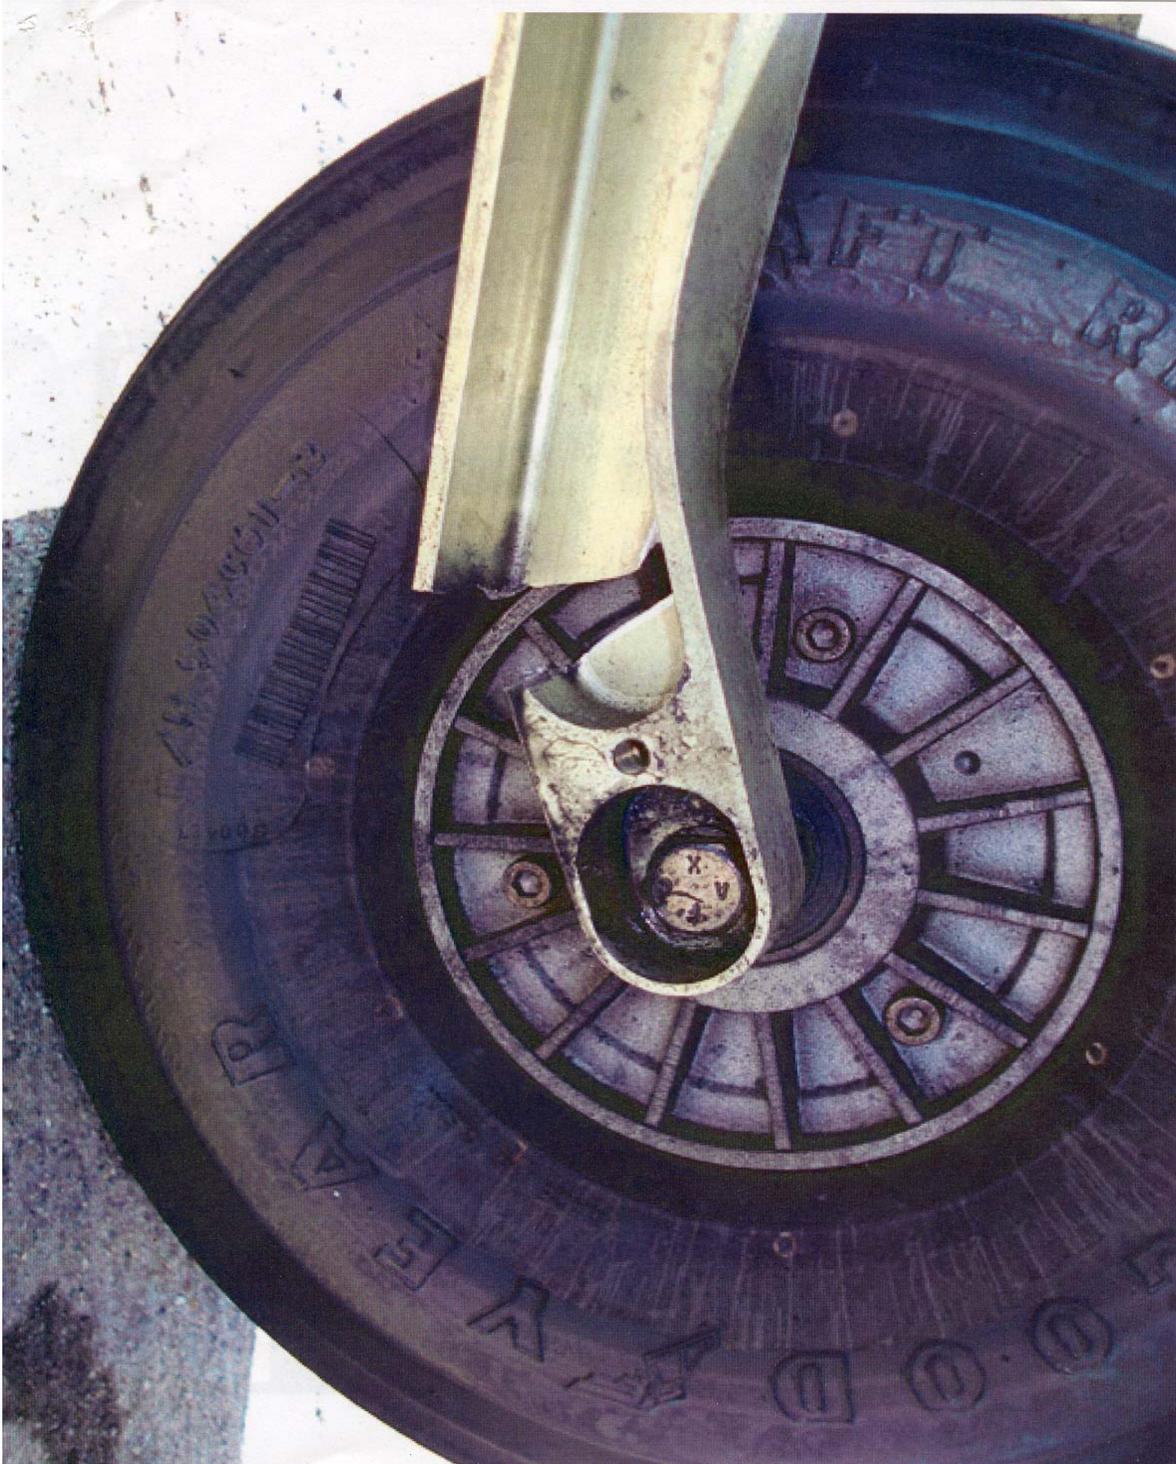
Second Report: August 2010. (Same P/N as above.)

Part Total Time: 573.6 hours

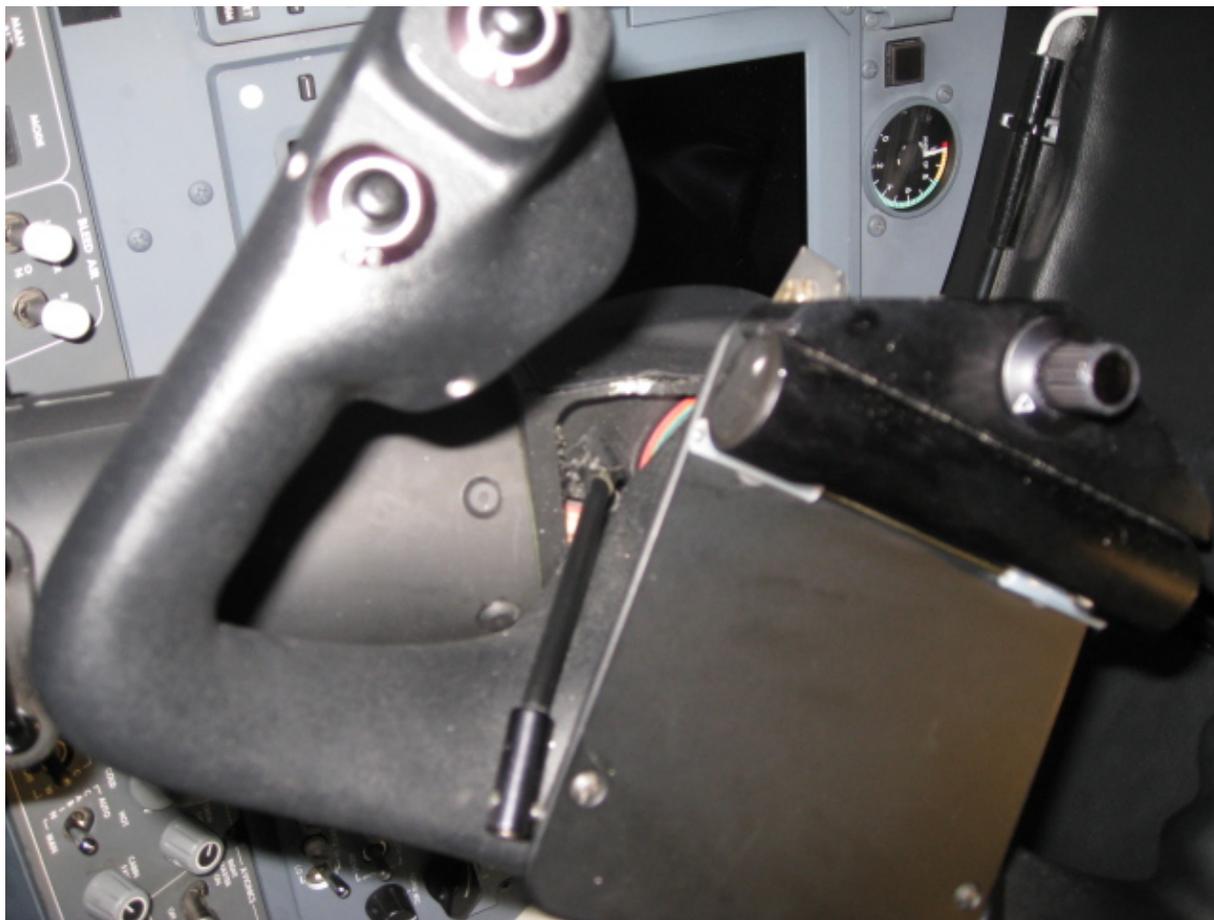
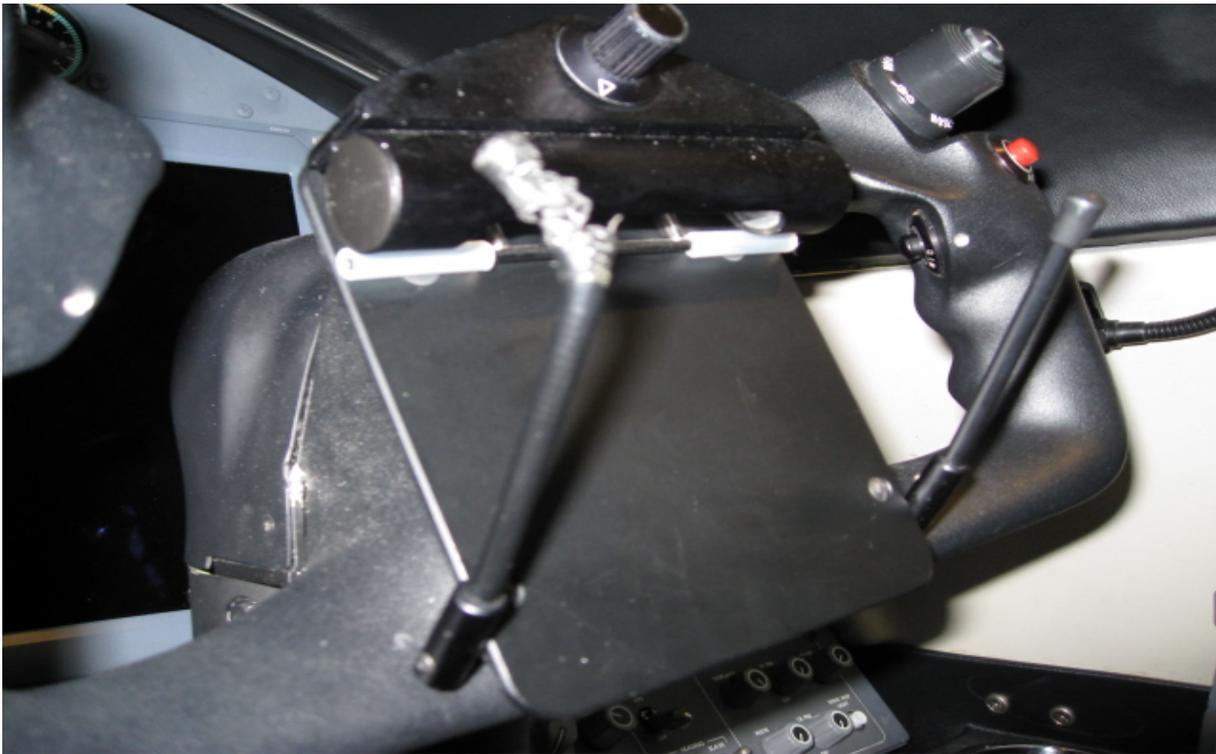
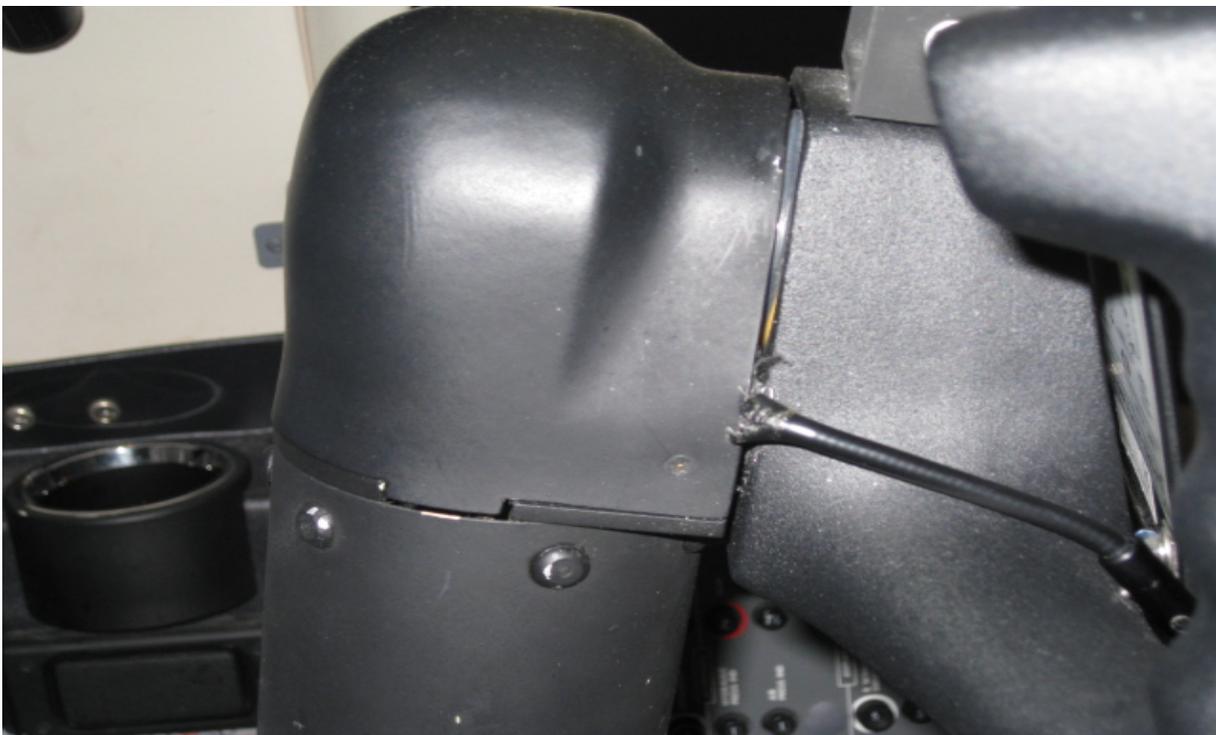
**Learjet: 60; Chart-holder Binding Aileron Controls; ATA 2510**

"During completion of the takeoff climb," says the submitter, "the PIC (*pilot in command*) reported there was trouble moving the aileron to the starboard position. The aircraft made an uneventful landing. (*After inspection*) it was found that the extension arms on the chart holder attached to the co-pilot's yoke were extended forward, and (*these*) became caught in the yoke cover, increasing the turning resistance of the aileron. The extensions were retracted and subsequent tests of the aileron movement revealed no further discrepancies.."

(*Chart holder P/N: 106201.*)

Part Total Time: 1,728.0 hours

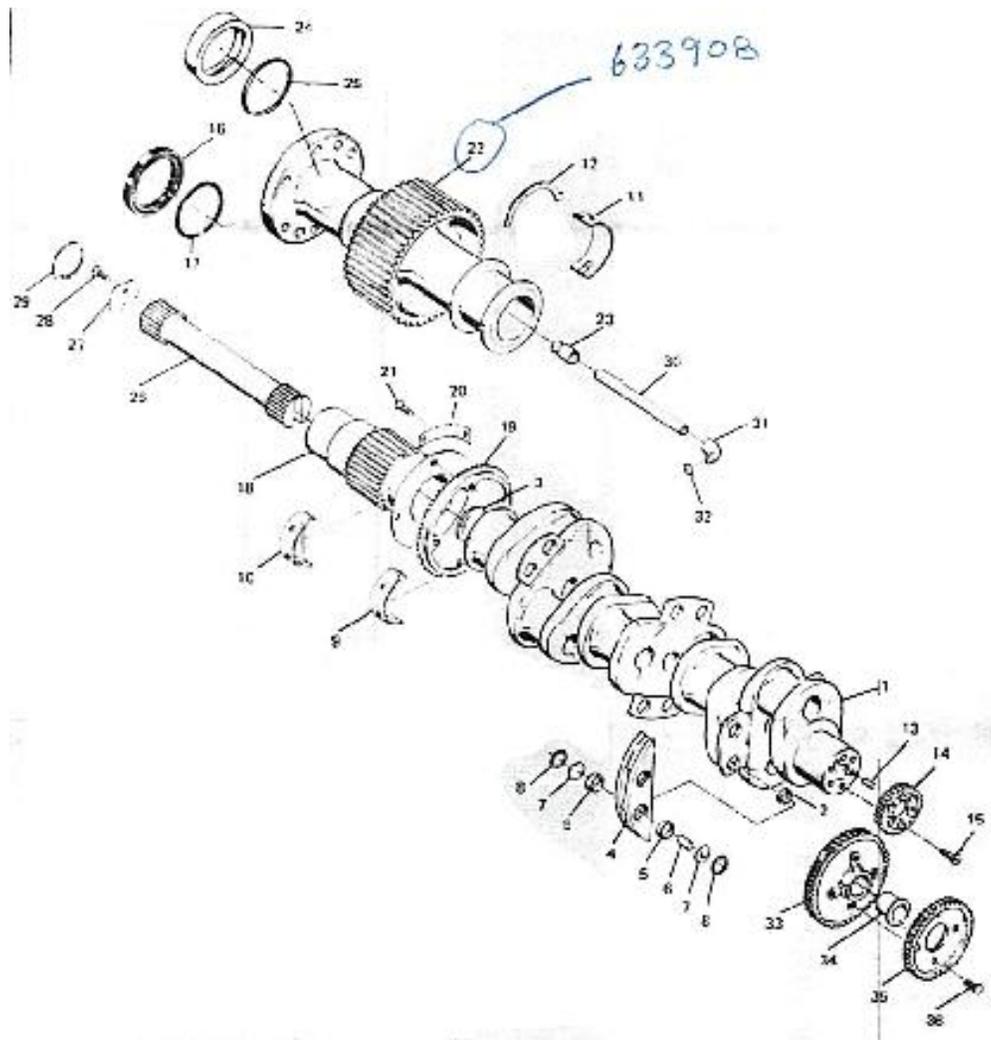
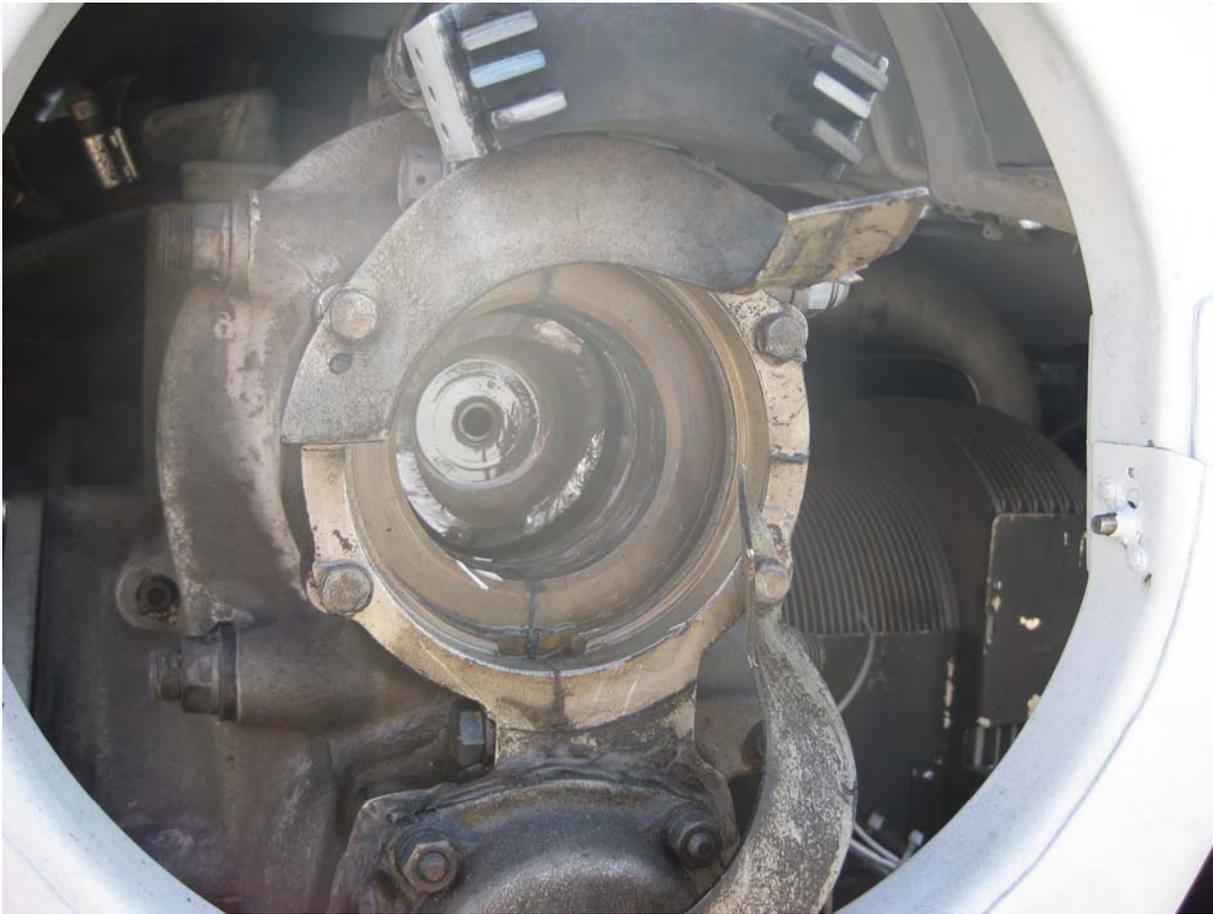
**Continental: GTISO520H; Cracked Propeller Shaft; ATA 8510**

"The *(Cessna 421)* pilot had a rough running engine," states a technician, "and difficulty controlling the engine RPM's. *(He)* shut down and feathered the right engine, landing safely at *(the airport)*. Maintenance performed repair *(work)* on the propeller control cable, and proceeded to perform an engine run. However, the engine would not develop enough RPM to un-feather the propeller. The mechanic boarded the aircraft to observe the gauges—at which time the propeller separated from the engine. It has been determined by metallurgical *(analysis)* that the propeller shaft failed by fatigue cracks from an initiating crack, followed by fracture. The fatigue cracks grew over some period of time." *(Propeller shaft P/N: 633908)*.

Part Total Time: 1,349.0 hours (time since overhaul)

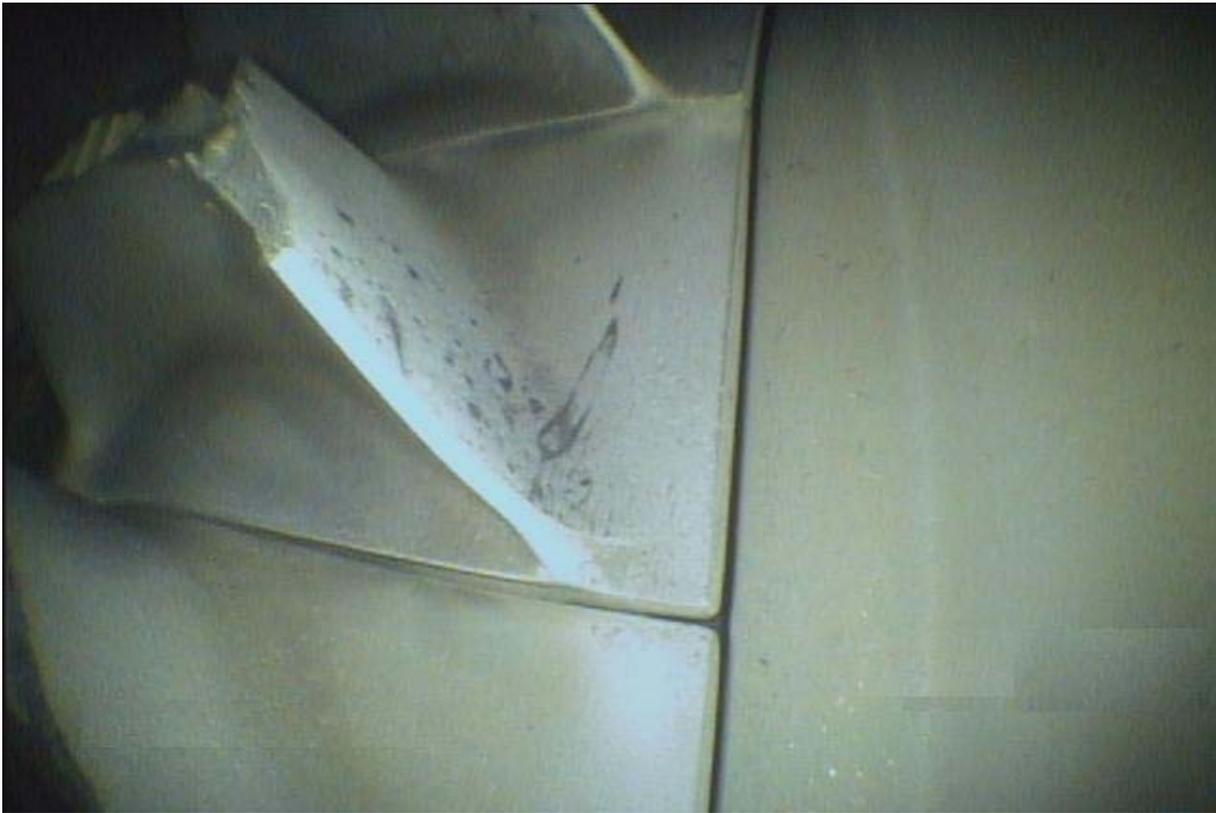
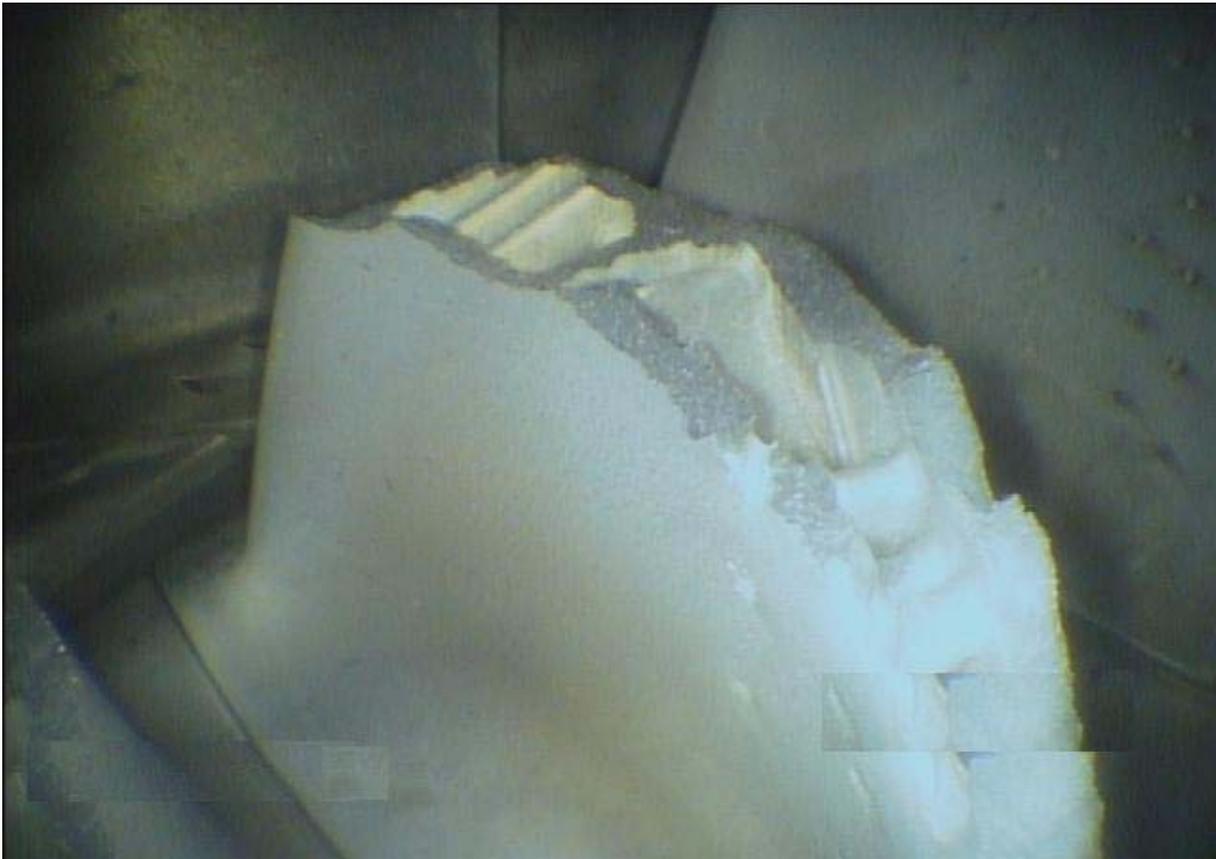
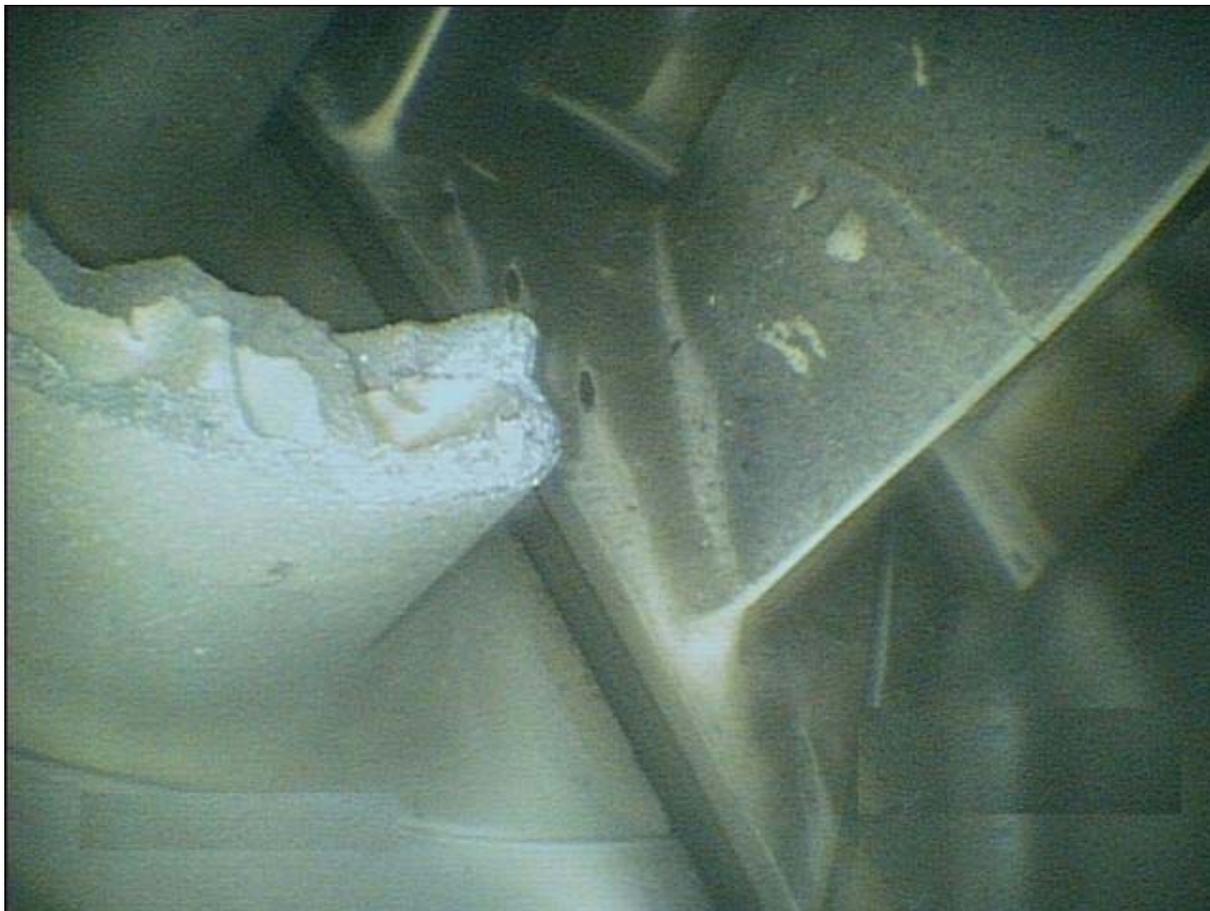
**Pratt & Whitney: PW306A; Failed Turbine Blade; ATA 7250**

A technician says, "About 45 minutes into the flight and climbing through flight level 360, the crew heard a loud 'bang' and felt vibration. The ITT (*internal turbine temperature*) began an immediate climb, followed by the 'FIRE' light and smoke in the cabin. The crew brought the throttle to idle, shut down the engine via the fuel cutoff switch, declared an emergency, and was vectored by ATC to the nearest suitable airport."

Part Total Time: 3,195 hours

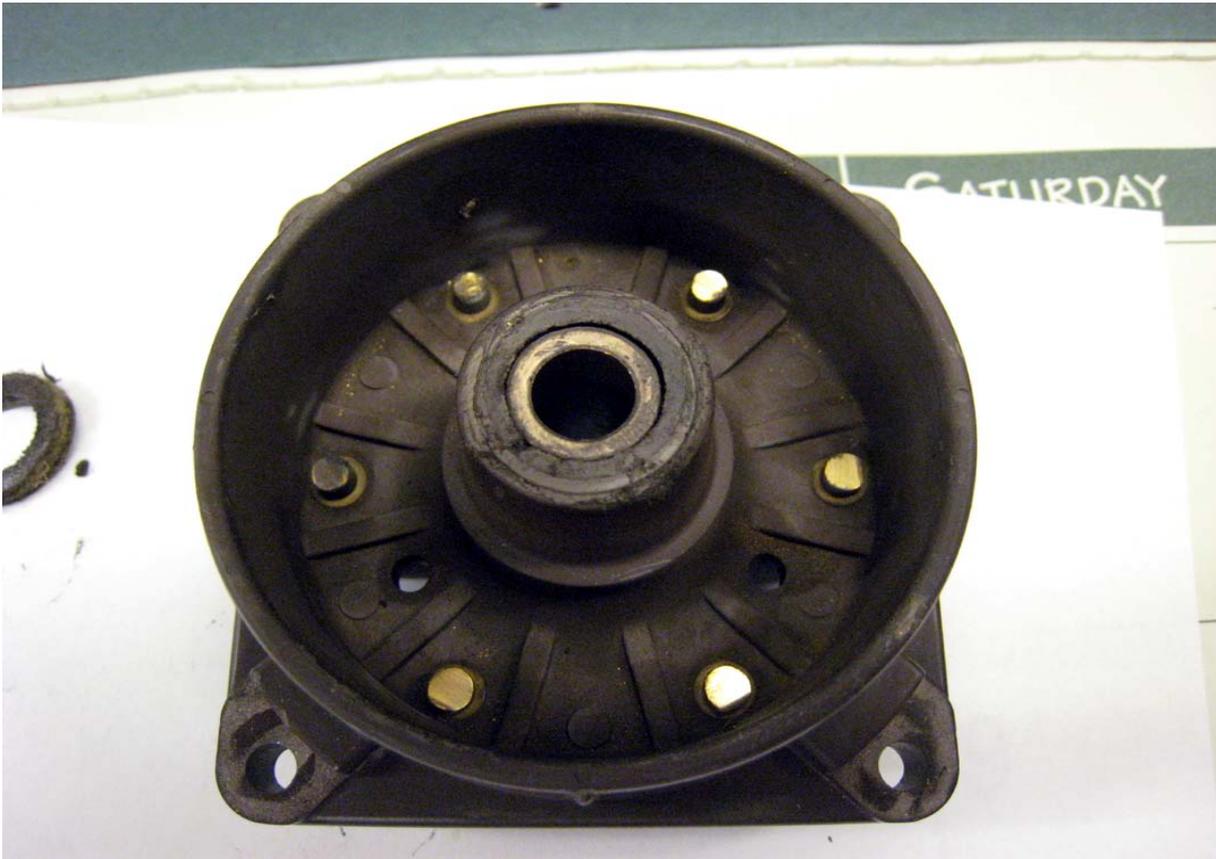
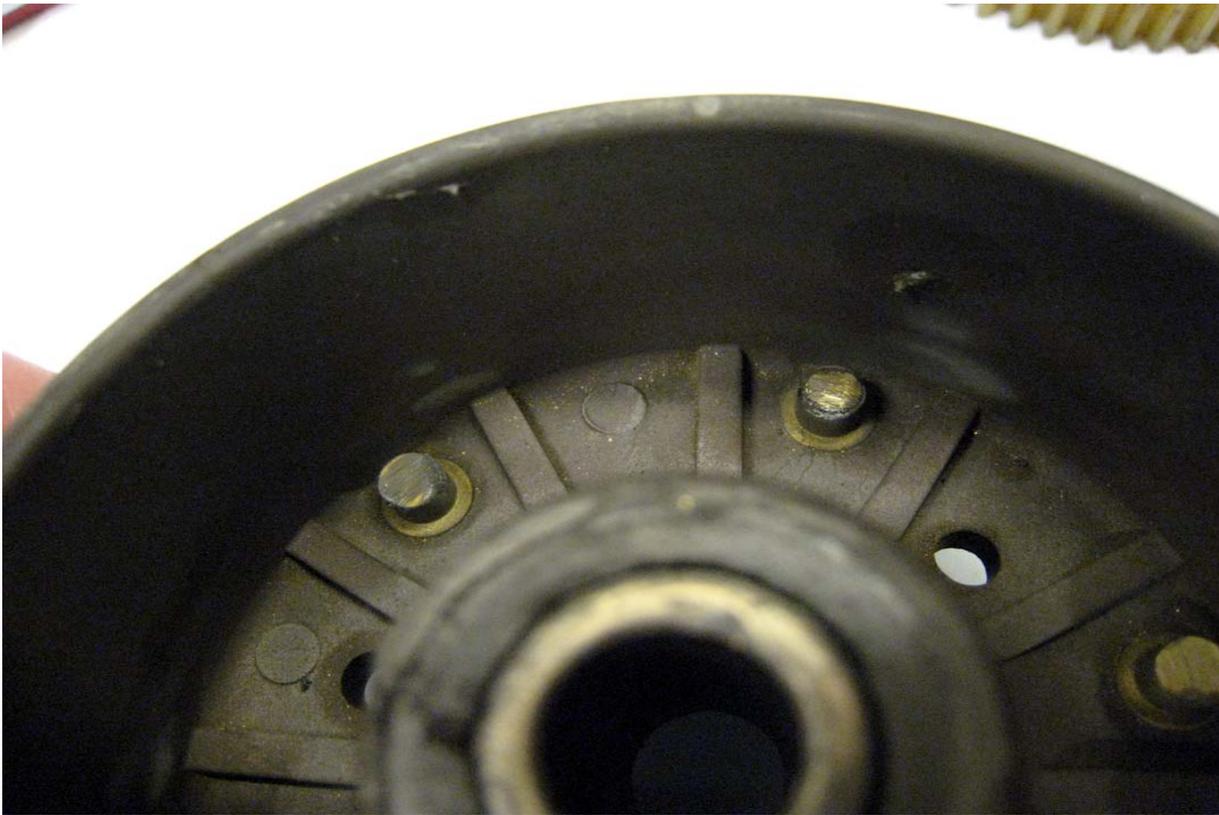
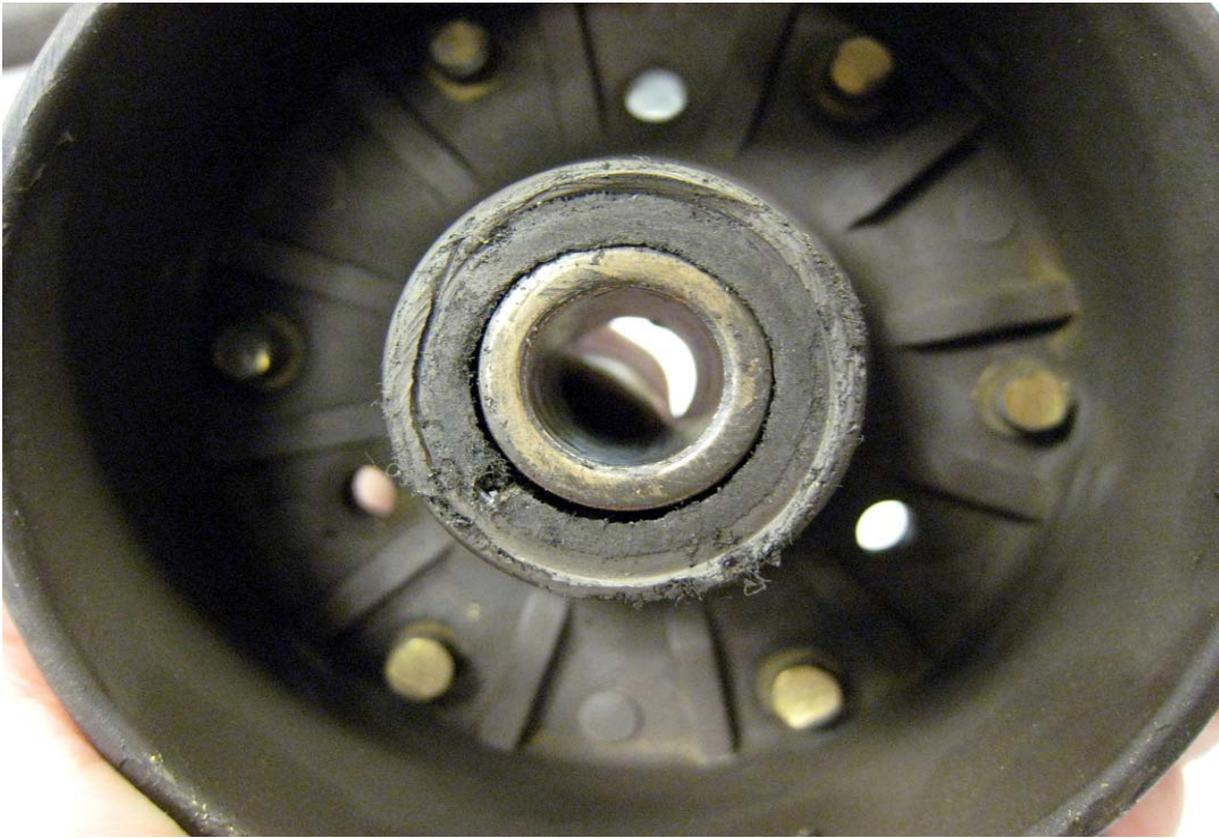
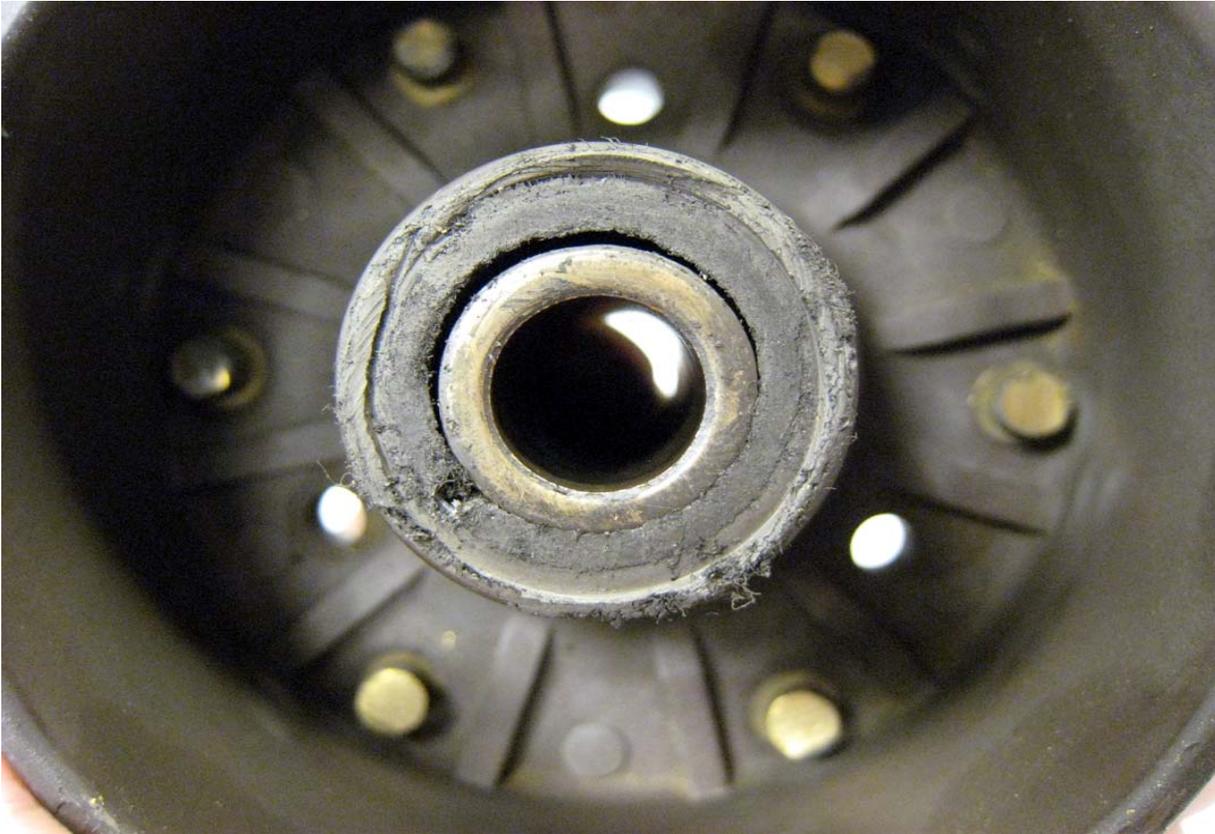
### **Bendix Magneto: S6RN1225; Failed Bearing; ATA 7414**

Chief Inspector Raymond Benischeck from Quest Diagnostics Flight Operations states, "During a preflight run-up, the left engine was observed to only produce about 2000 RPM. Inspection of the left magneto revealed the bronze bearing had become loose in the distributor block, allowing the distributor gear electrode to strike and damage several of the distributor block electrodes. This is the third instance of a Bendix 1200 series magneto to fail in this condition—around 1300 hours. These magnetos have been inspected in accordance with the 500 hour requirements of the TCM 1200 series maintenance manual at the required intervals. All these failures have occurred within a six week time frame. TCM has been contacted and they are aware of two other, similar failures. They are performing analytical inspections on the returned units." *(Component number: BL3493504; the Part Number 10391586 reflects eight times in the SDRS database—all for loose bearings!)*

Part Total Time: 1,307.0 hours
