**Federal Aviation
Administration**

ADVISORY CIRCULAR

AVIATION MAINTENANCE ALERTS

**ALERT
NUMBER
398**

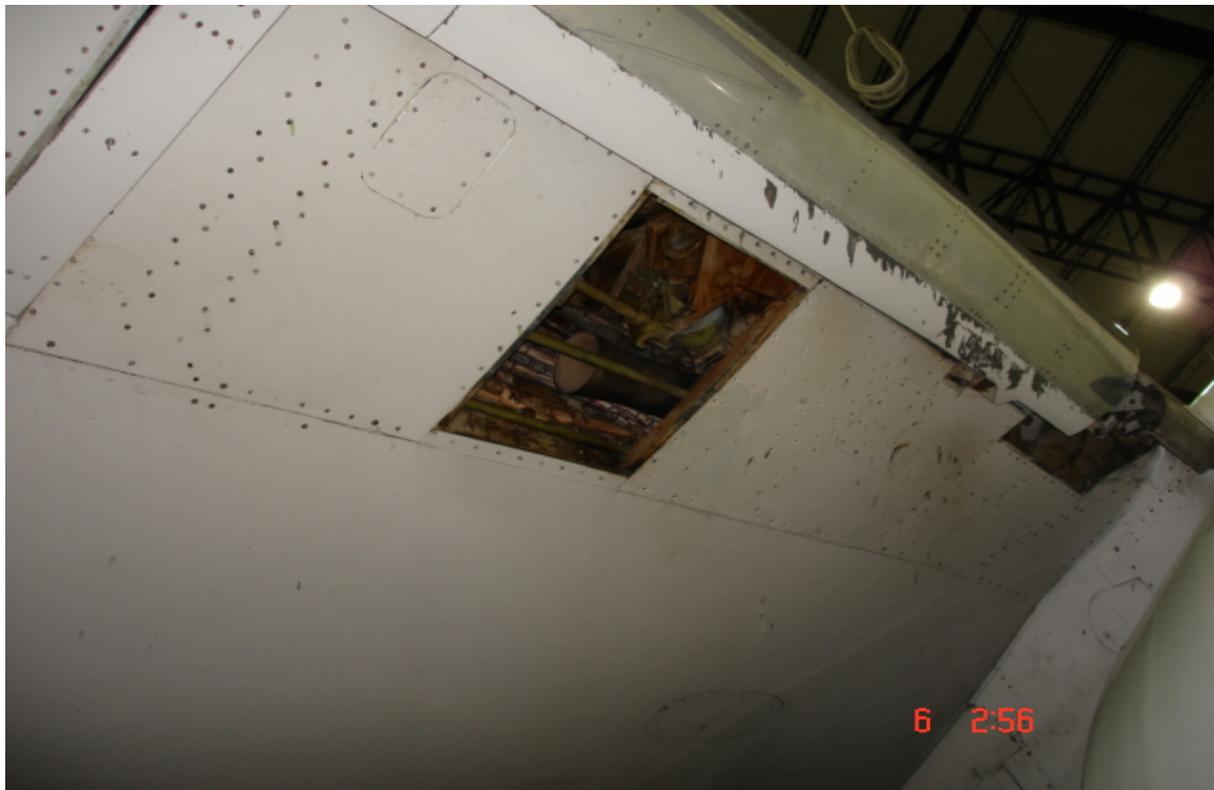
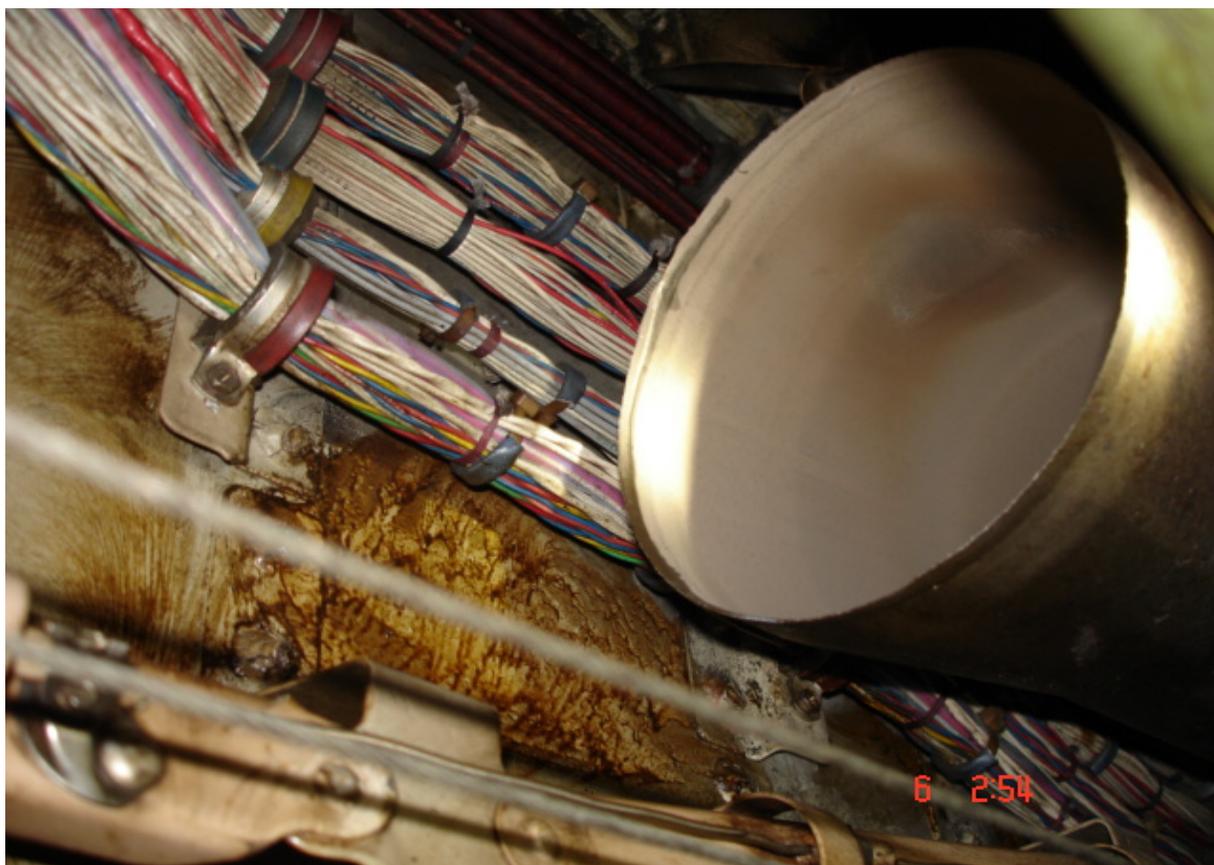
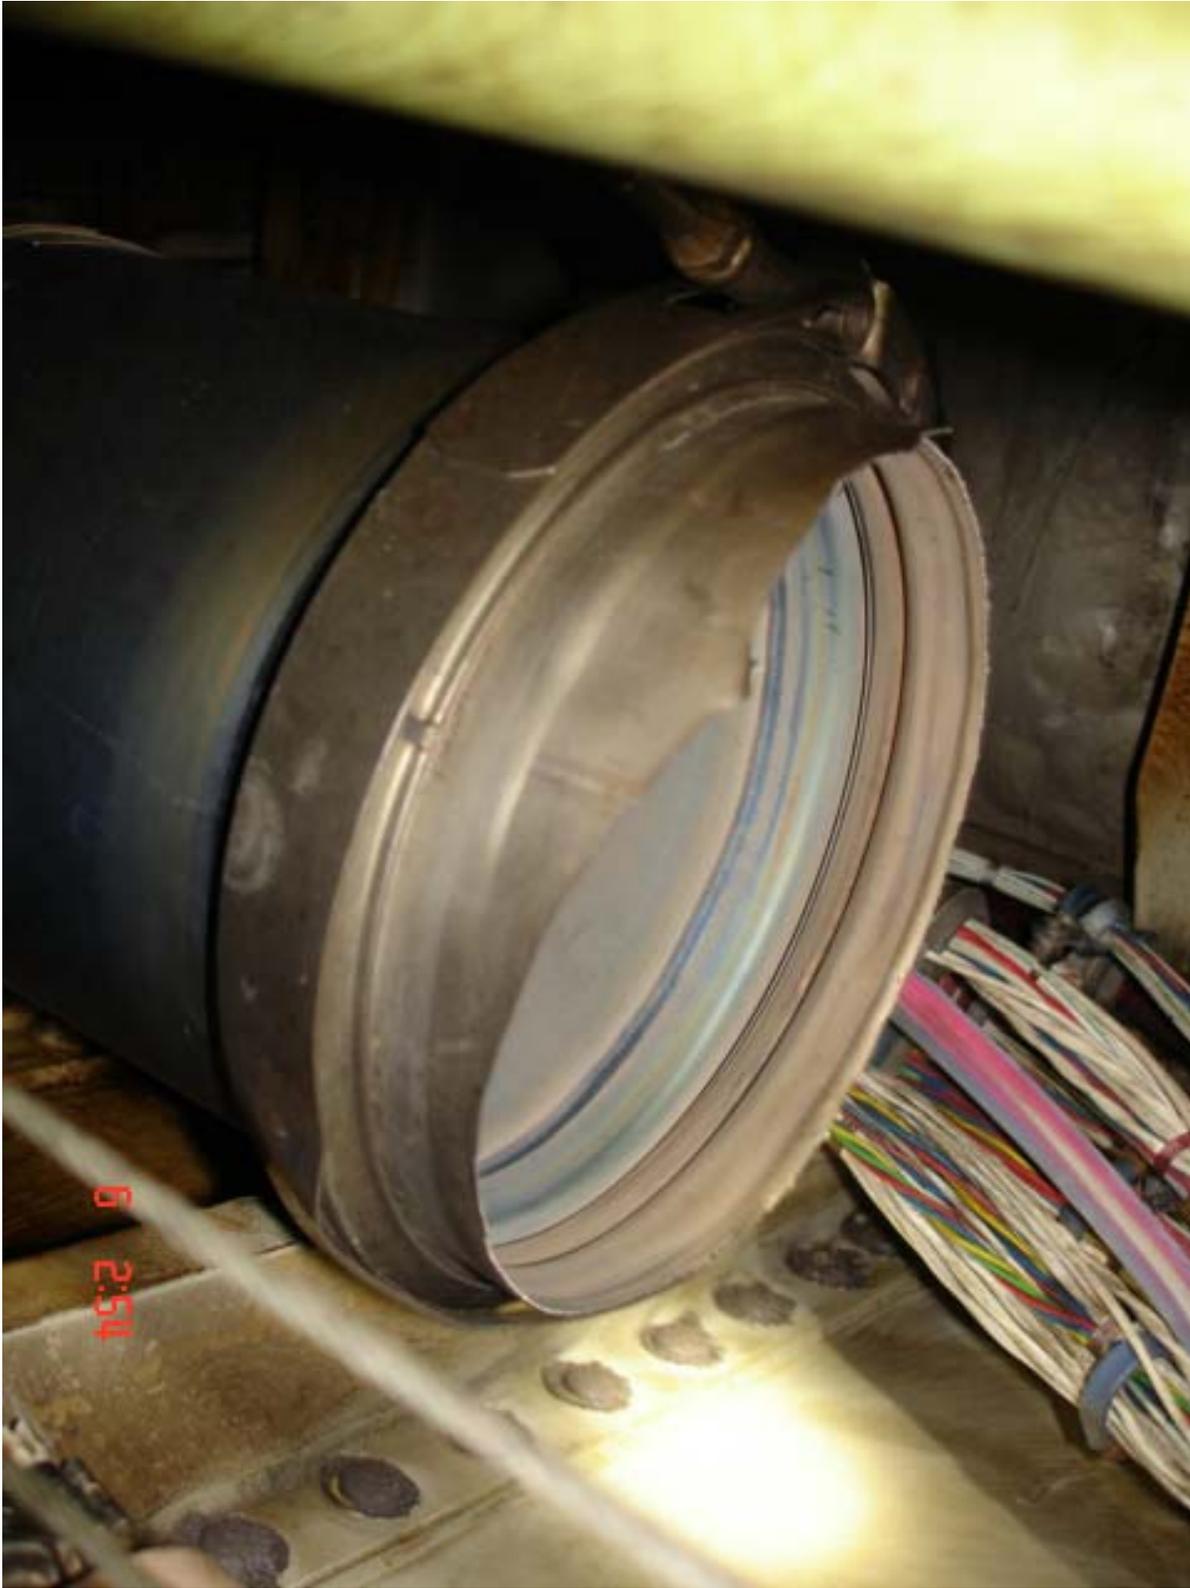
Boeing: 767-200; Broken Bleed-Air Duct; ATA 3610

A pilot's report states, "During takeoff, the EICAS (*Engine Indicating and Crew Alert System*) gave a 'Left Bleed Duct' message, followed by 'Leading Edge Slat Asymmetry'. After 45 minutes of flight, the aircraft returned to (*base*). Ground inspection found the L/H wing, fixed leading-edge lower panel (511KB) missing, the L/H wing leading-edge air supply duct (and support clamp) dented and broken, (*a second*) support clamp (*missing*), the left wing (*number one*) engine thrust pulley broken, and the left wing duct leak-loop support channel (*also*) broken. This aircraft was declared 'aircraft on ground—no spare parts in stock'. The rupture of the ducts caused the 'bleed air' and 'slat asymmetry' (*warning*) messages. (*Maintenance*) performed dye penetrant inspections to all ducts of the pneumatic system to find cracks. No (*other*) cracks were found."

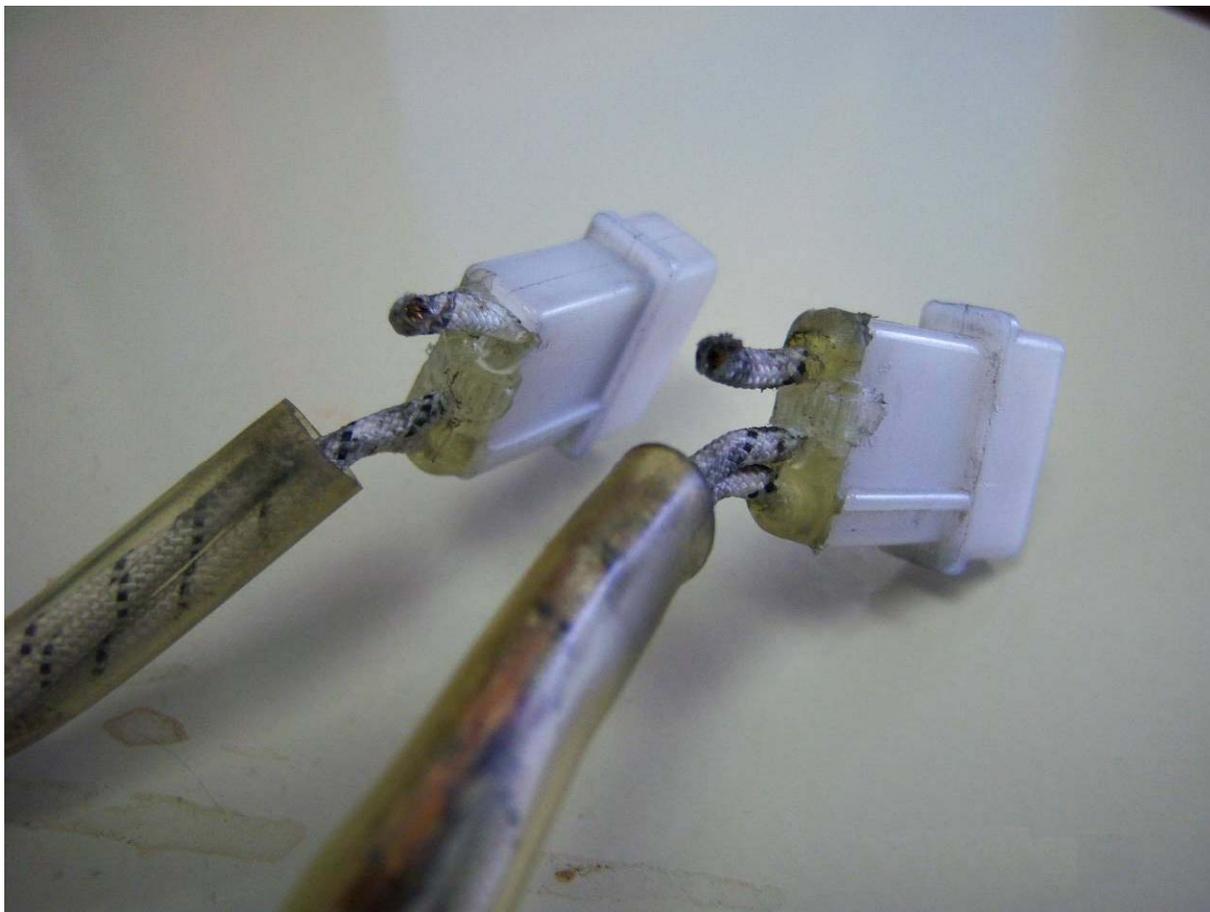
Swearingen: SA227AC; Burned Deice Boot Wires; ATA 6112

"During a routine service check inspection," says a Chief Inspector, "two of the four propeller deice boot leads (P/N SMR23692) were found to have broken and burned ground wires. The ground wires were broken in the exact same place and showed small signs of burned or singed insulation at the point where the wire separates." (*Rotol propeller model R321482F8.*)

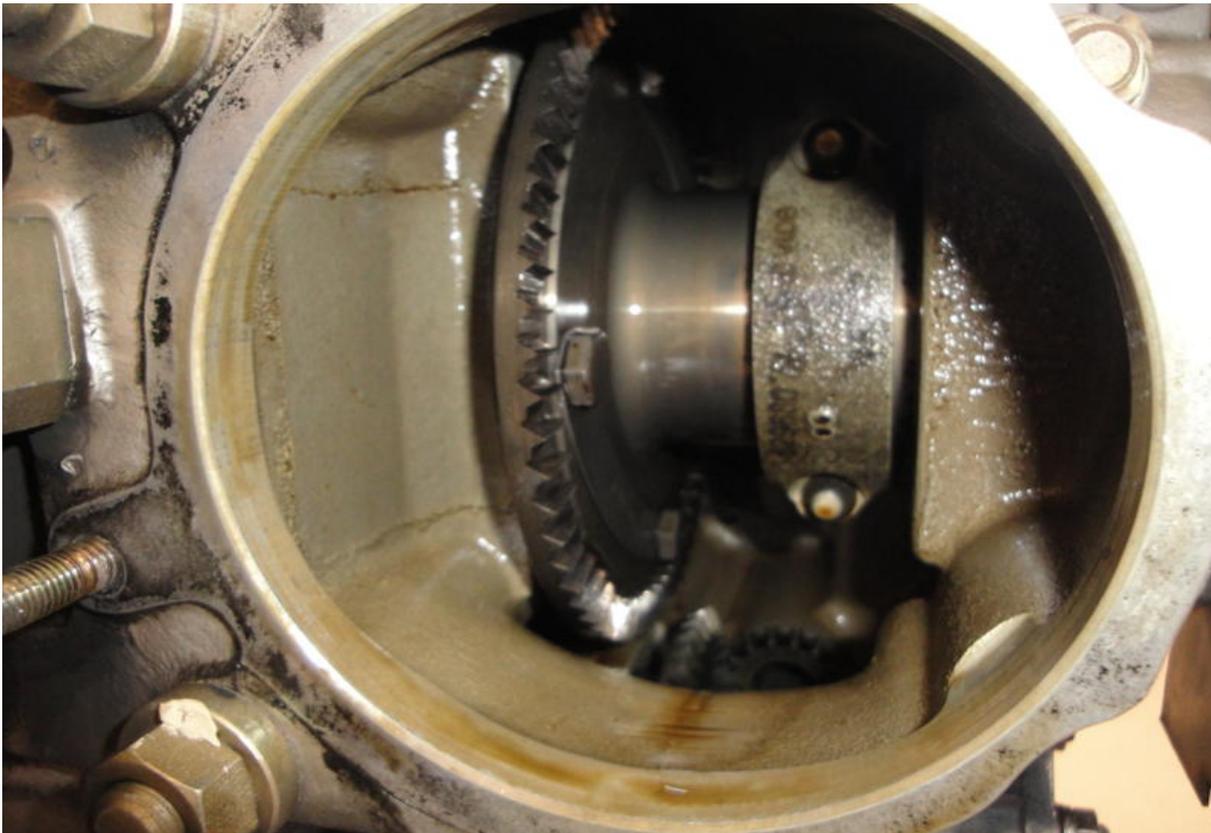
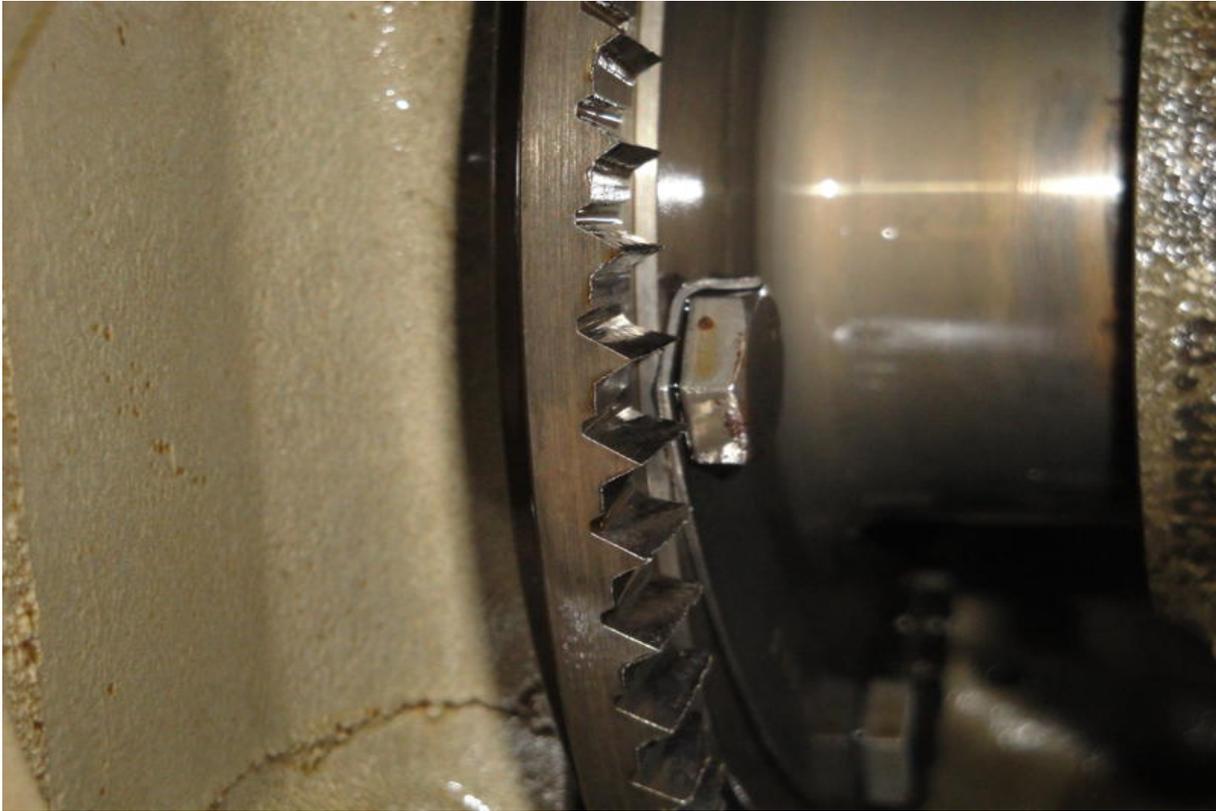
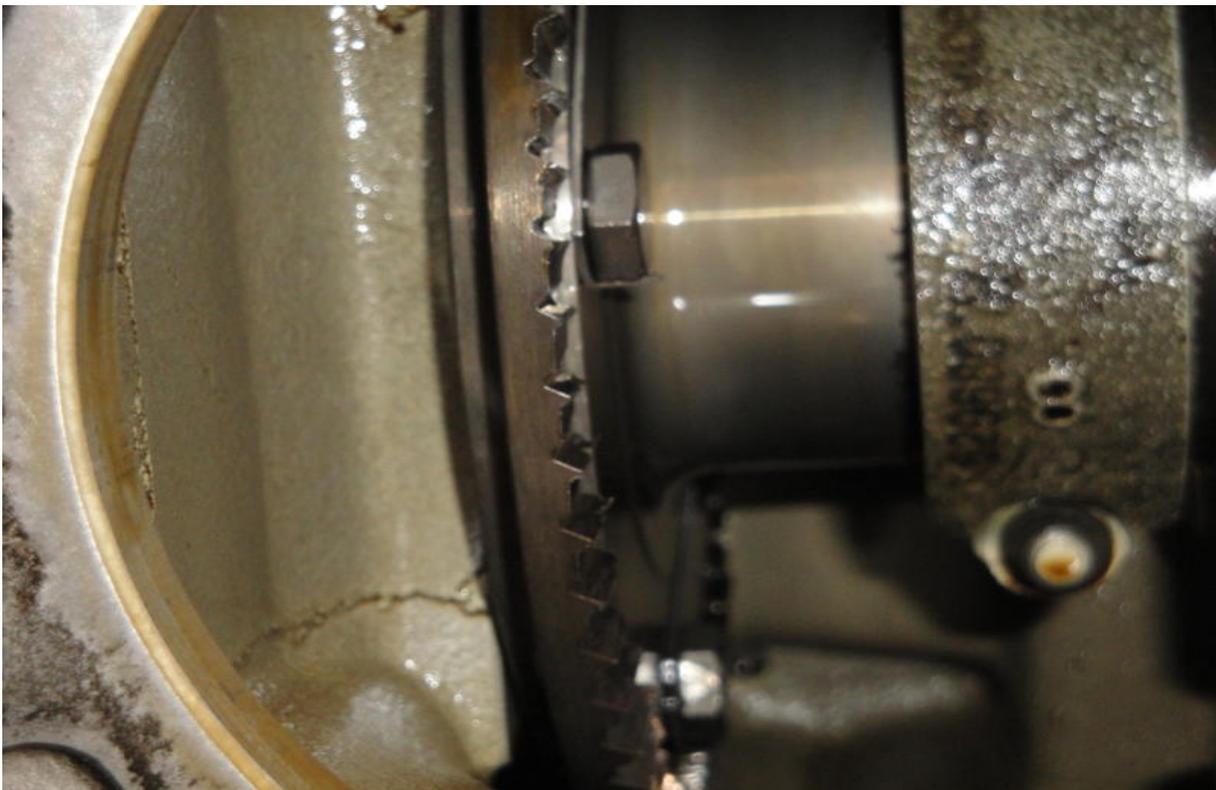
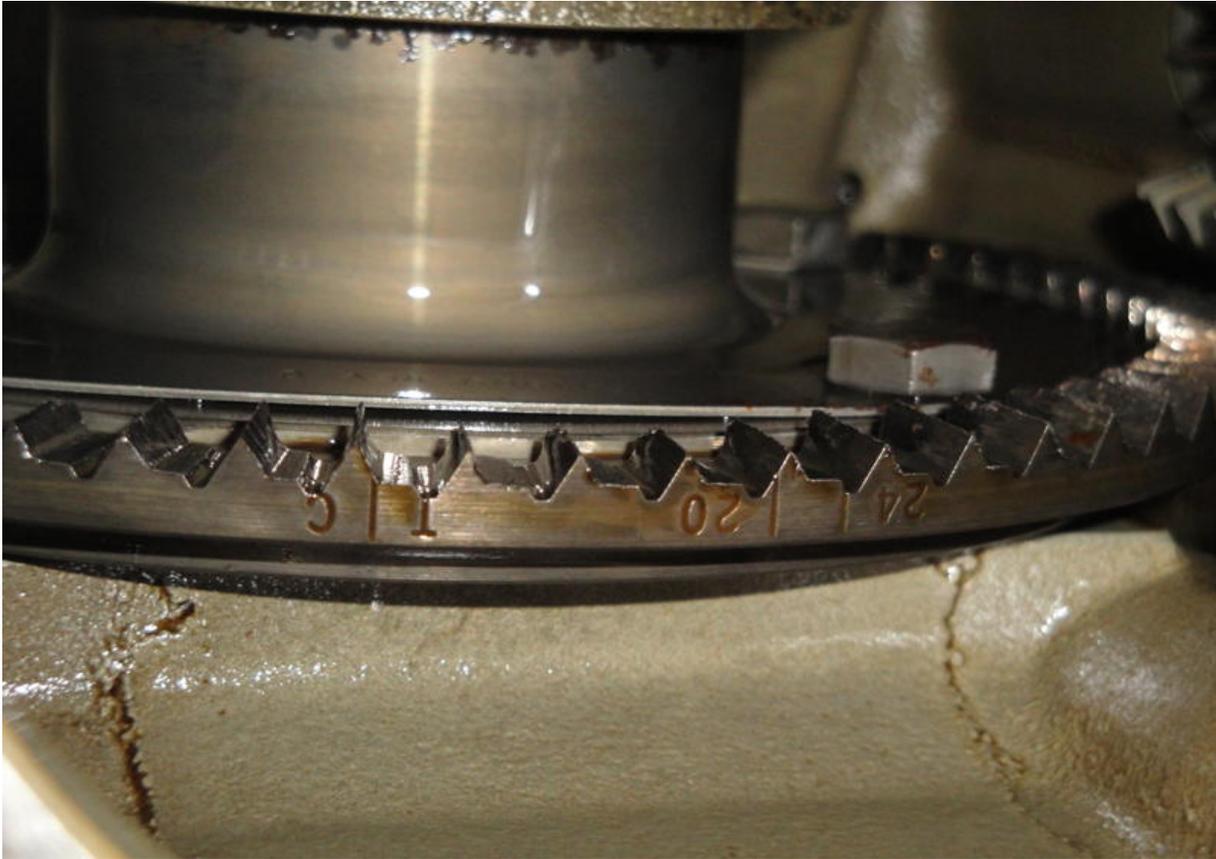
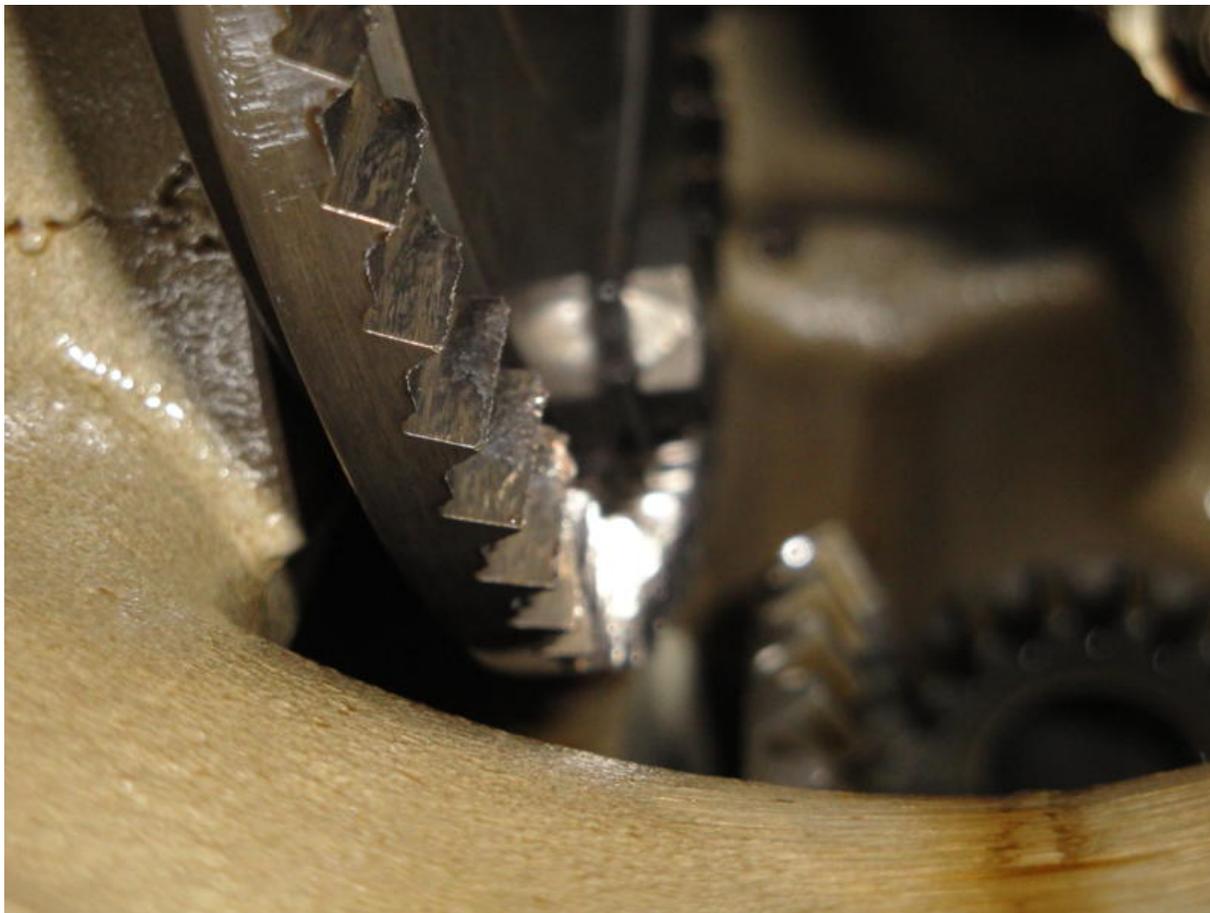
Continental: IO550N; Worn Crankshaft Gear; ATA 8520

"While performing an Annual Inspection of the engine," says this submitter, "*(I)* noticed the alternator housing was loose. I (*also noted*) the 500 hour alternator inspection was due. So, upon removal of the alternator for inspection, I (*observed*) all of the teeth on the crankshaft gear face were either missing or severely worn. There was no indication of alternator failure prior to this discovery. On the incoming engine run-up, oil pressure was (*seen*) to be on the lower side of the green band. However, the magnetic drain plug was covered with filings. Cutting open the oil filter found the paper element was covered in silver—(*but*) with no debris. If there wasn't a 500 hour inspection due on the alternator this problem would not have been found." (*Crankshaft gear P/N: 632018. The SDRS database reflects this part number eight times.*)

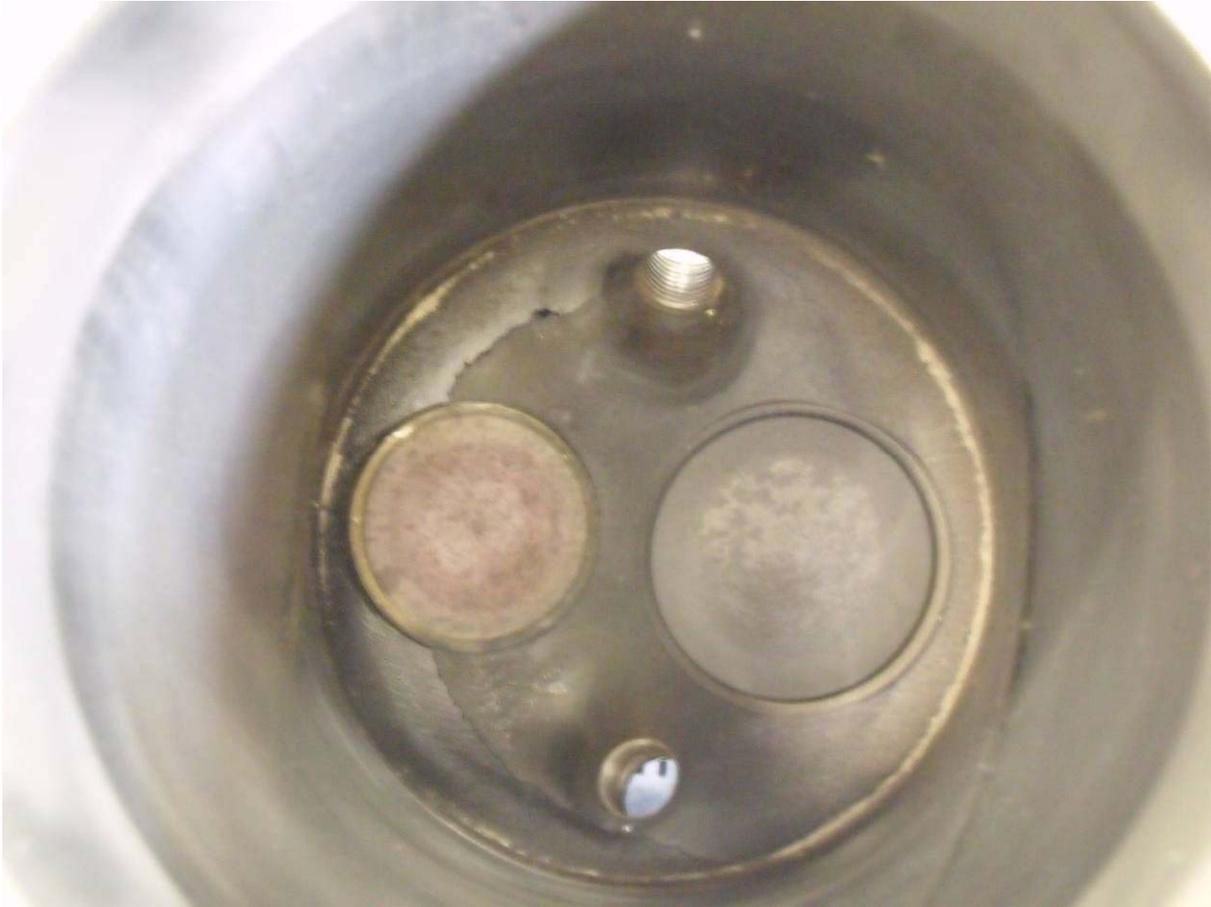
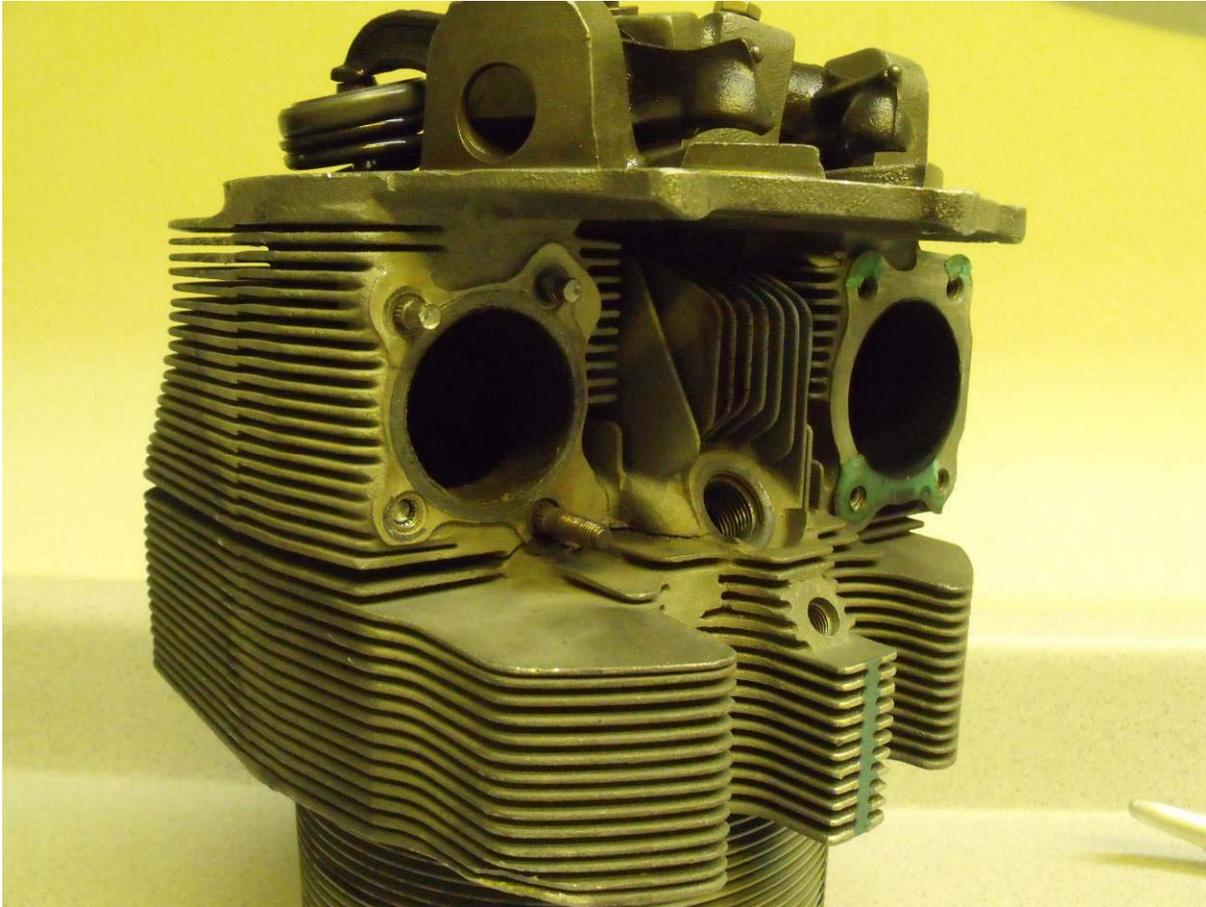
ECI Cylinder: ECC712CN; Cracked Head; ATA 8530

A technician states, "On initial climb-out the pilot noticed a vibration, and elected to return for landing. The number two cylinder was found cracked—from the spark plug past the exhaust valve, (*continuing*) approximately three-fourths (*the distance*) around the cylinder's head. This cylinder (*P/N ECC712CN*) had good compression two months (*ago*), after being repaired."

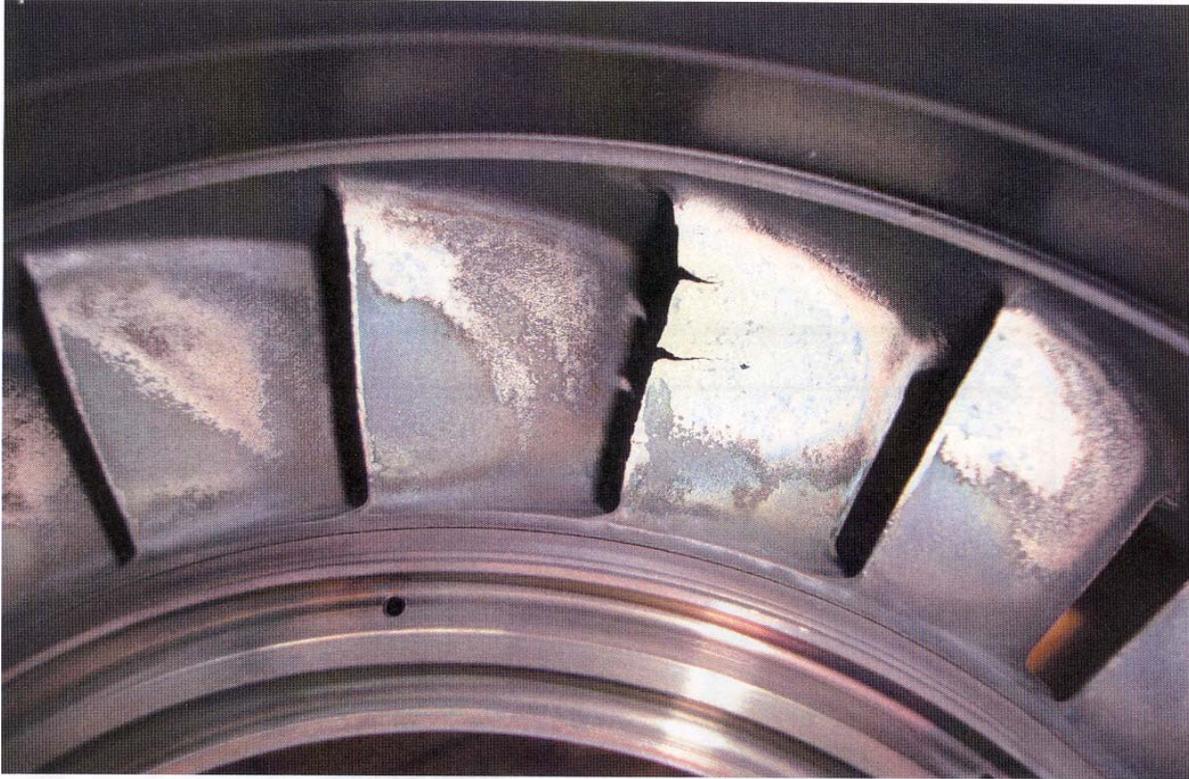
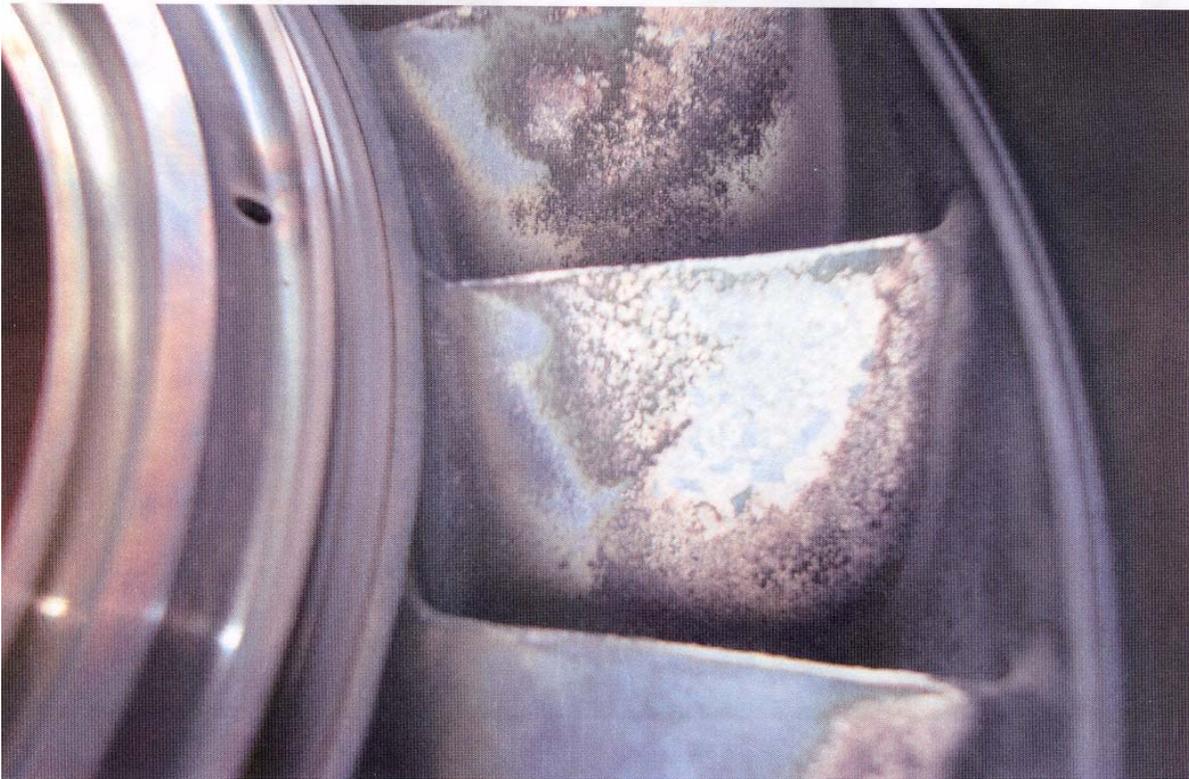
Turbomeca: Arriel 1D1; Cracked Nozzle Guide Vane; ATA 7250

"While performing modification TU347 to module 3," states this engine technician, "we discovered the second stage nozzle guide vane eroded and cracked. We reassembled module 3 and are sending it to a Turbomeca level 4 repair center for repair." *(Nozzle guide vane; P/N 2292401800.)*

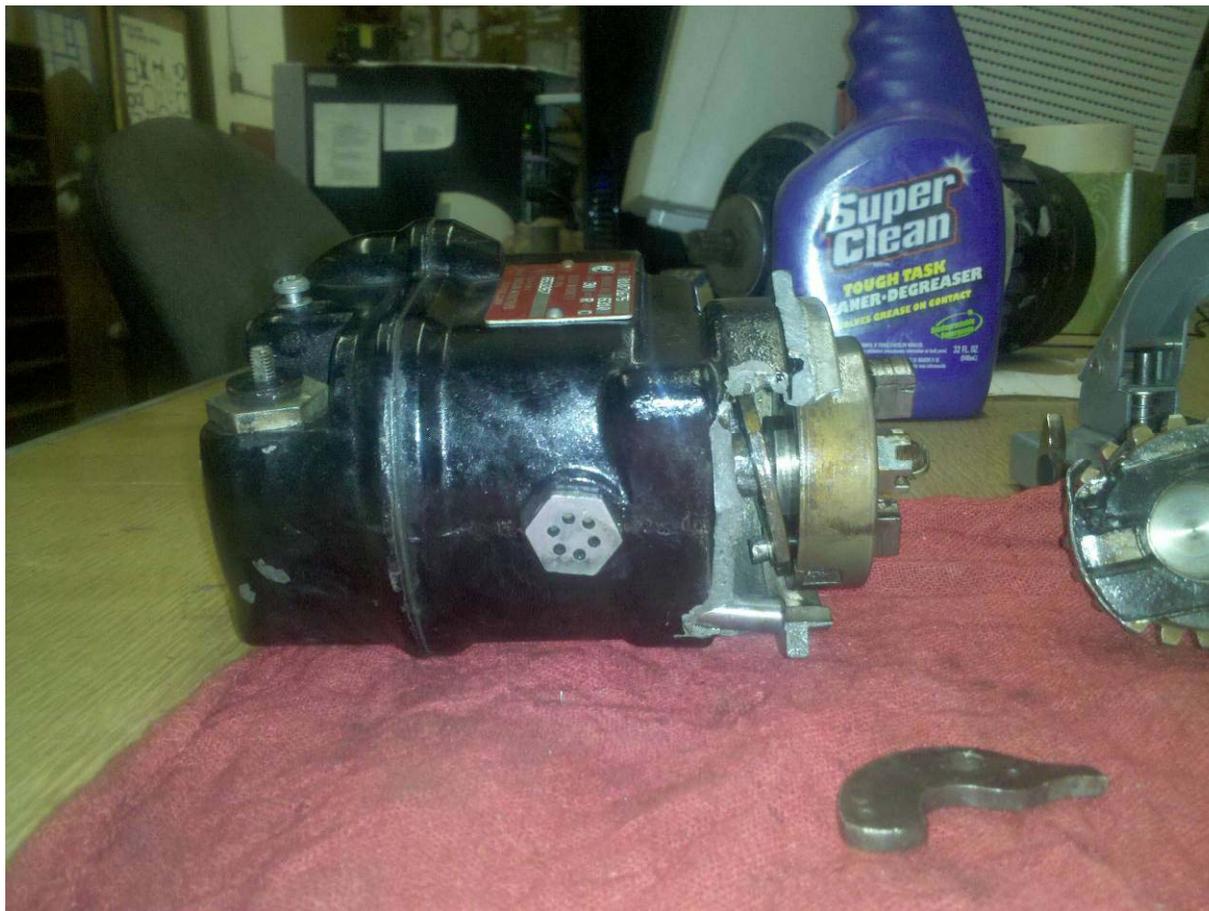
Slick Magneto: 6310; Fractured Housing; ATA 7414

An unidentified submitter says, "The impulse coupling came apart and fractured the magneto housing." *(The impulse coupling P/N: M3050 has 14 entries in the SDRS database. Magneto 6310 has 36 entries.)*
