U.S. Department of Transportation
Federal Aviation Administration

43-16A

AVIATION MAINTENANCE ALERTS

ALERT NUMBER 328

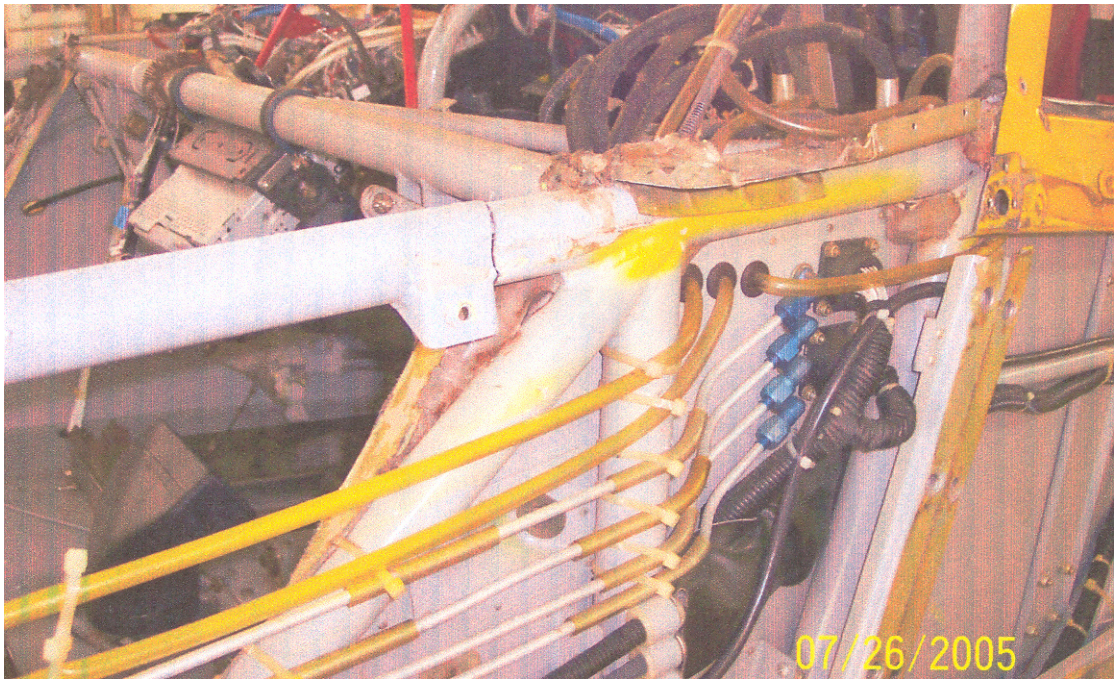
Ayres: S2R-T34; Cracked Longerons; ATA 5313

A mechanic's inspection of this agricultural airplane found significant structural failure. "Both upper longerons were cracked approximately 54 inches aft of the datum. The area is difficult to inspect as it is three-fourths covered by the hopper *(tank)*. Pictures were taken after the hopper was removed *(see below)*. This is a very unusual area to find such a defect. The aircraft has no damage history and has not been abused." *(Of six submitted scan photos, three are shown. They have been slightly cropped and rotated.)*

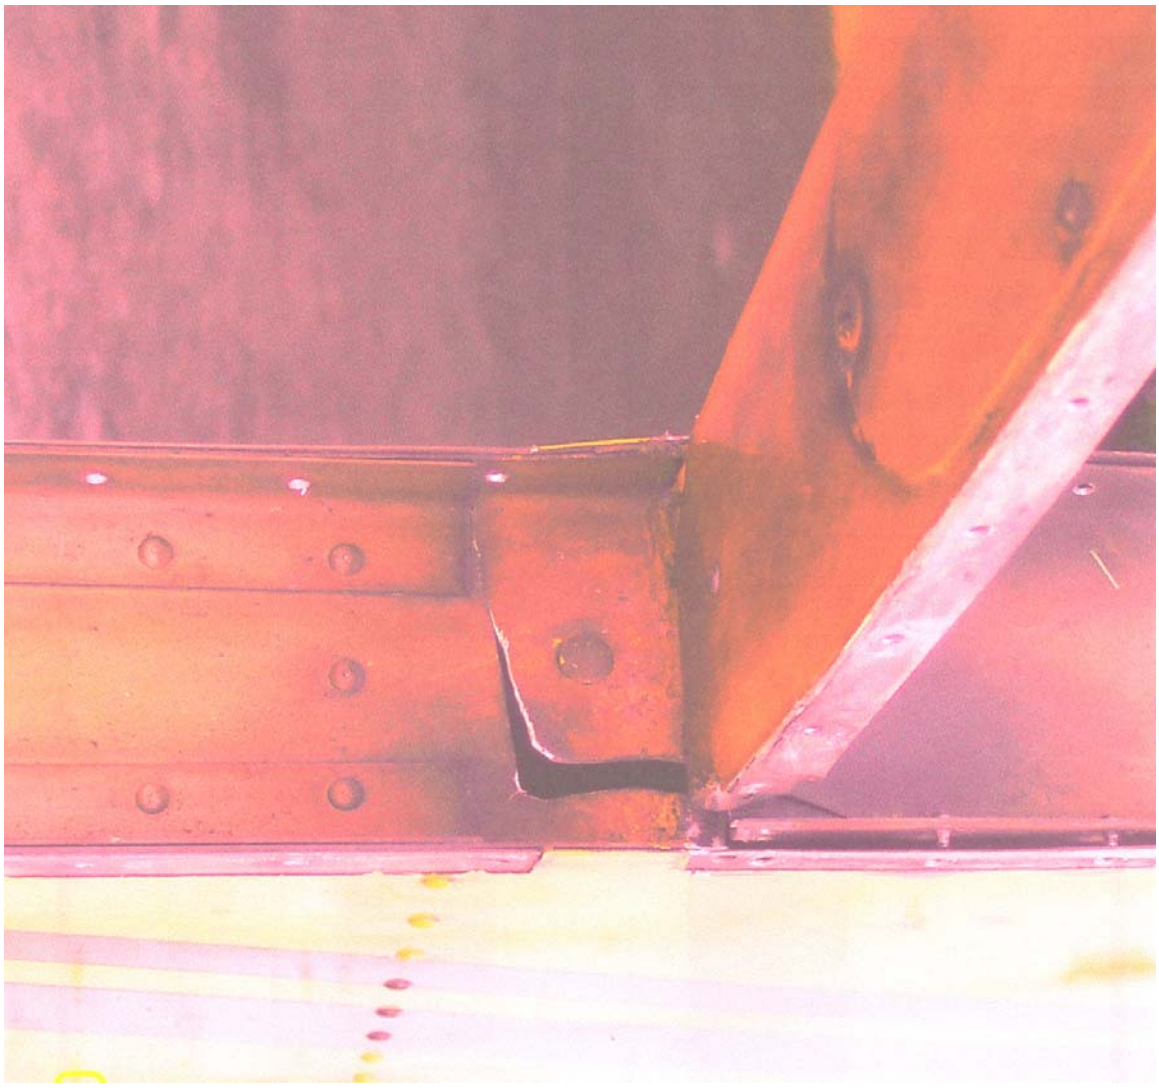
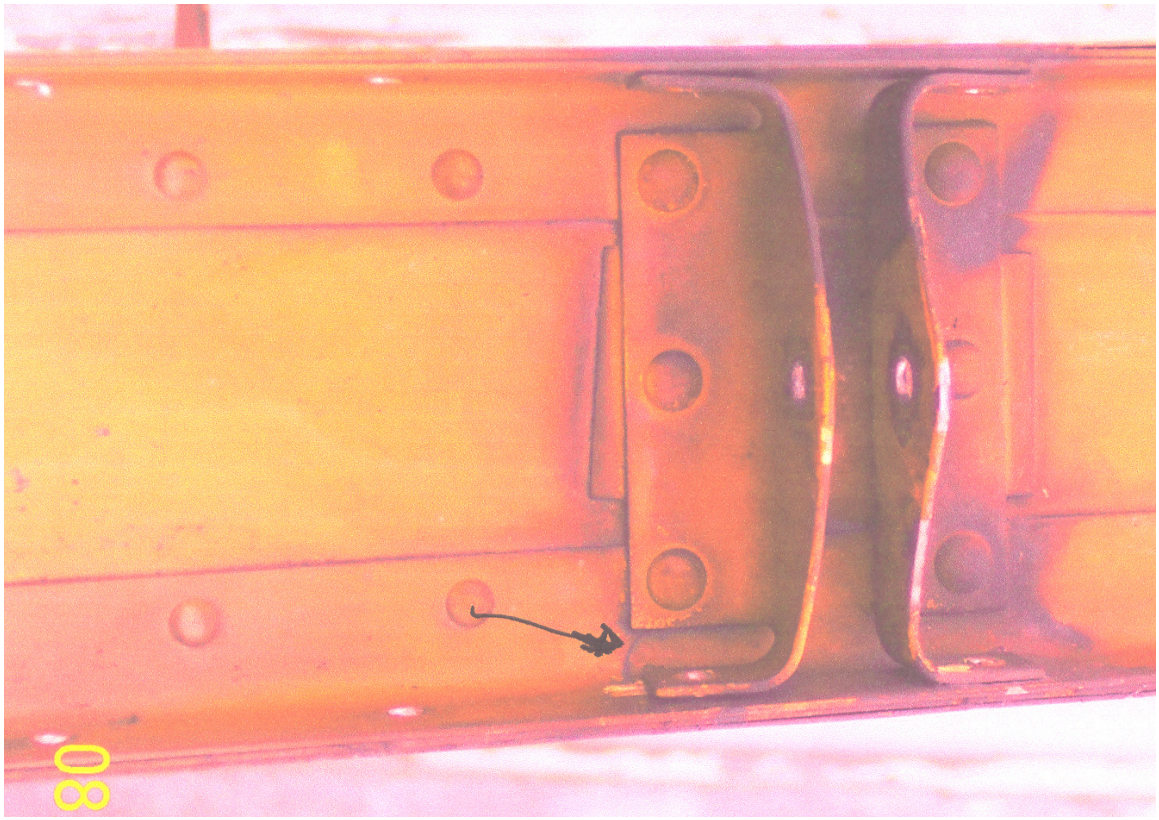
Ayres: SR-T660; Cracked Rudder Spar; ATA 5541

The submitter for the preceding report finds another crack. He states, "The upper rudder spar *(was found)* broken 12.5 inches above the upper hinge. In addition, the spar was cracked under the upper hinge fitting. This caused the rudder counter-balance to be loose, resulting in rudder flutter. Further flight could have resulted in loss of rudder control. The spar web is made of .040 inch aluminum channel with very little in the way of stiffeners. The spar needs to be beefed-up. Photos are included." *(Part numbers were not provided. Four of nine submitted photographs are shown below. They have been cropped from their original size.)* (A 1996 SDRS entry for a similar aircraft described multiple cracks found in this rudder spar and its connecting ribs. Submitter believed designed reinforcement was required for this rudder structure.)

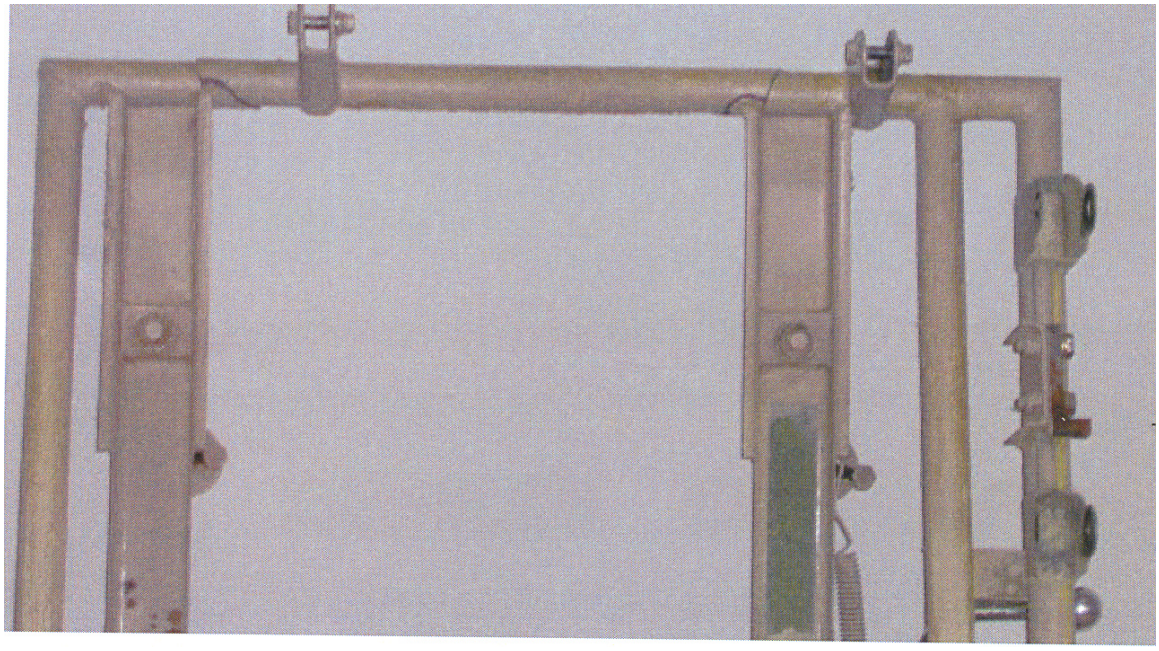
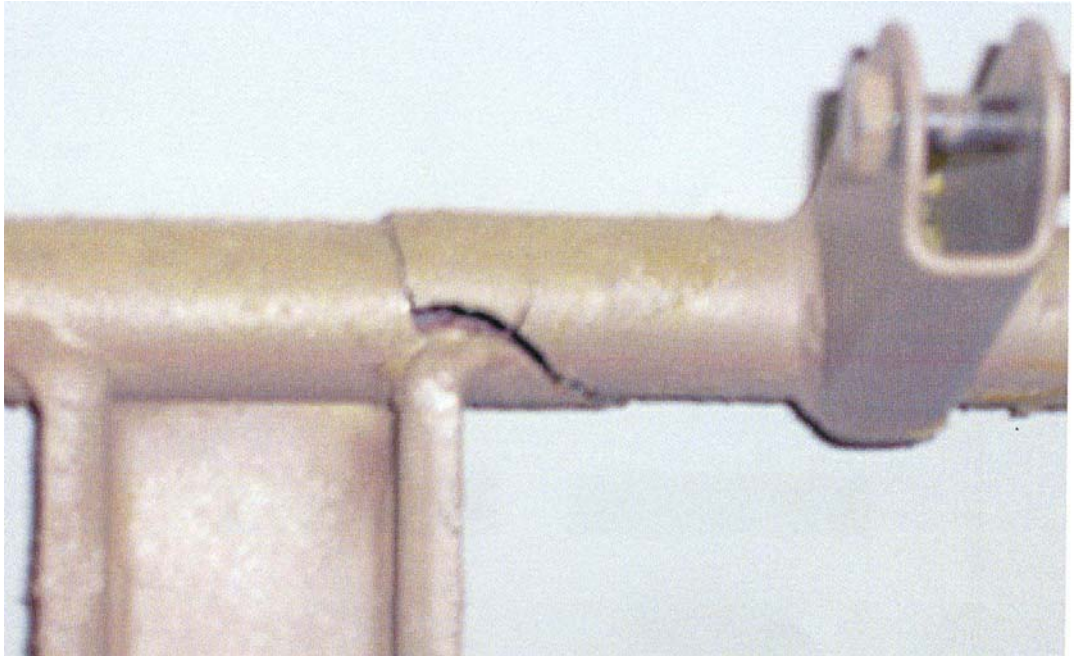
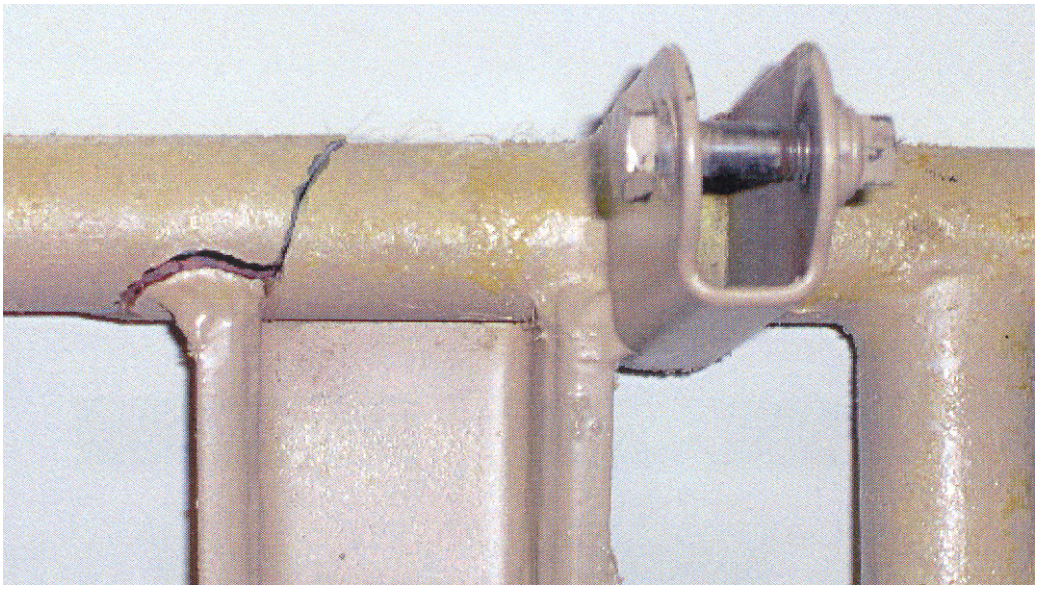
Cessna: 550; Cracked Seat Frames; ATA 2510

A repair station technician finds this aircraft's seat structure broken (P/N 5519009-22). "The upper chair base assembly is cracked at the chair back attach points." He speculates stress and metal fatigue are the probable cause of this discrepancy. "The chair was repaired in accordance with Aviation Fabricators STC ST01042WI Structural Seat Repair." *(See also last July and September's Alerts for similar defects. SDRS search yields nine entries. Factoring in repaired frames never reported, it would be wise to inspect these items frequently.) (Pictures have been slightly cropped.)*

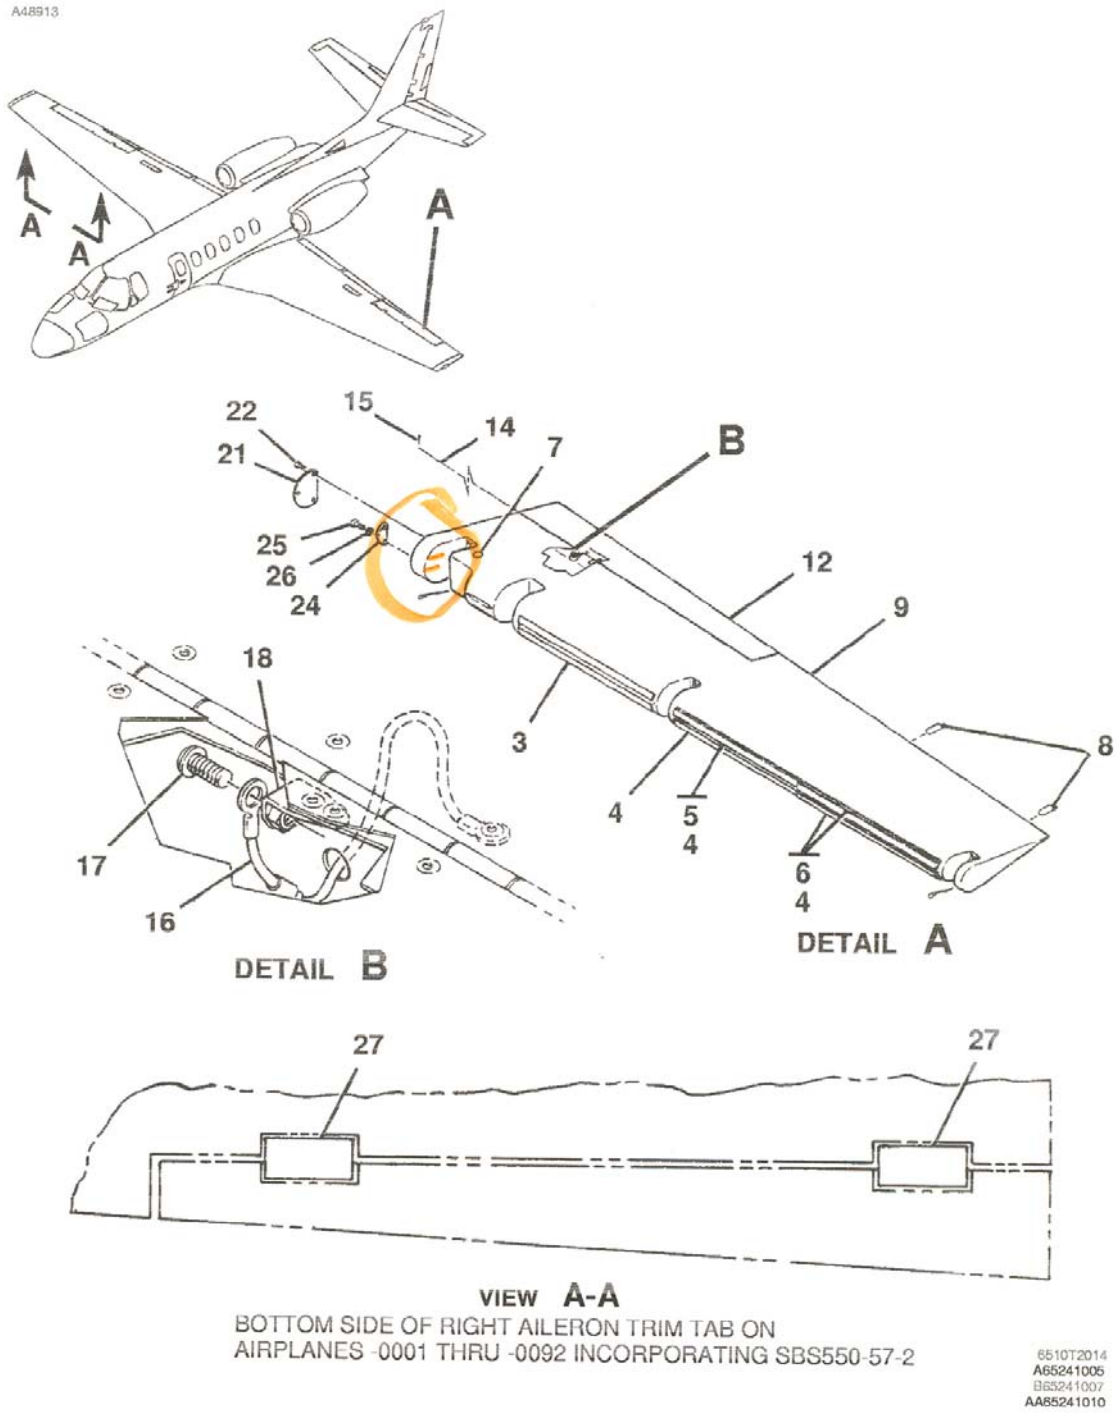
Cessna: S550; Loose Aileron Balance Weights; ATA 5751

A technician notes what appears to be "...cock-eyed" bolt heads on the aileron balance weights during a phase 2 inspection (P/N 6524004-12). Further investigation revealed the weight stack had developed significant corrosion, which enlarged the retaining bolt holes. This also allowed the stack to be loose. New parts were installed to fix the discrepancy. "Detailed inspection of this area is not on any inspection form. I suggest operators of this model aircraft remove the ailerons and *(perform)* a complete and detailed inspection of these weights."

(The submitter cropped the specific page reference. Other included references may indicate this page as being from the Cessna Illustrated Parts Catalog: 57-60-00; figure 1.)

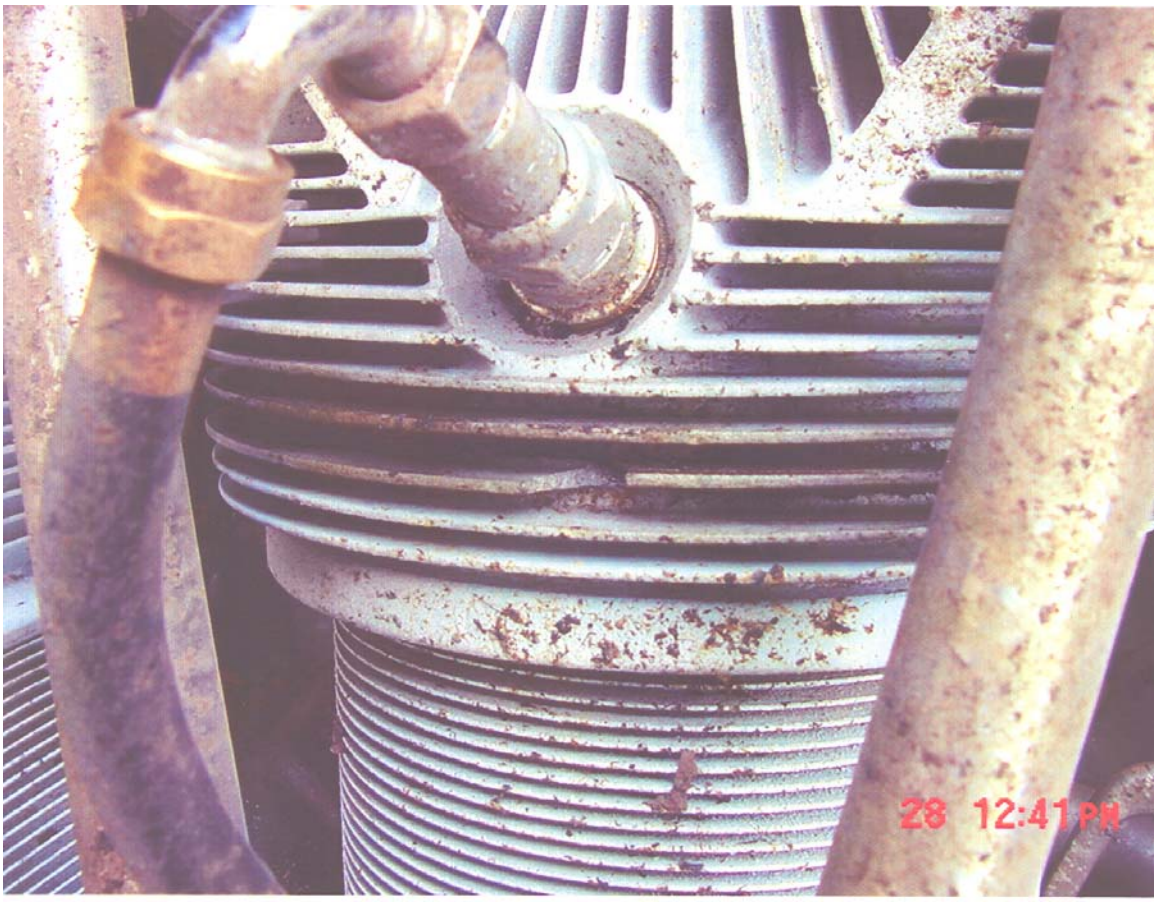
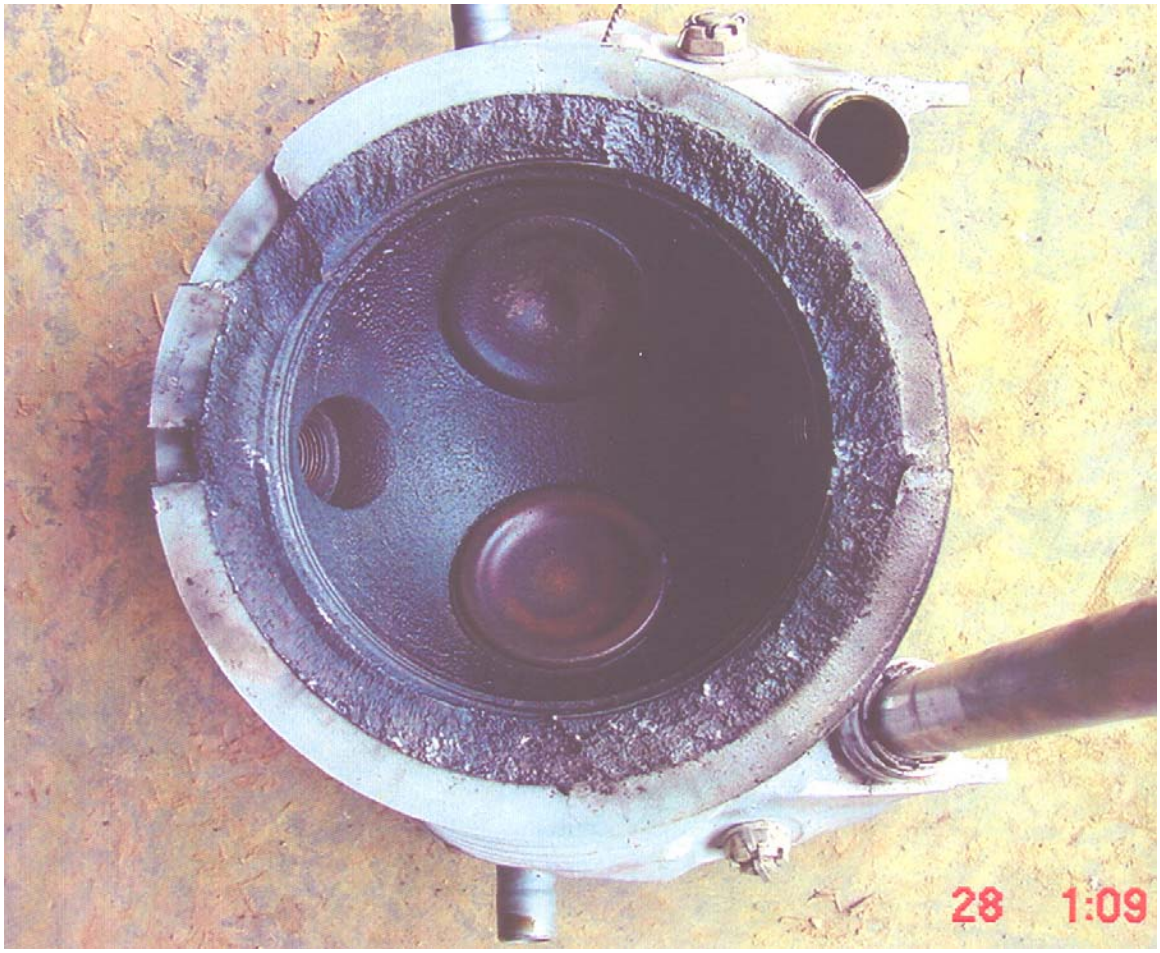
"During spraying operations," the submitter says, "the aircraft was climbing into a right-hand turn. The pilot heard a loud 'bang', then the engine began to run very rough. The aircraft made a forced landing.

"Inspection of the engine found the number two cylinder head *(P/N 399354)* separated from the sleeve at the number three, larger cooling fin from the bottom. Airworthiness Directive 78-08-07 was complied with during the last overhaul, 43 hours earlier." *(This aircraft is a Weatherly 620B.) (Pictures have been slightly cropped.)*
