**Federal Aviation
Administration**

ADVISORY CIRCULAR

AVIATION MAINTENANCE ALERTS

**ALERT
NUMBER
393**

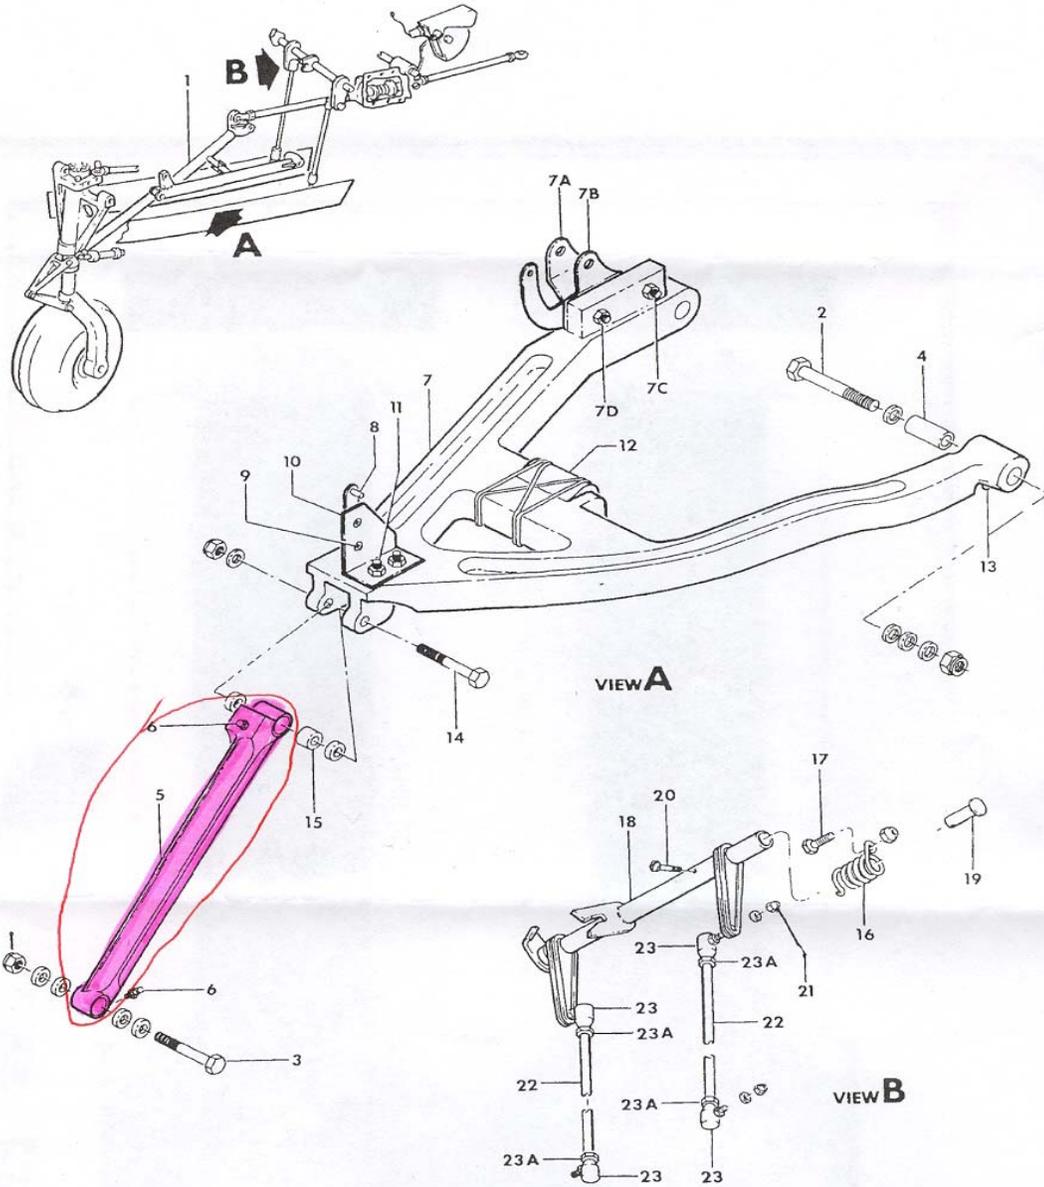
58P-212-14

Beechcraft: 58P; Failed Nose Gear Drag Leg; ATA 3230

An FAA inspector says, "*(This aircraft)* landed with the nose landing gear in the unlocked position. The pilot reported on take off the aircraft had a severe vibration at (approximately) 85 knots. He continued the flight, *(allowing)* a second aircraft to verify the nose landing gear was 'flopping around'. The pilot burned off fuel, and then landed with crash response at the airport. The aircraft nose settled upon landing, remaining on runway center. Damage was minor. The nose landing gear drag leg assembly had failed at the top end of the casting (P/N 002-820017-1). The metal broke apart—with indications it had been cracked for some time. This *(area)* cannot be inspected with the part on the aircraft."

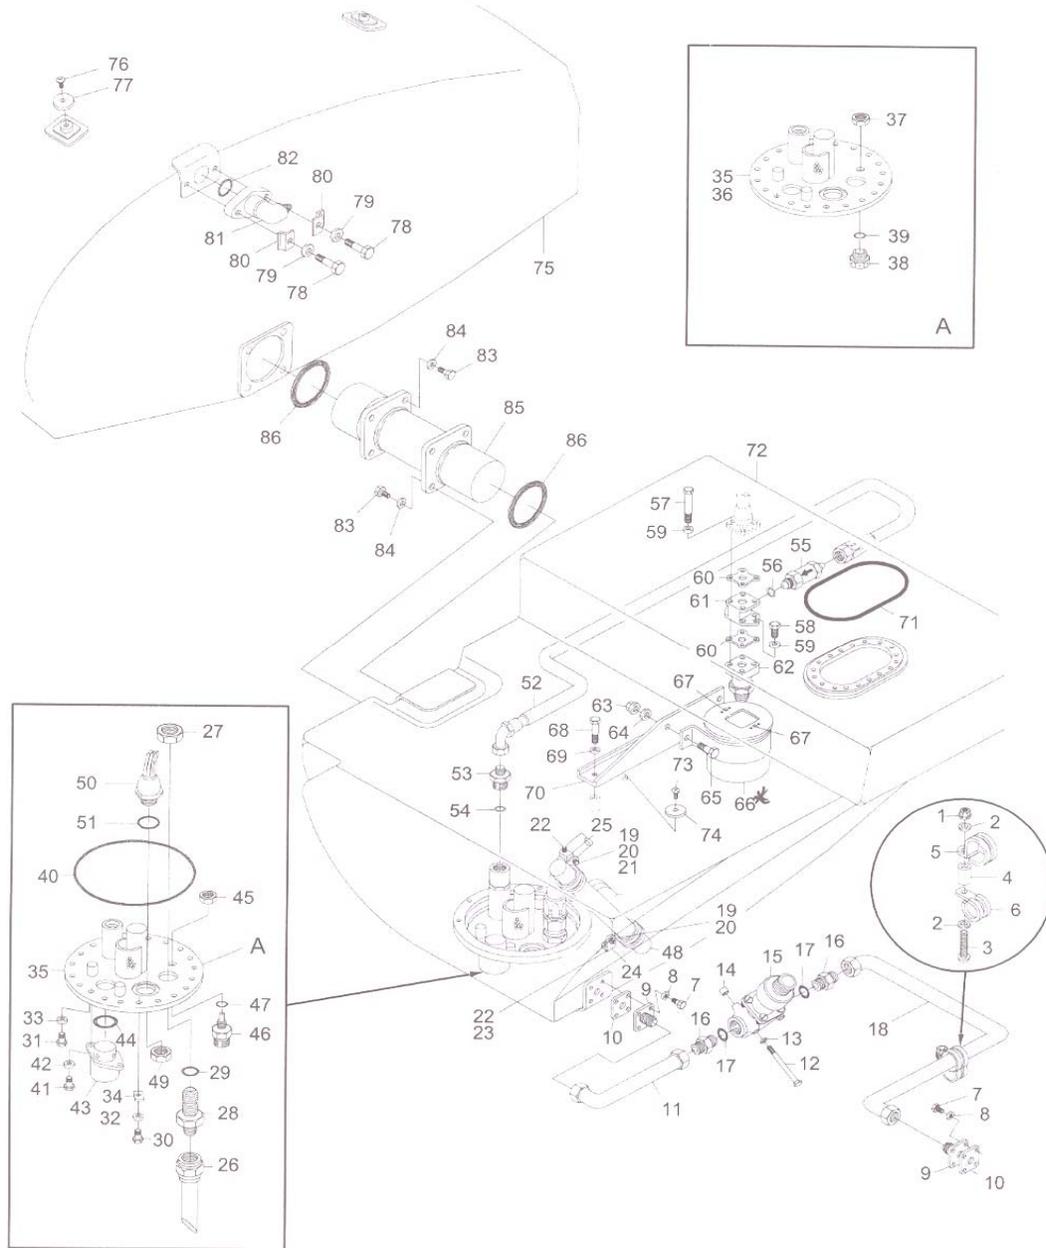
Figure 28-1003. Fuel System Installation and RH Fuel Cell

Bell: 430; Broken Fuel Screen Mounting Bracket; ATA 2821

A repair station submitter says, "A broken fuel screen mounting bracket was discovered by inspection when installing the fuel cell (ref. item 66; figure 28-1003; BHT-430-MM-4; P/N 222-066-624-101).

"This mounting bracket is a two part (*assembly*) and is attached to the screen housing by spot welding. These spot welds on one part of the bracket completely failed—the remaining spot welds on the second part of the bracket appear to have cracks in the area of the welds. This bracket and housing hold the engine fuel supply hose in place. Complete failure of the bracket could allow the supply line inlet to drift up in the fuel cell and lead to engine flame-out.
